# ARCHAEOLOGICAL IMPACT ASSESSMENT OF FOURTEEN BORROW PITS IN THE AURORA AND REDELINGHUYS AREAS, PIKETBERG AND CLANWILLIAM MAGISTERIAL DISTRICTS, WESTERN CAPE

(AIA conducted under Section 38 (1) of the National Heritage Resources Act  
as a freestanding AIA.)

**Jeffares & Green (Pty) Ltd**

17 January 2007

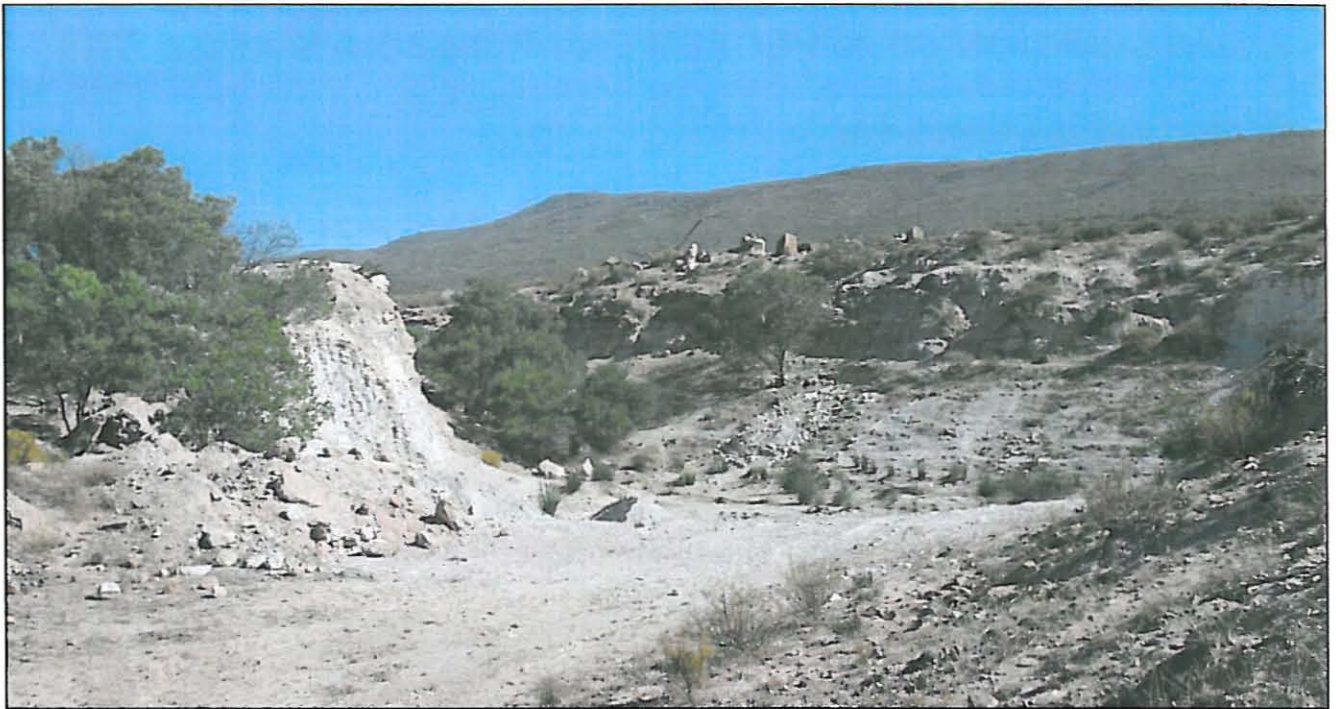
**Plate 2:** The existing borrow pit at MR531/54.44/R/30.

- **Archaeology:** Occasional quartz artefacts were noted in the flat area above the borrow pit and a moderate density artefact scatter (Site 1) was found stretching around the lip of the existing borrow pit.

- **Site 1:** This site lies between 32° 31' 19.9" S 18° 38' 00.2" E and 32° 31' 16.4" S 18° 37' 59.3" E. The artefacts are most dense at the first co-ordinate but a reasonable scatter is also present at the second. The scatter is of quite low density between the points and extremely low elsewhere. It is clear that the borrow pit was excavated into a small hill and that the people who occupied the area took advantage of the good visibility over the valley afforded by the high ground (Plate 3). The majority of artefacts were Later Stone Age (LSA) and made of quartz (Plates 4 & 5). Some silcrete LSA artefacts were also found. A few flakes and chunks of silcrete were almost certainly Middle Stone Age (MSA). Among the LSA artefacts was a probable adze made from quartz (Plate 6).

It is recommended that quarrying at the fourteen borrow pits be allowed to proceed but that mitigation actions be carried out at MR531/55.1/R/50 (Site 1) and MR531/63.9/R/150 (Sites 2, 3, 4 & 5) as outlined above. The cottage at OP585/0/L/320 should be avoided during excavation and damage to the tree line at MR534/25.65/R/520 should be kept to a minimum. Rehabilitation of the OP585/0/L/320 site, which lies immediately adjacent to Aurora is important.

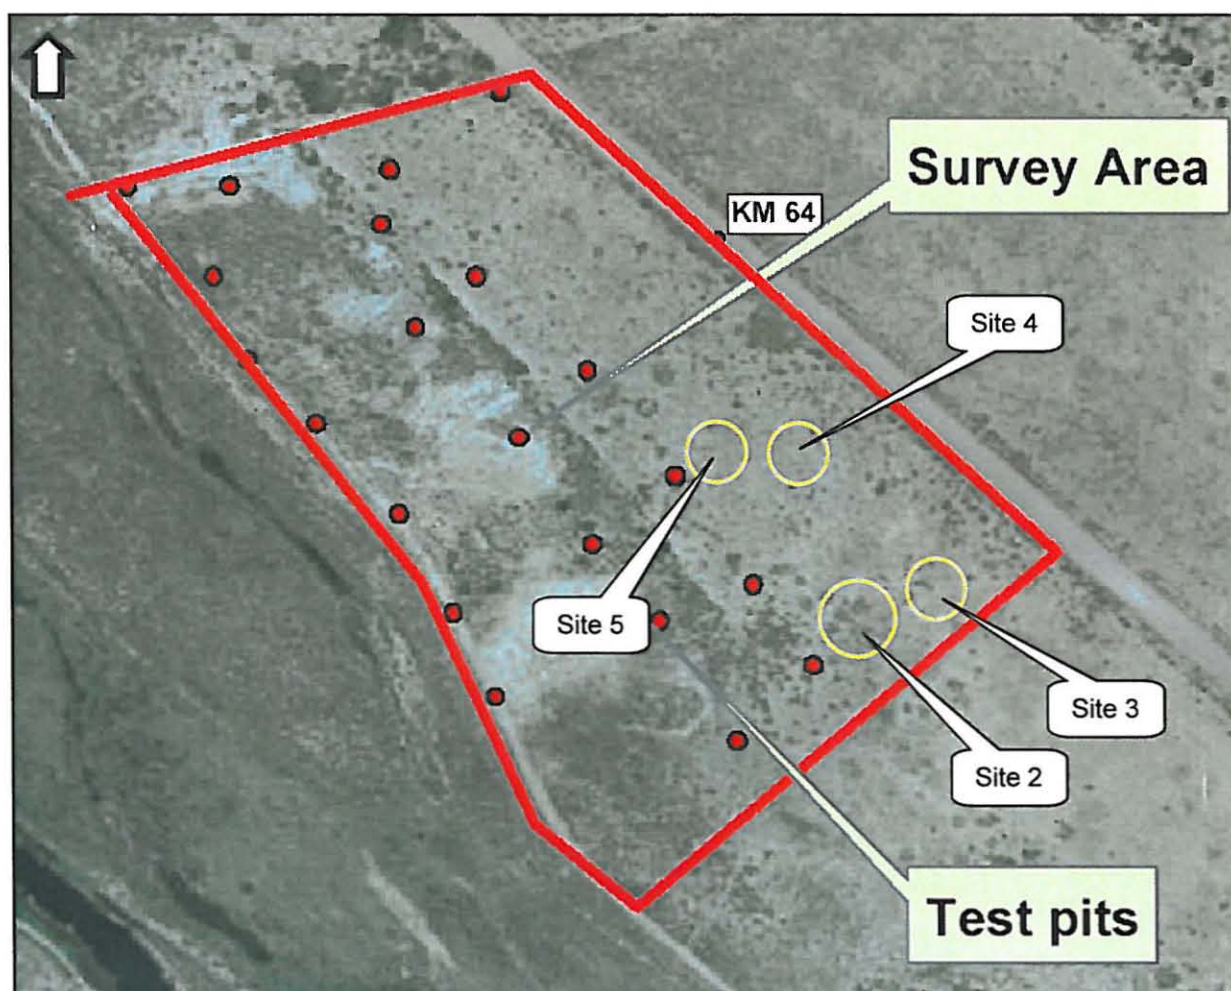
Figure 7: Aerial photograph of the surveyed polygon at MR531/63.9/L/200.

- Site 2: This scatter is located at 32° 29' 06.3" S 18° 33' 13.8" E and is just above the slope. It is a fairly extensive scatter of flaked artefacts with vein and crystal quartz, quartzite, sandstone and silcrete all present (Plate 9). No formal tools were seen but the site is clearly LSA. The densest scatter lies within a diameter of at least 30 m.

Those at Borrow Pit MR531/63.9/L/200 (Sites 2, 3, 4 & 5) are in a very sandy area and, given the prevalence of archaeologically significant deflation hollows within the general area (Manhire 1987), it is likely that the artefacts seen there originated in a deflation hollow that was ploughed flat during cultivation. The possibility still exists that further non-lithic finds could be present in the area and, given the high density of artefacts noted, sampling of these sites would be of value. It will be possible to sieve the sand here to maximise the amount of material collected but detailed spatial information is unlikely to be present. A 1.5 mm sieve is likely to be feasible here. Collection within large grid squares of perhaps 3 m by 3 m could serve to isolate any gross spatial information that may still be preserved. A single grid should cover the whole area.

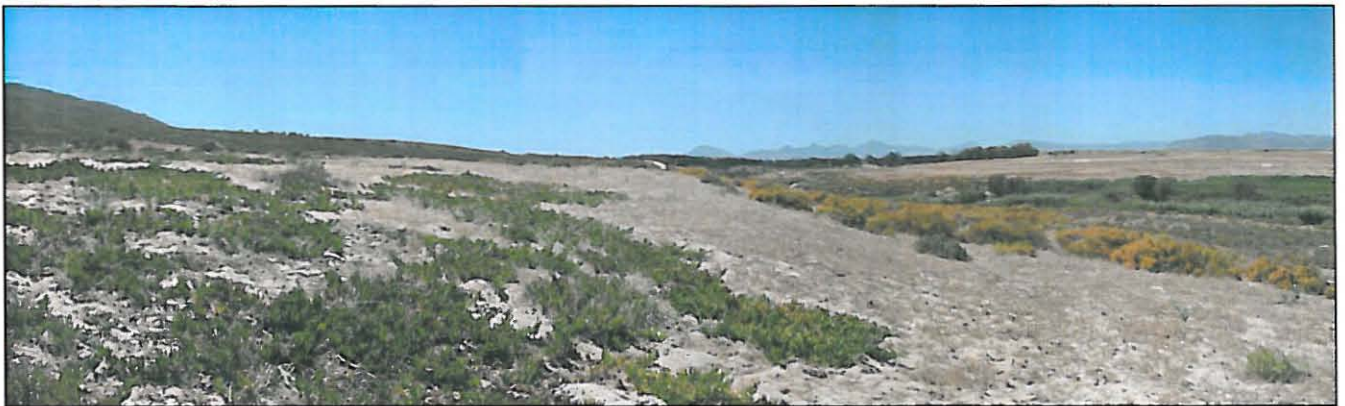
**Plate 8:** View towards the southeast showing the flat, sandy ploughed area to the left and the river and floodplain on the far right. The sites are located on the flat, sandy area.

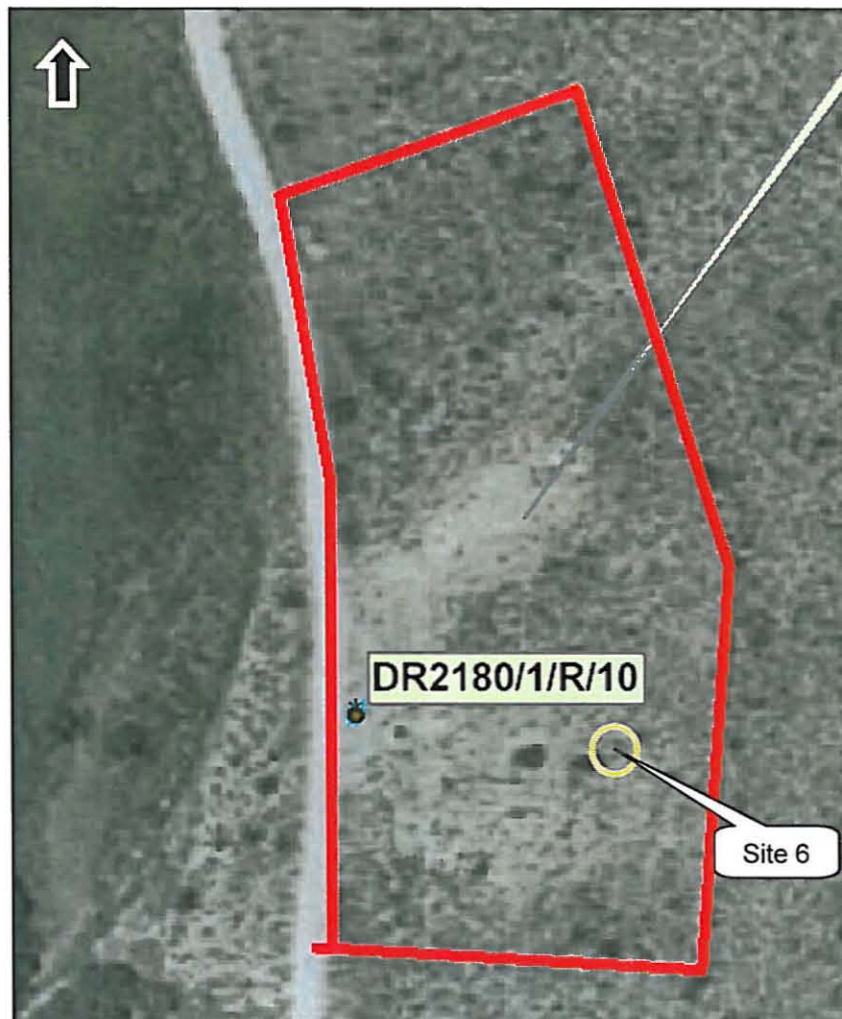
Figure 9: Aerial photograph of the surveyed polygon at DR2180/1/R/10.

- **Site 6:** The site is a tiny sandstone quarry located at  $32^{\circ} 27' 57.6''$  S  $18^{\circ} 33' 00.1''$  E. (Plate 13). It is likely that during the early years of construction in the area people wandered around the hills looking for suitable sandstone outcrops, probably those displaying sedimentary stratification. No more than about  $3 \text{ m}^3$  of rock would have been removed from the site. A small scatter of stone dressing debris lies just below the excavated area (Plate 14).

Only two historical sites were located within the surveyed areas. One, a small sandstone quarry (Site 6; DR2180/1/R/10), is of very low significance and requires no further consideration. The other comprises a small cottage of early-mid 20<sup>th</sup> century age (Site 10; OP585/0/L/320). It has been much modified and is not highly significant but should be avoided during quarrying operations. Care should also be taken not to damage it in any way. Should any need arise to remove this cottage then a permit would need to be applied for from Heritage Western Cape.

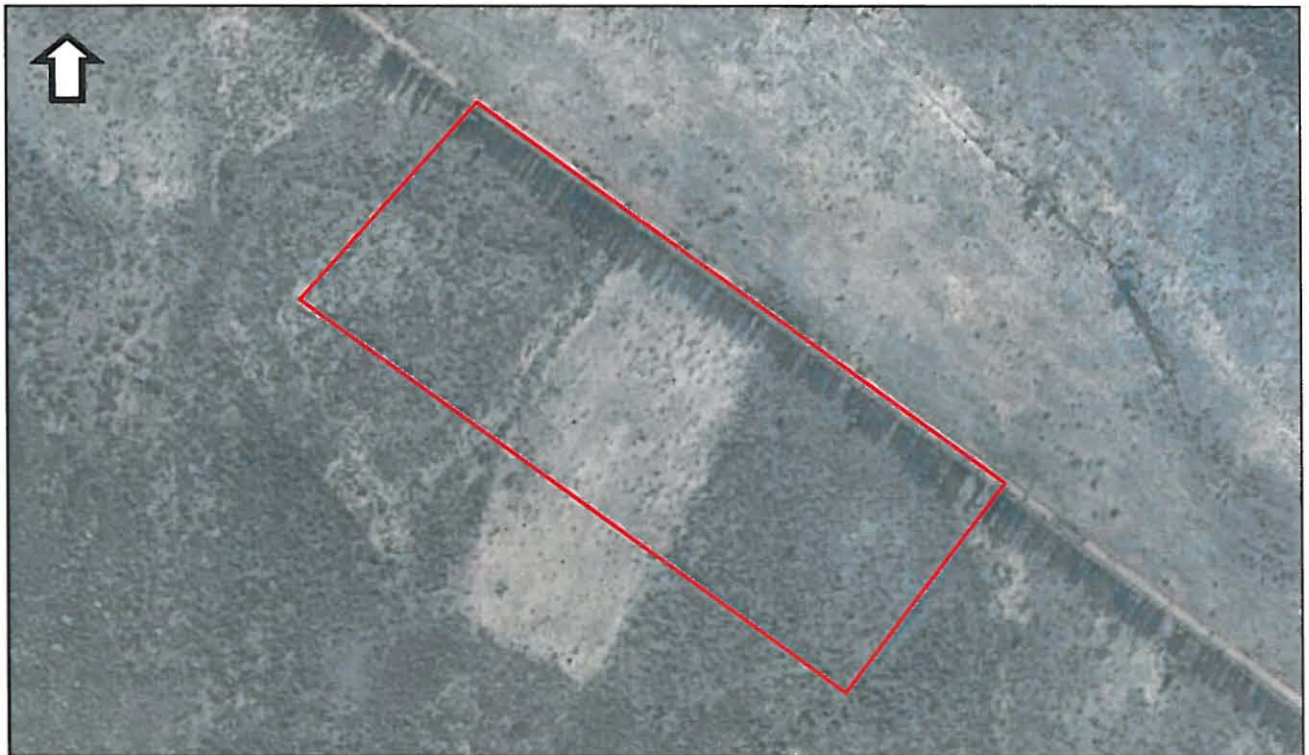
Archaeology: No prehistoric archaeology was seen at all. The only item of concern here is the line of pine trees along the road (Figure 13, Plate 20). These trees comprise an element of the cultural landscape although they may well only be some 40 to 50 years old. Unfortunately all the trees alongside the borrow pit location have been burned.

**Figure 13:** Aerial photograph of the surveyed polygon at MR534/25.65/R/5200.

One other cultural landscape feature was noted. This is the tree line at Borrow Pit MR534/25.65/R/5200. It is not very significant but it is suggested that it be avoided as far as possible during excavations. Unfortunately the tree line has already been damaged by the recent mountain fire that occurred in the vicinity.

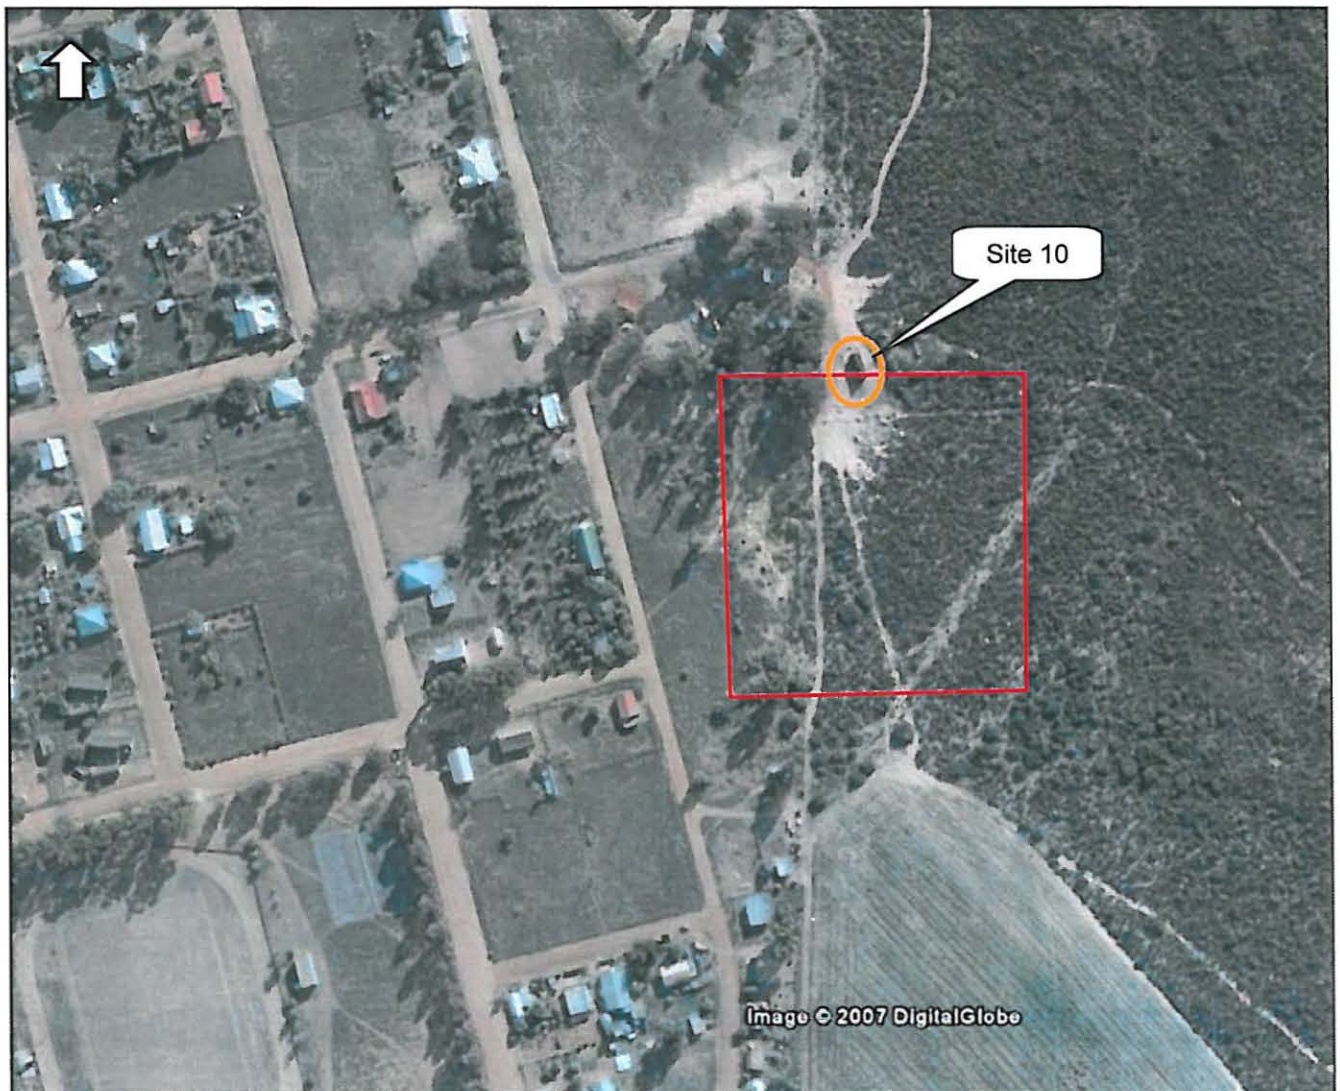
Archaeology: Only one isolated quartz flaked artefact was seen in a disturbed part of the surveyed area. A small cottage (Site 10), probably dating to the 1930's or 1940's is present on the northern boundary of the polygon (Plate 26). Given the proximity to the town and the age of some of the houses in it, the area also needs to be considered as part of a cultural landscape (Site 11).

Figure 15: Aerial photograph of the surveyed polygon at OP585/0/L/320.

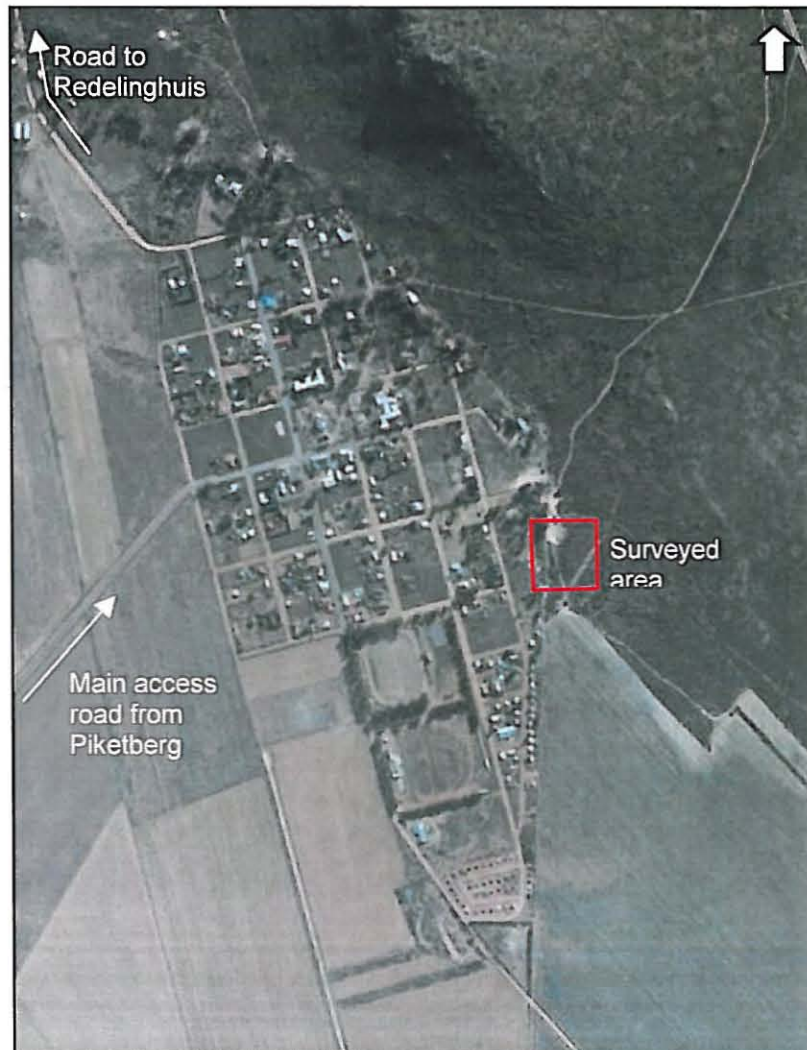
- **Site 11:** This is the rural village landscape of Aurora. Aurora is a small settlement covering approximately 1.0 km by 0.6 km. The built-up area is quite low density with fields and grassed areas in between the houses (Figure 16). The town is surrounded by farmlands on the southern and western sides and by indigenous fynbos to the north and east. Some 0.60 km east of the town the fynbos gives way to farmlands once more. The town contains several houses dating back to the early 20<sup>th</sup> century although some may be late 19<sup>th</sup> century in age.

**Figure 16:** Aerial view of Aurora showing the position of the surveyed polygon relative to the built-up area of the town.

Only one cultural landscape of significance was noted during the survey. This is the rural village landscape of Aurora (recorded as Site 11). Although there are many late 20<sup>th</sup> century buildings in the village, several early 20<sup>th</sup> century and possibly late 19<sup>th</sup> century buildings are also present (Plates 34 & 35). Most of these have been very well maintained although some modification is occasionally evident. Overall, though, the village area has good scenic and aesthetic value. In mitigation of impacts to this landscape care should be taken to rehabilitate the borrow pit after completion of quarrying so as to maintain and even improve the scenic value of that part of the town.

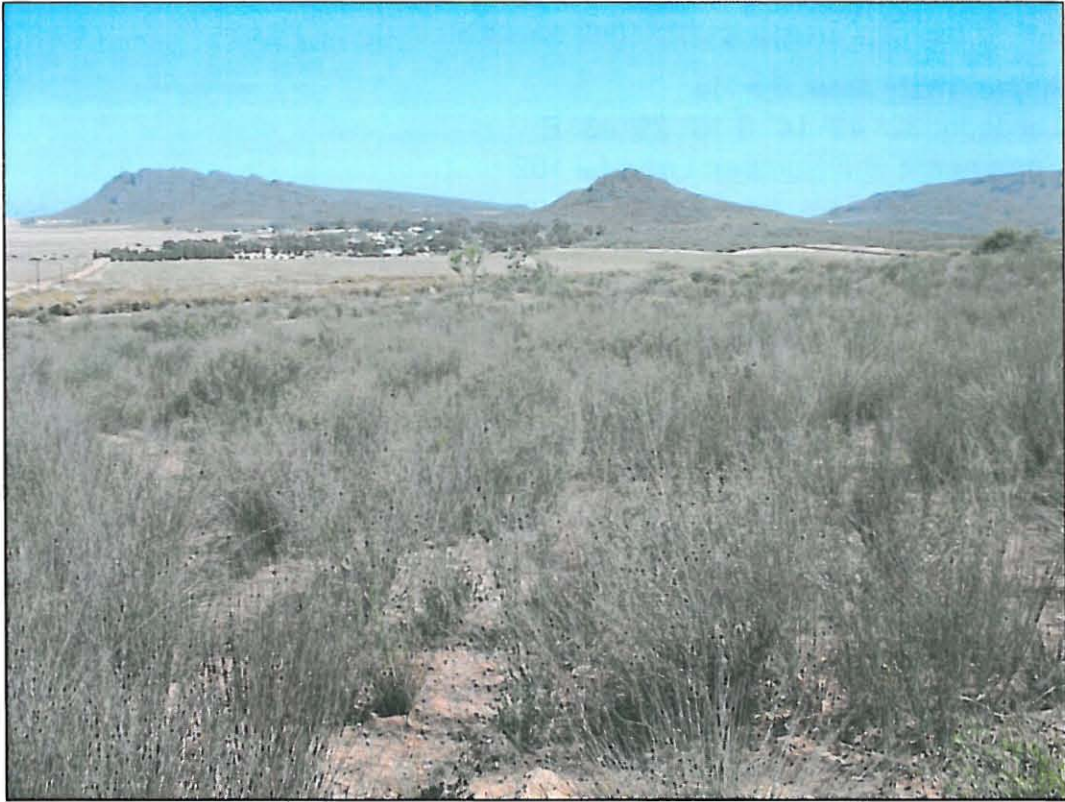
**Plate 27:** View towards the northwest showing the typical vegetation cover. The village of Aurora is visible in the background just more than 1 km distant.

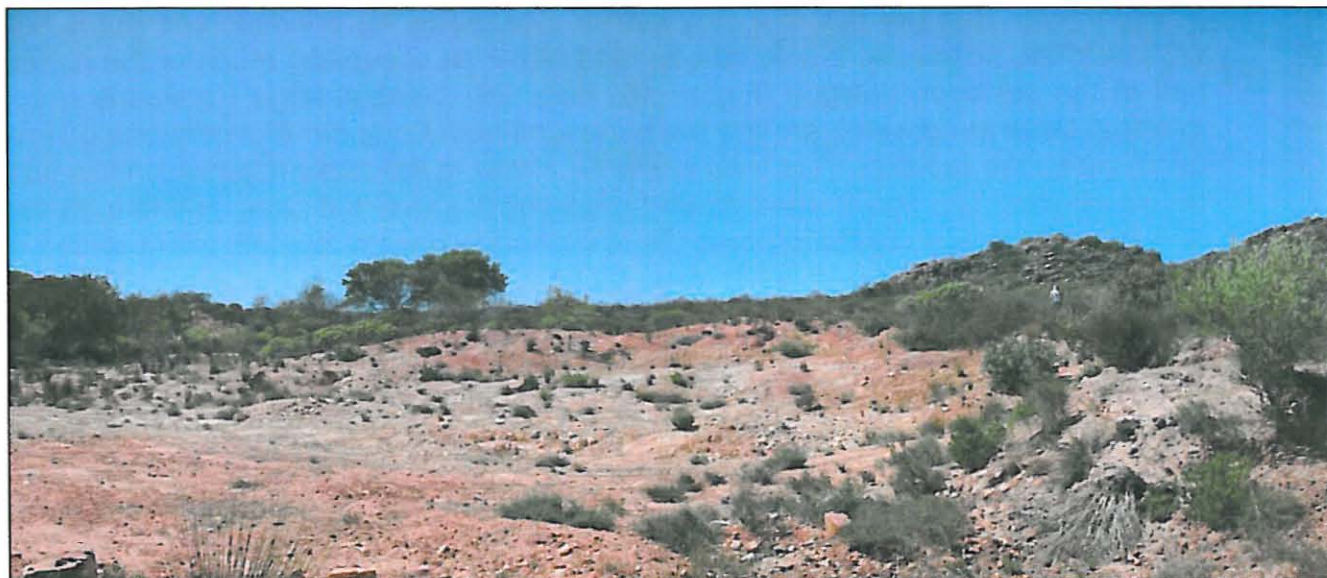
- Archaeology: As with the previous borrow pit, the close proximity to the rocky ridge has resulted in many random quartz flaked artefacts having been deposited in the area. One area of particularly high density was isolated as Site 12.

**Plate 29:** View towards the southeast showing the existing borrow pit as well as the eastern end of the rocky ridge in the background.

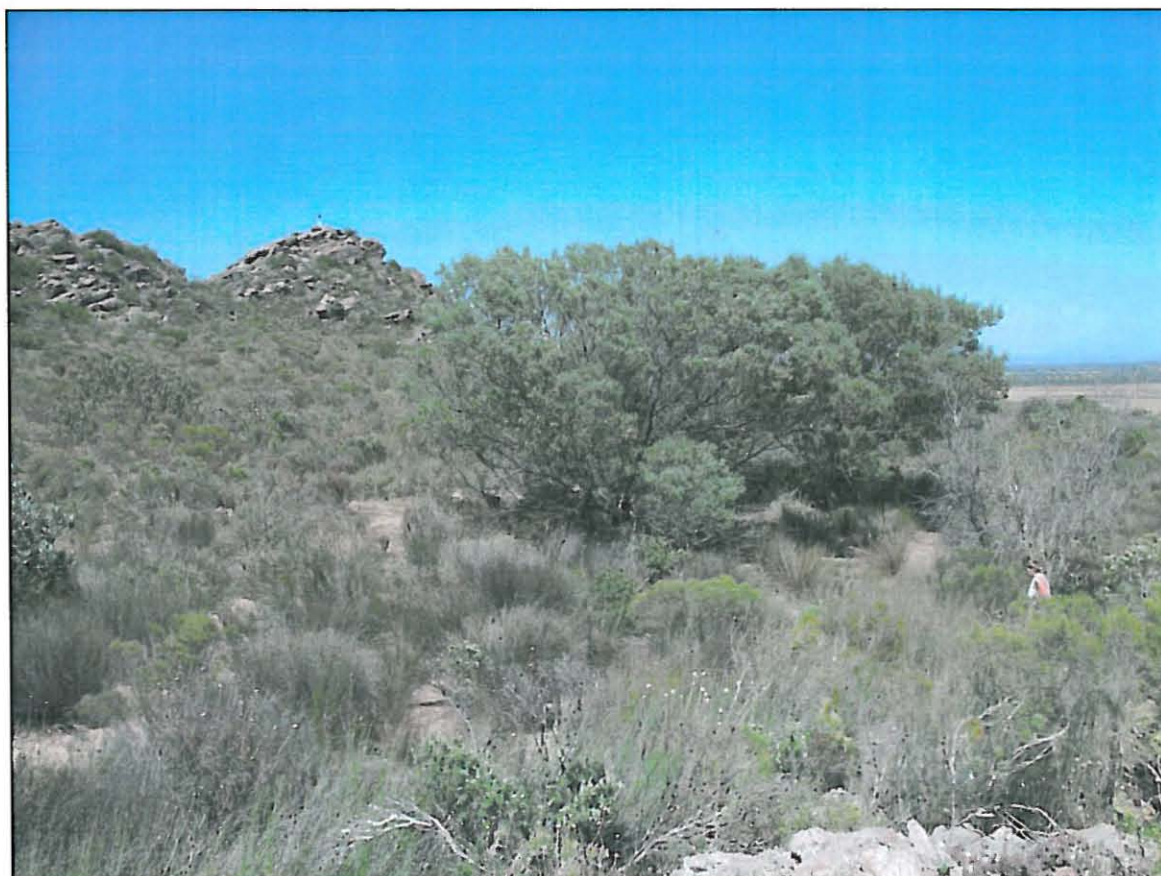
**Plate 30:** View towards the south showing the undisturbed part of the polygon as well as the rocky ridge in the background.

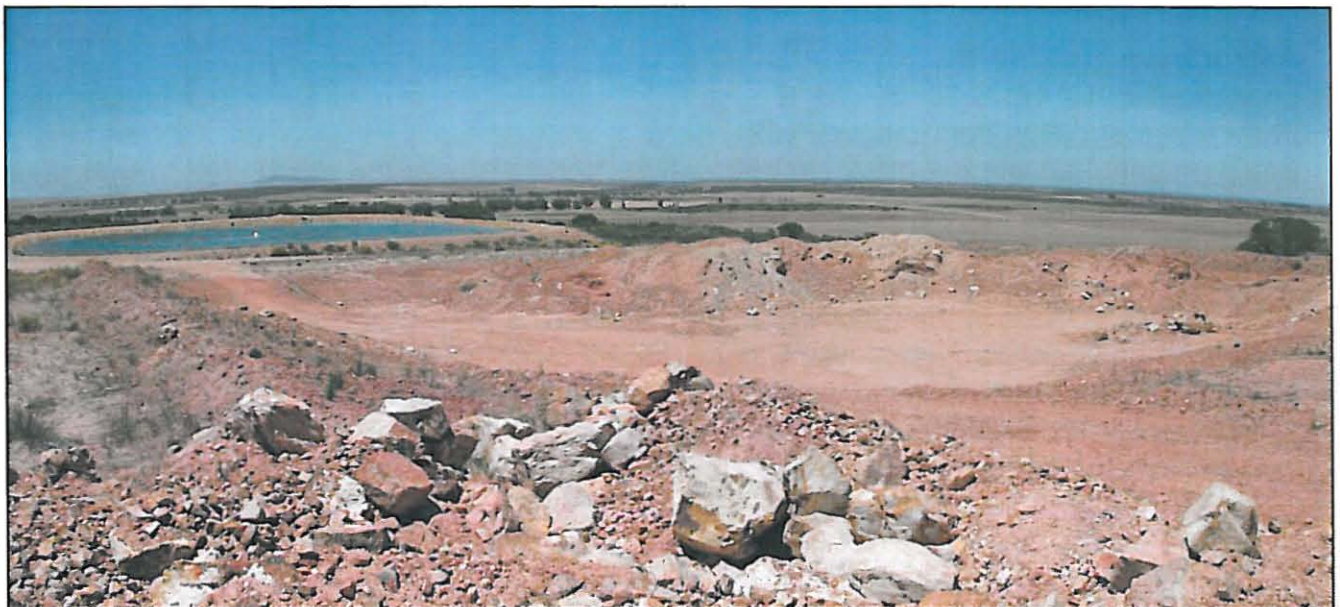
Environment: This area is quite flat and sandy. Not evident in the aerial photograph (Figure 15) is a large very recently excavated borrow pit occupying about half the survey area (Plate 32). It lies along the south-western side of the polygon. Several strips of land have also been ploughed and cultivated in the past (Figure 19, Plate 33) and occasional very small rocky outcrops are present in the area. Although much of the area was disturbed, those areas still containing indigenous fynbos were quite thickly vegetated offering limited visibility. The ploughed areas, however, gave a good indication of what might be present in the vicinity.

**Plate 32:** View towards the south from the middle of the polygon showing part of the recent borrow pit that has been excavated. The farm dam lies just outside the area.

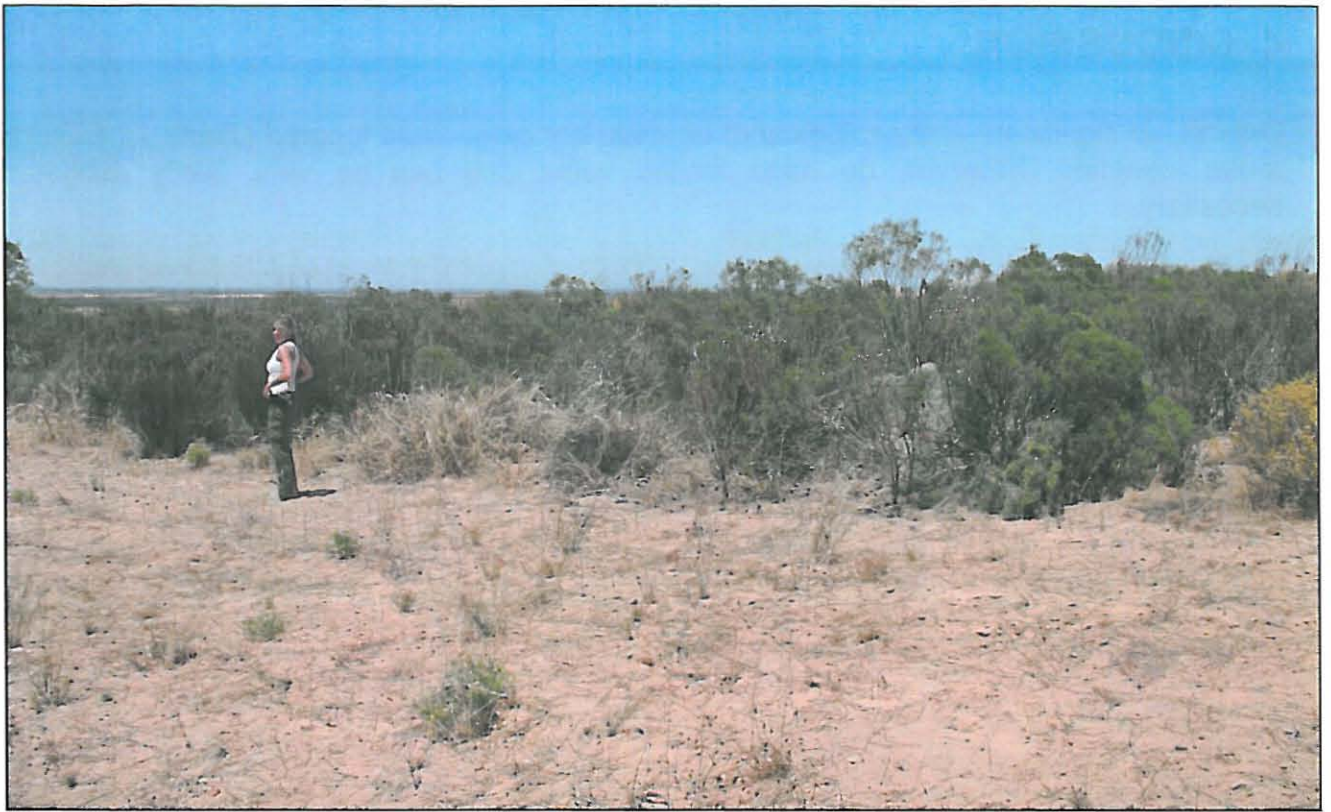
**Plate 33:** View towards the south showing the thick indigenous vegetation alongside one of the ploughed strips.
