HERITAGE IMPACT ASSESSMENT THE PROPOSED RAISING OF THE CLANWILLIAM DAM WALL, OLIFANTS RIVER VALLEY, CLANWILLIAM DISTRICT

Ninham Shand Consulting (Pty) Ltd
As part of an EIA

October 2005

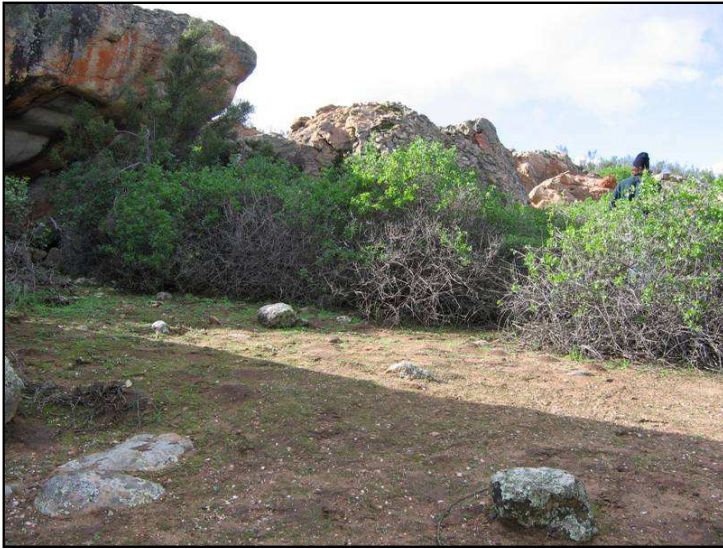
Plate 10: CDE5. The terrace area in front of the rock shelter has a dense artefact scatter on its surface. This terrace would quite likely have been the main activity area during occupation of the site.

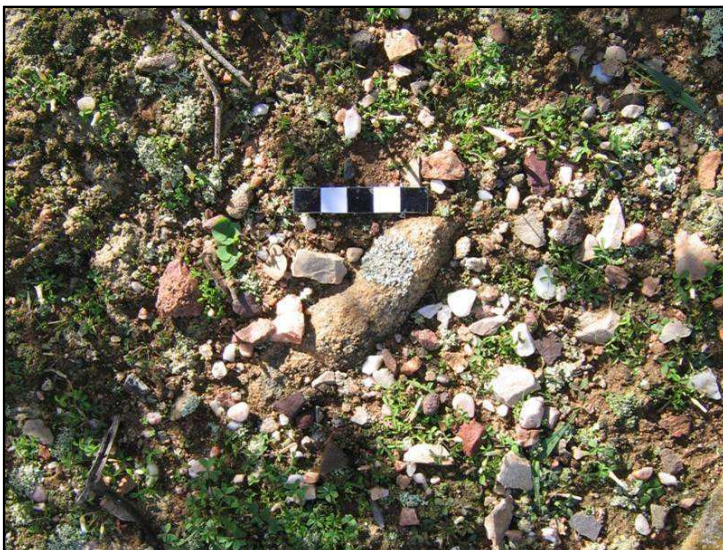
Plate 12: CDE5. A close up of the artefact scatter on the terrace pictured in Plate 9. The scatter on this terrace is particularly dense (scale in cm).

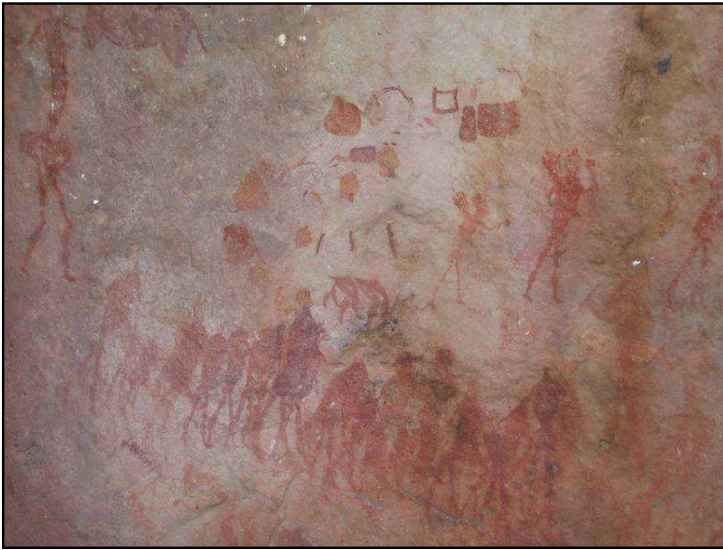
These six Later Stone Age sites are located in an area just to the south of the campsite and are all in close proximity to one another. Two important rock art sites are located here (CDE1 and CDE2). Most of the rock art at CDE1 is of relatively poor quality and sadly some has already suffered vandalism. However, a tiny panel depicting ten indigenous fat-tailed sheep has survived in the middle of the rock shelter wall (Plate 42). While fat-tailed sheep are not particularly uncommon, we consider the painting of a whole flock to be extremely rare. Site, CDE2, contains a large group scene containing many figures, bags and other motifs (Plates 14 & 19). Again, paintings of group scenes are not particularly uncommon, but the spectacular preservation of this painting makes it unique. Both paintings have been executed in immaculate detail and there is no doubt that they are both highly significant in terms of the local spectrum of rock art.

Plate 19: CDE2. An example of an almost perfectly preserved rock painting. This group scene consists of numerous human figures as well as various other objects including bags. An eland torso can also be seen in the upper left hand corner. Various shades of red and orange are still visible but all traces of white have disappeared. The rock shelter containing this painting is shown in Plate 8.

- Three rock art sites will be difficult to mitigate successfully as their removal from their natural surroundings is recommended. This will involve physically removing the painted panels of rock by judicious and expert use of explosives or diamond saw cutting. It is likely that expertise from outside of the country will be needed to assist with this.
- Some of the historical sites will need substantial and detailed historical research incorporating oral histories and archival work. To this end, records of the Superintendent General of Education and the various missions that have worked in the area might be helpful. Specialist historians should be employed to work on the study.
- The graves will need a full public participation process prior to any disturbance and a suitable location would need to be established for their re-interment.

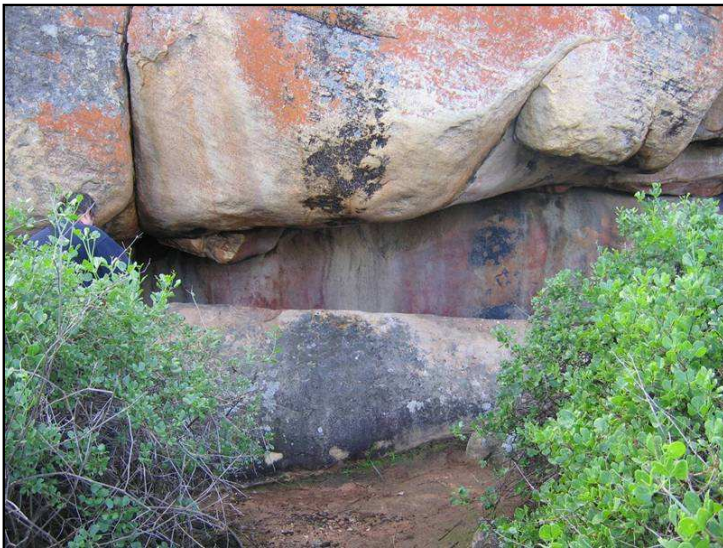
Plate 20: CDE2. The protected location of this unique painting beneath a rock overhang and behind a boulder has resulted in its near perfect preservation. The panel depicted above is located on the left hand side of the recessed surface. More paintings are present on the central and right hand portions of the wall.

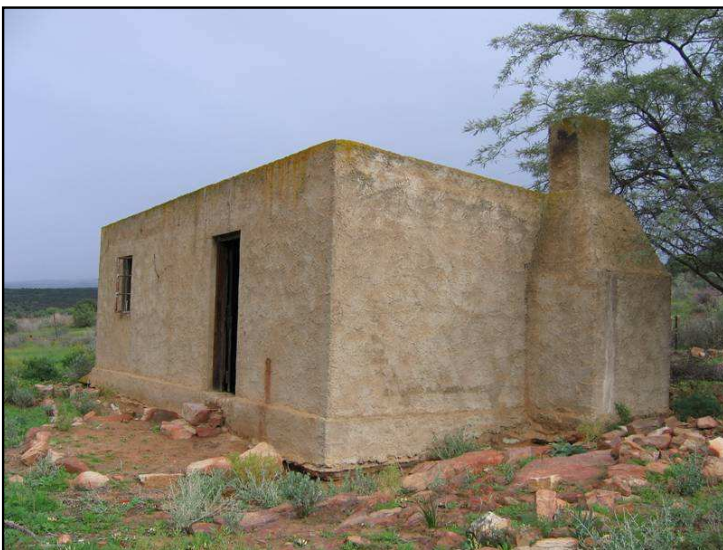
Plate 24: CDE16. An example of a presumed late 19th century dwelling that is now abandoned. Several other features related to this little workers house are to be found in the immediate area.

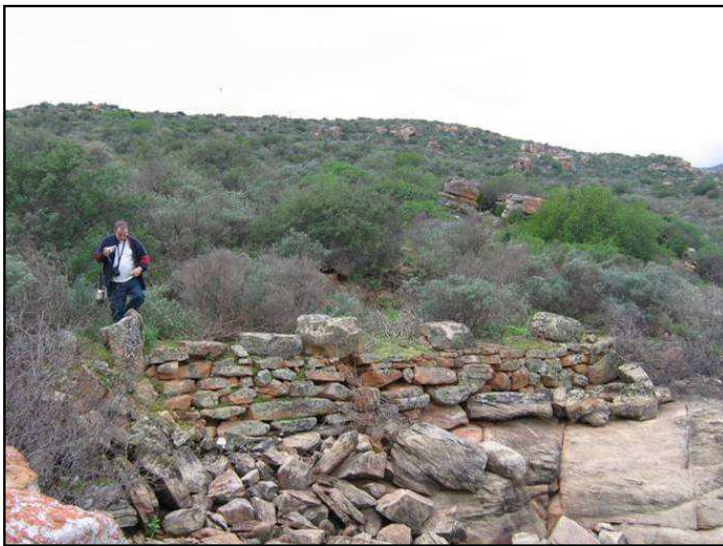
Plate 26: CDE08. This section of dry stone retaining wall on the 1860 road is located immediately alongside the current full supply level. It supports the road from beneath.

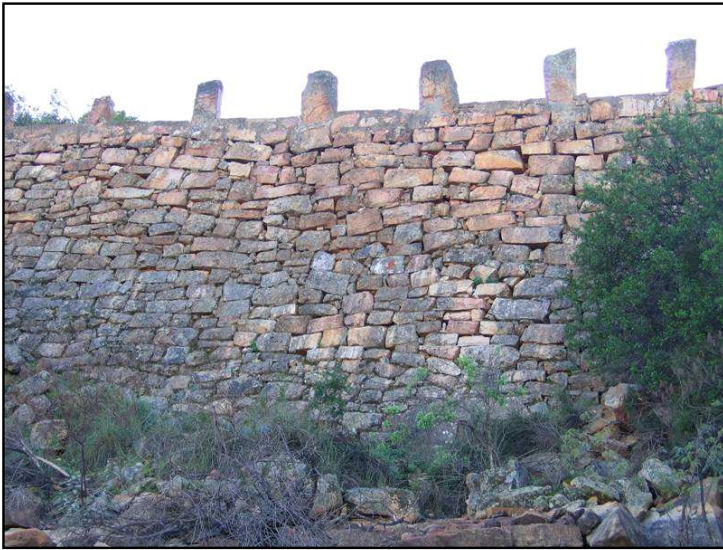
This road (Plate 30 & 31) is of special significance since it has far wider value than most heritage resources in the area. The loss of this road will affect access to farms, remove a drive with high scenic value and impact on tourism and tourism potential in the area. Unfortunately loss of the road is un-mitigable, short of the proponent devising an alternative route with similar visual qualities and tourism potential.

Plate 30: CDE14. At this point a large retaining wall had to be built to support the 1930's road as it traversed a steep section of the valley.

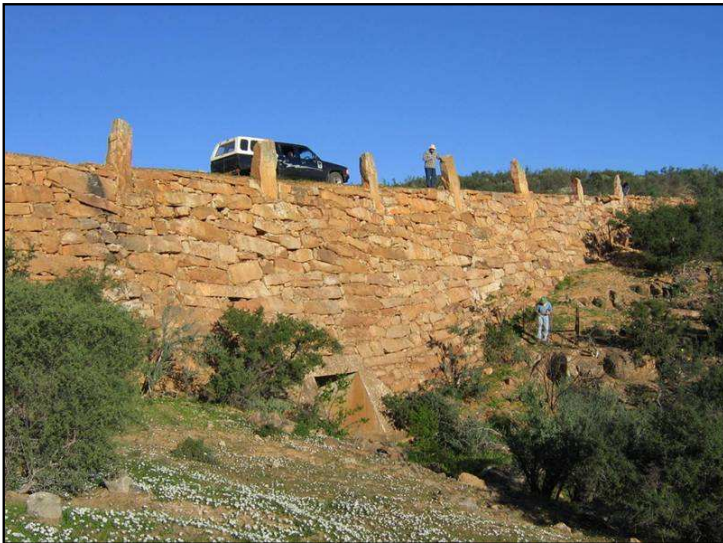
Plate 31: CDE31. Another section of the 1930 road built up with a retaining wall. This section crosses a small river valley and had to have a concrete culvert inserted at its base. Such culverts were very commonly employed along the length of the road.

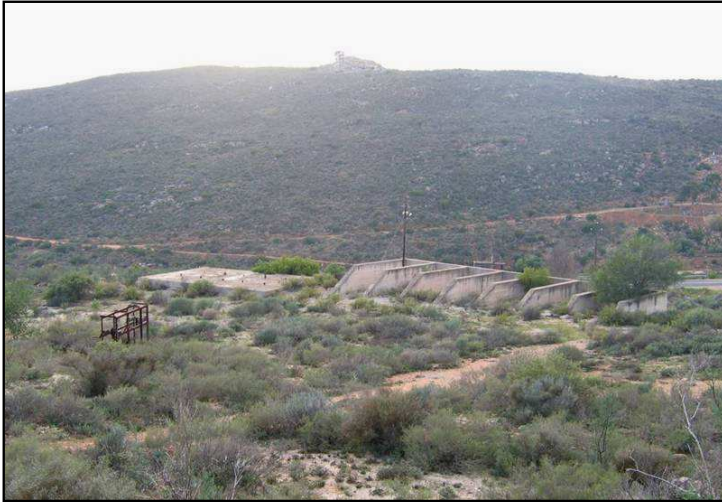
Three areas were identified to contain features classified as industrial infrastructure. These all pertain to the original construction of the Clanwilliam Dam in the 1930's. They include the dam wall itself (Plate 32), the construction site area (Plate 33) and an area assumed to have been the labour compound (Plate 34). The construction site and compound contain numerous foundations of buildings, sheds and plant bases scattered over a wide area.

The dam was built in the early 1930's, making it greater than 60 years of age and hence protected under Section 34 of the NHRA. One of the machine bases at CDW1 has the date 19.1.33 inscribed on it. The wall was raised slightly in 1966 when the upper portion and sluice gates were added. The newer concrete can be seen in Plate 32.

Plate 33: CDW01. This site comprises the construction area of the Clanwilliam Dam. It contains various structures and machine bases and is located immediately to the west of the dam wall. A date of 19.1.33 is inscribed on one of the structures.

present operation aspects of the dam be video/photographed. It is also strongly recommended that a small visitor's centre be established that interprets the history of the dam and Olifants River Irrigation Scheme, acknowledges the engineer involved in its original construction as well as the ecology of the Olifants River system.

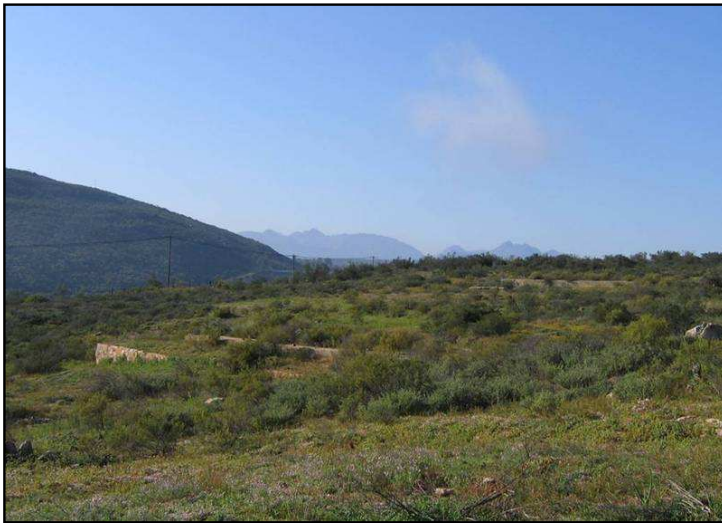
Plate 34: CDW56. This area contains several concrete foundations and retaining walls and is thought to be part of the labour compound from the building of the Clanwilliam Dam.

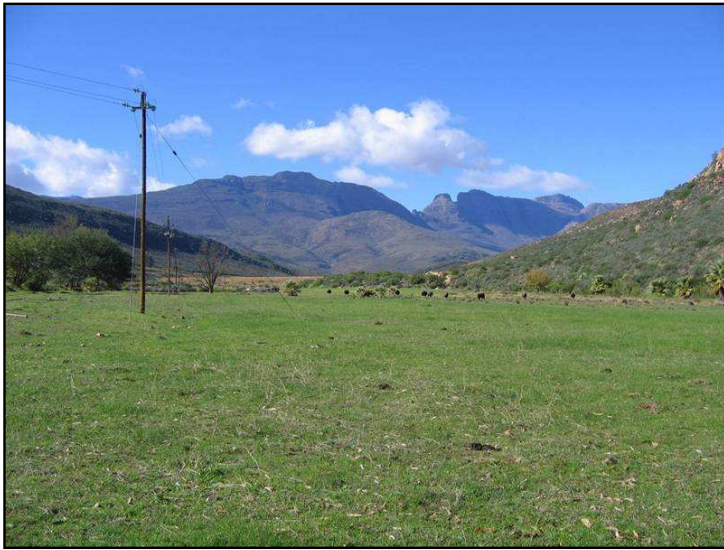
Raising of the dam will impact existing agricultural landscape, especially at Rondegat, Kriedokrans and Andriesgrond - Olifants Dam where a number of orchards will be lost.(e.g. Plate 36). Fruit farming has taken place in the valley since the 19th century – loss of orchards does affect the identity of the area.

Plate 36: CDE21. This cultural landscape is located just to the east of the low water bridge leading to Algeria. It is still fully functional and has not been impacted on by the current dam as many other farming landscapes have.

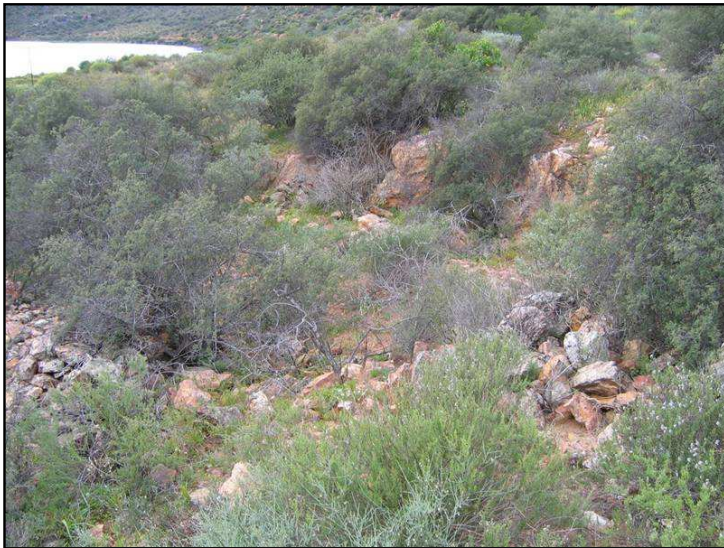
Numerous small quarries are present along the length of the east bank the Olifants River (e.g. Plate 37). These are associated with various episodes of road building in the years since 1860..

Plate 37: CDE47. An example of a small quarry occurring alongside the 19th century road. Numerous such quarries are present near to both this and the 20th century road that is still currently in use today.

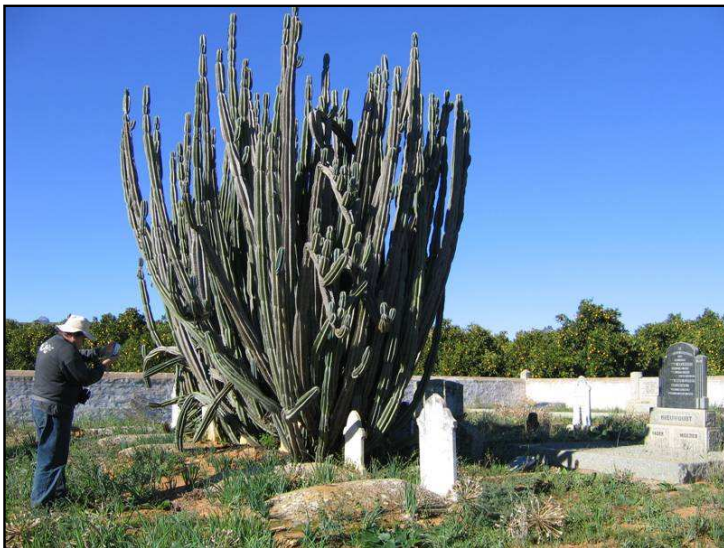
A family burial ground at Rondegat (Plate 38) and a single grave at Holfontein are the only clear locations containing human remains found. The Holfontein grave dates back to 1935 while the burial ground at Rondegat contains at least fifteen formal graves (several of which contain more than one individual) with engraved headstones or only marked with sandstone rocks at the head and feet (Plate 39). It is estimated that there are at least 30 people buried there;

This site is the Rondegat Graveyard (Plates 38 & 39). Although not specifically protected under Section 36 of the NHRA (it is protected by other legislation), it contains graves in excess of 100 years old and is certainly part of the cultural heritage of the area. The names on the headstones include Nieuwoudt, Van de Merwe, Smit, Raad, Van Wyk and Du Plessis. At least five of these names are known to us as being still associated with farms in the Cederberg and Oliphants River Valley and it is therefore clear that this graveyard was, and still is (the most recent grave is dated 1995), an important place for the local farming community. Furthermore, some graves are marked only by sandstone head- and footstones suggesting that these are of lower status or greater antiquity.

Plate 38: CDE22. The Rondegat graveyard contains approximately 20 graves, probably representing some 30 individuals.

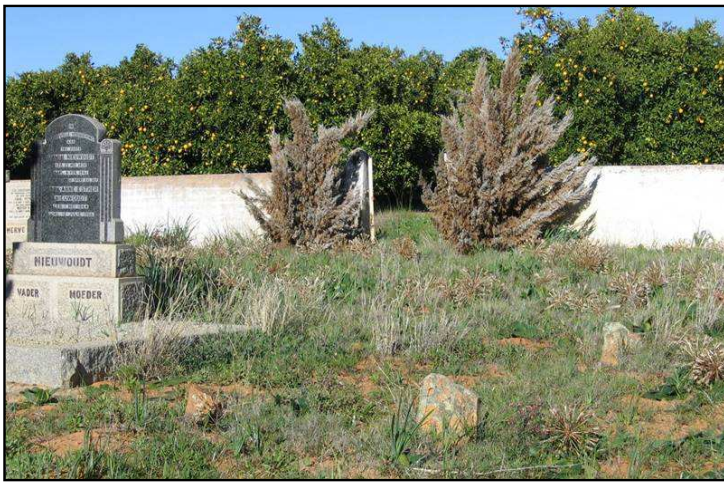
Plate 39: CDE21. Both the formal engraved headstones and the less formal sandstone head- and footstones can be seen in the Rondegat burial ground.

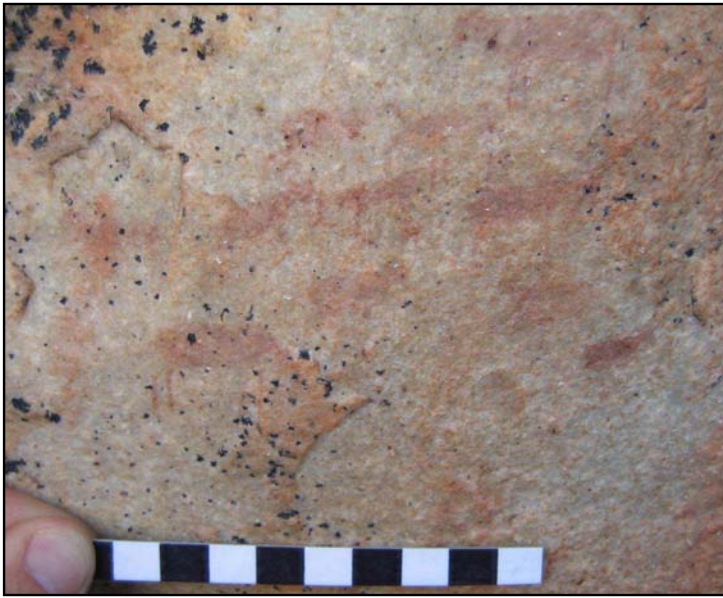
Plate 42: CDE1. This photograph illustrates the very unique and tiny flock of ten fat-tailed sheep painted at this site. The scale is in cm.

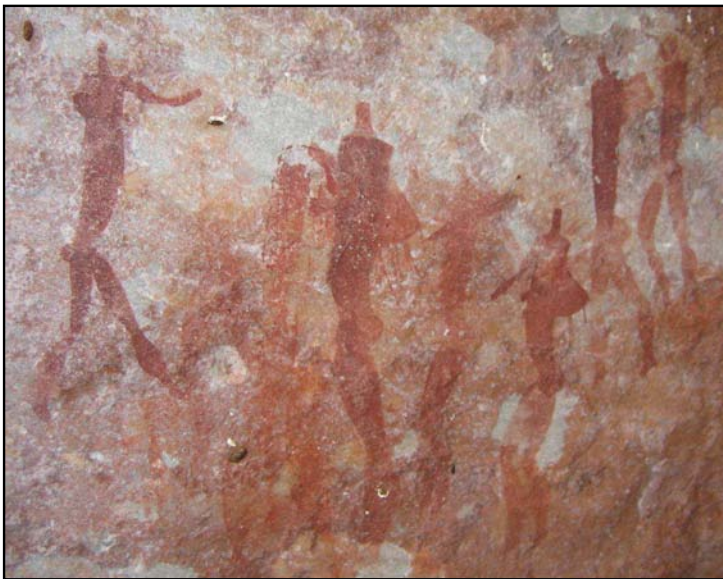
CDW10 is a rock art site with a large number of images, mostly in an excellent state of preservation. The art depicts a number of human figures, both male and female, several bags with detailed tassels and a number of other images (Plates 43 & 44). Animals are rare. The subject matter is not uncommon but overall the two panels, split by a natural fissure in the rock wall, are among the most spectacular in the Oliphants River Valley, being created with great attention to detail. As such they certainly deserve conservation.

Plate 43: CDW10. A detail of the main rock art panel showing human figures, some carrying tassled bags.

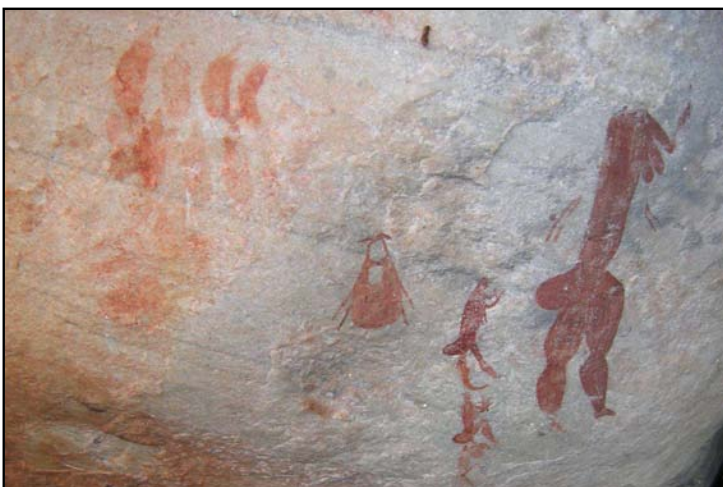
Plate 44: CDW10. These images are located just below the main panel and show human figures, a tassled bag hanging on a peg and several other shapes.

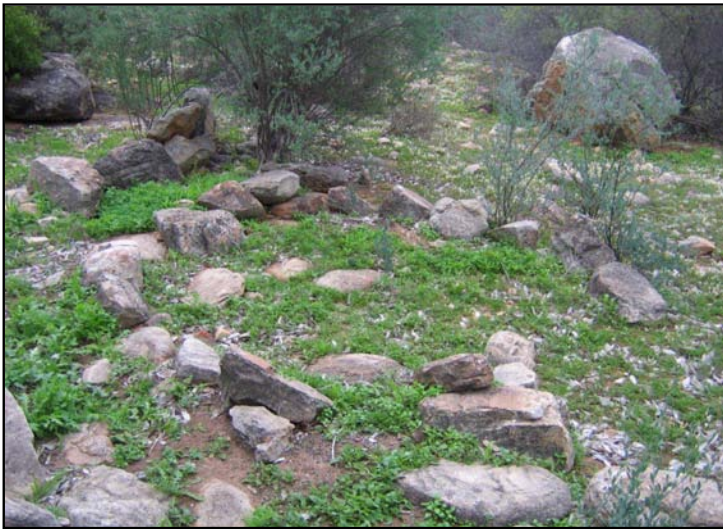
CDW11 contains a prehistoric kraal (Plate 45) complete with a smaller "lammetjie kraal" (Plate 46) near its entrance. Prehistoric kraals are seldom seen in the south-western Cape.

Plate 46: CDW11. Here the small circle of the “lammetjie kraal” can be seen. This lies at what appears to be the entrance to the main kraal.

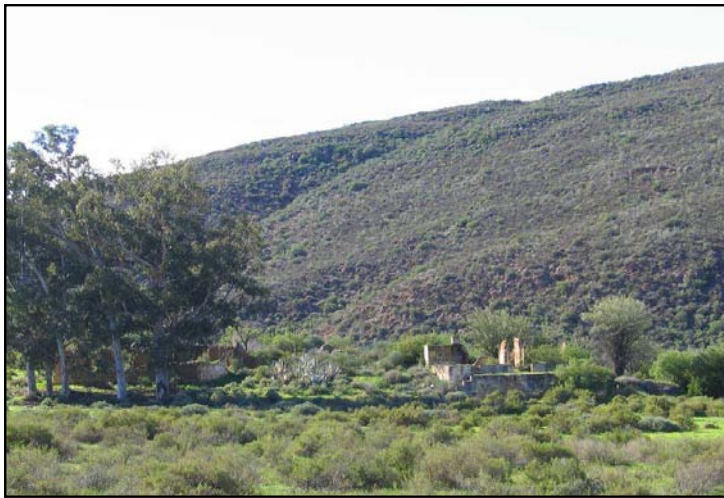
This site consists primarily of five closely related structures (CDW13) (Plate 47). One is said by the current landowner (Mr Du Plessis) to have been a school and another, the house of the principal. Although the structures are in a poor state, it is our opinion that they hold the potential to yield far more information than is evident from their physical examination. Related to the building complex is a grave (CDW15) (Plate 48) which adds to the significance of the area.

Plate 47: CDW13. The two main structures of this complex, the school and the principal's house, can be seen here.

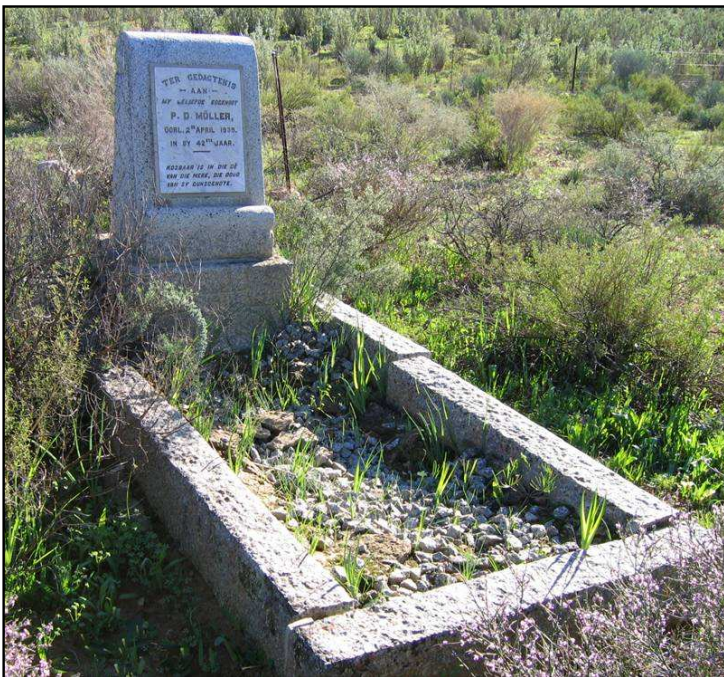
Plate 48: CDW15. This single grave lies just north of the school complex (CDW13) and is dated 2 April 1935. The remains are those of a P.D. Moller.
