Addendum to the

1st phase H.I.A. of a proposed upgrading and extension of the proposed storm-water management project at Venetia Mine, Limpopo Province, South Africa

For De Beers Consolidated Mines (Pty) Ltd.

Project number DEB-VEN-21-02-03

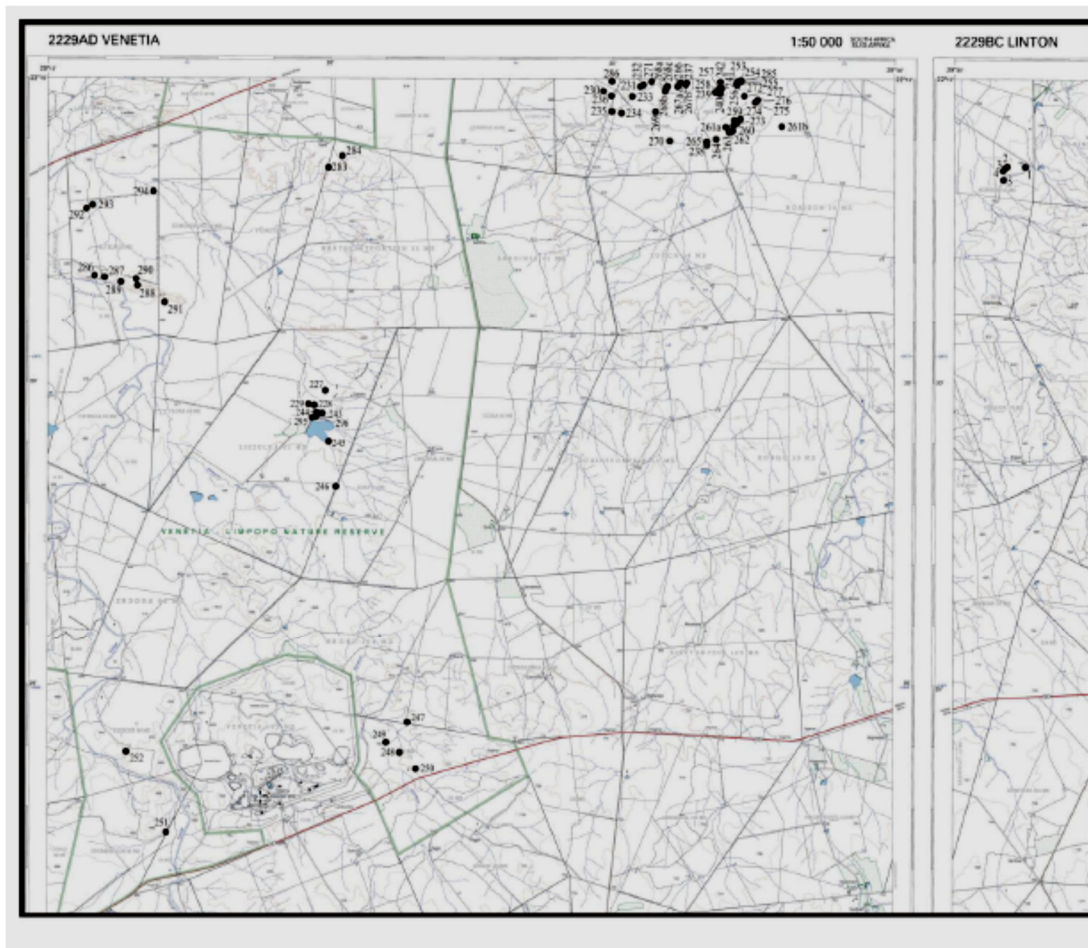
Fig. 03. The hypothesis of settlement distribution in relation to geology and vegetation is then also underlined by this map kindly supplied by Tom Huffman which is the result of years of research in the Vhembe district by the Wits Department of Archaeology (Map Tom Huffman.¹)

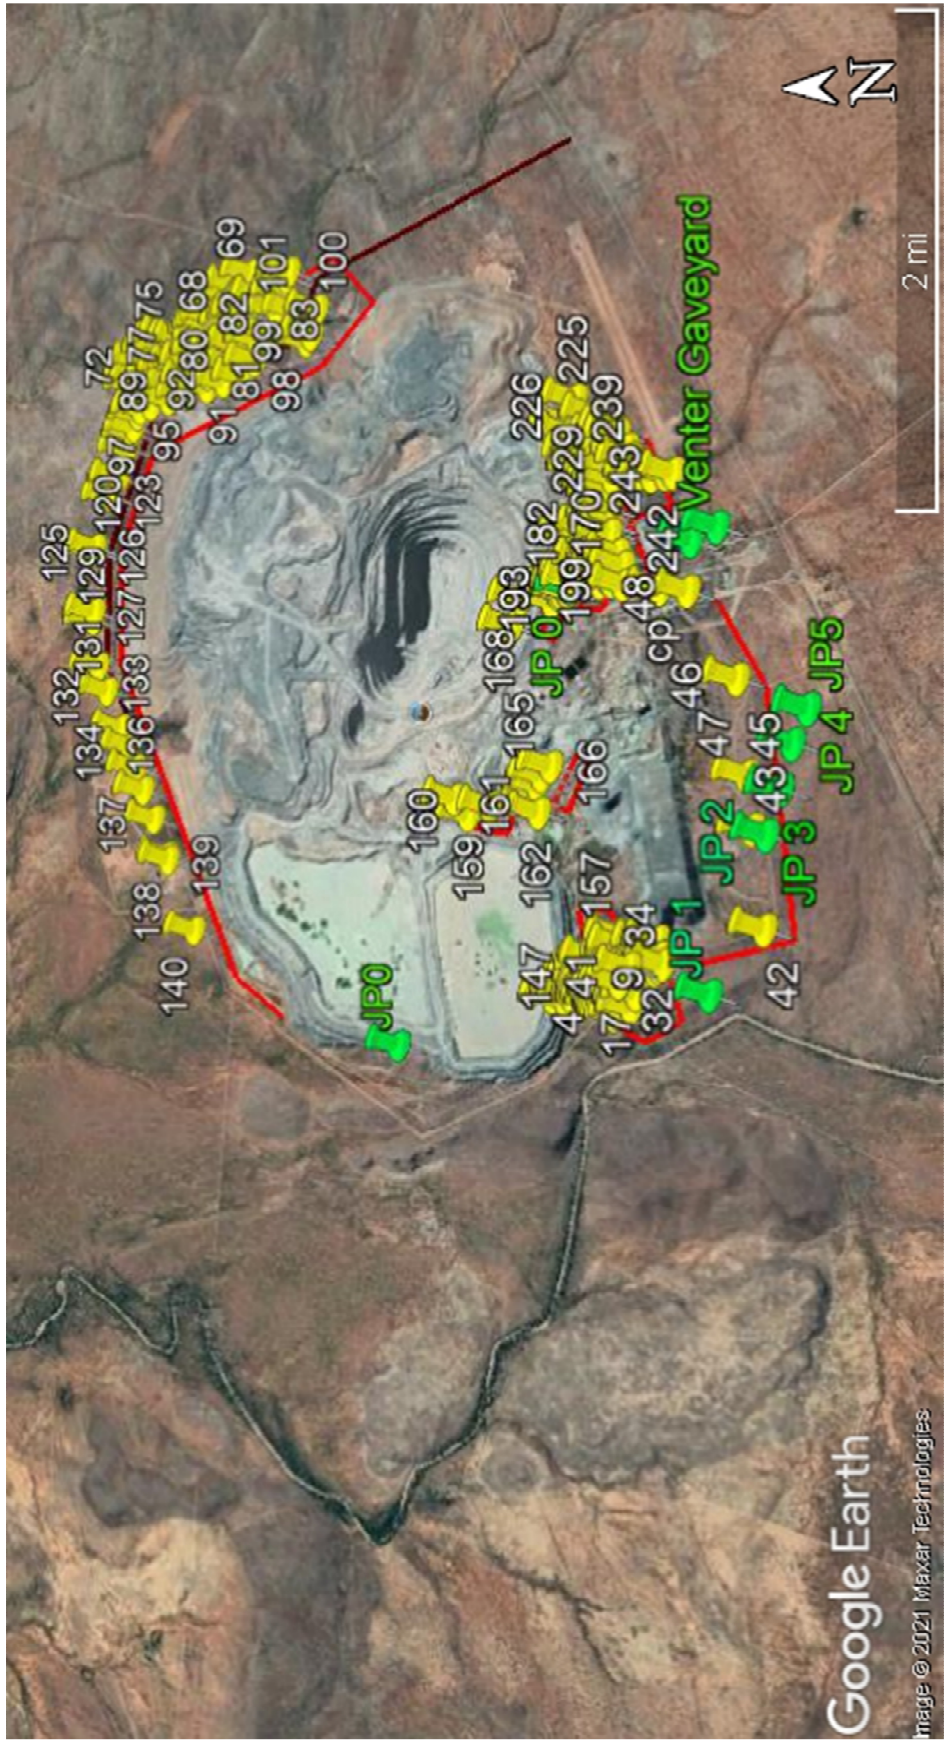
Fig. 06. All the points visited during the investigation marked by four dimensionally verified photographs. (Google Earth 2020.)

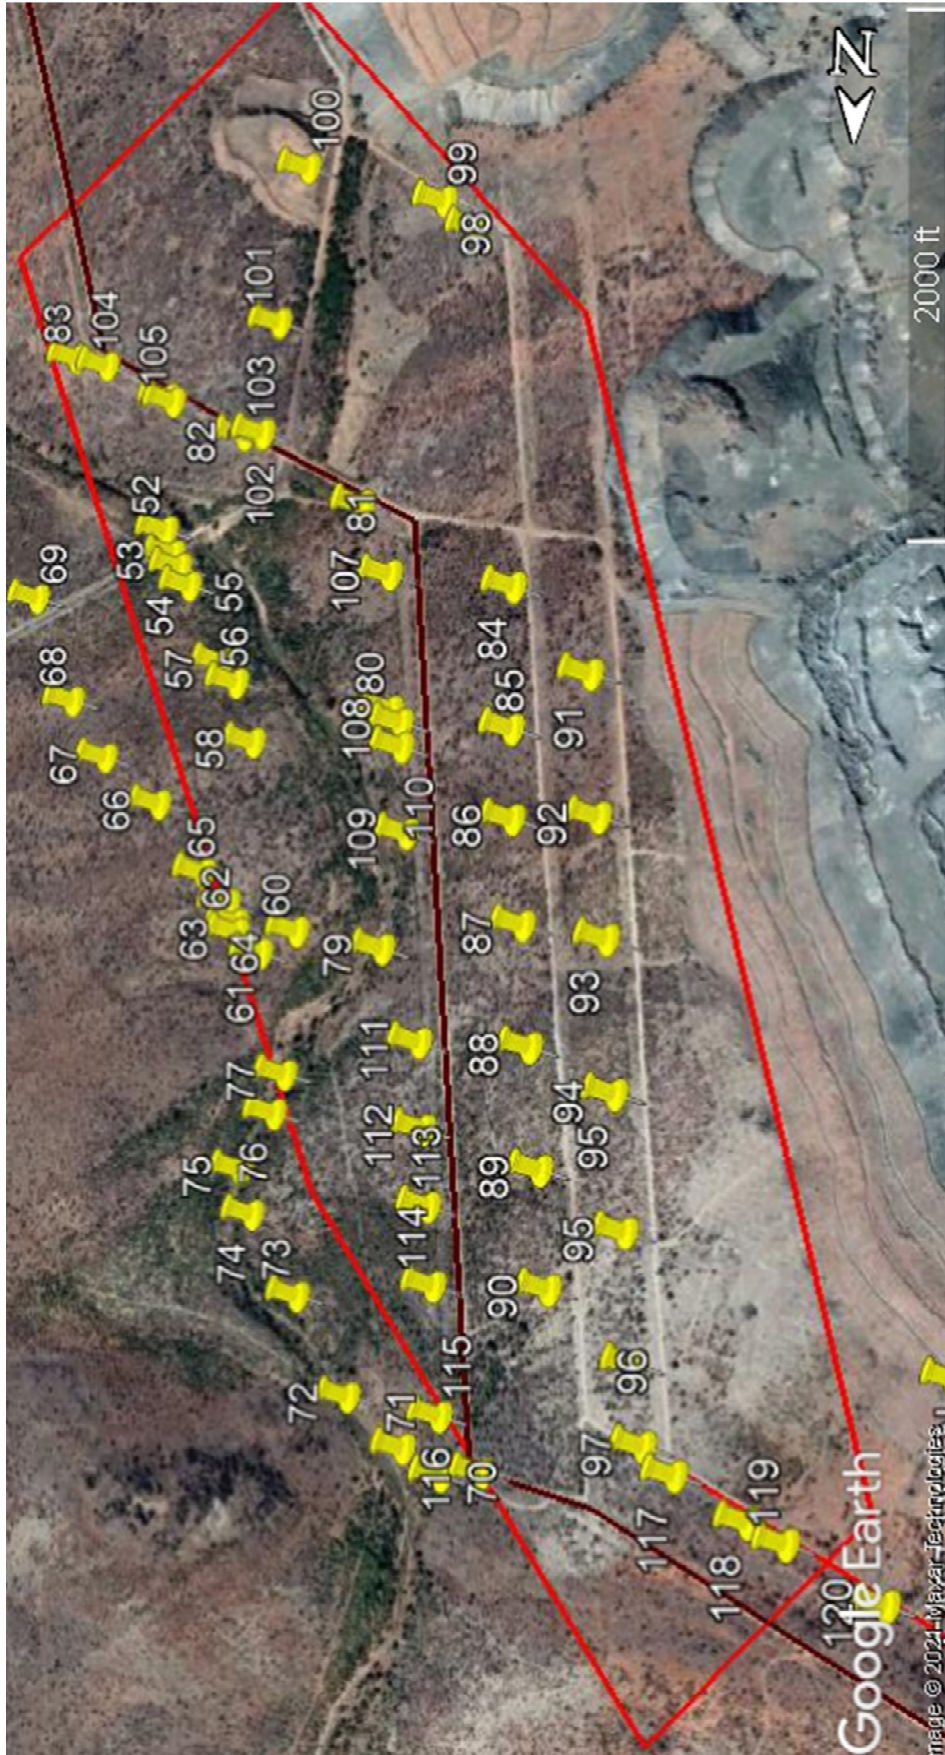
It can then also clearly be seen in Figs 7 and 9 that the consultant covered these areas inside the game farm on foot to find conditions likely for settlement.

Fig. 07. All the points of the eastern portion visited during the investigation. (Google Earth 2020.)

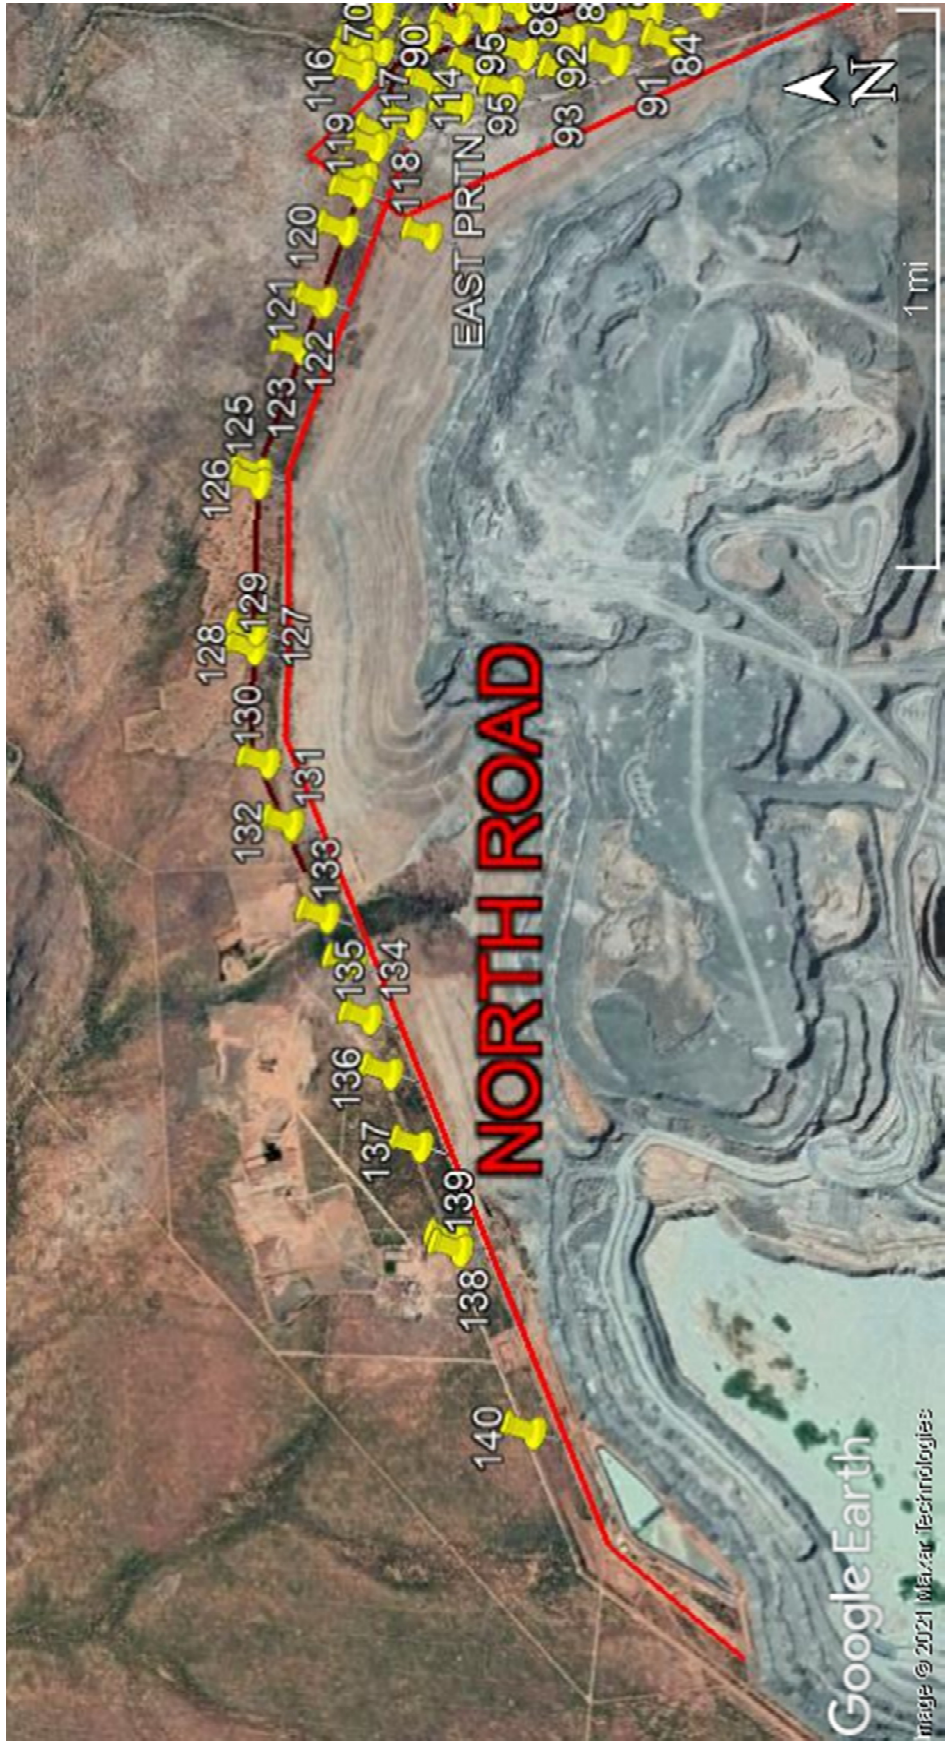
Fig. 08. All the points on the north road visited during the investigation. (Google Earth 2020.)

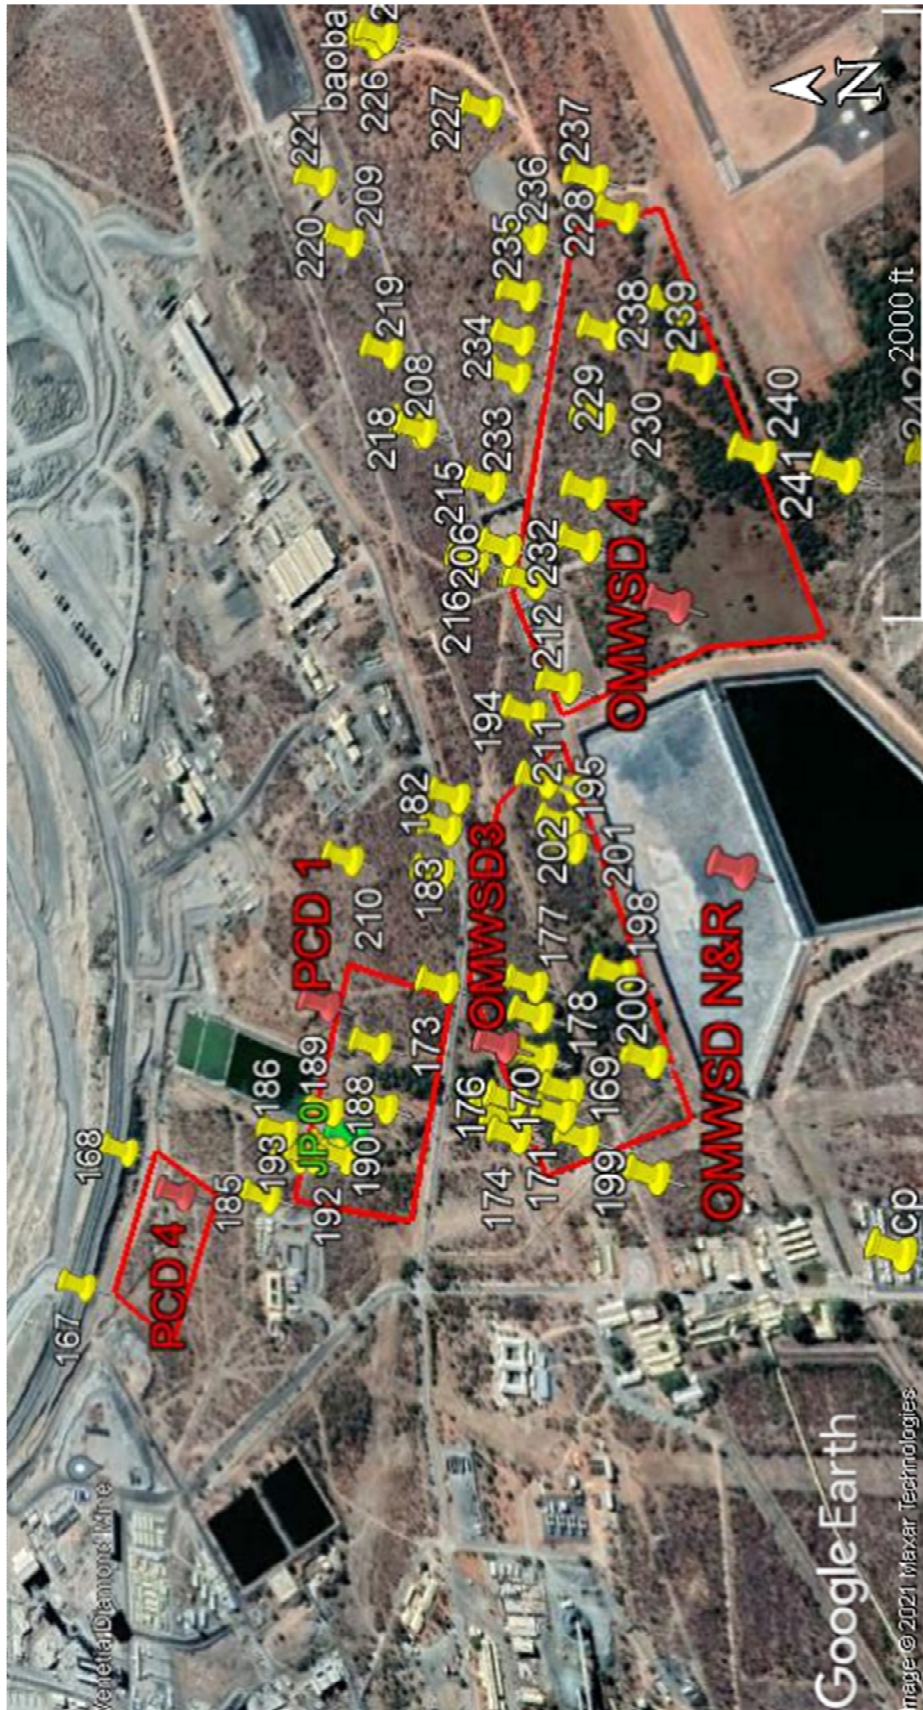
Fig. 11. All the points visited in PCD 4, PCD 1, OMWSD 3, OMWSD 4 and OMWSD N&R during the investigation. (Google Earth 2020.)

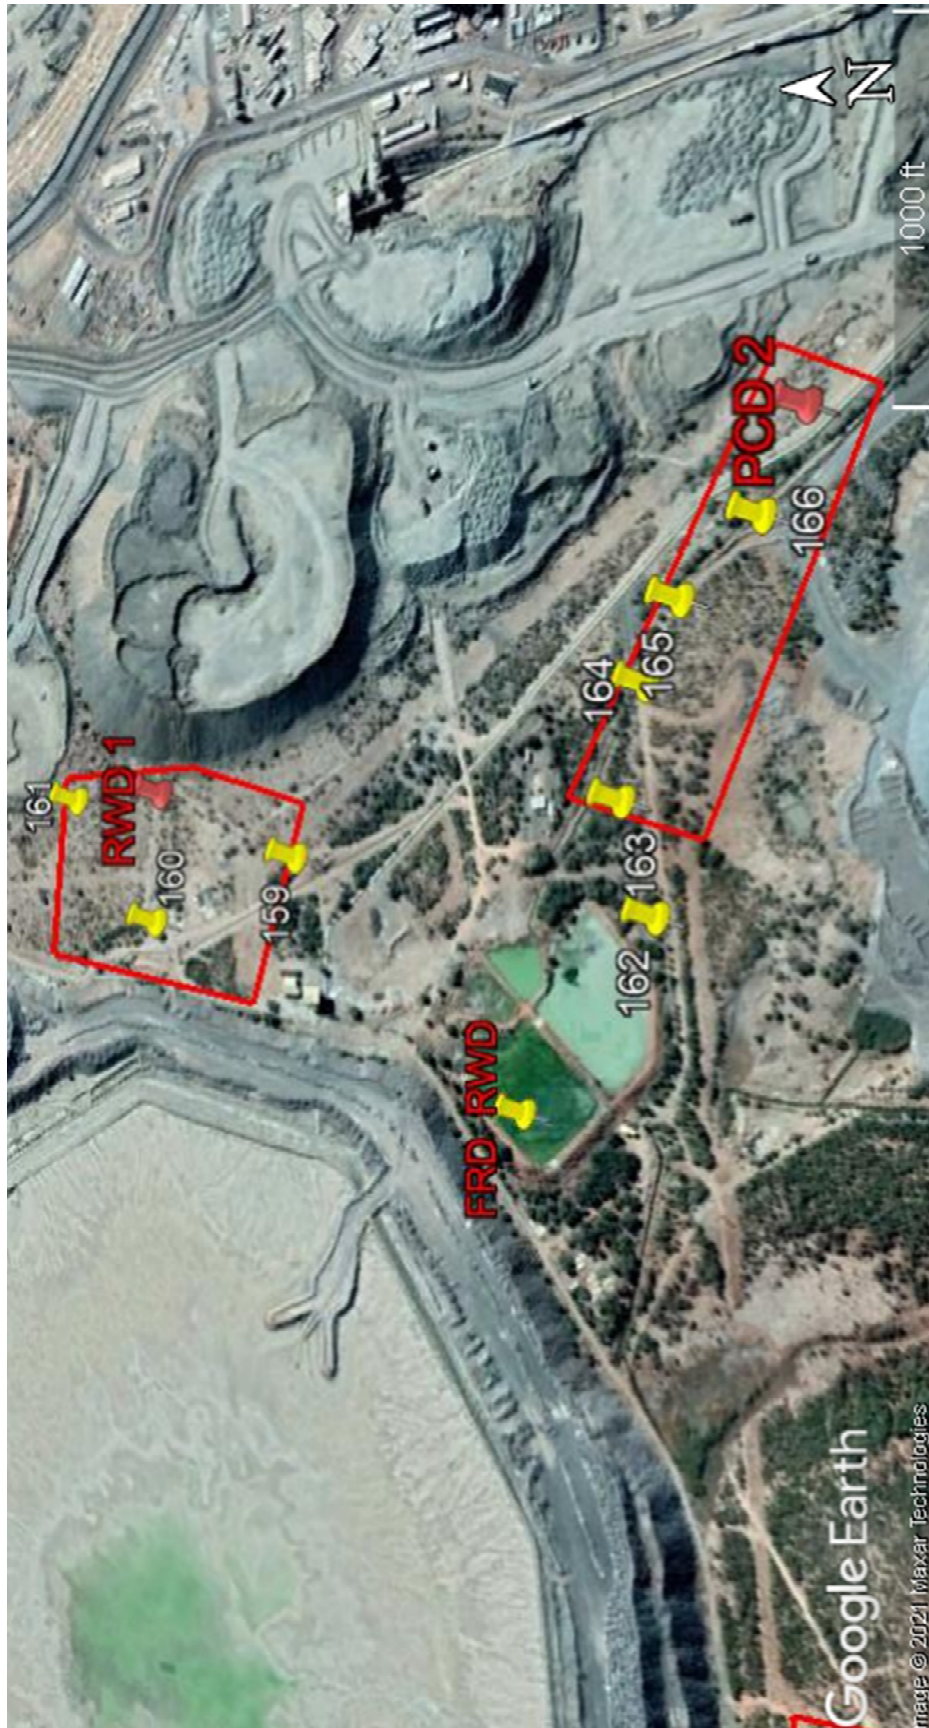
Fig. 12. All the points visited in RWD 1, PCD 2 and FRD RWD during the investigation. (Google Earth 2020.)
