AN ARCHAEOLOGICAL WALKTHROUGH SURVEY OF THE PROPOSED TURBINE FOOTPRINT AND INFASTRUCTURE FOR THE MSENGE EMOYENI WIND ENERGY FACILITY, BEDFORD DISTRICT, BLUE CRANE ROUTE MUNICIPALITY, EASTERN CAPE PROVINCE.

Prepared for: Savannah Environmental (Pty) Ltd

Prepared by: Dr Johan Binneman

Date: March 2014

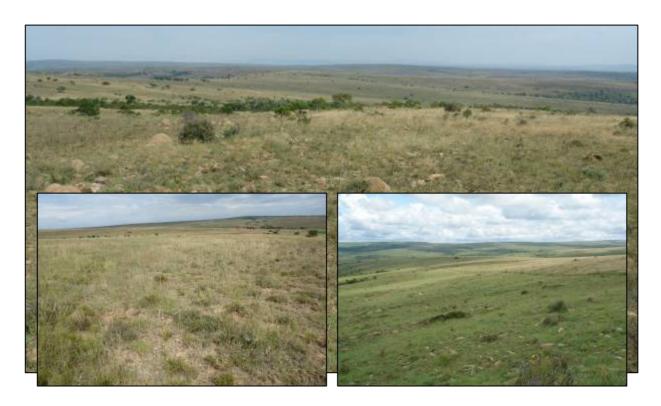
The general landscape comprises a gentle undulating hill landscape, lowlands and non-perennial open valley drainage systems/lines (Figure 1). No perennial rivers traverse the study area. The major rivers occurs many kilometres to the north, east (Great Fish River) and west (Sunday's River). The dominant natural vegetation is grassland, small, low shrubs in places and patches of *Acacia karroo* in the drainage valleys. The main activity in the study area is commercial stock farming and the land is used for grazing of livestock. Apart from the usual small scale disturbances due to farming activities such as fences, tracks, dams, soil erosion and power lines which crosses through the area, the hill tops shows little disturbances. Most development and disturbance, such as homesteads, and associated infrastructure occur mainly along and adjacent to the network of gravel roads which traverse the study area, or in valleys areas close to drainage lines.

Figure 1. General views of the Msenge Emoyeni Wind Energy Facility site.

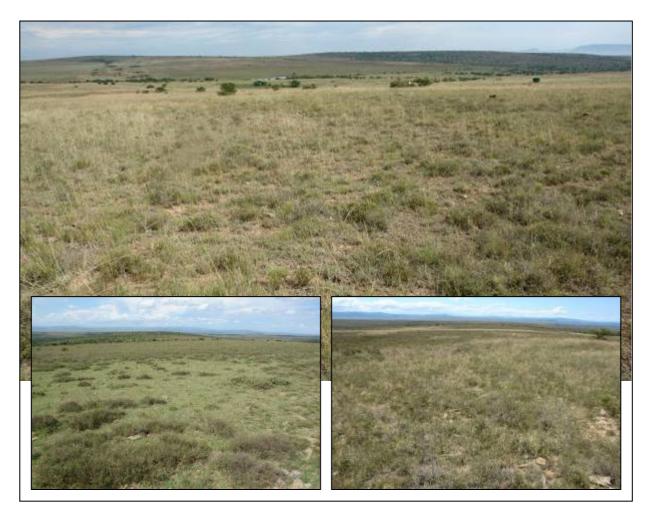
Figure 4. Views towards turbine positions 11-53-34 along the ridge in the background (main image).

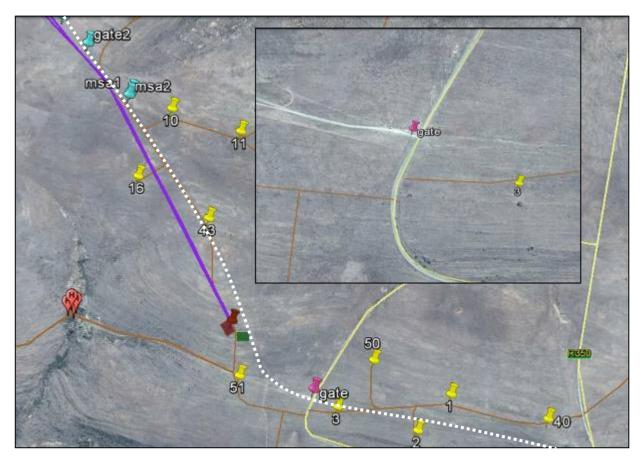
Two dry packed stone wall gates were also observed, one (gate) at the entrance to Alstonfield (Figure 5) (Map 7) and the other one (gate2) higher up the slope (Figure 3) (Map 5). No mitigation is necessary for both of the structures because they are more than 50 metres from the nearest developments, but precautions must be taken that the structures will not be damaged during the construction phase. Only one dry packed stone kraal (Figure 6) (Map 8) was observed near the service road between turbine positions 52 and 41. No mitigation is necessary for this structure because it is more than 50 metres from the service road, but precaution must also be taken that the structures will not be damaged.

Map 7. An aerial image of the locations of the substation, maintenance yard and turbine positions 1-40-50. The possible route of the ox wagon road is marked by the broken white line.

A more detailed archival study is conducted by a historian to establish/confirm the historic ox wagon transport road and how it will be impacted by the development (recommendations to follow).

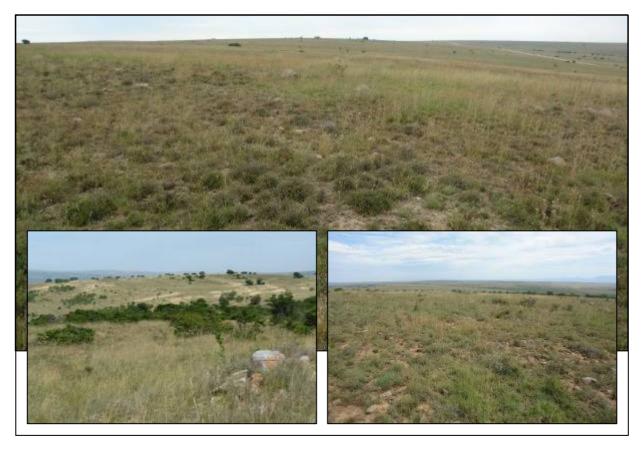
Figure 9. Views of the turbine positions 14-24 (main image), 45-18 (left insert) and 37-47 (right insert).
