# **EXCAVATION OF ARCHAEOLOGICAL FEATURES DISCOVERED DURING CONSTRUCTION WORK AT THE RAILWAY STATION CONCOURSE, CENTRAL CAPE TOWN**

**Magisterial district: Cape Town**

Prepared for  
**Vidememoria**

April 2010

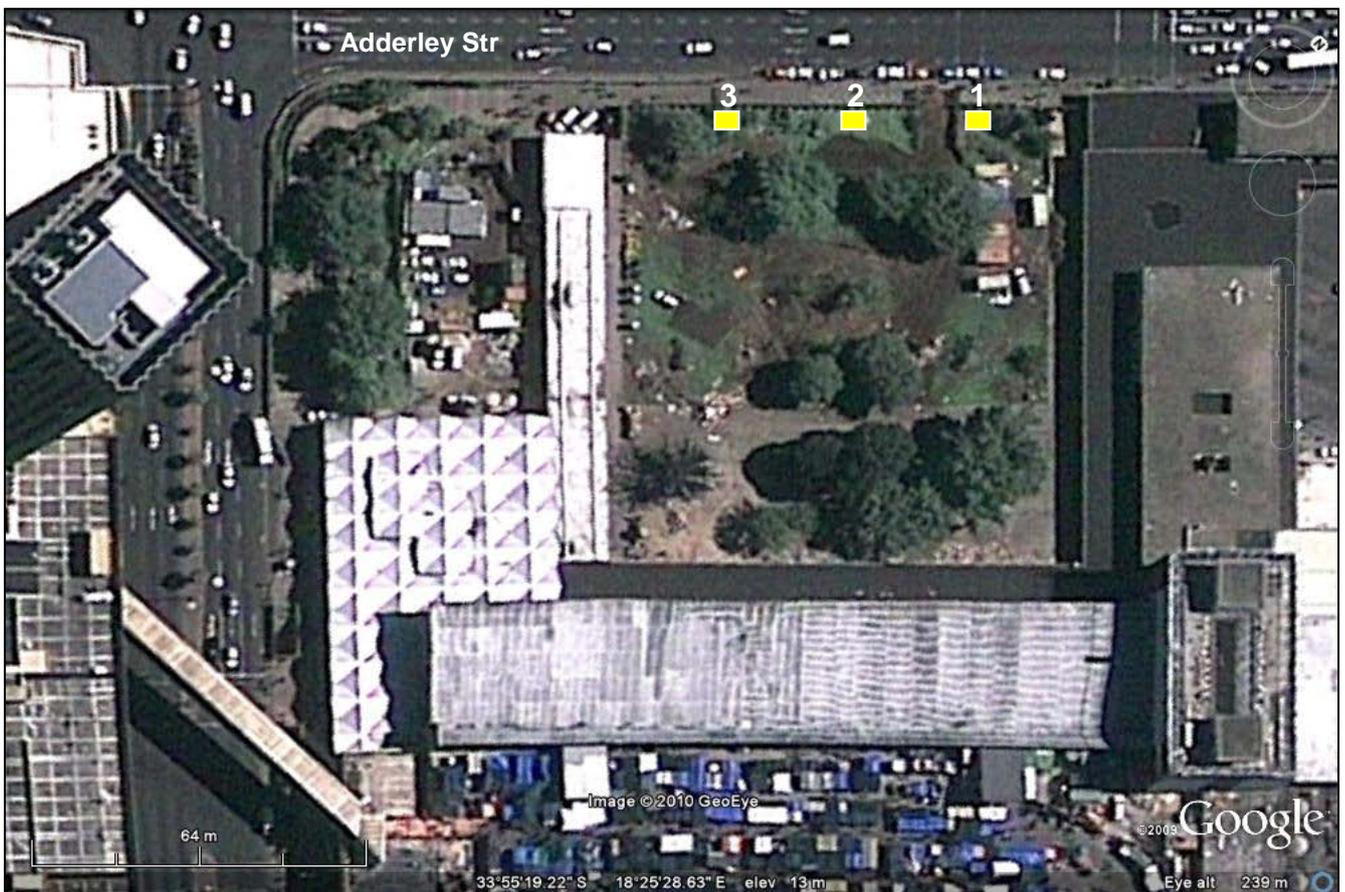
**Figure 1:** The approximate locations of the construction activities (yellow) at the station precinct in which structural remains have been found. Anchor from Hole 1, walling in Holes 2 and 3, well and timber in Hole 3.

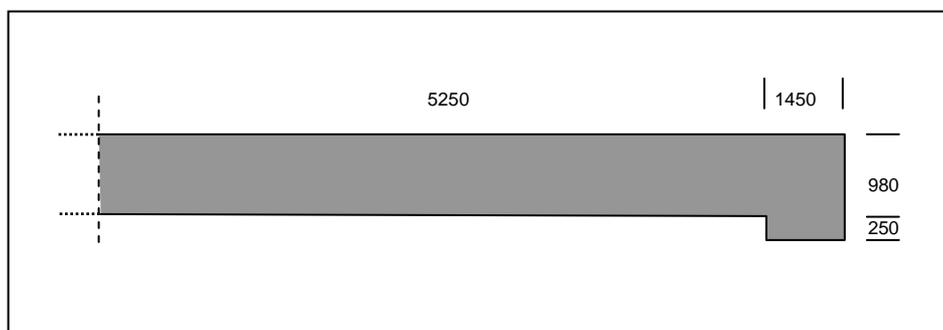
The course of the wall was cleared of soil revealing that it continued to just short of the nw section ending in a broader “plinth” (Plates 3 & 4, Figure 2). No other adjoining walls were observed suggesting that this was the end of the feature. To the south the wall continued into the section that we note runs at a slightly divergent angle with Adderley Street.

Figure 2: Schematic diagram of the stone wall with dimensions (not to scale)

Despite its appearance (resembling a Dutch wall made with dressed shale blocks held in place with shell lime cement) the stratigraphy of the surrounding deposits suggests that the construction dates to the 19<sup>th</sup> century. We have noted glass and distinctive transfer printed “willow pattern” refined earthenware ceramics at the top of the brick and rubble rich deposits at the lower part of the sequence. These deposits appear to be cut by a substantial (>1 meter wide) “trench” to the west of the wall (see Plate 5). A layer of brown gritty sand in turn covered by a layer of brick rubble, does not show evidence of the cut and suggests that it was deposited after the wall was constructed. Deposits to the east are substantially different and appear to post date the wall in their entirety (Plate 6).

Test holes on both the east and west sides of the wall showed well finished faces on both sides (Plate 7). The test hole on the east side was dug to the water table (approx 830mm below the remaining top of the wall), and a probe was hammered into the ground in 3 different positions to determine the depth of the foundation, where resistance occurred at depths ranging from 530 - 630mm below water table. We were unable to dig into the waterlogged clayey soil to determine the nature of the lower deposits and can therefore not say if the foundation was in *in situ* shoreline deposit or into rubble fill.

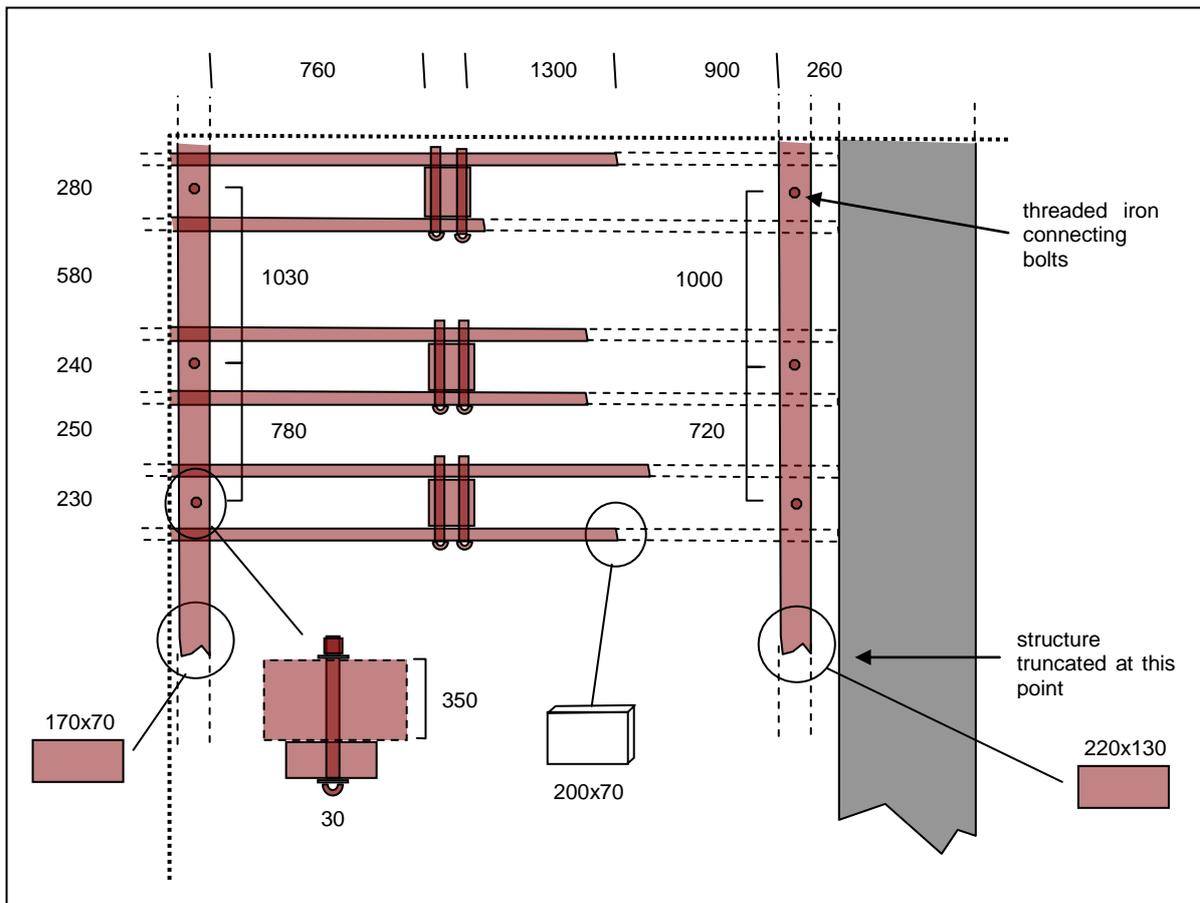
The size of the timber elements along with the associated metal bolts, suggests that all were at one point connected to form a structure (Plates 8 & 9, Figure 3). Considerable wear and degradation of the wood in places suggests that it has been exposed to water. The form of the timbers, wear patterns and context suggests that this was once part of a jetty or slipway.

All the linear timber elements are aligned at 90° to the stone wall and would seem to indicate a direct link between the two features. They were either erected at the same time or the timber alignment took its cues from the wall alignment at a later stage. This being the case, it would seem logical to deduce that the timber structure also dates to the 19<sup>th</sup> century. Also, the use of threaded iron connecting bolts and nuts was more common in the 19<sup>th</sup> century than before when forged and riveted fixtures were more common.

The wood is in poor condition and in places was represented by nothing more than a dark stains in the soil. In places there are marks suggesting that connecting timbers were recently removed, and are likely to be places where the stockpiled timbers were once positioned. We noted that timber continued into the east and south sections where because of the circumstances, we were unable to continue excavating. Three large square posts supported the visible structure Excavation of the bases however showed that they did not penetrate far into the soil, and no dark stains at the base showed that it was not just a case of the wood having rotted off. This was moderately troubling in terms of its use as a jetty as we had expected them to be much deeper set. If however we assume that the shoreline sloped upwards, we may have found the shallowest part of the structure where it lay partially on the shore (for example Figure 4). Truncation of the structure did not permit more observations to

**Figure 3:** Schematic diagram of timber elements with dimensions in relation to stone wall (not to scale)

- **Timber elements:** The feature has been measured, surveyed and photographed. The timber is in extremely poor condition and will not withstand exposure for long. We do not believe that the feature could be conserved.

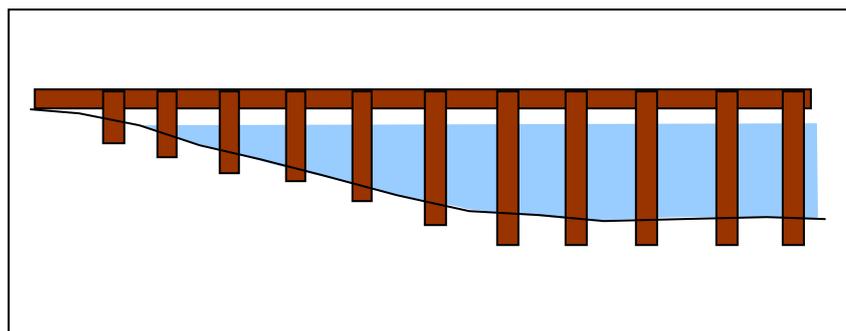
**Figure 4:** Schematic indicating variable pile depth on a sloping shoreline

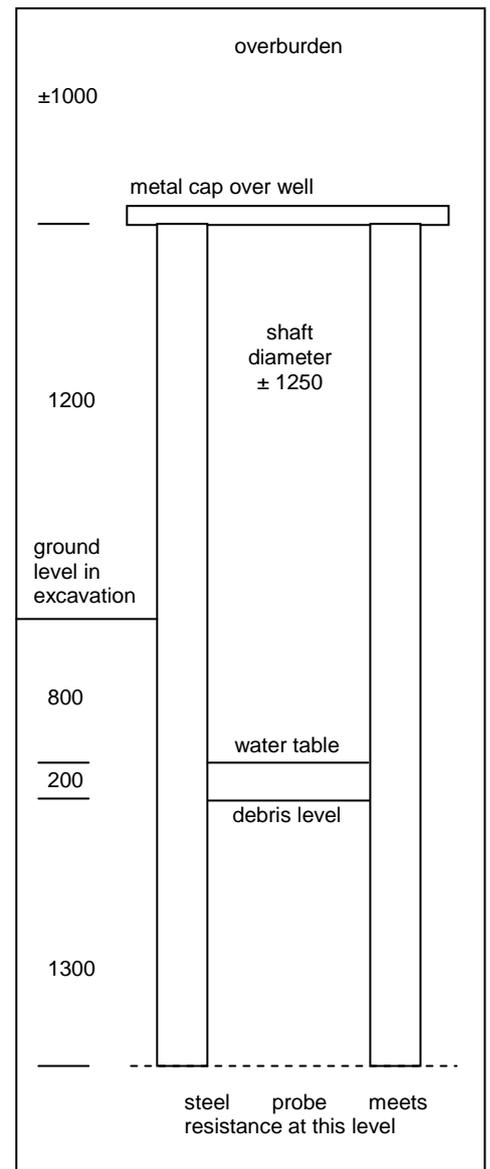
When the well was encountered during the mechanical excavation of the hole, the side of the shaft was damaged resulting in the structure becoming unstable. As it had been capped by a metal sheet (presumably when it was no longer in use) and then covered by approximately a meter of soil, considerable weight was bearing down on the unstable structure and it was therefore too dangerous to contemplate archaeological excavation. Some observations of the structure were however made (Plates 10 & 11, Figure 5).

**Figure 5:** schematic diagram of the well structure with dimensions (not to scale).

Faint traces of a cut were visible approximately 1 meter to east and west of the shaft. By probing depth of the debris fill with a metal probe and adding the other measurable dimensions, we estimate that the well was 3.5 meters deep when in use.

- **The well:** Positioned as it is in the section means that it could be successfully avoided by the proposed building activities. An engineering solution should be found to accommodate the construction activities while maintaining the well into the future as a heritage resource. The engineer will have to resolve possible future collapse of the metal sheet capping in a way that is acceptable to the heritage authority. As this represents one of very few historic elements on the site, some consideration may be given to utilising it as a feature of the redevelopment. Engineering work and/or rehabilitation of the structure should be approved by HWC.
