Babylonstoren Farm 1268
Archaeological Monitoring Report
Stables Building

14 March 2011

Executive Summary

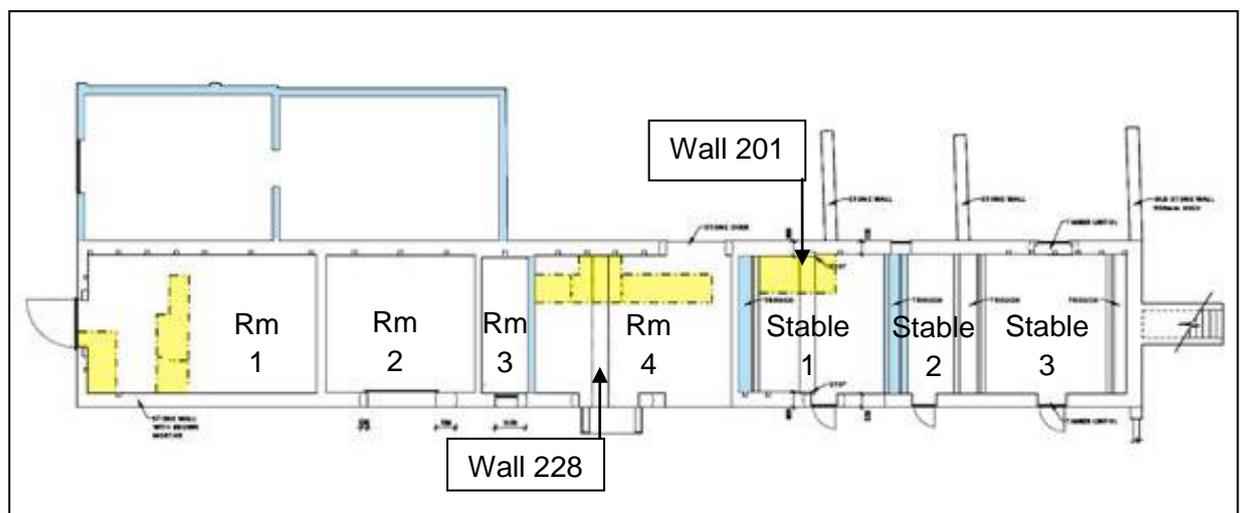
Figure 4: Location of rooms and trenches described in Smuts and Clift (2010: 3). Features to be demolished indicated in blue.

No findings of significant archaeological features were uncovered during the lowering of the floor levels. Existing floor levels were reduced to between 75mm and 100mm and these alterations did not truncate the stratified archaeological deposits. The only exception to this was in the far western part of the building – stables 1,2 and 3 – where floor levels were lowered to accommodate the insulation and electrics for the milk room (see Figs 5a and 5b). This truncated the upper course of the north-south wall exposed in excavations in 2010 (Smuts & Clift 2010: 13-14).

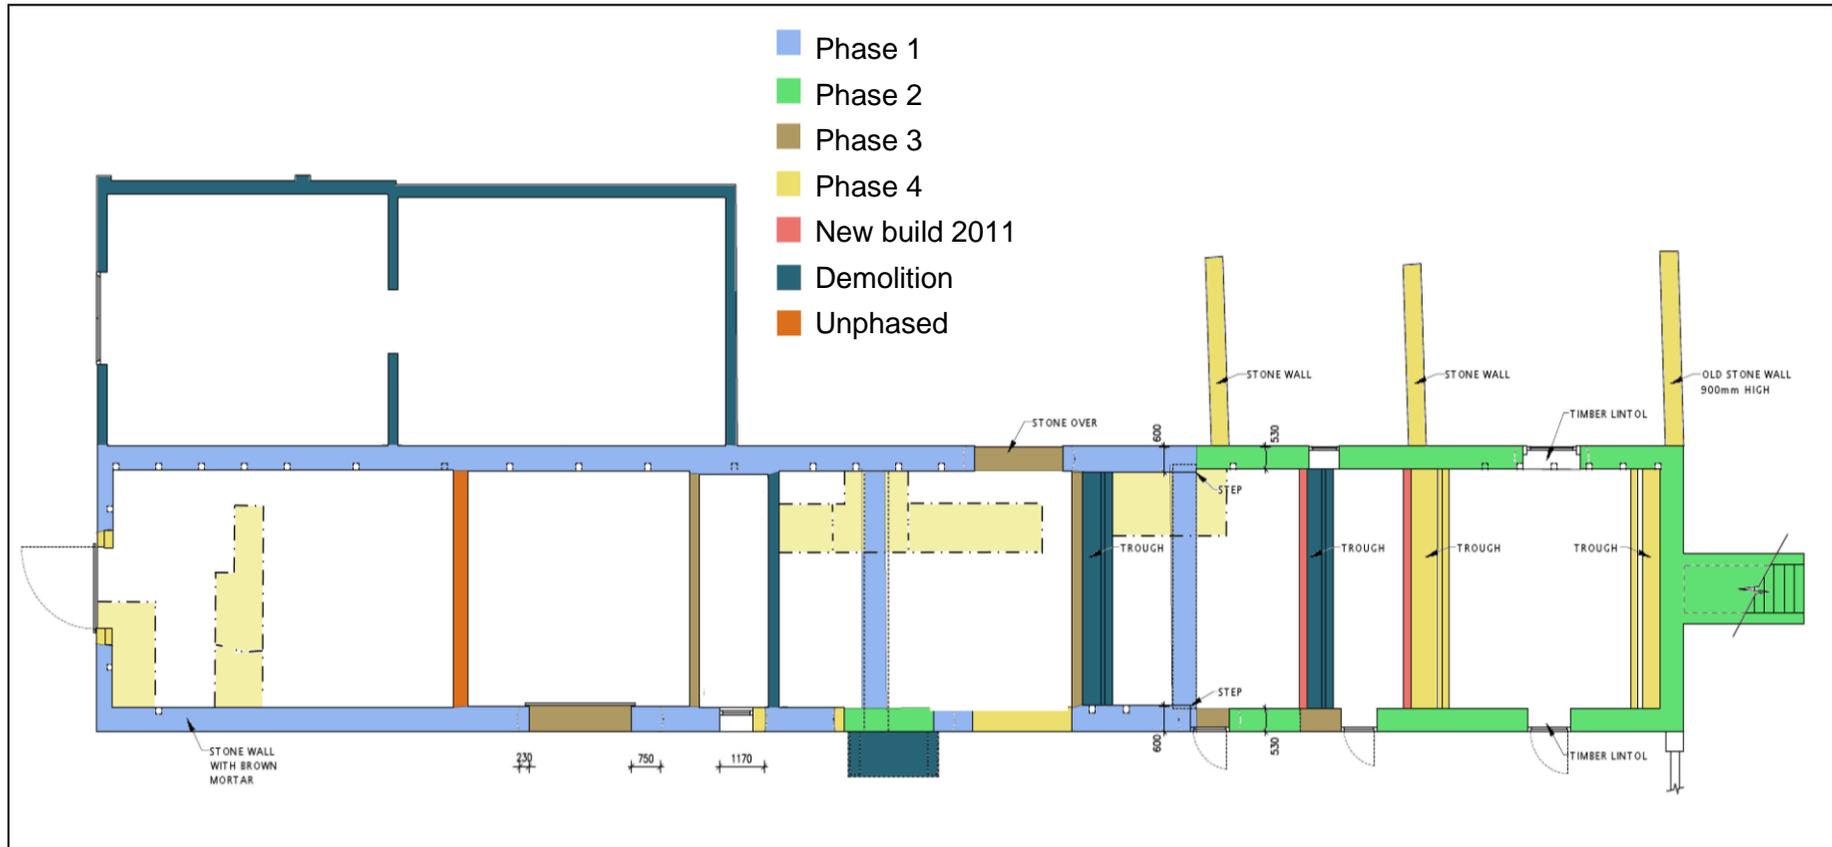
The monitoring process has shed more light on the original layout of the building, but this has not greatly changed our understanding of it. We can now be fairly certain that the wall between Rooms 1 and 2 is not a phase 1 structure and that the wagon house originally extended past the central doorway and possibly as far as wall (228). It is difficult to ascertain the date or phasing of the partition wall between Rooms 1 and 2 as its dark bricks have rarely been found on the farm and are certainly not present anywhere else in the stable building. The only other example where similar dark bricks were used is in the cellar building where they filled a rafter hole in the stone walling of the earliest part of that building. Whether this infilling and the construction of the wall were contemporaneous events or whether the rafter hole was plugged at a later time with reused bricks cannot be known. While this fact does not assist us in resolving the dating of this wall it does once more highlight the enormous importance of studying these farms in their entirety.

Figure 17: Phased plan of stable building showing demolition, new construction and the unphased wall between rooms 1 and 2 (Adapted from Clift & Smuts 2010: 23).
