PROPOSED BLACK MAMBAZO MUSIC ACADEMY, LADYSMITH, KWAZULU-NATAL

Phase 1 Heritage Impact Assessment

November 2018 Updated March 2019

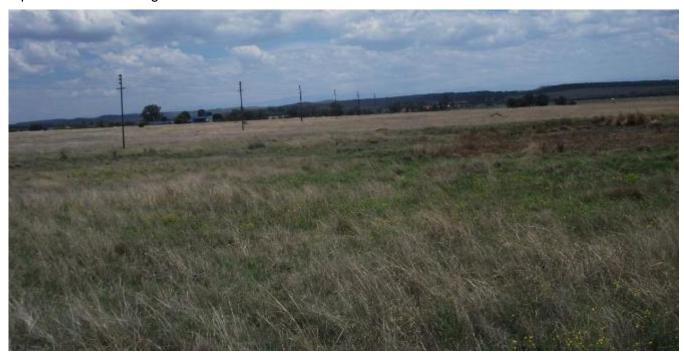
The project area is largely undeveloped and covered with a thick grass layer. Drainage lines and a power line run through the area and a man-made dam occurs on the site.

Figure 3: Project area looking southwards with power line and dam in right hand corner

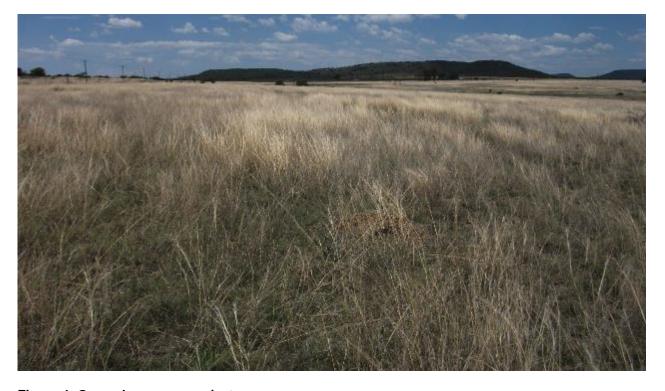
Figure 4: Ground cover on project area

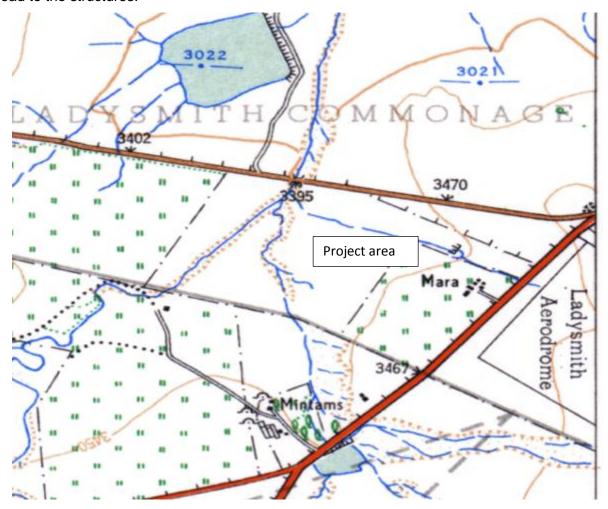
The 1:50 000 topographical map (2829DA) (air photography was undertaken in 1945, the area was surveyed in 1954 and the map drawn 1956) shows cultivation of the south-eastern section of the project site (referred to as Mara in the figure below) as well as structures and an access road to the structures.

Figure 5: Early topographical map of project area

The remains of the structures mentioned above were found amongst gum trees and other exotic trees. These remains are located at 28°34'38.0"S 29°44'39.7"E, 28°34'37.41"S 29°44'39.18"E and 28°34'38.2"S 29°44'38.2"E (coordinates for centre of these remains). The area is strewn with rubble. The historical topographical map confirms that the remains of the structures are older than 60 years.

It is recommended that the area where the remains of the structures (as depicted in **Figure 5**) were found is to be secured by an 80 m buffer to avoid impacting on graves that could be amongst the ruins. No construction may take place within the buffer and the buffer should be made of a highly visible and durable material. The buffer would include the round structure (borehole or grave) and stone walling.

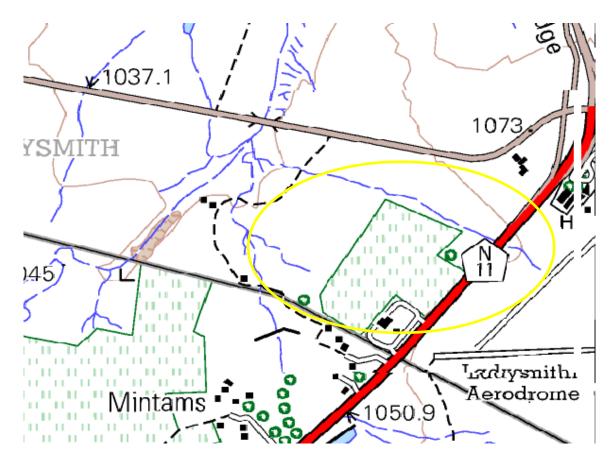
The year 2000 topographical map (see below) is much the same but without evidence of the structures mentioned above.

Figure 6: 1:50000 map with project area outlined in yellow

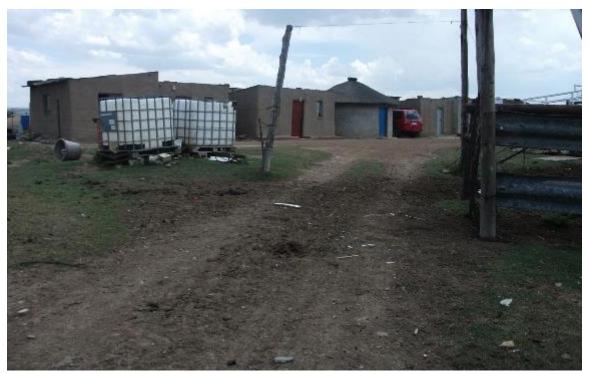
Several occupied houses and associated structures were located towards the western boundary of the project area and close to a large stream. The houses are recent structures. There are five graves situated to the west of the structures and one grave located in a cattle kraal. The five graves are delineated with rocks and are located at 28°34'29.2"S 29°44'01.2"E and the single grave is located at 28°34'29.5"S 29°44'01.2"E.

Figure 17: Residential structures

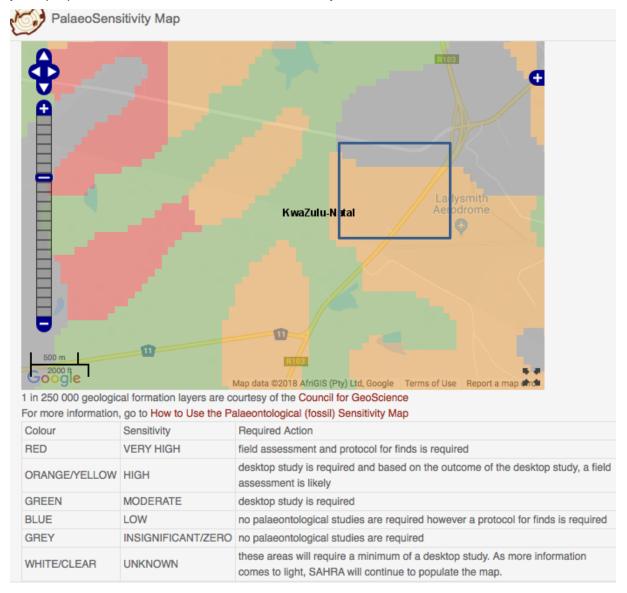
The South African fossil sensitivity map indicates that the project area falls within an area of high fossil sensitivity (indicated by orange colour) with a small section of along the Bloubank road of insignificant or zero fossil sensitivity (indicated by grey colour) in **Figure 25** below. An area of high fossil sensitivity requires a desktop palaeontological study as can be seen in the Legend

Figure 25: Fossil sensitivity of project area which is outlined in blue

The desktop assessment found that the proposed site lies on the Early Permian Ecca Group Vryheid Formation, sandstones, shales and mudstones. Although fossils have not been reported from this site there is a small chance that typical (but very infrequent) early *Glossopteris* flora plants could occur in the sediments just below the surface. Surface exposures are likely to be very weathered. To date no fossils have been reported from the Ladysmith area although there are numerous sites farther to the west (north), such as Harrismith, and to the south such as Estcourt, Colenso, and Loskop.

above. As much of the project area is undeveloped, it was recommended that a desktop palaeontological study be undertaken to determine whether significant fossil finds will be impacted by the proposed construction of the music academy.
