HERITAGE STATEMENT FOR THE PROPOSED OUTENIQUAS DRIFT ON THE GOURITZ RIVER, RIVERSDALE AND MOSSEL BAY MAGISTERIAL DISTRICTS, WESTERN CAPE

(Assessment conducted under Section 38 (8) of the
National Heritage Resources Act (No. 25 of 1999) as part of an EIA)

12 March 2010

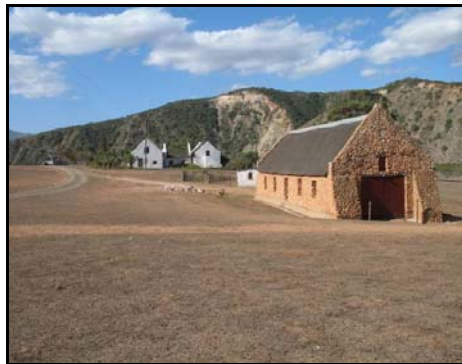
Here just two artefacts, one historical and one Stone Age, were found (Figure 30). One is a Stone Age flake of indeterminate age and the other a historical plate fragment. This point is essentially the southern limit of the farm werf which consists of a few buildings. The one at this point is modern (1992) but a smaller outbuilding further north seems older. The main homestead has three components². The original wing, closest to the river, is approximately 200 years old with the extension forming a T being slightly younger. The second addition turned the house into an H in 1989. The house was not visited as all these structures are well away from the study area.

Figure 31: The buildings at BD-03. The stone one dates to 1992..

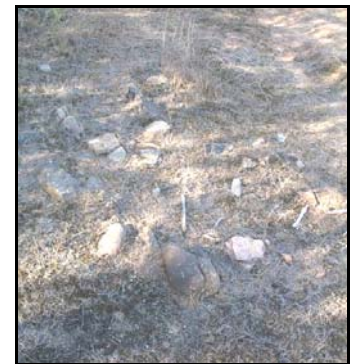
Figure 32: The group of stones at BD-04.

This point refers to a grouping of stones alongside the access road on the northwest side of the river (Figure 32). It has the appearance of a grave but its location makes this seem highly unlikely. It is recorded just in case there is a grave present.

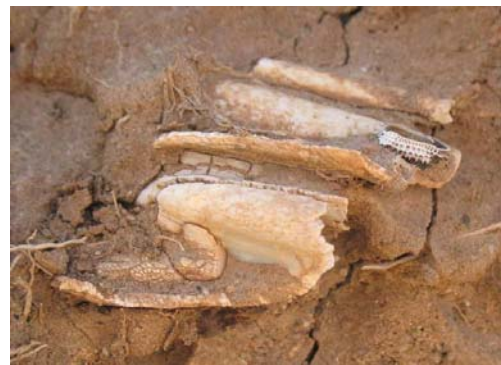
This site lies on the edge of the uppermost river terrace and its content is being revealed through natural erosion (Figure 33 & 34). It probably represents a location where people camped overlooking the river. Items noted were stone artefacts of quartzite as well as ostrich eggshell fragments and a bovid tooth (Figures 35 & 36). The deposits appear to contain quite a low density of archaeological material but the potential for *in situ* remains to be preserved is good. Inclusion of MSA material cannot be discounted.

Figure 36: Bovid tooth from MD-02.

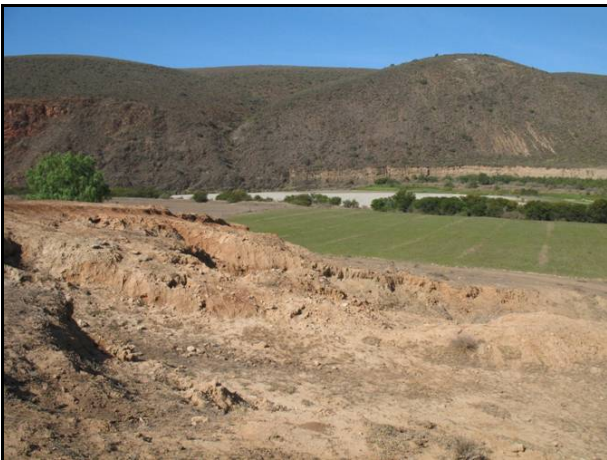
Figure 37: The location of site SD-03.

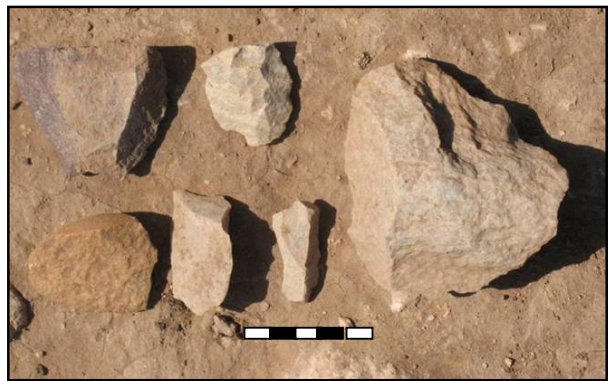
Figure 41: Stone artefacts from SD-02. Scale in cm.

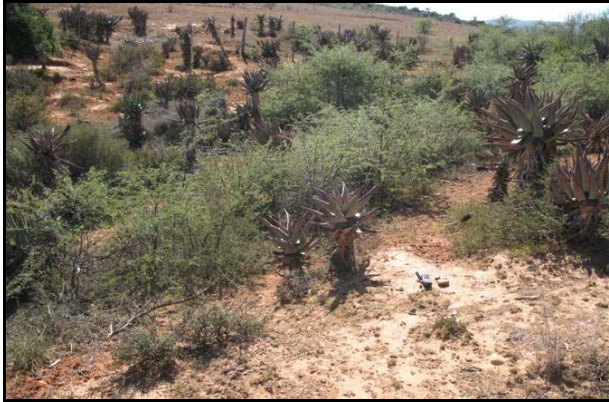
Again this site is an ephemeral scatter of artefacts. It differs only from the others in that it is not located along the edge of the terrace but slightly further back on level ground (Figure 42). It is alongside a small valley that leads down towards the main Gouritz River channel but is interrupted by a ploughed field. Quartzite and silcrete artefacts were noted (Figure 43).

Figure 42: The site at SD-04.

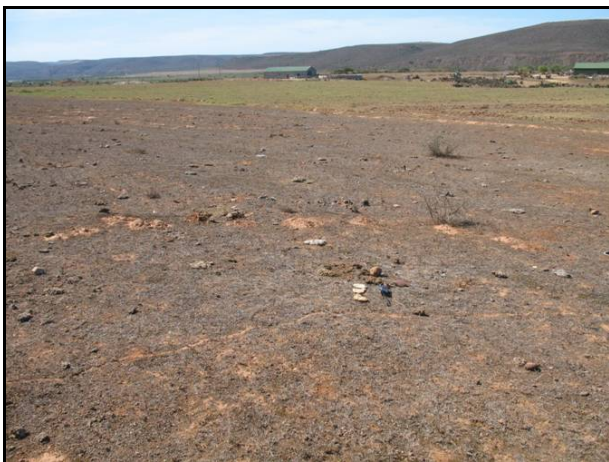
Figure 44: The location of SD-05.

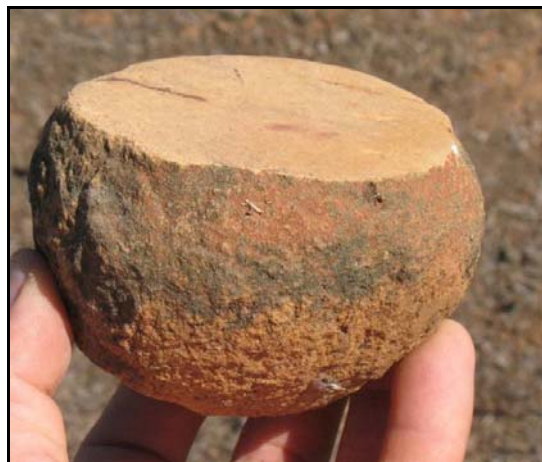
Figure 45: The upper grindstone from SD-05.

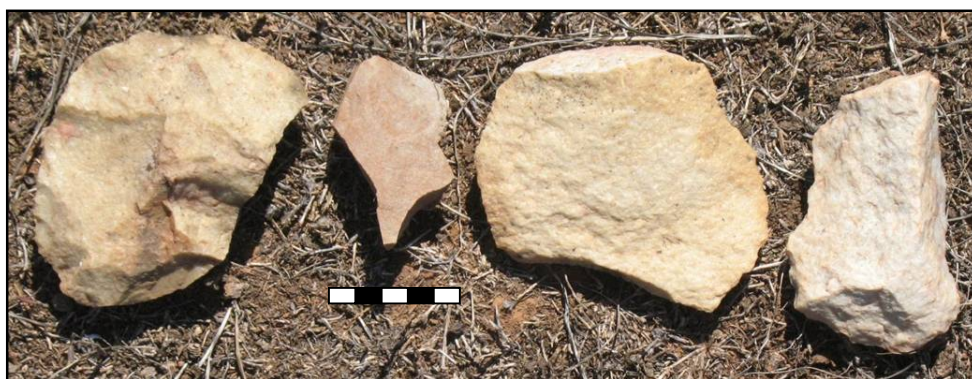
Figure 46: Stone artefacts from SD-05. Scale in cm.

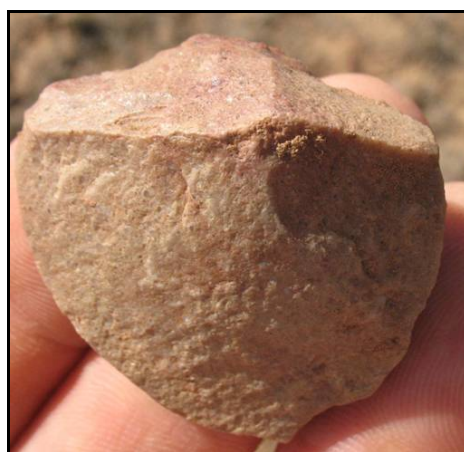
This is another scatter of artefacts located at the edge of the uppermost river terrace. Most artefacts were of quartzite but one silcrete flake with a faceted platform was also found (Figure 49). This platform indicates that the piece is likely to be Middle Stone Age. The site has little potential.

Figure 49: The flake with faceted platform from SD-07.

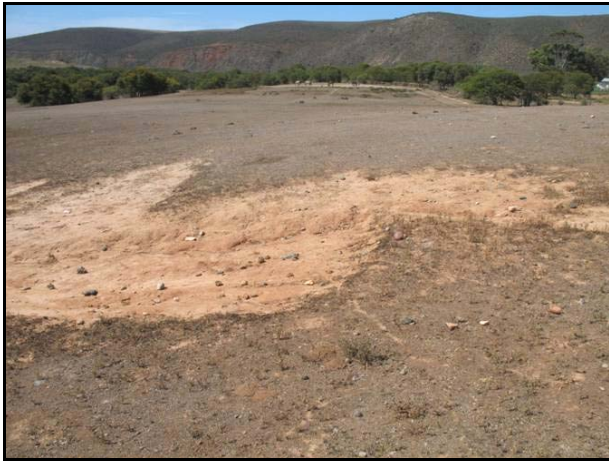
Here a low density scatter of mixed age was revealed by surface erosion. A few probably Later Stone Age flakes were found along with several historical items including ceramics,

glass and bone fragments. The historical artefacts no doubt originate from the ruin located very nearby (MD-06).

Figure 50: The location of MD-05.

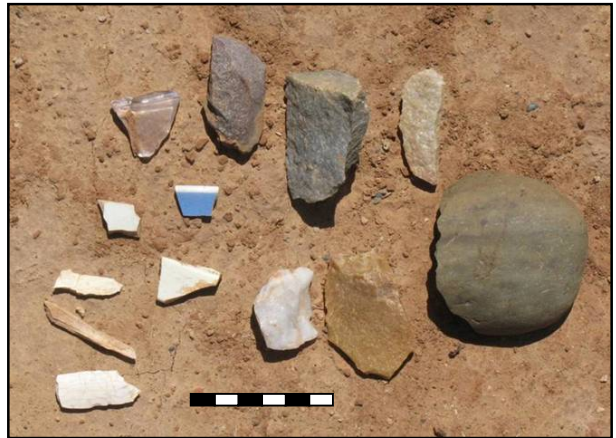
Figure 51: Artefacts from MD-05. Scale in cm.

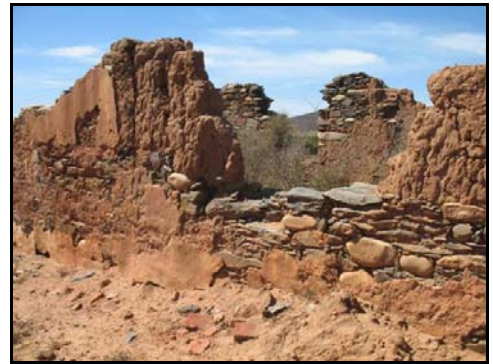
This site is a ruined house that was built from stone and mud with a mud plaster (Figures 52 & 53). It seems wider than a traditional long house but it had its rooms side by side. Its total floor area is about 18 m by 6 m which includes a stoep extending along the front. It faces south. While the age of this ruin is unknown, it must date to at least the mid- to late 19th century.

Figure 53: Close-up of the walls at MD-06.

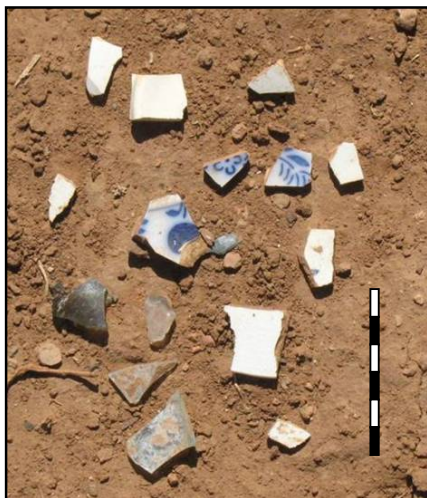
This is a scatter of historical artefacts most likely connected with the ruin at MD-06. It consists of glass and ceramics only and they seem to date to the late 19th or early 20th century (Figure 56).

Figure 56: Artefacts from MD-08.
Scale in cm.

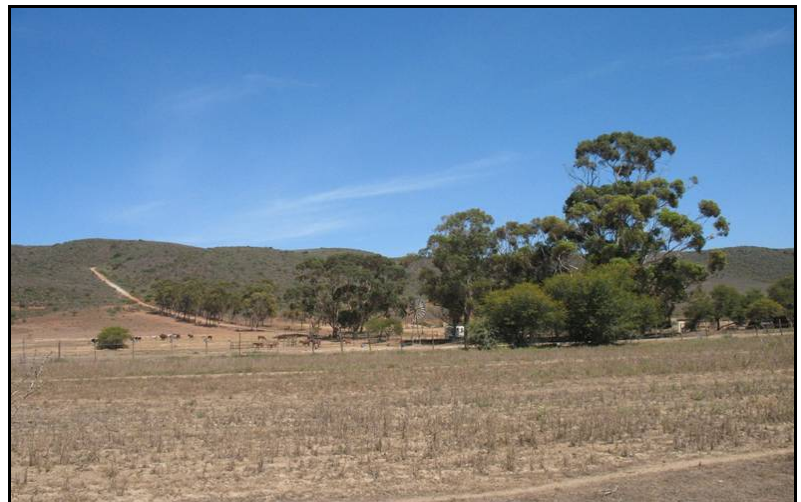
This tree line was not visited but is recorded here as a heritage feature. It consists of gum trees lining the road that leads onto the farm (Figure 57). Some of the trees closest to the river are very large, while those further away (to the southwest) are much smaller. Such tree lines are very characteristic of rural areas in the Western Cape and provide visual interest to the landscape.

Figure 57: View of the tree line along the access road.
