HARMONIE FARM 744
PORTION OF VERGELEGEN, SOMERSET WEST
HISTORICAL SURVEY AND STRUCTURAL INVESTIGATIONS
OF THE 18th CENTURY BARN (WORKSHOP)

JUNE 2009

Report Prepared for
NICOLAS BAUMANN & SARAH WINTER
Heritage Resource Consultants
P.O. Box 281 Muizenberg 7950

Prepared by
HENNIE VOS, MA
Historical Archaeologist & Consultant
ARCape Consultancy
P.O. Box 379 Stellenbosch
(082-217-0032 Fax 021 889-8956)

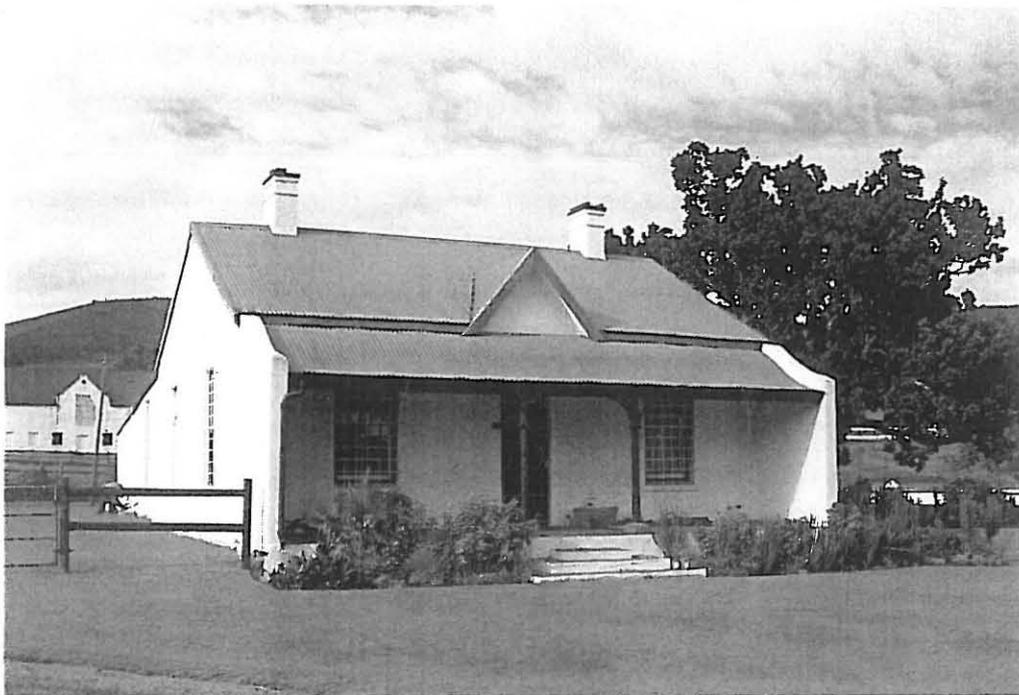
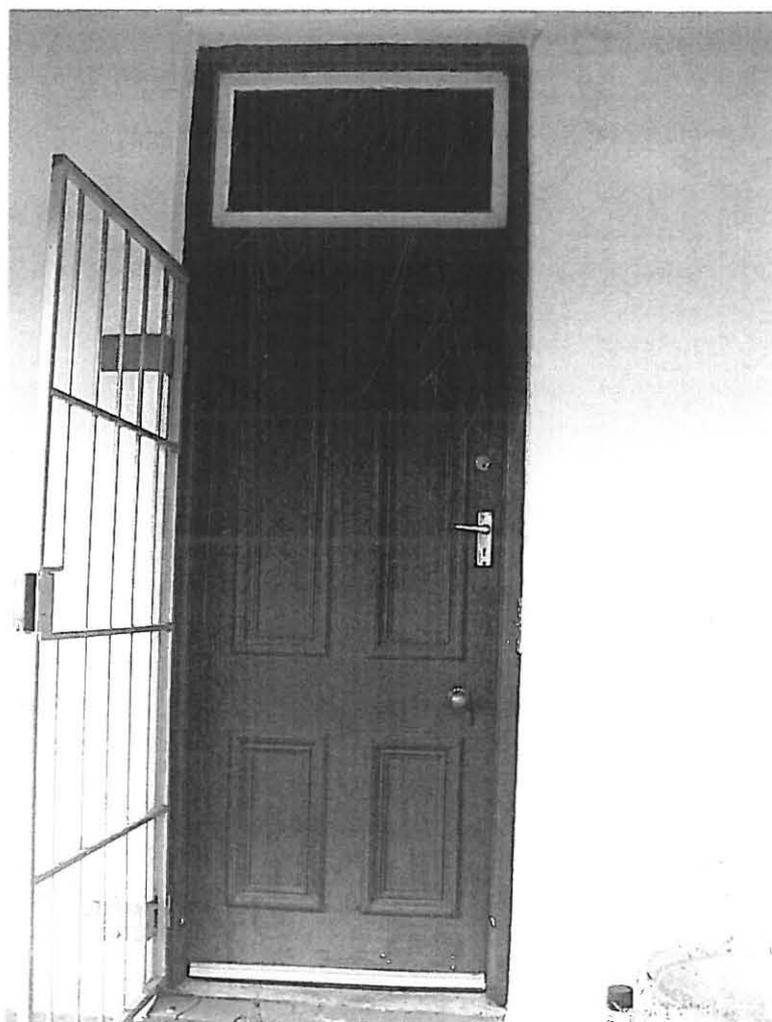
6, 7. Simplistic cottage of 1880-1900, has sash-windows (4 large panes each), with a four panel door (1880) and plain fanlight. This cottage is built on the site of the H-dwelling (18th c) (looking S).

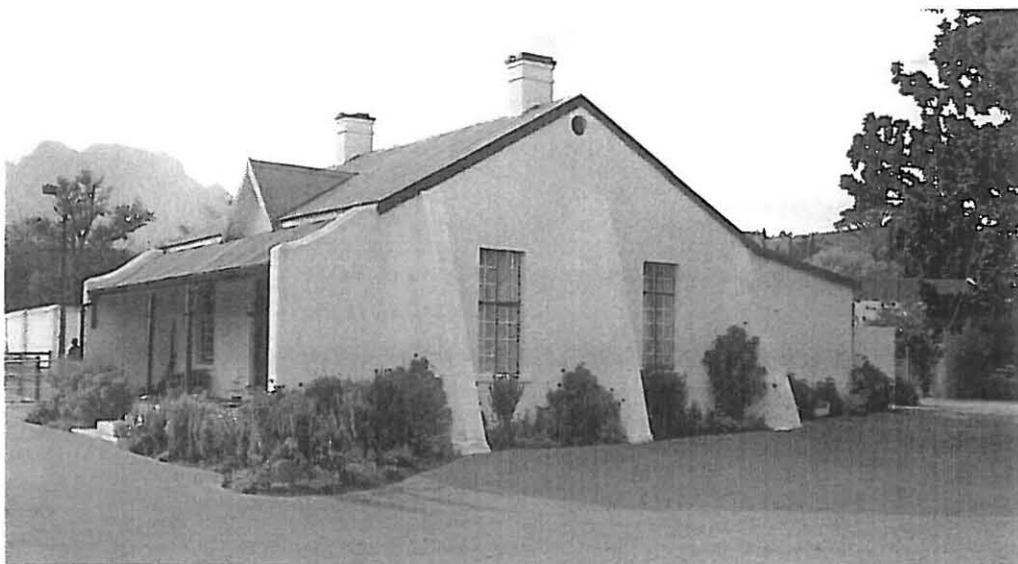
8. View of the cottage from the side with 3 large buttresses and unusual, steel-framed windows (re-used) (looking E).

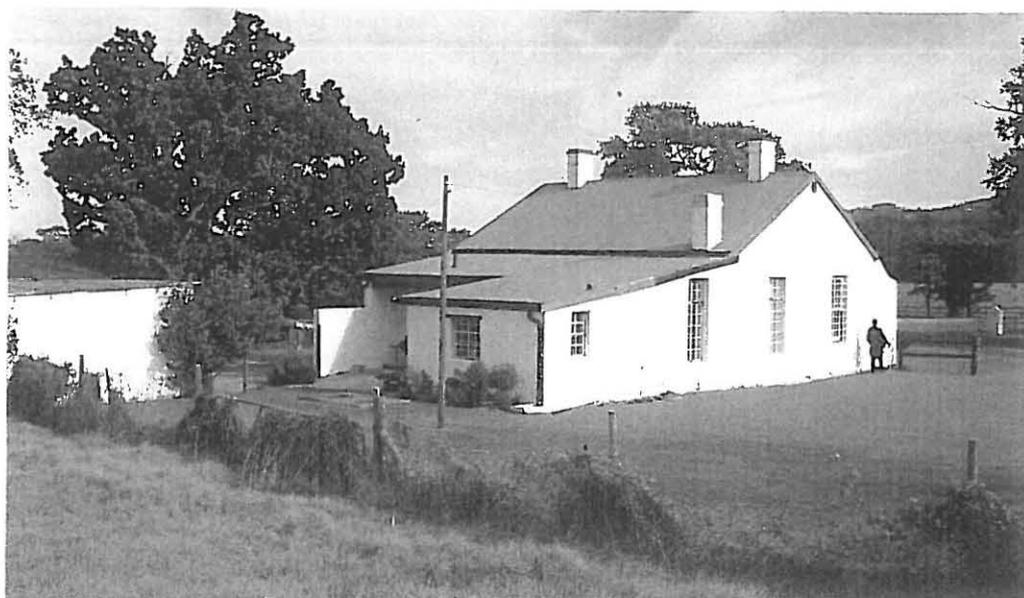
9. View of the cottage from the back, with its lean-tos. Note the large 18/19th century oak tree, part of the werf of the H-dwelling (looking NW).

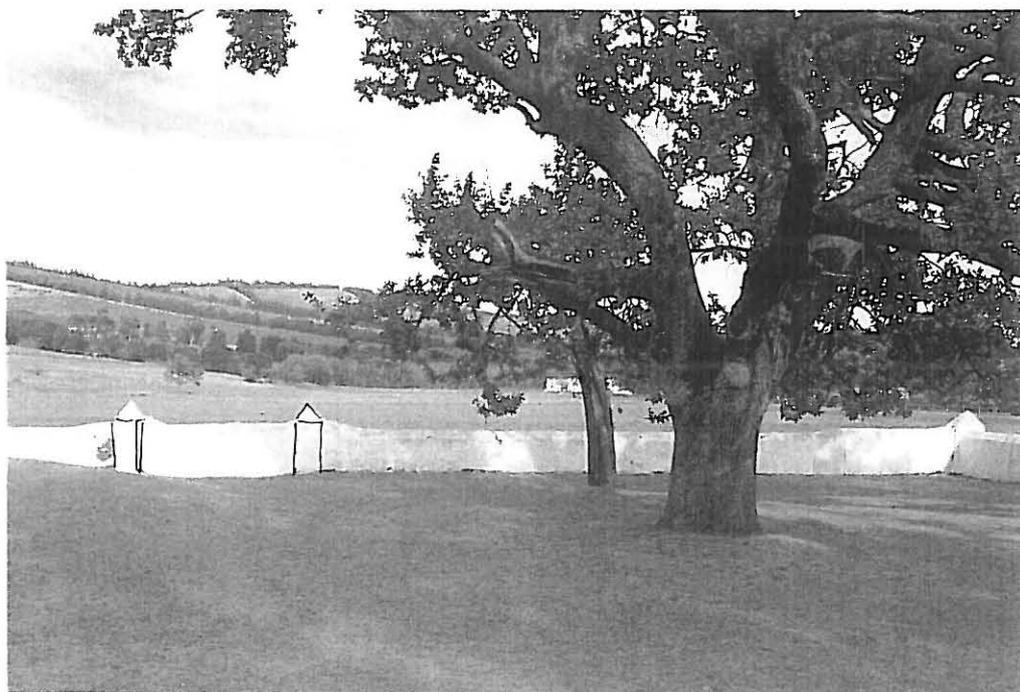
11. Portion of the old ringmuur yard of Harmonie on its NW perimeter. Note the blocked-up posted gate, leading to Morgenster (modern buildings in background). The old avenue of trees has retained a few stalwarts from the 18/19th century.

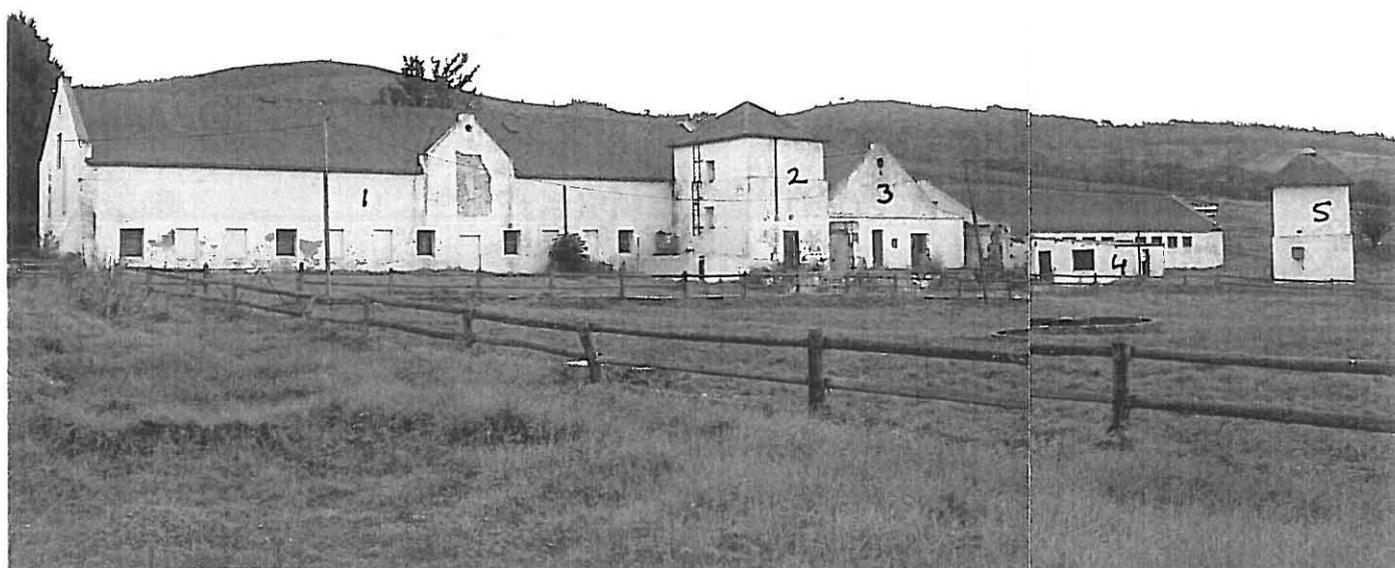
13. View towards the Dairy complex (>1920), much dilapidated after many years standing derelict:

1. Barn with loft 2. Square cooling tower 3. Cowshed 4. Milking shed 5. Silo.
On the horizon are the flowing hills of Schapenberg (looking S).

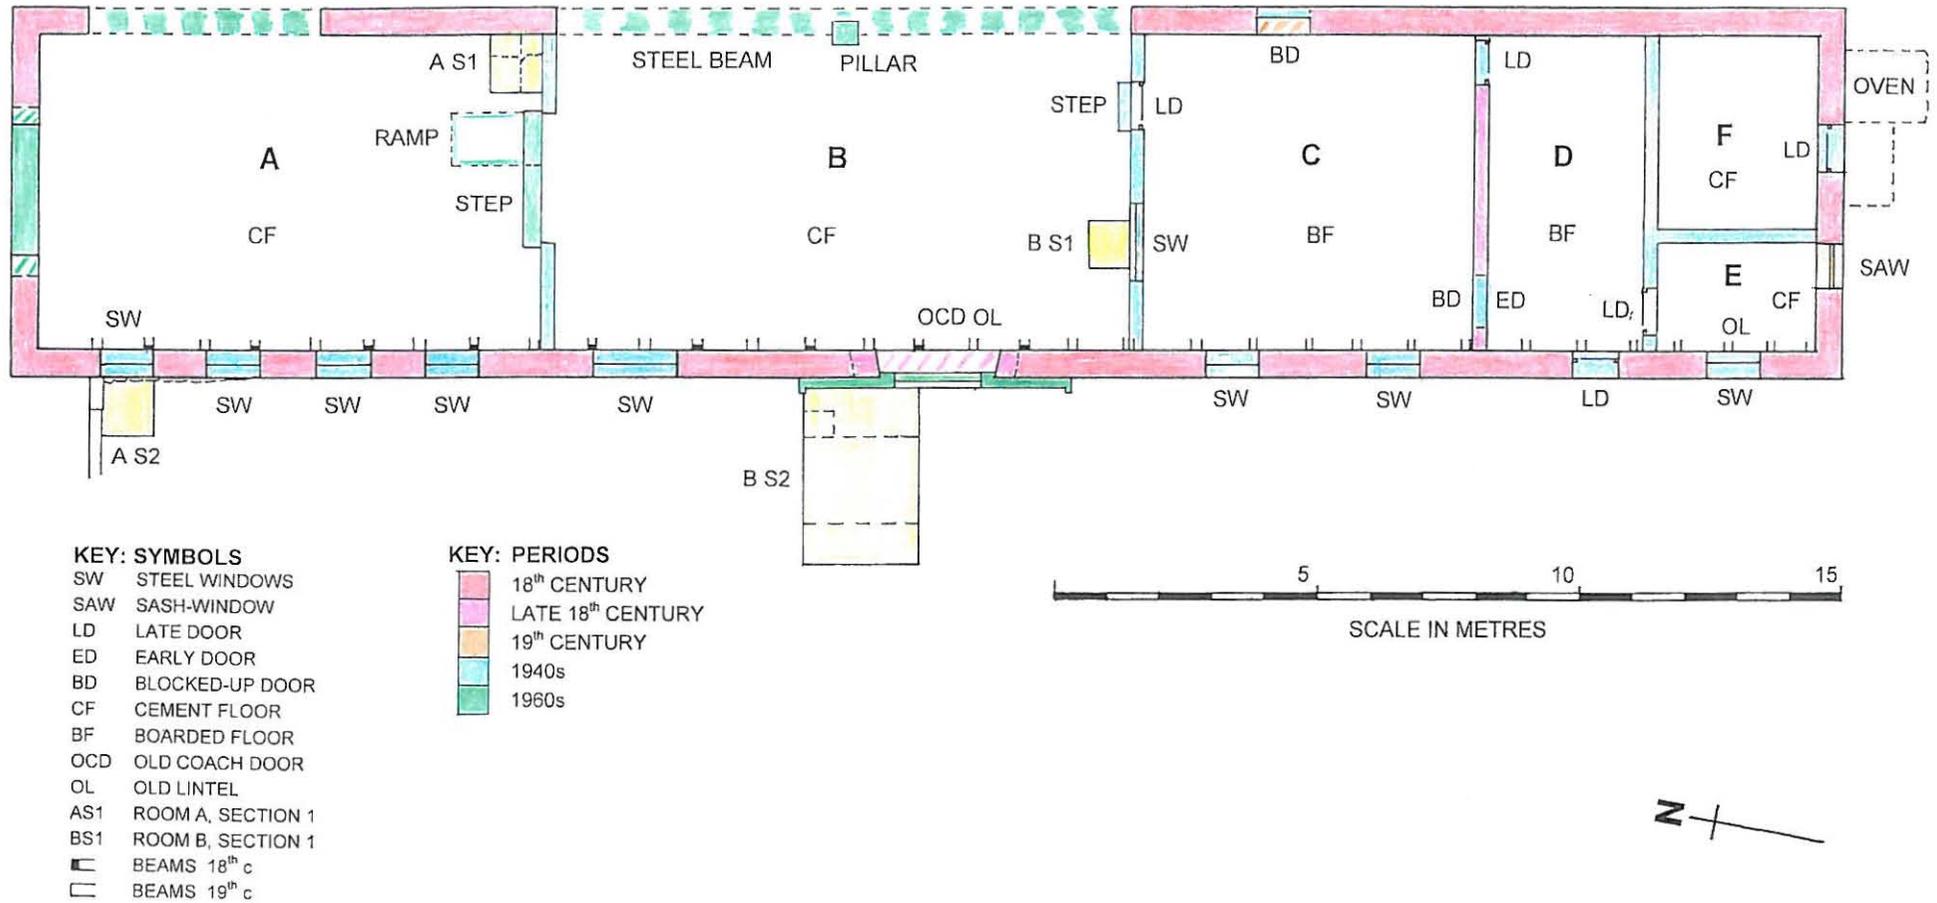
HARMONIE BARN SITE PLAN 2009

FIG.15 Site plan of the Harmonie Barn with a chronological interpretation and archaeological excavations. Note the lean-tos which distort its original outlay (Architect Goddard 2008; amendments Vos 2009).

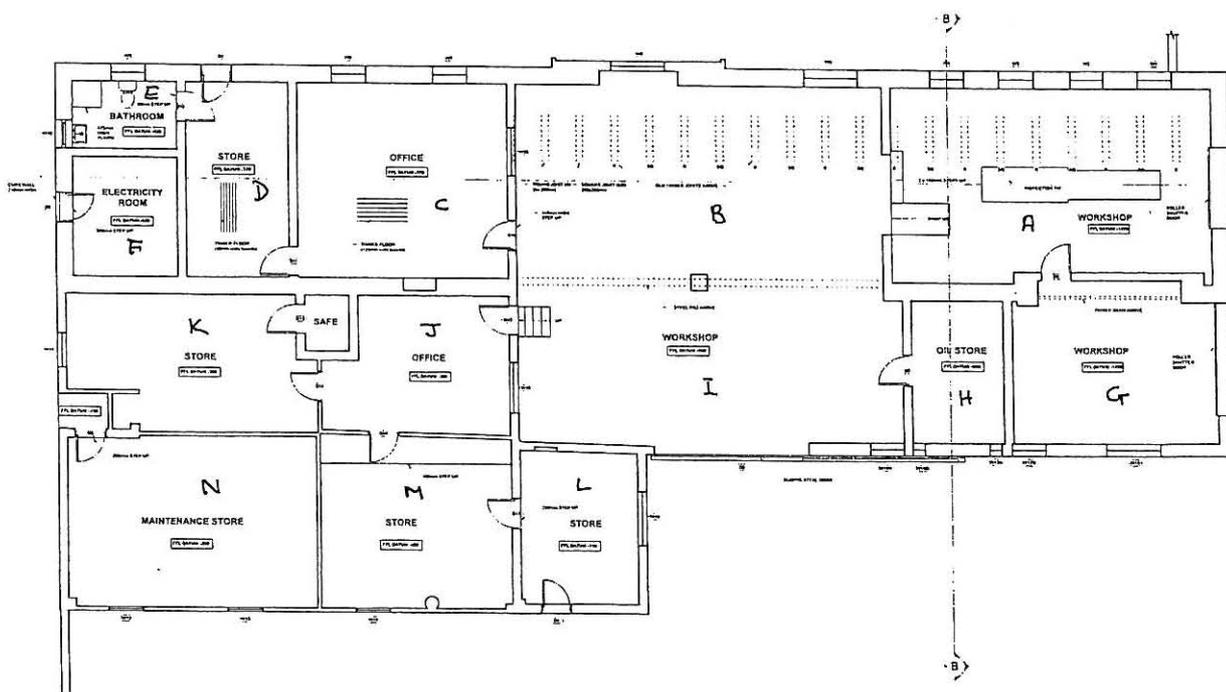
The building had a make-over between 1940-50, and the fenestration on the west exhibits regularly spaced steel windows, with all earlier openings blocked-up. Lean-to extensions on the east are all post-1920 or 1950, and give the appearance of a larger building. Their functions are related to the main Workshop, e.g. various stores, workshops or administration offices (see also B&W 2008:13; evaluation of structures) (FIG.16, FIG.17).

FIG.16 Site plan of the existing Barn as documented by the architect, with functional room layout (Architect Goddard 2008).

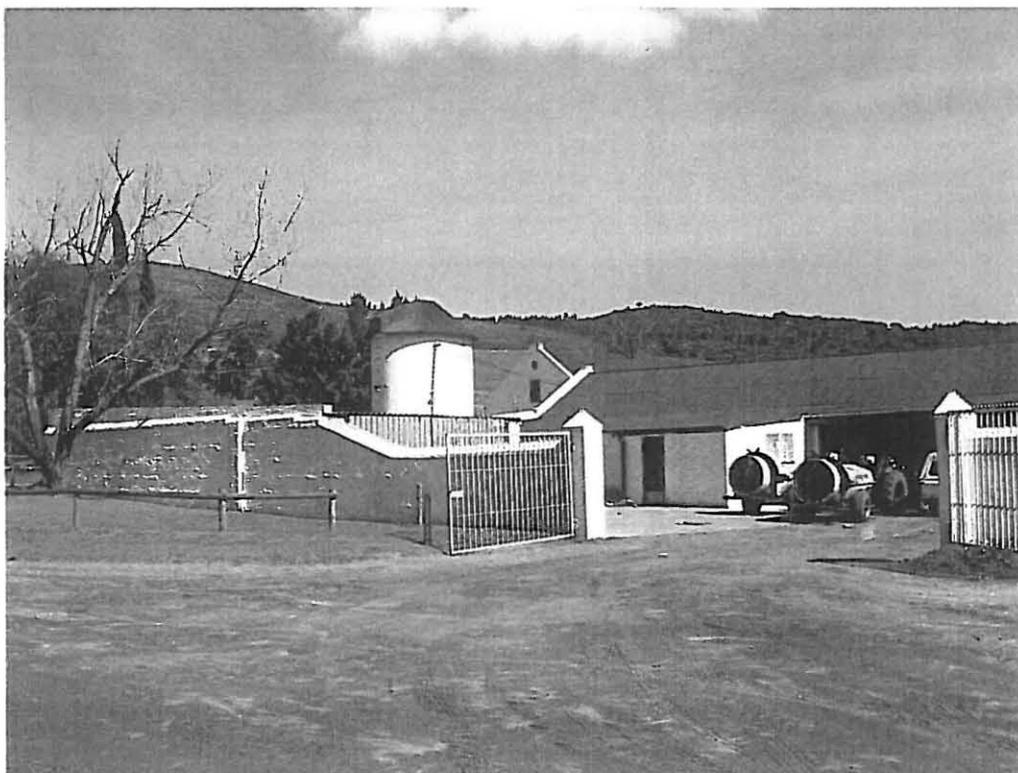
16. View towards the modern lean-to's against the Barn (centre), with >1950 high boundary walls. The site formed part of the Dairy Complex (looking W).

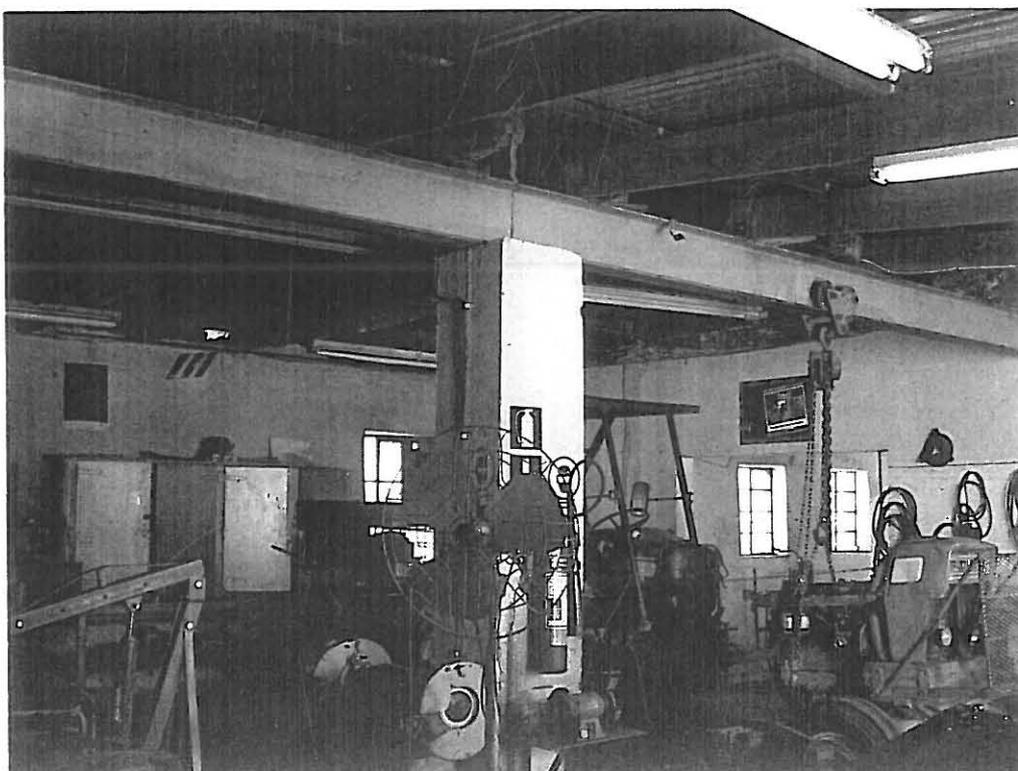
18. Room B has been particularly damaged by the workshop alterations of >1940. Nonetheless, in the rafters the old square and round beams are still in position. The wall (east) has been demolished and replaced by a yellow steel girder (looking S).

19. Another view of Room B, looking west, from the lean-to. Note again the steel girder, where the exterior wall would have been.

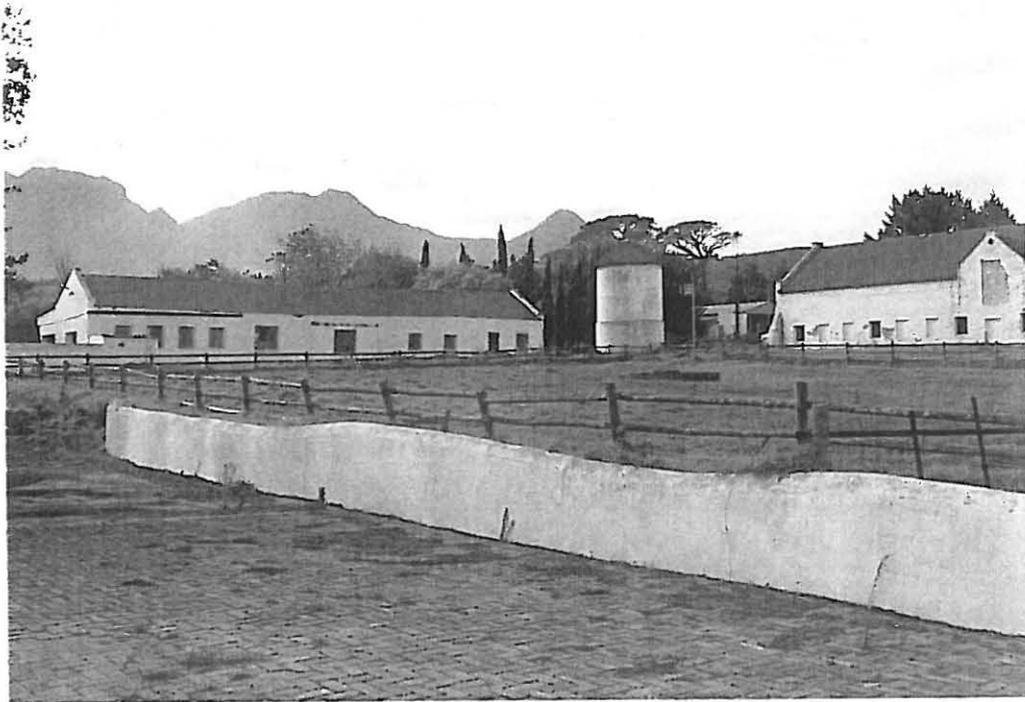
20. The long Barn with its intact walls and beams is in close proximity to the Silo and Dairy Complex. The undulating wall in front is modern and thin (30cm) (looking E).

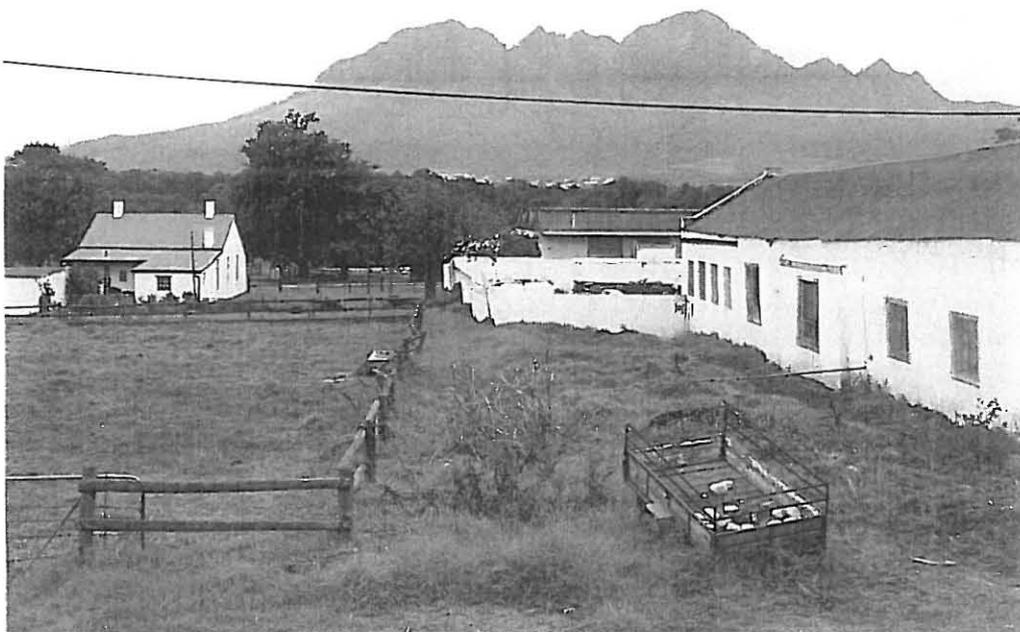
21. The old barn (right) has a modern yard directly north of it, with the Green Cottage at the approximate site of the 18th c H-dwelling (looking N).

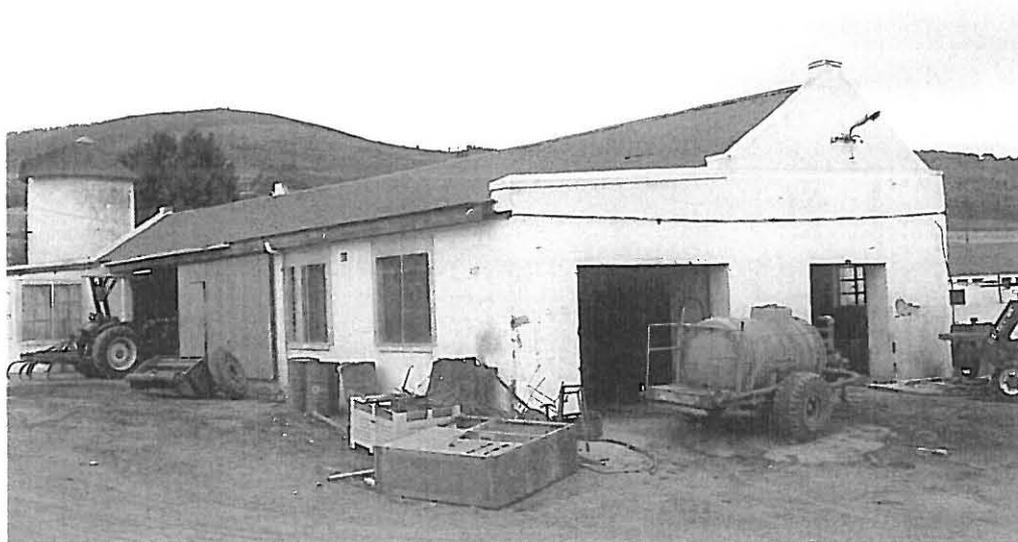
22. In this view of the Barn, the lean-to on its eastern flank, gives the impression of a much bigger building. Note the steel windows in the lean-to (looking S).

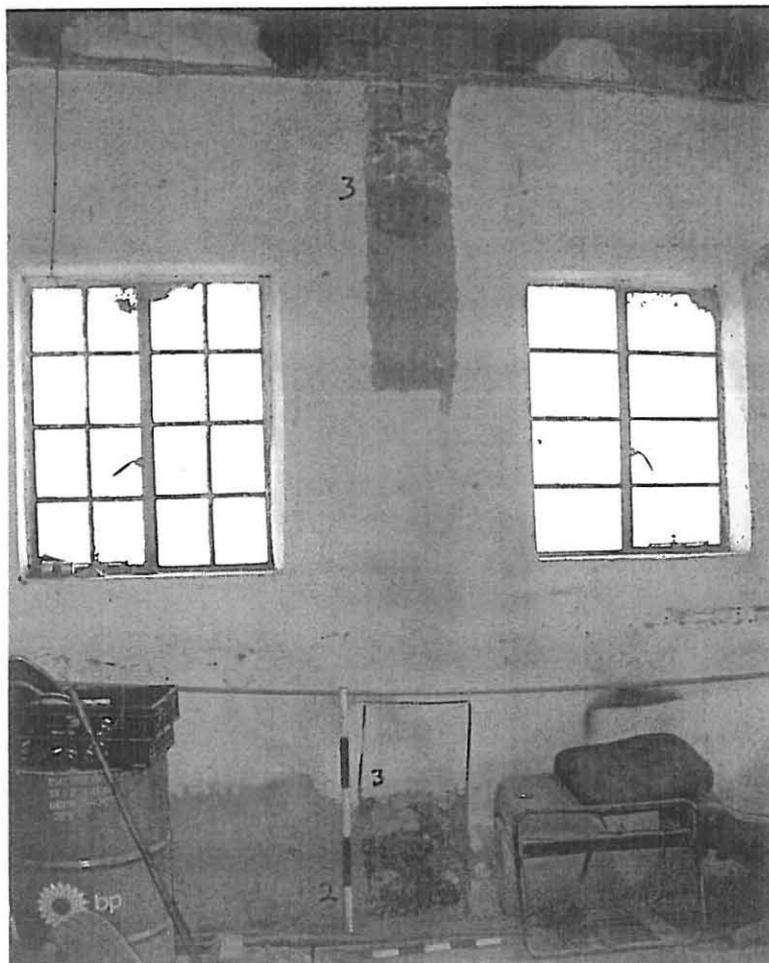
27. In Room A the steel windows (>1940) are regularly spaced in the old 52cm wall, cut into the 18th c ferricrete wall. Earlier openings are likely. Above the alternate beams the ceiling boards are absent (looking NW).

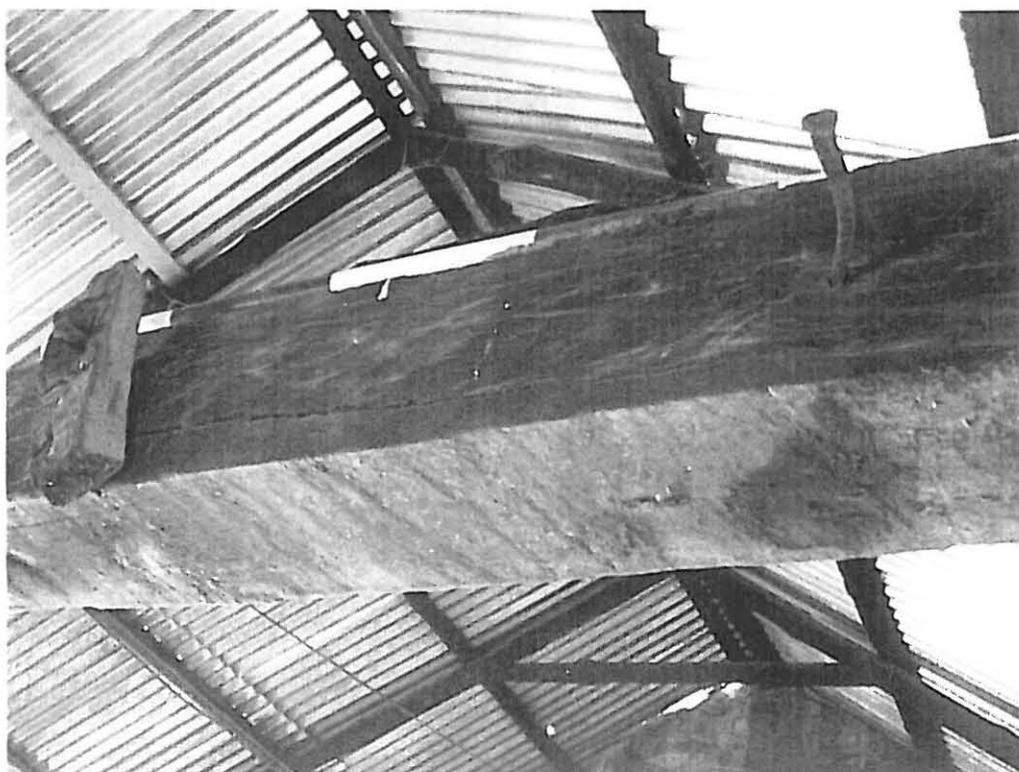
29. In Room A the alternating beams (square and round) give an indication of how intact the old Barn is (looking N).

30. Close-up of a square beam with an old nail (right) and a piece of wood, also with a nail. Note the "sawed" marks at the base and the blackened blotches (Room A).

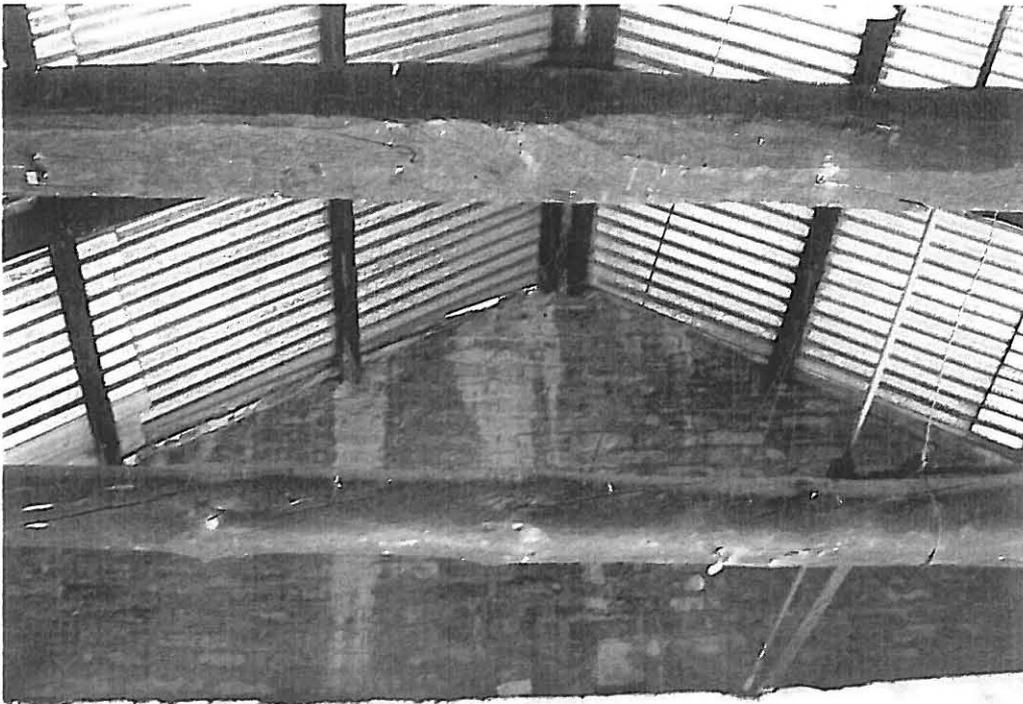
31. The end gable of Room A2 has been rebuilt in modern brick (>1960) (looking N).

It is not certain why the endgable A2 was rebuilt. I presume when the corrugated roof was put up, a gable was in existence (19th c). When the new garage door was broken in (>1940s), the gable may have partially collapsed or was intentionally demolished. A new brick and cement gable was drawn-up.

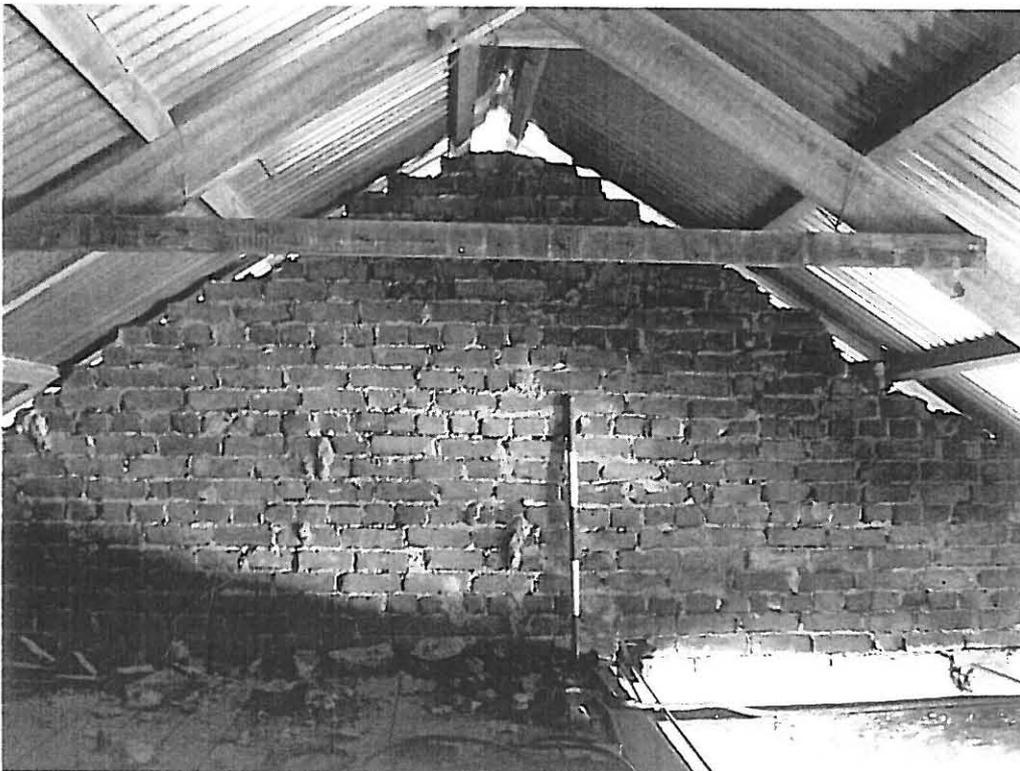
32. In Room B2, the dividing wall is also in modern brick and cement mortar (scale 1m) (looking N).

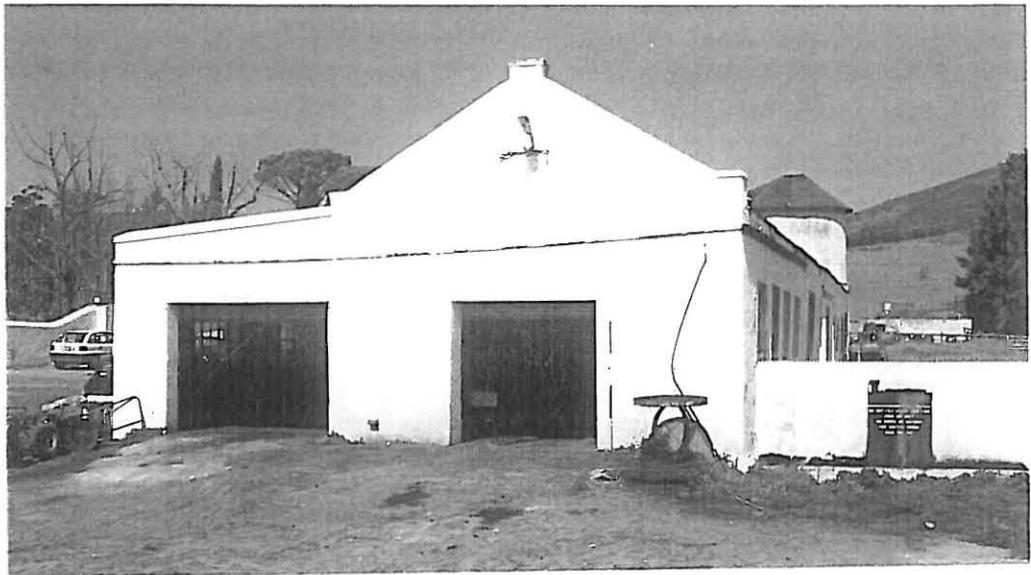
1. The endwall in Room A2 is built in stone and the small exterior plaster strip revealed a large granite stone, indicating possibly a wall built in dressed granite, or of granite/ferricrete. The garage door opening is of 1940s with modern brick as reveals. Was there an earlier door or coach-door opening? The fact that granite is used here, while ferricrete in the rest of the building may indicate an early opening (18th century). But post the ferricrete period. A large portion of wall A3 has been demolished, but the extant portion indicates a solid wall, as the "back" of the building. The upper portion of the upper gable A2 is in c.1940 brickwork.

33. A clear view of the modern northern coach-door entrances of the Barn (scale 2m) (looking S).

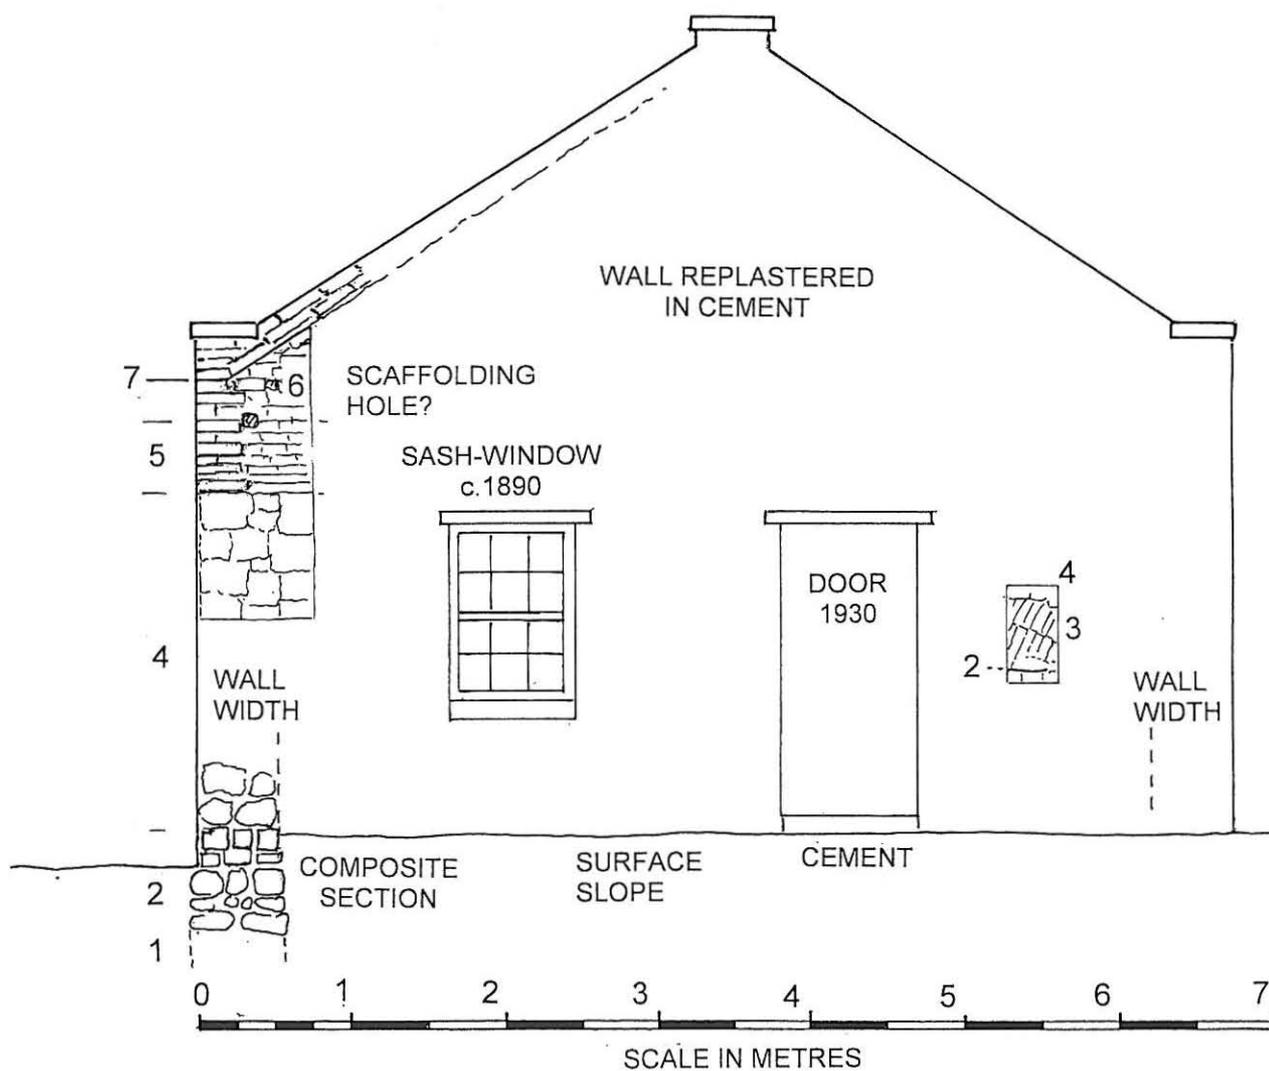
HARMONIE BARN
SOUTHERN ENDGABLE
LOOKING NORTH

FIG.20 Exterior wall elevation of endgable EF4 with a section of the possible oven on the right (looking N) (Vos 2009).

2. **Wall EF4** is of greater interest (**FIG.20**). Some plaster has been exposed on the **exterior** only. Once again the ferricrete is built-up to an height of 2.75m (same as in A3). Note that the old exterior surface is filled up with 25cm of gravel clay, which prevents one from observing any old artefacts or cobbling. The sash-window and door are of 19th/20th century, but earlier openings are possible.

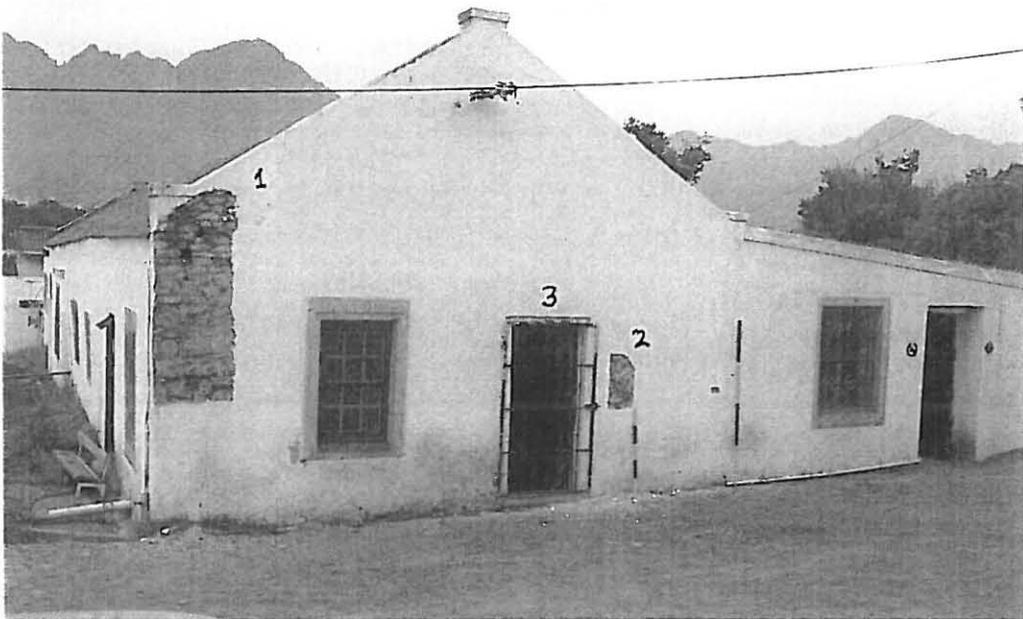
35. View of the southern endgable, with some plaster stripping visible.
(Compare with FIG.20)

1. left corner
2. oven area
3. Door leads to the electrical Room F
(scales 2m, 1m)(looking N).

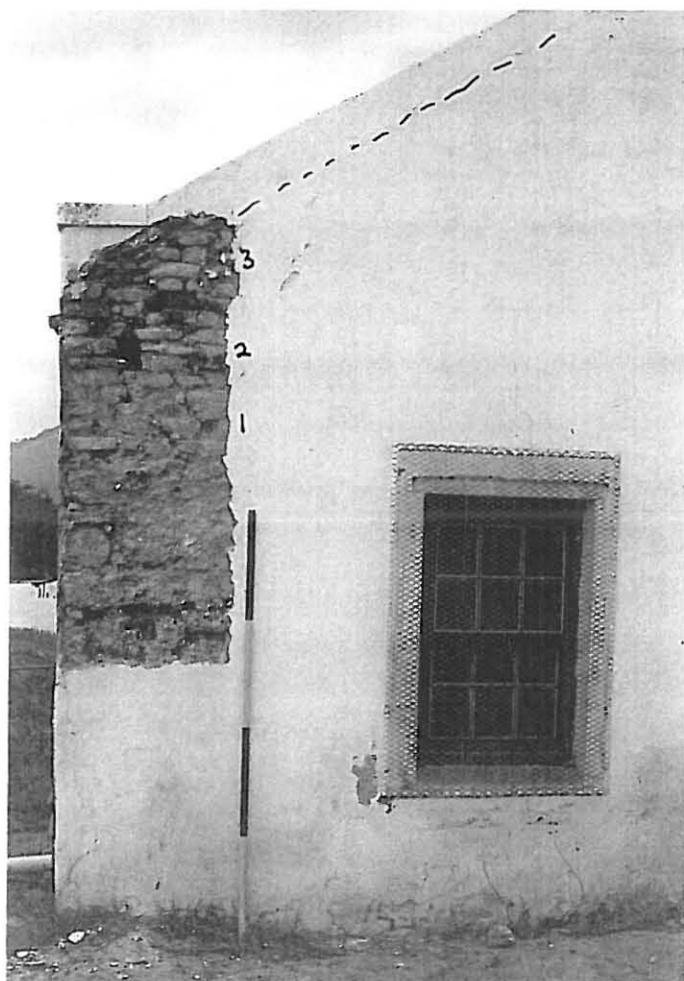
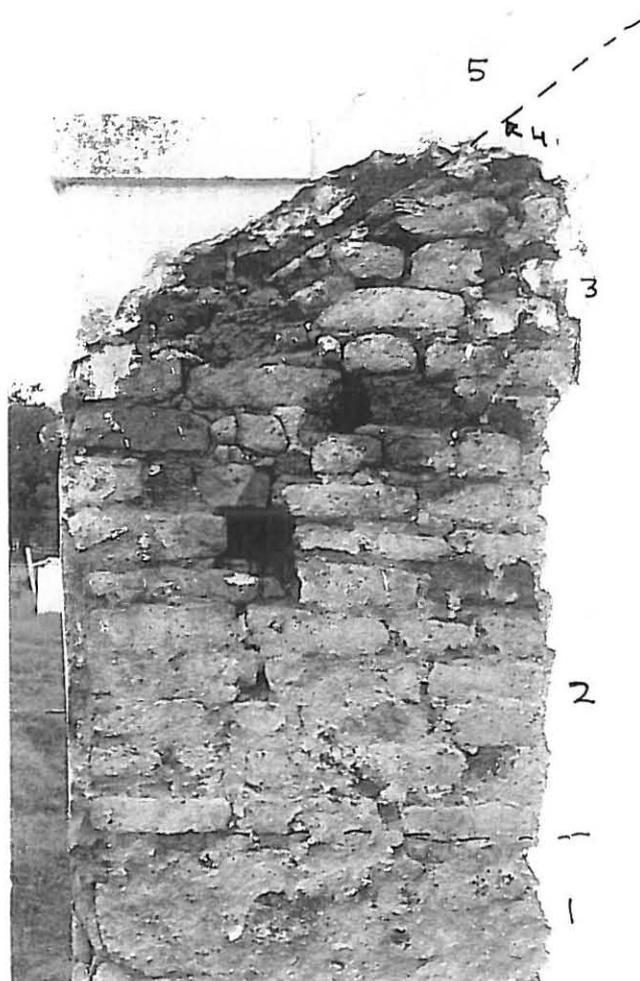
39, 40. The corner of the endgable reveals:

1. Ferricrete.
2. Thin brick layers.
3. Thick brick layers (hole = scaffolding hole?)
4. Plaster line of 40°.
5. Brick at 40° parallel to gable line.

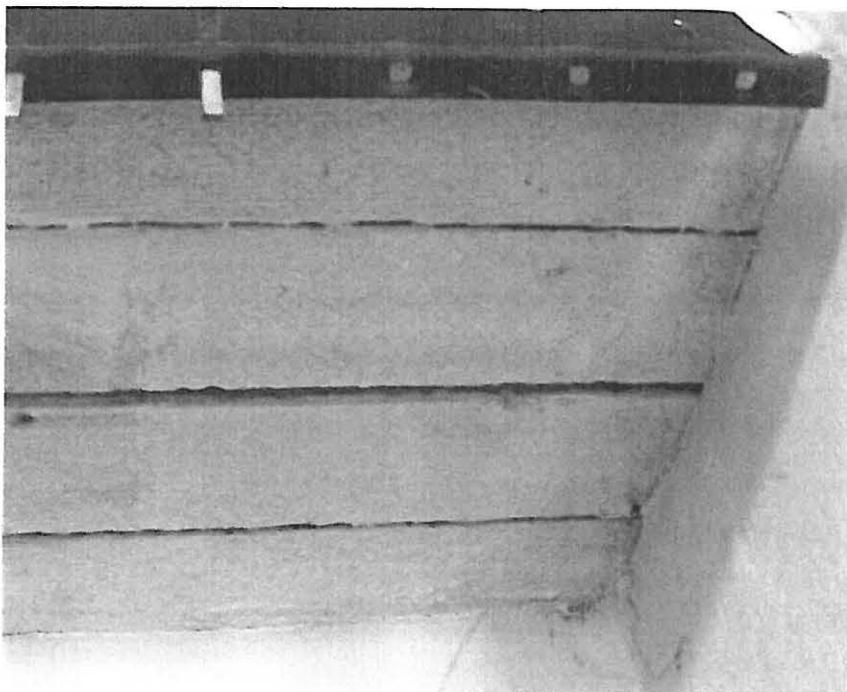
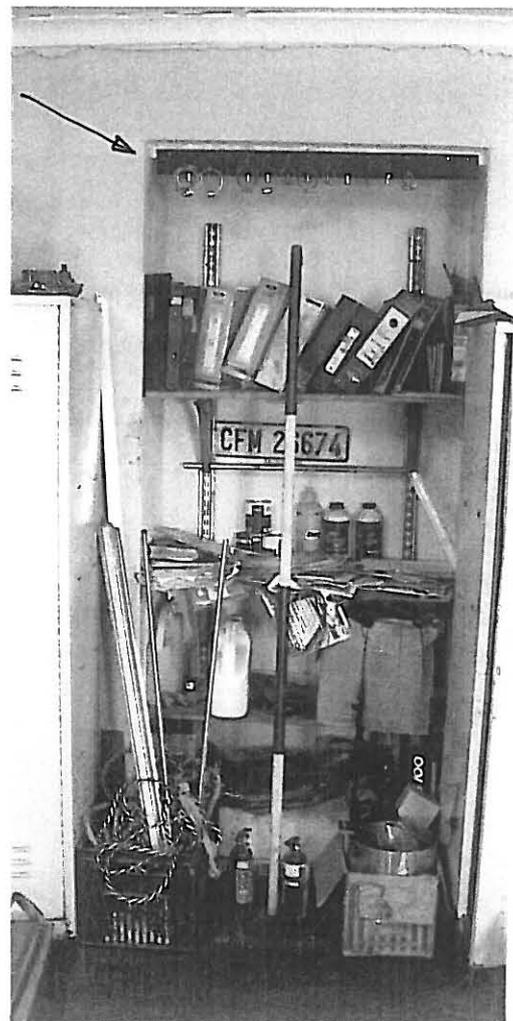
41, 42. The only exterior door opening (19th?) (Room C3) is narrow and blocked-up, with a lintel consisting of 4 pine panels (scale 2m) (looking E).

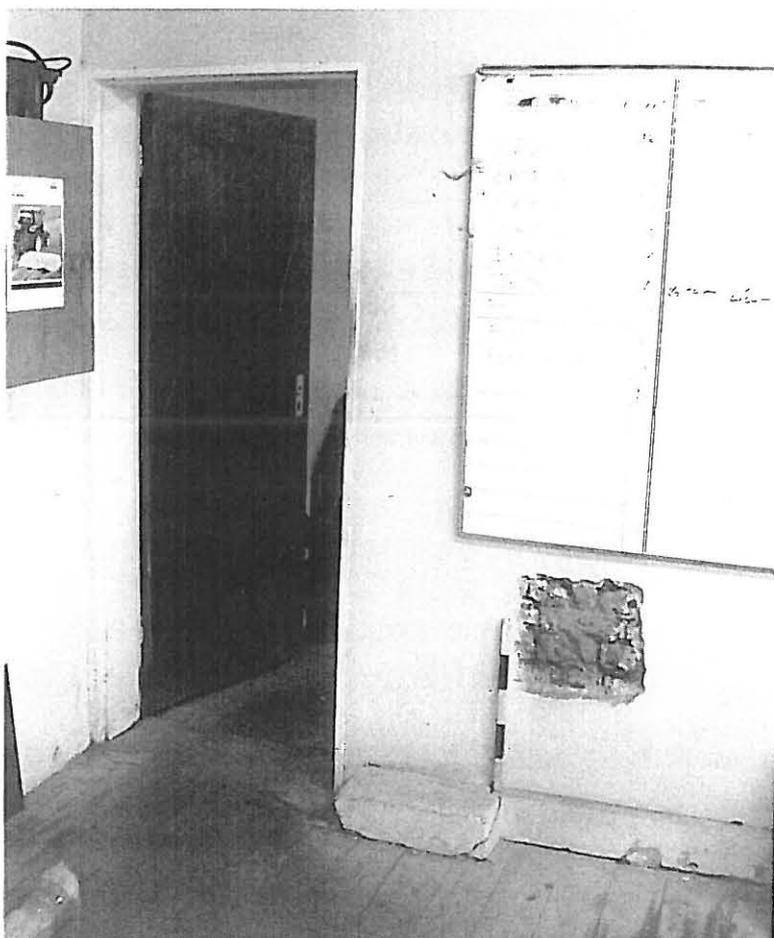
3. Only the **dividing wall C4** (28cm) is of the 18th century, built in brickwork with heights of 65 to 75mm, indicating brickwork of about the mid 18th century. An older door opening is blocked-up. This wall may originally been solid with no openings.

43. Also in Room C4 is a dividing wall of 18th century, built in mud brick and mortars. It constitutes the only old interior wall (scale 50cm) (looking S).

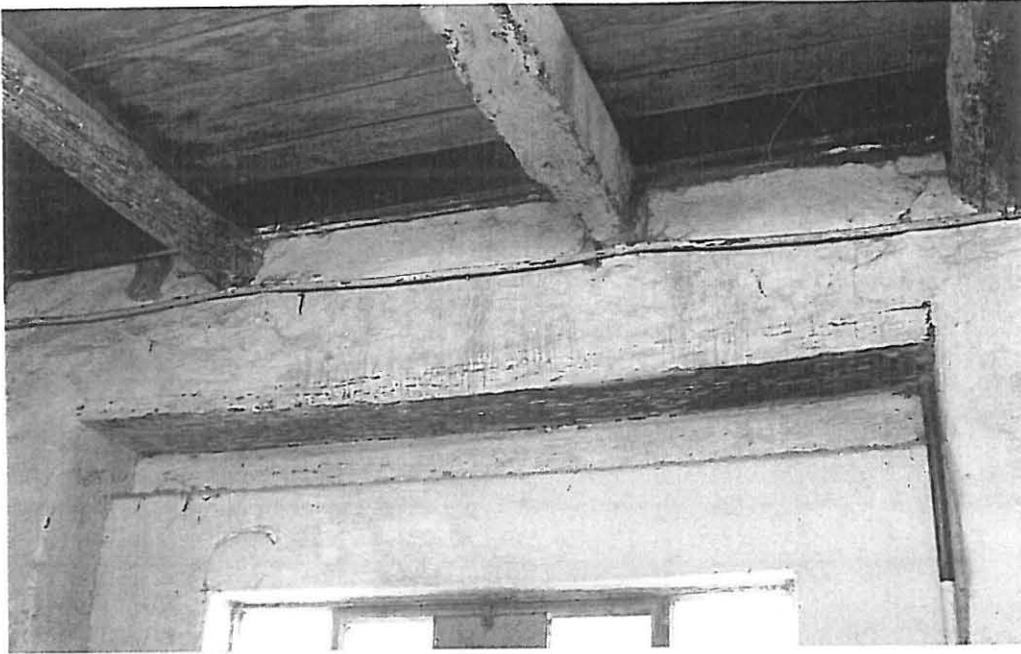
44. Close-up in Room B1 of the 18th century lintel of the coach-door (looking W).

1. In its present state, the Barn is relatively stable, except for **wall B1**, where the coach-doors are situated. As none of the 10 beams are anchored on the eastern side (rest on a c.1990 steel beam), the roof forces are pushing this portion over. The water from the tin roof falls directly against the wall and on the clay soil. Cobble foundations in clay thus are plastic and facilitate movement of the wall. The engineer should make effective recommendations (Gutter, anchoring of beams, slope soil away from building, etc.).

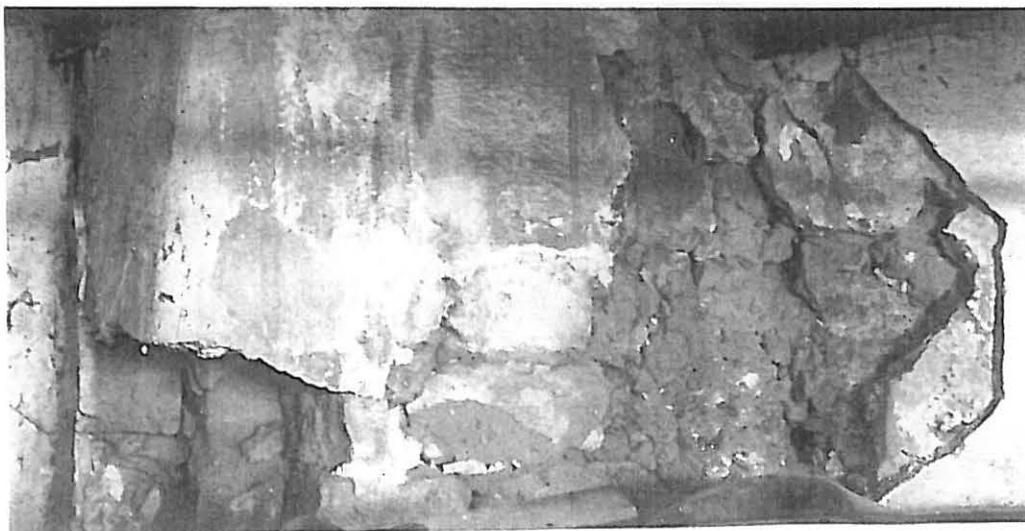
46. Below the work bench, the reveal of the coach-door shows brickwork in brown mortars (late 18th c, used to line the reveals of the ferri-crete walls (looking W).

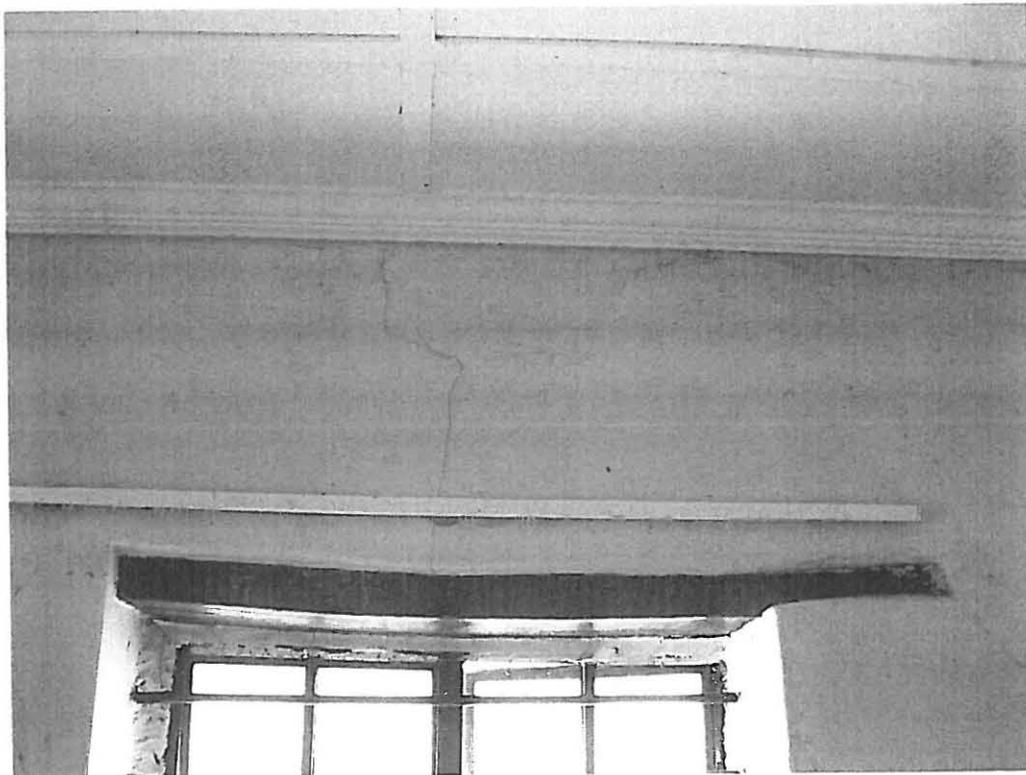
48, 49. In Room D1 another old, plain lintel (18th c) is to be seen above a steel window. Whether the lintel is *in situ* can be determined by plaster stripping (looking W).
