HARMONIE FARM 744
PORTION OF VERGELEGEN, SOMERSET WEST
HISTORICAL SURVEY AND STRUCTURAL INVESTIGATIONS
OF THE 18th CENTURY BARN (WORKSHOP)

JUNE 2009

Report Prepared for
NICOLAS BAUMANN & SARAH WINTER
Heritage Resource Consultants
P.O. Box 281 Muizenberg 7950

Prepared by
HENNIE VOS, MA
Historical Archaeologist & Consultant
ARCape Consultancy
P.O. Box 379 Stellenbosch
(082-217-0032 Fax 021 889-8956)

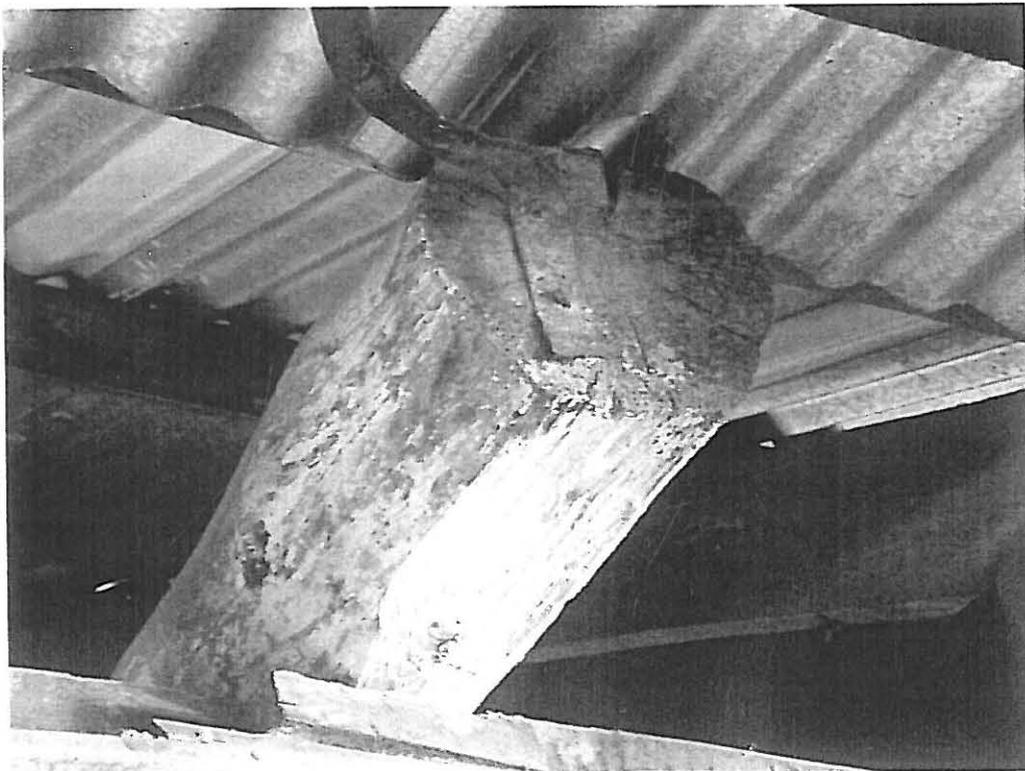
50. In Room B the loft (razed by an earlier fire) has been replaced with pine boards of the 20th century. Note the alternating poplar and square beams, all showing signs of fire soot (looking N).

51. End piece of a poplar beam, but loosely resting on the steel girder (Room B).

1. In its present state, the Barn is relatively stable, except for **wall B1**, where the coach-doors are situated. As none of the 10 beams are anchored on the eastern side (rest on a c.1990 steel beam), the roof forces are pushing this portion over. The water from the tin roof falls directly against the wall and on the clay soil. Cobble foundations in clay thus are plastic and facilitate movement of the wall. The engineer should make effective recommendations (Gutter, anchoring of beams, slope soil away from building, etc.).

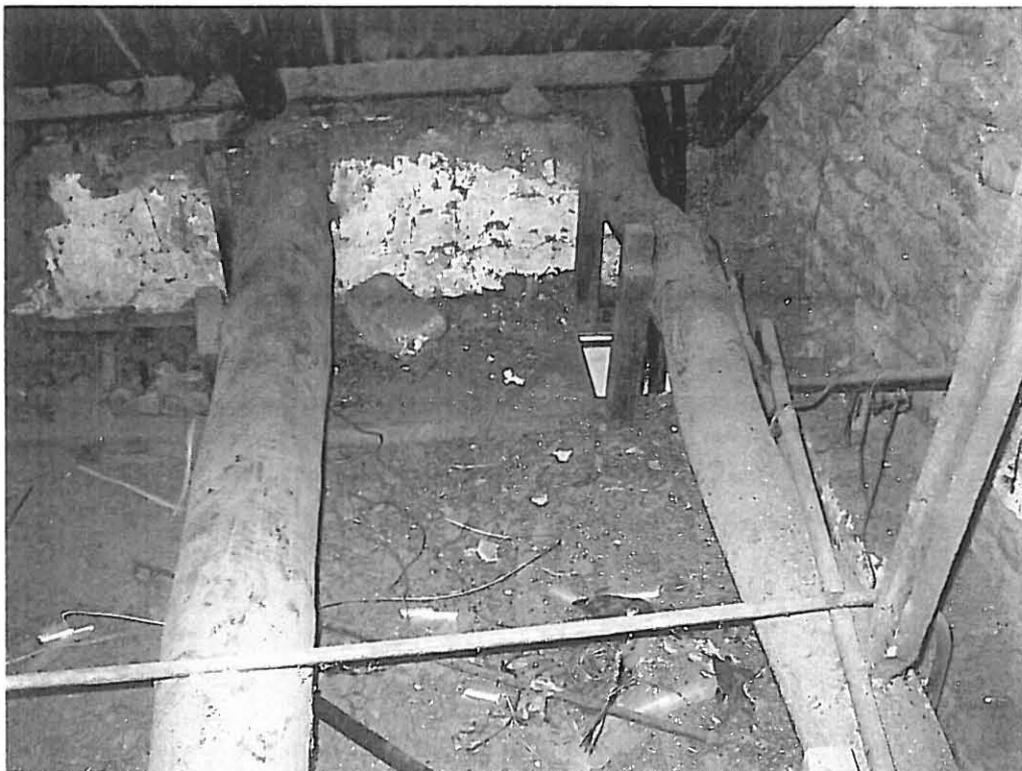
54. In the loft above Rooms DEF, the large and thick (c.25cm) poplar beams are discernable (looking S).

55. Against the endgable corner (E3/4) the thick beams are level with the eaves, built-up in brick, plastered and white-washed (looking E).

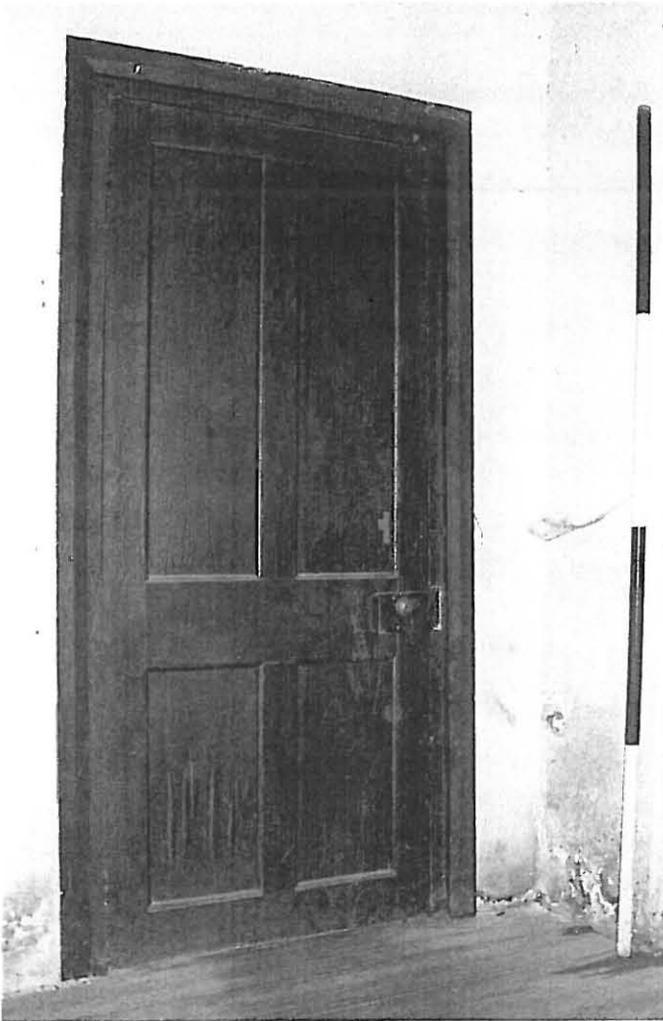
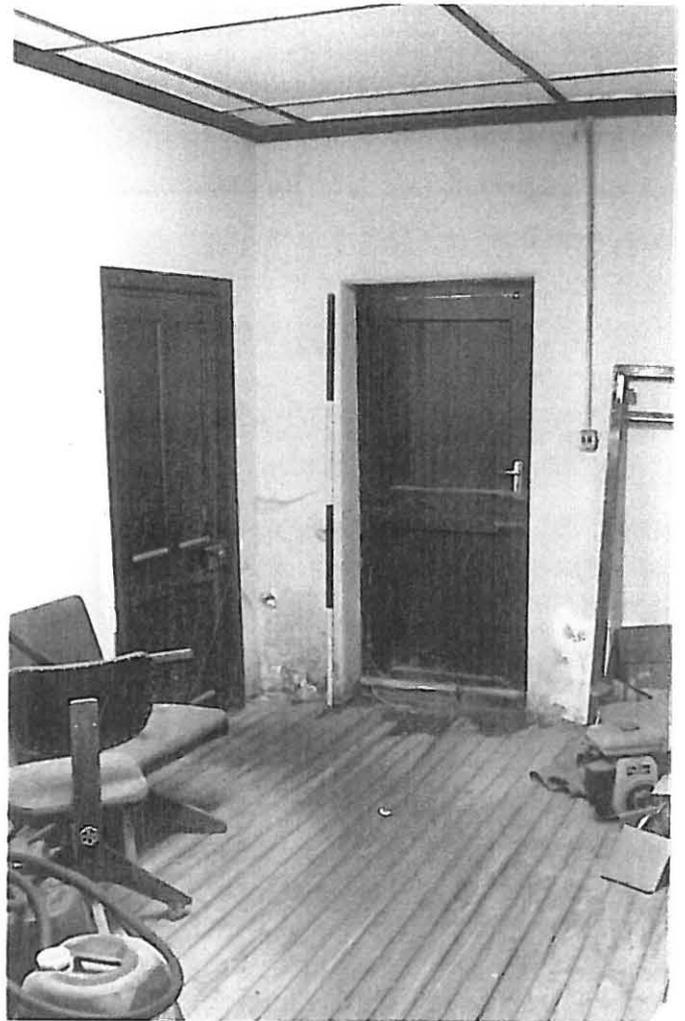
60, 61. The left door, 4 panelled, is of late 19th century and shows signs of having been in a fire. The doorknob and lock is typical.

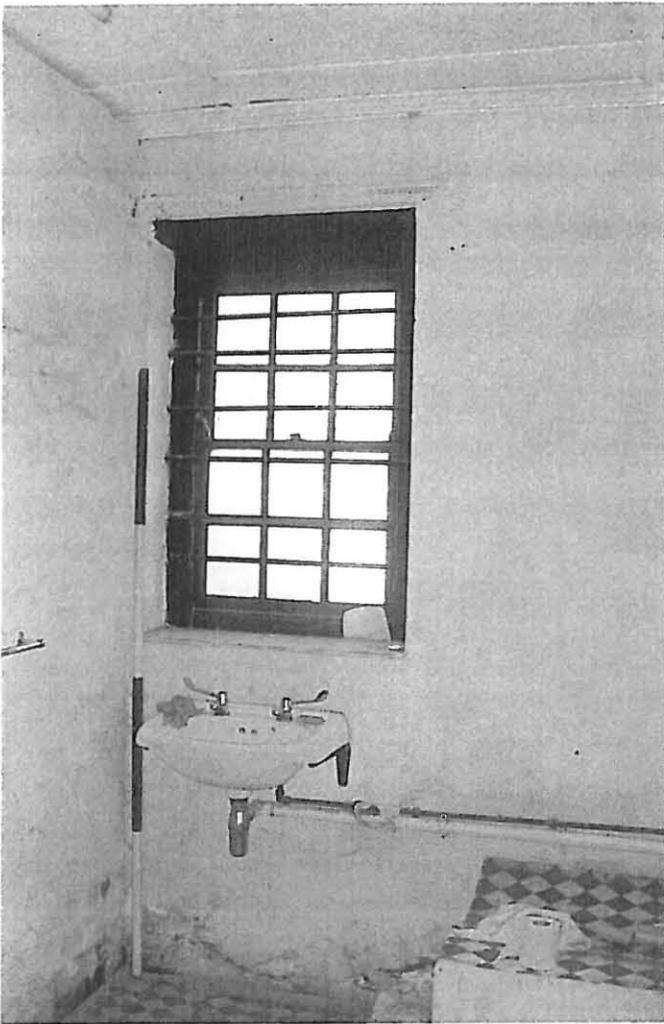
62. The sash-window (c.1880) has been reutilized in this portion (E4) (scale 2m) (looking S).

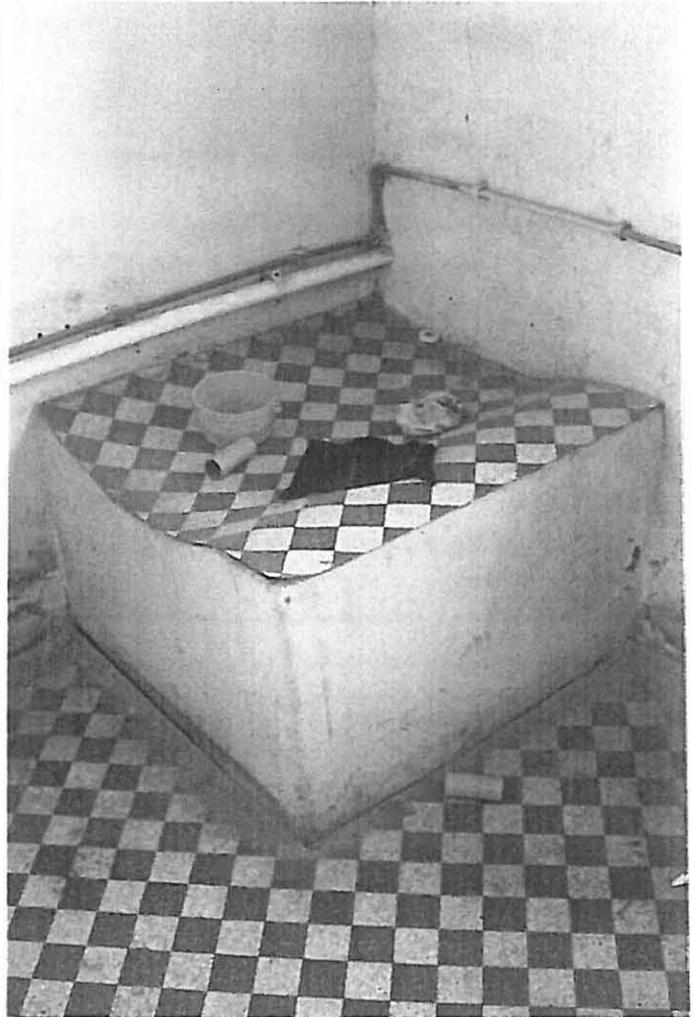
63. A wash basin / washing area(?) is seen on the right side.

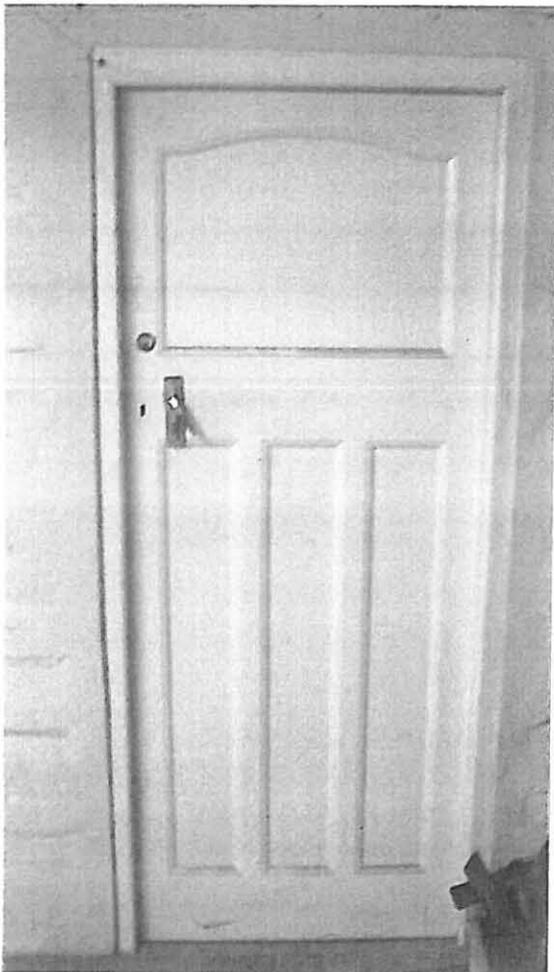
64. A reused door of the 1930s is found in the lean-to J3 (looking E).

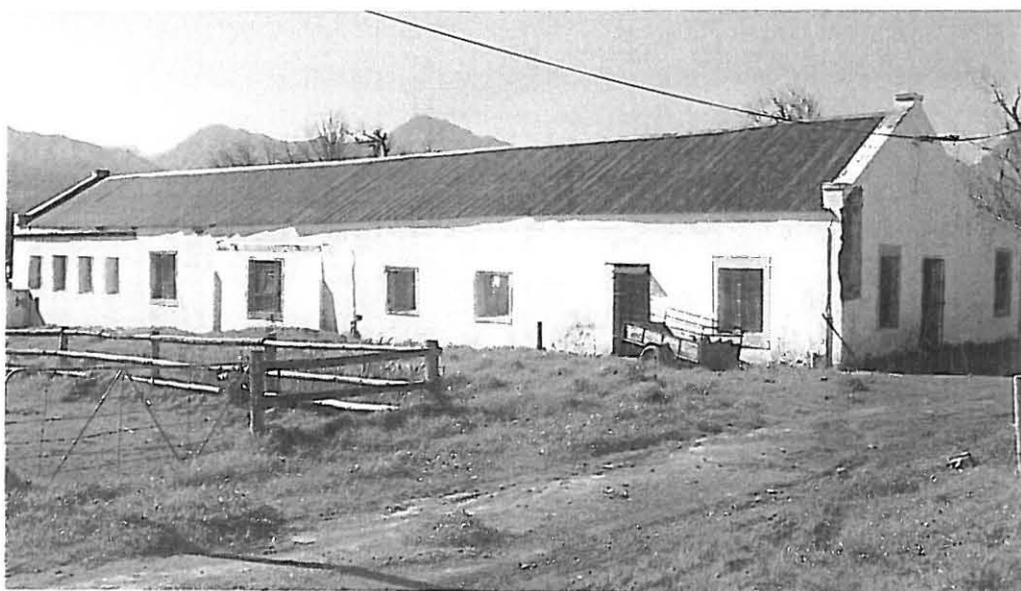
65. Practically all windows (steel-framed) on the western side of the Barn have been installed during the 20th century (looking NE).

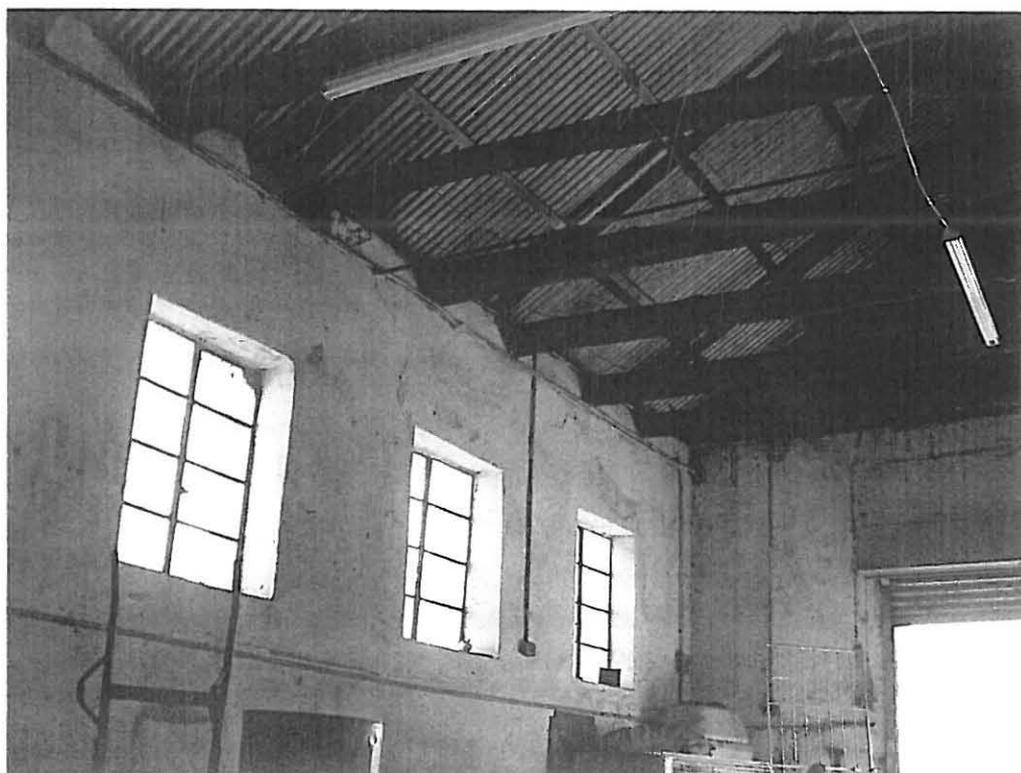
66. The four steel-framed windows in Room A1 date all to about 1940s (looking NW).

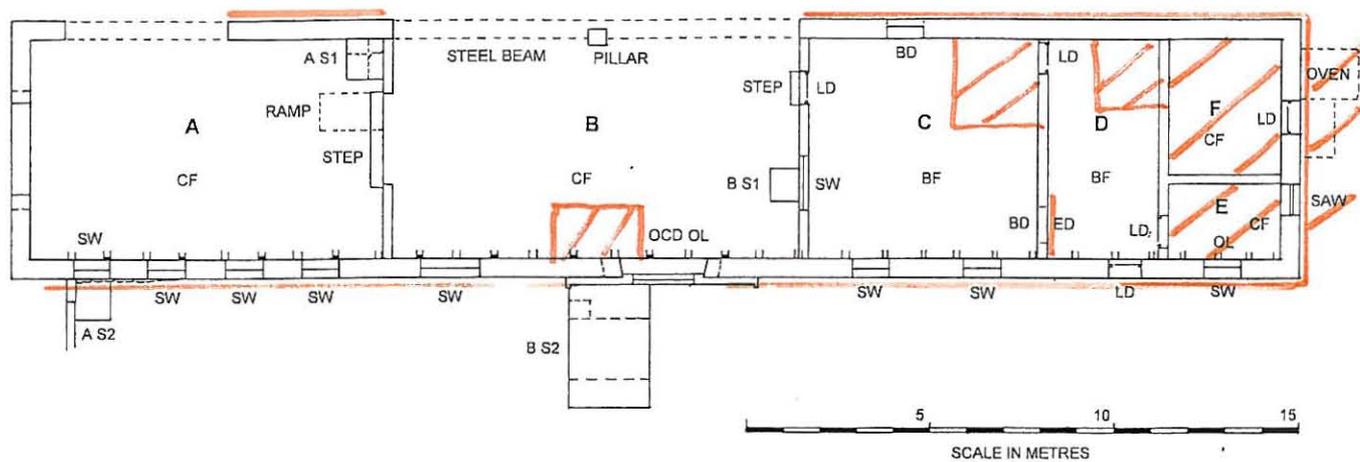
HARMONIE BARN
SITE PLAN 2009

FIG.22 Site plan of the Barn with indications of plaster stripping and excavations to establish more definitive answers on the building's development.

4.2 With the limited access to original fabric, the existing report could not answer definitely on function, fenestration and the Barn's development. To this end it further excavations and investigations are recommended (**FIG.22**).

- .1 Plaster stripping in a narrow band on the walls in order to locate earlier openings.
- .2 The form and size of such openings will date the building more accurately, as well as in determining the function of each part of the building.
- .3 Excavations of the floors in DEF are recommended, as Kitchens supply the most information.
- .4 The exterior area of the bakoond (DE) would be important for investigation.
- .5 Finding the original kitchen door would indicate the area of rubbish scatters or deposits.

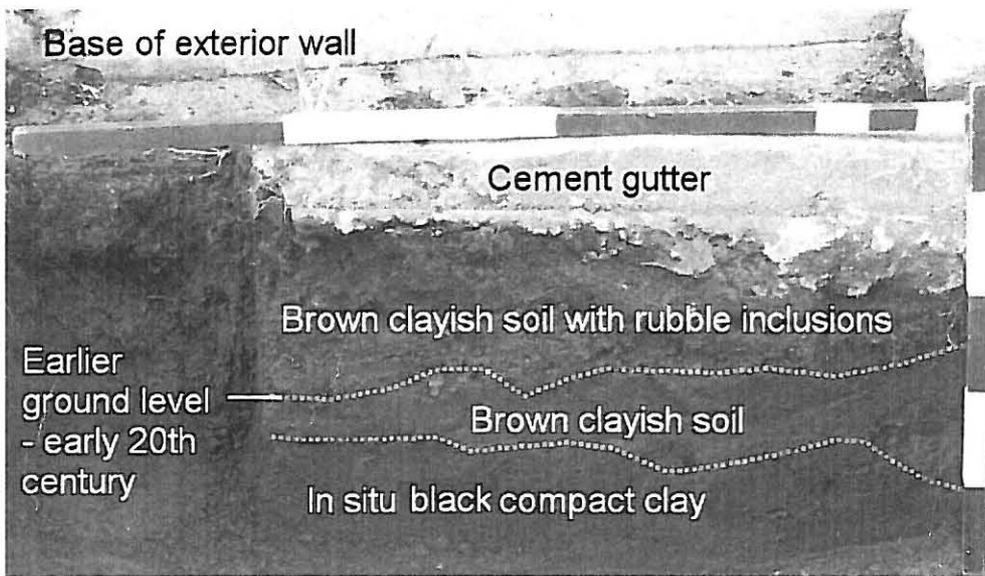
Test Section B1: Exterior of the building (SW wall) opposite built-up Doorway / *waenhuis* entrance.

Excavated 450mm away from the SW wall of the barn, along the cement gutter. The area to the south of the test excavation had cement surfacing. In September 2008, in response to the recommendations of the structural engineer, considerable soil overburden and grass was removed from this area, revealing the cemented surface.

In situ clay occurs 320mm below the cement gutter.

69. Test section B1 on the exterior, is in relation to the gutter furrow and next to the blocked-up coach-door (scales 1m, 50cm) (looking SE)(Vos).

4. The archaeological sections (A3/4, B4) should be filled up with builder's sand and a cement topping. On the exterior the two sections (B1 and C1) should be filled with a material that prevents it as catchments of drainage water (use weak mixture of cement and sand, as per the engineer).

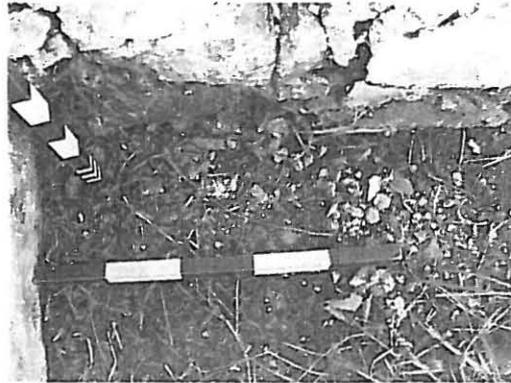
Roughly dressed sandstone was clearly visible near the base of the wall, appearing to form a plinth.

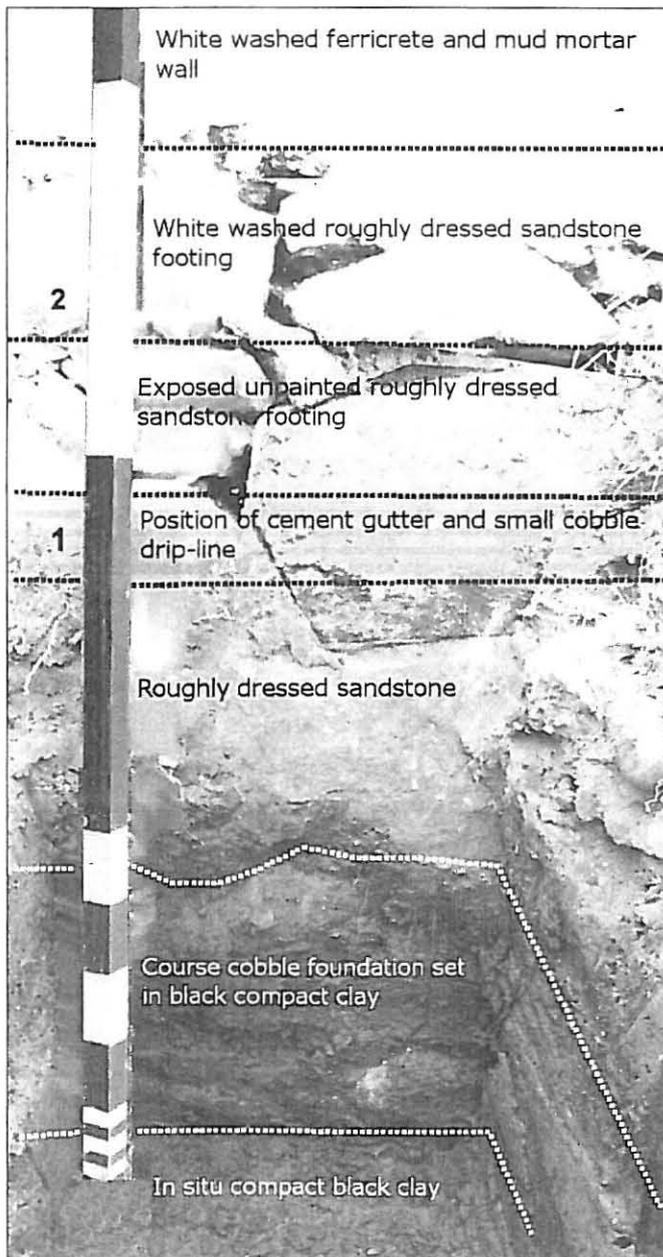
This test pit was excavated to the base of the foundation to a depth of 830mm below the present surface level.

As with the other test pits, the foundation was set in the hard compact black clay, and no artifacts were uncovered.

The foundation of the wall consisted of large river cobbles set in the black compact clay. In Test Section A1, the foundation was recessed by about 30mm beneath the sandstone.

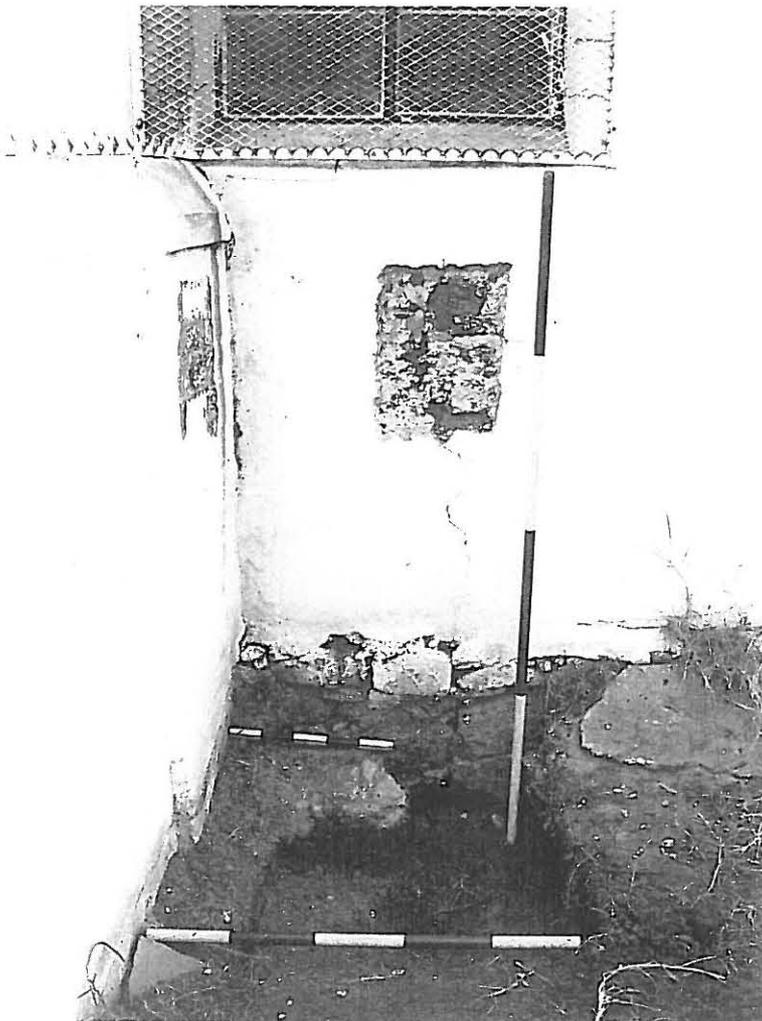
Test Section A3: Interior: motor workshop (Room A)

This test pit was situated in the E corner of the motor workshop; at the junction of the remaining portion of the NW exterior wall and an interior wall. The test revealed that the interior dividing wall A4, partially constructed of older brick, has a modern cement foundation and probably dated to the early 20th century.

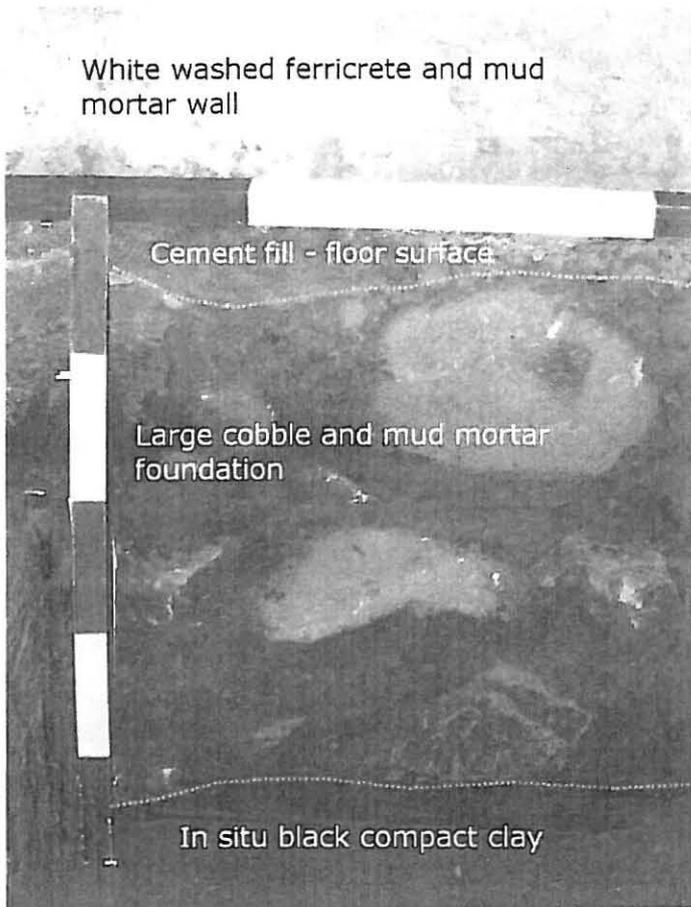
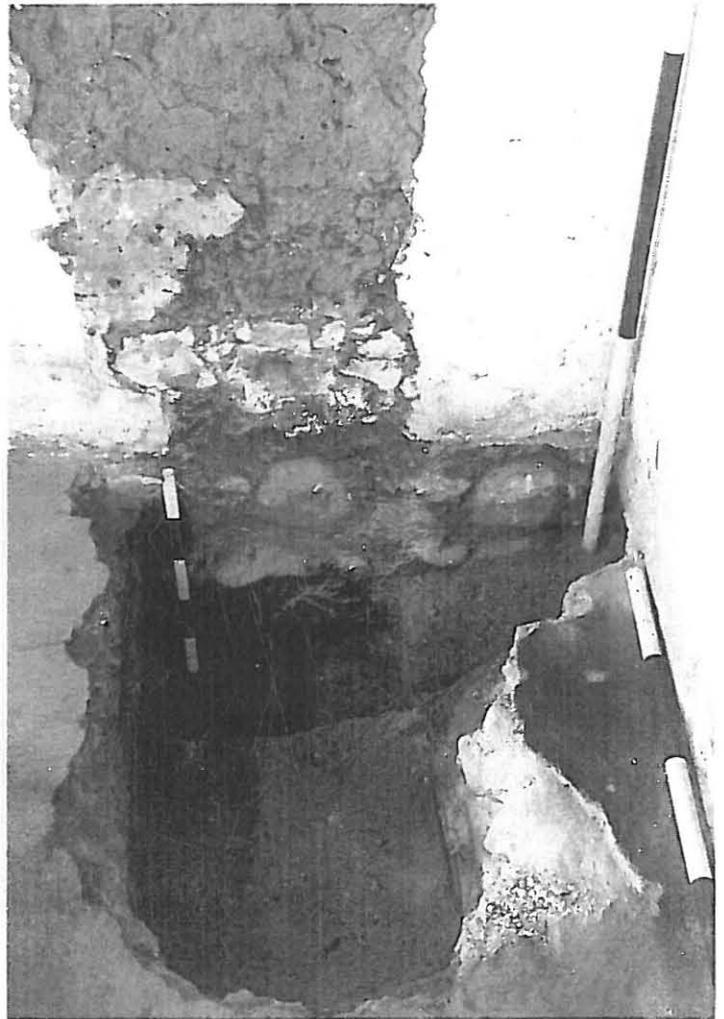
The large cobble foundation extended to a Depth of 400mm below the current floor surface. The base of the foundation was set in dark, compact black clays. No artifacts were found.

72. Test section A3, interior lower portion. The low cobbling is about 45cm below the concrete surface (Vos).

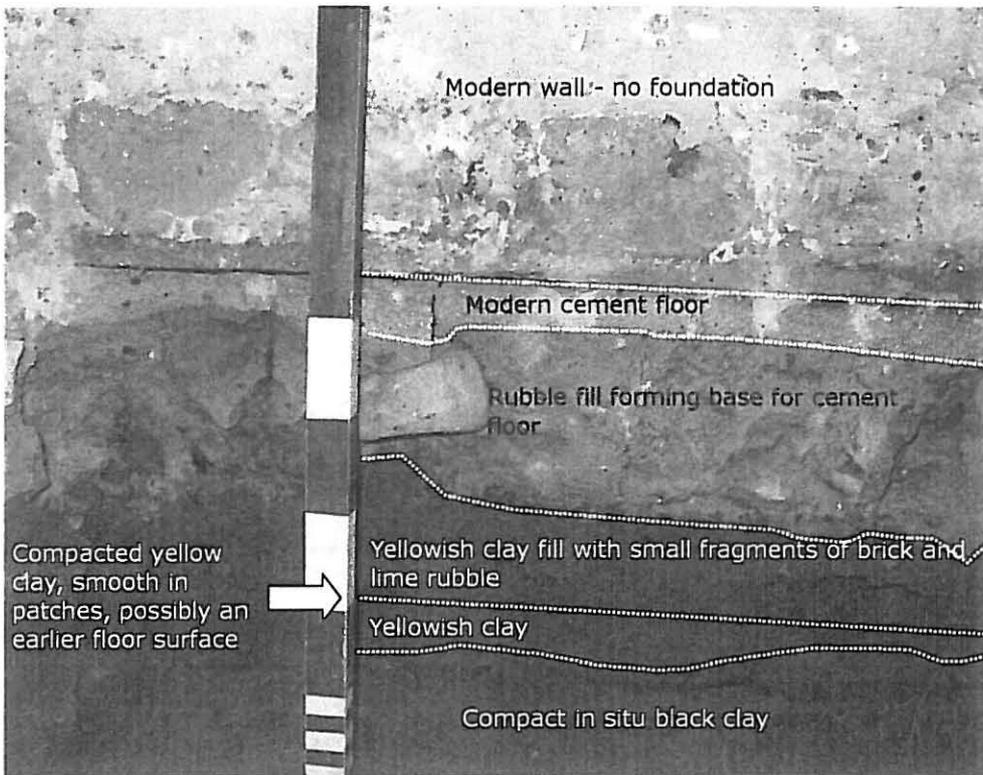
Test Section B4: Interior: Workshop area (Room B)

This test pit was situated in the workshop abutting the interior wall separating the office from the workshop area.

Test Section B4 was the only of the test pits that had a suggestion of an earlier floor surface, viz a compact yellowish clay layer in which patches were suggestive of a floor surface. No artifacts were uncovered in this test pit.

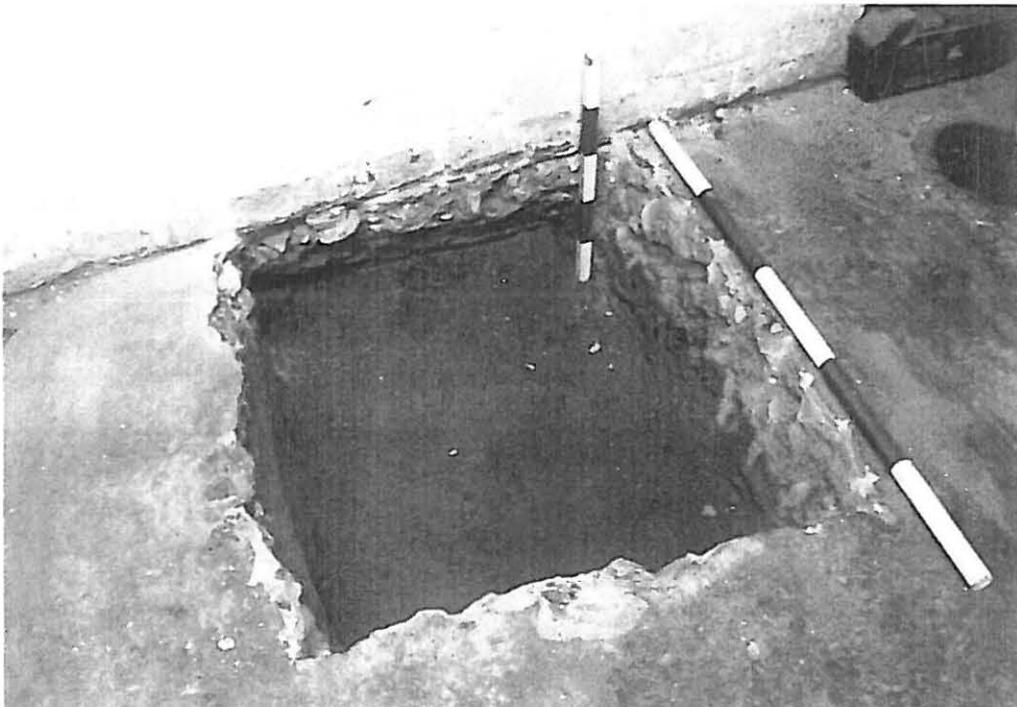
73. Test section B4 was the most informative and possibly least disturbed. Lower surface is the black clay (scales 1m, 50cm) (Vos).
