County of Pembroke

Shipwreck Report

Vanessa Maitland

**Port of Ngqura
Eastern Cape
South Africa**

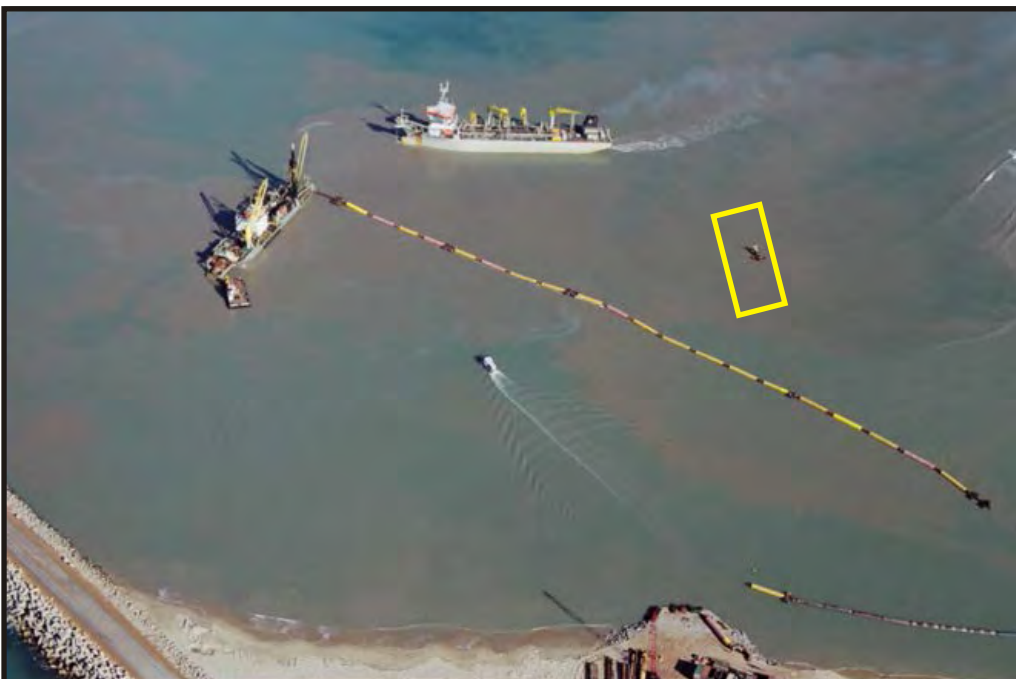
Figure 45: Aerial view of the barge anchored over the wreck site in 2004. Large dredgers can be seen working around the site. (Photo Subtech)

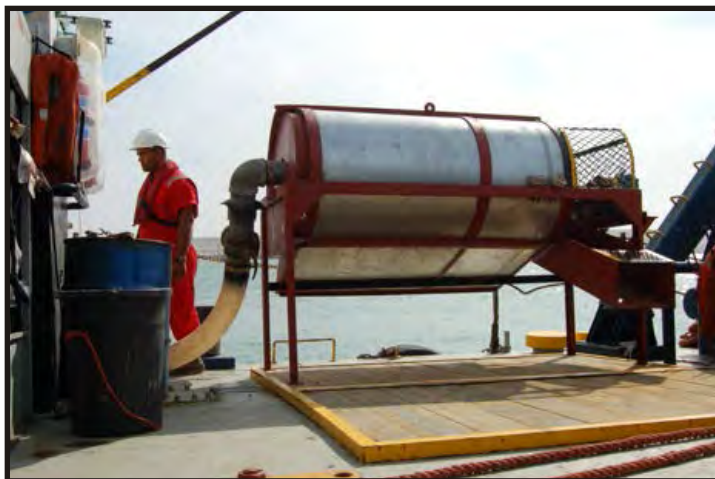
Figure 50: The 'classifier' is attached to the barge, was supposed to catch any small items dredged up. But it was not used. The debris passed through the dredge pump and the impeller broke everything up, nullifying the classifier. (Photo V. Maitland)

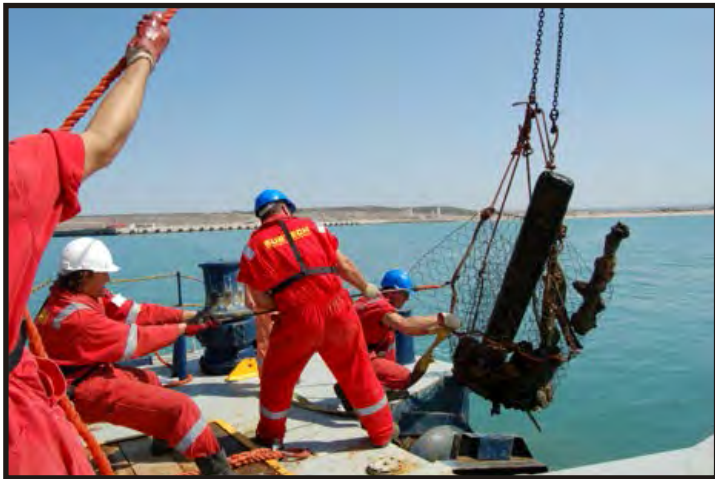
Figure 57: At first, wire gabions were used for lifting objects, however they were too weak and collapsed on retrieval. (Photo V. Maitland)

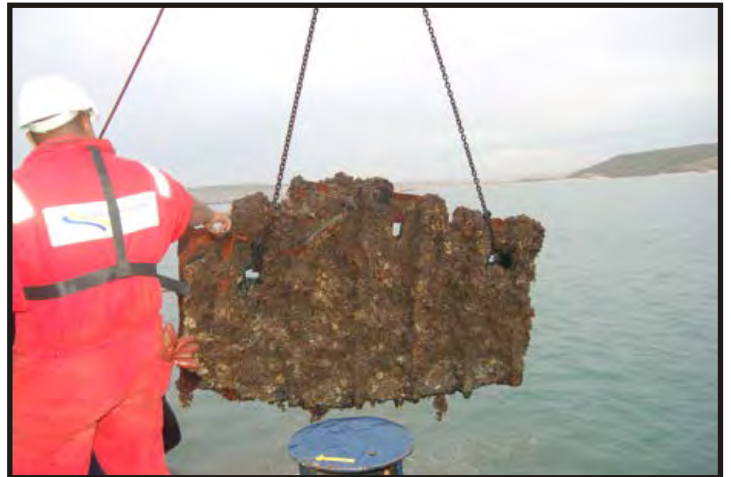
Figure 81: 2 x 3m section of side plating. The hull was cut underwater using broder rods and then lifted onto the deck of the *Ubejane*. (Photo V. Maitland)

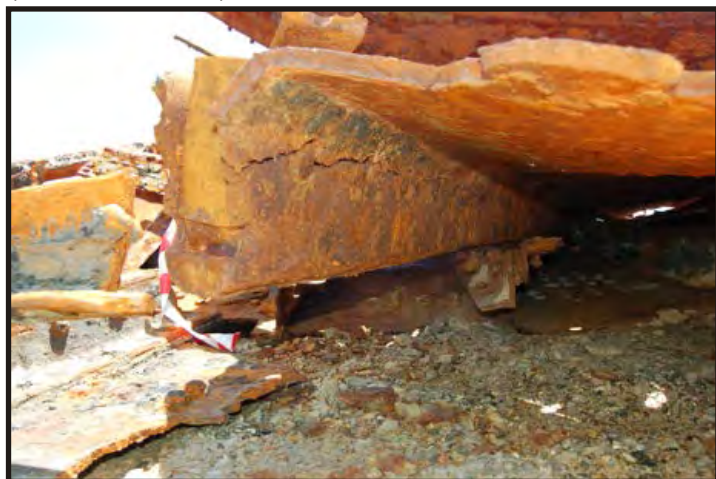
Figure 101: Bar keel from underneath, showing the corroded garboard strake. (Photo V. Maitland)

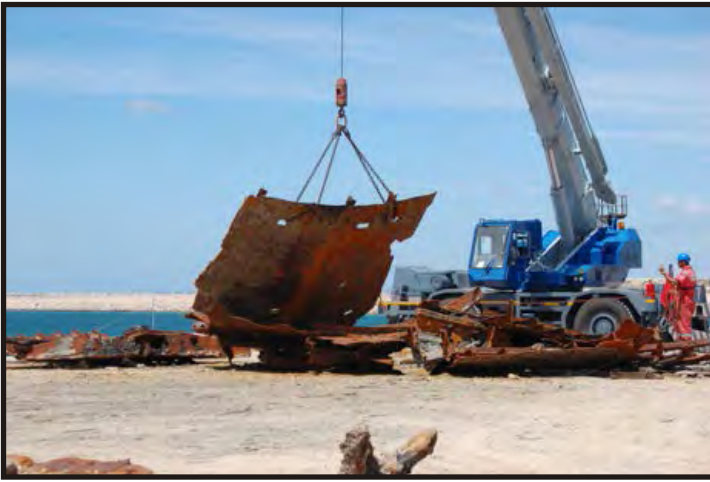
Figure 106: Section of side plating. At the upper edge of the plating, note the in-and-out system. (Photo: V. Maitland)

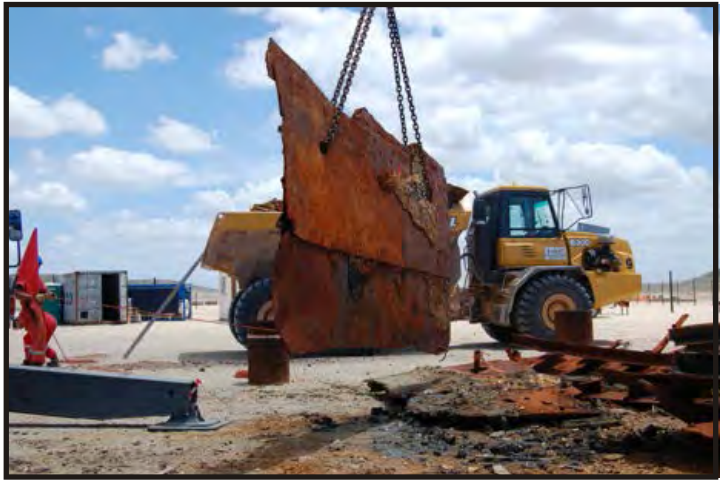
Figure 107: Section of side plating. The in-and-out system of plating can be seen. (Photo: V. Maitland)

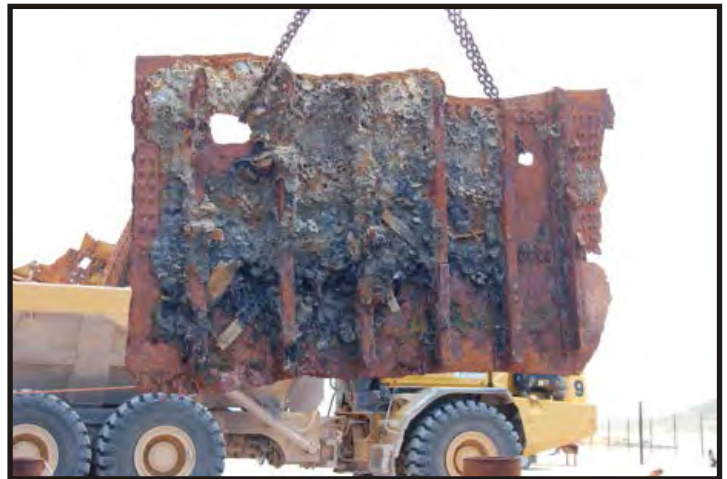
Figure 108: Side plating showing the frames and two butt straps. (Photo V. Maitland)

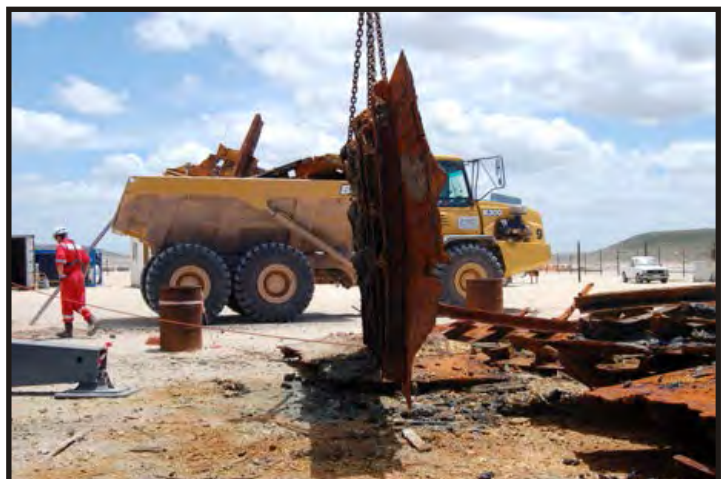
Figure 110: Side view of side plating. The in-and-out system of plating and the butt strap can be seen. (Photo: V. Maitland)

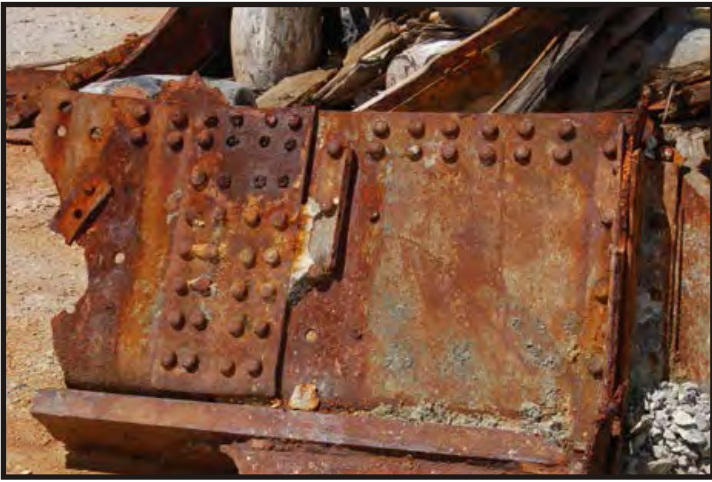
Figure 111: Section of the keel and garboard strake with a butt strap. (Photo V. Maitland)

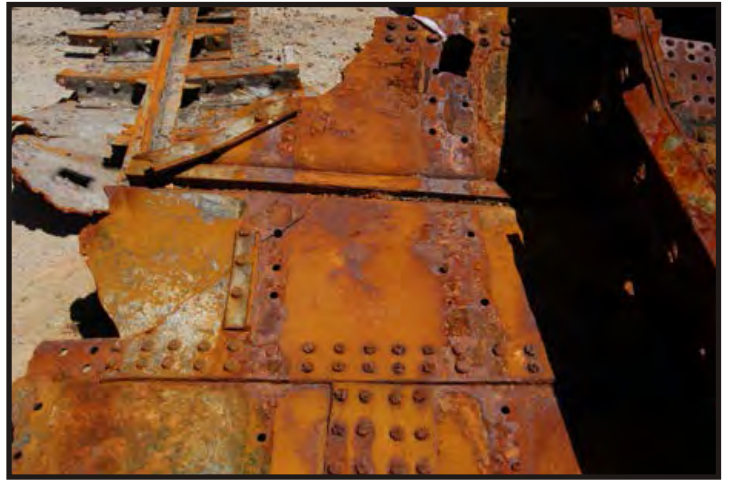
Figure 112: Section of the keel, garboard strake and keel strake with a butt strap. The joints are staggered to strengthen the hull. (Photo V. Maitland)

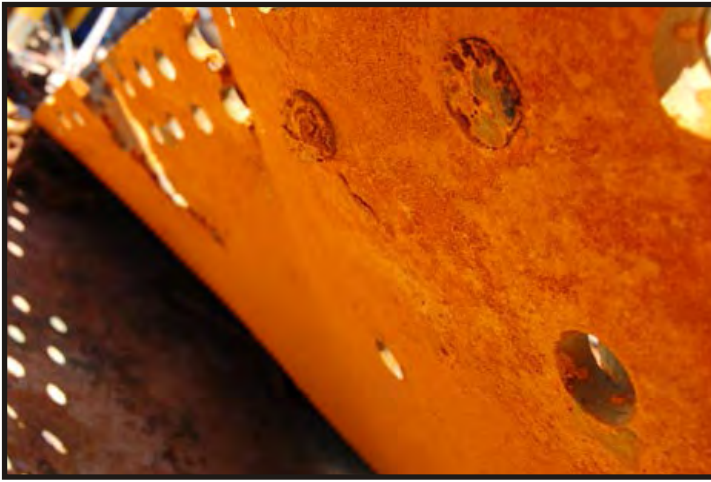
Figure 120: Flush points of pan head rivets, corrosion has bulged it slightly. (Photo V. Maitland)

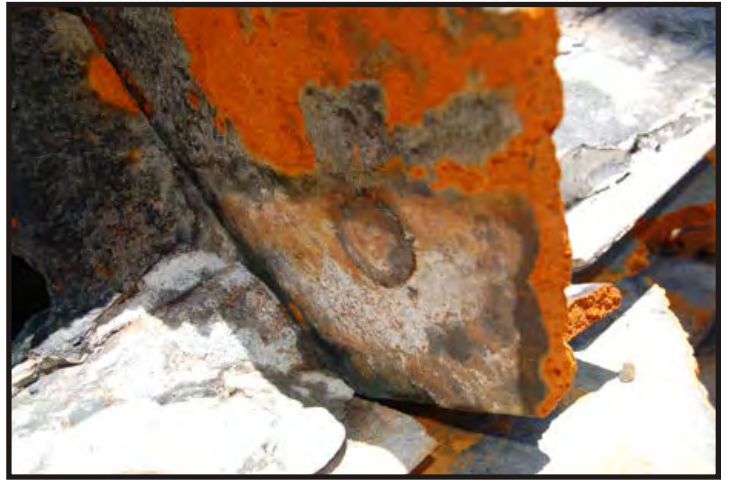
Figure 121: The point of a pan head rivet; this point is a lot less corroded and is a full point. (Photo V. Maitland)

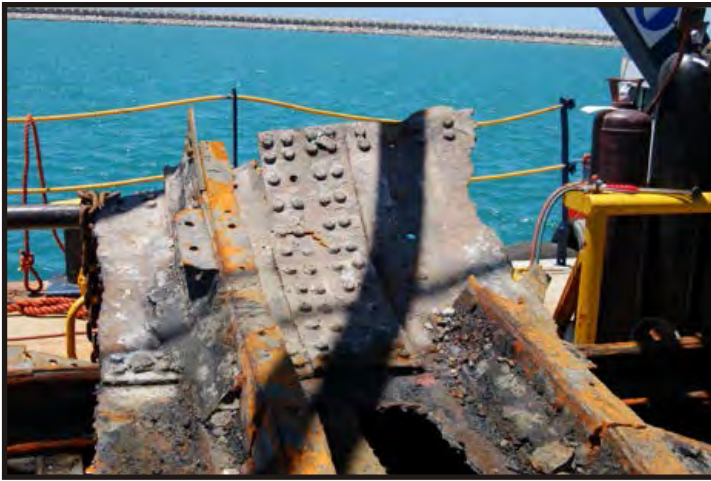
Figure 122: Four rows of chain riveting on a keel butt strap. (Photo V. Maitland)

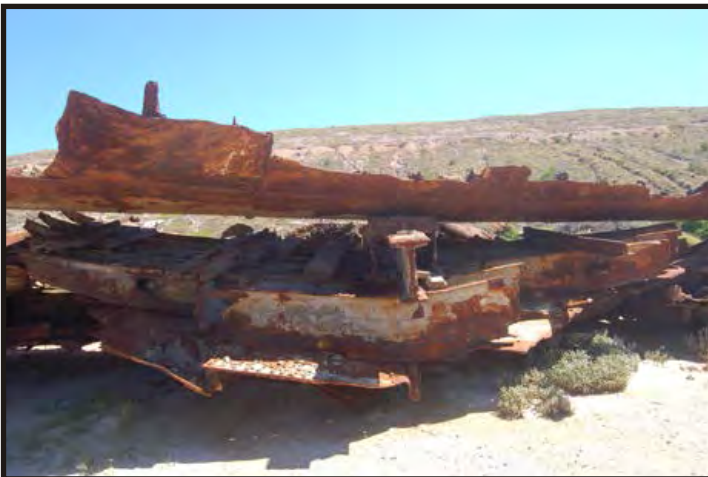
Figure 127: Keel, floor frames and centre keelson. (Photo V. Maitland)

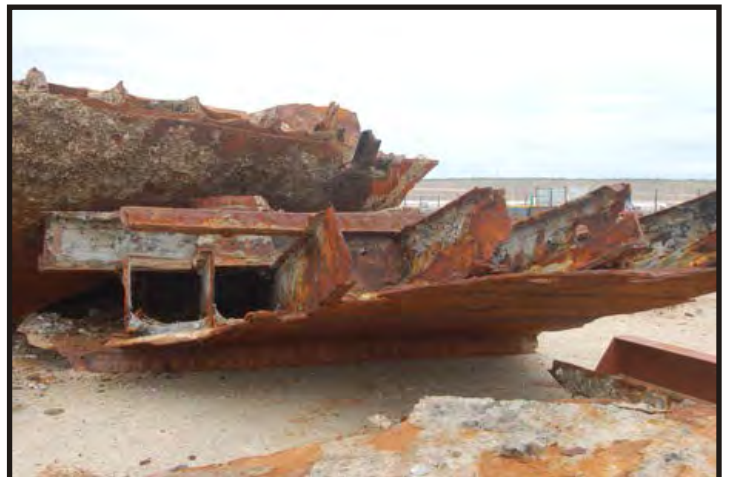
Figure 128: Side view of floor frames. (Photo V. Maitland)

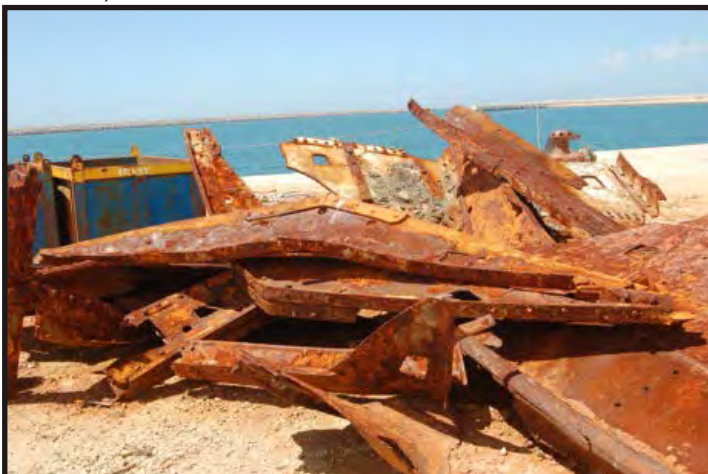
Figure 129: Close-up of floor web frames, they are angled towards the bilges. (Photo V. Maitland)

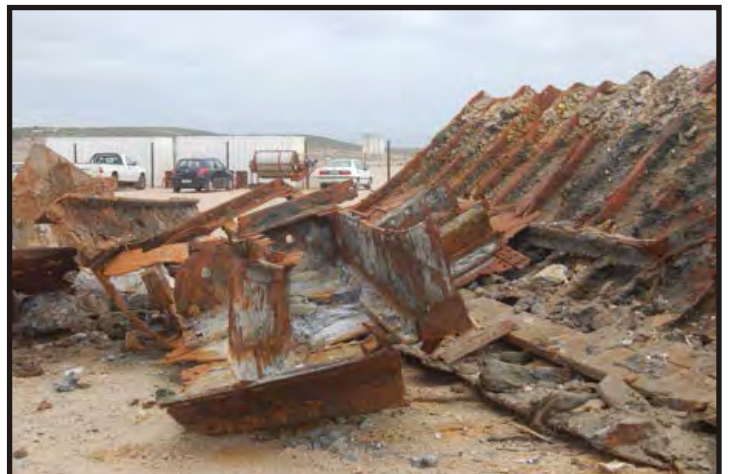
Figure 130: The floor web frames are much wider midships and get narrower towards the bow and stern. This section is probably from the midship area. (Photo V. Maitland)

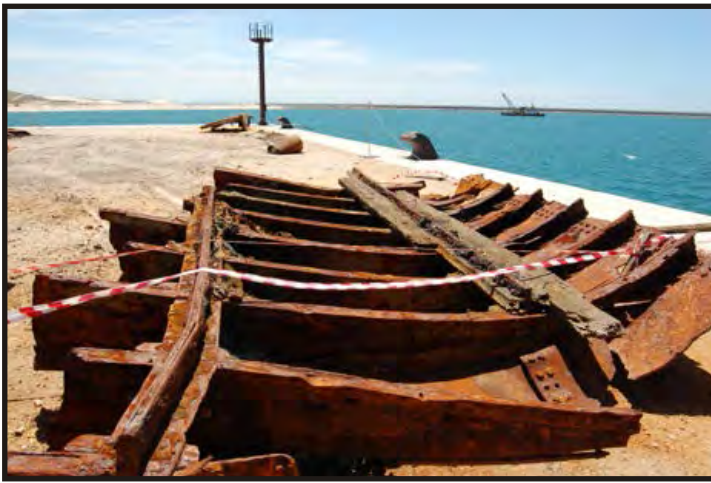
Figure 131: There are no brackets in the bilge in keeping with earlier iron vessel designs. There is a bilge keelson, on the floor head, visible in the Doxford drawing (Figure 95). (Photo V. Maitland)

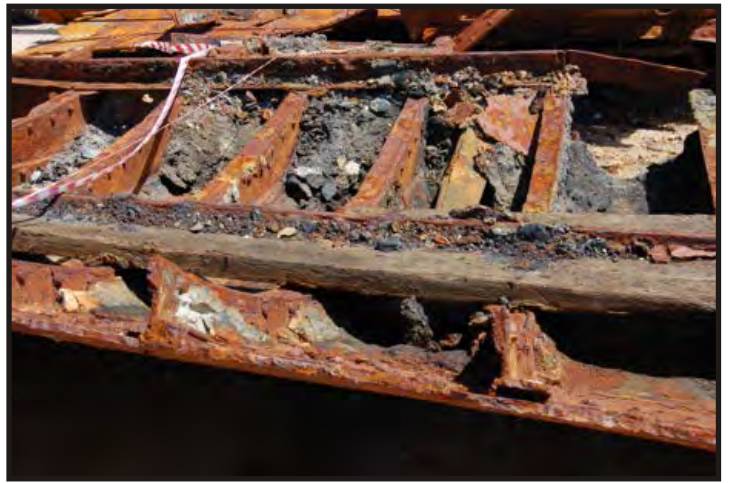
Figure 132: This view of the bilge shows the frames. The frames change from web frames on the floor to frame and reverse frames on the bilge and sides. (Photo V. Maitland)

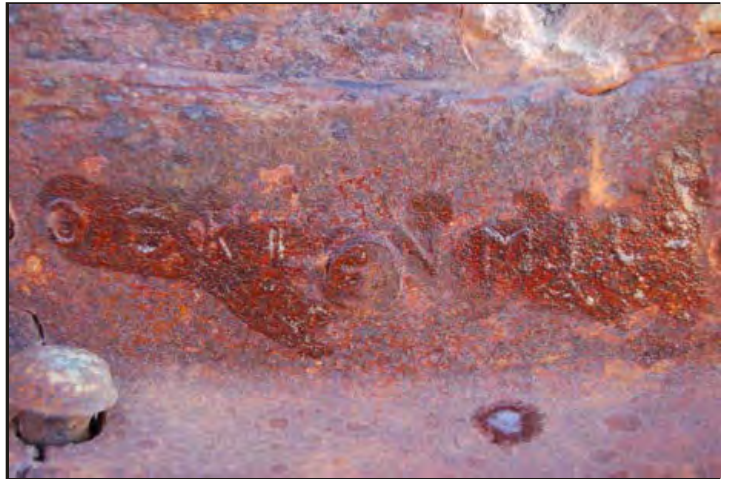
Figure 134: Manufacturer's stamp on the web framing. All that can be seen is OCKTON M IC^o. The Lloyds' Survey states the iron comes from the West Stockton Iron Co, Stockton. (Photo V. Maitland)

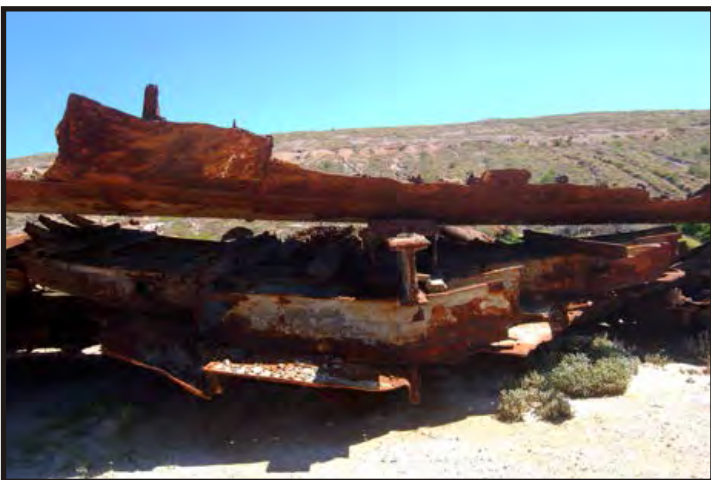
Figure 135: The *County of Pembroke* had a bar keel. The keelson is a built H-beam, running fore and aft, it has a rider plate above it. There are four side keelsons, two per side. There are two bilge keelsons, these are the precursors to brackets and add strength. (Photo V. Maitland)

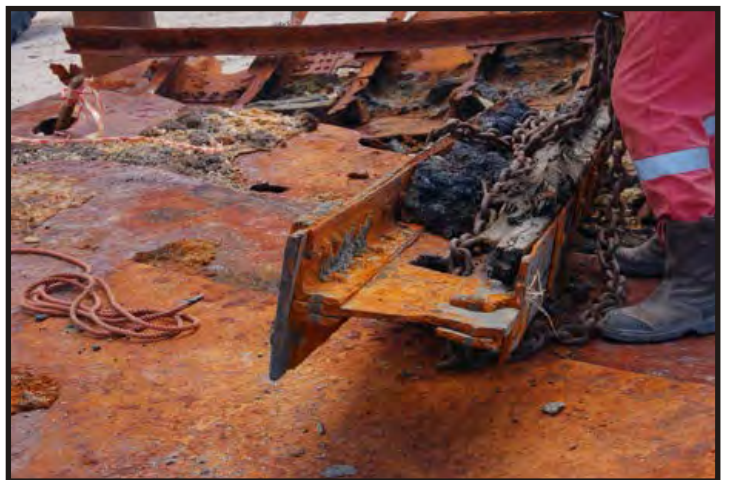
Figure 136: Detached section of the centre keelson. The structure of the built H-beam and rider plate are visible. (Photo V. Maitland)

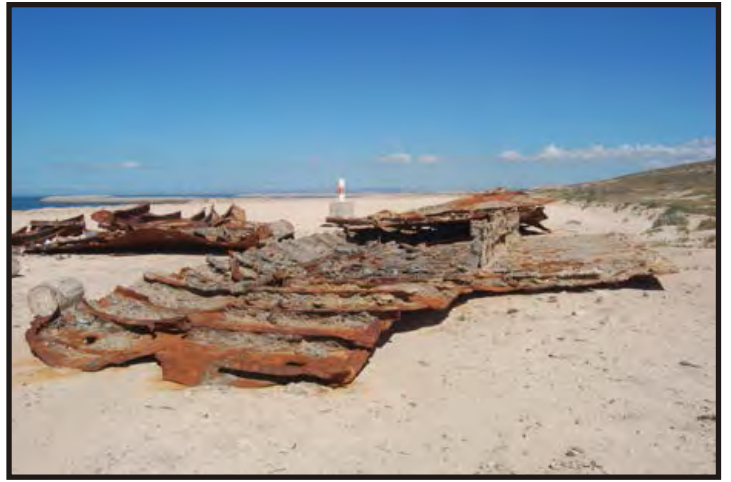
Figure 143: The side plating with frames, side stringers and 'tween deck. (Photo V. Maitland)

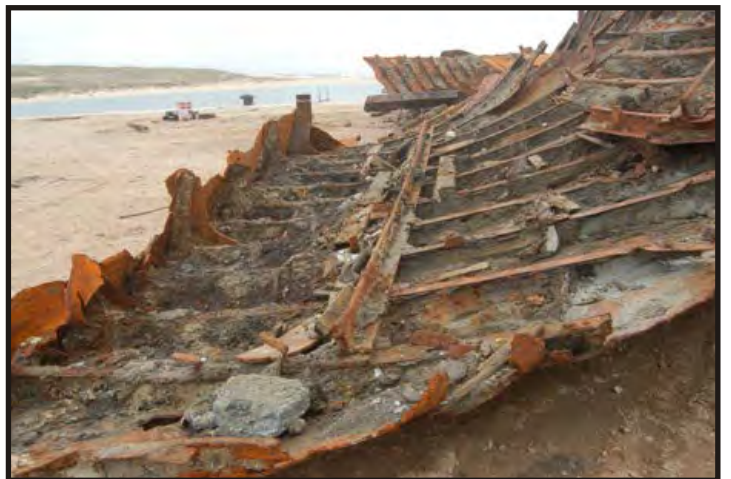
Figure 144: Side plating showing frames, side stringers and beam knees of the 'tween deck. (Photo V. Maitland)

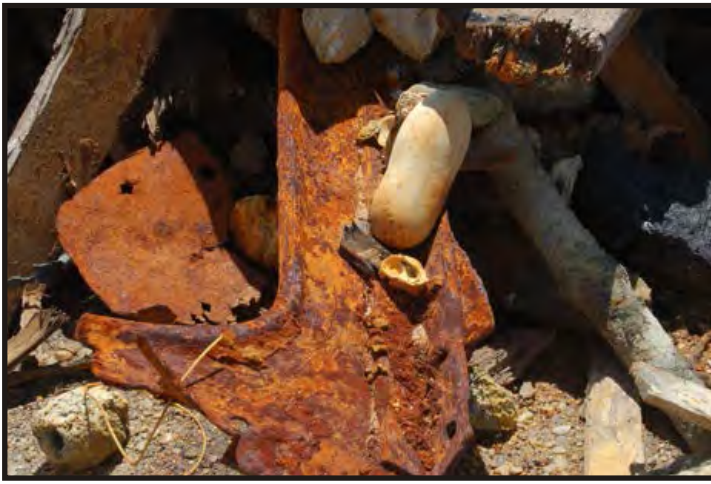
Figure 147: Close-up of the beam knee. It is still attached to the side frame. Rivet holes are visible on the upper edge where it was attached to the 'tween deck beams. (Photo V. Maitland)

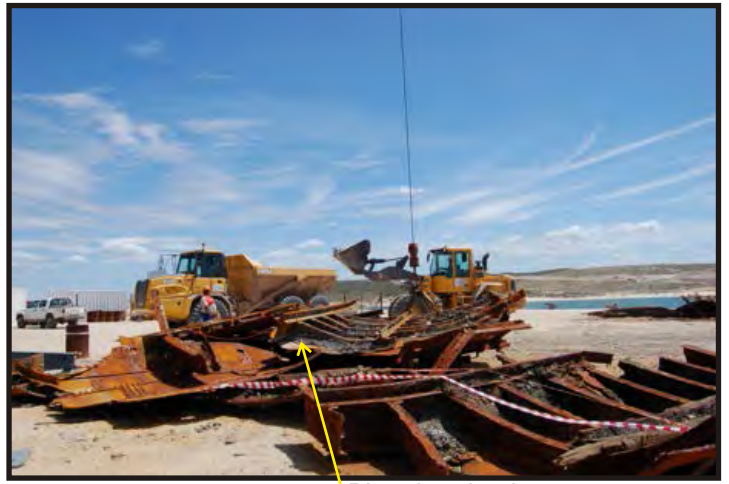
Figure 148: Section of side plating with the plate bracket knee that supported the main deck. (Photo V. Maitland)

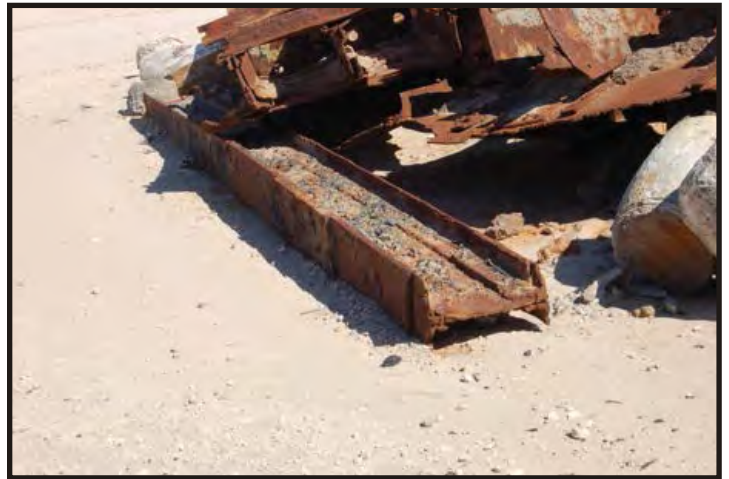
Figure 149: Built H-beam. These were used where strong support was required. (Photo V. Maitland)

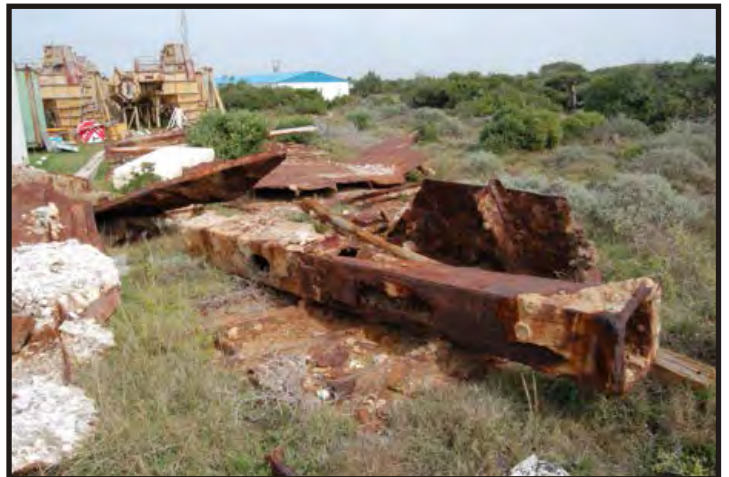
Figure 151: This square beam was recovered in 2004. It had two round holes in the side and is flanged on the end. (Photo V. Maitland)

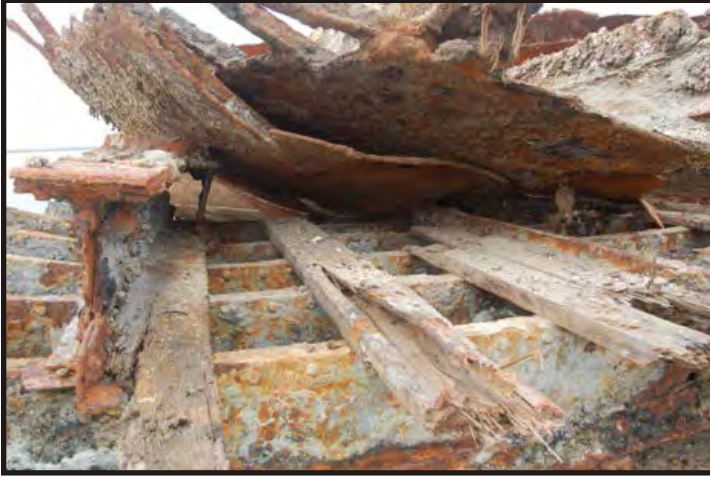
Figure 152: Most vessels have permanent dunnage or a ceiling covering the open floor, it creates space to dry up Maitland) moisture. (Brown 1931:391; Photo V. Maitland)

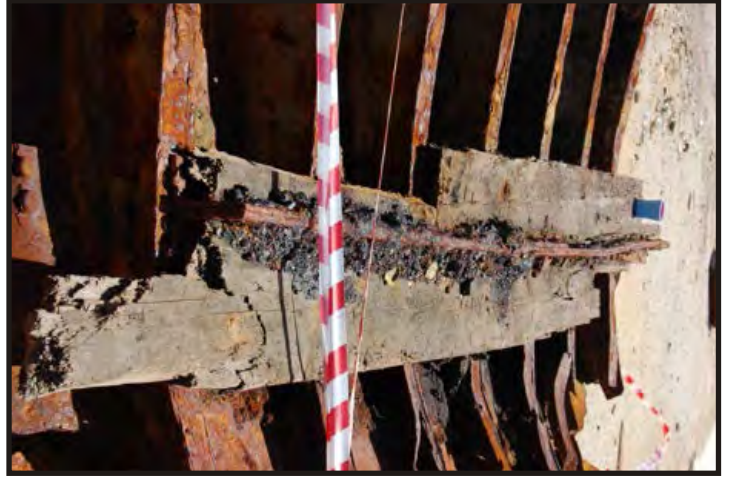
Figure 153: Ceiling next to the side keelson. (Photo V. Maitland)

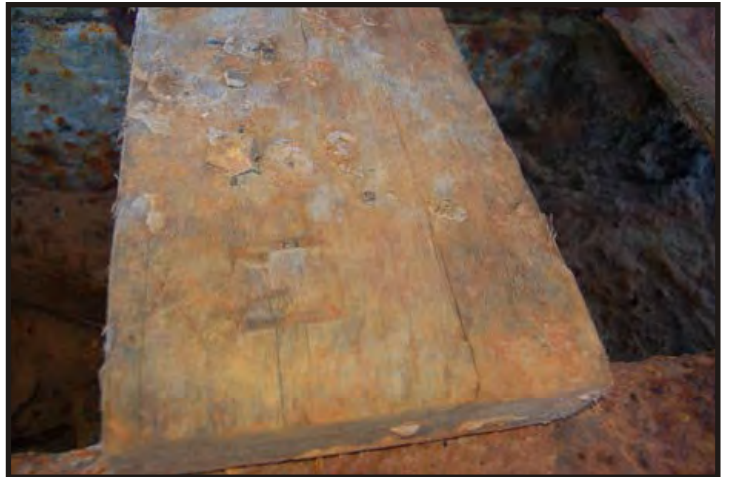
Figure 155: Close-up of the Roman numeral II on the hold ceiling. (Photo V. Maitland)

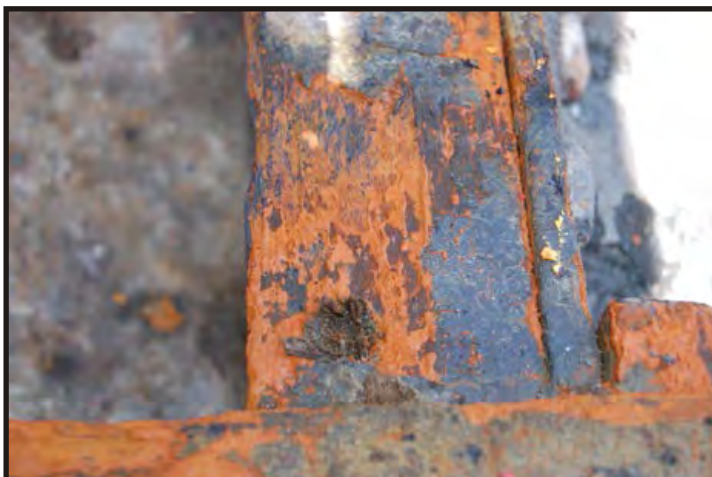
Figure 156: Top view of wooden dowel. The ceiling on the keel floor was attached with wooden dowels. (Photo V. Maitland)

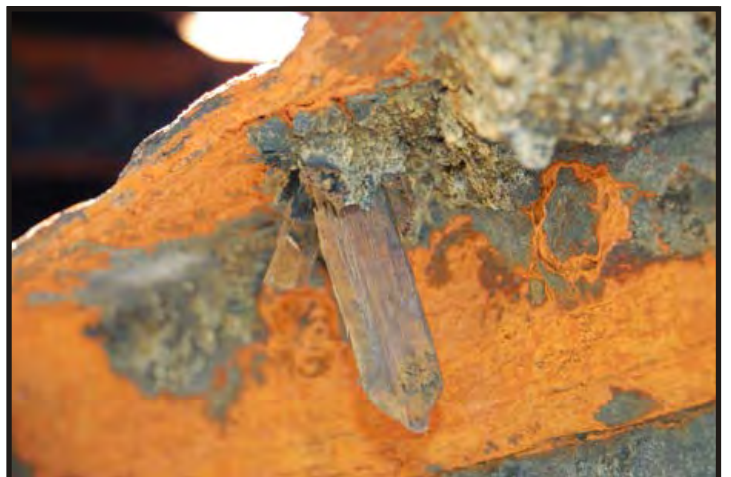
Figure 157: Bottom view of wooden dowel. (Photo V. Maitland)

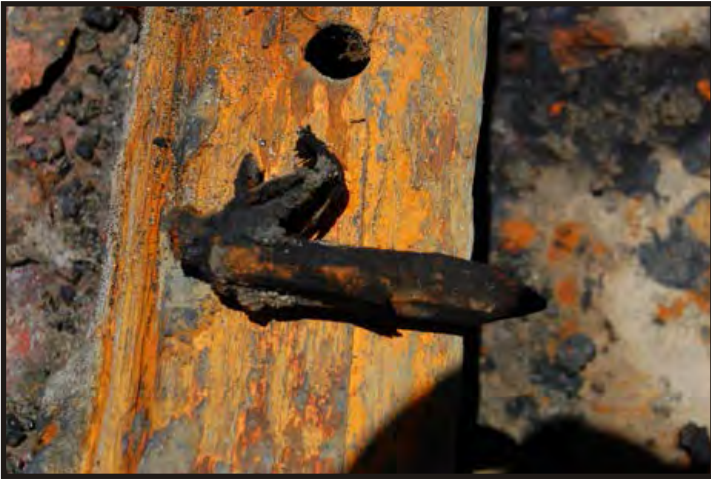
Figure 158: An extracted wooden dowel. (Photo V. Maitland)

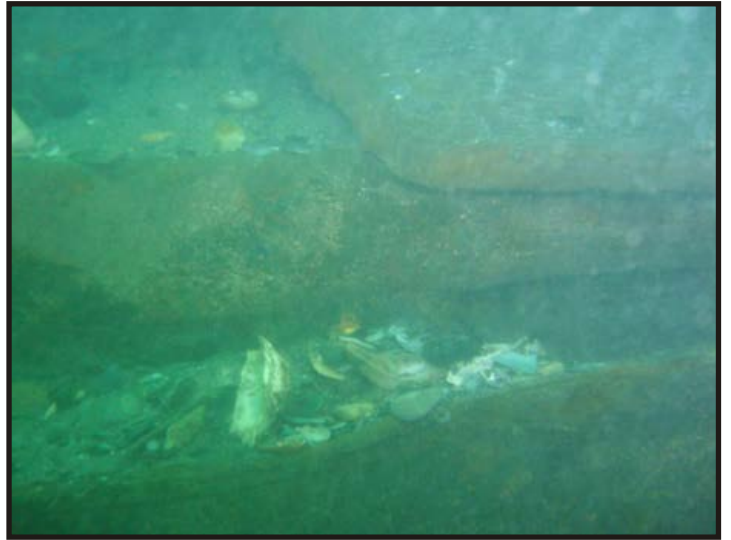
Figure 159: In-situ view of the hold ceiling. (Photo V. Maitland)

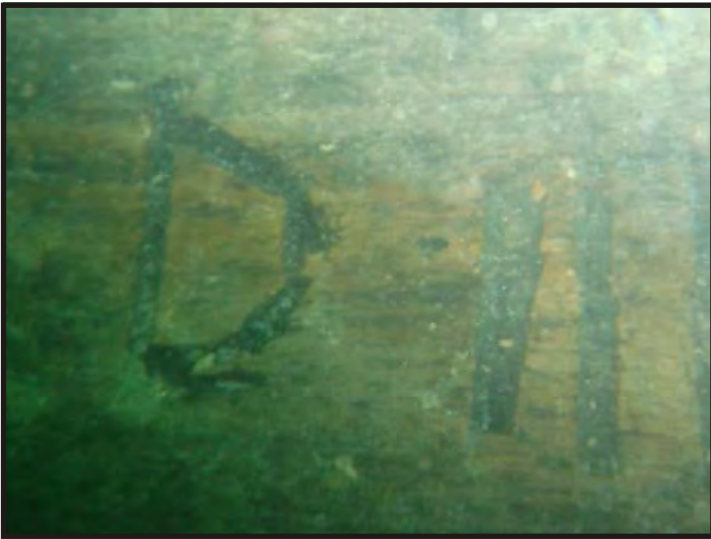
Figure 160: In-situ view of the hold markings in the fore section of the barque. Roman numerals DII. (Photo V. Maitland)

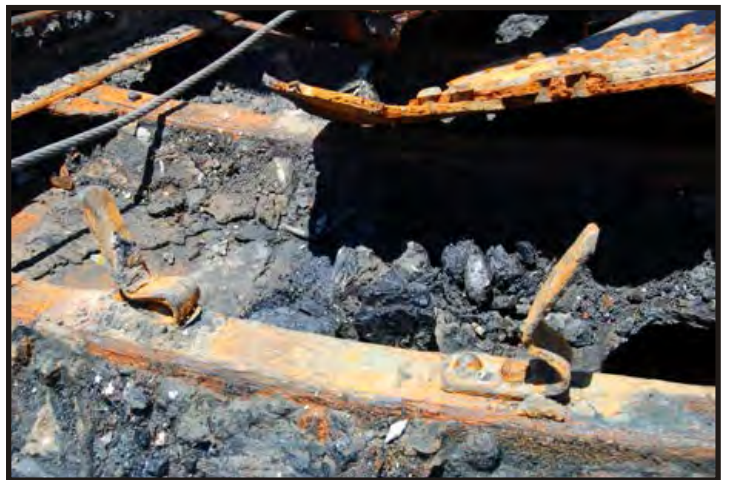
Figure 168: Turn of the bilge, showing the ceiling. (Photo V. Maitland)

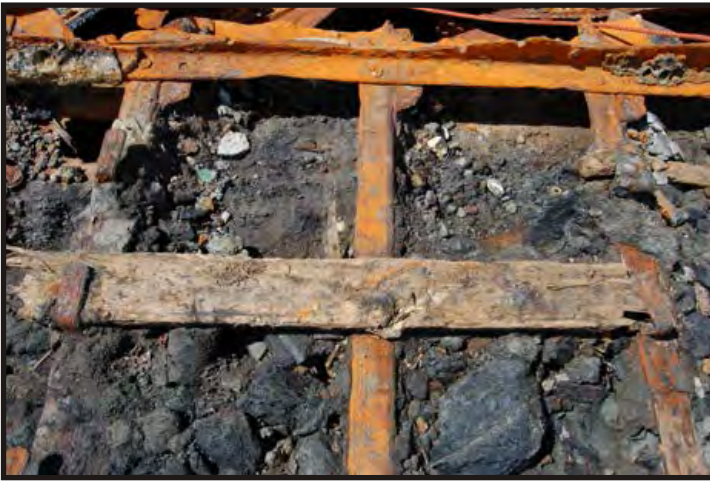
Figure 169: Cleats on side frames. These hold the side battens, which are part of the hold ceiling. This permanent dunnage is sufficient for rough cargoes and other goods not liable to absorb moisture. (Brown 1931:391; Photo V. Maitland)

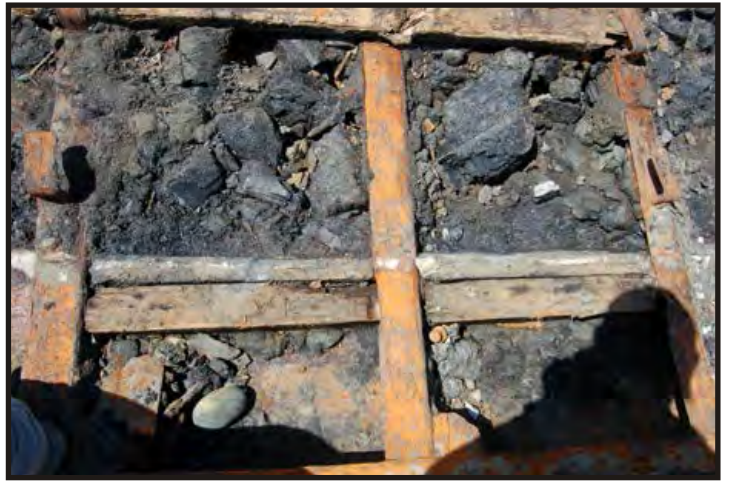
Figure 170: Side battens fixed in cleats. (Photo V. Maitland)

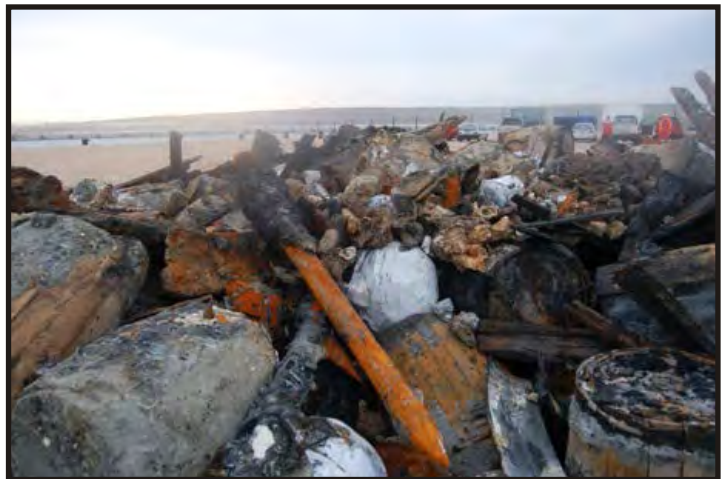
Figure 178: Pillar attached to the deck beam. (Photo V. Maitland)

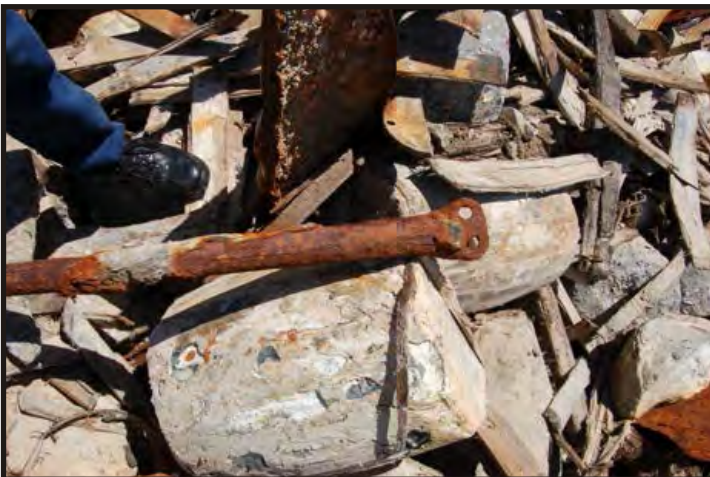
Figure 179: Pillar. The end is not pointed as it appears, it's sheared off. (Photo V. Maitland)

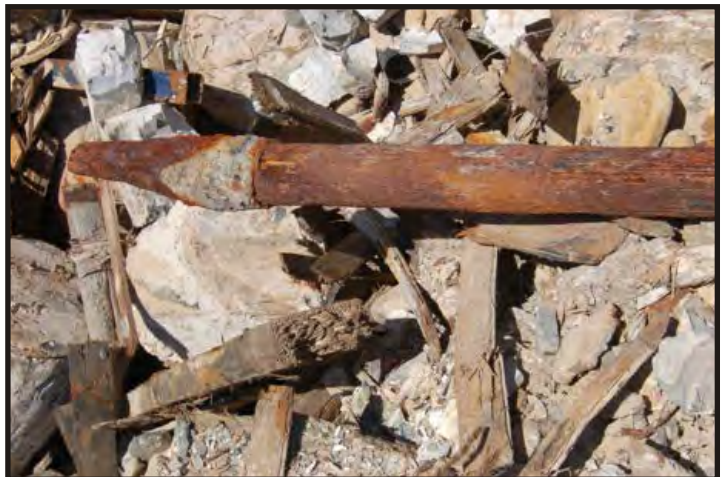
Figure 180: Head of a pillar, where it was riveted to the deck beam. (Photo V. Maitland)

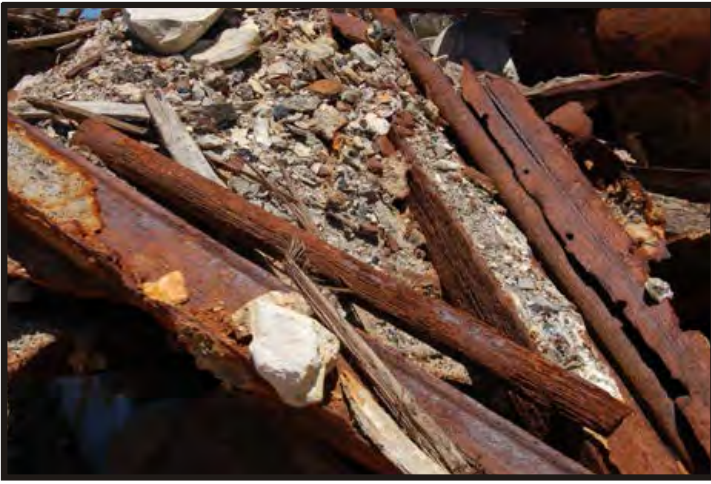
Figure 181: End of a pillar, that seems to have a sleeve attached. (Photo V. Maitland)

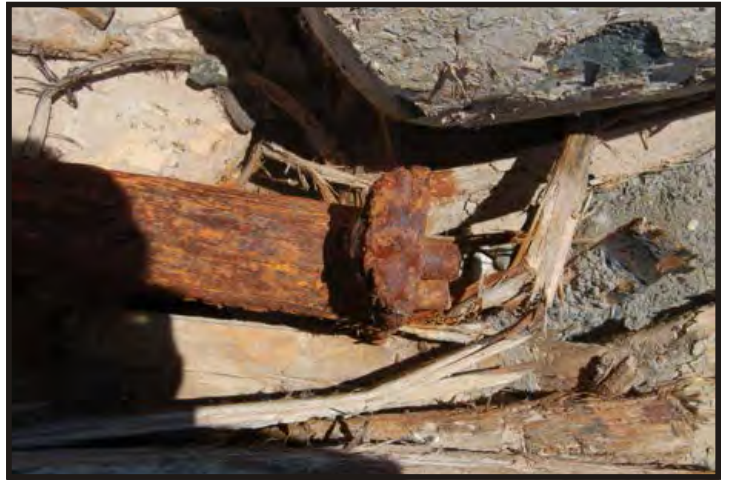
Figure 182: Pillars at the dump site. (Photo V. Maitland)

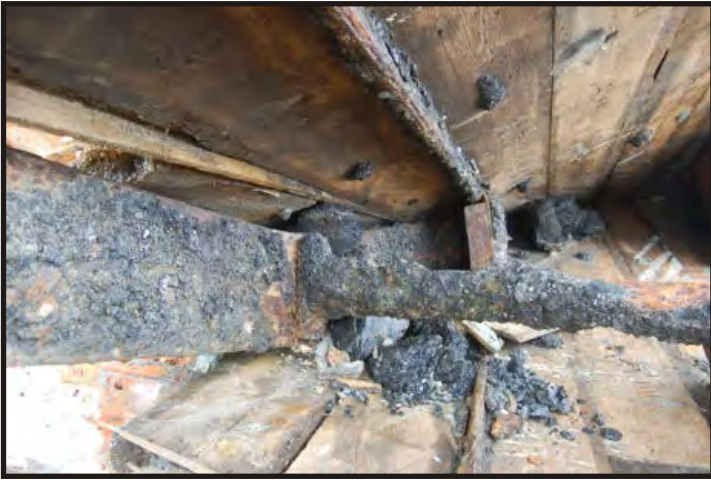
Figure 183: Heel of pillar, it is a T-section riveted to the beam or centre keelson. (Photo V. Maitland)

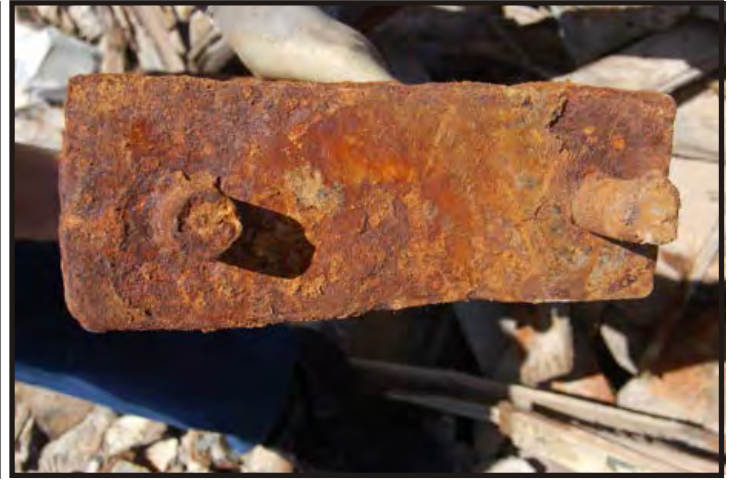
Figure 184: Heel attached to rider plate of the centre keelson. (Photo V. Maitland)

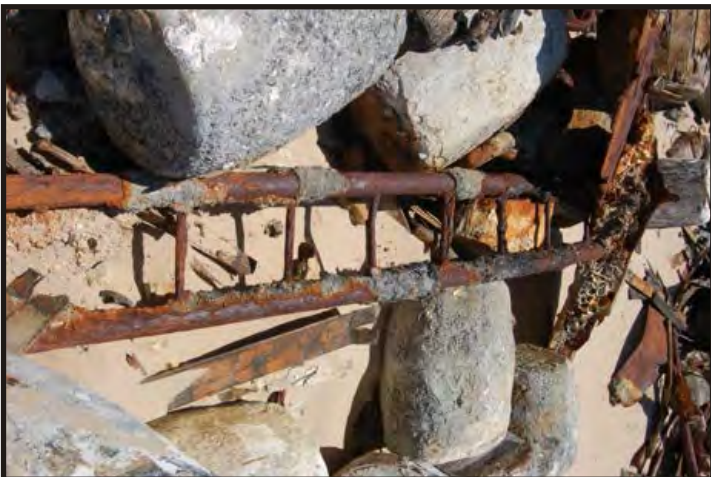
Figure 186: 7-rung section of ladder. (Photo V. Maitland)

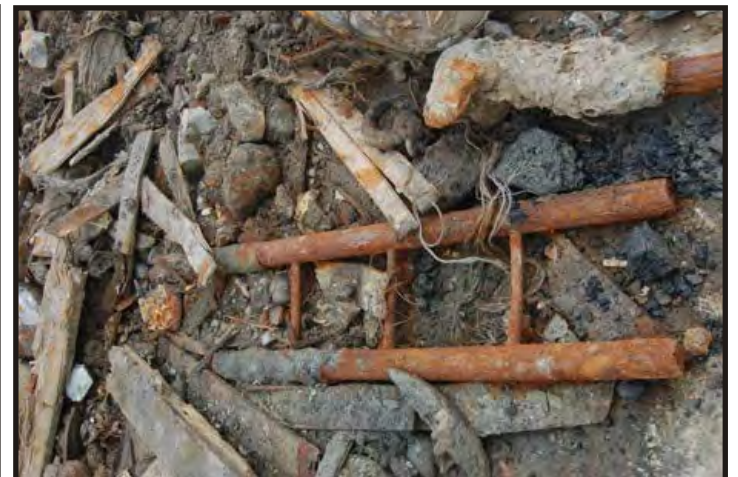
Figure 187: 4-rung section of ladder. (Photo V. Maitland)

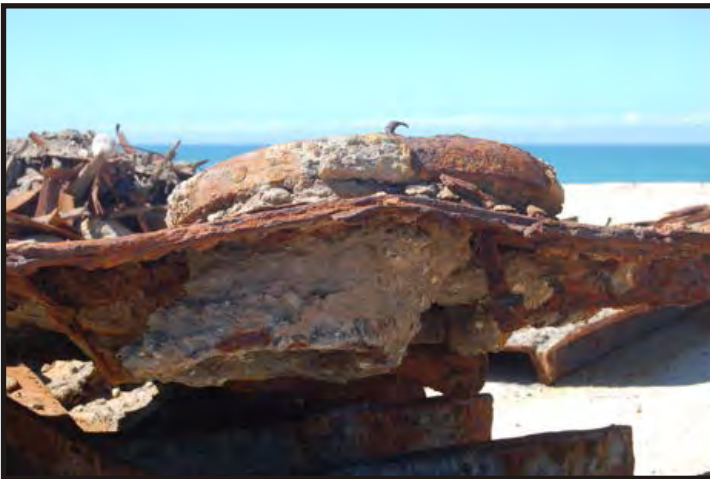
Figure 189: Side view of the lower end of the hawsepipe as it passed through the side plating. (Photo V. Maitland)

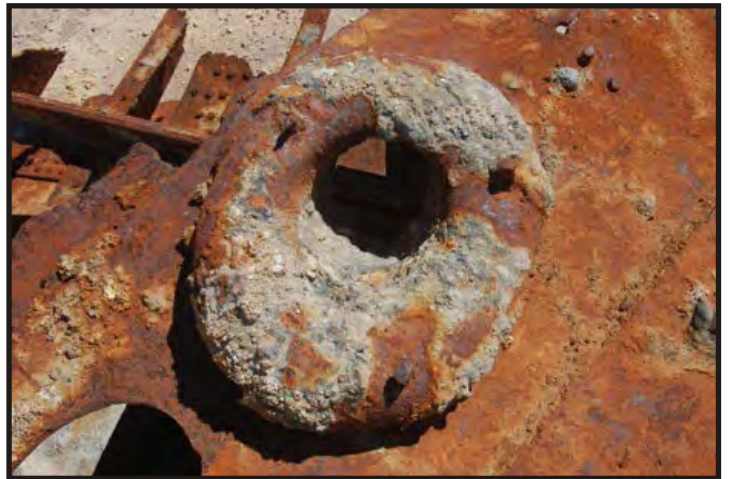
Figure 190: Top view of lower end of hawsepipe as it passed through side plating. There are four rivets attaching it to the plate. (Photo V. Maitland)

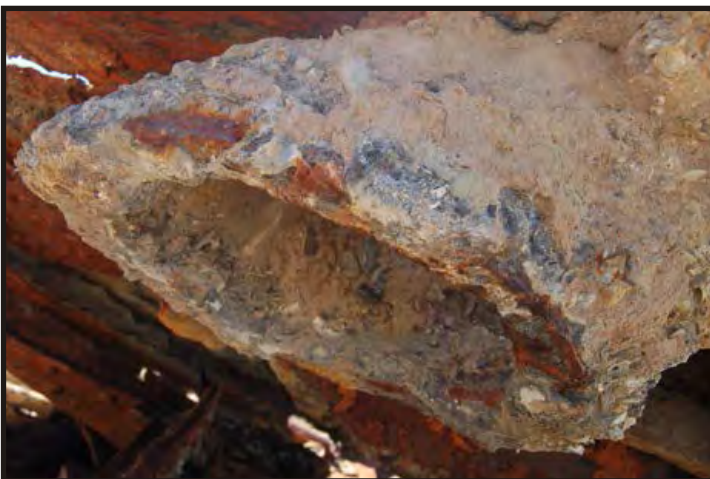
Figure 191: Side view of lower end of hawsepipe on the inner surface of the side plating. (Photo V. Maitland)

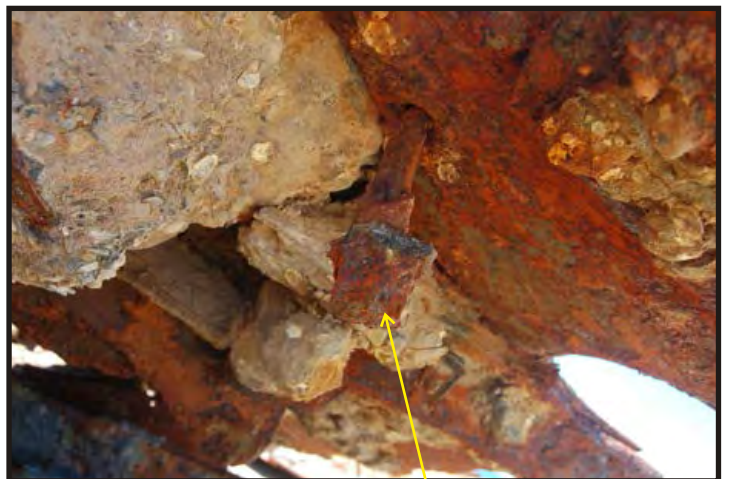
Figure 192: Close-up of lower end of hawsepipe on the inner surface of side plating. The rivet is visible. (Photo V. Maitland)

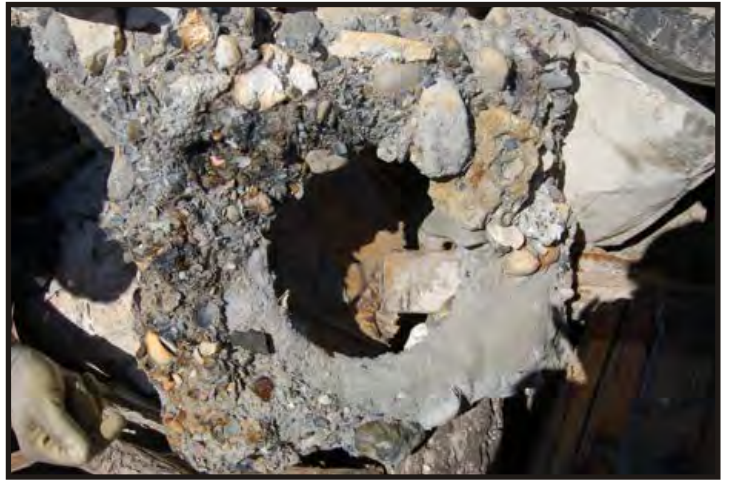
Figure 194: Top view of upper end of hawsepipe, this was riveted to the deck. (Photo V. Maitland)

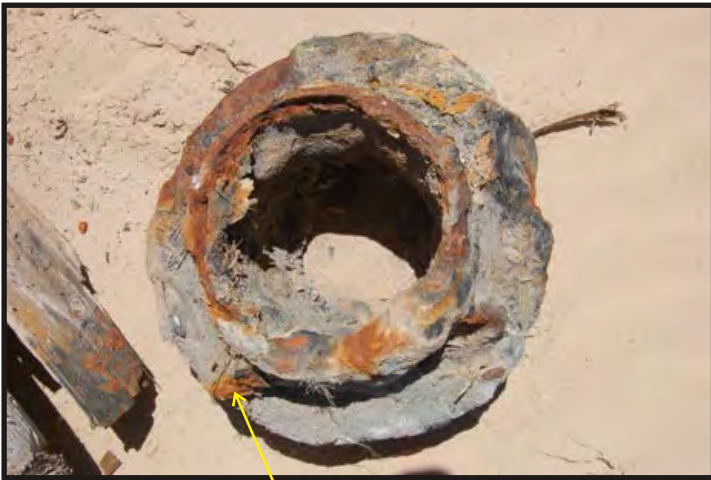
Figure 195: bottom of the upper hawsepipe. A section of the deck planking is visible. (Photo V. Maitland)

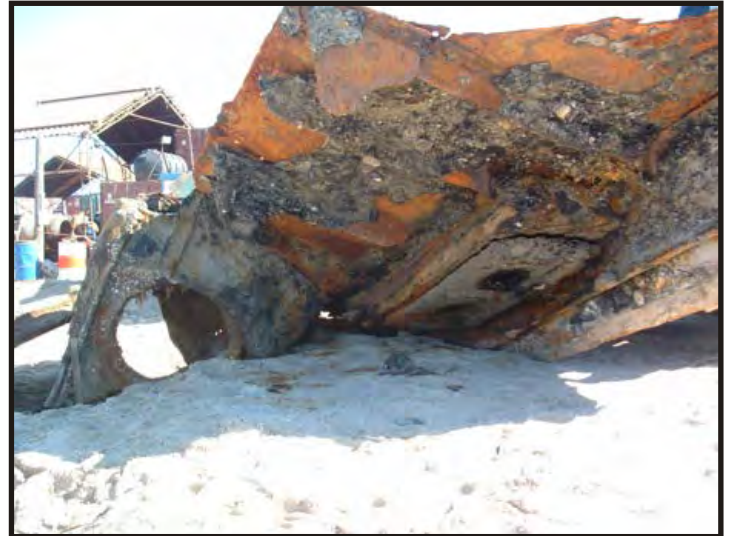
Figure 196: Bottom of starboard bow hawsepipes. Most vessels had three hawsepipes on the bow, one on the port and two on the starboard side. One on each side is for the bower anchors, the second one on the starboard side is for the sheet anchor (Blackburn 1981:157; Photo V. Maitland)

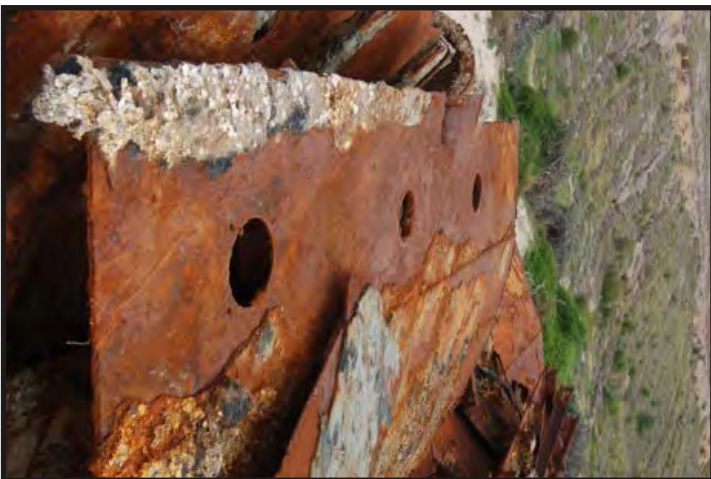
Figure 197: Stern porthole. After studying the high resolution picture of the *County of Pembroke*, I can discern three or more portholes on the upper section of the stern. (Photo V. Maitland)

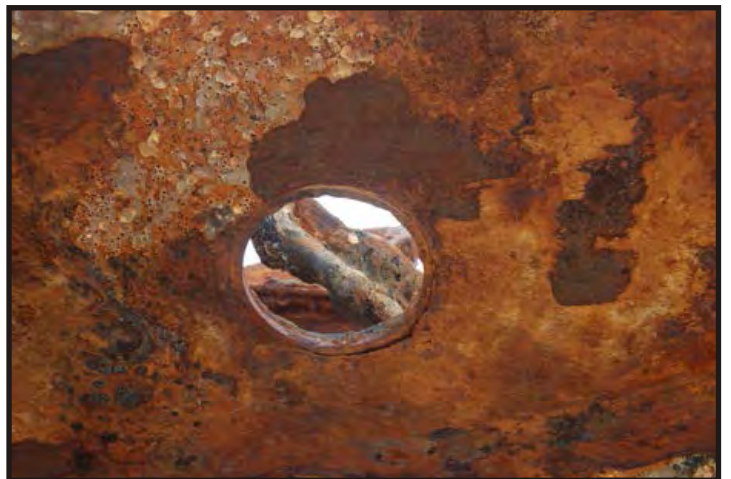
Figure 198: Close-up of inner side of the porthole. The correct terms for a porthole are deadlight or scuttle. (Blackburn 1981:243; Photo V. Maitland)

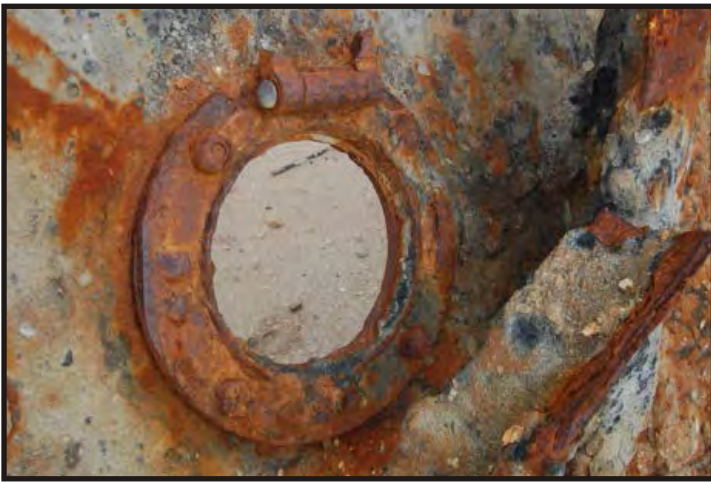
Figure 199: Close-up of a stern porthole. It still has the frame riveted to the plating. (Photo V. Maitland)
