County of Pembroke

Shipwreck Report

Vanessa Maitland

**Port of Ngqura
Eastern Cape
South Africa**

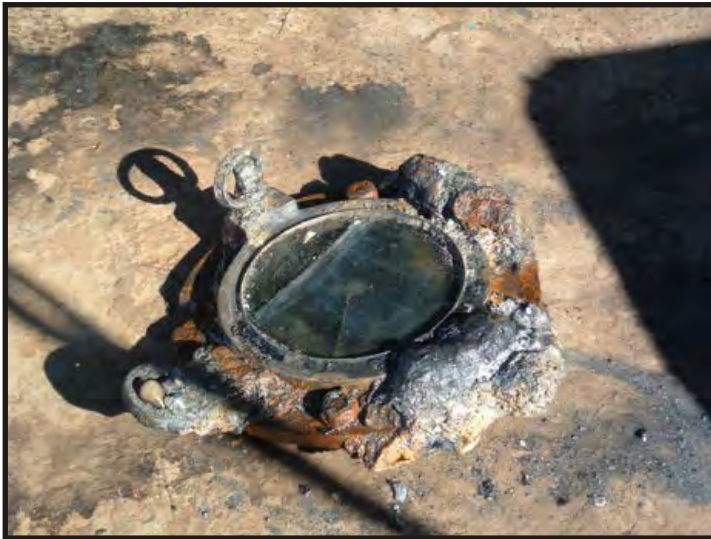
Figure 201: Front of a complete porthole recovered during operations in 2004. (Photo V. Maitland)

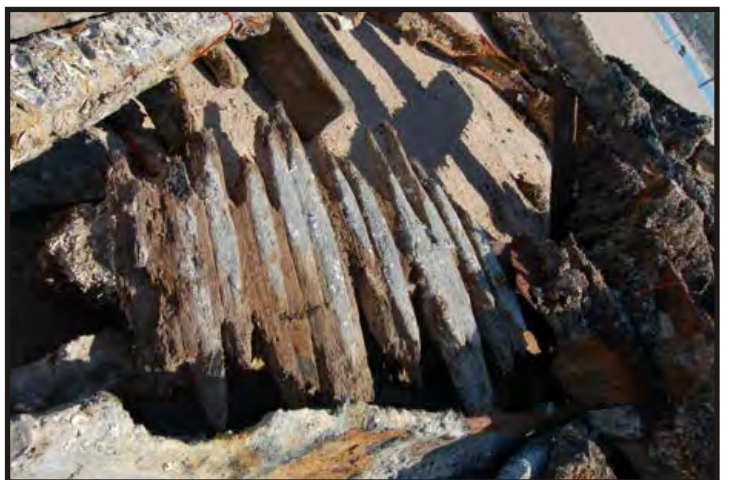
Figure 210: Upper wooden decking. According to Lloyds' Survey of 1881 it was yellow pine and the 'tween deck was Baltic white pine. The decking that was retrieved from the wreck was badly preserved. It had been attacked by various marine organisms. (Photo V. Maitland)

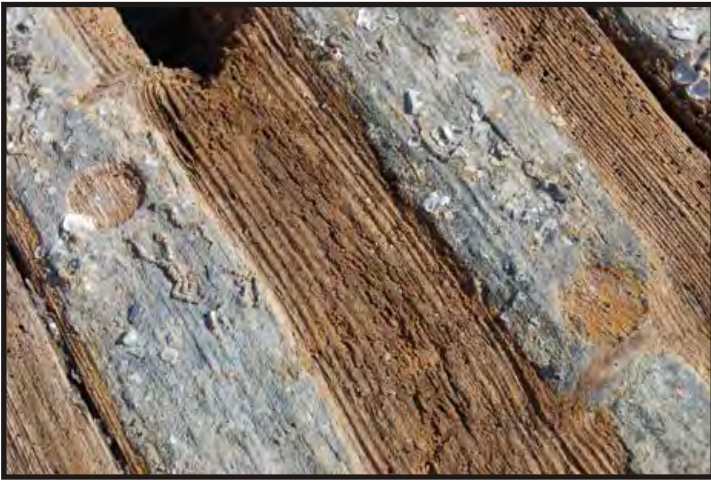
Figure 211: Close-up of the deck. The wooden dowels are visible. According to Bisset (1958:67) when the ship was stuck in the doldrums, the pitch in the deck seams softened and the crew had to haul up buckets of sea water to douse the decks. (Photo V. Maitland)

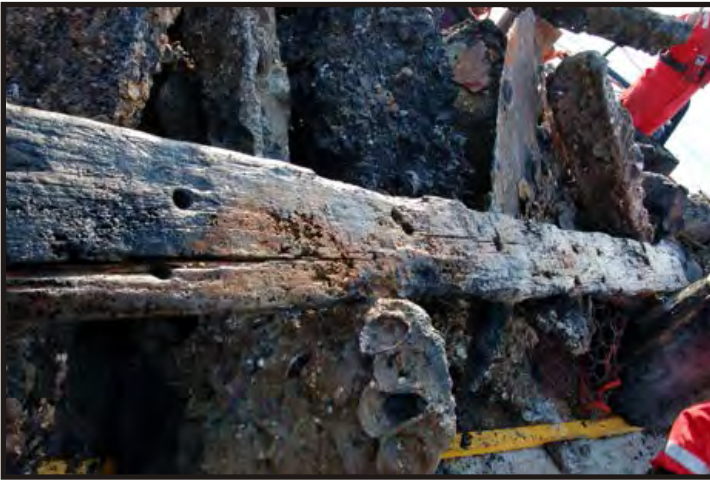
Figure 217: Deck plank. This is different from the other planks, it has several rows of three holes each for fasteners; it could be from a different part of the barque or from another wreck. It is possible that when the wreck was removed from North End Beach, the salvors loaded parts of other wrecks onto the *County of Pembroke* to clean up the problems that wrecks were causing. (Photo V. Maitland)

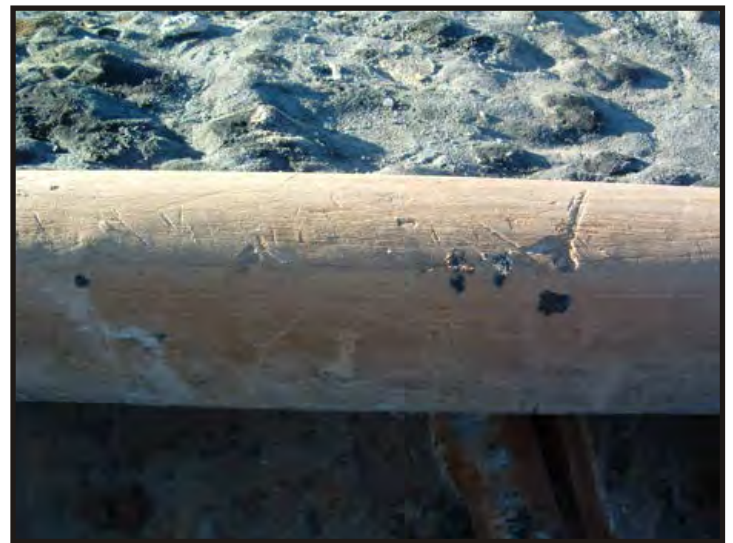
Figure 225: Close-up of the gunwale, nicks and scratches from shipboard work visible. (Photo V. Maitland)

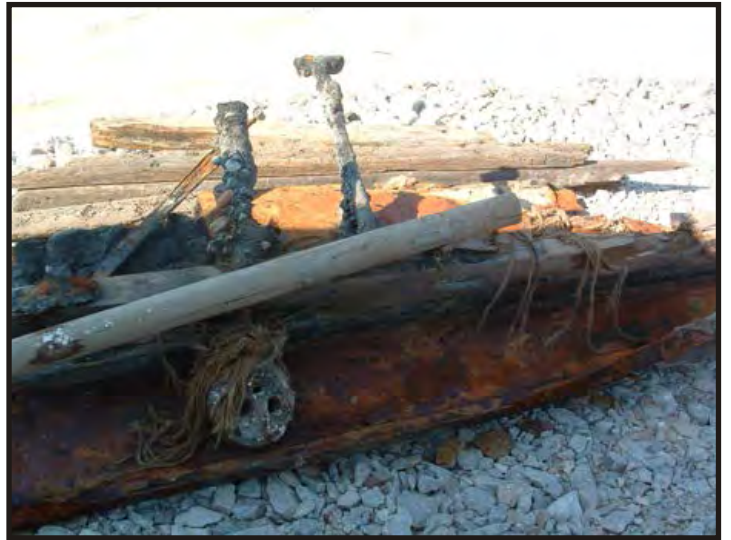
Figure 230: Channel showing a stanchion and dead-eye. Cordage is tangled around the dead-eye. (Photo V. Maitland)

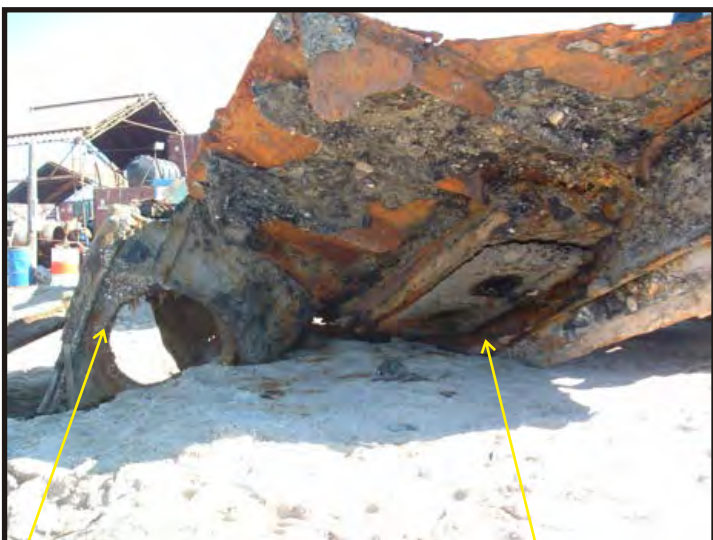
P
E
M
B
R
Figure 252: Outline of the barque's name. This section was buried under sand, lying with its outer side in conglomerate. The brass letters which may have left the imprint were never found. The outlines of the letters were visible on this section, allowing identification of the wreck. (Photo V. Maitland)

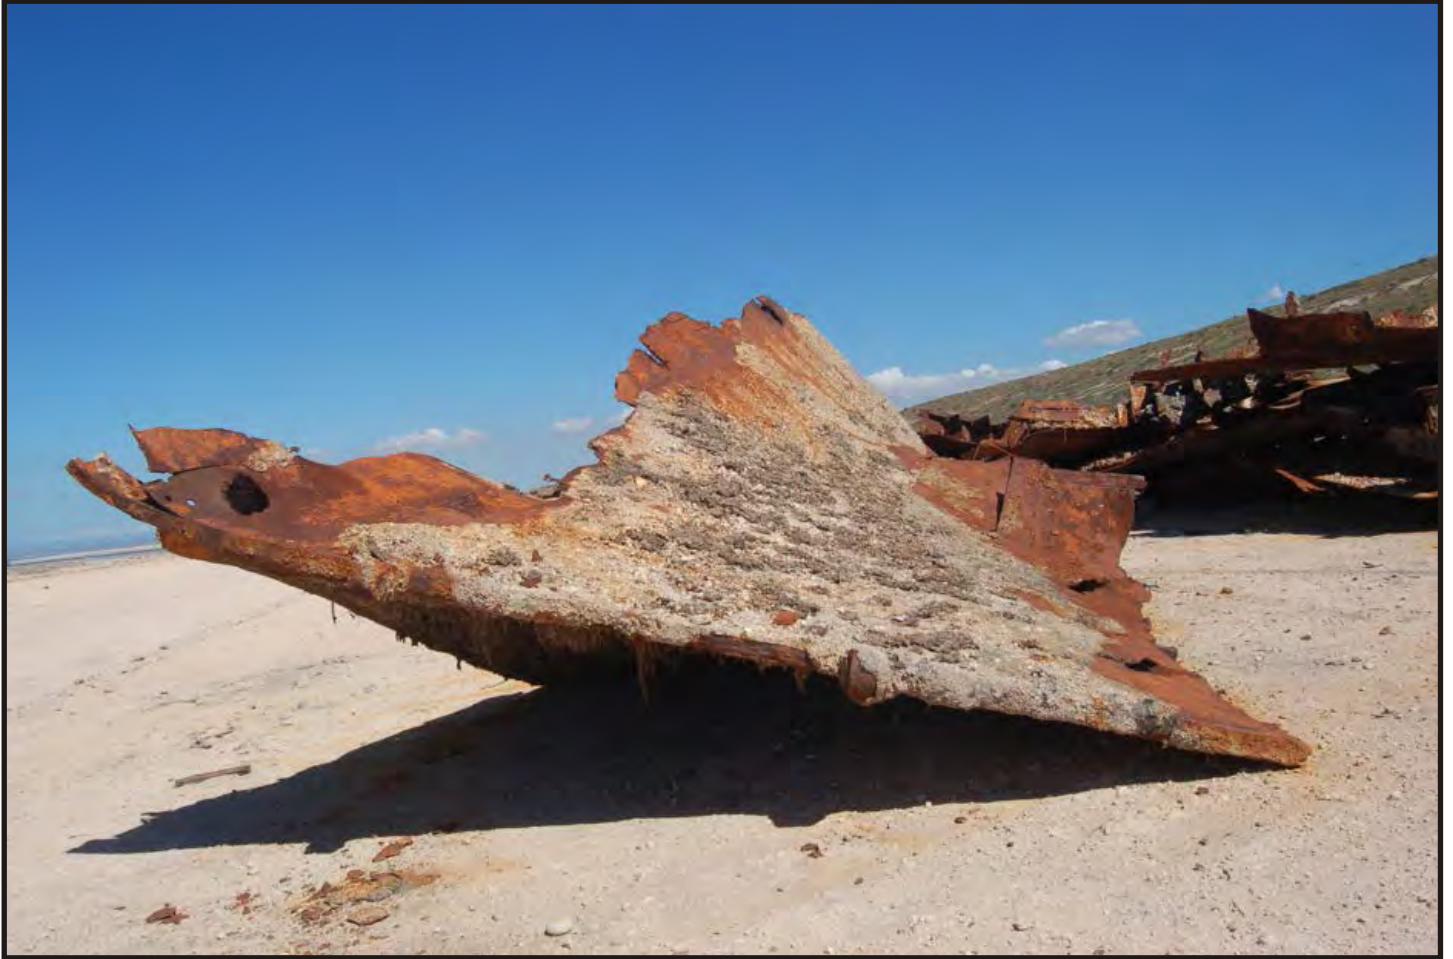
Figure 260: Stern. Gudgeons are on the rudder post and pintles fitted into the gudgeons. According to the Lloyds' Survey of 1881, the stern post is the same dimensions as the keel and stem. Unfortunately the keel was not attached to the stern.

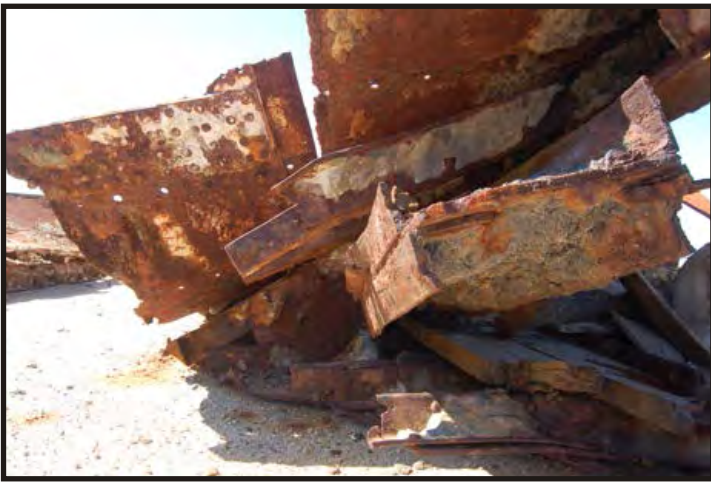
Figure 264: Close-up of the keel section of the stern. The keel is gone, the keelson is still visible. (Photo V. Maitland)

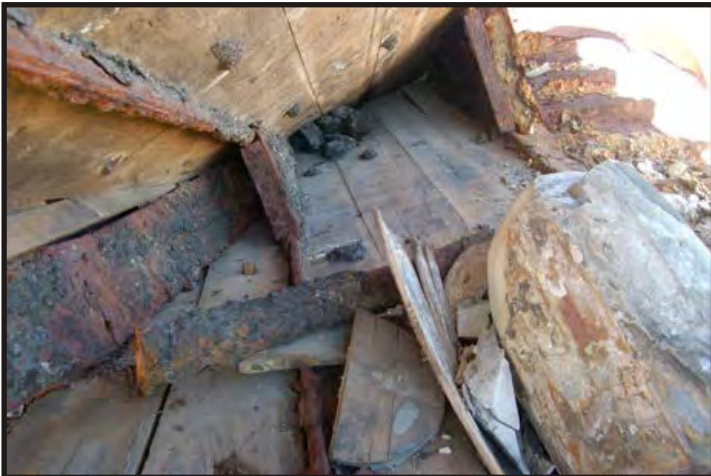
Figure 266: Close-up from the side towards the rudder-post. The keelson can be seen running under the two rider plates. (Photo V. Maitland)

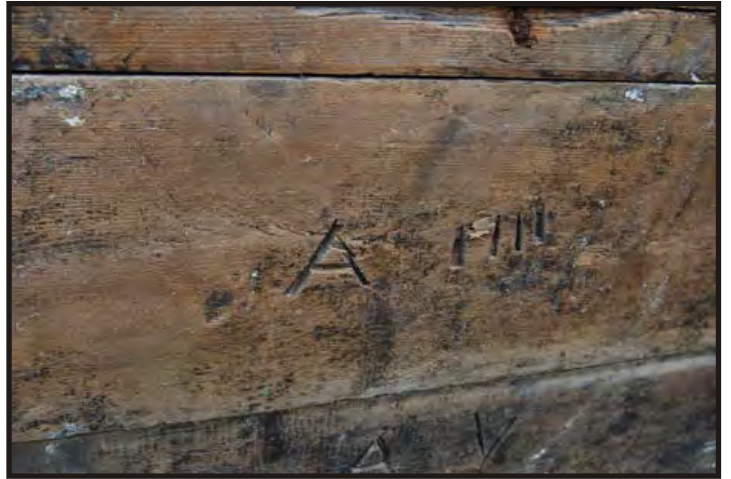
Figure 286: Ceiling marking - AIII (Photo V. Maitland)

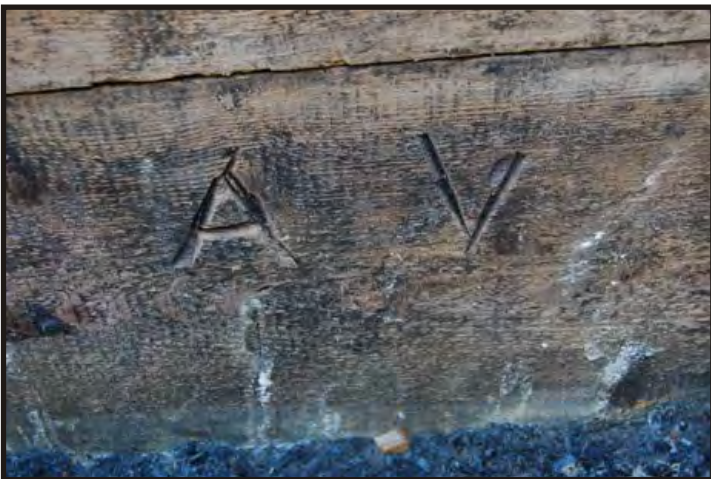
Figure 287: Ceiling marking - AV (Photo V. Maitland)

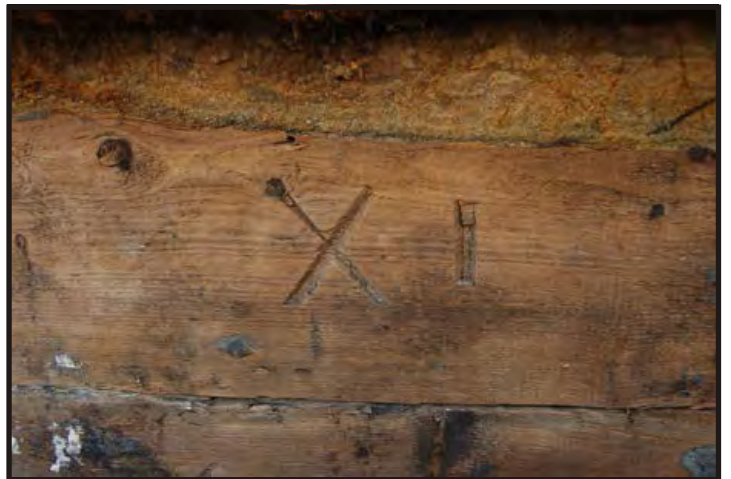
Figure 288: Ceiling marking - XI (Photo V. Maitland)

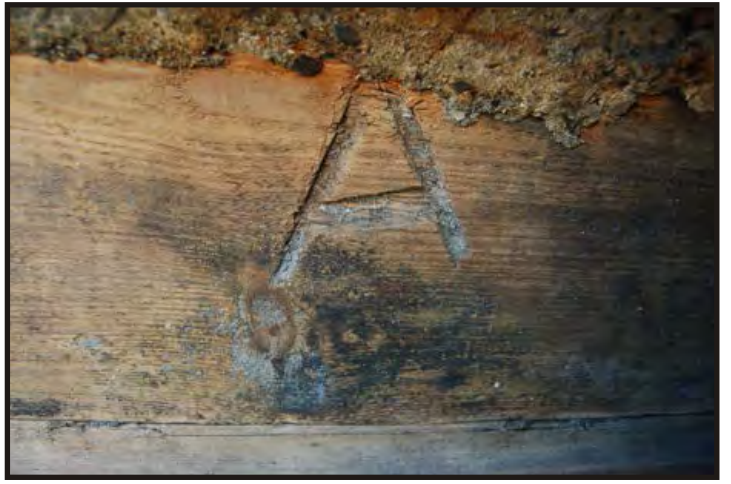
Figure 290: Ceiling marking - A (Photo V. Maitland)

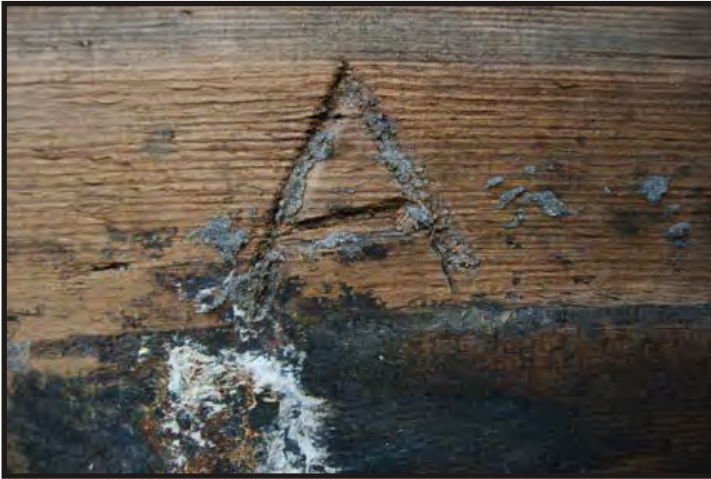
Figure 291: Ceiling marking - A (Photo V. Maitland)

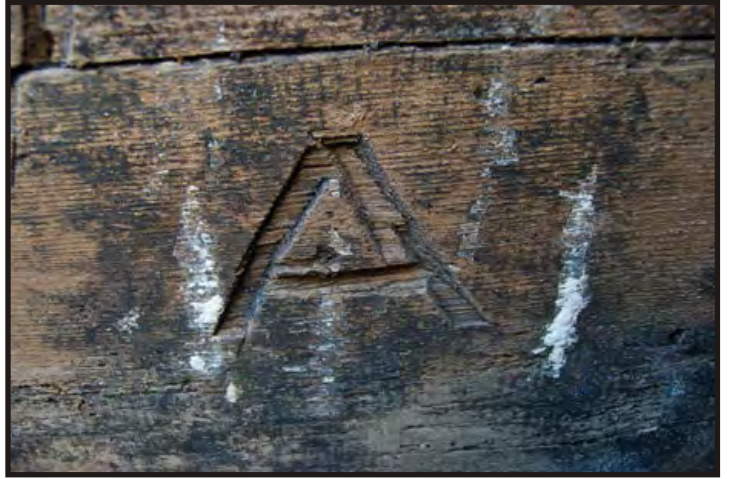
Figure 292: Ceiling marking - A II (Photo V. Maitland)

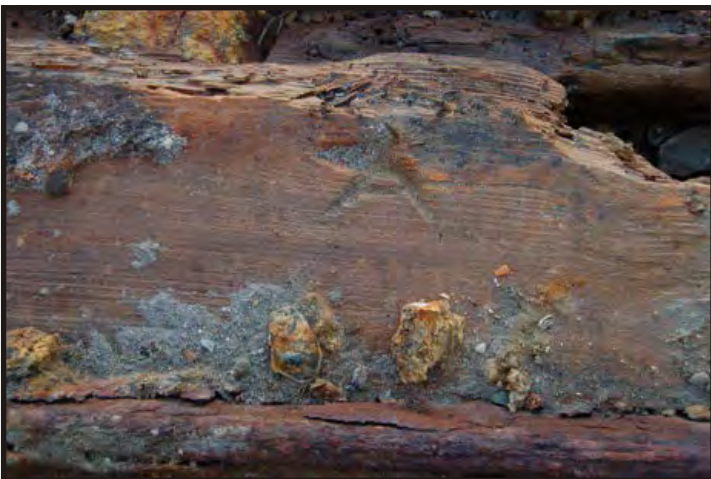
Figure 293: Ceiling marking - A (Photo V. Maitland)

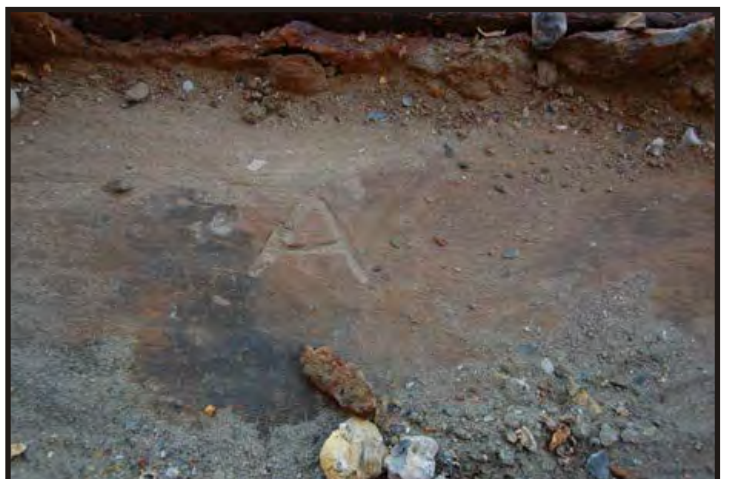
Figure 294: Ceiling marking - A (Photo V. Maitland)

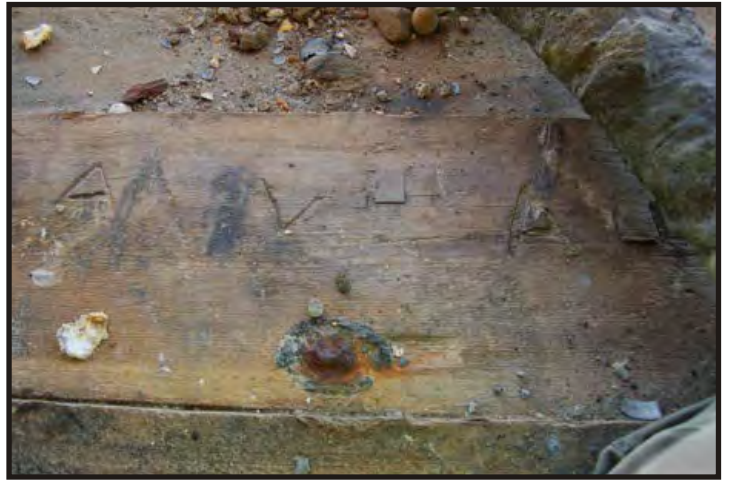
Figure 296: Ceiling marking - A V III A III (Photo V. Maitland)

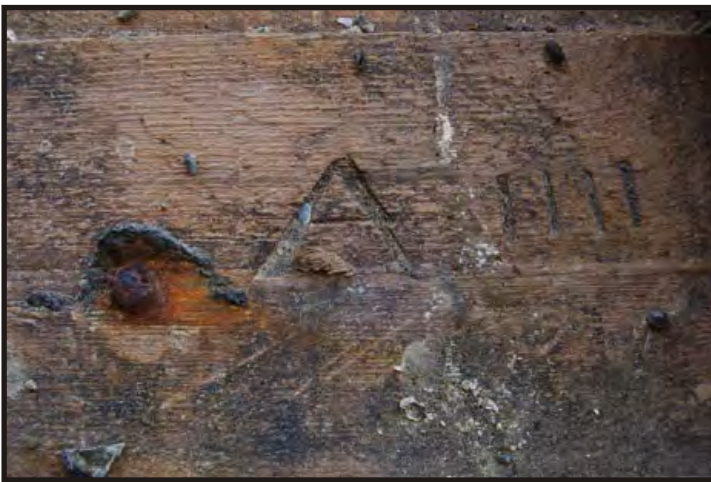
Figure 297: Ceiling marking - A III (Photo V. Maitland)

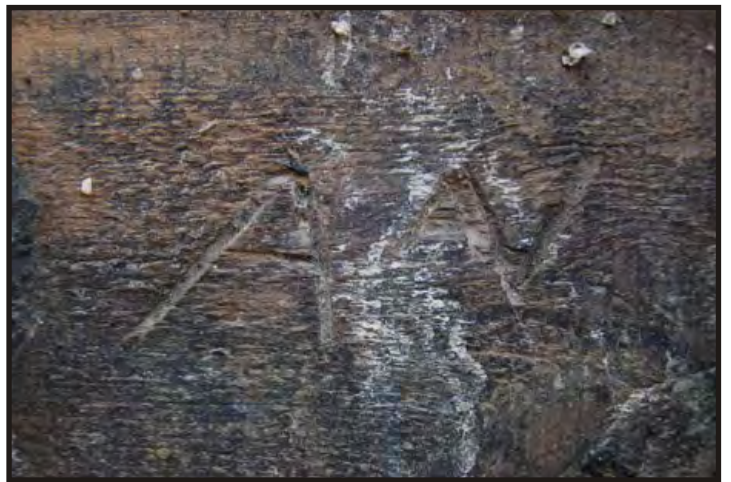
Figure 298: Ceiling marking - A V (Photo V. Maitland)

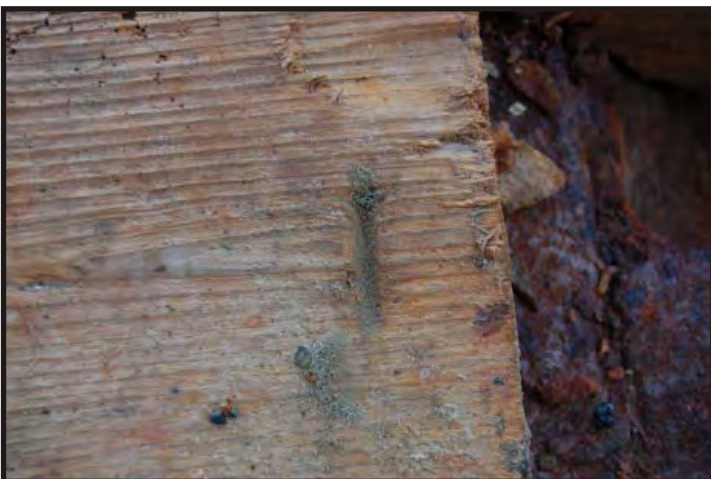
Figure 299: Ceiling marking - I (Photo V. Maitland)

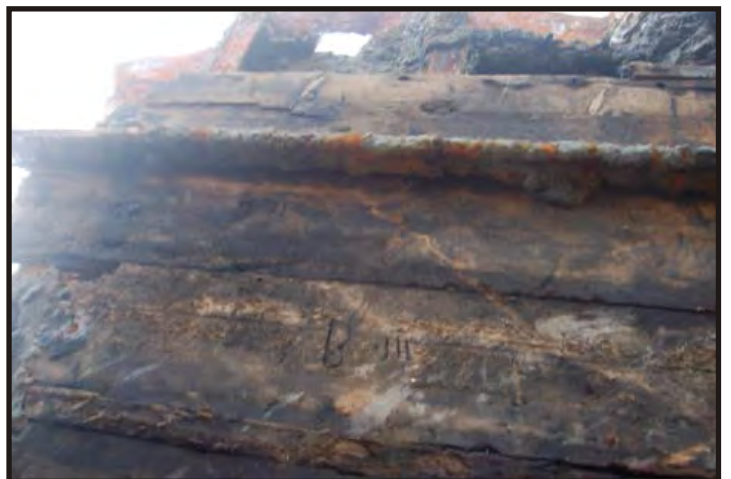
Figure 300: The ceiling in the hold shows the side stringers projecting above the ceiling. Thin filler planks are visible at the bottom of the photograph. (Photo V. Maitland)

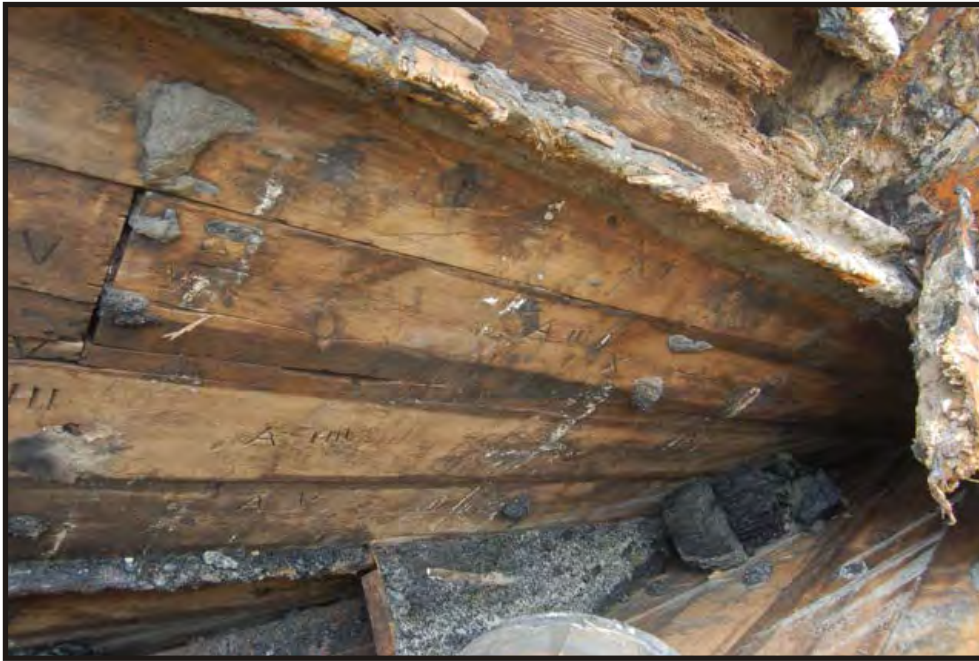
Figure 301: Close-up of the hold ceiling showing the general layout of the markings. (Photo V. Maitland)

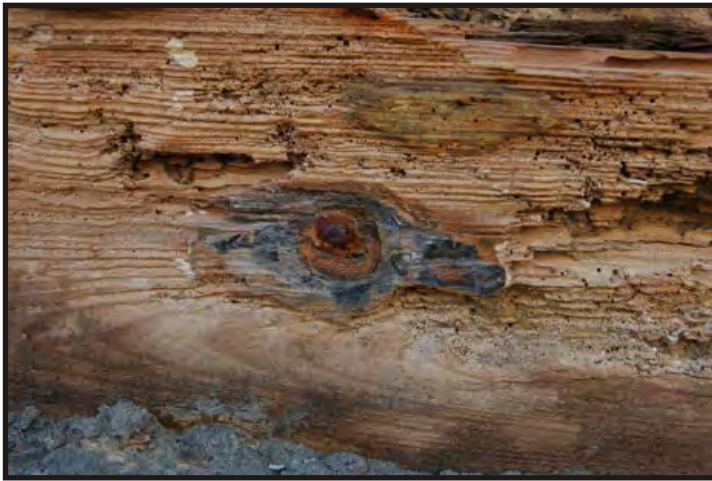
Figure 302: The ceiling was attached to frames with iron bolts. (Photo V. Maitland)

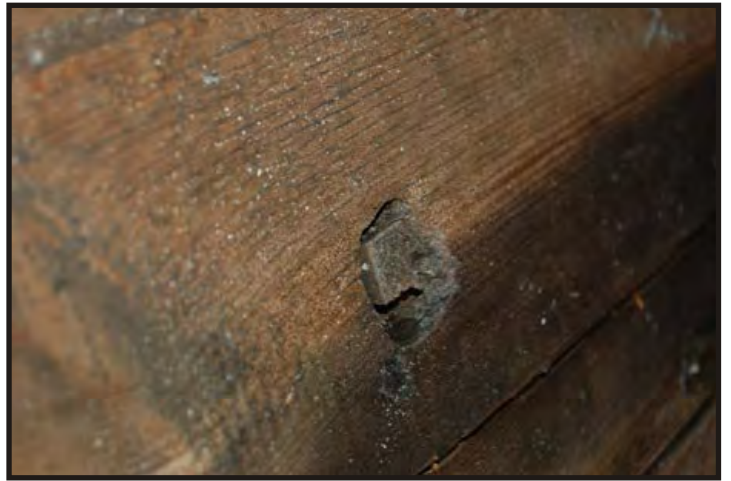
Figure 303: Wooden dowels are used intermittently throughout the cargo ceiling. I don't think these formed part of the attachment system as they were not carefully fitted or glued like the deck dowels. They may have been used as fillers for knot holes or other holes in the planks. (Photo V. Maitland)

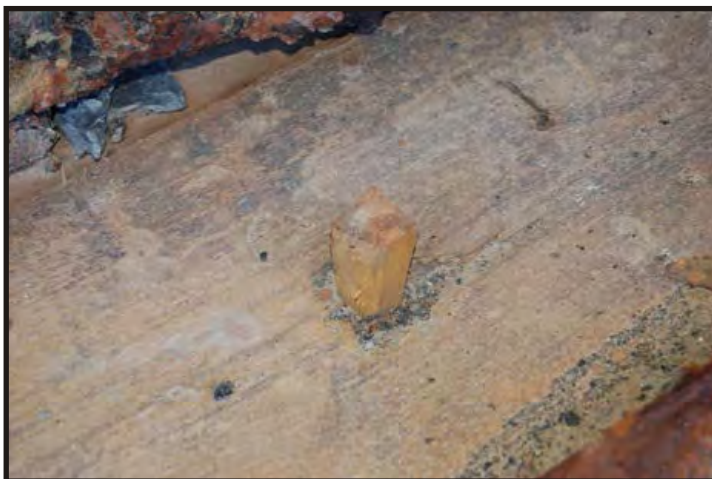
Figure 304: Wooden dowel in the hold ceiling, this one is particularly badly fitted. (Photo V. Maitland)

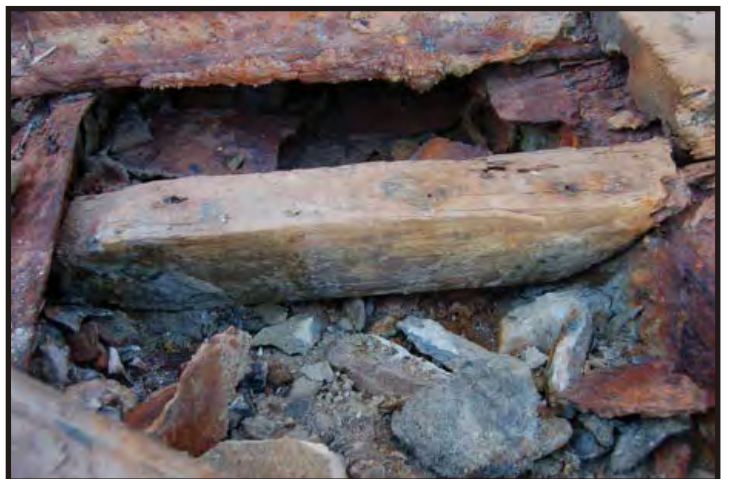
Figure 305: Intercostal wooden block. (Photo V. Maitland)

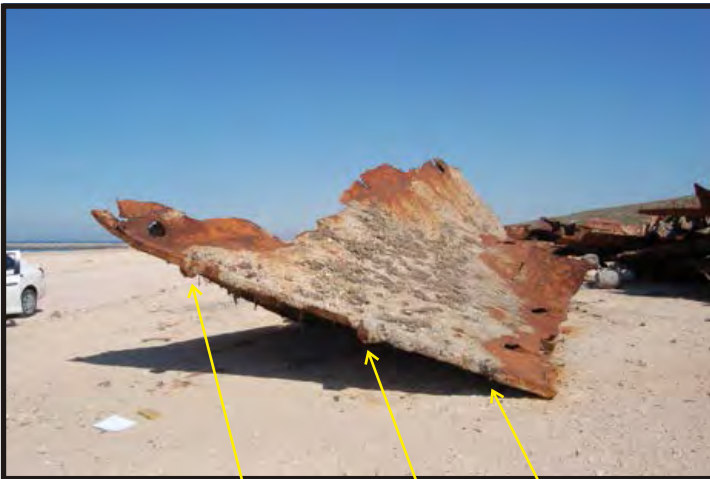
Figure 307: Rudder post with three gudgeons. These are eyes into which the rudder pintles fit. (Blackburn 1981:148; Photo V. Maitland)

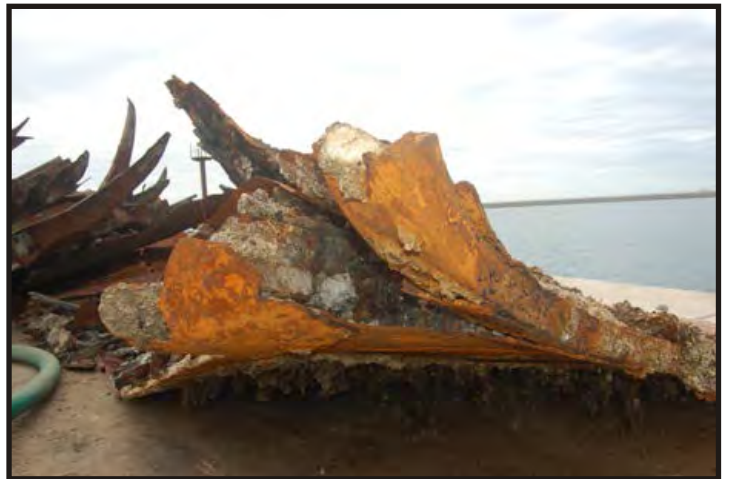
Figure 308: Close up of the sheared off rudder post. (Photo V. Maitland)

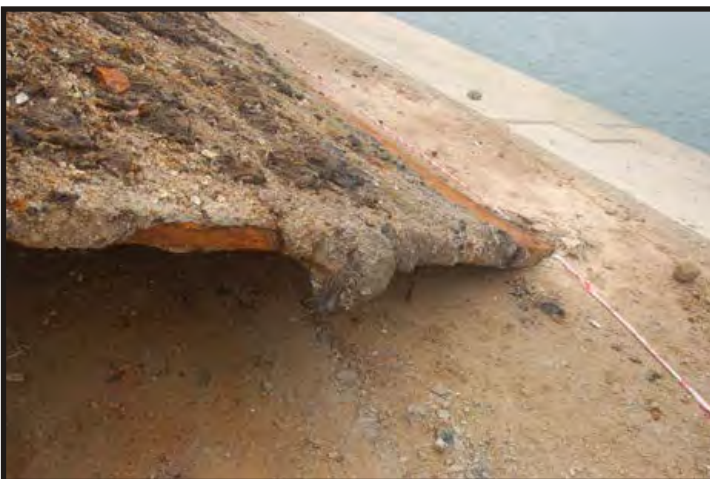
Figure 309: Gudgeon for the bearing pintle. (Photo V. Maitland)

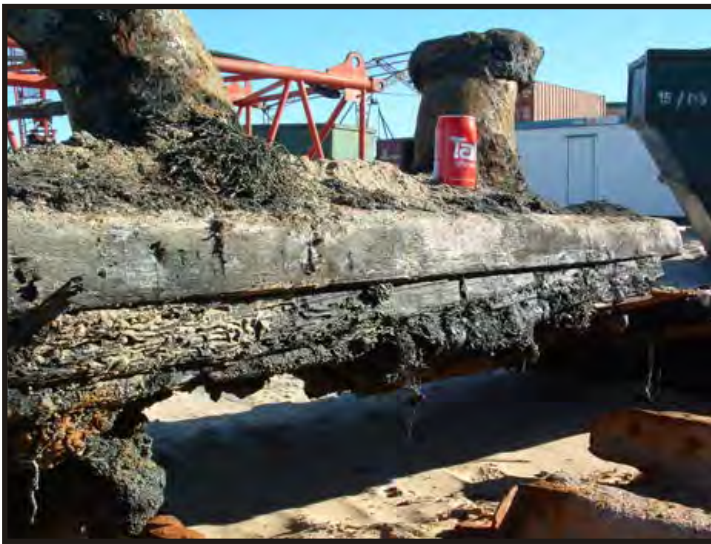
Figure 314: Close-up of the bollard, bollard plank, deck plank and rider plate. (Photo V. Maitland)

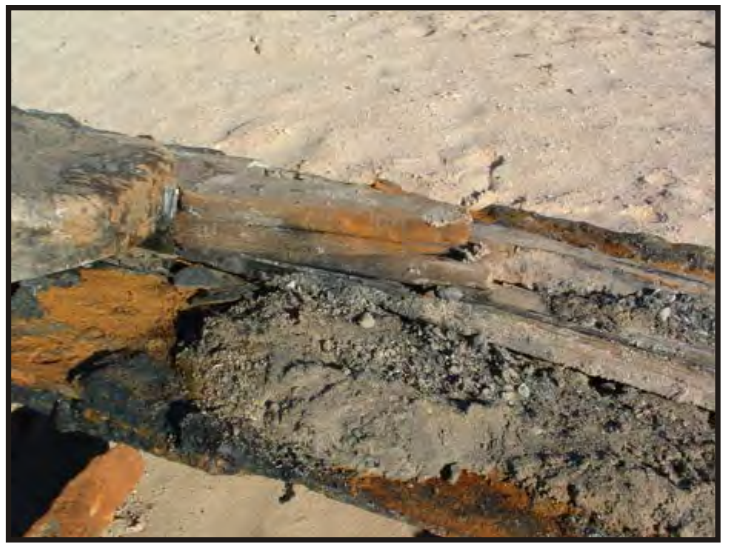
Figure 315: Close up of shaped end of the bollard plank. (Photo V. Maitland)

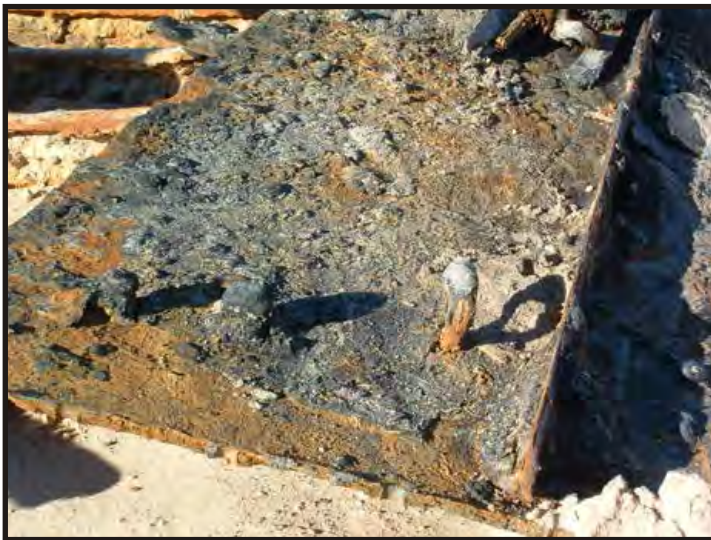
Figure 316: Close-up of rider plate and deck bolts. (Photo V. Maitland)

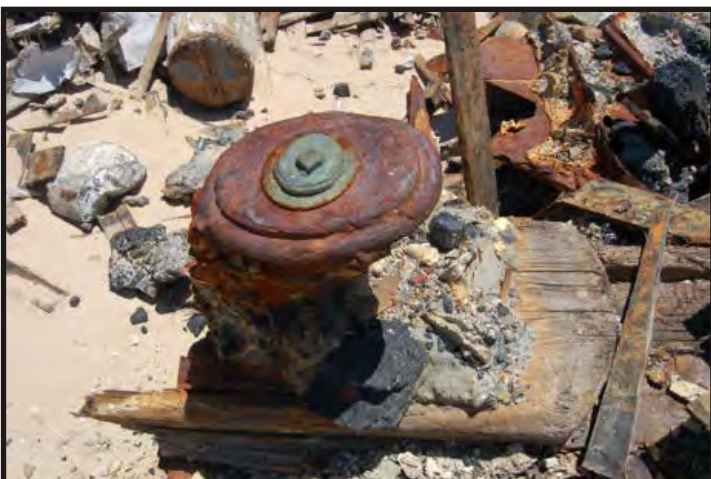
Figure 318: Top view of the bollard. The shaped bollard plank attached to the deck is visible. (Photo V. Maitland)

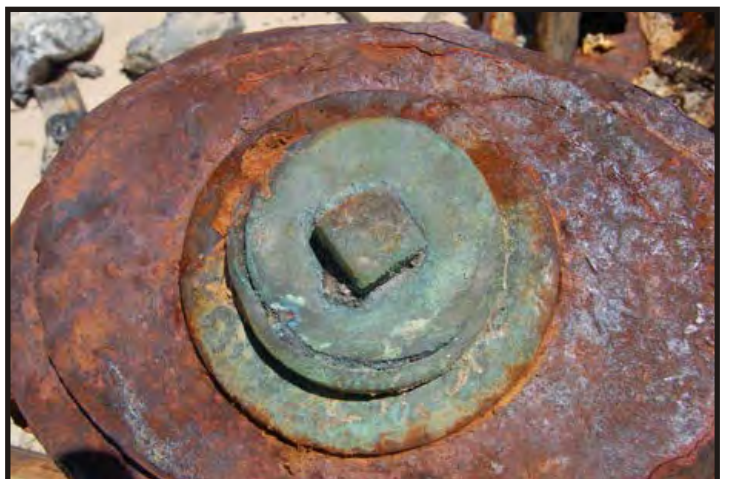
Figure 319: Close-up of the bollard top, with a square bolt and three brass 'washers'. (Photo V. Maitland)

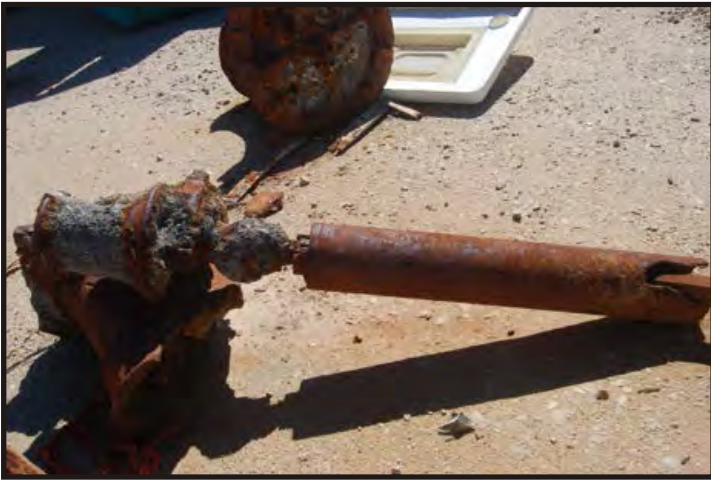
Figure 322: Drum end and winch reel of a small windlass, possibly for moving and tightening yards and stays. (Photo V. Maitland)

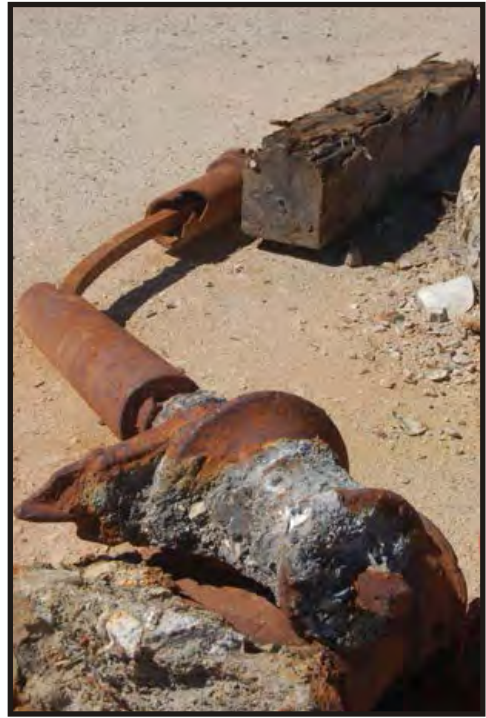
Figure 323: View from top of the drum end and winch reel. Cog on the far end possibly to attach to a gypsy. (Photo V. Maitland)

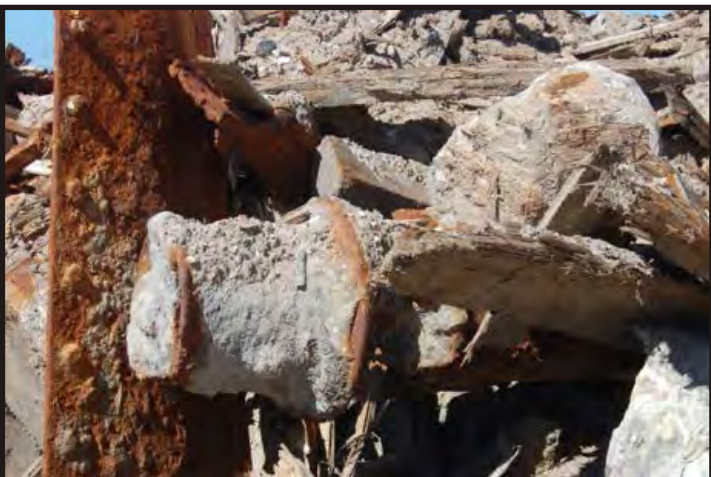
Figure 326: Drum end of windlass. Directly to the right of the drum is a gypsy. (Photo V. Maitland)

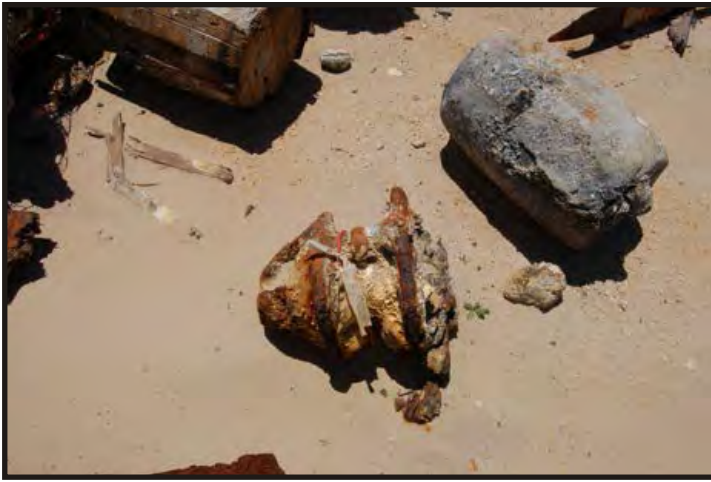
Figure 328: Side view of gypsy, part of the windlass. (Photo V. Maitland)

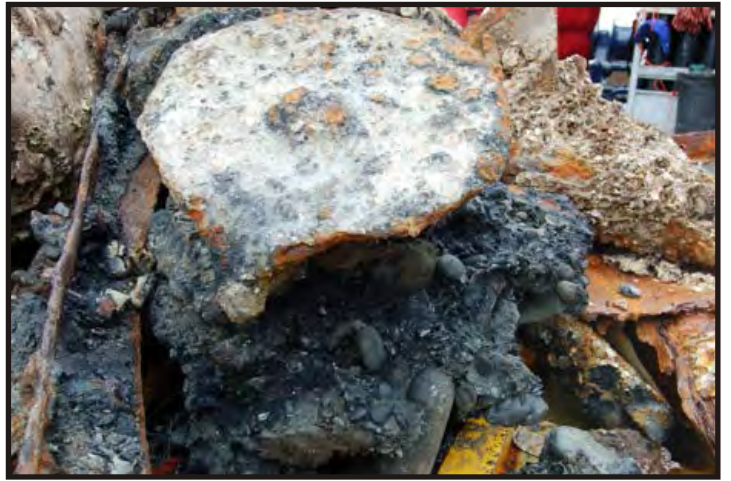
Figure 331: Top view of a possible gypsy. This piece of equipment was heavily encrusted with marine growth, it may be a different type of gypsy, perhaps for a larger windlass. (Photo V. Maitland)

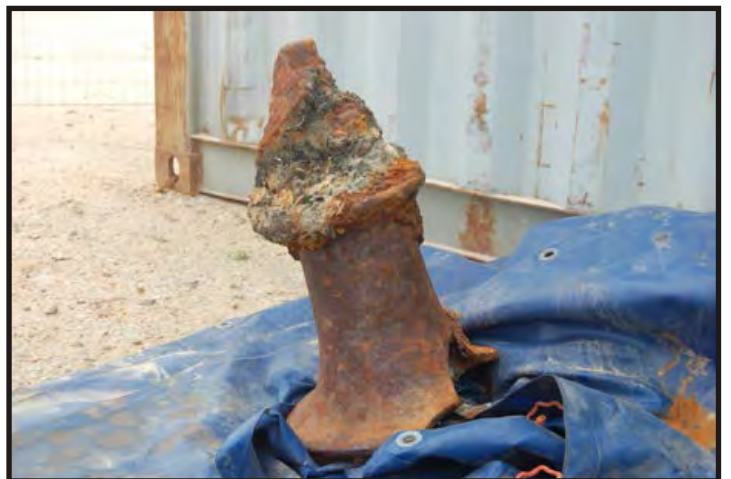
Figure 333: This may either be a drum end of a windlass or a winch, which is a small vertical drum around which a rope or line is passed in order to make it easier to pull the rope. The principle difference between the two, is a windlass is horizontally mounted on the deck while a winch is vertically mounted and is an integral part of the deck. (Blackburn 1981:341; Photo V. Maitland)

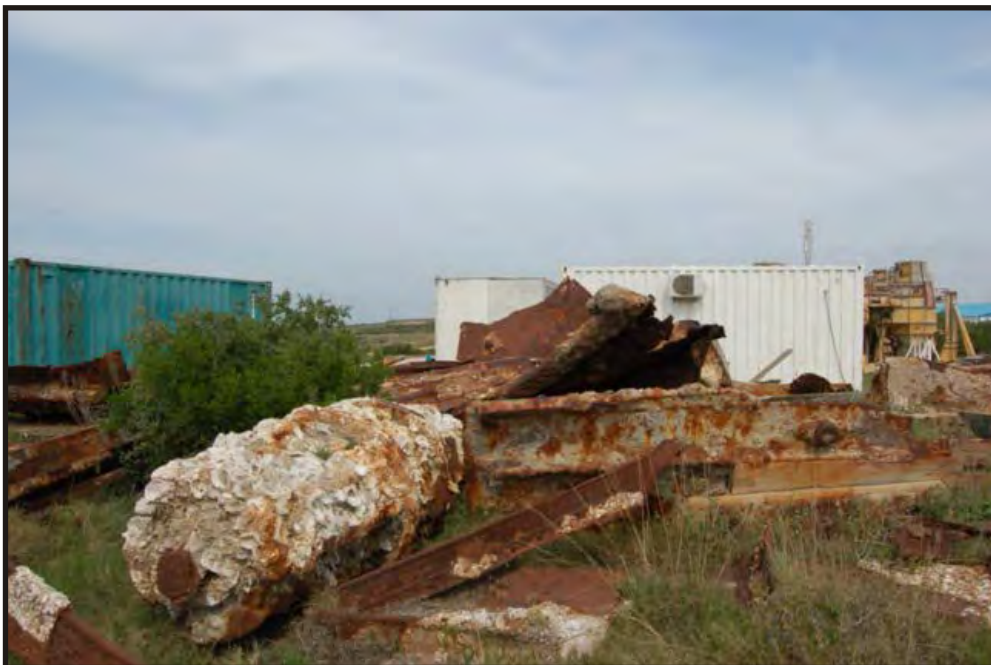
Figure 335: Anchor windlass from the *County of Pembroke*, recovered in 2004. (Photo V. Maitland) Bisset (1958:89) states that, on arriving at their destination, "We now raised the anchor cables from the chain lockers, ranged them on deck abaft the windlass, and shackled the end to the anchors". While negotiations with the harbour pilot were in progress, all hands were "...busy forrard since dawn unlashng the two old-fashioned heavy iron anchors on the forecstlehead, and getting ready to let go". He describes (1958:69) the windlass as having heavy iron levers which were unshipped during sailing and lashed to the bitts near the fo'c'slehead and the use of it, "...we manned the windlass and began to heave up and down on the long levers, to the song of 'Rolling Home.' This type of windlass was known as 'the Armstrong Patent.' Some idea of its efficiency may be gathered from the fact that it required more than two hours' hard heaving to get in the seventy-five fathoms of cable link by link and break the anchor out of the rocky bottom." (Bisset 1958:202). Armstrong Patent is an expression from the turn of the 19th century to represent a vessel with no patent mechanical aids and had to rely on the strength of crews' arms (Blackburn 1981:15).

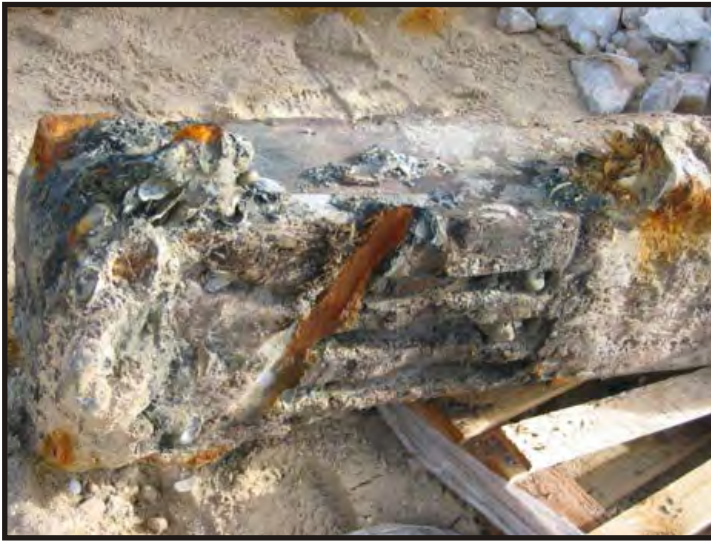
Figure 343: Underside view of the cathead and its sheaves. (Photo V. Maitland)

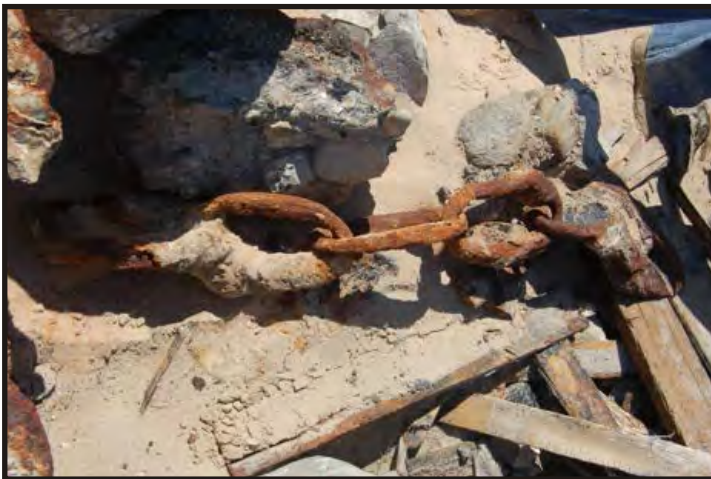
Figure 347: Iron stream cable attached to wood. According to the Lloyds' Survey of 1881, the stream cable was 15/16" and 90 fathoms long and attached to the stream anchor. (Photo V. Maitland)

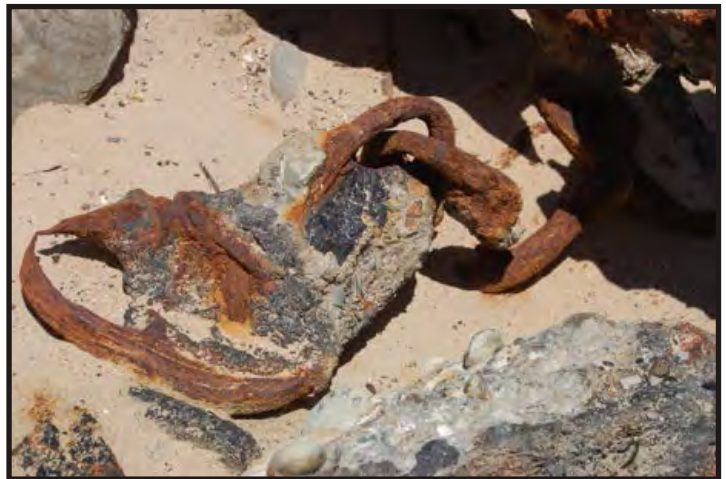
Figure 348: Close-up of the stream cable, it's much thinner than the bower cables. (Photo V. Maitland)

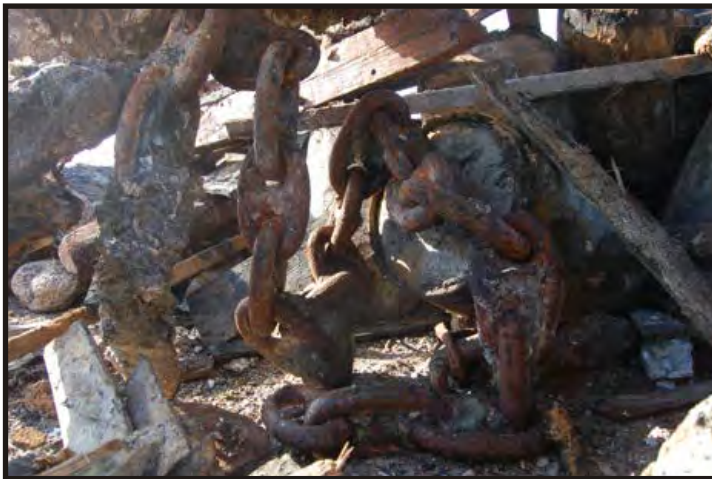
Figure 351: Remains of the bower cable. (Photo V. Maitland)

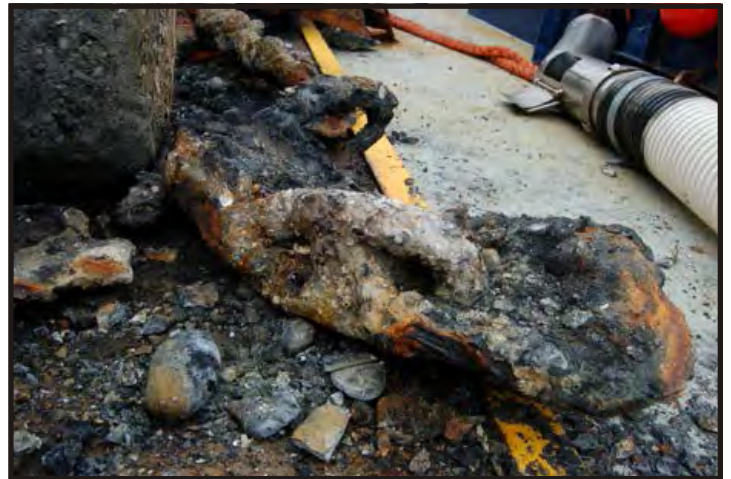
Figure 352: Chain links after it was brought up from the wreck. (Photo V. Maitland)

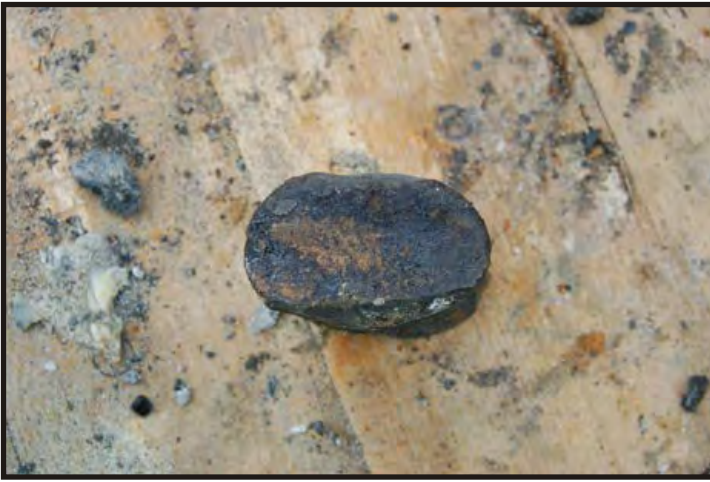
Figure 355: Close-up of the top of the chain stud. Studs were fitted in the links to keep the chain from kinking and added strength to the chain. (Brown 1931:119; Photo V. Maitland)

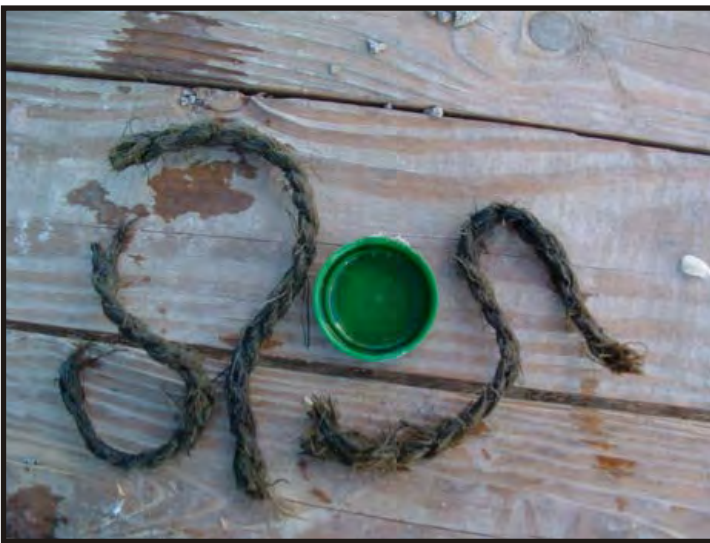
Figure 357: Lloyds' Survey of 1881 states that the ropes on the barque were manilla. These strands were made from two yarns. Normally strands were made by twisting three yarns together (Luce 1891:598). (Photo V. Maitland)

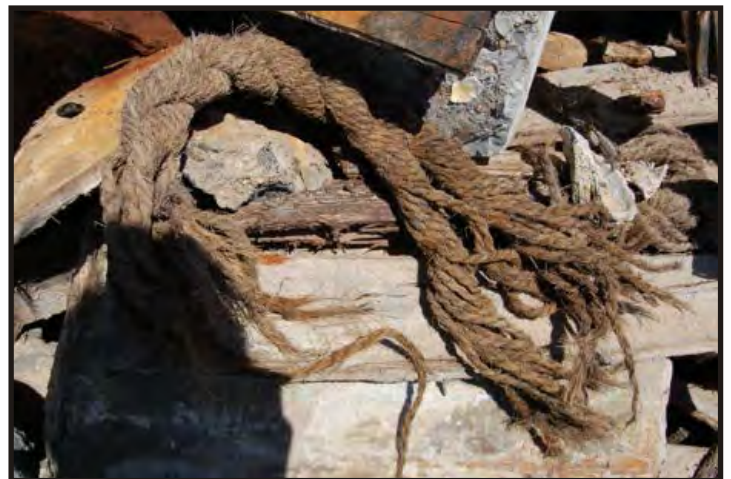
Figure 358: Manilla cable. Fourteen, two-yarn strands were twisted together to form a rope and two ropes were twisted together to form a cable. Each layer is twisted in alternating directions to give the final cable greater strength and distribute the strain among the fibres (Luce 1891:598). (Photo V. Maitland)

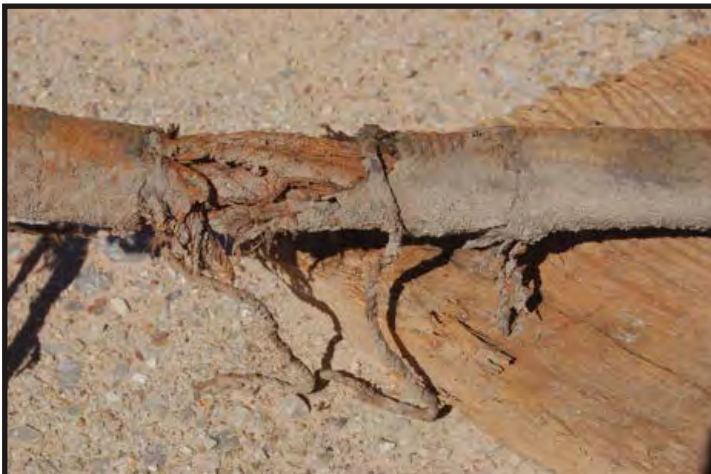
Figure 363: Section of wire rope showing the disintegrated manilla covering and exposing the wires beneath. (Photo V. Maitland)

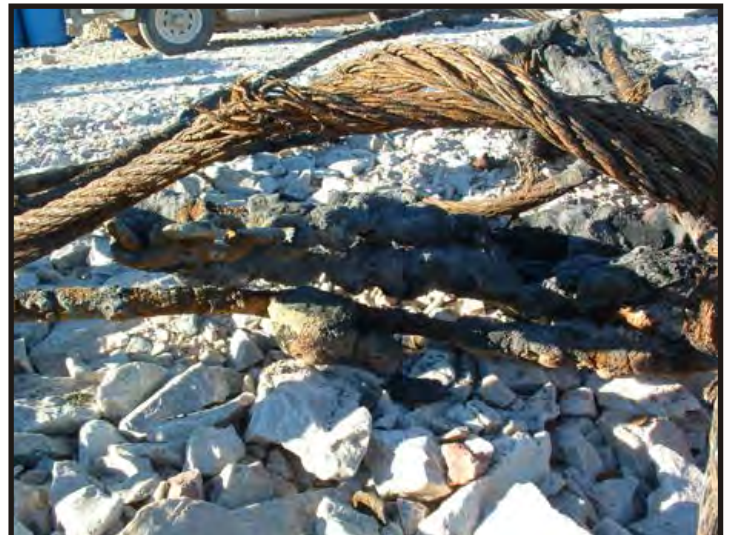
Figure 364: Wire rope without a manilla covering. (Photo V. Maitland)

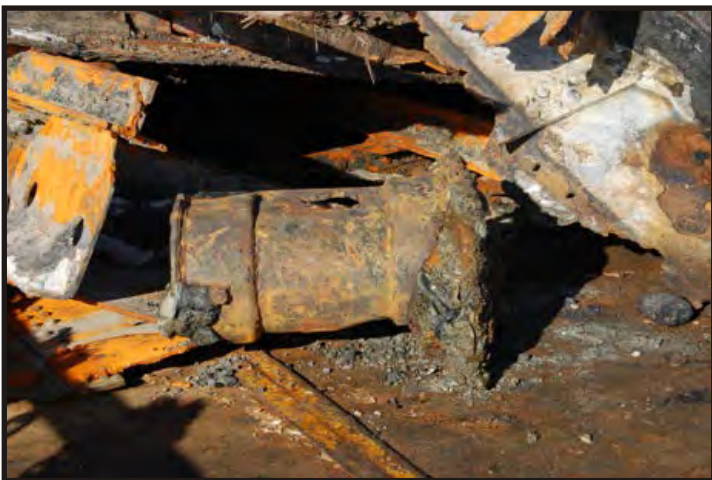
Figure 373: Pump. Two of these were found. This is the discharge end of the pump. According to the Lloyds' Survey of 1881, the *County of Pembroke* had two metal chambered pumps aboard. Bisset (1958:52,201) states that the fresh water was stored in two iron tanks set amidships in the hold. Water was drawn with a hand pump on deck into buckets. The ration per man per day was three quarts. The other pump may have been a bilge pump. (Photo V. Maitland)
