County of Pembroke

Shipwreck Report

Vanessa Maitland

**Port of Ngqura
Eastern Cape
South Africa**

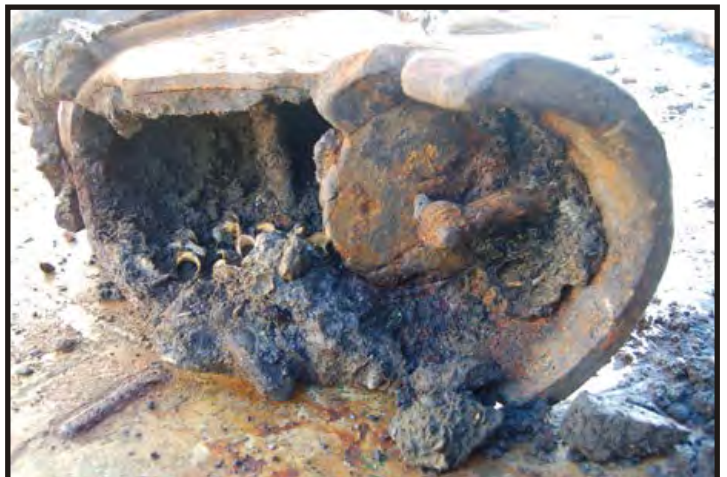
Figure 374: Top of chambered pump. (Photo V. Maitland)

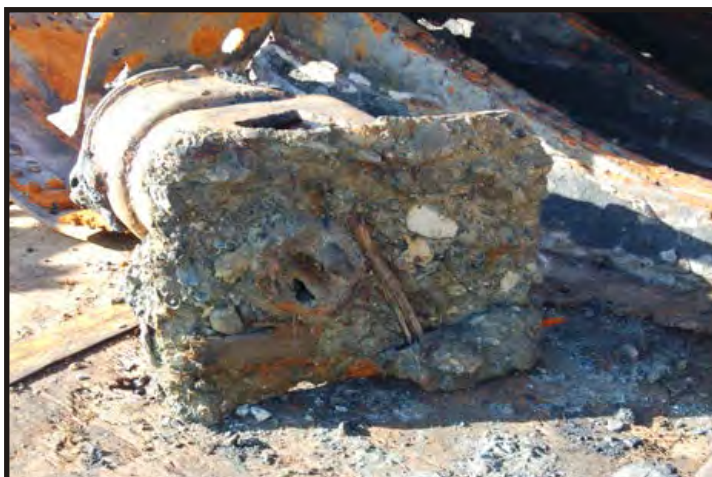
Figure 375: Bottom of pump. The pipe and remains of the deck are visible. (Photo V. Maitland)

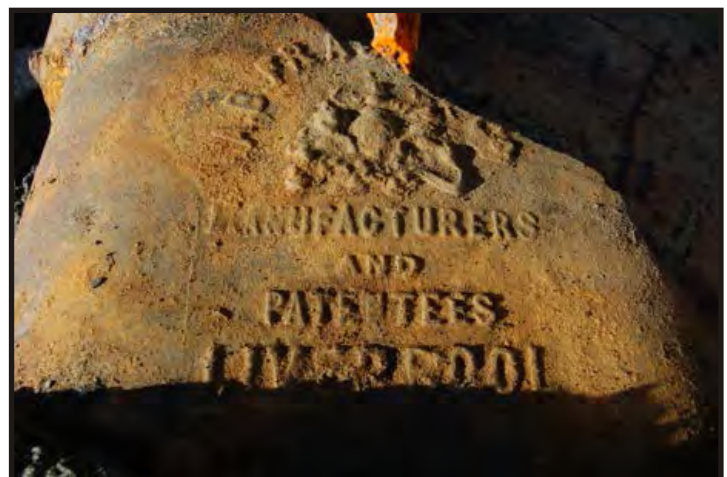
Figure 376: The name of the pump manufacturers. Unfortunately all that is visible is A.B. FRA... Manufacturers and Patentees Liverpool N°2.15. (Photo V. Maitland)

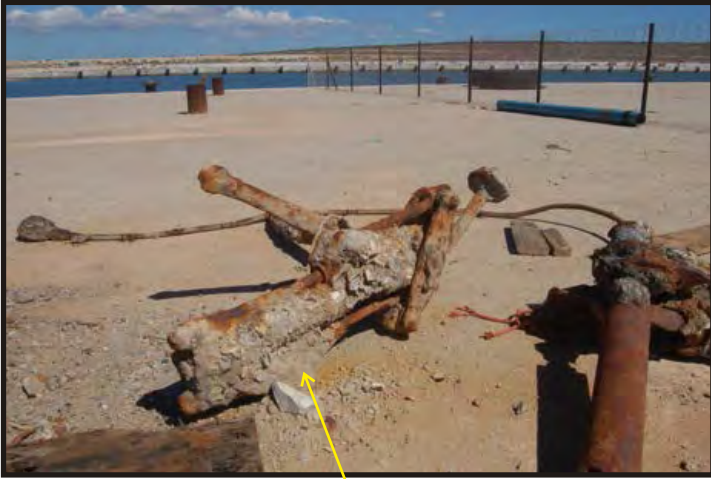
Figure 377: Possible anchor release mechanism, similar to that shown on the *Lawhill* in Figure 311. (Photo V. Maitland)

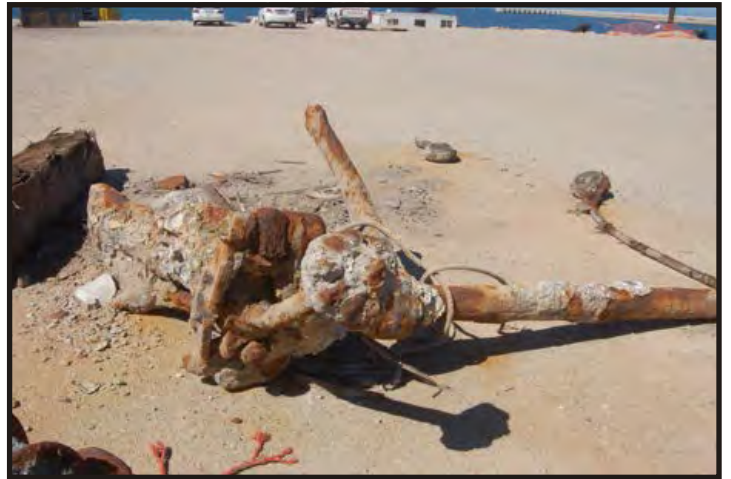
Figure 378: Possible anchor release mechanism from the other side. (Photo V. Maitland)

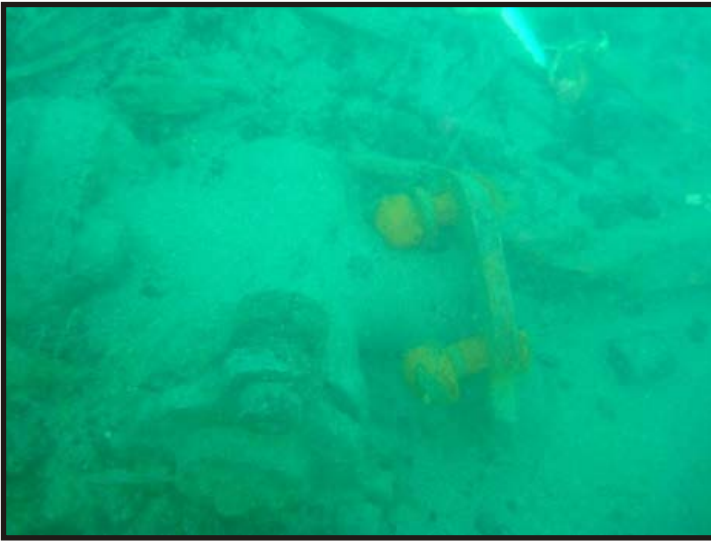
Figure 389: In-situ piece of equipment, found below deck level. It may have been part of the steering gear. (Photo Subtech)

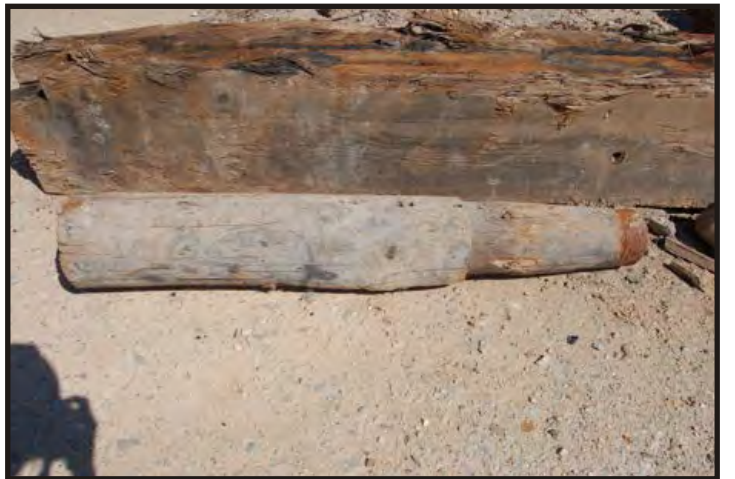
Figure 406: Wooden pole. It had a metal band on the end, possibly to keep it from splitting. It also had a routed area that may have had a cleat or some other fitting. This may have been a belaying pin on the fife rail. (Photo V. Maitland)

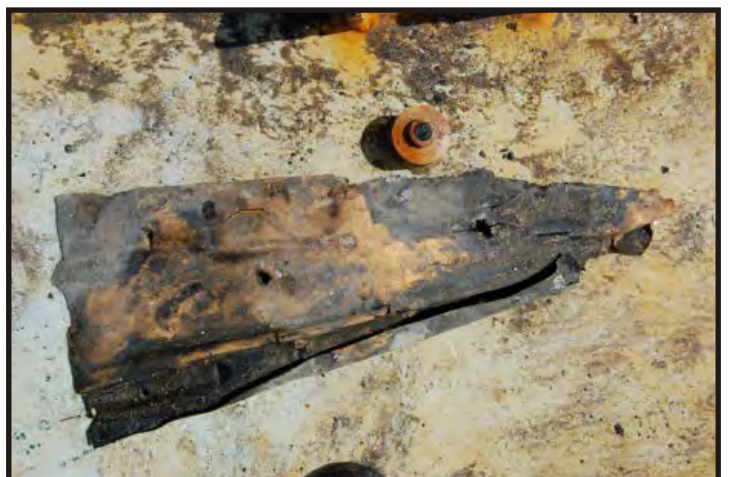
Figure 417: Copper sheeting. This was used to cover repairs to the wood. (Photo V. Maitland)

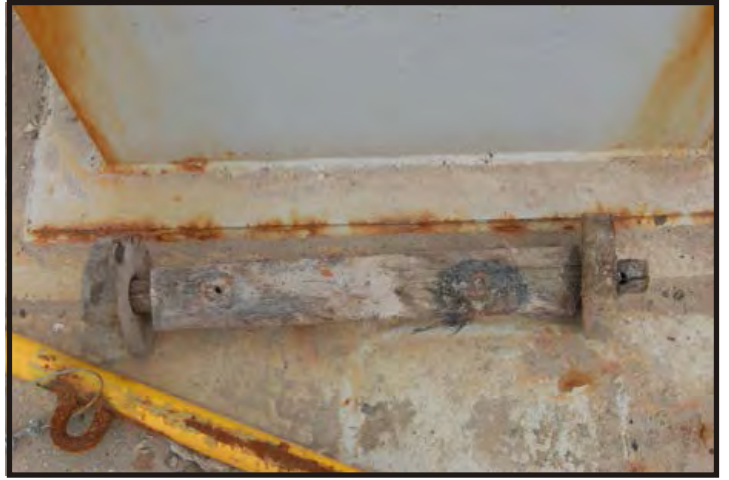
Figure 424: Wooden axle and wheels, probably from a deck trolley. The remains of iron bolts on the axle are visible. (Photo V. Maitland)

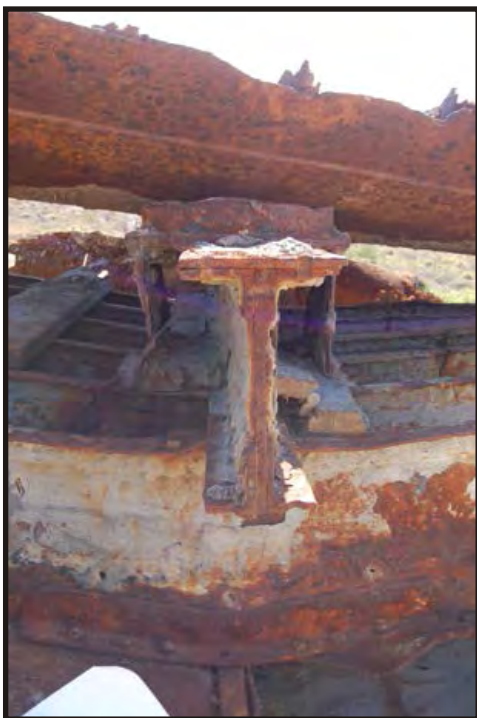
Figure 443: Centre keelson and mast step. The downward thrust that a mast exerts at its heel means the mast must be strongly supported and stepped (Pursey 1942:144). By putting the mast through the decks, it added support to the mast. In the *County of Pembroke* the mast was stepped on the centre keelson; it had a reinforcing bracket where it's wider than the keelson. (Photo V. Maitland)

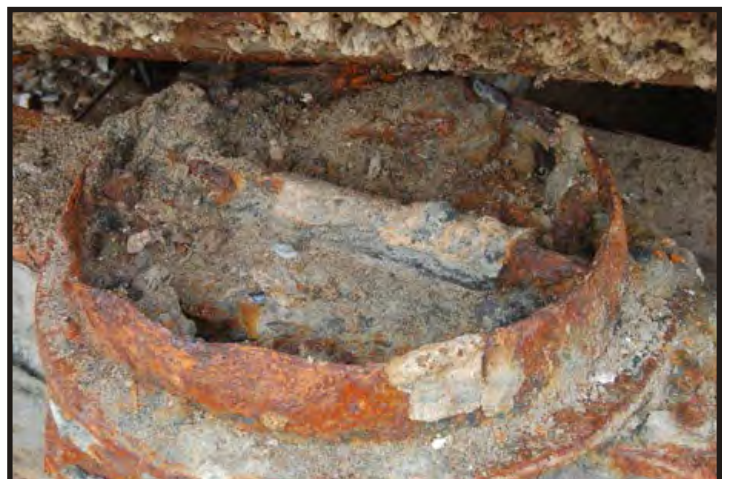
Figure 444: Close-up of the mast step. (Photo V. Maitland)

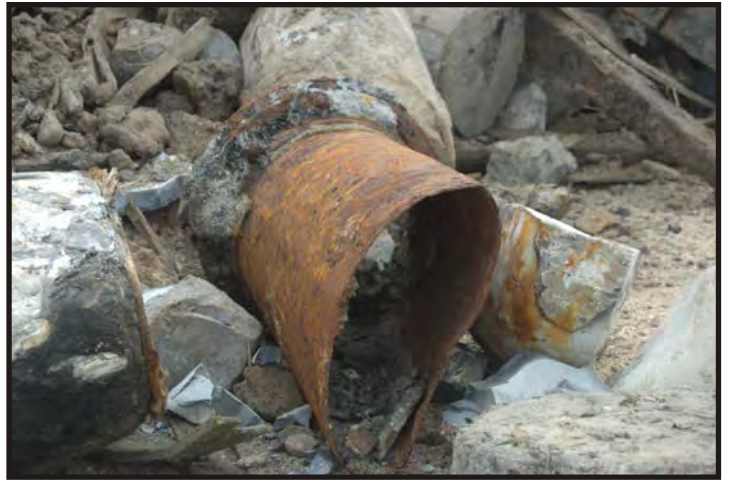
Figure 446: Mast heel. (Photo V. Maitland)

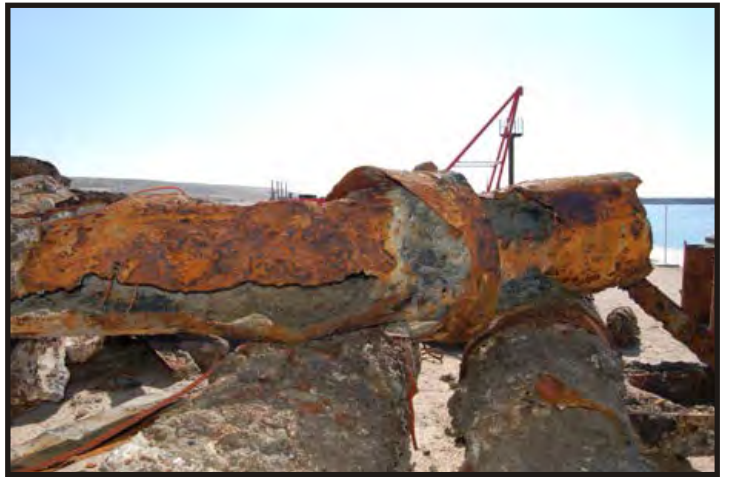
Figure 448: Section of mast with the wedge strap, this was a doubling of the mast where it went through the deck. (Photo V. Maitland)

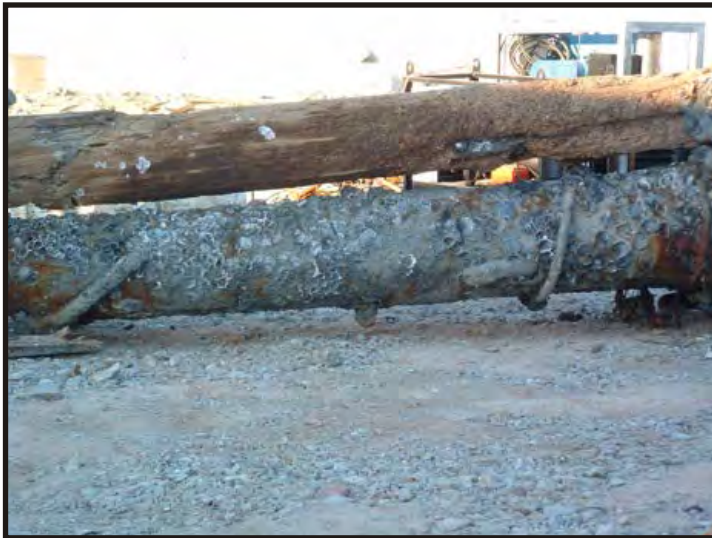
Figure 451: Close-up of the doubling. Cables from the rigging are still wrapped around the iron mast. (Photo V. Maitland)

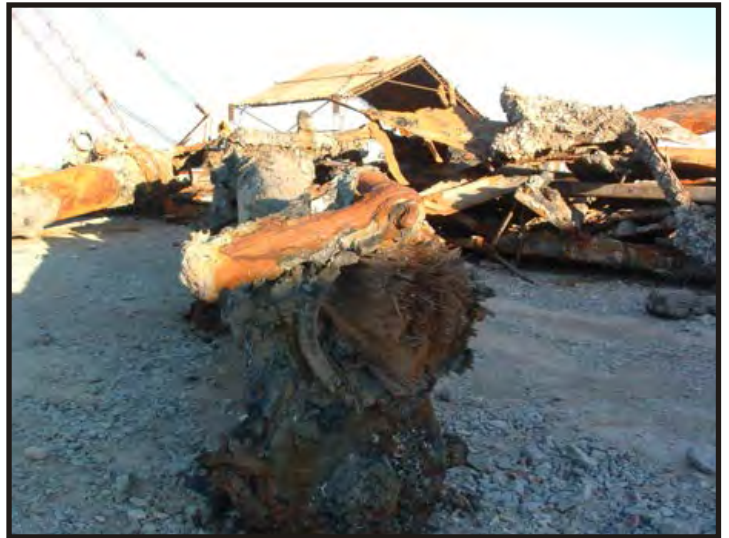
Figure 452: Close-up of the cap of the lower iron mast and the trunnion hoop around the wood. It appears there are shaped wooden wedges between the hoop and the wood top mast. The metal apparatus may have been to tighten the trunnion hoop. (Photo V. Maitland)

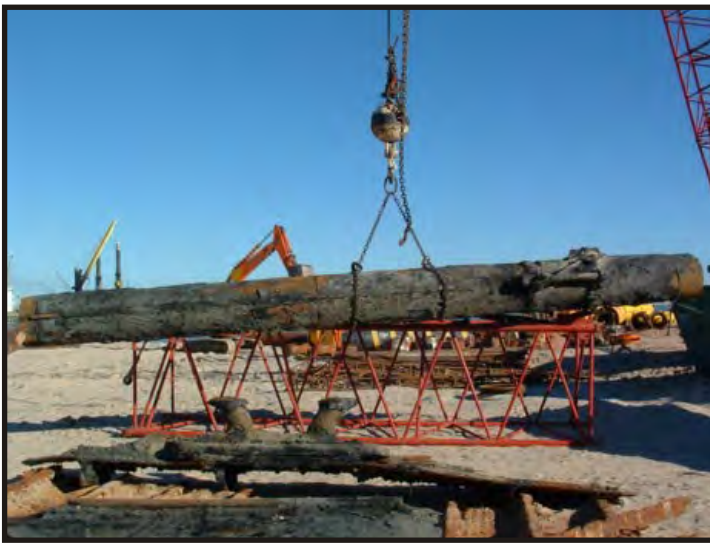
Figure 455: Lower main mast. The bottom of the mast, just above the partners, is ringed with cleats. (Photo V. Maitland)

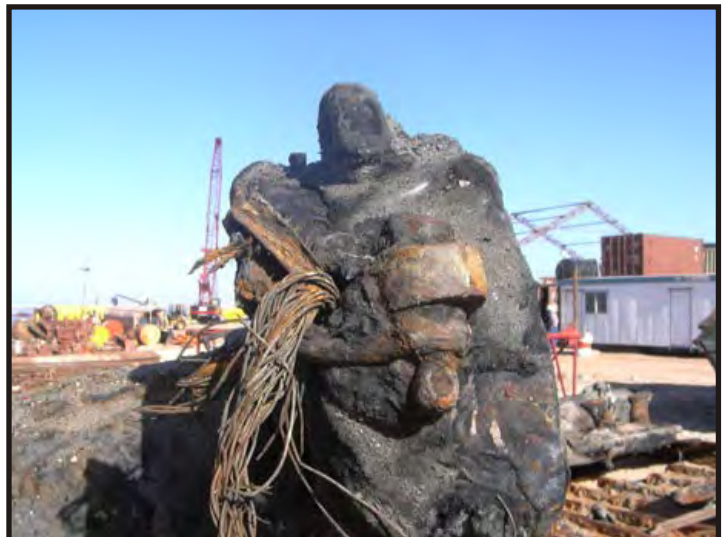
Figure 471: Close-up of an eye on the trunnion hoop for the rigging. Wire cable is still attached. (Photo V. Maitland)

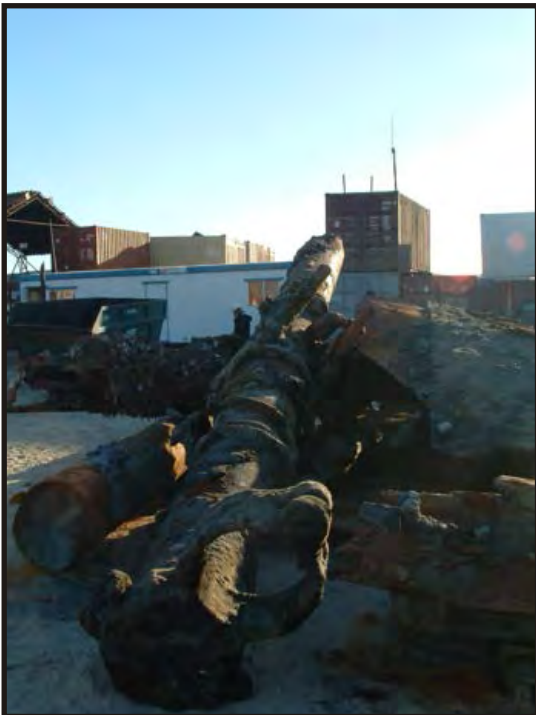
Figure 473: Lower mizzen mast, showing the cap, trunnion hoop and top cheeks. Cable is still wrapped around the mast. (Photo V. Maitland)

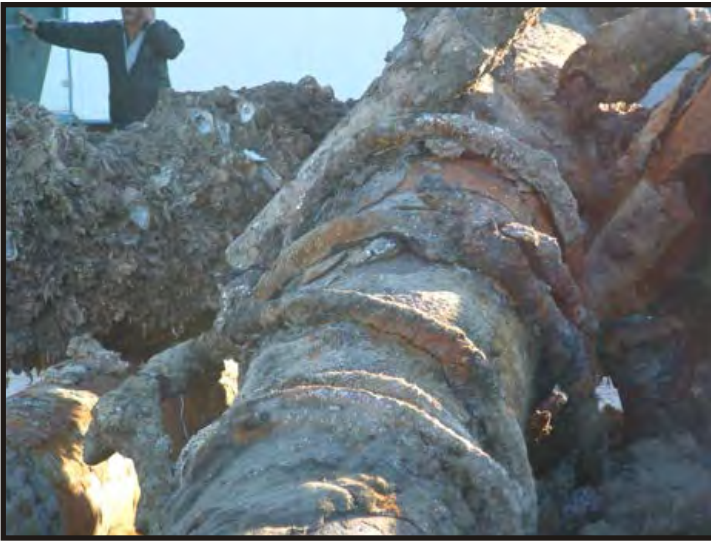
Figure 475: Close-up of cable wrapped around the lower mizzen mast. (Photo V. Maitland)

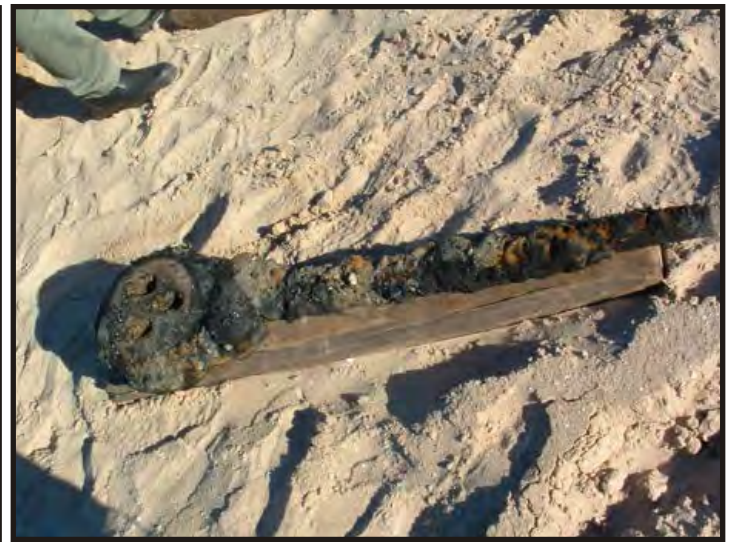
Figure 488: Dead-eye from the channel. (Photo V. Maitland)

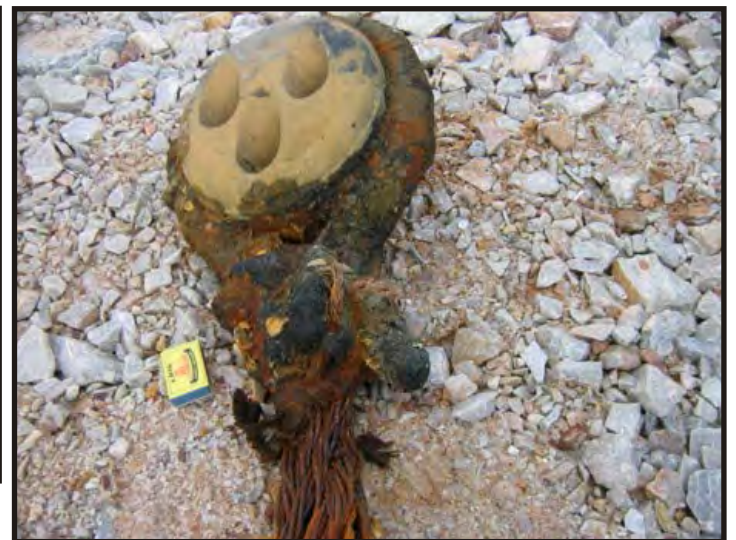
Figure 490: Close-up of dead-eye. Iron wire cable is in the groove. (Photo V. Maitland)

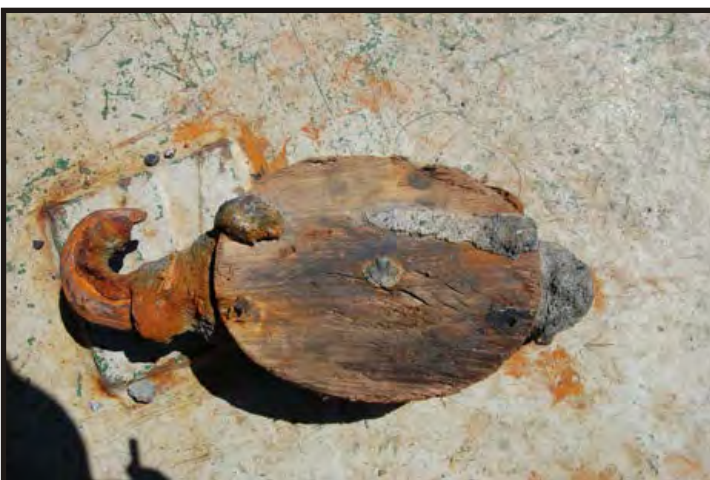
Figure 495: Single, iron strapped block. The hook is shorter and fatter. Unfortunately the conglomerate around the neck of the hook was too thick and I was unable to determine whether the hook could swivel or not. (Photo V. Maitland)

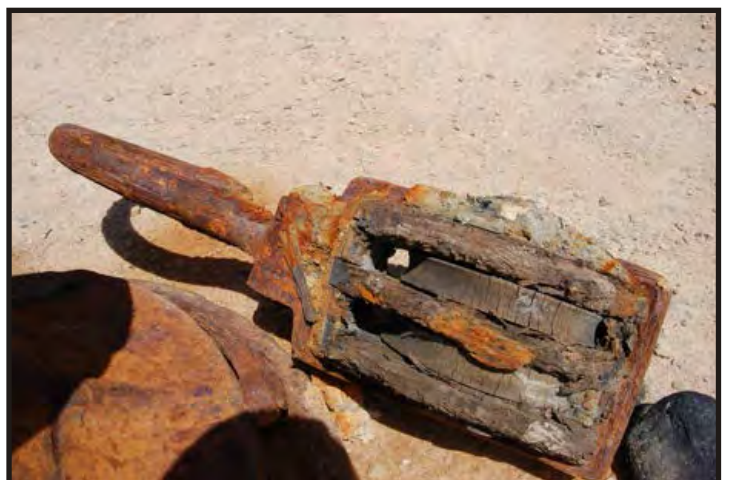
Figure 496: Double, iron strapped block. The large hook appears to hinge onto the iron strap and was probably able to pivot. The iron strap is still in place. (Photo V. Maitland)

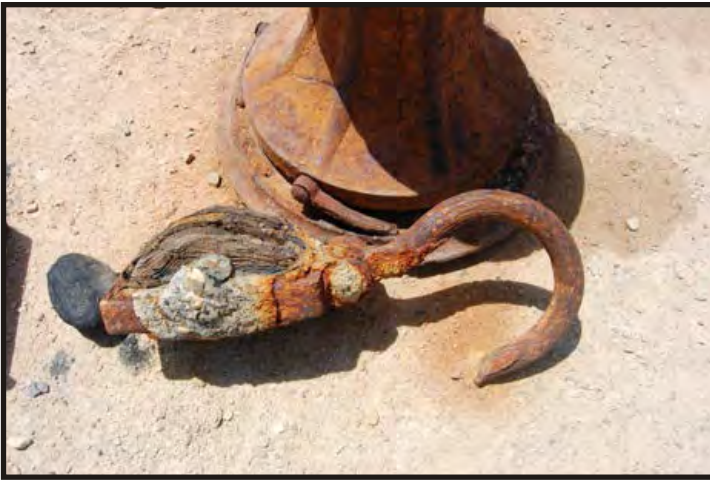
Figure 497: Double iron strapped block. (Photo V. Maitland)

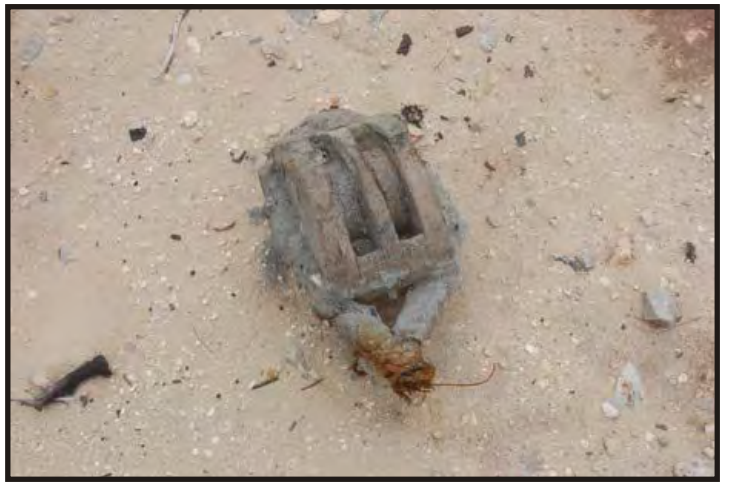
Figure 498: Double block that is strapped with wire rope. (Photo V. Maitland)

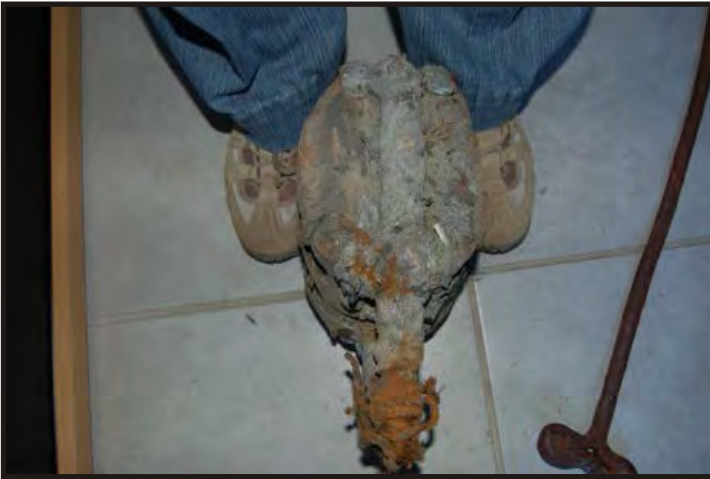
Figure 499: Side view of the double block and wire rope strap. (Photo V. Maitland)

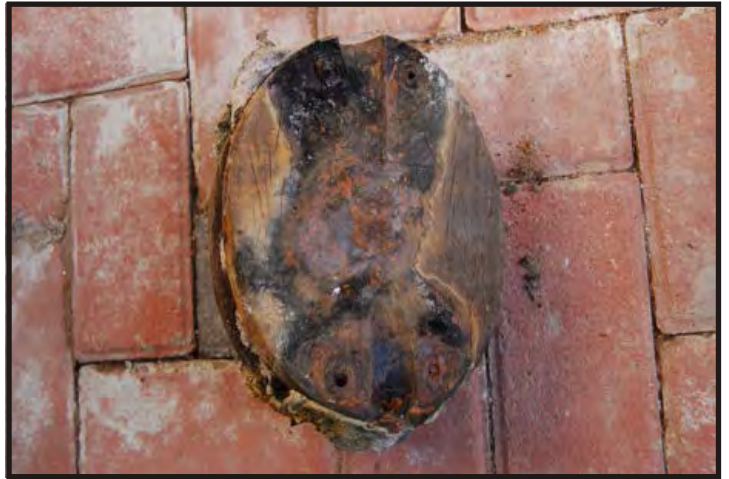
Figure 500: Single block that was strapped with wire rope. The scores cut at the ends of the shell for the straps are visible and judging from the outlines left by the decayed material, it appears that a securing iron plate was attached over the wire rope strap by the scores. (Photo V. Maitland)

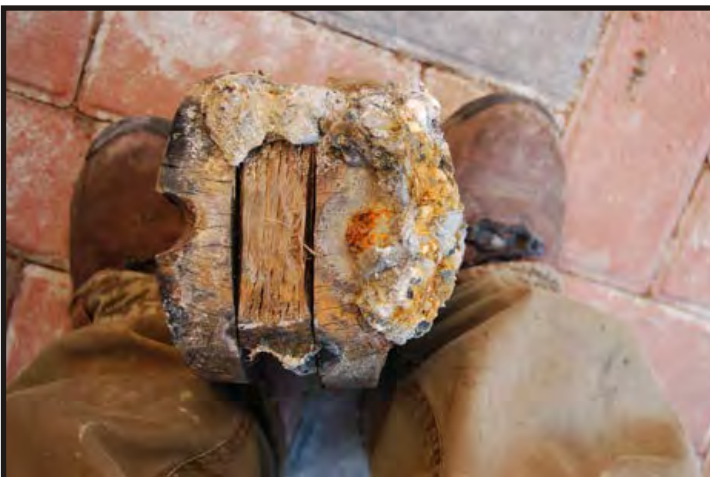
Figure 501: Top view of the scores in the block shell. (Photo V. Maitland)
