**ASSESSMENT OF THE IMMEDIATE SURROUNDINGS OF THE OLD BUILDING AT THE VOORSPOED
DIAMOND MINE AS WELL AS THE WIDER CULTURAL LANDSCAPE**

Version 2.0

14 February 2014

CLIENT: De Beers Consolidated Mines Limited

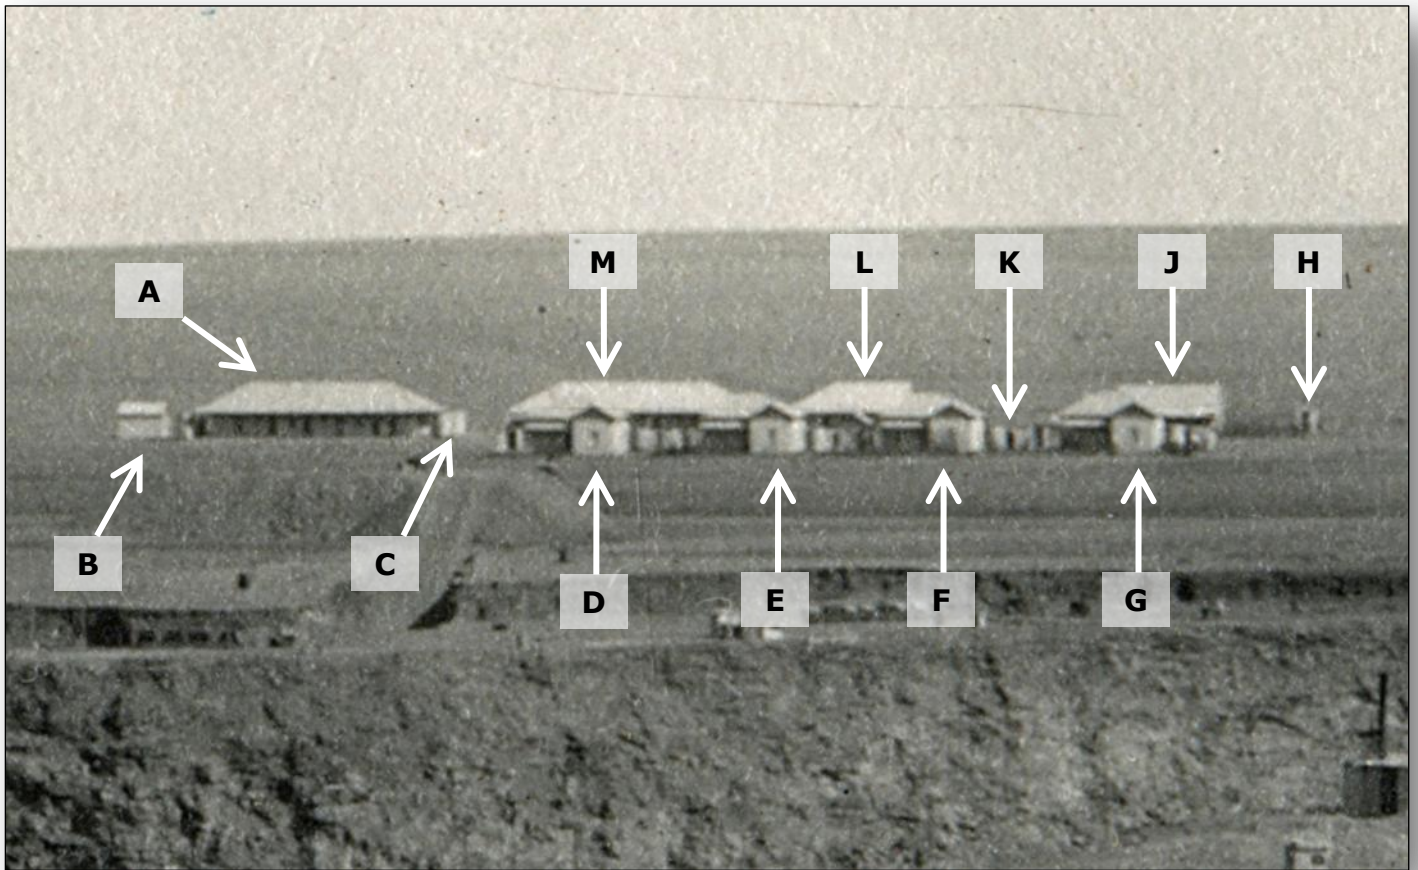
The historic photograph indicates that at the time the old building was located in a sparse landscape to the side of an active mine. The building was associated with two corrugated iron structures which appear to have been a mess and a kitchen. To the north-east, four married quarters were located. These buildings were likely constructed of brick and would have had corrugated iron roofs. Furthermore, each of these dwellings contained a number of outbuildings, including what would have been an outside toilet. Behind the row of married quarters three unidentified structures are depicted. Due to the flat perspective of the photograph it is currently impossible to state whether these unidentified structures were located directly adjacent to the old building, adjacent to the married quarters or in between the two. The low resolution of the photograph also makes the identification of these three structures very difficult.

Figure 3 Detailed view of the historic photograph which depicts the old building and its immediate surroundings. The depicted letters can be described as follows (A) Old Building (B) Corrugated Structure which may have been the Mess (C) Corrugated Structure which may have been the Kitchen (D - G) Married Quarters (H) Outhouse associated with Unidentified Structure (J,L & M) Unidentified Structures which may have been associated with either the Old Building or the Married Quarters (K) Outbuilding associated with Married Quarters. It is important to note that due to the distance from which this photograph was taken, perspective has been flattened. As a result, although the married quarters appear to be located directly adjacent to the old building in reality these two features would have been at least 120m apart.

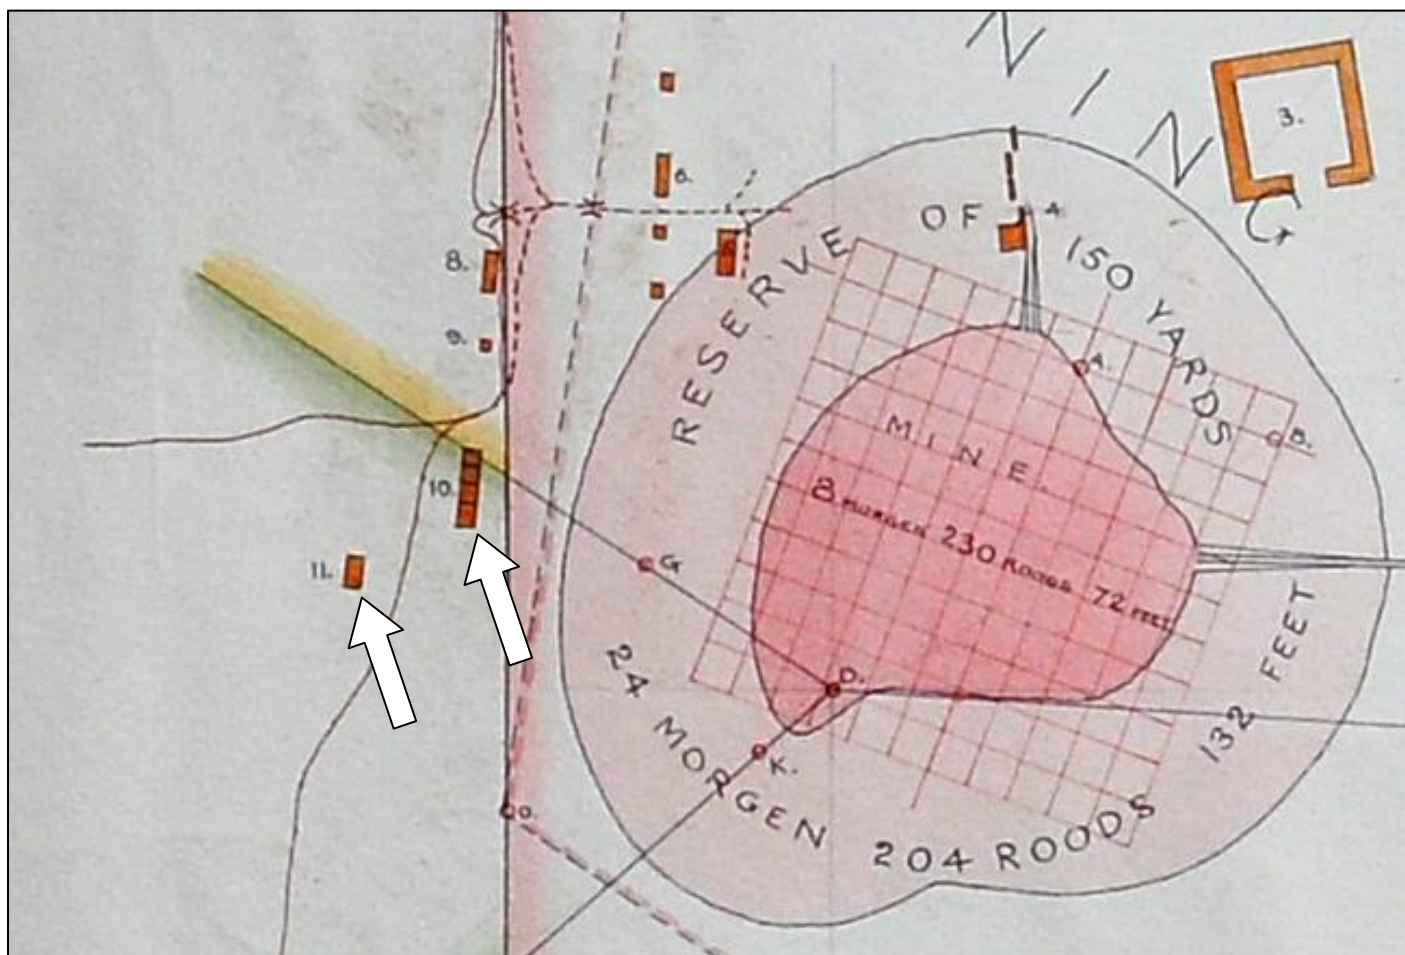
The map clearly shows that the building located at the archaeological site that is the focus of this report existed at the time and was used as bachelor’s accommodation. This means that the building was used to house single white mine workers. In terms of the direct surroundings of the study area, the map depicts only one other building located some distance to the north-east. This second building comprises staff quarters consisting of four blocks aligned in a single rectangle. Judging from the historic photograph above, these four blocks represented four individual dwellings used for accommodating married staff members and their families.

Figure 4 Section of a map titled "Voorspoed Diamond Mining Company Limited: Plan of Extended Mining Area" which is dated June 1909. The arrows indicate the position of the old building and nearby married quarters.

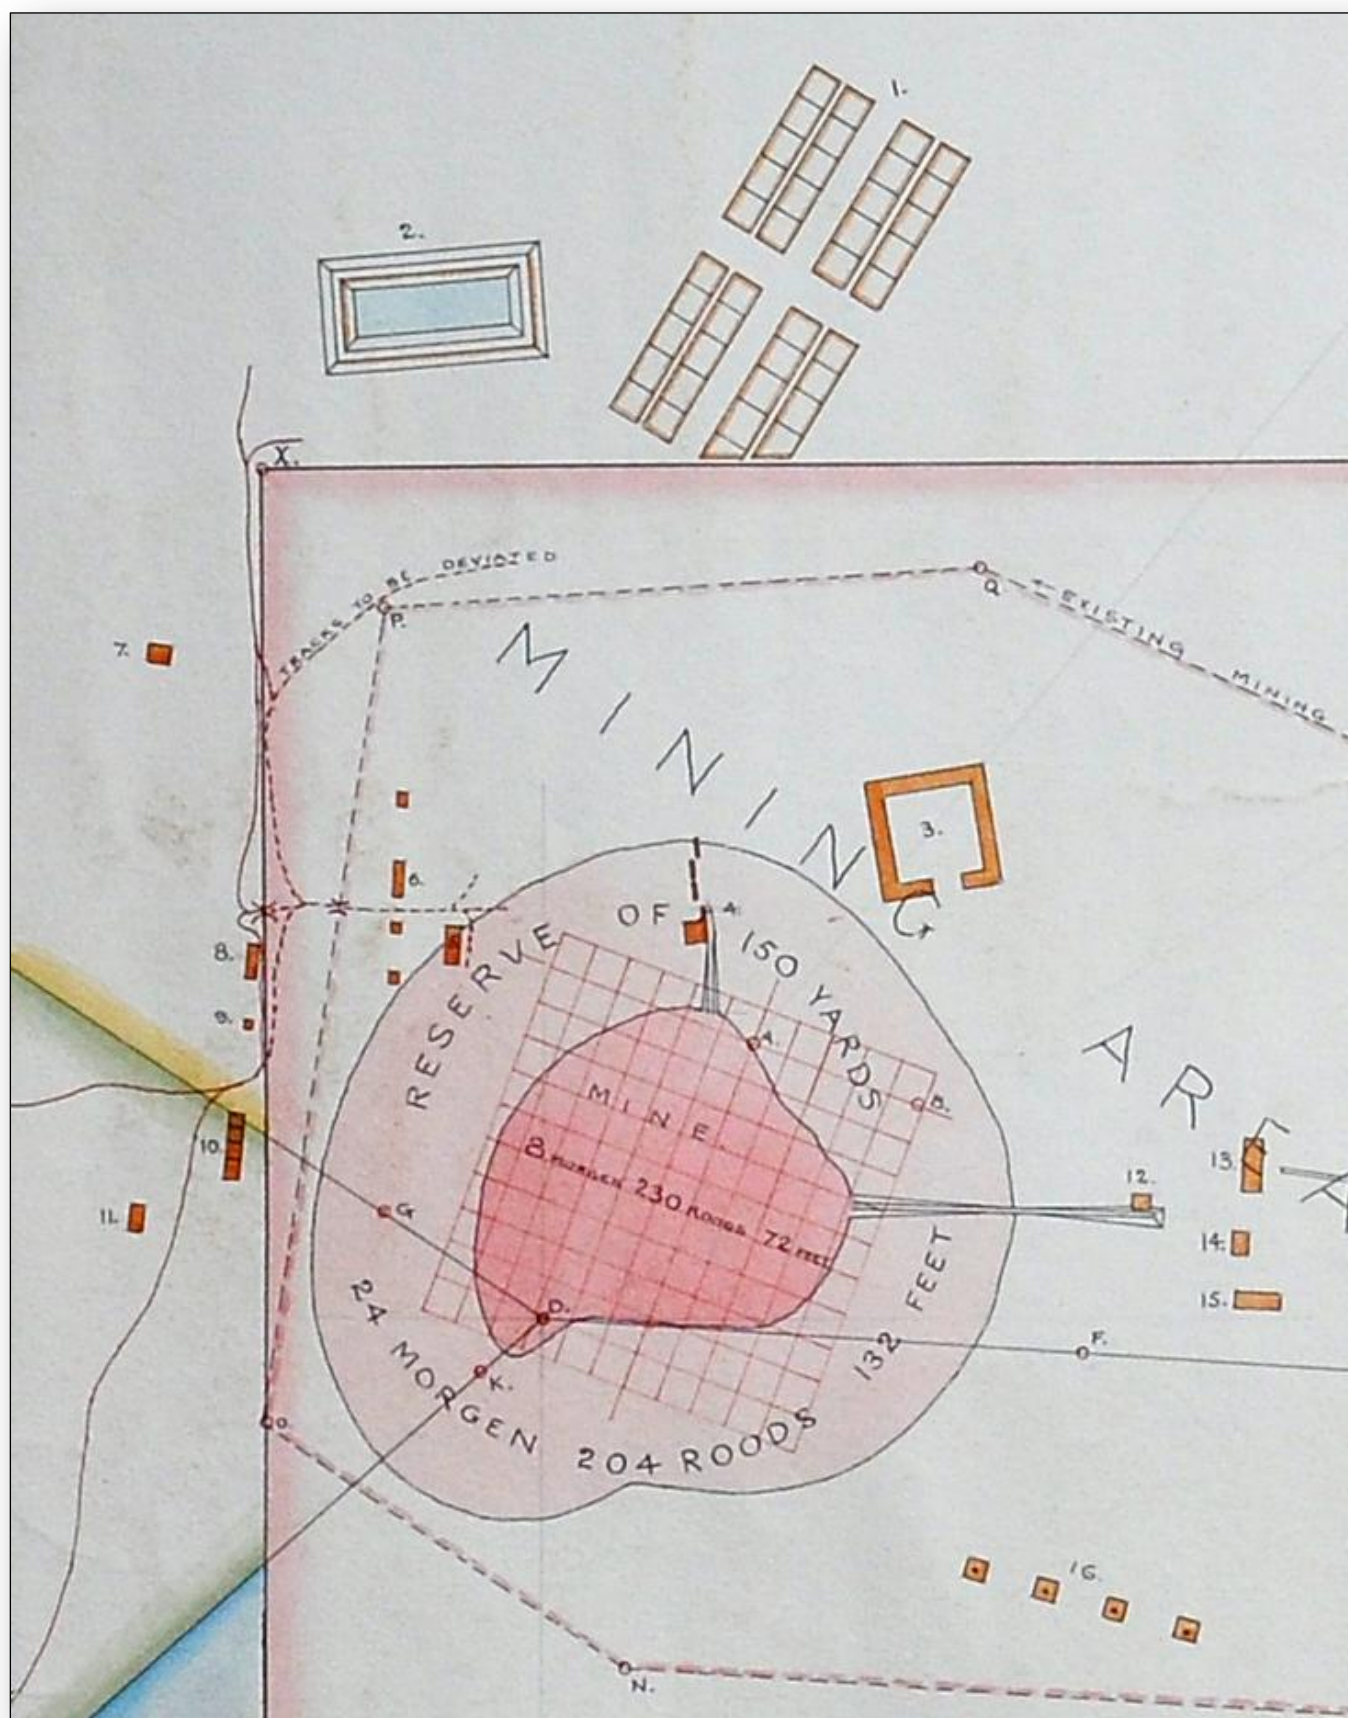
On the northern end of the mining property a massive water reservoir is depicted. The capacity of this water reservoir is given as seven million gallons which equates to an impressive 26,497,882.49 litres or 26 mega litres.

In proximity to the water reservoir a total of 39 residential stands that are grouped in four blocks are depicted. These residential stands would have been the start of the mine village where white married staff and their families would have been able to reside.

Figure 8 Section of a map titled "Voorspoed Diamond Mining Company Limited: Plan of Extended Mining Area" which is dated June 1909.

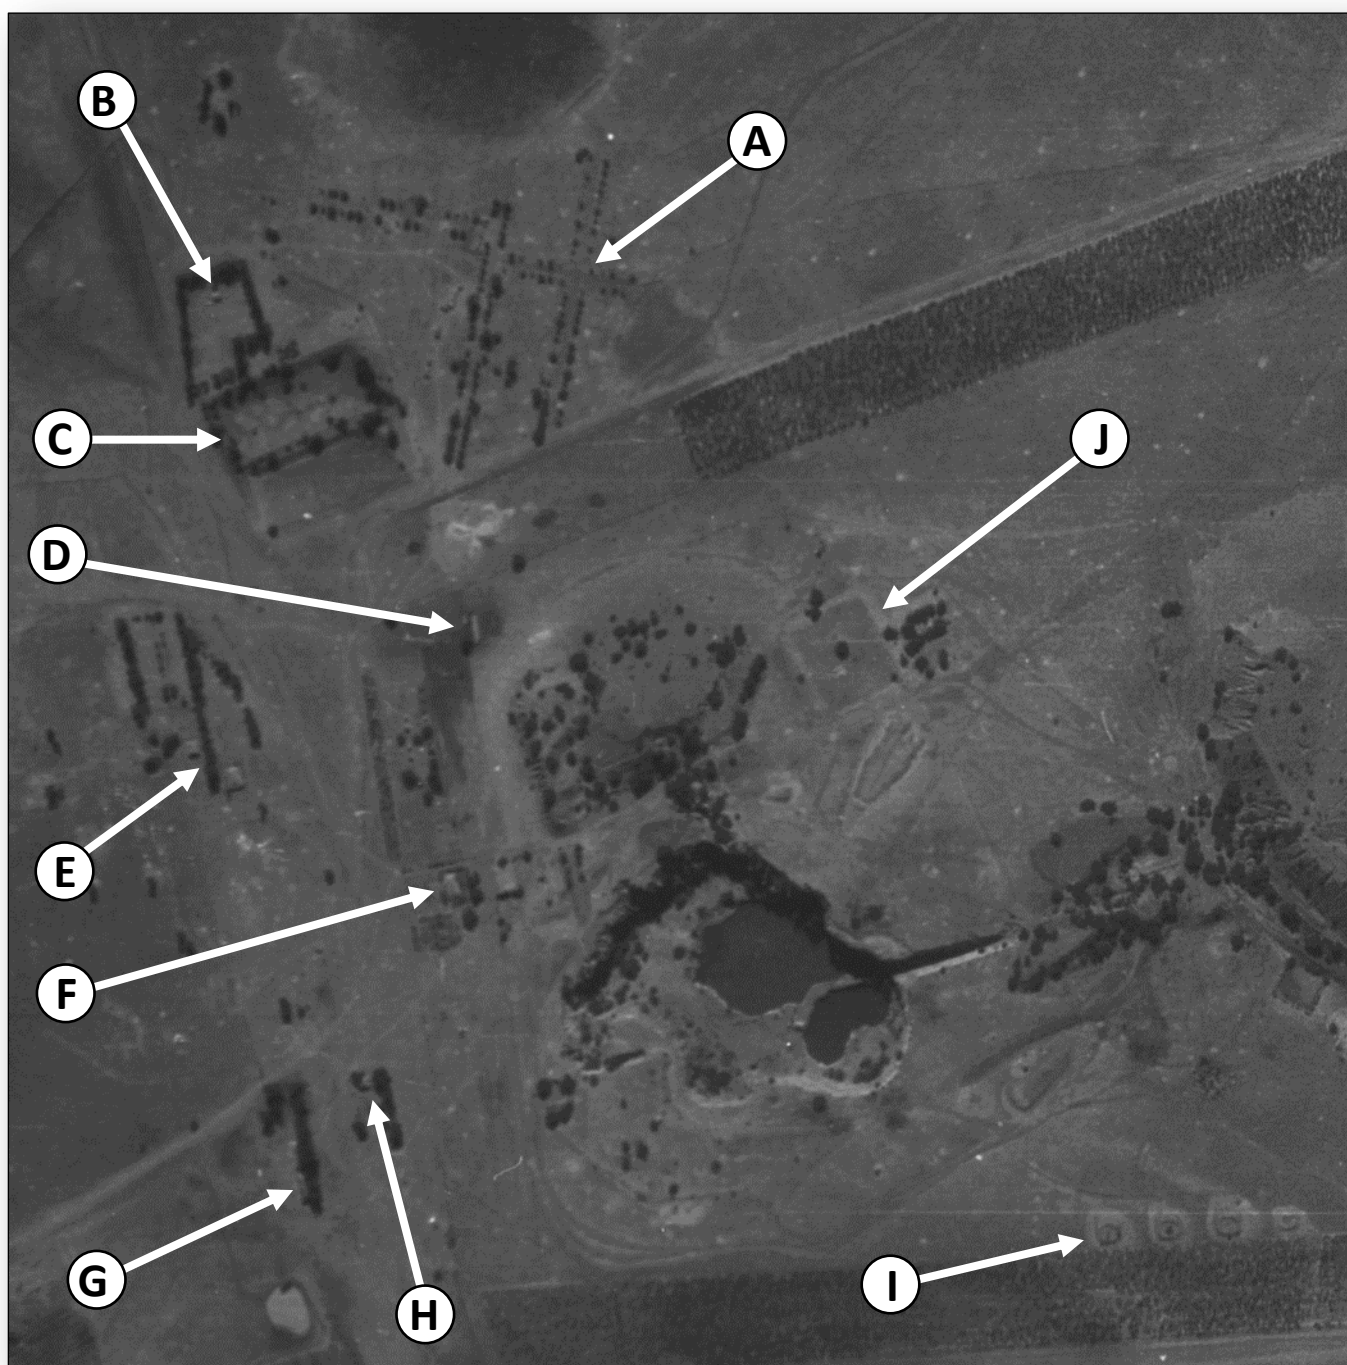
A general observation which can be made is that the landscape has changed significantly in the 42 years since the original mine map was compiled. From the features depicted on the original 1909 map, only the water reservoir, mine manager's house, old building and explosives magazines are still visible on the 1951 aerial photograph.

Furthermore, a number of buildings had evidently been added to the landscape during this time including the unidentified structure at Building D, the cluster of three buildings at Building E as well as a cluster of two buildings at Building F.

Figure 9 Portion of the 1951 aerial photograph (NGI, Aerial Photographs, 206_1951_11_321).

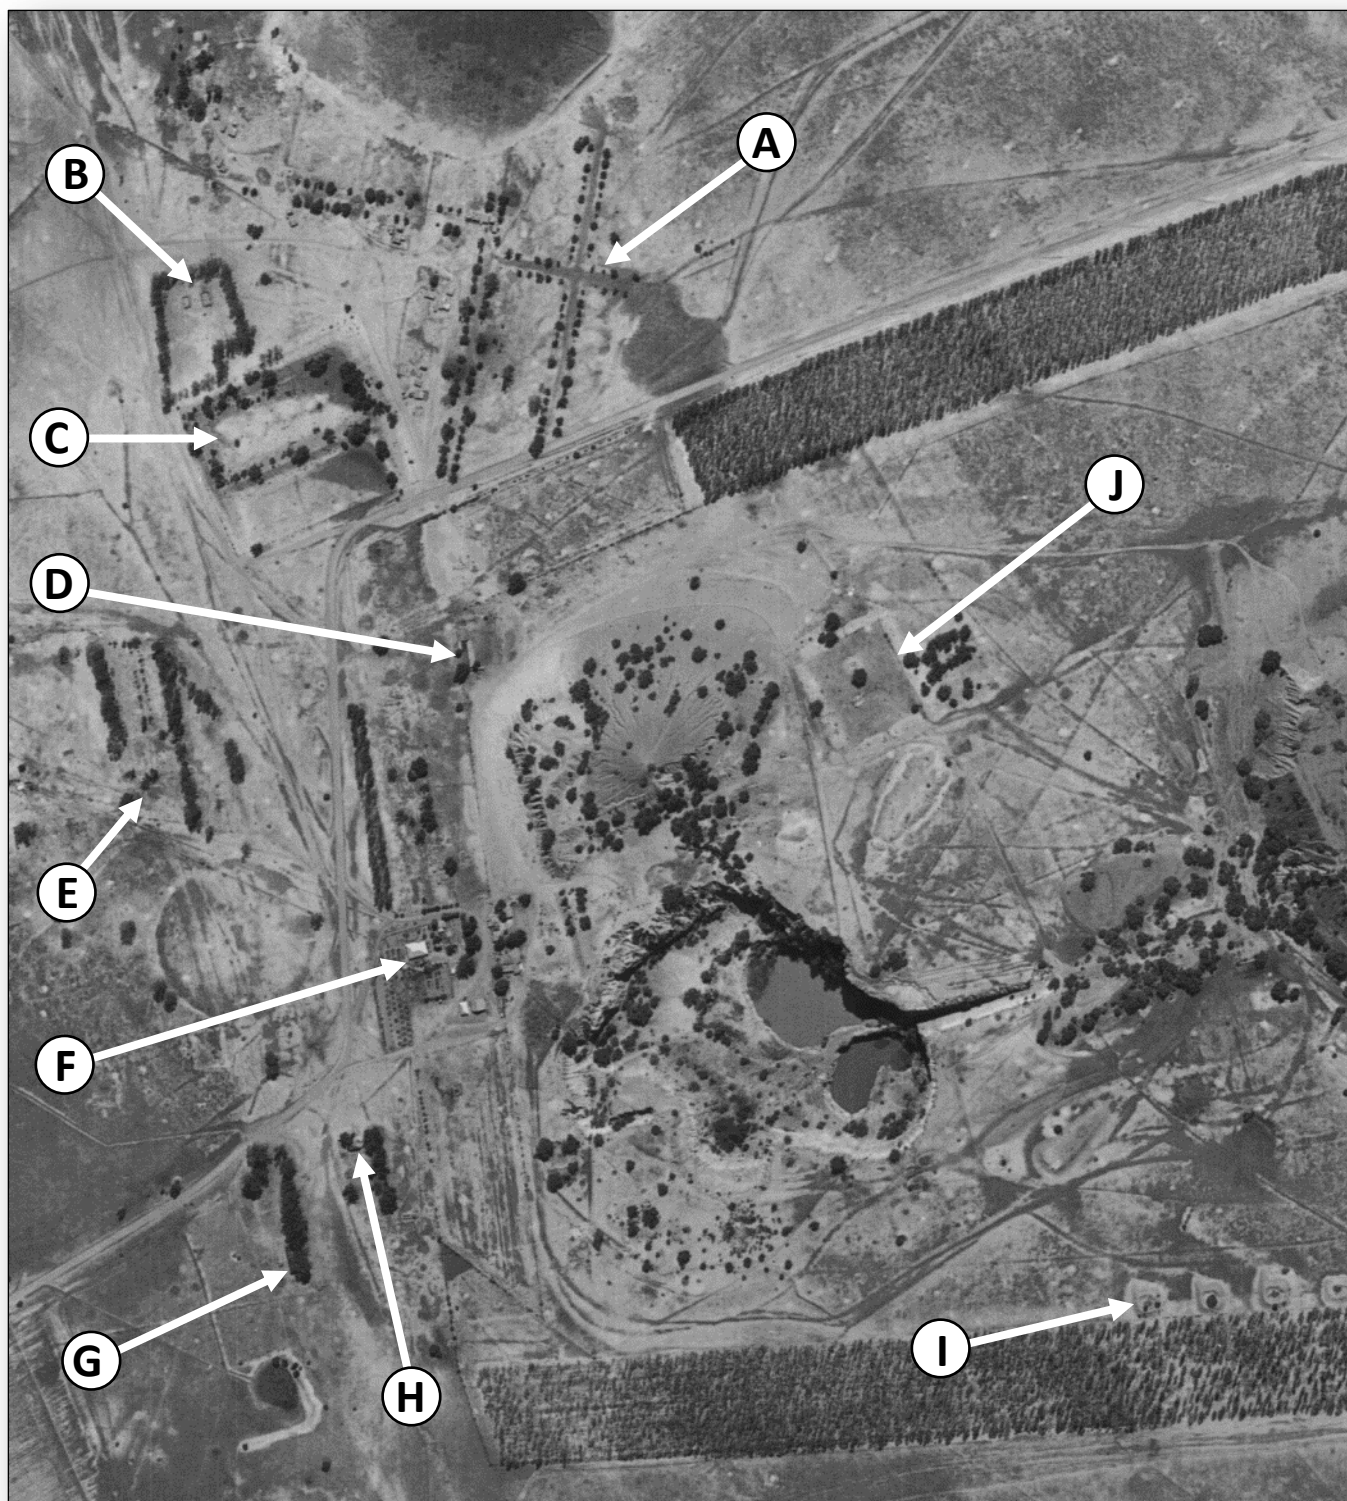
- (I) Four explosives magazines are still depicted here.
- (J) The remains of the old compound can still be identified here.

In general terms, although some changes have taken place in the landscape in the 13 years since the previous photograph had been taken, the most significant change appears to be the re-use of the old mine village and the construction of a number of houses here. These buildings may either have been constructed for use by the mine during the exploration activities which commenced during the 1960s or alternatively the buildings were erected as accommodation for farm workers.

Figure 10 Portion of the 1964 aerial photograph (NGI, Aerial Photographs, 519_1964_08_3399).

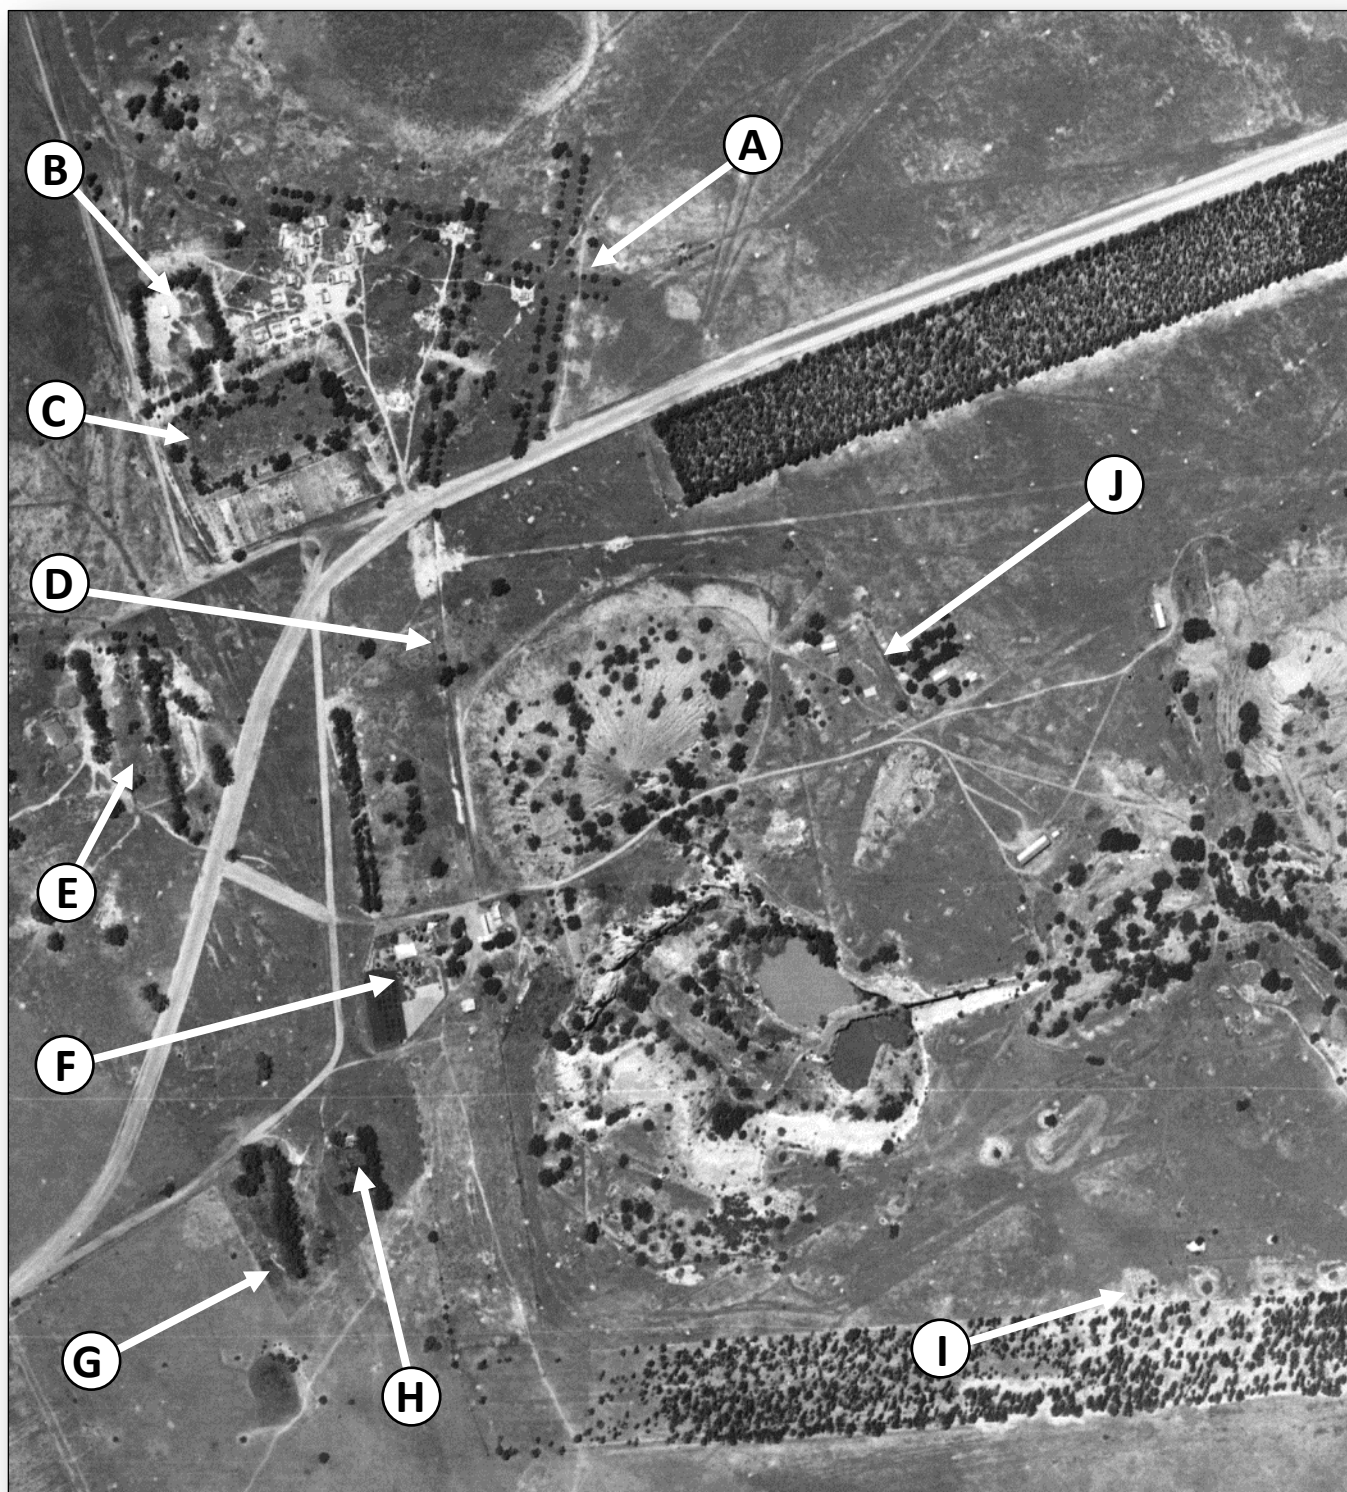
- (G) The old building forming part of the site is depicted again.
- (H) The same unidentified building that was depicted here on the 1951 image is shown again.

- (I) Four explosives magazines are still depicted here.
- (J) The remains of the old compound can still be identified here. For the first time houses are shown at the site. It is possible that these houses were erected as accommodation for the black staff of the mine during exploration activities undertaken at the time.

Figure 11 Portion of the 1975 aerial photograph (NGI, Aerial Photographs, 755_1975_09_5359).

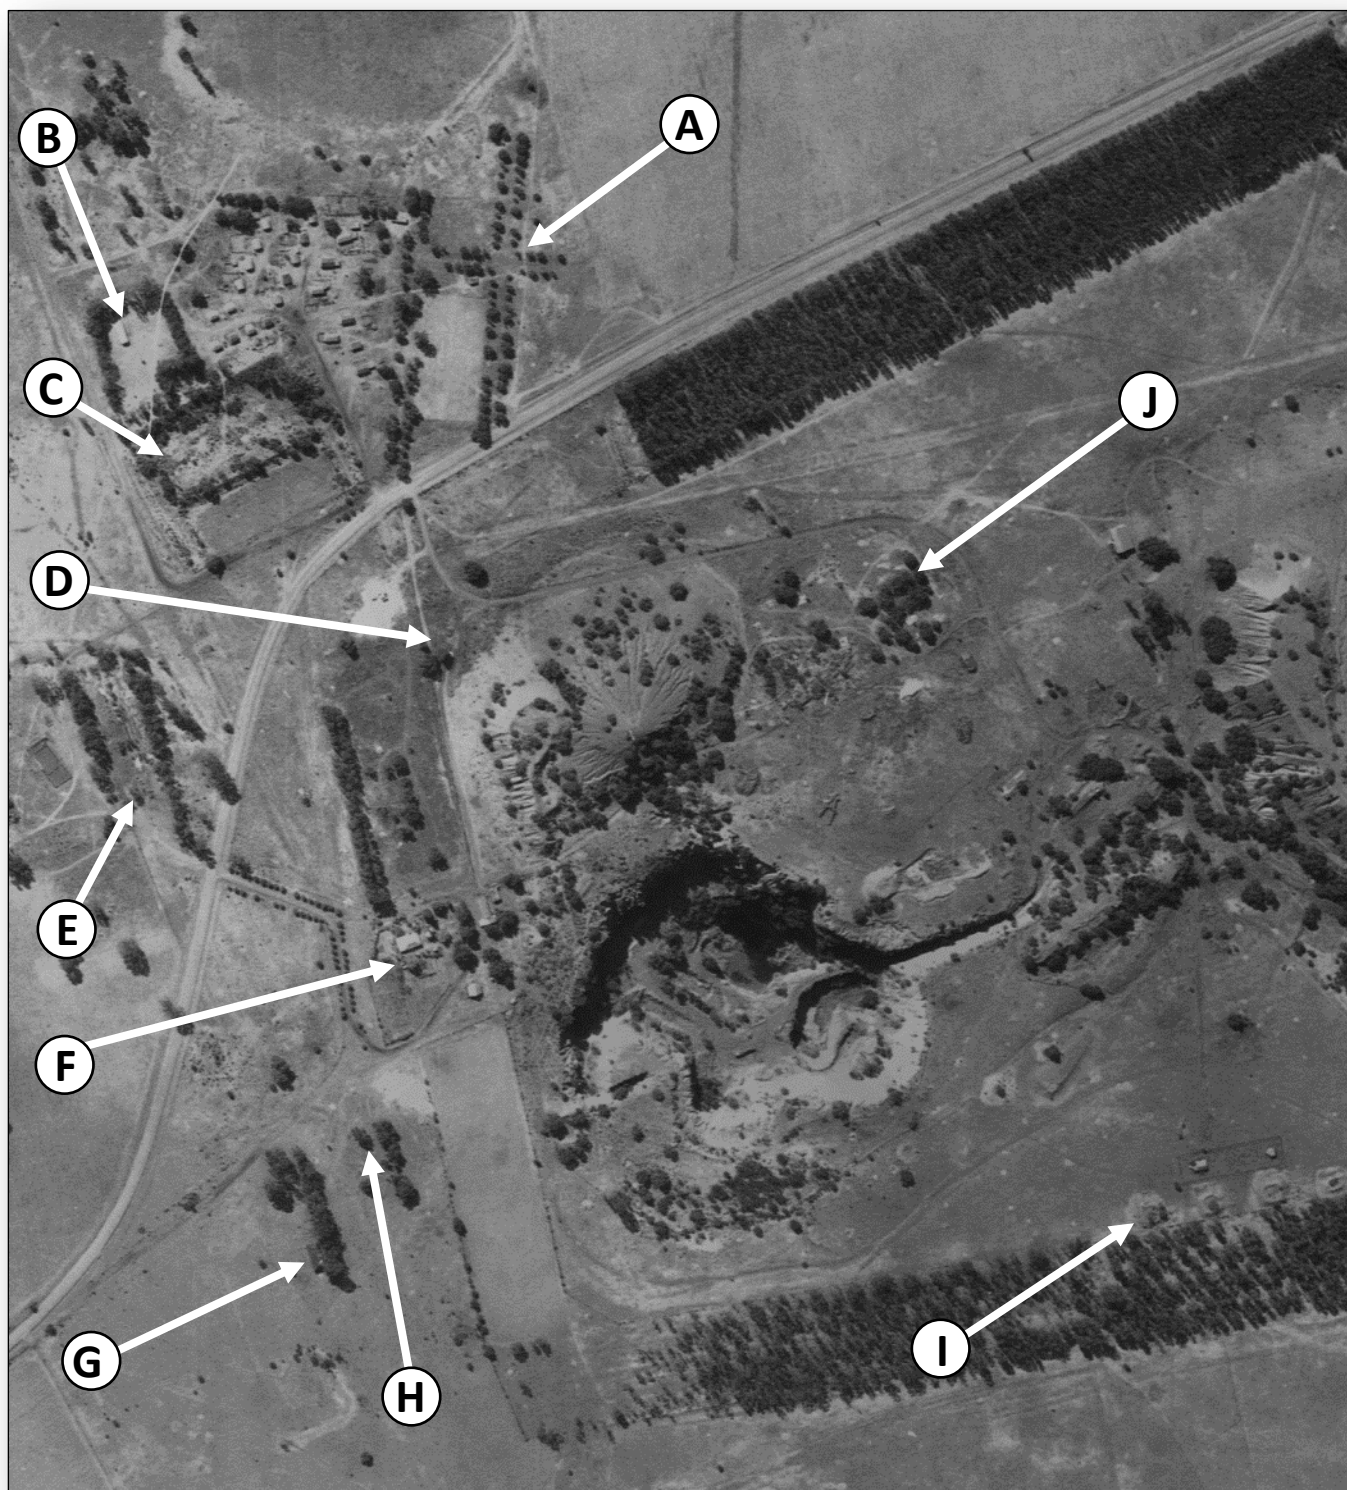
- (I) Four explosives magazines are still depicted here. Two new buildings are depicted north of the old explosives magazines.
- (J) Very little of the old compound can still be identified on this image. Furthermore, the houses that were depicted for the first time on the 1975 image are not shown anymore. A short distance to the east of where the compound was located a large new building is depicted. This building appears to have been a shed.

The additional houses at the old mine village, additional two buildings at the explosives magazines as well as the new large shed-like building can all be related to the exploration activities which had been undertaken in the years leading up to 1984. It is also known that during the mid 1980s the recommendation was made for mining to recommence at the mine. The abandoned appearance of Buildings F and G and the disappearance of Buildings D and H may have been related to the decision for mining to restart.

Figure 12 *Portion of the 1975 aerial photograph (NGI, Aerial Photographs, 498_203_1984_15_5542).*

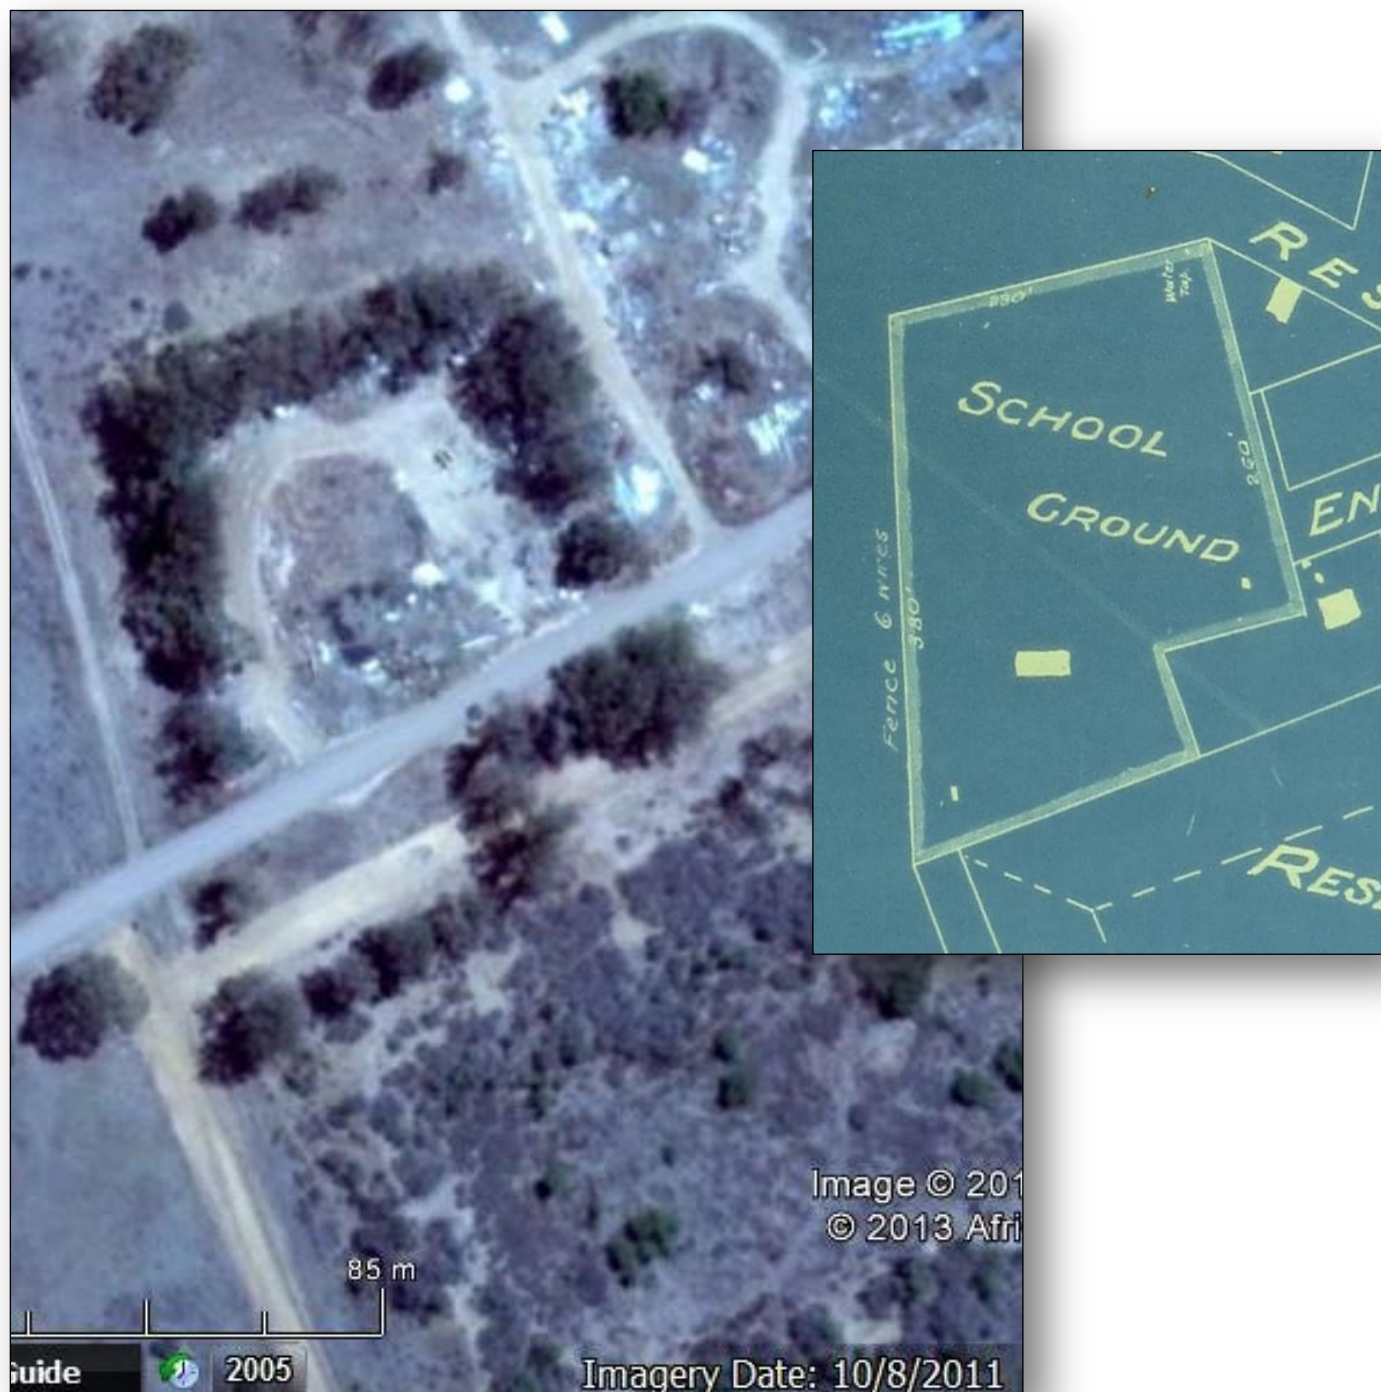
A short distance north of the water reservoir the tree-lined site of the old school yards was identified. While no complete buildings could be seen within this area, a close inspection revealed at least one section of a rectangular stone foundation. From archival evidence it is possible to indicate that this foundation structure represents a later use of the school. As highlighted in the discussion on the aerial photographs, various changes have taken place to this site during the period covered by the aerial photographs, namely from 1951 to 1983. In some instances buildings were added and then removed again over time.

The site is in a poor condition and due to the re-use of the site over the years very little of the original school appears to have remained. Furthermore, the original school building depicted on the 1911 plan appears to be currently located underneath a road which passes through the school yard site. However, the boundaries of the original school yard are preserved to this day in the layout of the trees surrounding the site. Although the school site itself is of Low Significance, the trees surrounding the site can be considered to be of a Medium to Low Significance.

Figure 17 A Google Earth Image depicting the area where the school yard is located can be seen on the left. On the right a section of a mine plan depicting the village of the Voorspoed Diamond Mine is depicted. The plan was compiled on 29 August 1911 (National Archives, SAB, PWD, 1881, 6711). If a comparison is drawn between the boundaries of the school yard as defined by the avenues of trees on the Google Earth image and the boundaries of the school yard as depicted on the 1911 plan, it is evident that the two are the same.

While no tangible remnants of the original school building appears to have been preserved, the eucalyptus trees surrounding the school yard defines a tangible link with the original school and school yard. The architectural study has showed that these eucalyptus trees are not associated with the original school. However, it is recommended that they be replaced on a tree-for-tree basis by indigenous trees and by doing this the delineation of the original school yard can be preserved.

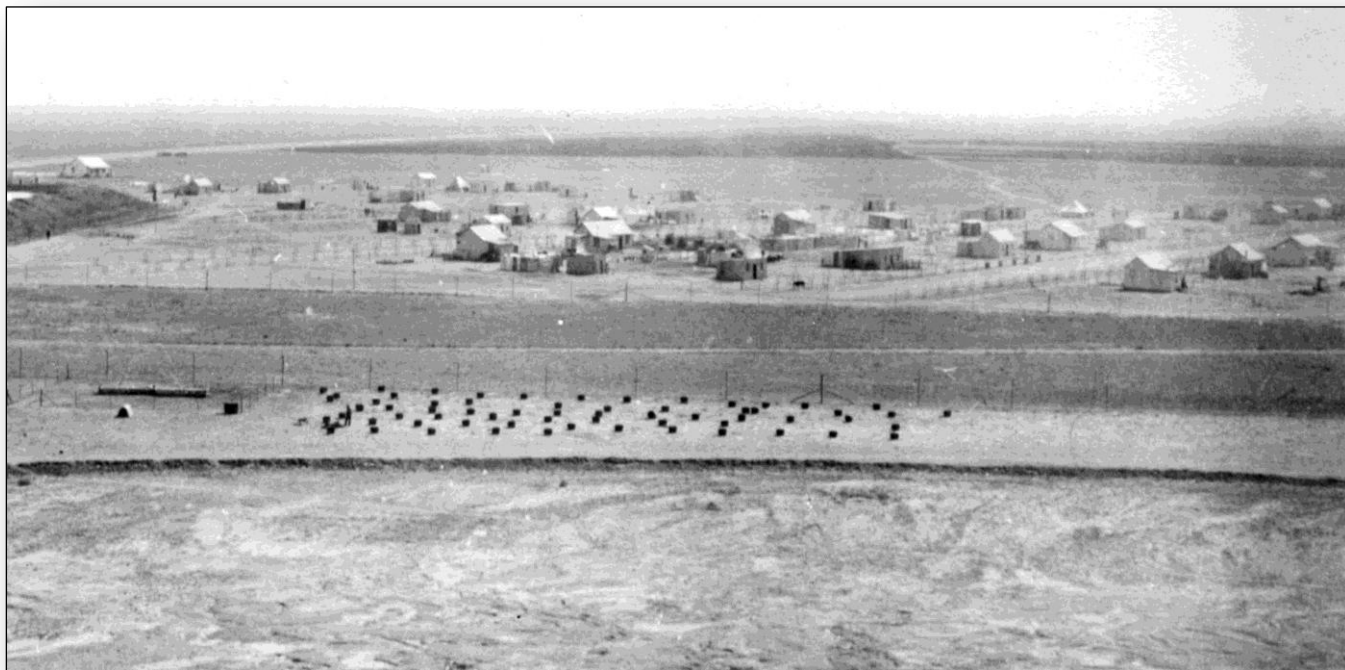
The site is in a poor condition and due to its re-use from the 1960s to 1980s very little of the original village has remained. The only tangible feature identified on the site comprises the presence of some trees. Without the presence of archaeological middens the site would be of low significance. However, the potential does exist for such middens and features to be located here. As a result, the site is deemed to be of Medium Significance.

Figure 18 *Historic photograph depicting the mine village with the water reservoir visible on the left (Free State Archives, VAB, Photograph, 7932). It is evident from this early photograph that the trees were planted at a later stage.*

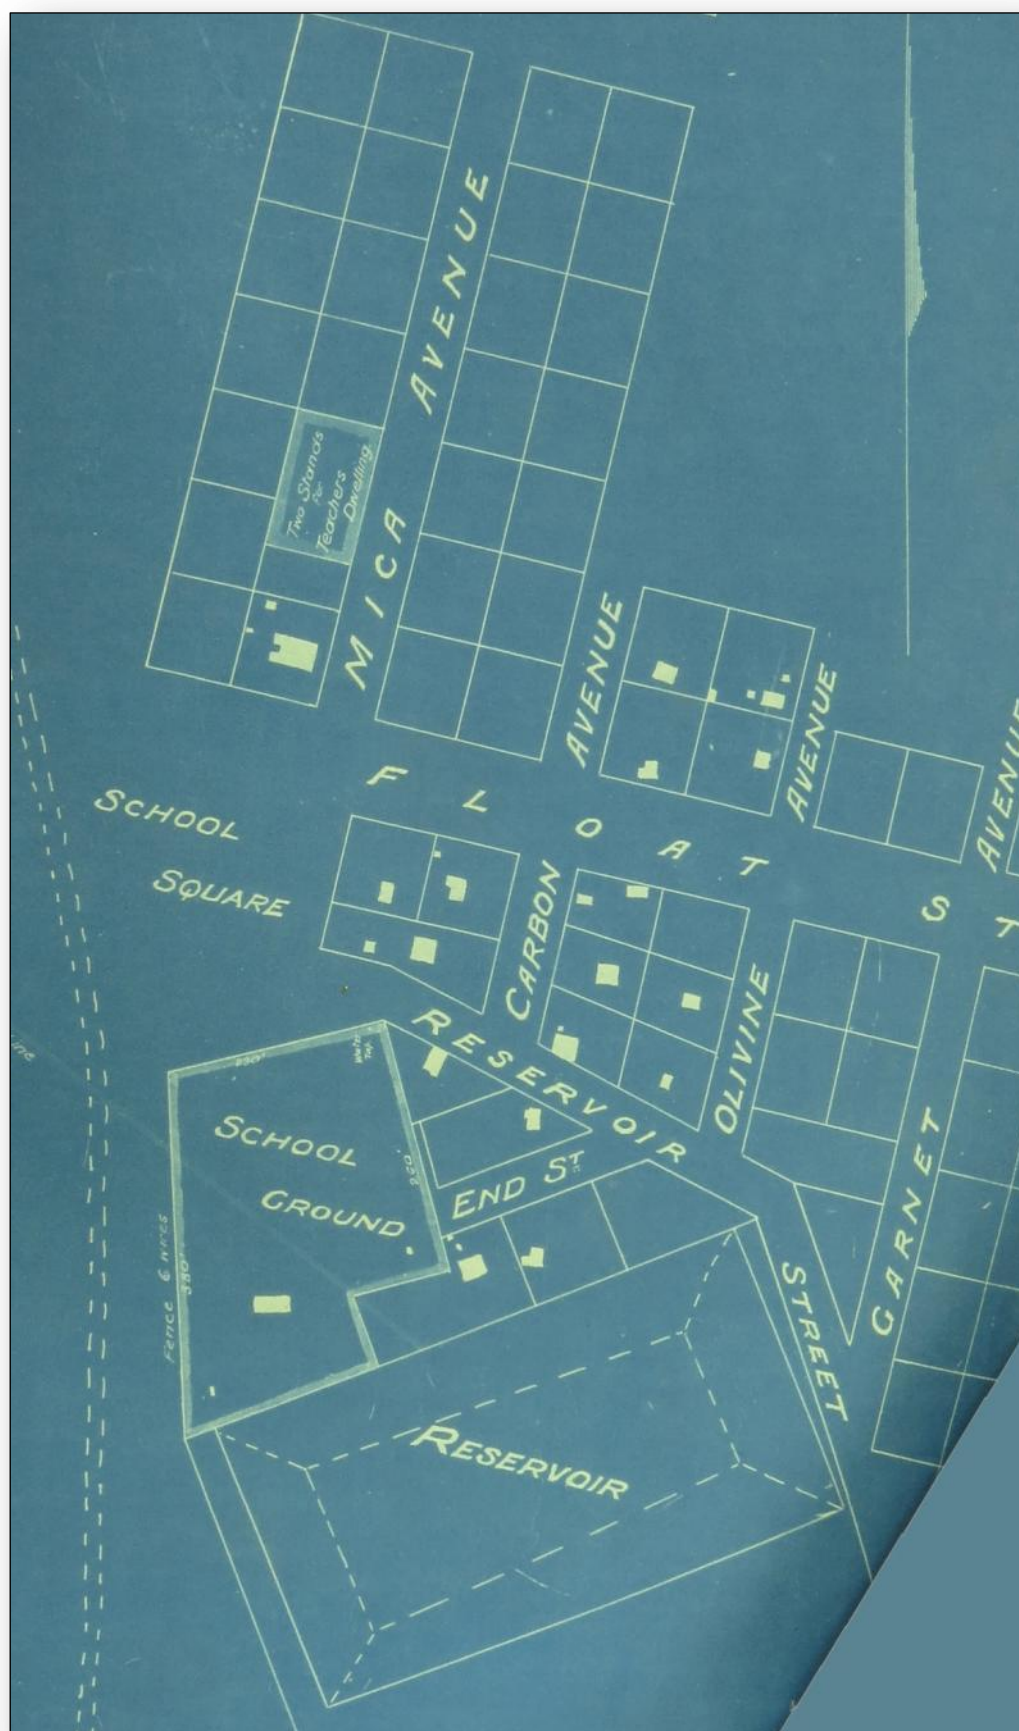
Figure 20 Portion of the plan depicting the village at the Voorspoed Diamond Mine. The plan was compiled on 29 August 1911 (National Archives, SAB, PWD, 1881, 6711).

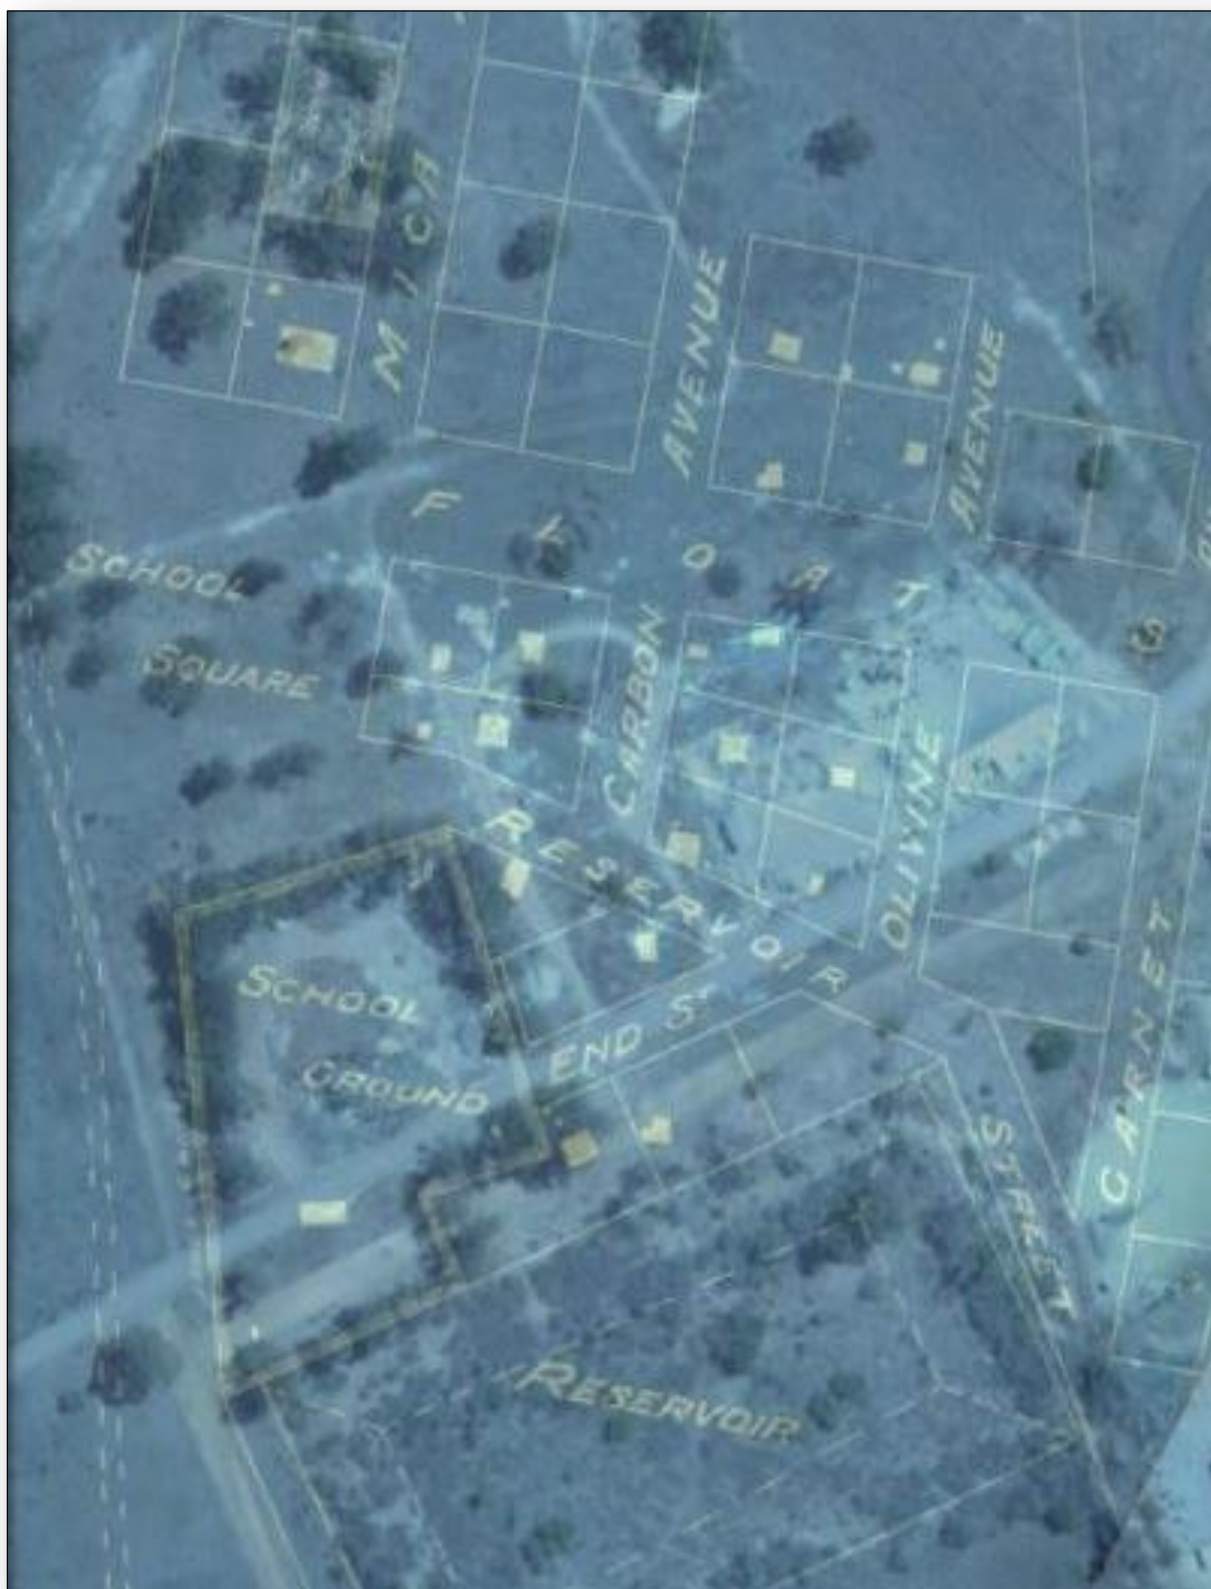
Figure 21 *Overlay of the 1911 plan depicting the original mine village on the latest available Google Earth satellite image taken in October 2011. It is evident from this image that although sections of the original mine village have been completely impacted upon by more recent activities, the possibility exists for archaeological features and middens to still be located here. The positions of the school yard and reservoir are also shown.*

No tangible remains of the original mine village could be observed. However, it is still possible for subterranean middens and archaeological features to be present at the site. As a result, should any impacts be expected within the demarcated site boundaries, archaeological mitigation and permitting would be required.
