**ASSESSMENT OF THE IMMEDIATE SURROUNDINGS OF THE OLD BUILDING AT THE VOORSPOED
DIAMOND MINE AS WELL AS THE WIDER CULTURAL LANDSCAPE**

Version 2.0

14 February 2014

CLIENT: De Beers Consolidated Mines Limited

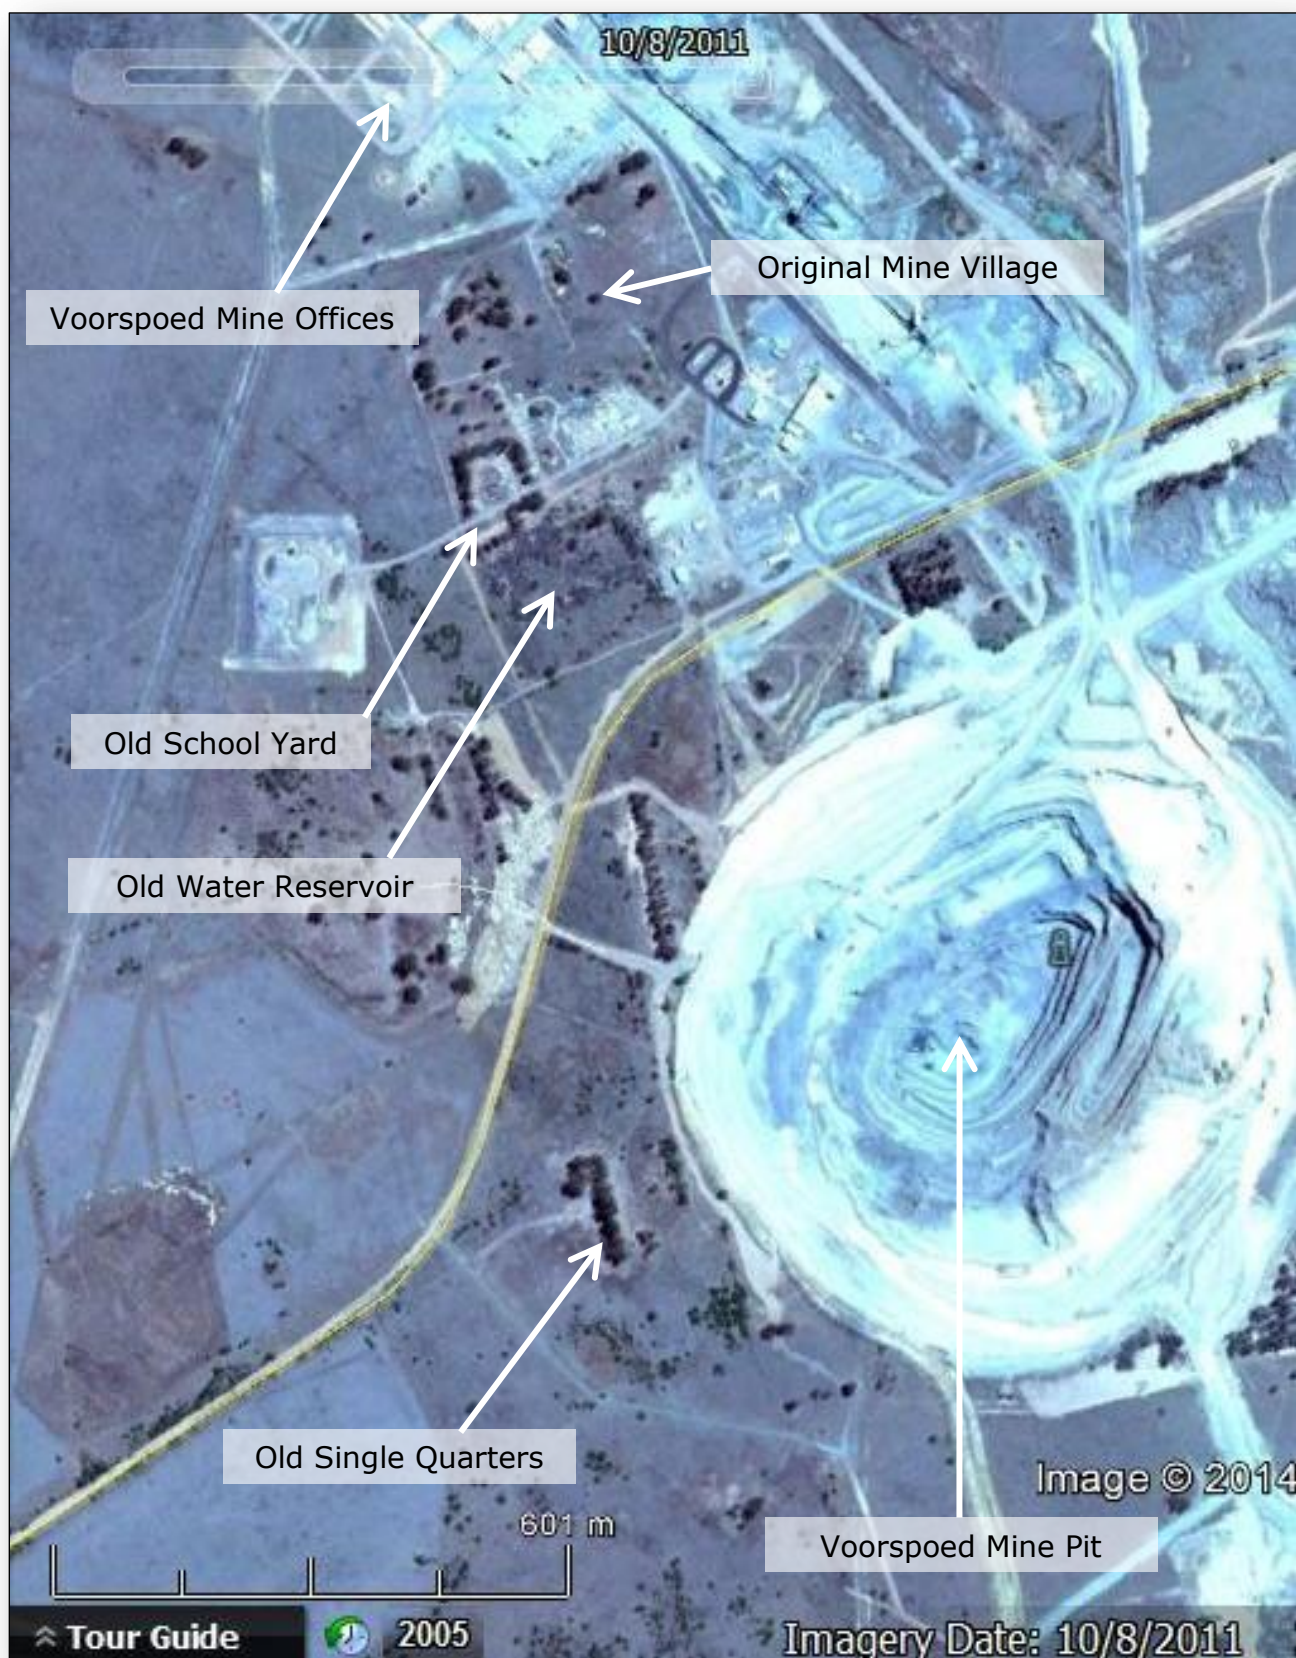
Figure 22

Google Earth image depicting the cultural landscape of the area surrounding the old building. The four remaining sites which could be identified comprise the old building (single quarters), water reservoir, school yard and site of old mine village. This satellite image is dated 8 October 2011, and as a result the mining development would have expanded from what is depicted here.

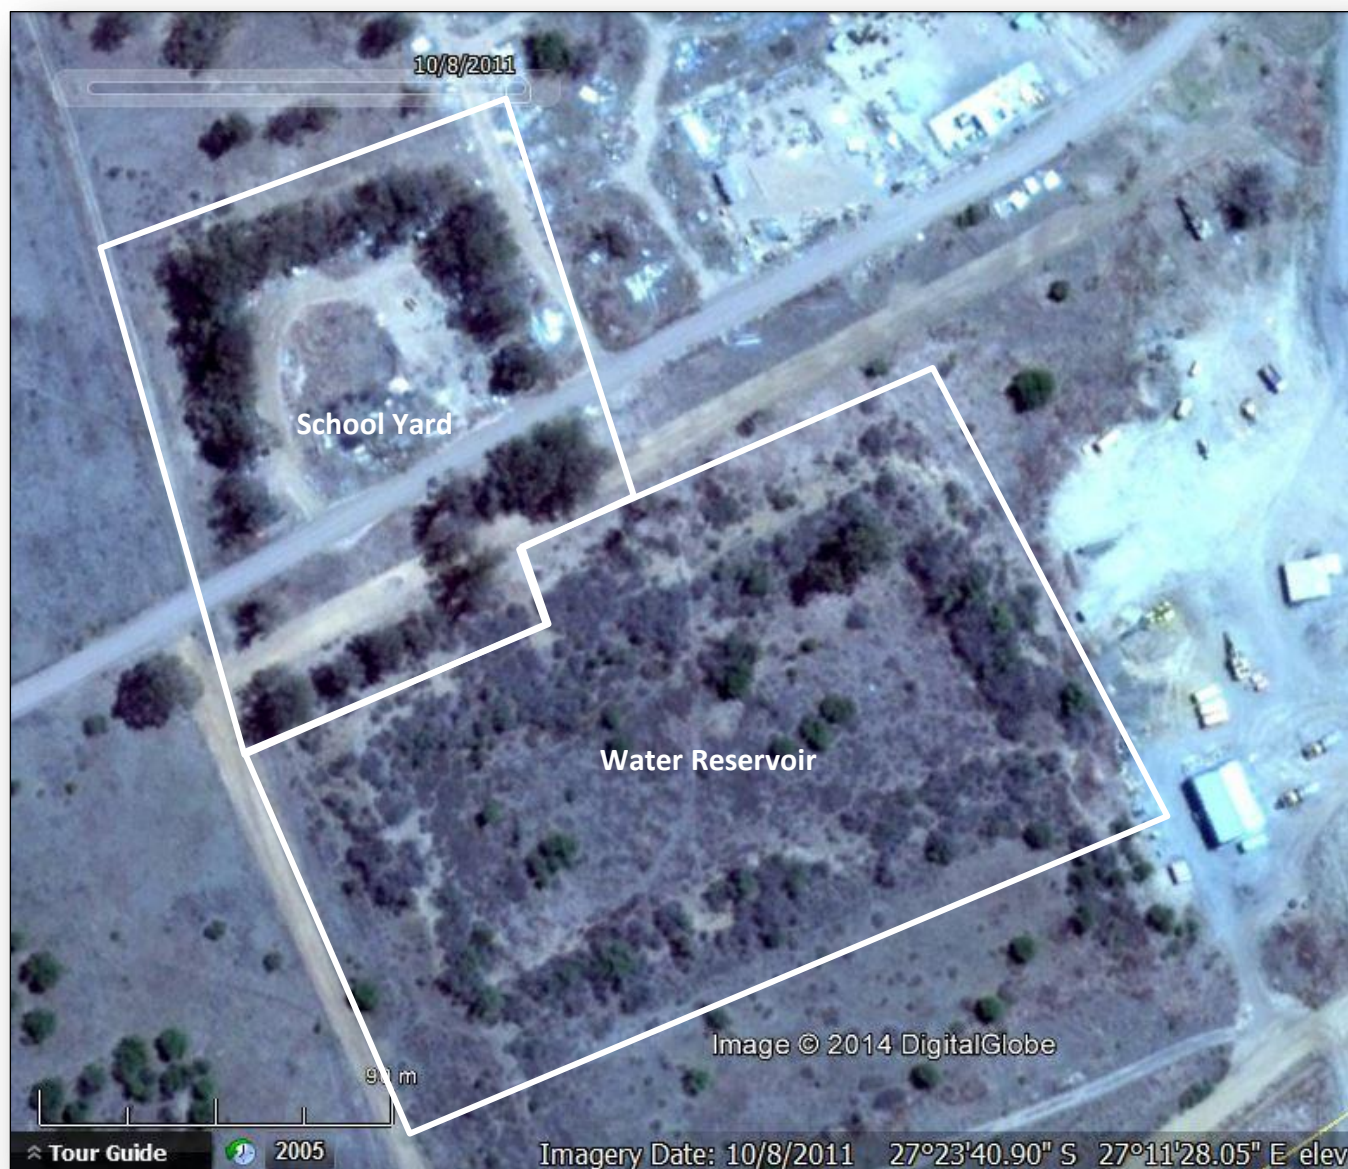
Figure 23 Google Earth image depicting the school yard and water reservoir. The boundaries for both these sites are shown.

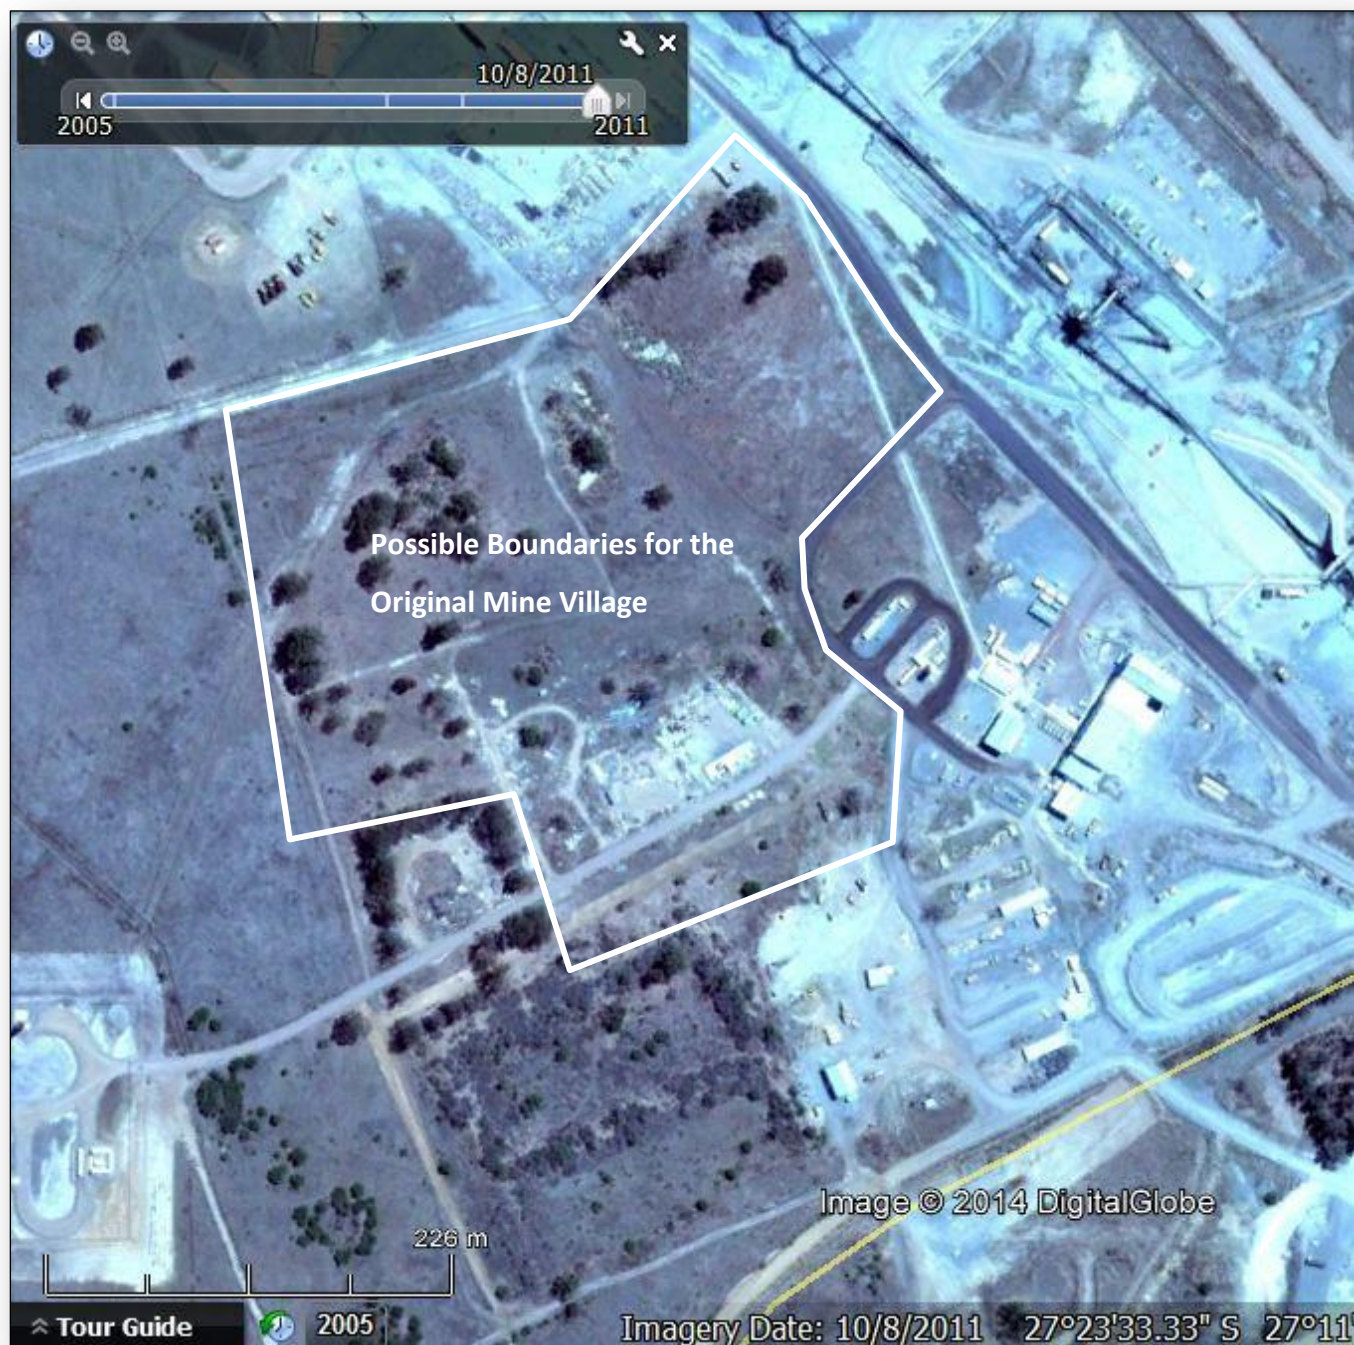
Figure 24 Google Earth image depicting the area where the original mine village was located. The possible boundary for this area is indicated.
