PARLIAMENTARY PRECINCT: OLD ASSEMBLY BUILDING: CAPE STORES: STRUCTURAL REPAIR WORK

C2567 / 31058-REP-001 REV 0

CONCEPT & VIABILITY REPORT

MAY 2016

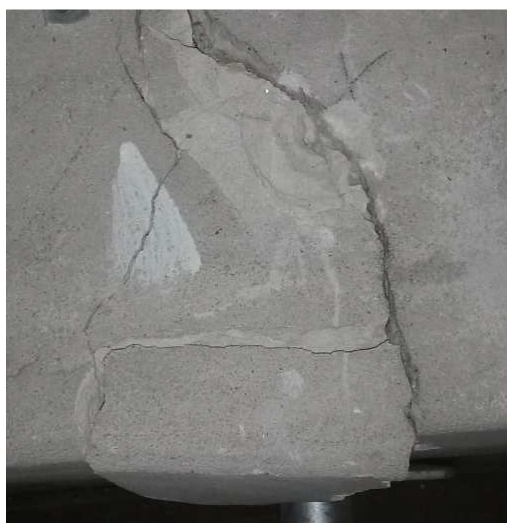
The structural make-up of the beams had to be verified, to understand the behaviour of these beams better. No reinforcing steel which would typically be found in modern day construction was observed. These beams are subsequently resisting the downward force by means of flexural resistance of the concrete which is about 1/10th as strong as the compressive resistance of the concrete. When a crack forms in these elements, the applied load from the weight of the building above needs to find an alternative route. This results in higher tensile stresses in the un-cracked section of the structure above, which may also result in further crack propagation, until localized collapse could occur.

Photo 4.5.1: Crack in beam that is propped, after a couple of blows with a hammer – some small cracks formed

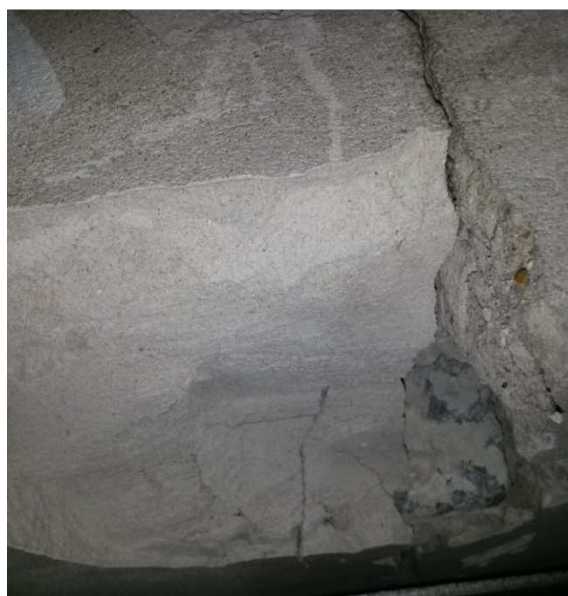
Photo 4.5.2 More blows - Large portion of plaster broke off

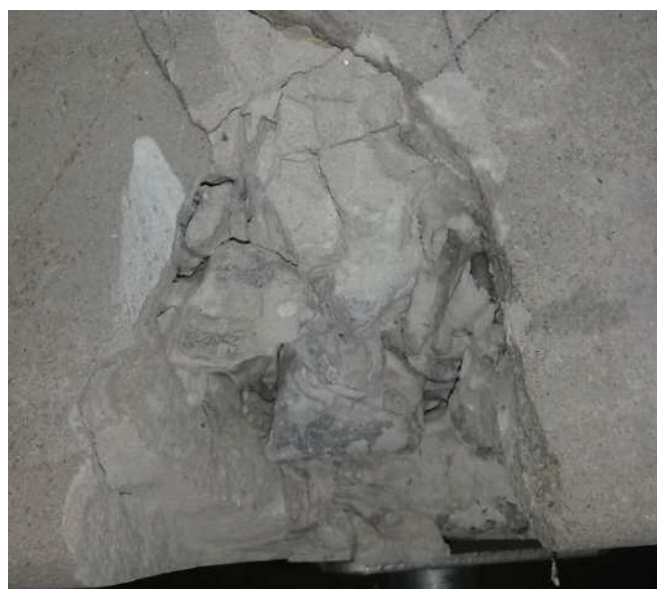
Photo 4.5.3 More blows – Plaster fell off exposing some large aggregate covered with a some intermediate cement

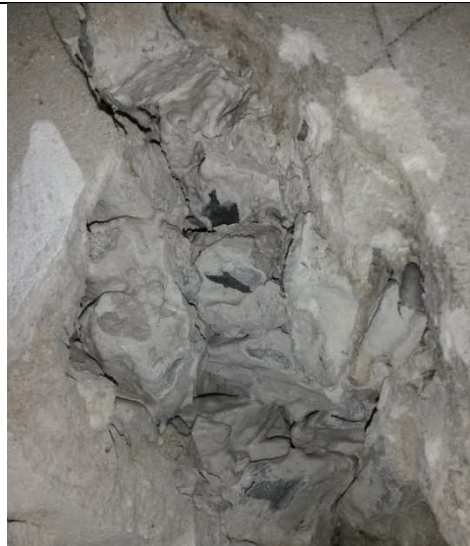
Photo 4.5.4 More blows – some of the aggregate falls out, with no visible reinforcing steel in the beams

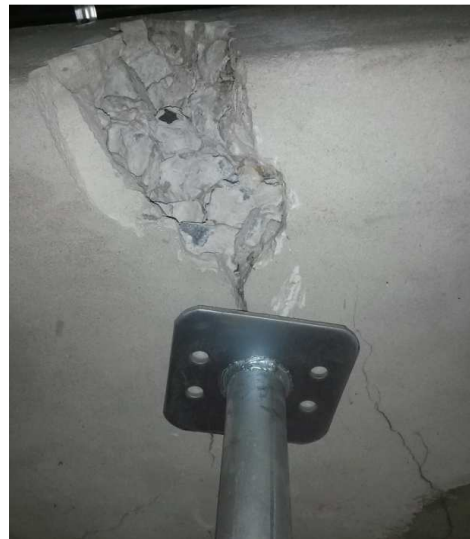
Photo 4.5.5 No more blows – size of exposed beam visible from below

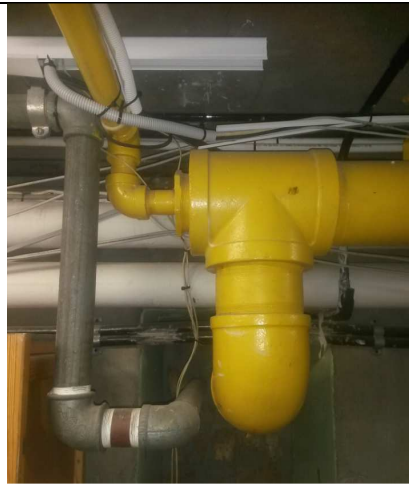
Photo 4.6.13: Fire water system reducer and other services

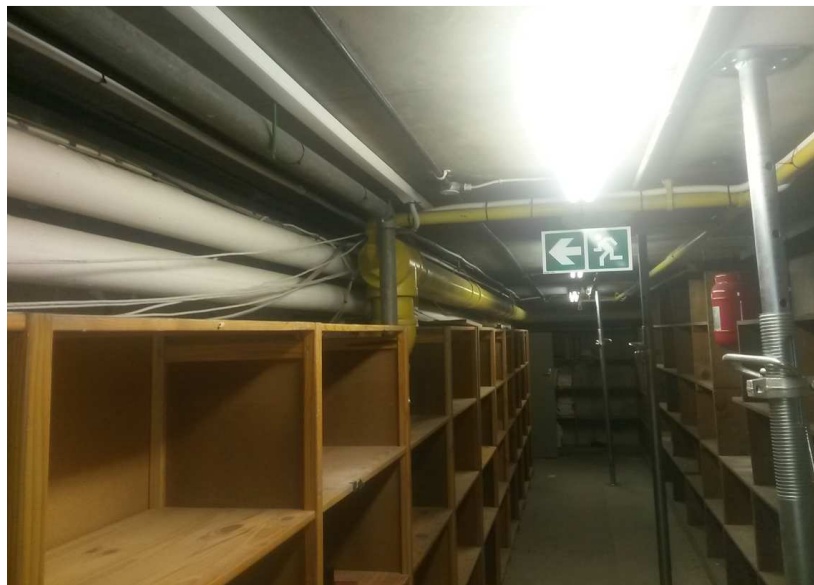
Photo 4.6.14: Passage 3 – View towards Passage 2 door - Yellow fire water line entering and exiting the passage with fire escape signage

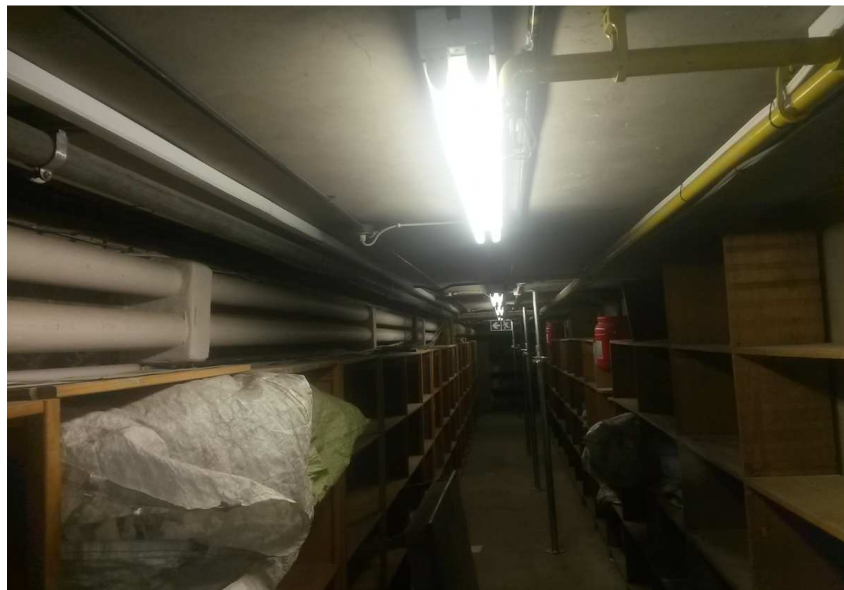
Photo 4.6.15: Passage 3 – View with basement door behind. Note fire suppression units

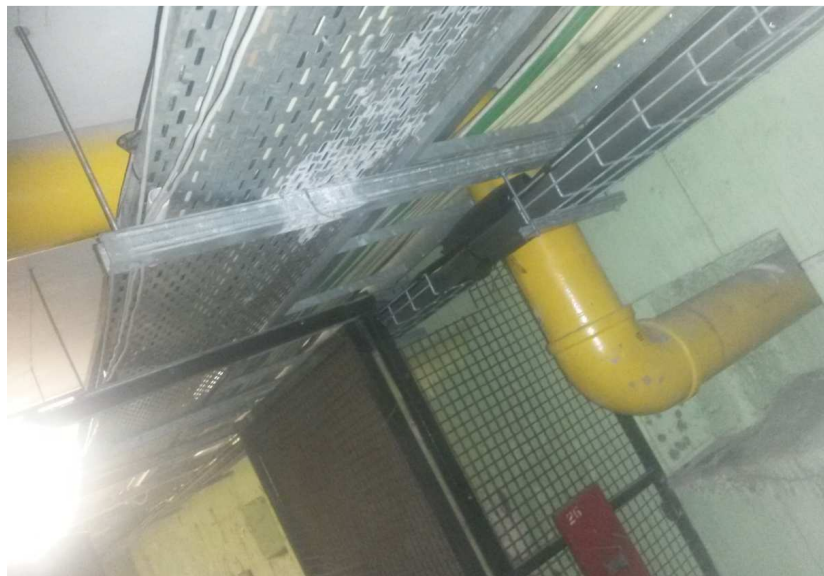
Photo 4.6.19: Passage 2 - Yellow fire water line exiting basement with cable tray below

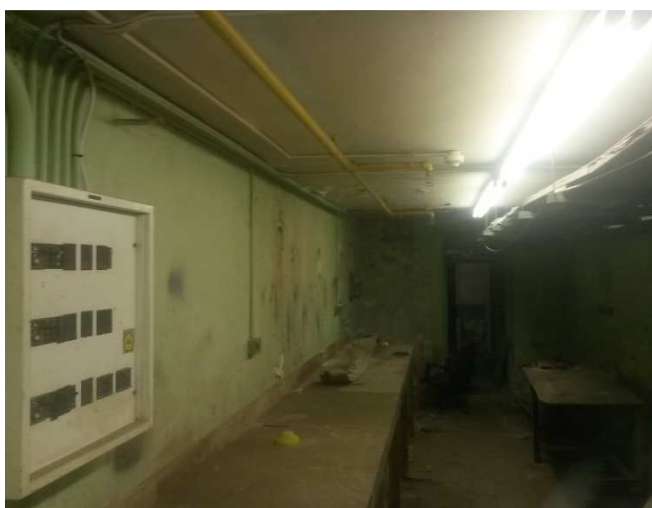
Photo 4.6.20: Passage 2 - Internal Distribution board at far end of basement corridor

These irregularities and non-compliance items will have to be resolved as part of this construction process as the basement will have to be eventually fully functional and compliant

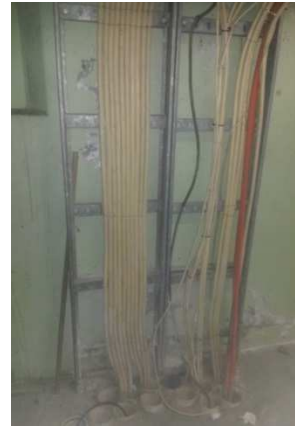
Photo 4.6.23: Passage 2 - Numerous Service sleeves in the basement floor

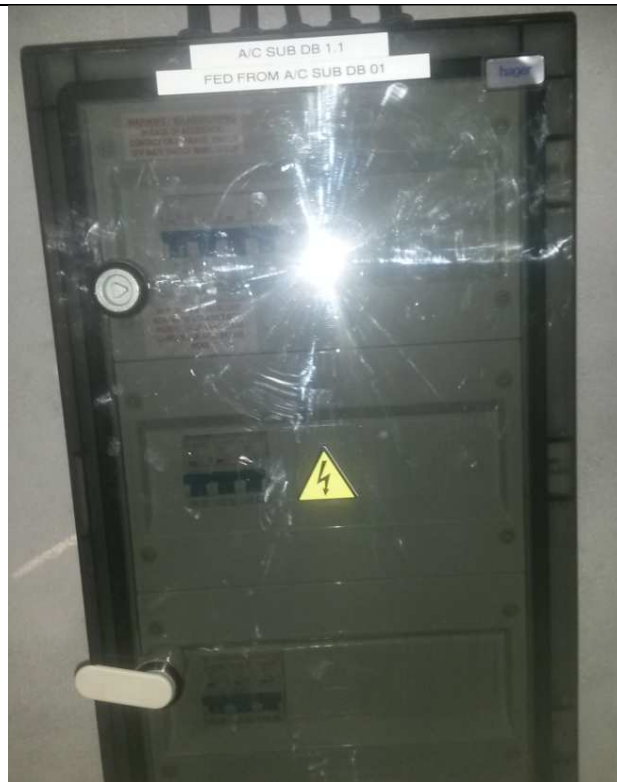
Photo 4.6.26: Basement - Sub DB at Passage 3 doorway

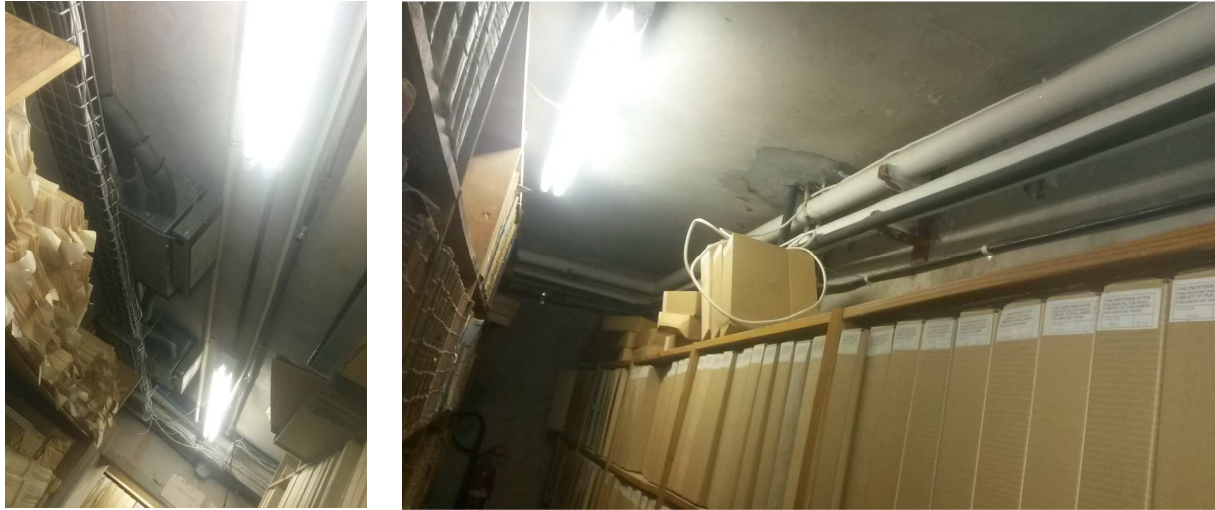
Photo 4.5.33 & 34: Overhead services closer to entrance of basement (far left corner)

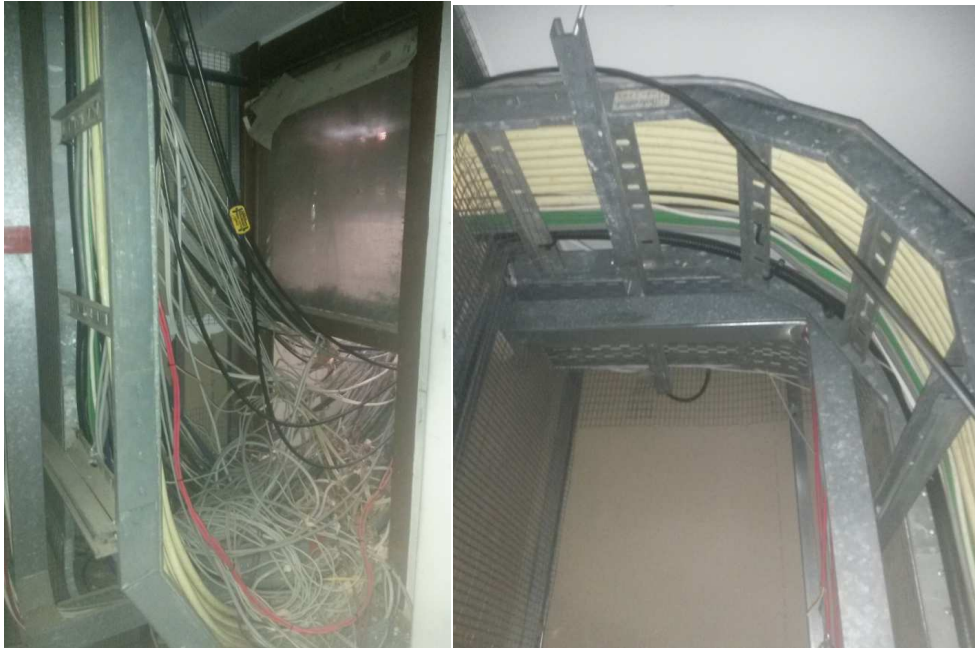
Photo 4.5.38 & 39: Numerous electrical cables entering the basement at the near left corner of the basement

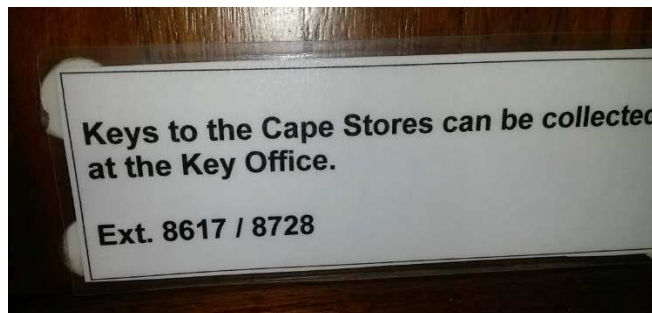
Photo 4.5.41: Notice on basement door to Cape Stores, for getting keys from Key Office.

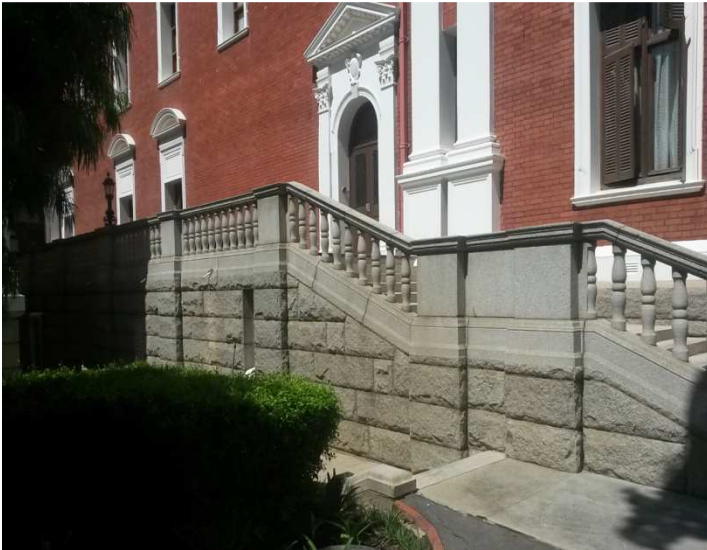
Photo 4.6.1: Granite cladded wall at side entrance staircase to external balcony

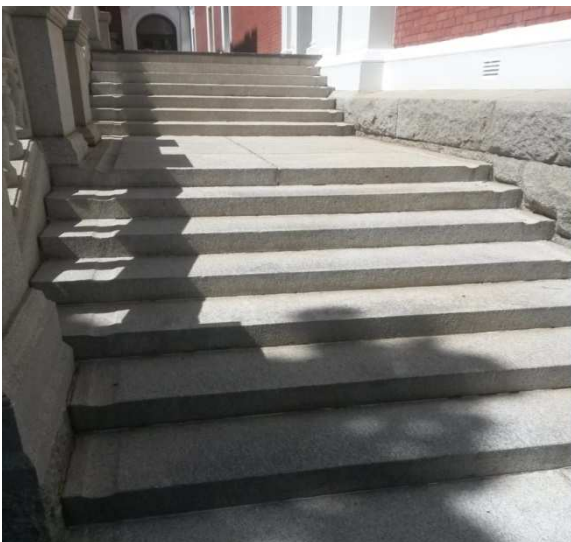
Photo 4.6.3: Granite cladded steps with grooves either sides for rainwater run-off

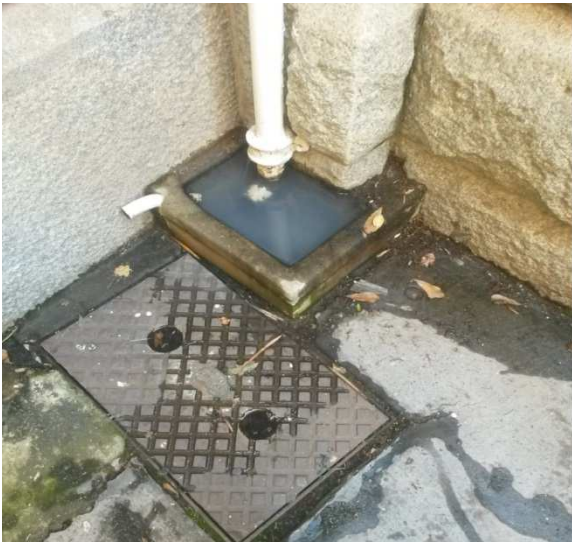
Photo 4.6.9: Close-up of blocked drain

<p>6. The restoration of inadequate rainwater conveyance, expansion joints and grouting.</p>	<p>There is currently a mixed approach to handling of storm water on the site. At some locations it is surface run-off and at some locations it is downpipes without catch pits for servicing.</p> <p>We propose to improve the drainage around the basement by installing an agricultural drain around the perimeter of the basement to drain all the ground water. All of the downpipes around the basement are also to be connected to an underground 300mm diameter concrete storm water pipe to run toward the existing storm water drainage system, identified on site.</p> <p>During the installation of the underground drainage pipes, the outside walls of the basement are also to be waterproofed with an approved membrane system with durable characteristics.</p> <p>These measures should ensure that the area is properly drained to limit the risk of moisture ingress through the basement walls.</p>

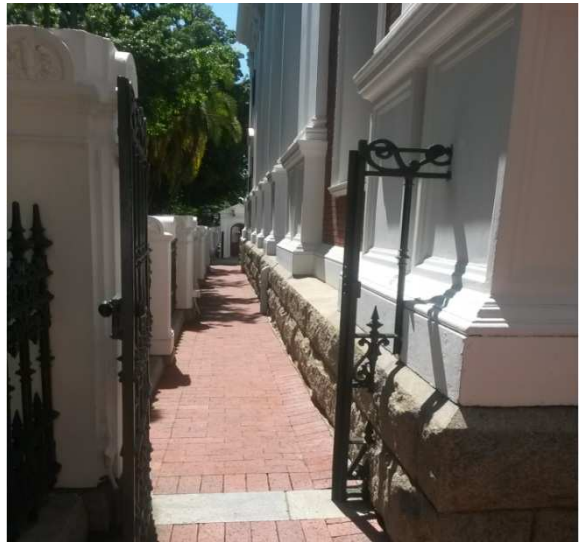
Photo 4.6.10: Side of building on Government Avenue with rainwater down pipes going underground next to granite cladding

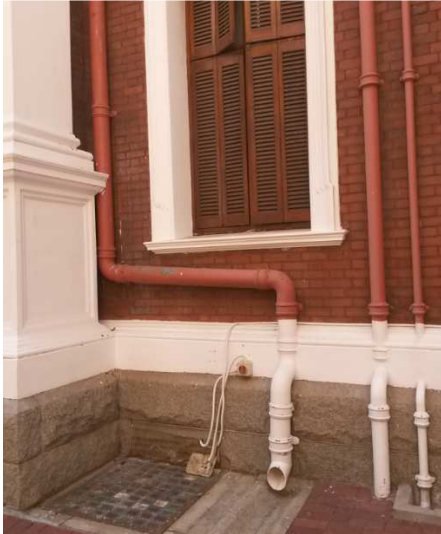
Photo 4.6.13: Rain water downpipe on other side of building Where stormwater is diverted via a surface channel.

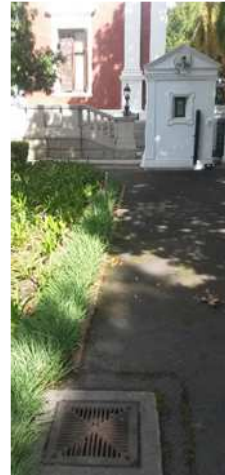
Photo 4.6.14: Storm water manhole close to basement
