PROPOSED EXPANSION OF KEMPDALE DAM, KOKSTAD, KWAZULU-NATAL

Phase 1 Heritage Impact Assessment

15 April 2021

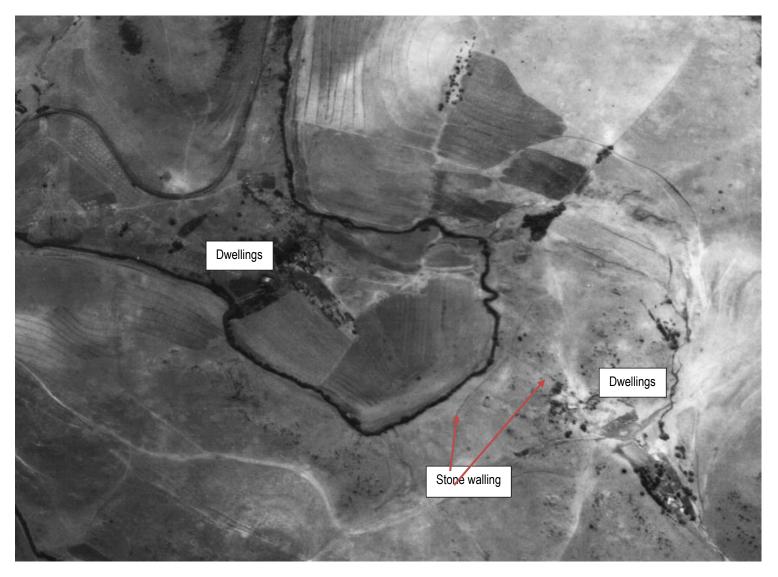
Figure 3: 1952 aerial image of Mzintlava River where dam now stands and surrounding area

A study of early aerial images of the section of the Mzintlava River where the dam is now located shows occupation of the area since the earliest image of 1952 (ref: 220_019_38524), the relevant section of which is shown below. The image shows dwellings in the area in the bend of the river, as well as outside the dam area and extensive cultivation within the bend of the river and immediately north of the river. The image also shows stone walling within and without the area of expansion of the dam especially on the southern and eastern sides of the river. The stone walling is even more visible in the 1955 image of the area as shown in **Figure 4** below (ref.: 358_009_05254).

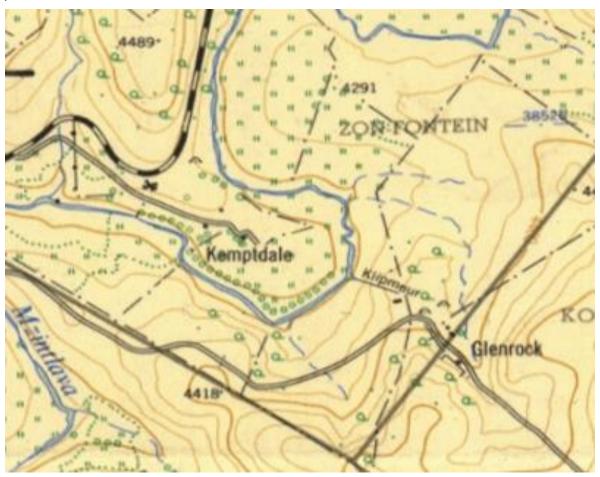
Figure 6: Relevant section of topographical map showing area where dam is now located

Mrs Bosman, who has lived on the farm for over 22 years, said that the stone walling and the grave mentioned below were there when her father-in-law bought the farm about 50 years ago. The 1963 topographical map (3029CB) (**Figure 7**) of the area of the dam shows a number of structures in the bend of the river as well as a kraal / homestead north of the farmhouses and the rocky outcrop. According to the Mrs Bosman, the remains of a kraal can be found on the top of the rocky outcrop north of the farmhouses but this was not found during the inspection due to the thick vegetation cover. The site of this kraal is situated well away from the proposed expansion level.

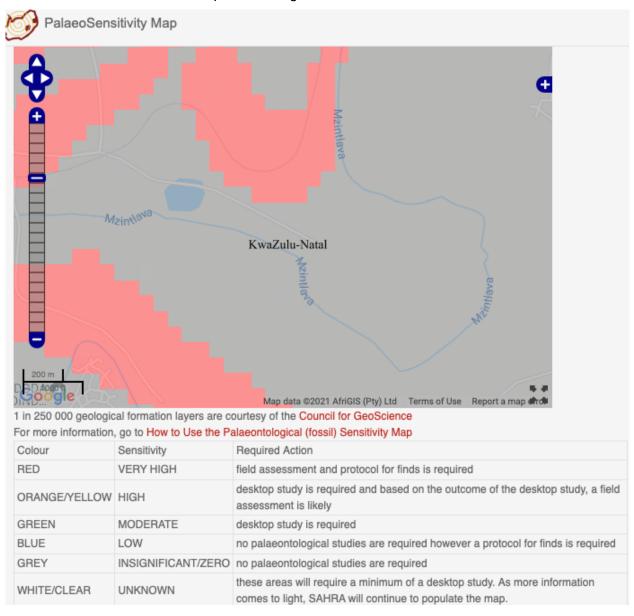
Figure 14: Fossil sensitivity of dam expansion

The fossil sensitivity map of the South Africa indicates that the project area falls into a zone of insignificant/zero palaeontological sensitivity as indicated with the grey colour on **Figure 14**. Only a very small area of the most northern section of the expansion falls into an area of very high fossil sensitivity. Inundation should not damage fossils neither will they be accessible therefore it is recommended that no further palaeontological studies are needed.
