**FINAL REPORT
PHASE ONE AIA 13 – 27 OCTOBER 2009
REMAINDER FARM 1511
(FORMERLY PORTION OF PLATTEKLOOF FARM 394)**

**HWC REF No. HM/CAPE TOWN/PLATTEKLOOF/FARM 1511 BARONETCY
PERMIT No. 2009/10/001**

26 February 2010

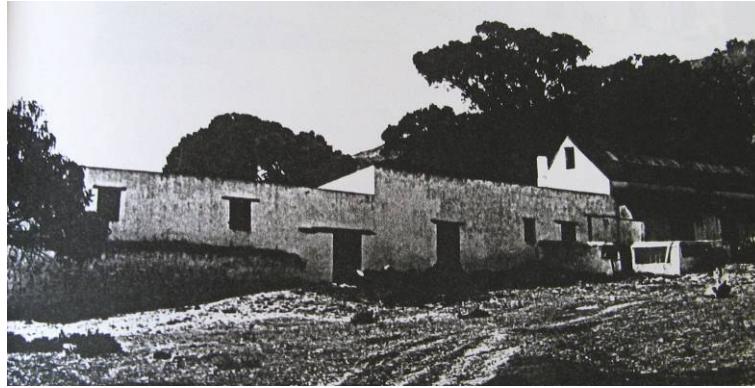
Figure 4: View of the 'Slave lodge' c1970 taken from the inside of the werf, facing northwards. The foothills of the Platteklouf is in the right background (Fagan 1994).

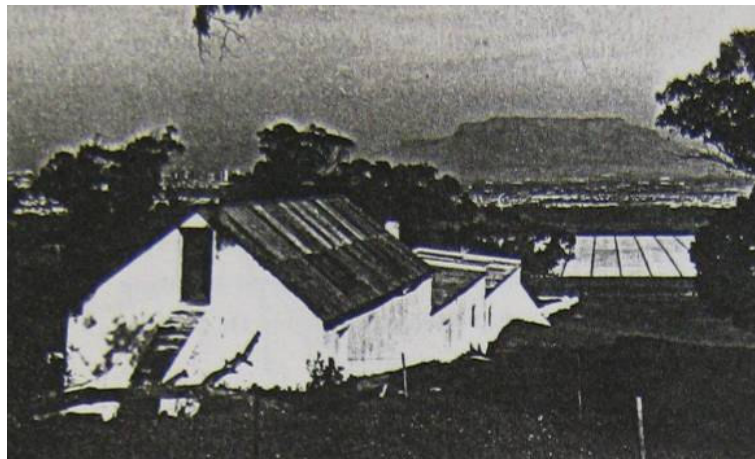
Figure 5: View of the 'Slave lodge' taken from the hill, looking southwards towards Table Mountain. The southeastern corner of the werf wall is clearly visible, as is the newly constructed Platteklouf Reservoir (Fagan 1994).

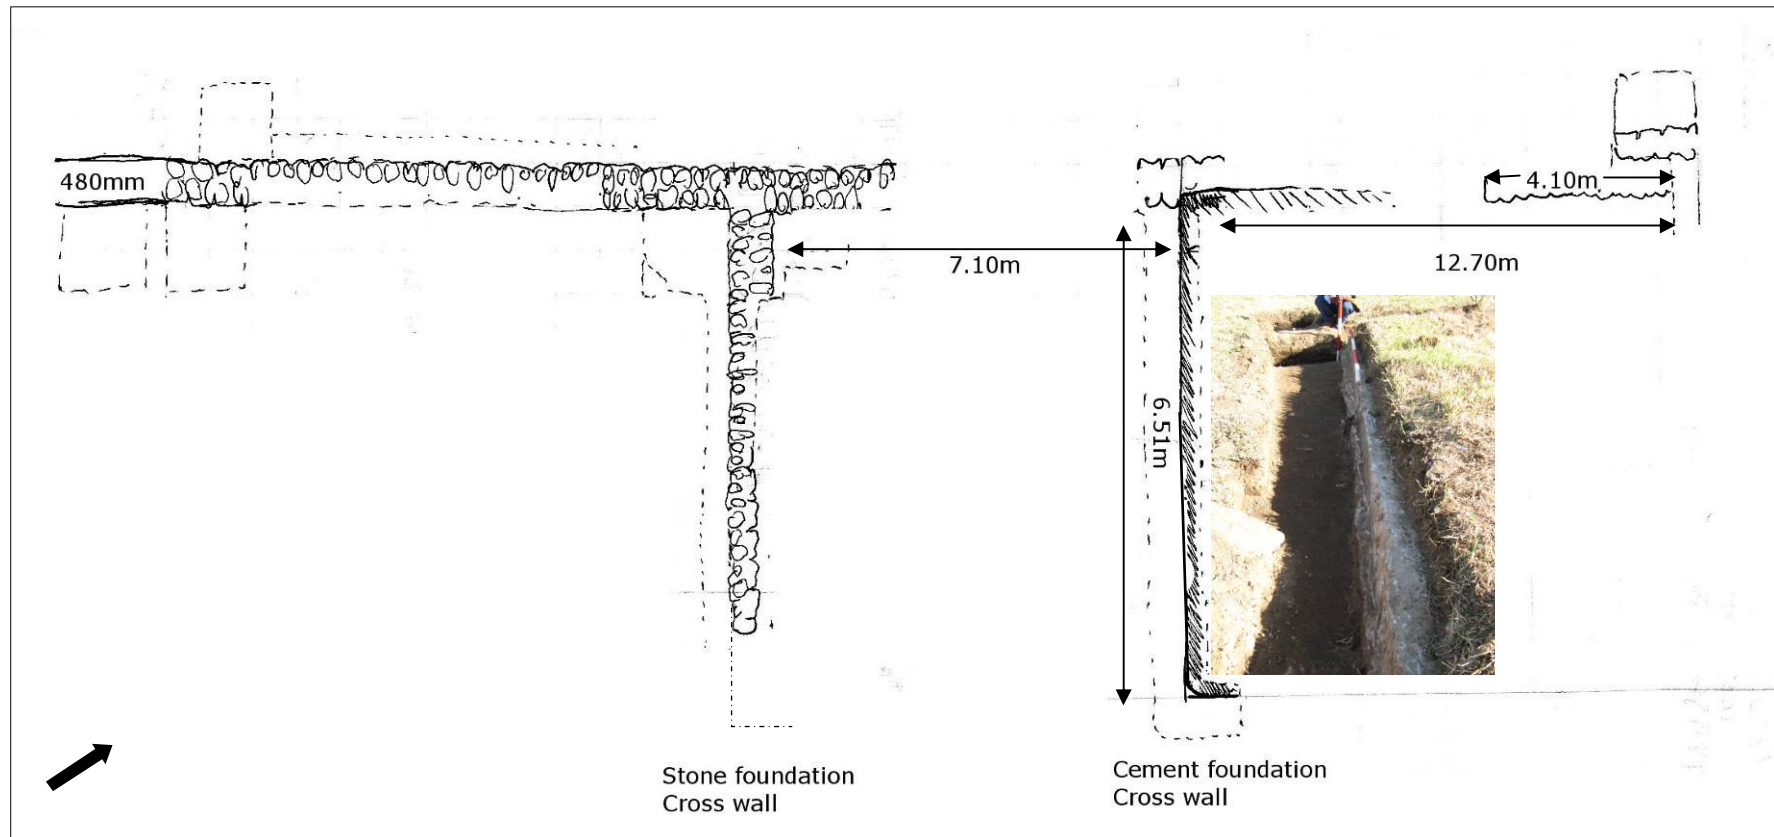
Figure 7: Sketch plan of the tests at the location of the 'Slave lodge'. The inserted image is of the cement foundation. An overlay with the 1992 survey of the building, suggests that this cement foundation is a subsequent cross wall in the first building shown in Figure 4. There is not an exact match between the 1992 manual survey and the 2009 electronic survey.

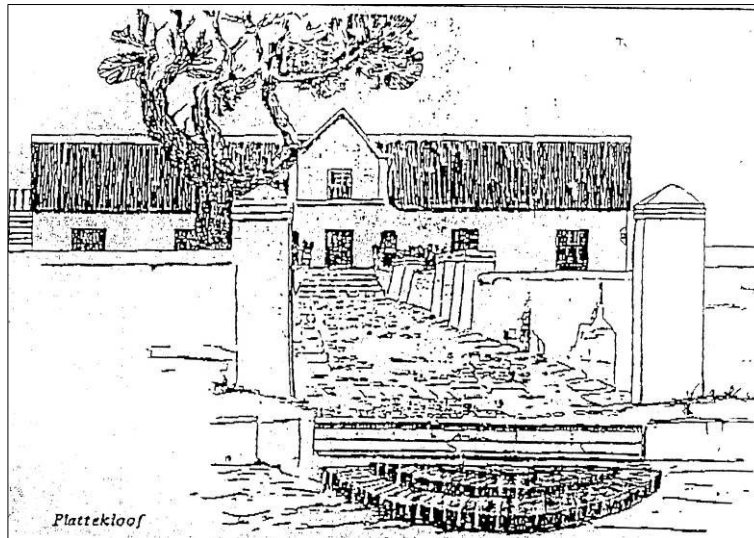
Figure 13: Trotter sketch of the Plattekloof farmhouse ?c1900 (Neethling 2003).

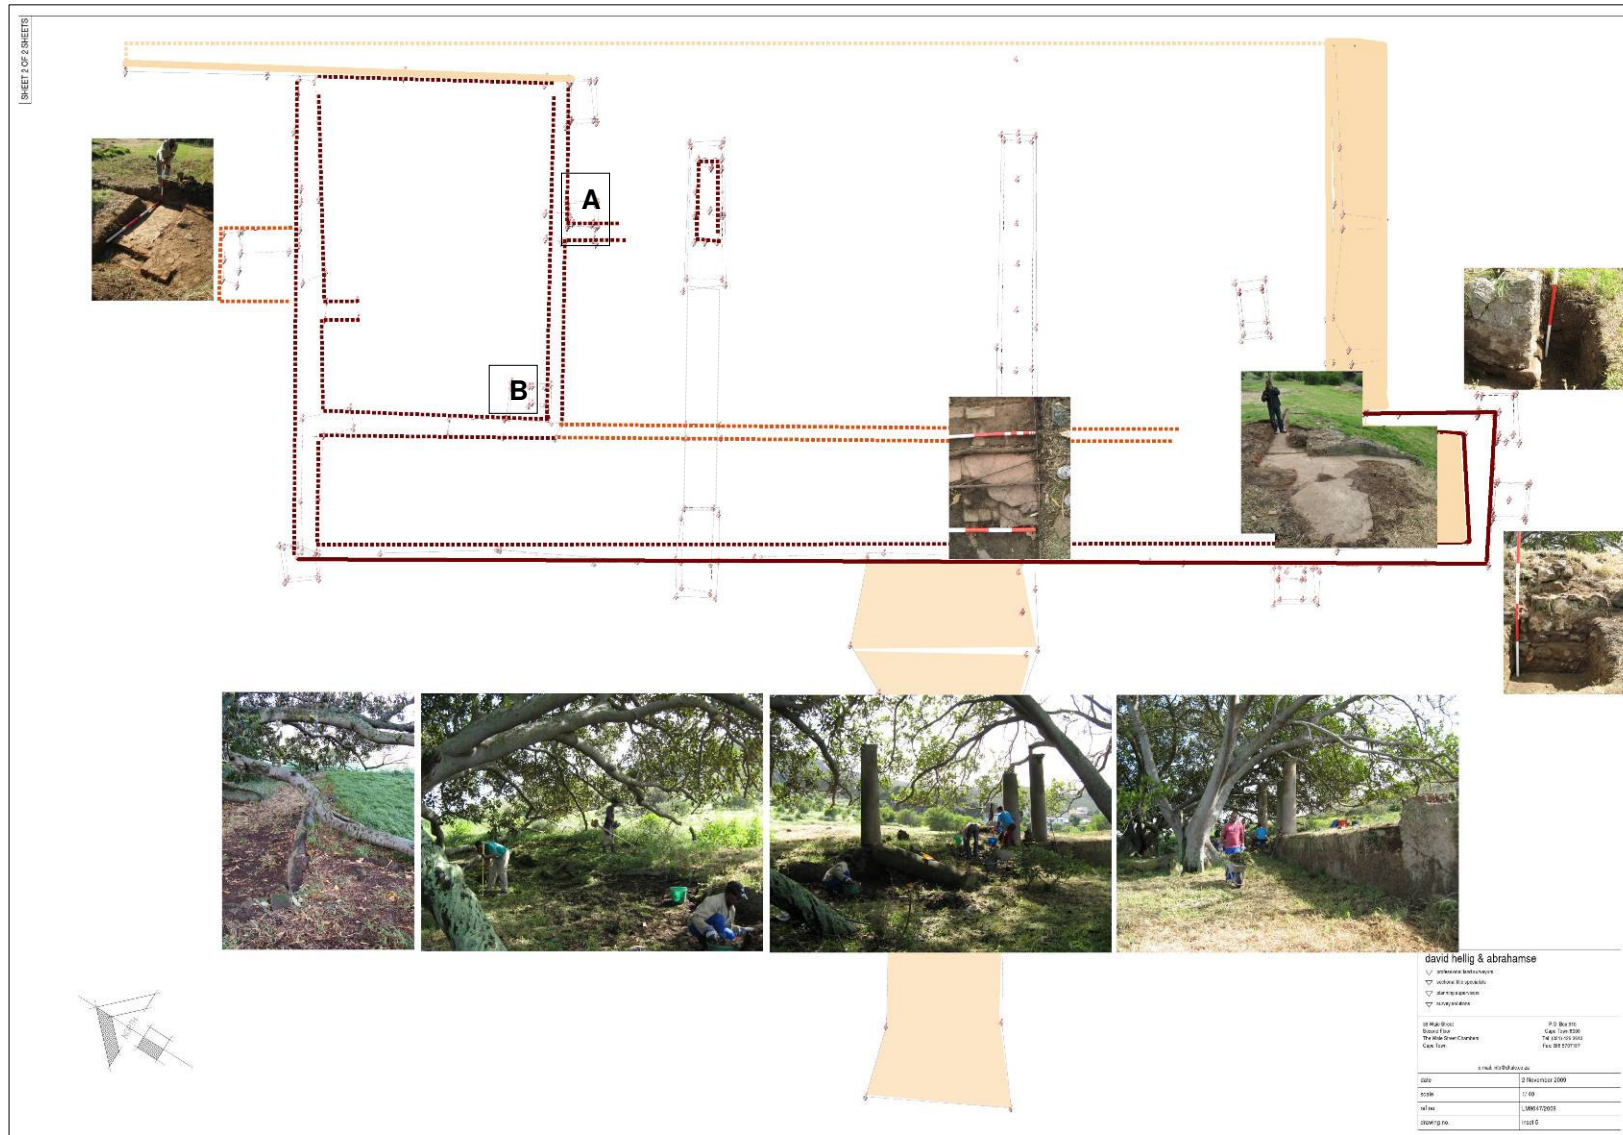
A dense layer of ash and fragmented Marseille roof tiles¹ was found throughout the areas tested, and in some cases underneath brick rubble, suggesting that the roof collapsed in the fire and some time after, the walls caved in. It is likely that the tiles are contemporary with the c1920s remodelling of the house which Neethling (2003) associates with the stoep pillars.

Figure 14: Site plan of the main house with stone foundations/walls indicated by brown lines and brick walling by orange lines. The tan areas represent cemented surfaces.

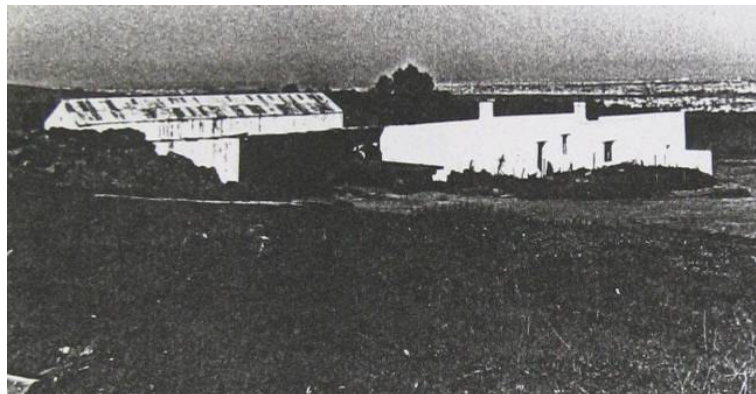
Figure 18: View of the 'Granary stable and kraal' (according to Fagan 1994), taken facing south southwest. The building in the foreground appears to have been residential (chimneys stacks visible). It is difficult to match the buildings in this image with those on the 1938 aerial photograph, but this image is included for the sake of completeness.

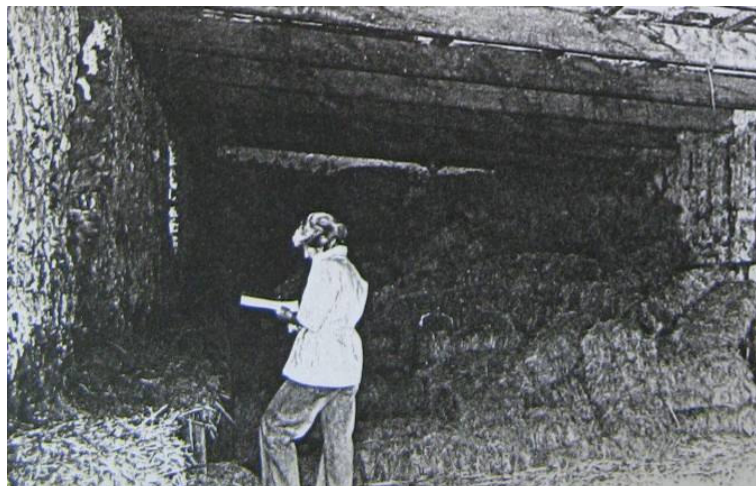
Figure 19: A survey of the structures undertaken in the 1970s show that these buildings had stone walling to ceiling level (albeit fairly low ceilings). It is not certain which of the two structures are shown in the photograph (Fagan 1994)

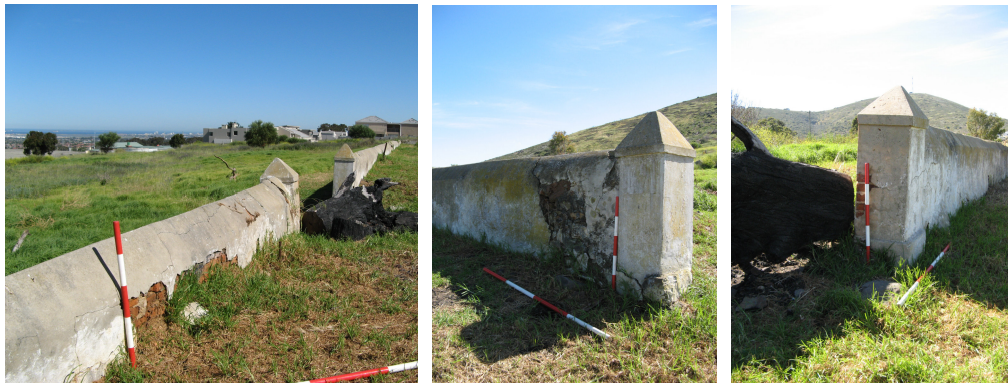
Figure 27: View of the southern gate and detail of the gate posts.

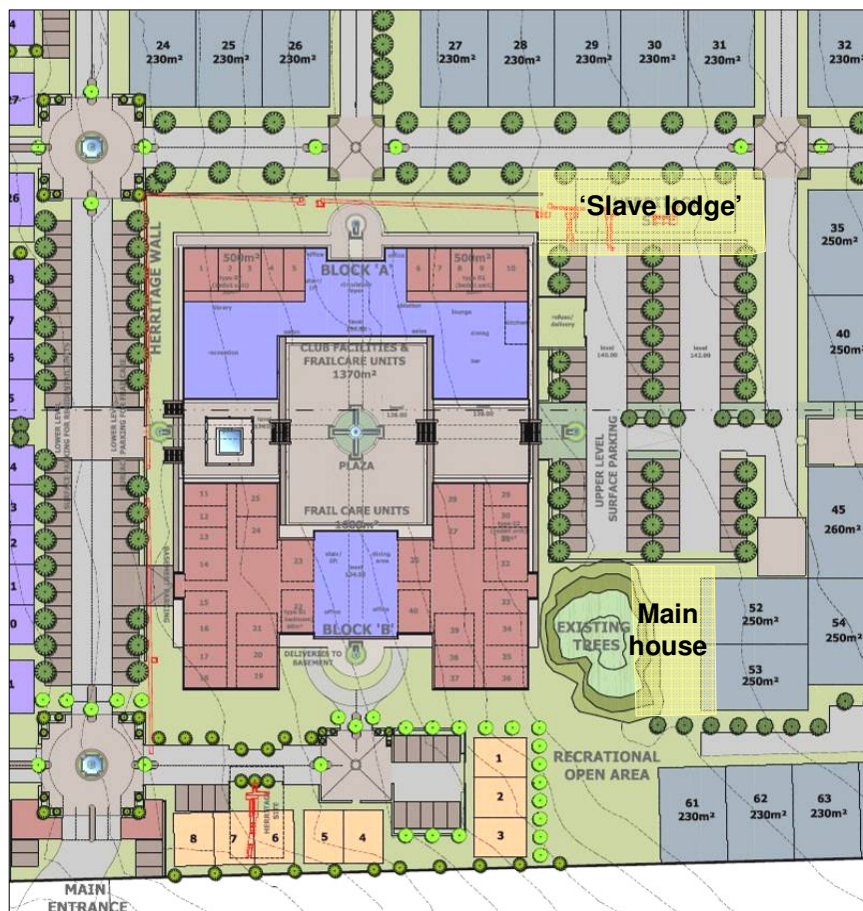
Figure 28 is the detail of the site development plan of Nov/Dec 2009. The werf wall is to be preserved in situ. The location of the 'slave lodge' has been set aside as an archaeological reserve. The ruins of the main house are proposed to be incorporated into a recreational open area. The parking area to the NE of the 'slave lodge' reserve encroaches slightly, and a minimum of 1m buffer should be allowed. Care should also be taken that the proposed erven 52 and 53 do not encroach too closely to the ruins of the main house.

Figure 28: Detail of the site development plan dated Nov/Dec 2009 (See Appendix 4 for plan)

- The werf wall needs to be stabilised and repaired. Specialist advice (engineer) needs to be sought to ensure that the wall is not destabilised during the construction period. A number of products are available that are more compatible with the soft brick used in older structures, and specialist advice (architect/builder familiar with old structures) should be sought as to how best to maintain this structure.
