HERITAGE STATEMENT

NIEUWEDORP, FOUNDERS' ESTATES, BOSCHENDAL FARMLANDS, DWARS RIVER VALLEY, STELLENBOSCH

**Application submitted to SAHRA in terms of Section 27 of the NHRA
(Act No. 25 of 1999) for:**

29th November 2013

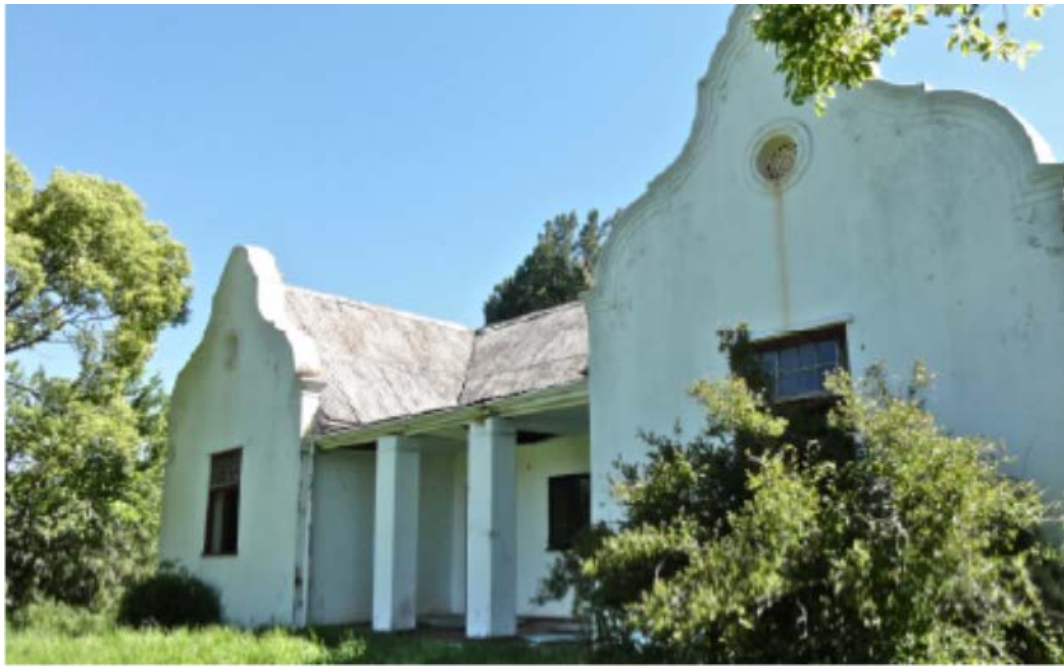
Figure 4: Nieuwedorp homestead front (east-facing) façade with its Cape Revival gables and stylistically characteristic front stoep and flanking projecting bays. This building is clearly architecturally less sophisticated than Champagne (Figure 5)

Nieuwedorp homestead has distinctive Cape Revival features in terms of its H-shaped plan form under a corrugated iron roof, curvilinear Rococo inspired 'holbol' gables. Its front (east facing) veranda, which is flanked by projecting bays, is classic Cape Revival in style giving it striking resemblance to Champagne, another homestead located approximately 1.5km to the east. Champagne appears to have been the architectural model for Nieuwedorp, with which it shares an almost identical floor plan. Champagne was built in 1900, designed by Baker Kendall, Masey & Earl (Titlestad 2008). However, the Nieuwedorp homestead, which is stylistically later (c 1920) is clearly not of the same design quality as Champagne, neither in terms of detailing nor finishes (Figures 4 & 5) and is very unlikely to be the original work of Baker *et al.* It is likely to post-date Champagne by a few decades, dating to the 1920s or 30s.

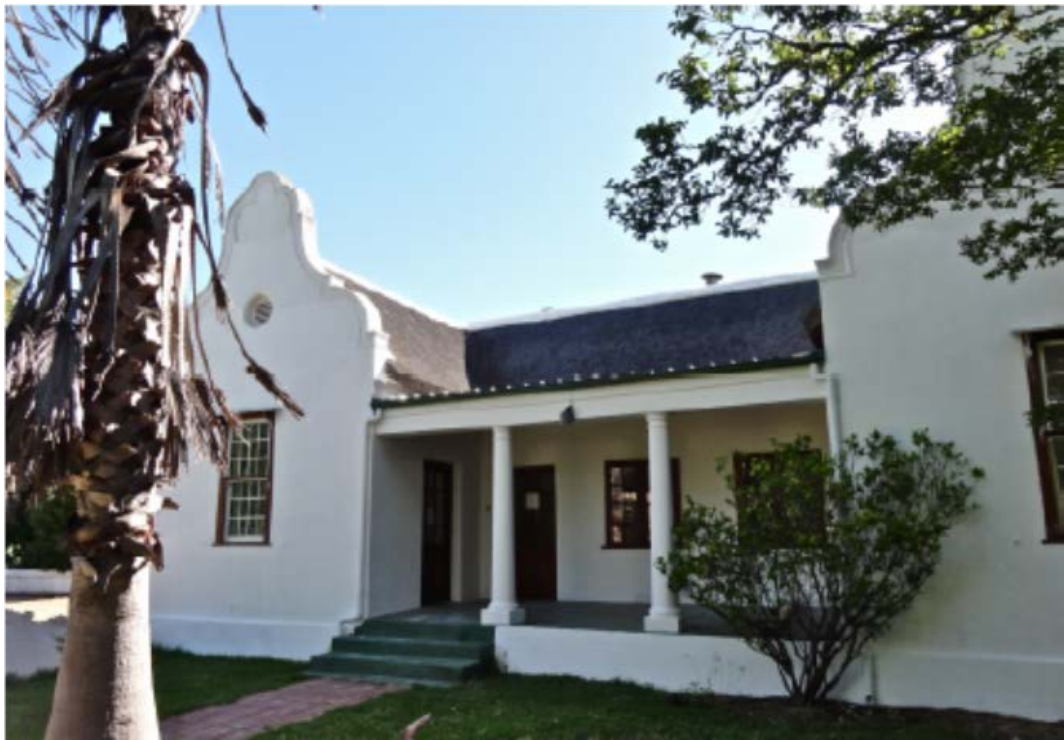
Figure 5: Champagne, with its architecturally more refined front façade compared to the Nieuwedorp homestead (Figure 4). Note for example its more finely executed stoep columns, better proportioned verandah eaves and bullseye gable windows, teak double sliding sash windows and thatch roof. (Image: Graham Jacobs, 21 November 2013)

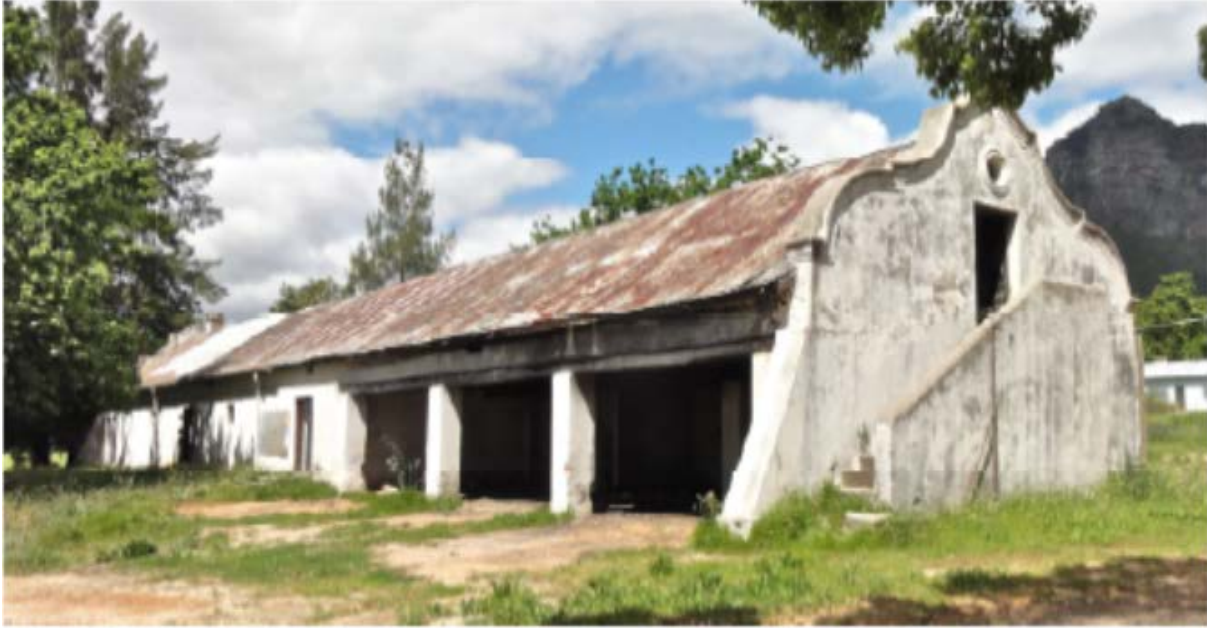
The long barn (Figure 8) to the rear (west) of the Nieuwedorp homestead has gables bearing some similarities to those of the homestead. The barn's exact age, use and modification over time is difficult to determine without more detailed fabric analysis. Its approximate 9m roof span is wider than the norm, imparting it with an almost 'double room' depth floor plan. The roof structure, corrugated iron roof and ceilings are clearly early 20th century although evidence of earlier, lower eaves lines (Figure 9) survive on both long facades, dating presumably from a time when the building was thatched. These features suggest that the building once had lower walls supporting a thatch roof that would have been taller than the current corrugated iron roof, given the considerable roof span of the building and the steeper pitch required of thatch. The structure may even originally have had a hipped thatch roof, with the gable ends added at the time the thatch was replaced with corrugated iron. Stylistically, it is quite possible that these alterations to the barn occurred in about 1920, i.e. at the time the homestead appears to have been built.

Figure 8: The Nieuwedorp long barn with squat proportioned Cape Revival end gables (northern gable visible) due to the wide roof span. (Image: Graham Jacobs, 21 November 2013)

- Repair and stabilize structural cracks in the southern gable end: to structural engineer's specification prepared in conjunction with an accredited heritage architect.
- Replace all roof sheeting with corrugated iron longspan roof sheets.
- Replace all gutters – preferably with ogee profile seamless aluminium gutters and PVC round section downpipes.
- Fix all roof and other leaks; make good using materials compatible with the affected existing fabric.

- Fill all wall cracks and make good using materials compatible with the affected wall fabric, e.g. lime putty, and lime-based mortars gauged with Portland cement to heritage architect's spec.
- Replace missing external doors; ensure that the exterior of the building is properly secured.
- Repair damaged timber window casements and frames. Re-glaze where necessary.
- Given that the exterior is coated with various finishes including both paint and limewash: scrape off as much paint and limewash as possible; prepare and overcoat the exterior with 'breathable acrylic paint coatings on an approved bonding liquid: all to manufacturers spec prepared in conjunction with an accredited heritage architect.

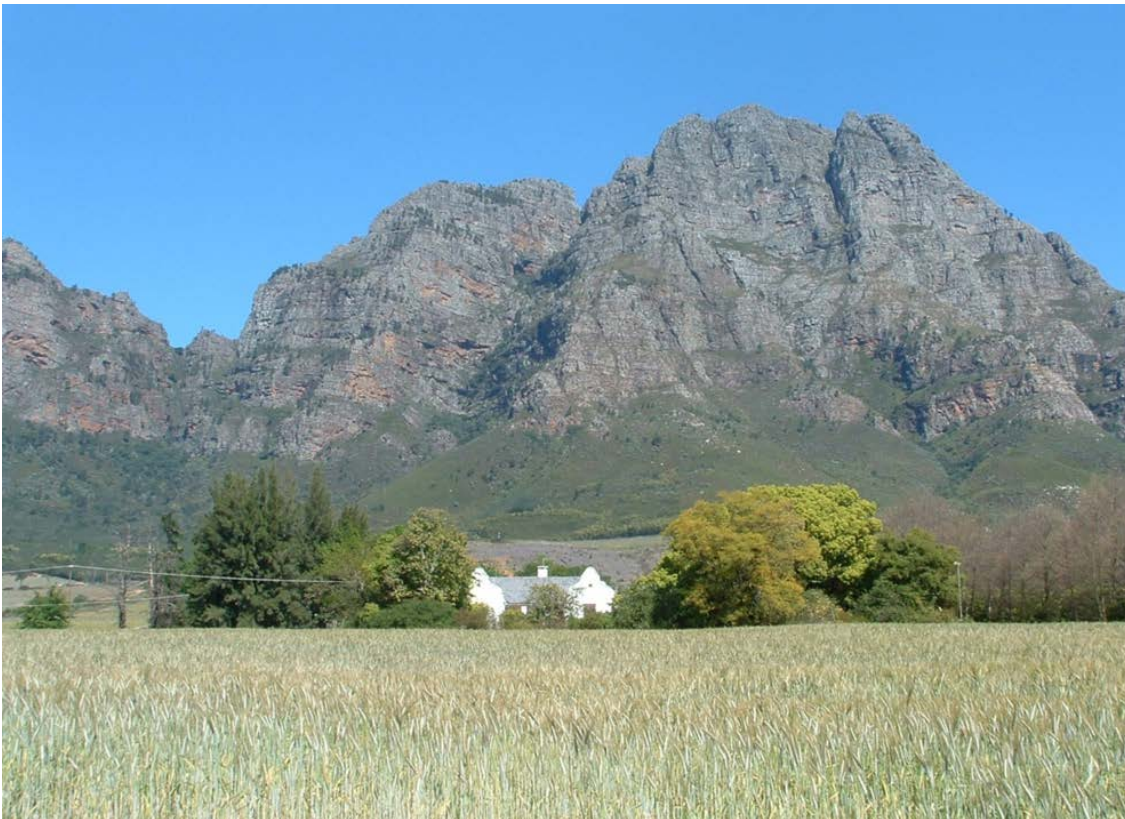
Figure 13: Nieuwedorp homestead with the backdrop of the Simonsberg

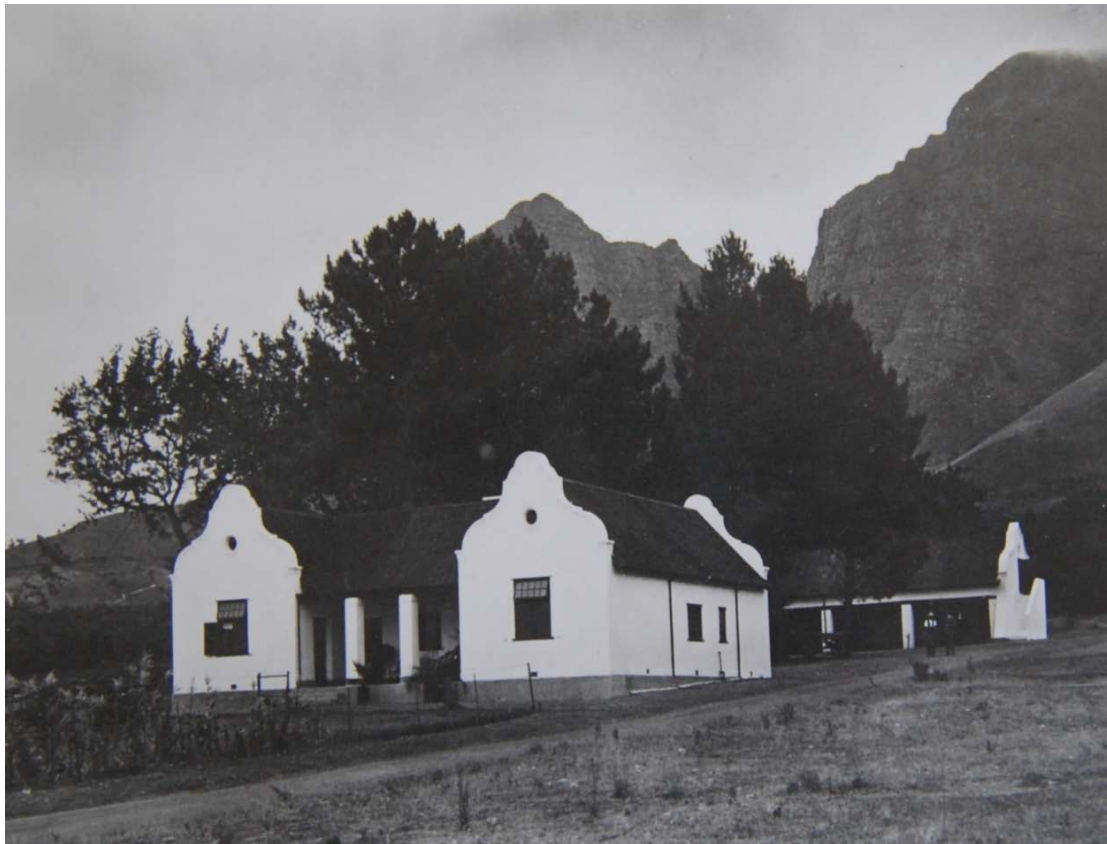
Figure 18: Nieuwedorp homestead and barn pre 1930 (CA AG7553)
