Native Hostel (Compound)

5.3.2.2 Mine Area B

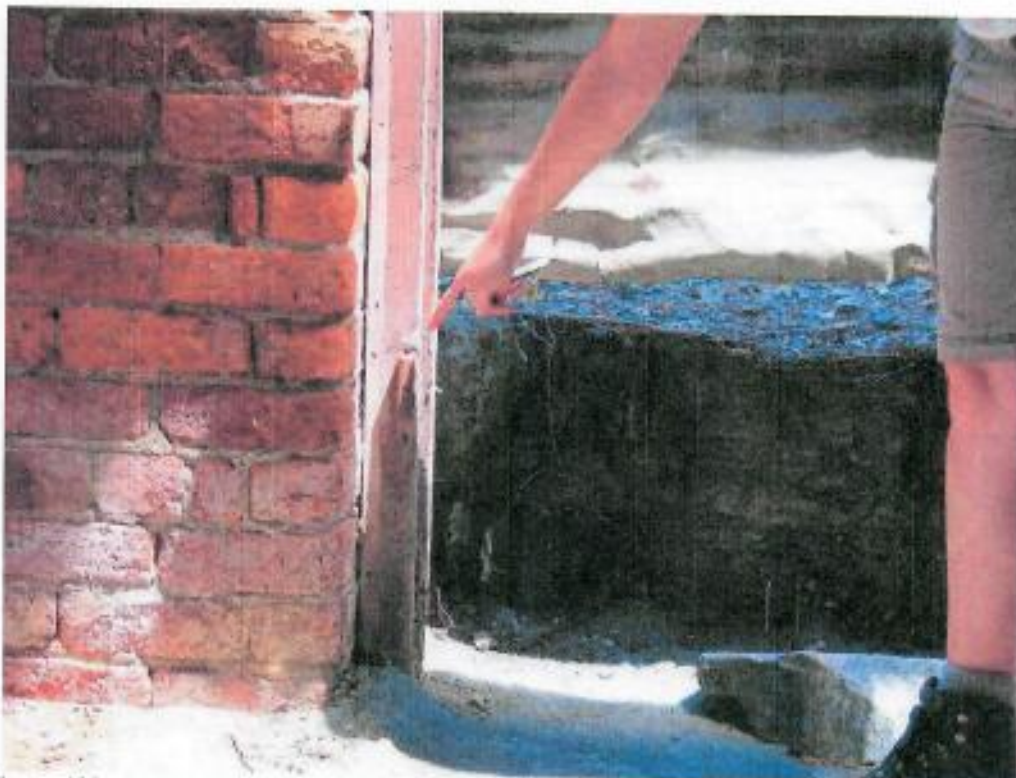
Figure 133: Photograph taken from inside Isolation Ward – note build-up of soil on the outside (southern side)

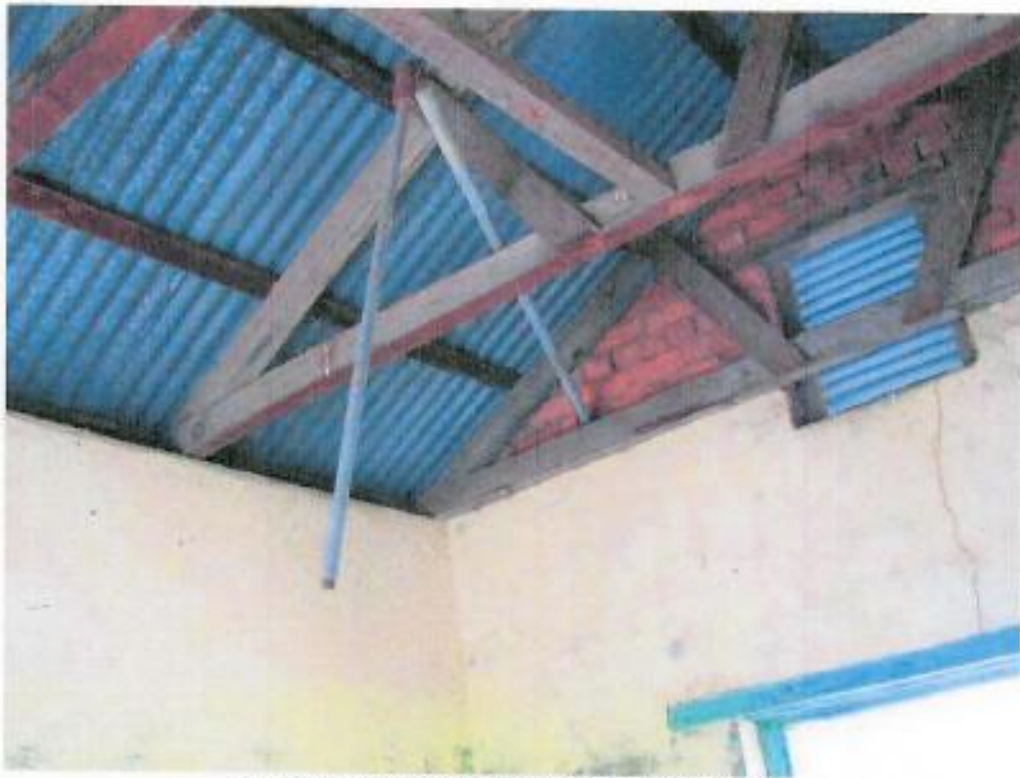
Figure 137: Water pipes suspended from ceiling
