**Jagersfontein Heritage Impact Assessment
Structures: Mine Area b
31/03/2009**

5.3.2.3 Central Section

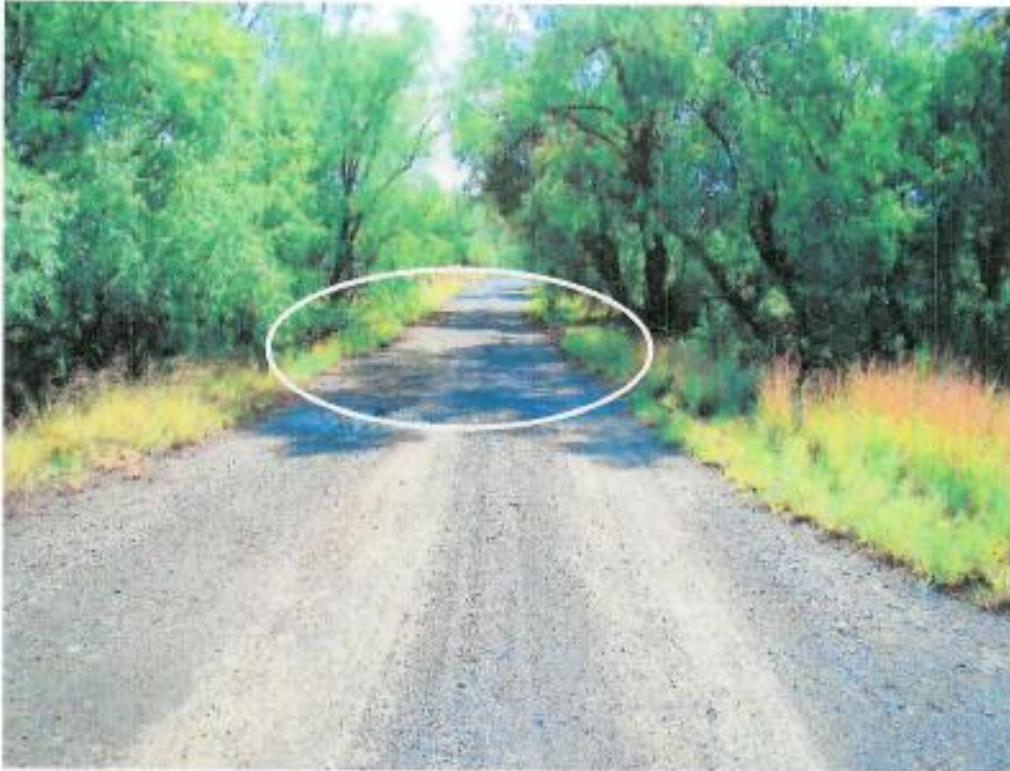
Figure 181: Bridge in encircled area

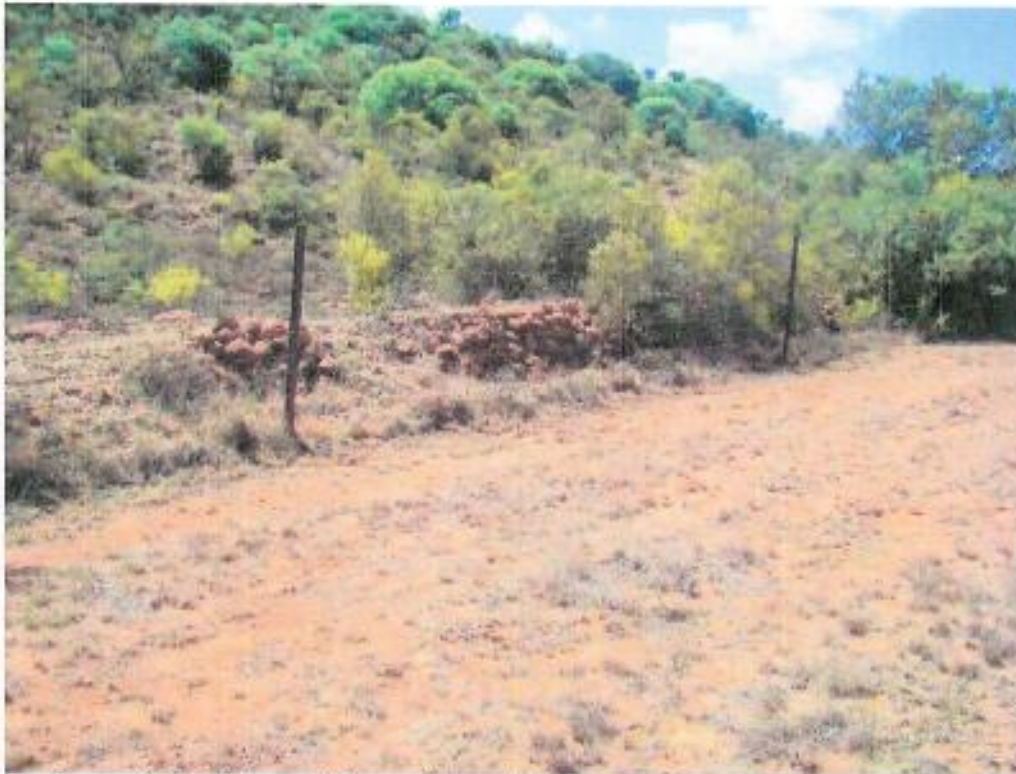
Figure 187: Retainer wall in southern section of surveyed area - see map on page 33

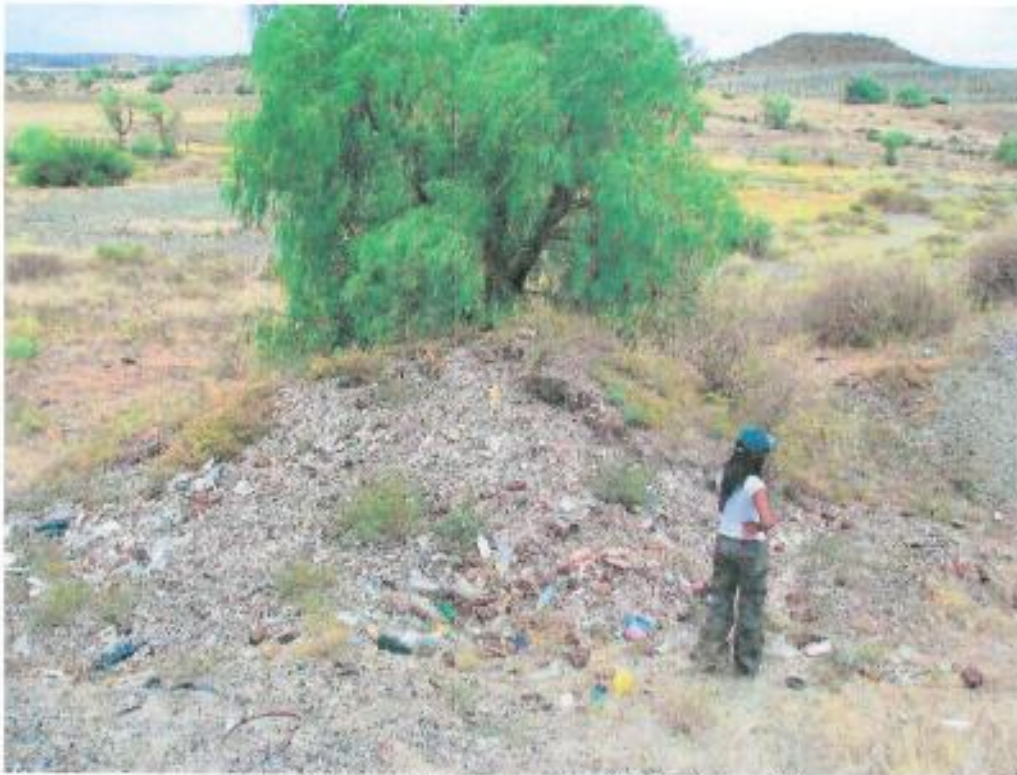
On the southern side of the remains of the Mine Stores is a rubbish dump that could possibly be related to the compound which is on the northern side of the Mine Stores. It is, however, possible that illegal dumping took place at this site since the mine's closure in 1971 as the upper layer contains both items dating to that period as well as a few items dating to a more recent period.

Figure 217: Rubbish dump south of Mine Stores (1)

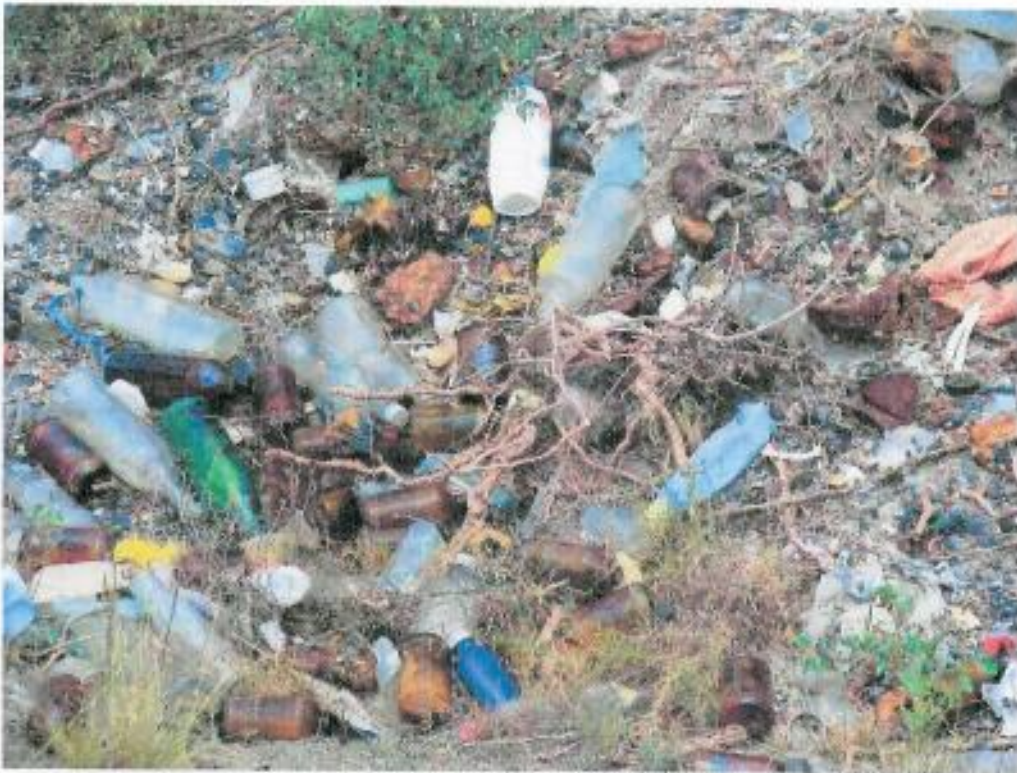
Figure 218: Close-up view of surface of rubbish dump south of Mine Stores (2)

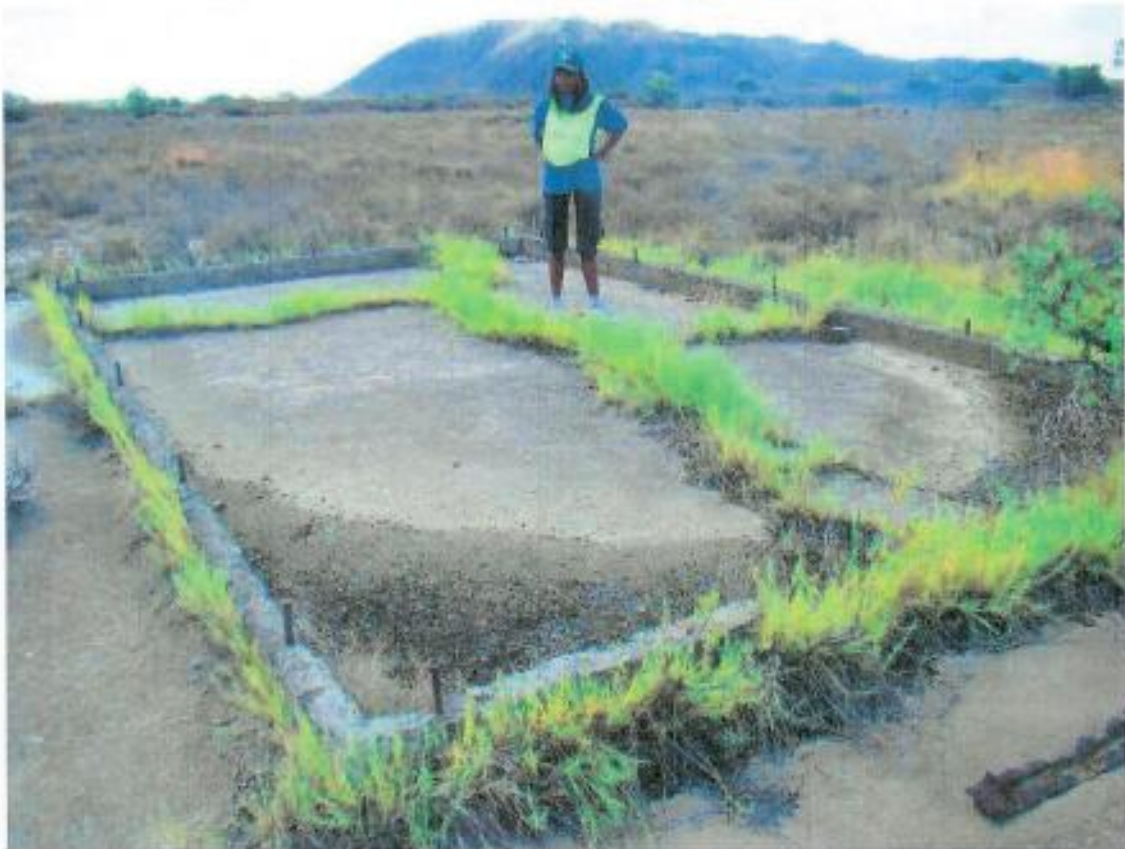
Figure 222: None of the mine maps identifies this structure (refer to map on page 182 for its location)

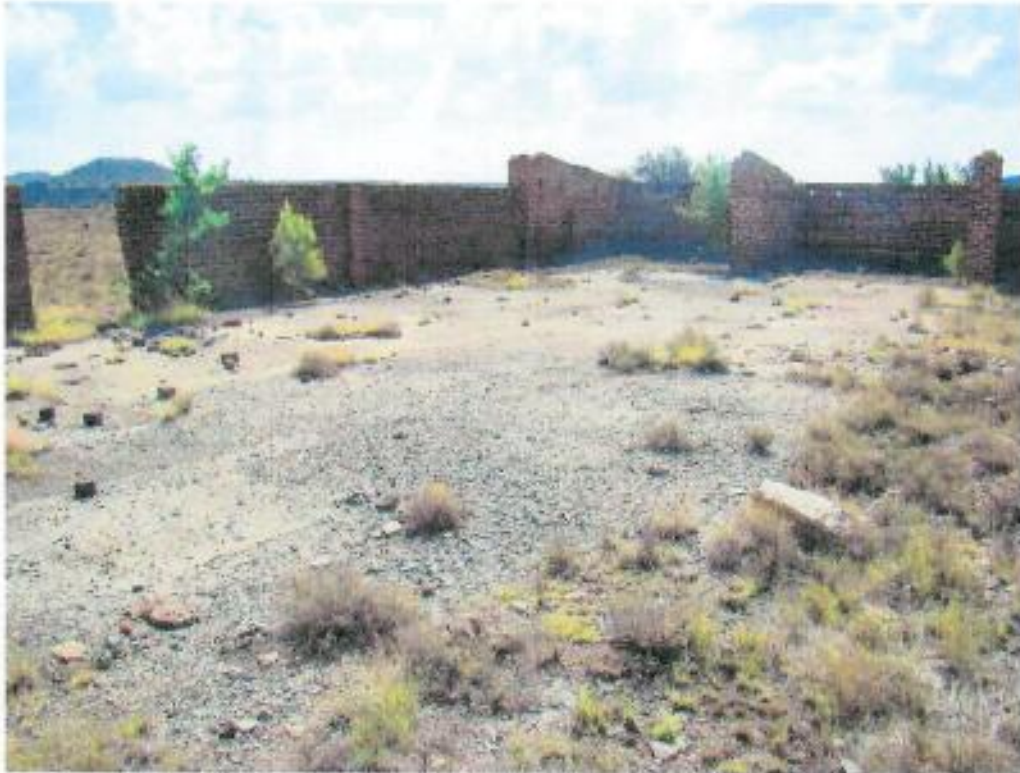
This structure was pointed out to us as "Mr Du Preez' coal depot". It seems to have served as animal shelter at a later stage because some of the cubicles contained feeding troughs.

Figure 228: Cubicles or rooms for coal storage (orientation west)

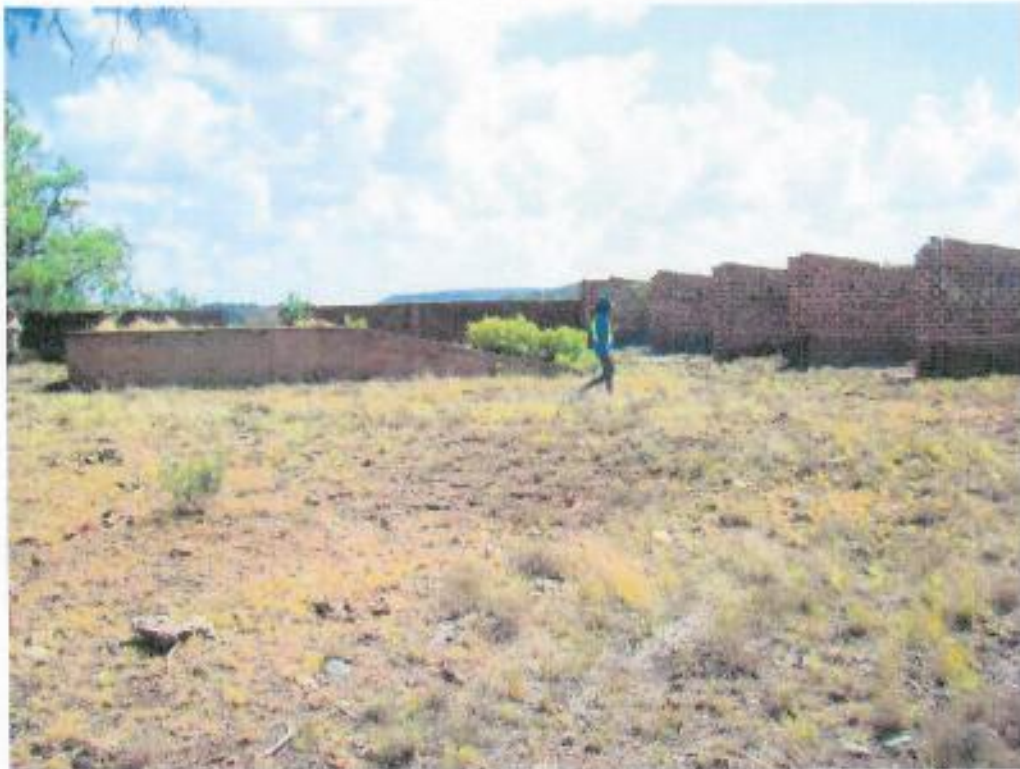
Figure 231: Loading ramp with cubicles on right hand side (orientation south)

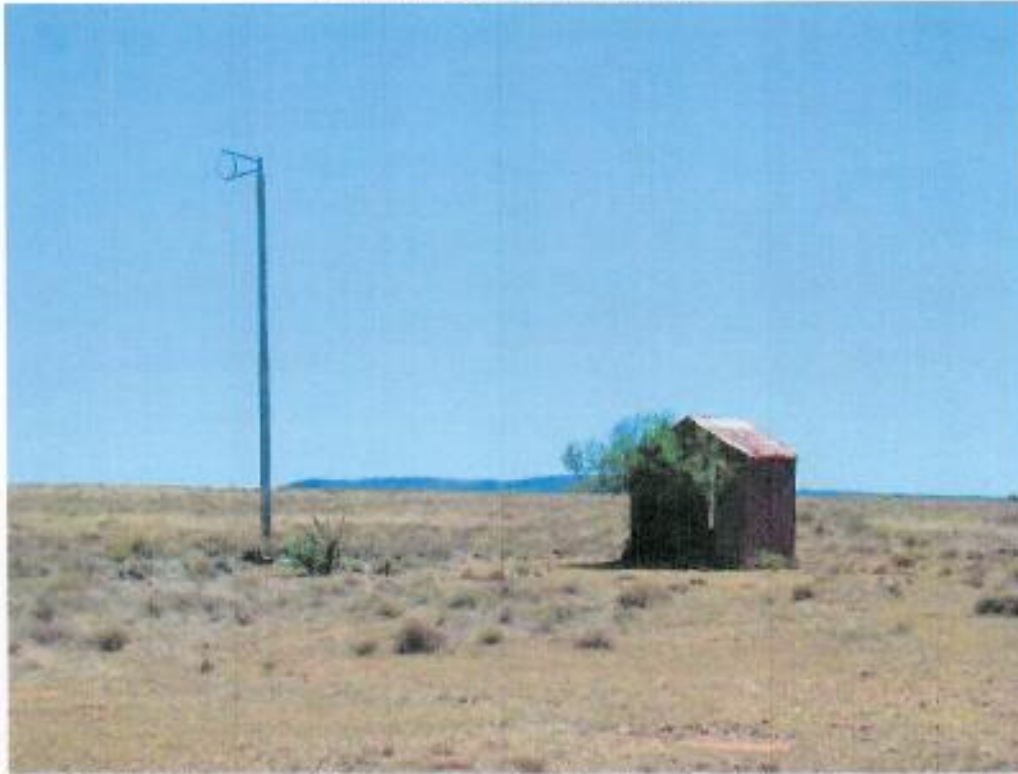
Figure 232: Small corrugated iron structure and windsock at intersection of two runways of the airfield

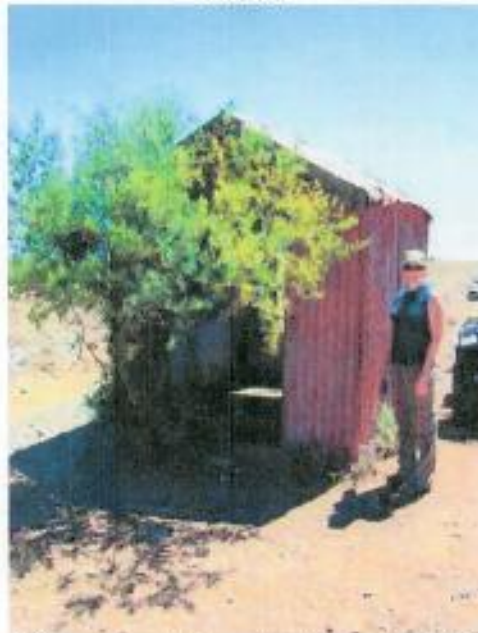
Figure 233: Close-up view of the corrugated iron structure - the interior suggests this to have been used as bathroom (toilets)

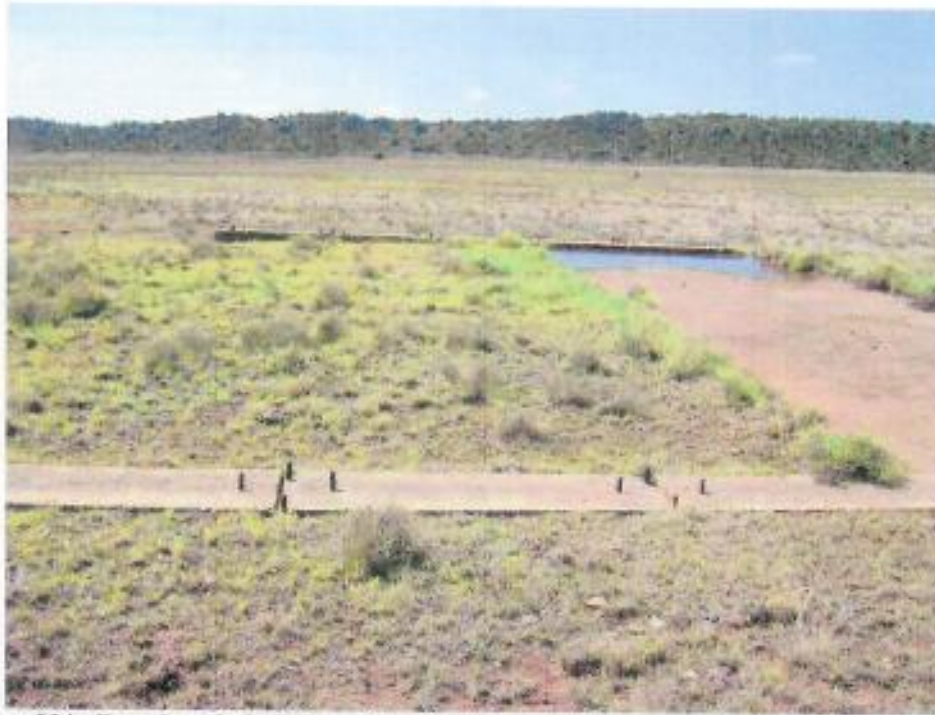
Figure 234: Remains of a building with cement foundation on opposite side to the toilet of the intersection (Possibly a hanger for a small aircraft)

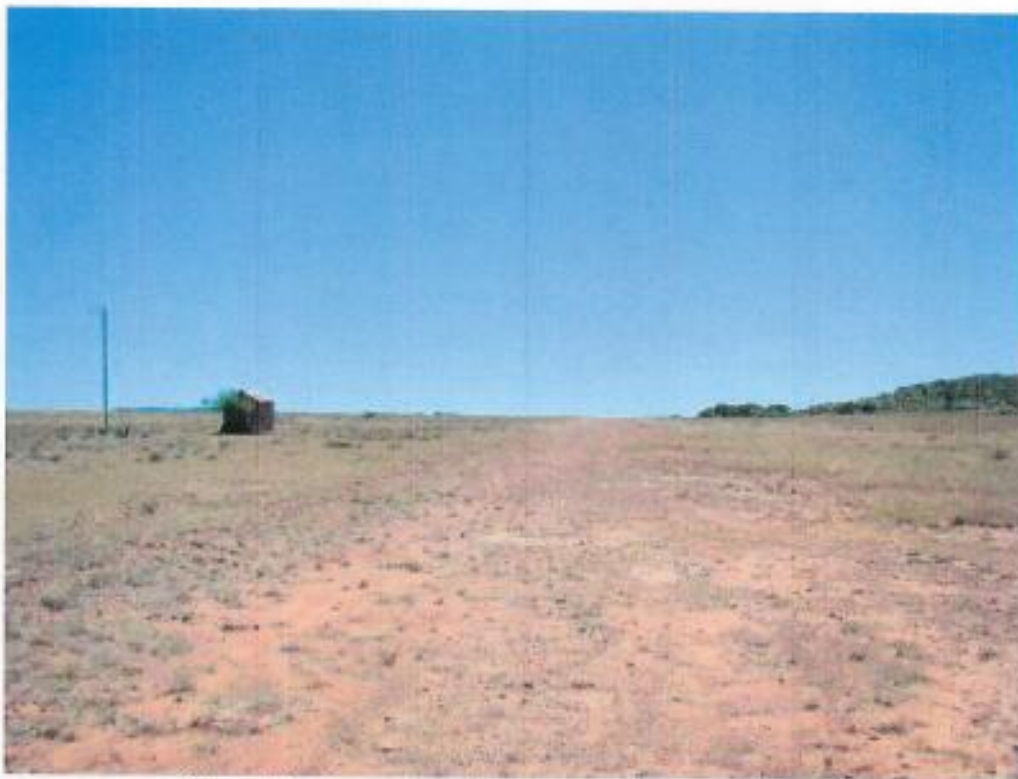
Figure 235: Runway running west to east (orientation west)

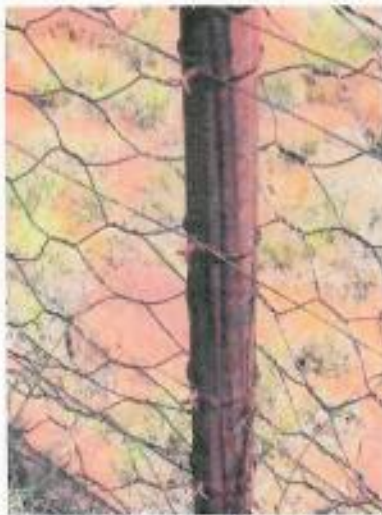
Figure 239: Close-up of fencing material

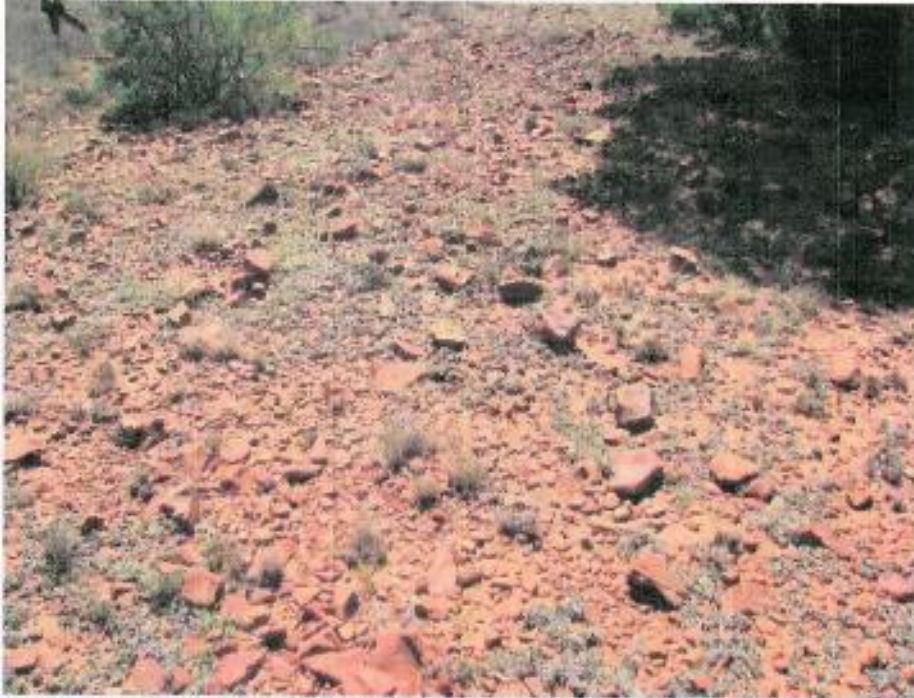
Figure 242: This particularly rocky patch on top of the western ridge could possibly be a source site for raw material for stone tools. The following photographs are all from this particular concentration of rocks.

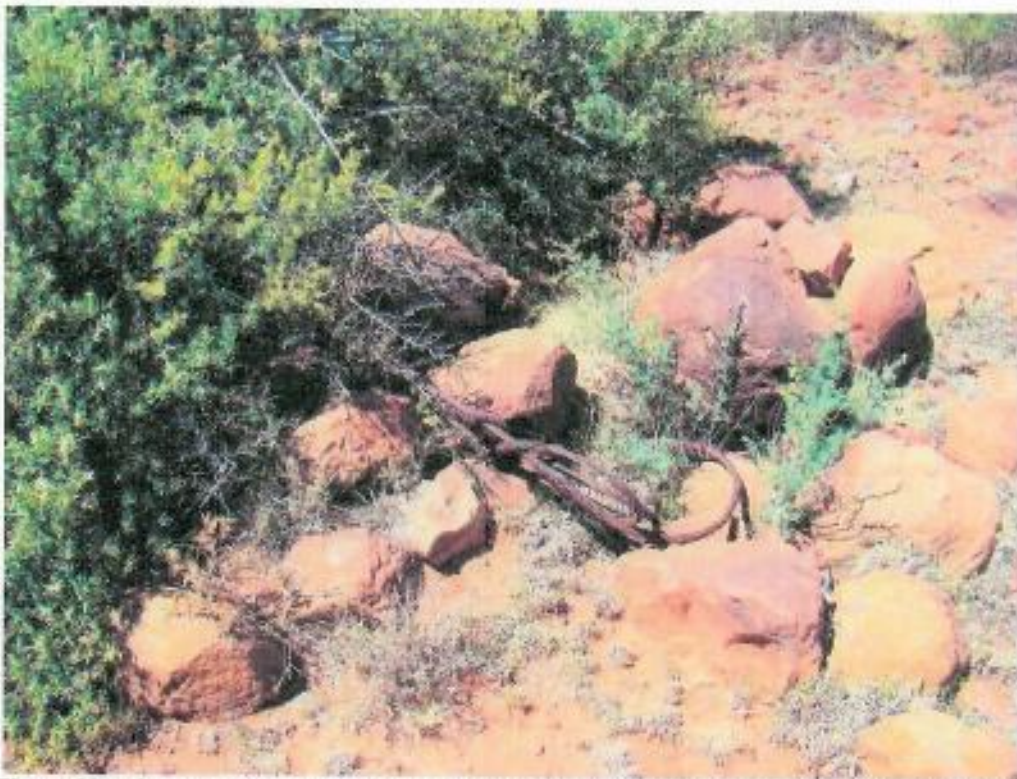
The ridges on the western side form several depressions which seem to have been used as natural cattle pens. No remains of any mining activities were found on top of the ridges apart from several piles of stones that acted as anchorage for thick wires. These might, however, be remains of old Escom lines.

Figure 251: Several stone piles similar to the one in this photograph were found on top of this western ridge. All of them have either a length of cable anchored in it or a portion of it lying nearby

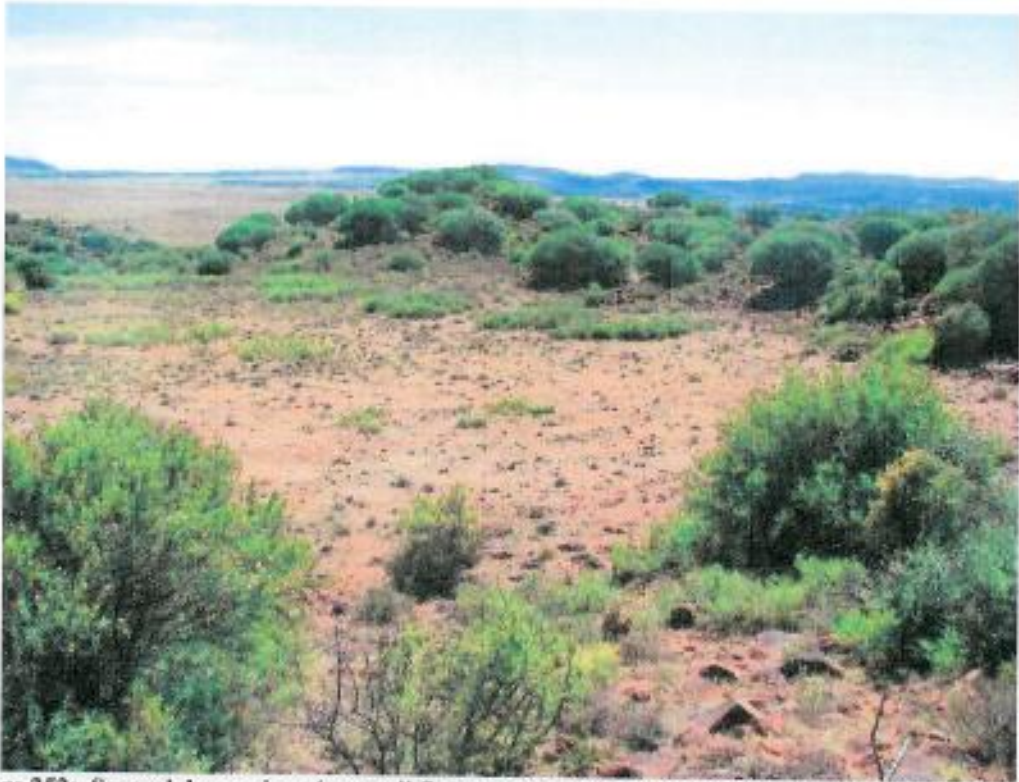
Figure 252: Several depressions (or small flat area approximately the size of a soccer field) similar to the one in this photograph can be found along this ridge and judged by the amount of cattle dung could possibly have served as natural cattle kraal
