SPECIALIST REPORT

A PHASE 1 ARCHAEOLOGICAL AND HERITAGE IMPACT ASSESSMENT OF THE
STONE WALLED SETTLEMENTS ON TAURUS PLANTATION, BARBERTON
DISTRICT, MPUMALANGA PROVINCE

**REPORT PREPARED FOR
YORK TIMBERS**

APRIL 2015

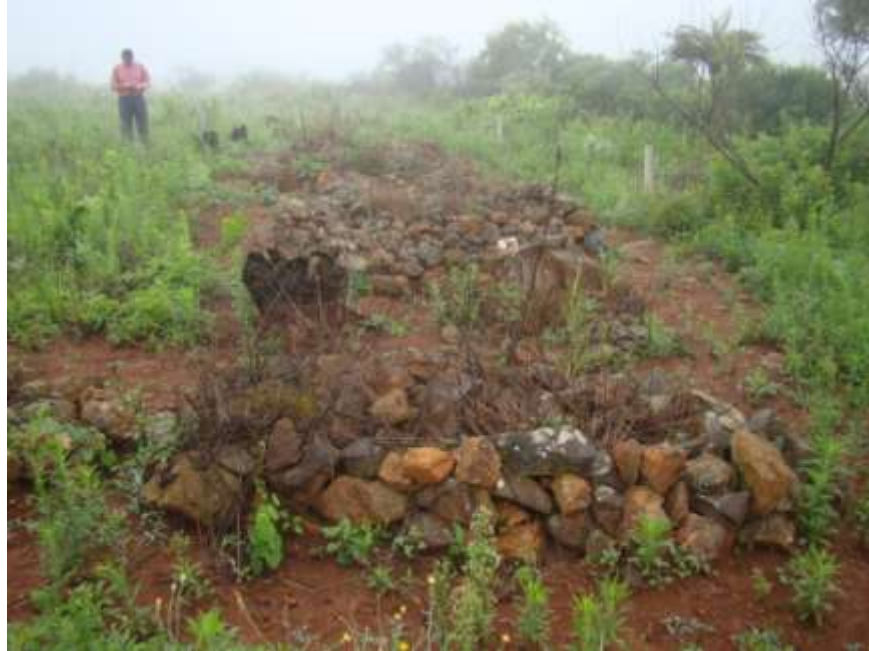
Fig. 3: Z38: 9 x Unmarked graves were identified near the Taurus offices and are marked as an ASI. The area is demarcated, maintained and vegetation growth is controlled.

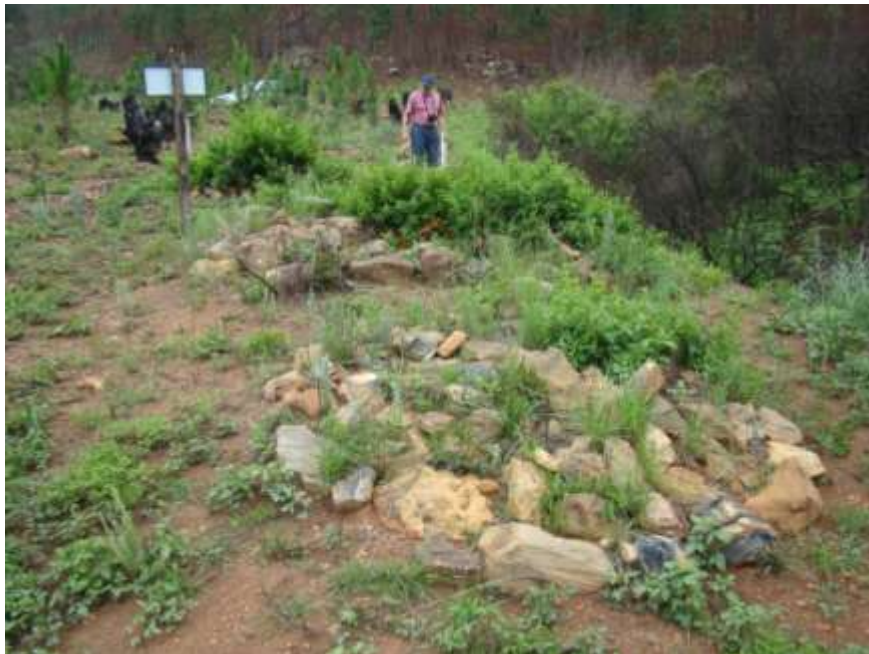
Fig. 4: C06: 3 x Unmarked graves were identified near an old Drift and cattle dip and marked as an ASI.

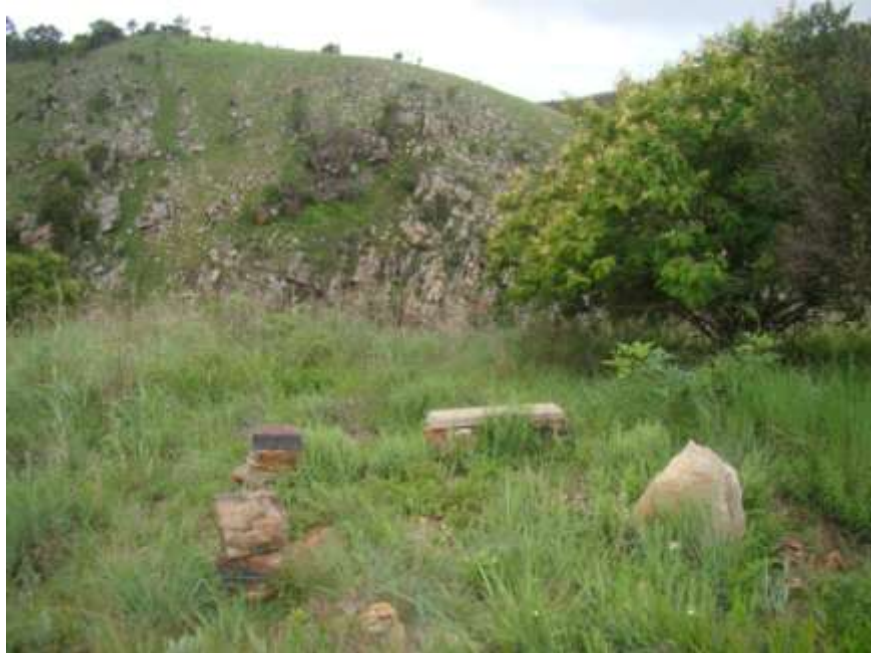
Fig. 5: Z77: A memorial site of the Landman family is located near the Log Cabin. The remains of members of the family are marked with headstones.

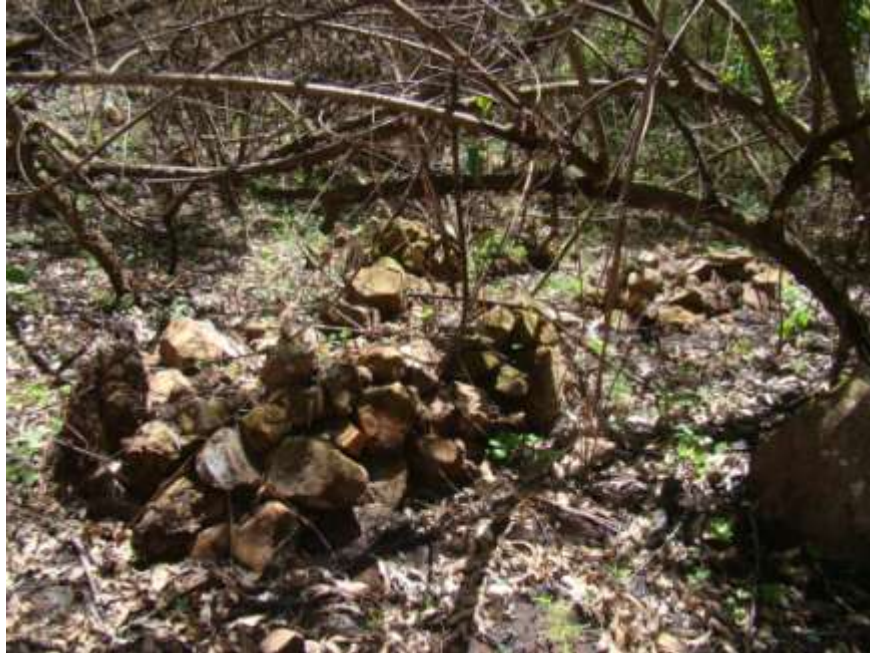
Fig. 7: A25/C32: 3 x Unmarked graves next to a circular unit and near historic remains of a kraal. Piles of stones mark the site but it is overgrown and neglected.

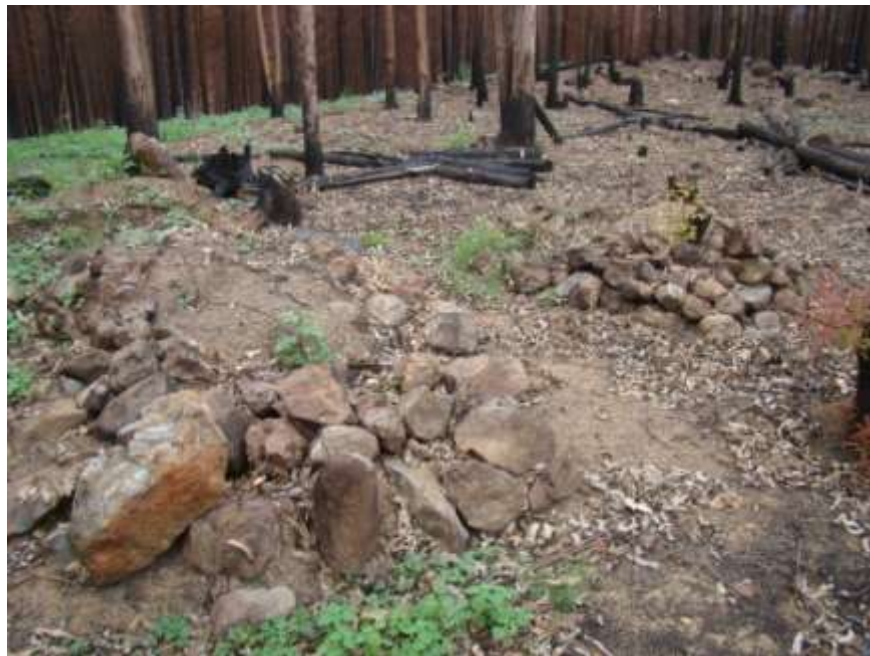
Fig. 8: B35B: Unmarked graves are located near a circular stone walled settlement in block B35B. The graves are neglected.

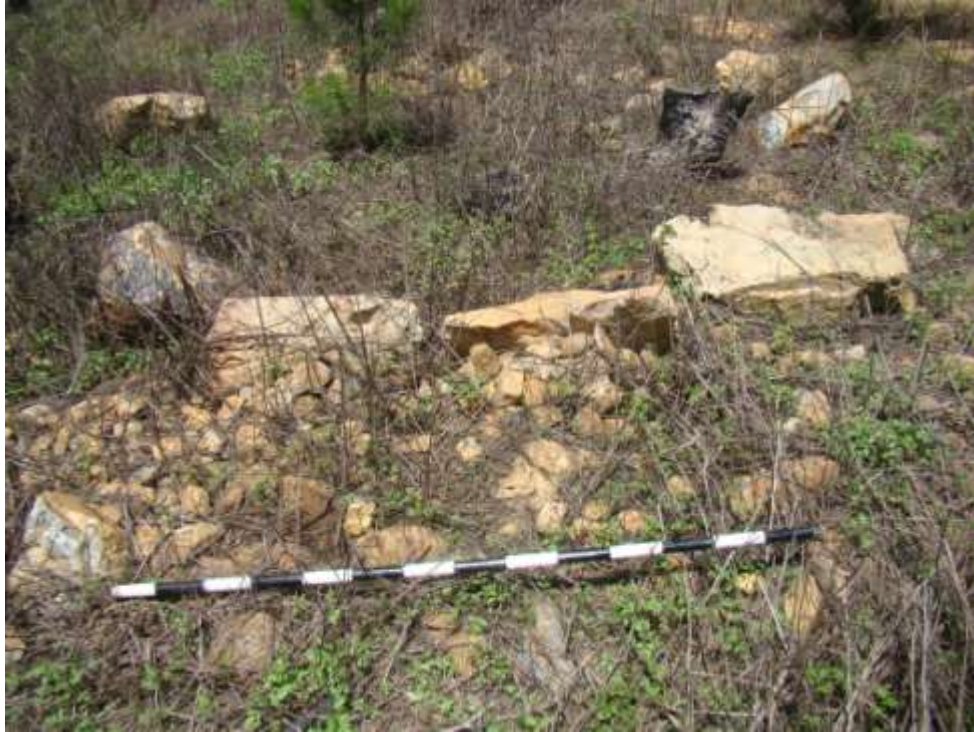
General comments A 12 – 1 & 2: No visible archaeological remains were observed in this section. The terrace wall in A 12 was destroyed by the construction of a road between compartment A12 and A13. The walls enter block A13 from the west and continue up the slope. Many circular units are visible in the young plantation.

Fig. 12: Terrace walls which have been damaged by a road between compartments A12 and A13.

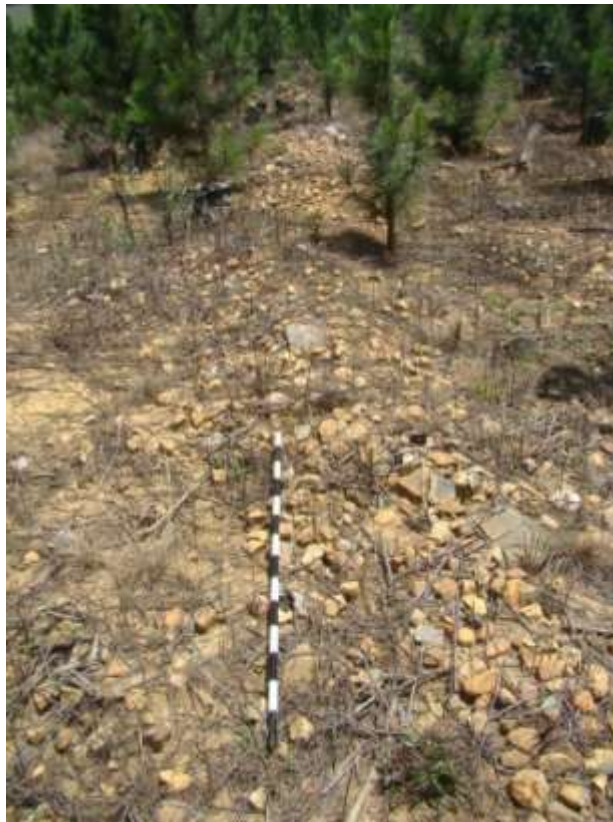
General comments A13: The settlement was located on a low hill which gently slopes towards the west, north and east. There are many circular units, terrace walls and cattle tracks in this compartment block but it has been extensively damaged by plantation activities. Many upper grinders, lower grinders (broken) and fragments of clay potsherds are visible towards the gravity low areas of the units, and in the dirt road.

Fig. 14: The terrace wall which continues up the slope. It is deteriorated and located in a young plantation.

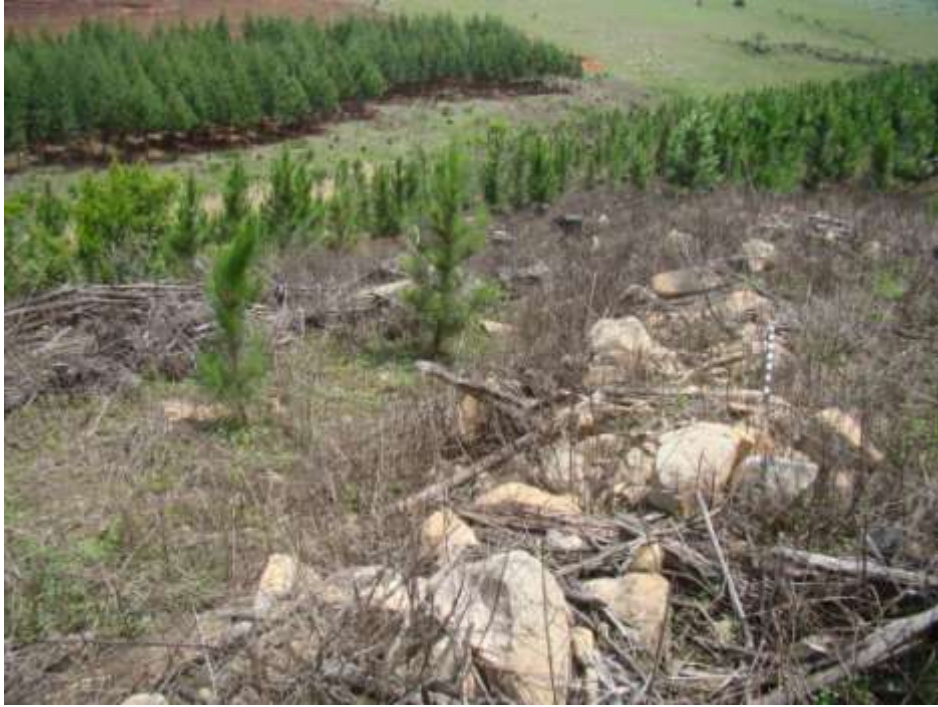
Fig. 15: A section of a cattle track is visible in the young plantation.

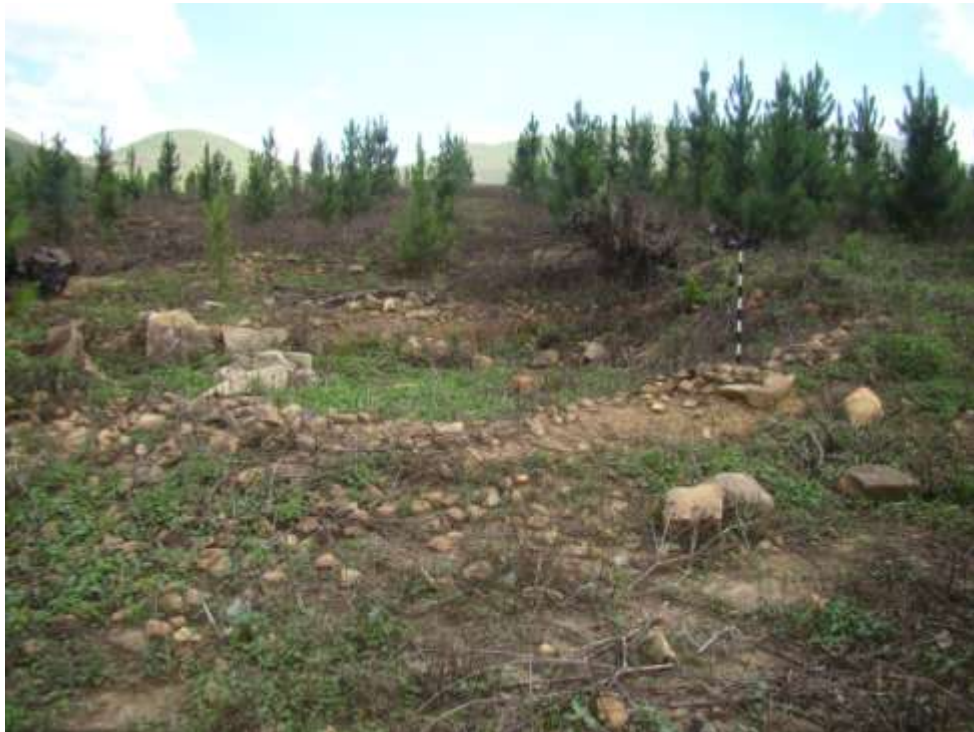
Fig. 16: One of three distinct circular units is visible in the young plantation.

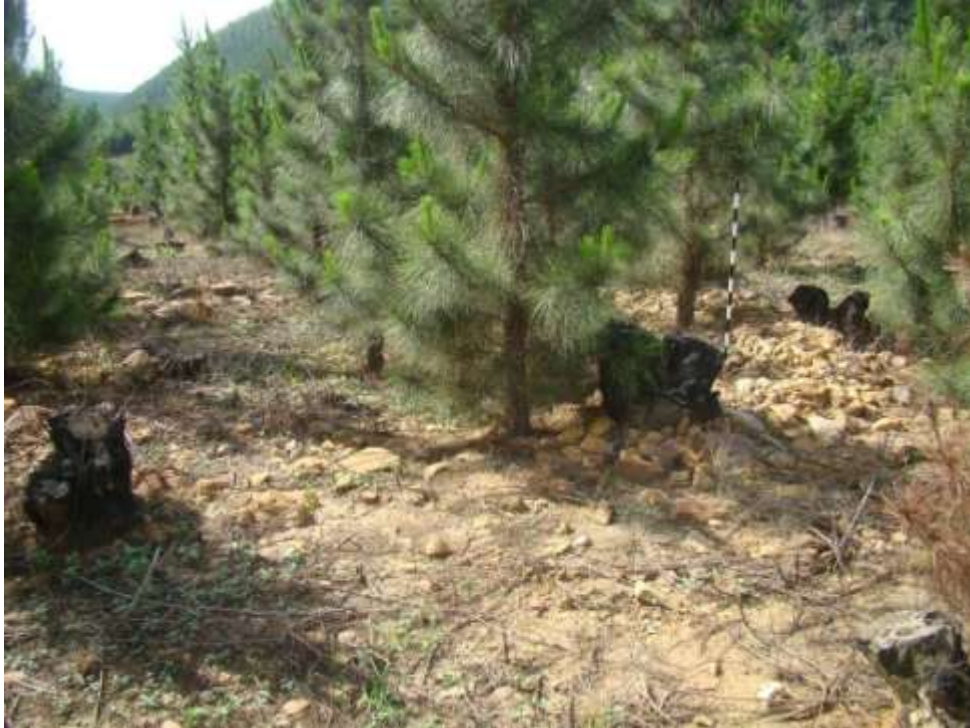
Fig. 34: The walls have been damaged severely by the plantation in this section.

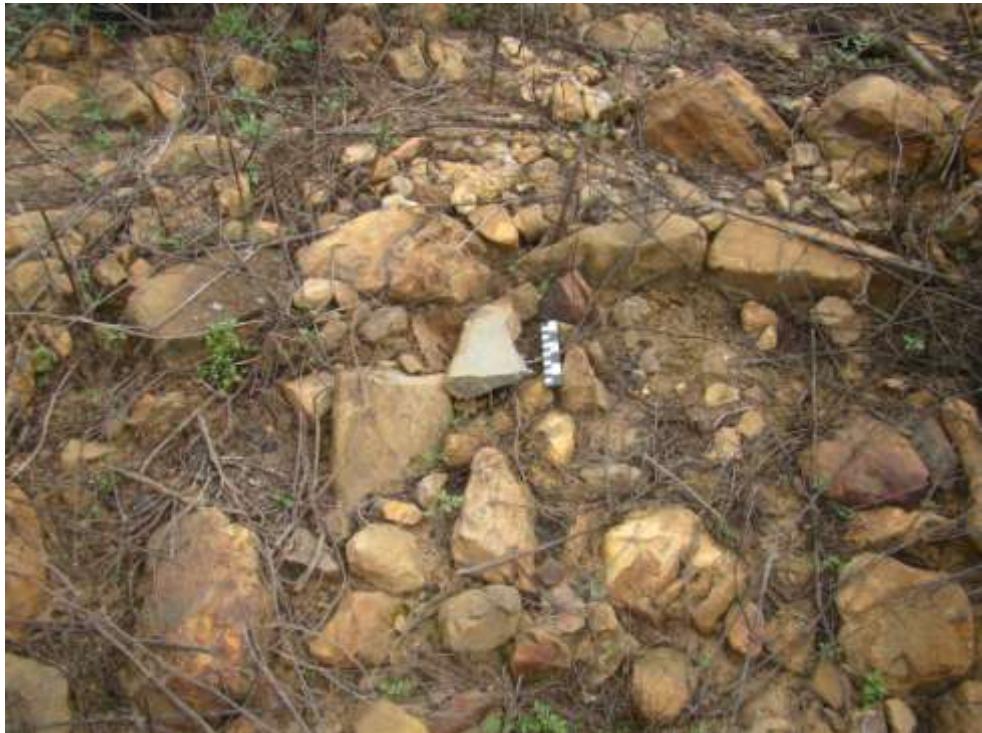
Fig. 37: A broken lower grinder inside a circular unit.

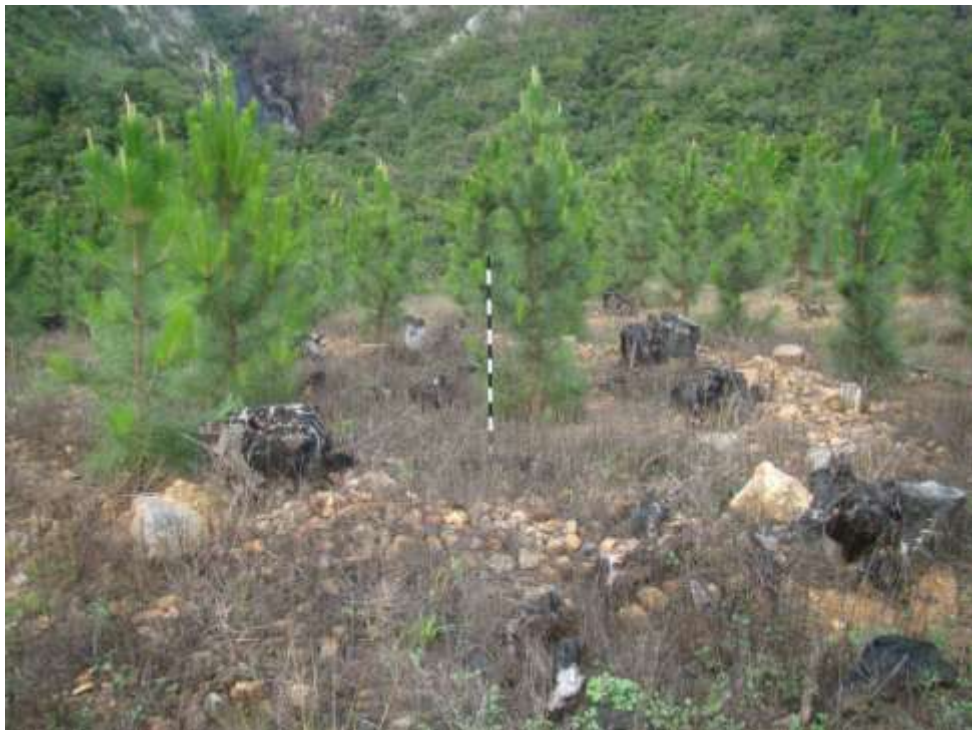
A14 – 2 & 3	2 x Circular stone walls	2 x circular stone walls – very deteriorated as a result of plantation activities.	Elev: 1283m S25° 54' 34.84" E30° 54' 32.19"
A14 – 4	Circular stone wall	This unit has a very distinct “long” entrance. It has been disturbed by plantation activities.	Elev: 1282m S25° 54' 34.98" E30° 54' 33.57"
A14 - d	Lower grinder –broken Potsherds fragments	A broken lower grinder, as well as many fragments of potsherds were visible in the section of unit A14 – 4.	Elev: 1282m S25° 54' 34.98" E30° 54' 33.57"
A14 - 5	Circular stone wall	Circular unit towards the north of above unit. Very disturbed and deteriorated as a result of plantation activities.	Elev: 1283m S25° 54' 34.51" E30° 54' 33.62"
A14 - e	Potsherds	Many potsherds were observed in this section.	Elev: 1283m S25° 54' 34.51" E30° 54' 33.62"

Fig. 43: A circular unit with a long entrance (not visible in photo).

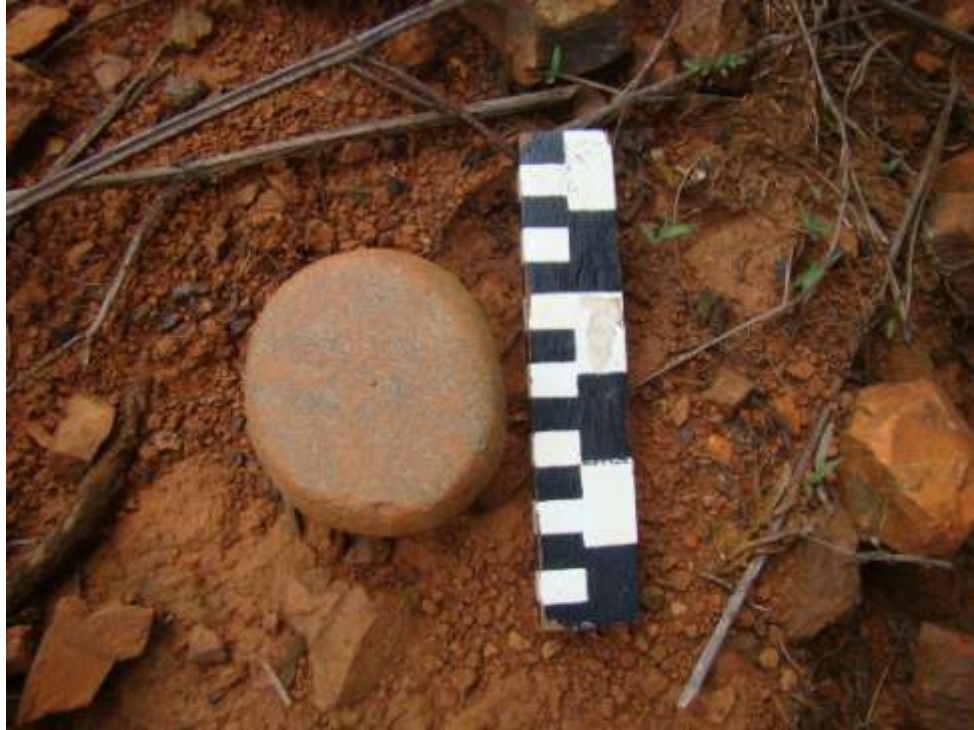
Fig. 44: Small upper grinder next to road.

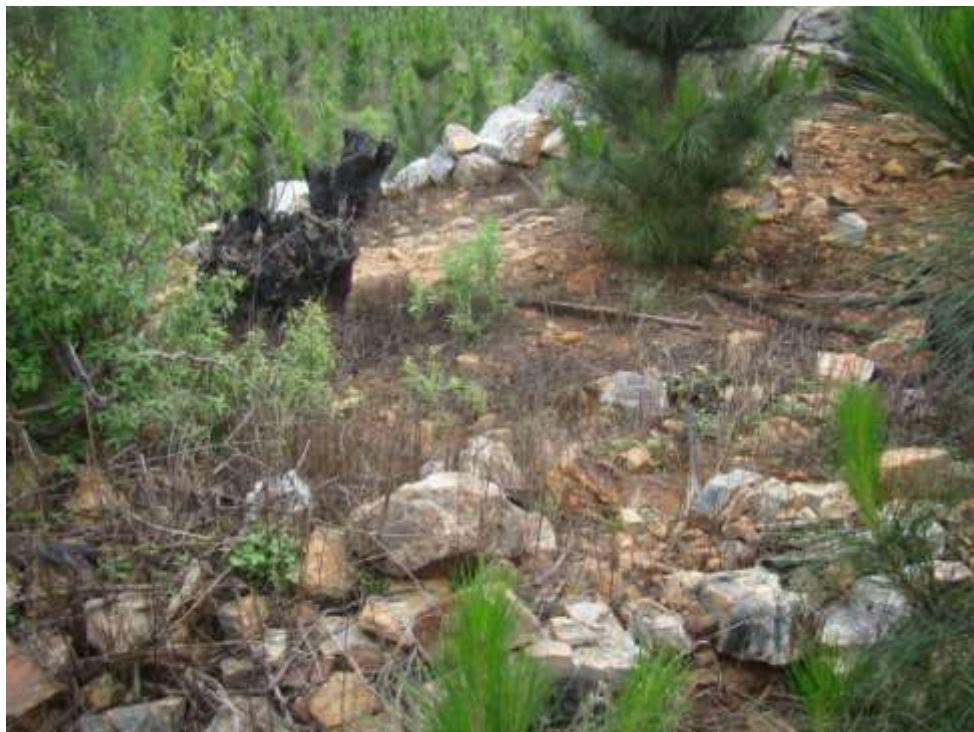
Fig. 45: A distinct cattle track on top of the ridge. Part of the natural ridge was used in the track.

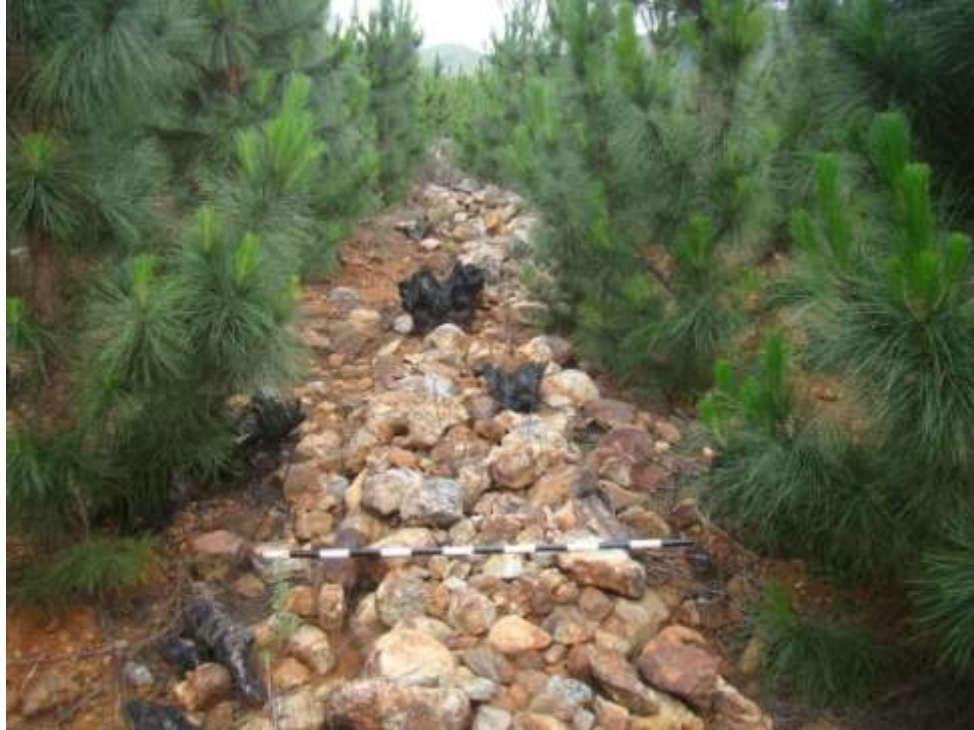
Fig. 46: A cattle track is deteriorated and run down but was approximately 1200mm wide.

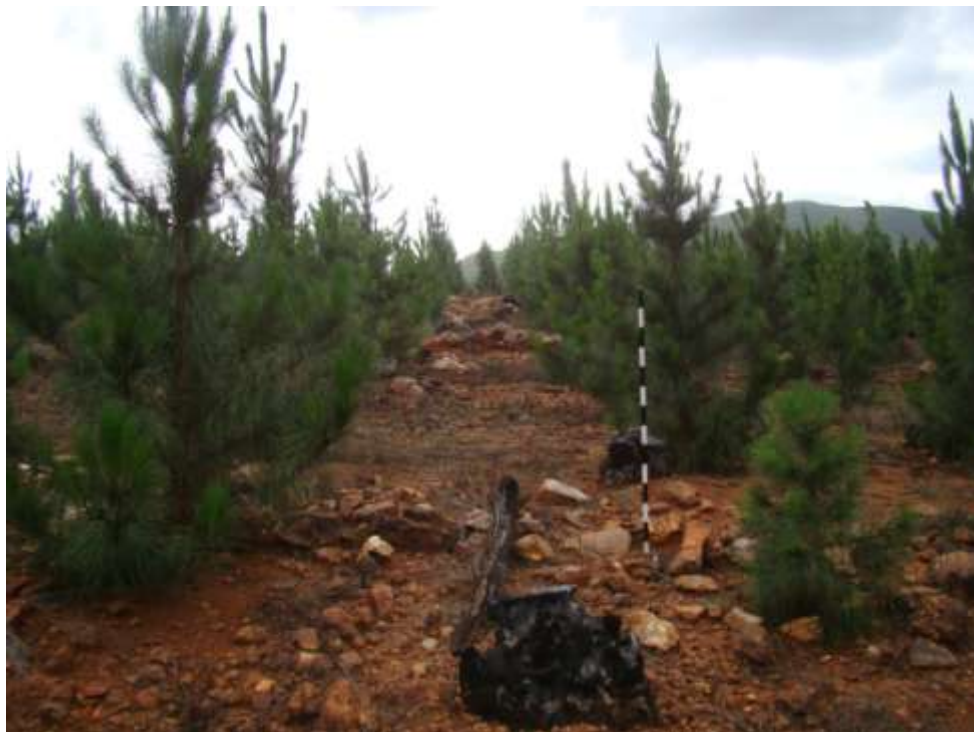
A 14 – 8 and 9 are not in a good condition and the lines of terrace walls are only recognizable in places. Google images are also not very clear. Plantation activities have contributed to the badly deteriorated walls as well as the presence of cattle.

Fig. 47: Terrace walls are still vaguely visible.

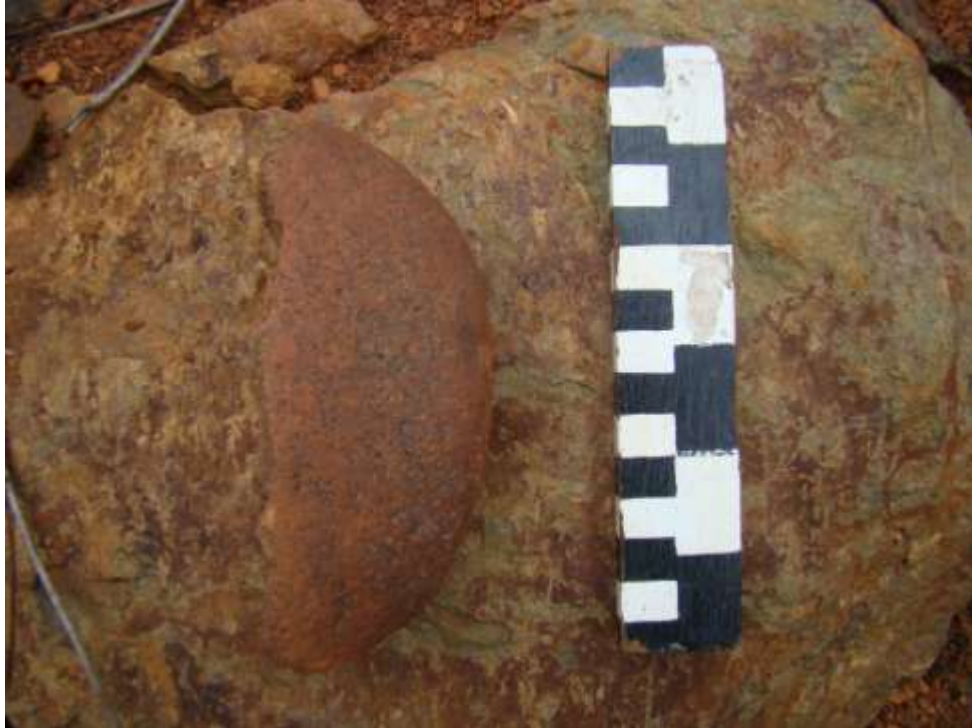
Fig. 48: Broken upper grinder in terrace wall.

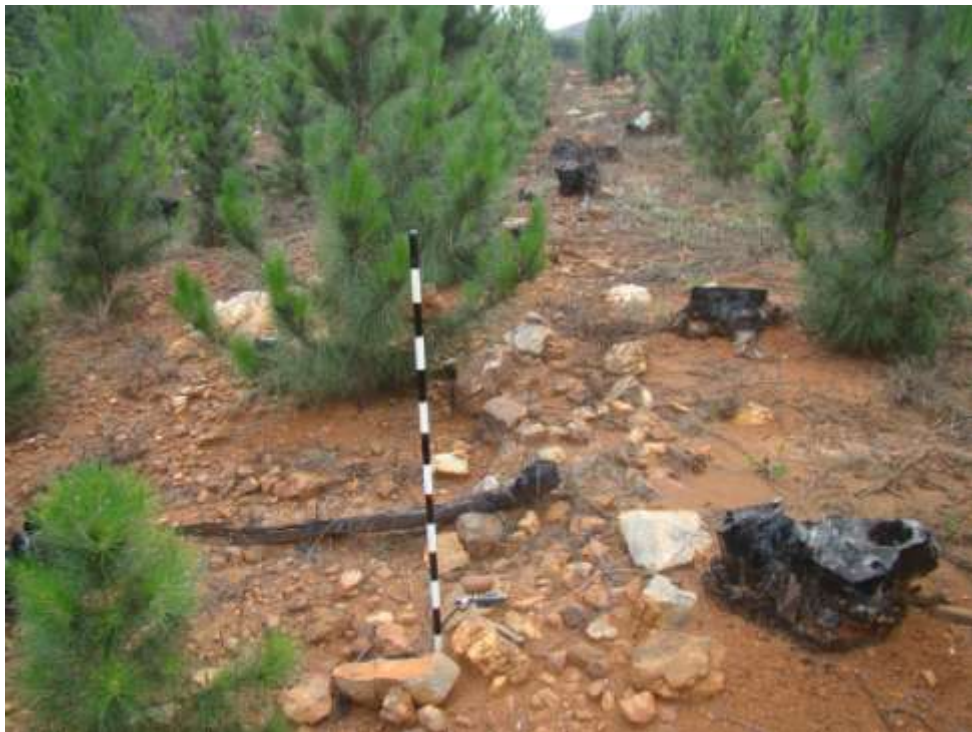
Fig. 49: A deteriorated terrace wall.

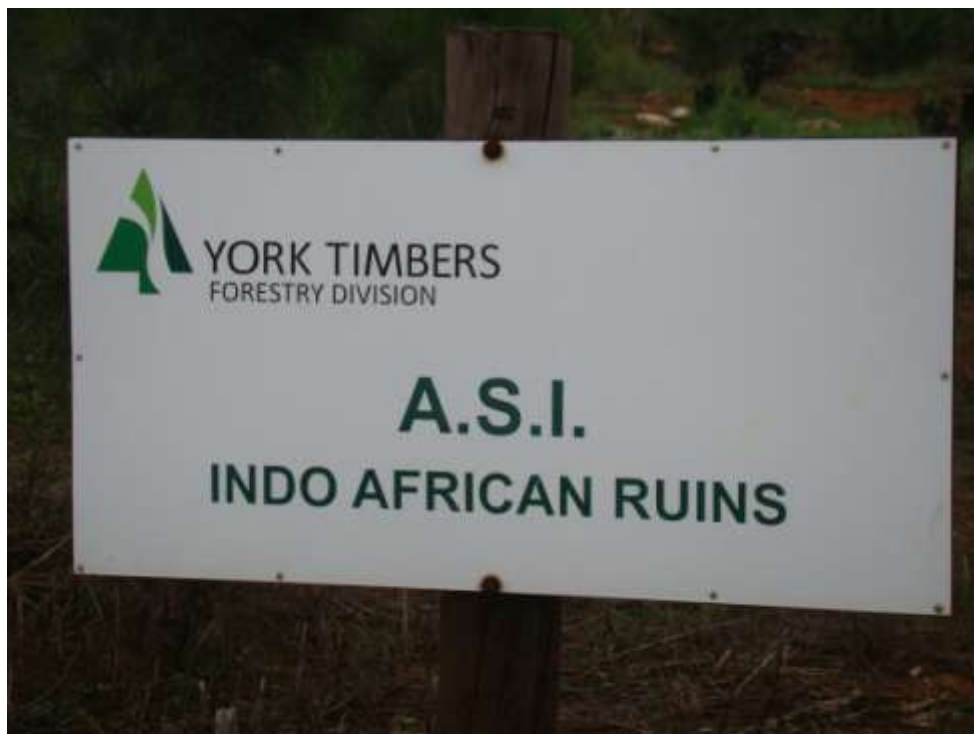
A14 – 10, 11 and 12 are marked as an Area of Special Interest (ASI) by York, and some maintenance is done in this section. The condition of the walls, are however not in a good condition.

Fig. 51: Some of the stone walls in this section are marked as INDO AFRICAN RUINS, an Area of Special Interest (ASI).

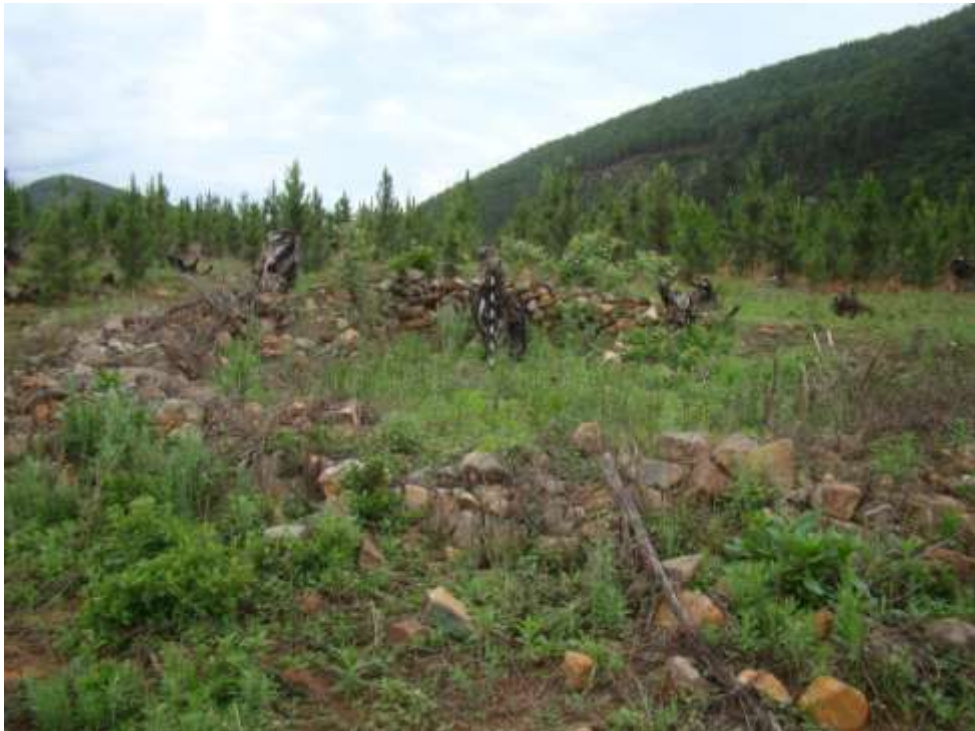
Fig. 53: The circular stone walls in this section are distinct and better preserved than most of the others.

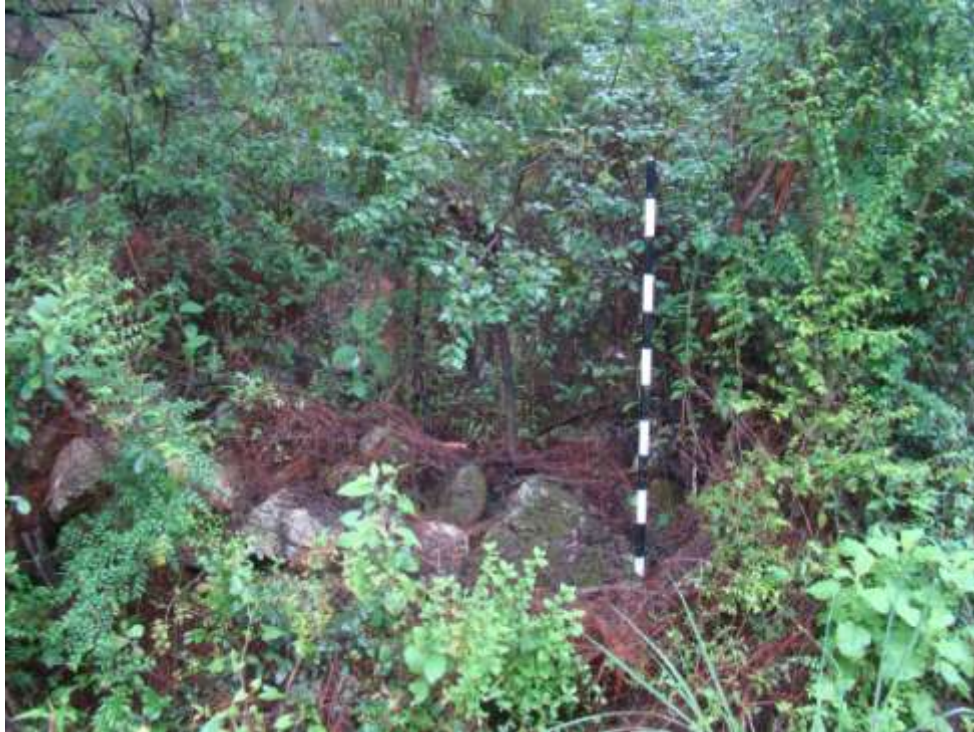
COMPARTMENT BLOCK: A 11B			
No:	Heritage feature	Description / Comment	Site Location
A11B - 1	Circular stone wall	A very distinct unit with fairly well preserved walls up to 800mm high. Damage has taken place by a road as well as plantation activities. The area is covered with pine needles. Fragments of walls are visible in the near vicinity.	Elev: 1403m S25° 54' 15.8" E30° 54' 36.3"

Fig. 57: A low wall which is overgrown with vegetation. This unit is damaged by road activities.

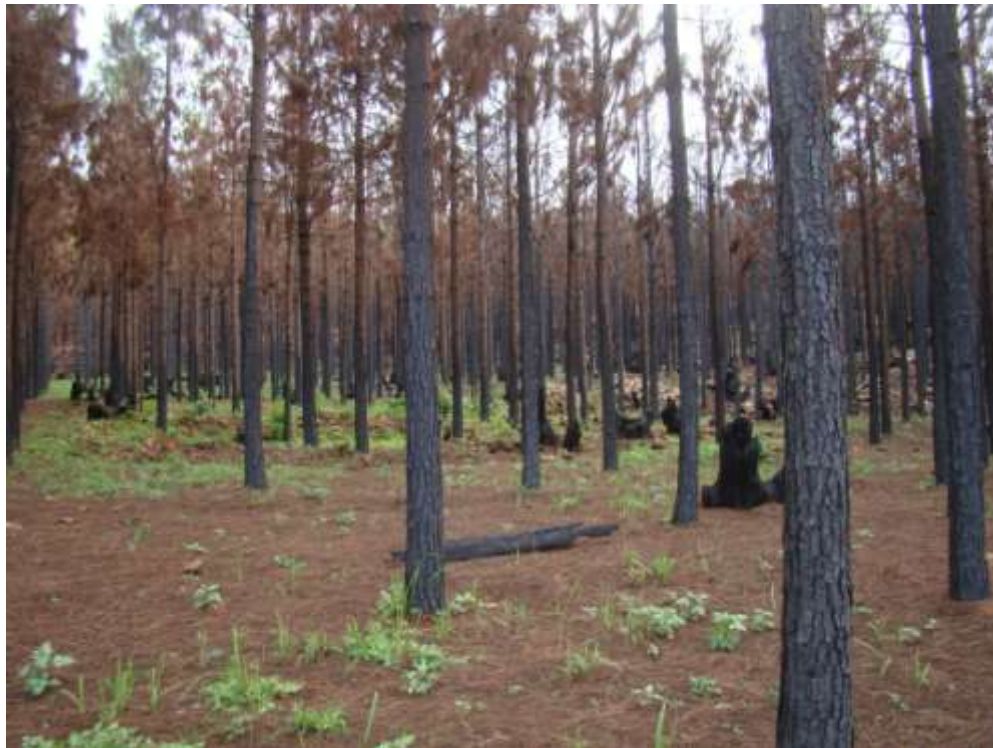
General comments C01: This section has recently burnt but visibility was restricted as the area was covered with pine needles. The area which was surveyed falls within the GPS co-ordinates of unit C01 – 1 and C01 – 15. The stone walls are situated in an existing plantation and are deteriorated and damaged by plantation activities. No archaeological material is visible due to a thick pine cover, and only a fragment of an upper grinder was identified.

Fig. 60: This section has recently burnt but visibility was restricted as the area was covered with pine needles. The circular units are visible through the trees towards the back.

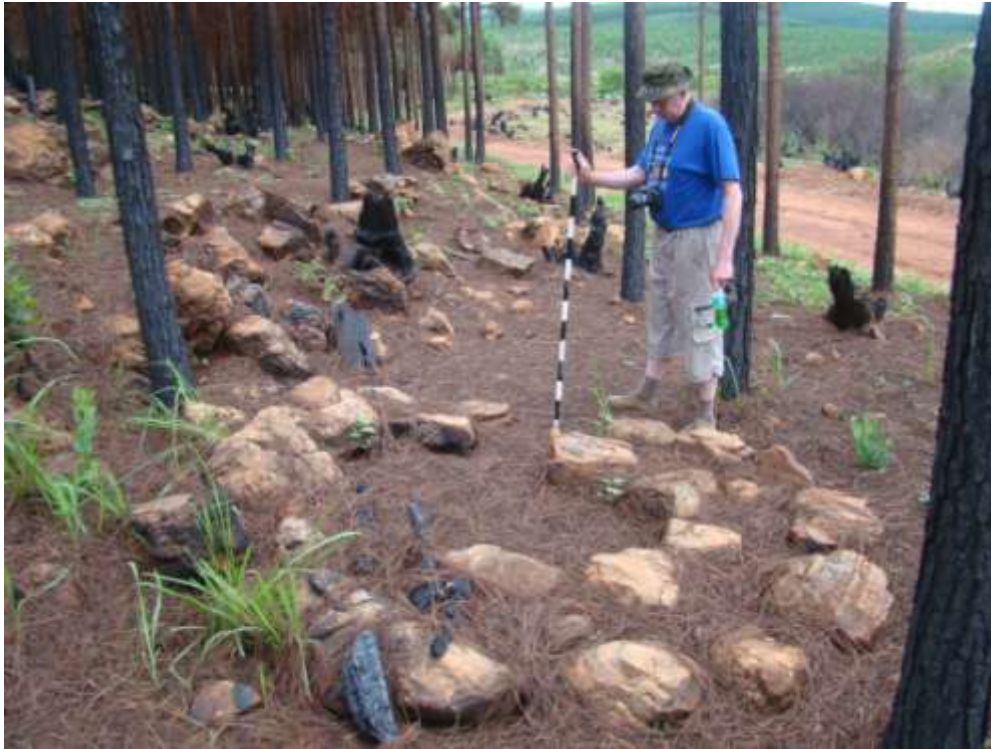
Fig. 61: A very small circular unit below the terrace walls.

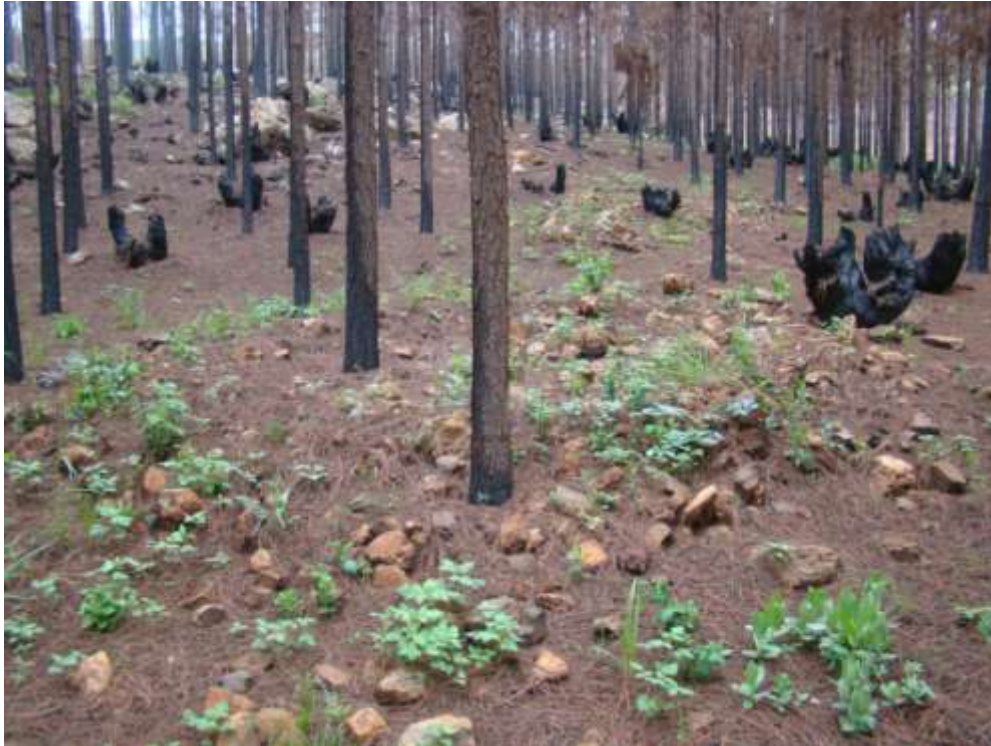
Fig. 62: The terrace walls which continue approximately for 30m, are distinct and located on a slope of a small hill.

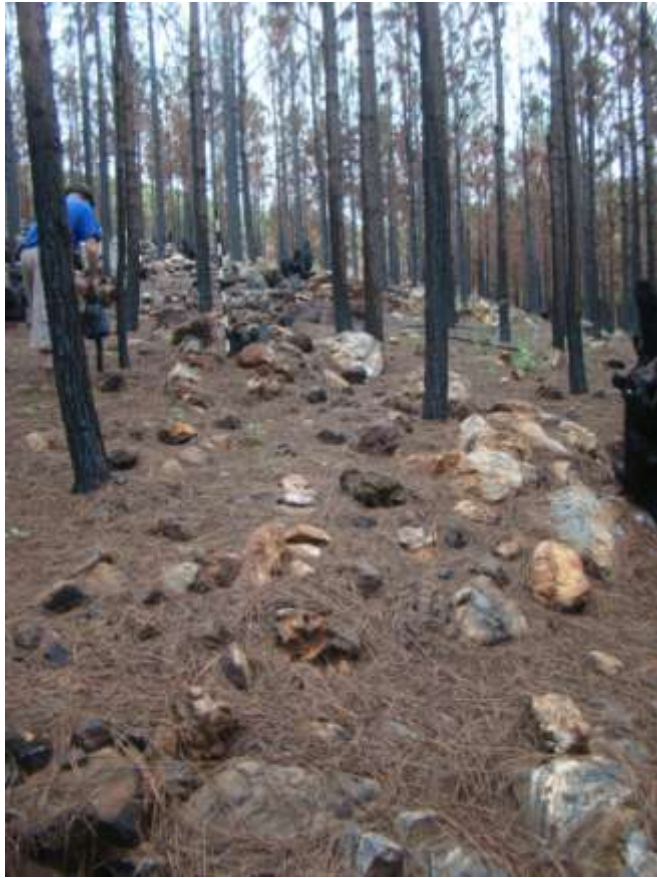
Fig. 63: Terrace walls going up the slope.

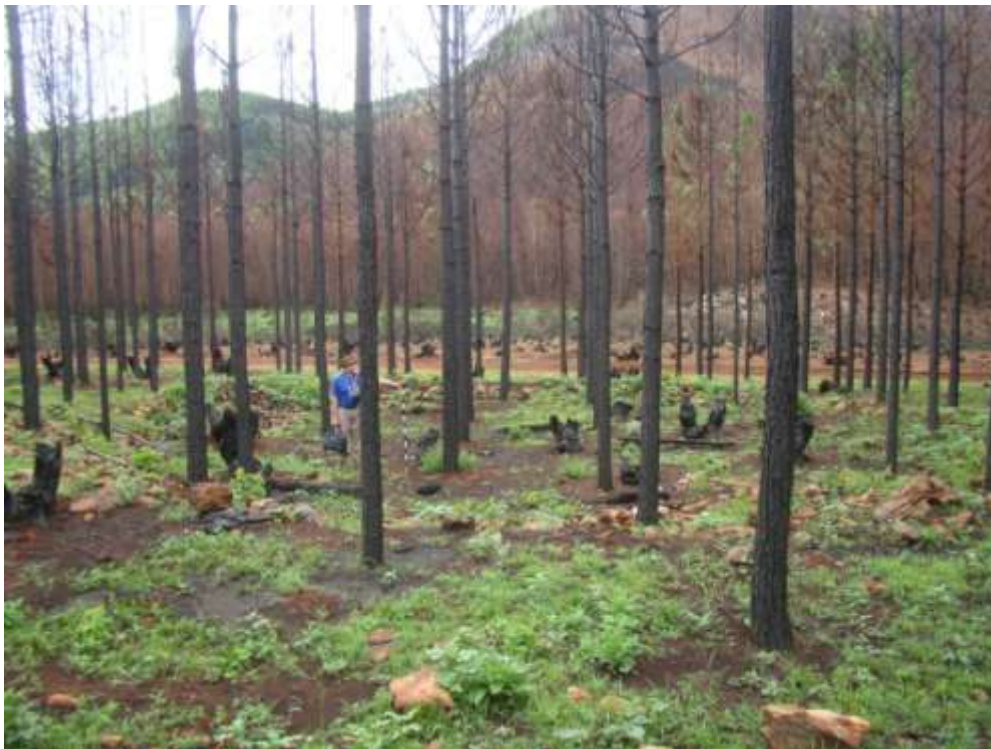
Fig. 68: C01 – 6: The units in this section are all clustered together and linked with a marked path towards C01–8.

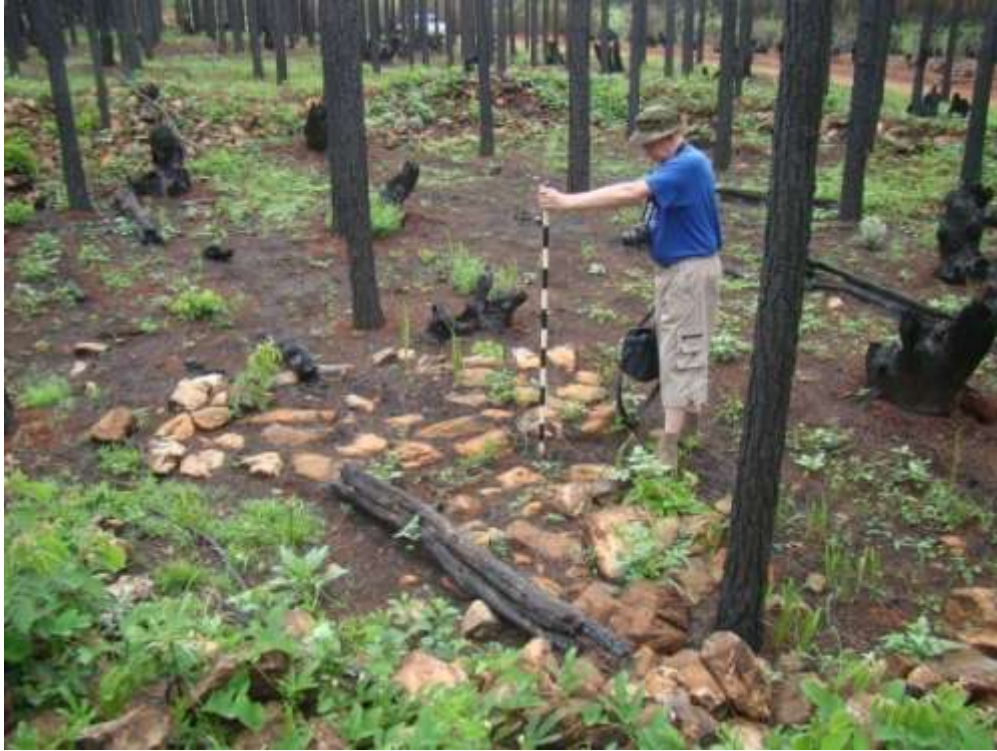
Fig. 69: A detail in unit C01 – 6.

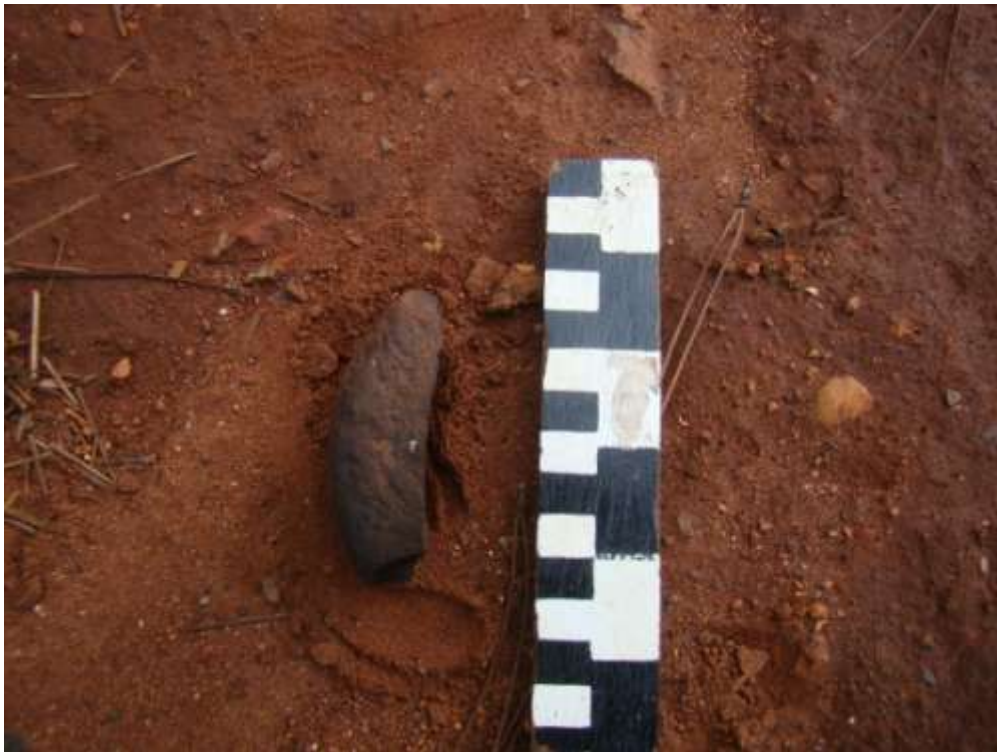
Fig. 70: A broken upper grinder was visible below unit C01 – 6, near the main access road.

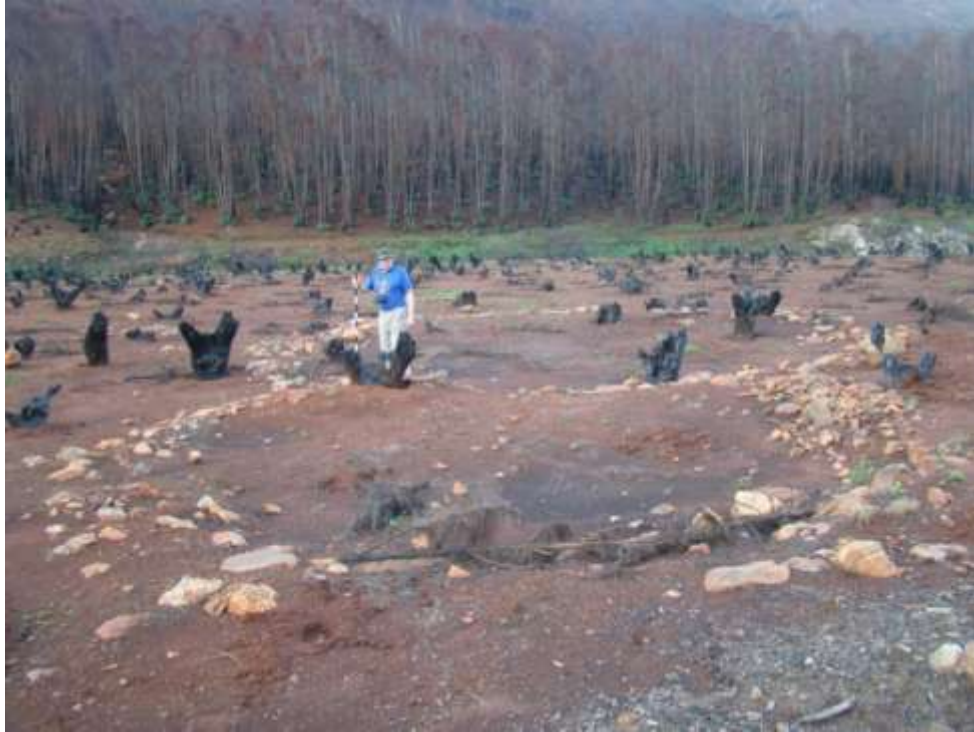
COMPARTMENT BLOCK: A20A (opposite C01 on other side of road):			
No:	Heritage feature	Description / Comment	Site Location
A20A – 1 & 2	Circular stone walls	2 x units close together. Only foundation stones visible. Badly deteriorated due to plantation activities. Area has been harvested and burnt and visibility was excellent.	Elev: 1261m S25° 54' 46.4" E30° 54' 57.8"
A20A - a	Upper grinder	Upper grinder (with three facets).	Elev: 1261m S25° 54' 46.4" E30° 54' 57.8"
A20A - b	Potsherds	Fragments of clay potsherds are visible in the entire area.	Elev: 1261m S25° 54' 46.4" E30° 54' 57.8"
A20A -3	Circular stone wall	Foundation stones are visible of one circular unit. Badly deteriorated due to plantation activities. Area has been harvested and burnt and visibility was excellent.	Elev: 1258m S25° 54' 45.9" E30° 54' 59.9"

Fig. 74: 2 x units together. Only foundation stones were visible. The area was badly deteriorated due to plantation activities. Area has been harvested and burnt and visibility was excellent.

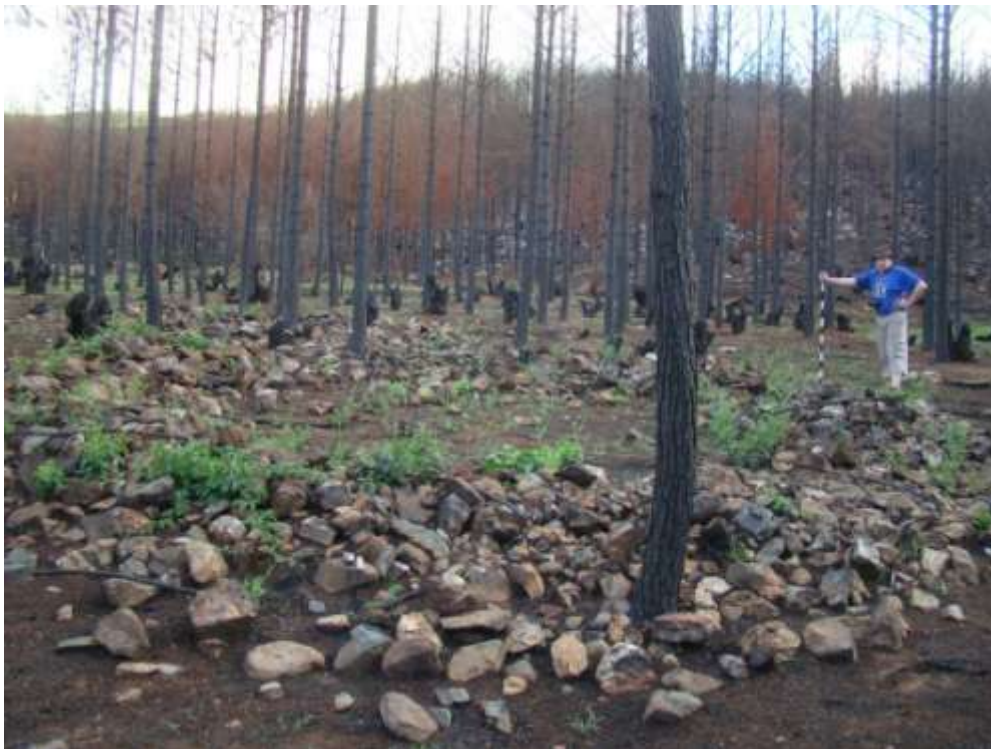
General comments C04: The two units are next to each other and are deteriorated and disturbed by plantation activities. A few fragments of lower as well as upper grinders are visible.

Fig. 78: Two circular units next to each other

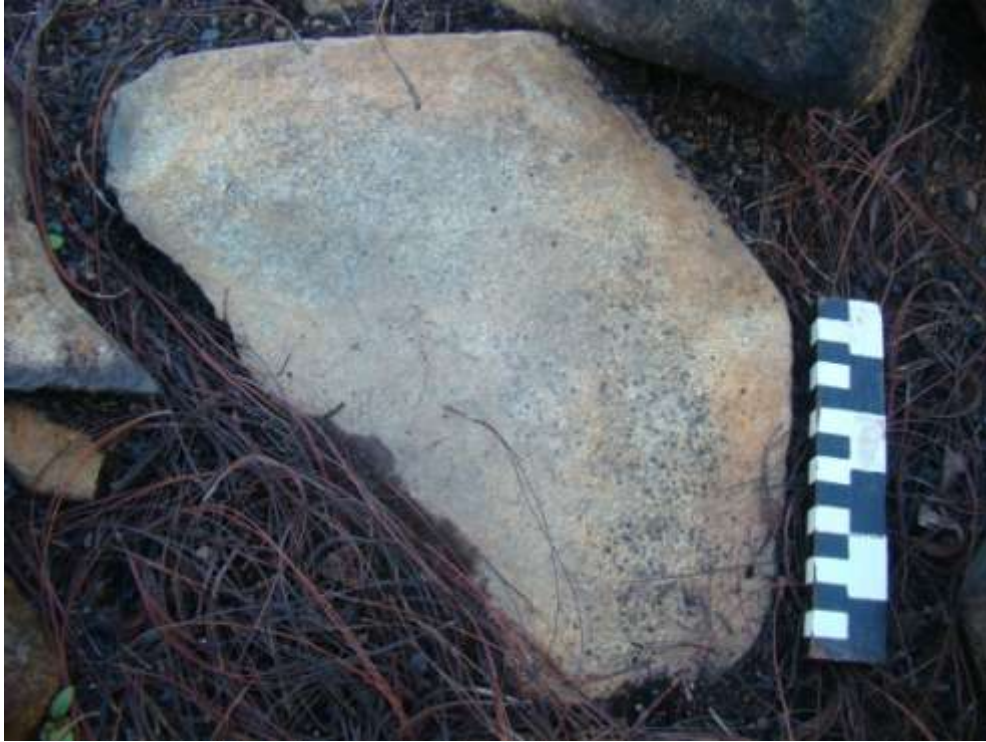
Fig. 79: Broken lower grinder between above units;
