SPECIALIST REPORT

A PHASE 1 ARCHAEOLOGICAL AND HERITAGE IMPACT ASSESSMENT OF THE
STONE WALLED SETTLEMENTS ON TAURUS PLANTATION, BARBERTON
DISTRICT, MPUMALANGA PROVINCE

**REPORT PREPARED FOR
YORK TIMBERS**

APRIL 2015

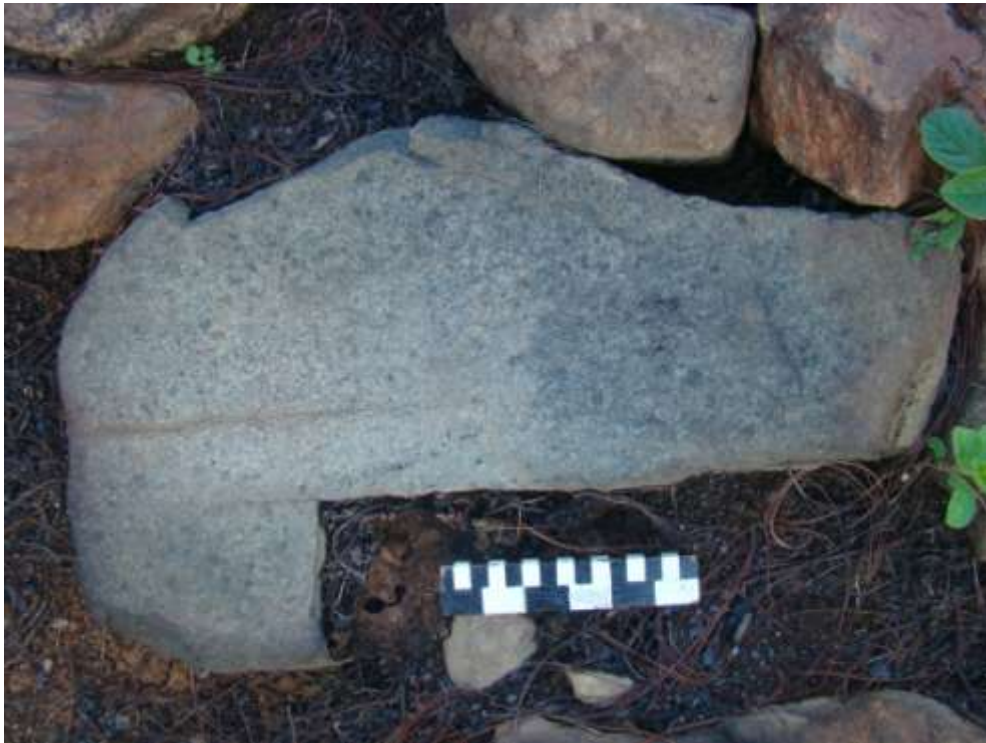
Fig. 80: Broken lower grinder

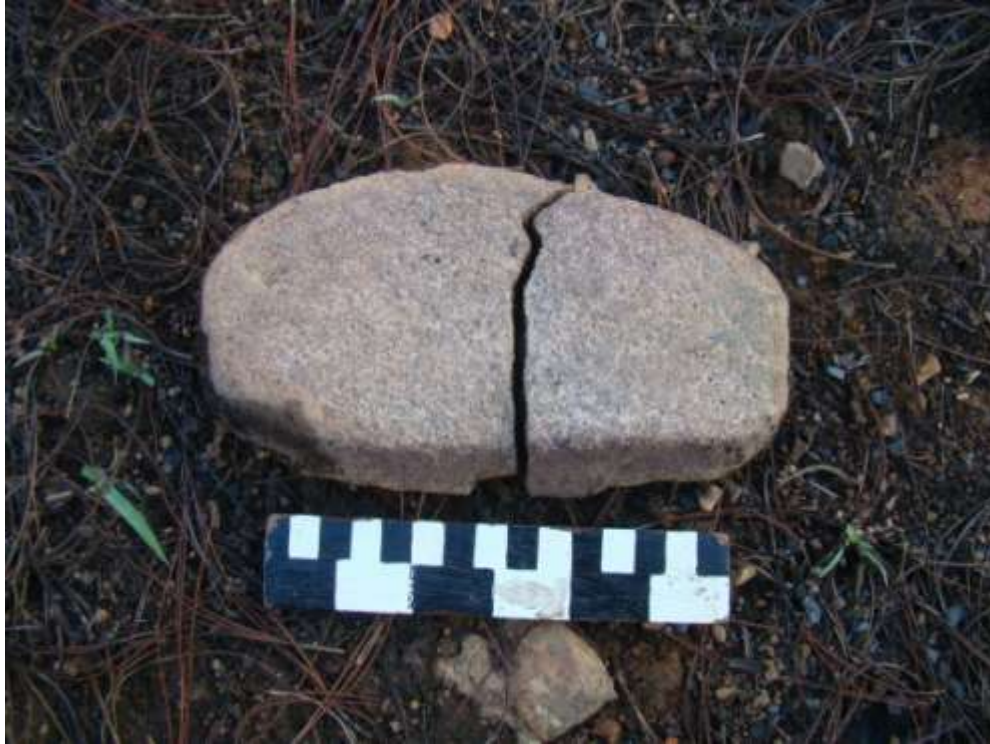
Fig. 81: Broken lower grinder

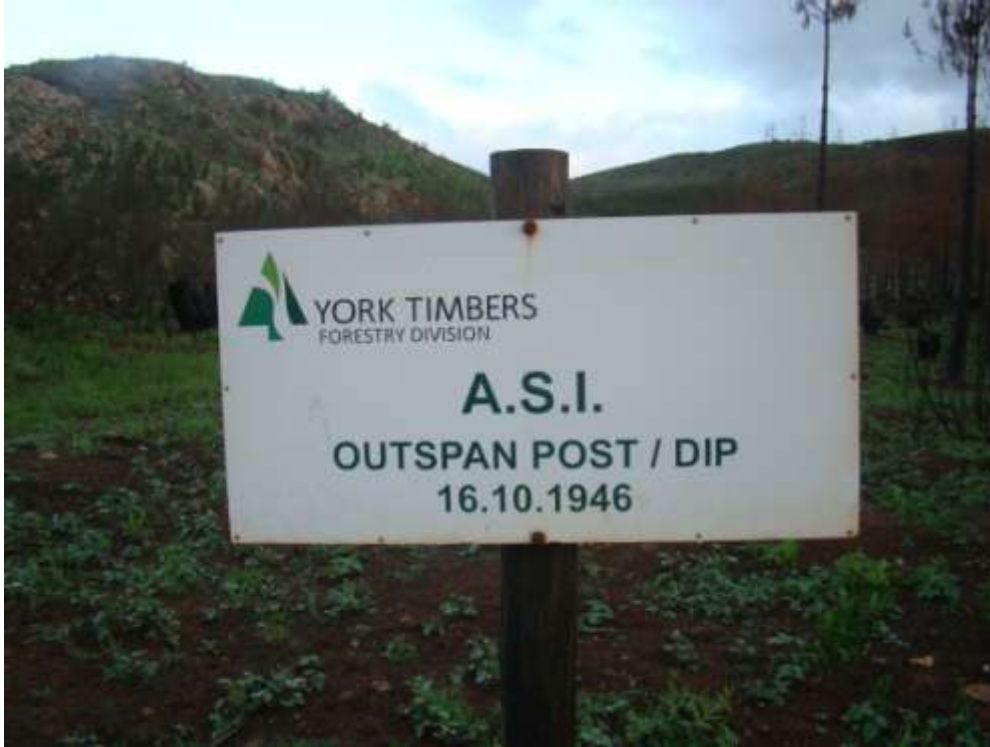
Fig. 84: The Outspan Post and Old Drift are marked as an Area of Special Interest (ASI) by YORK.

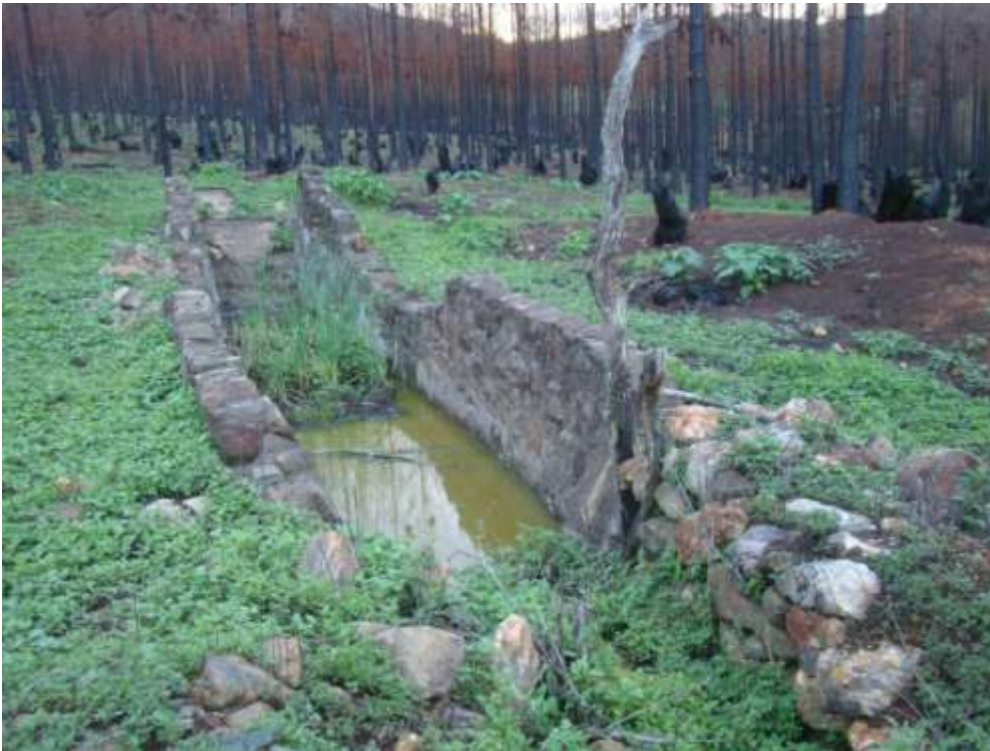
Fig. 85: Clear remains of an old cattle dip are visible at the Outspan post.

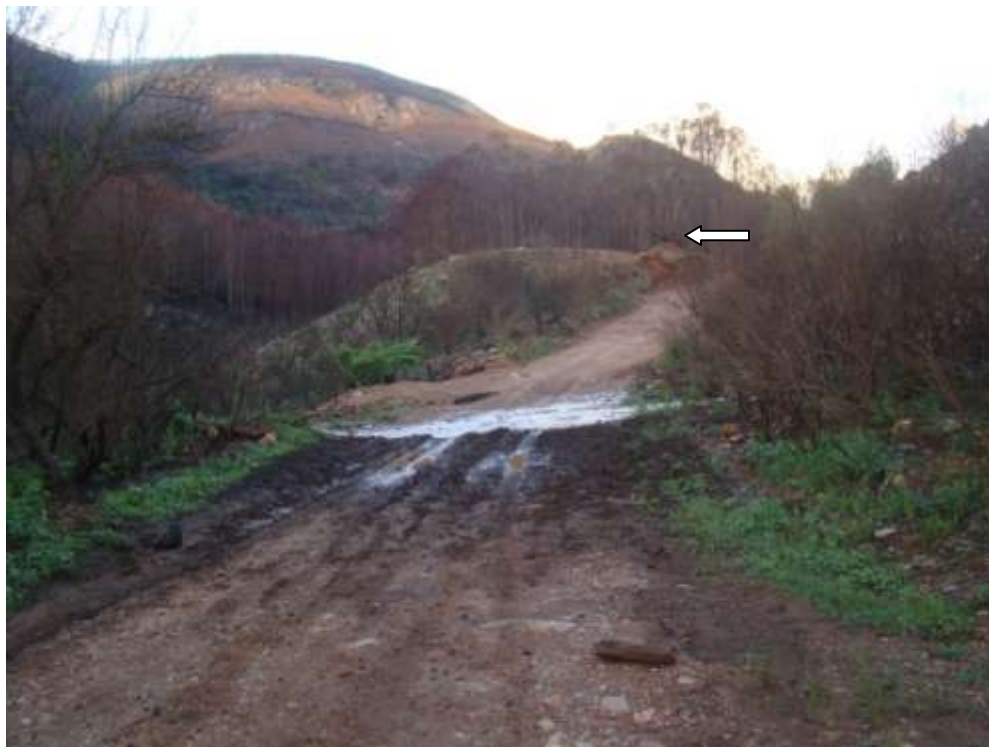
Fig. 86: Photo is taken in the area at the “old Drift” section, looking towards A20B (see arrow). The Mtsoli river is towards the left. A drainage line (visible in the picture) feeds into the river.

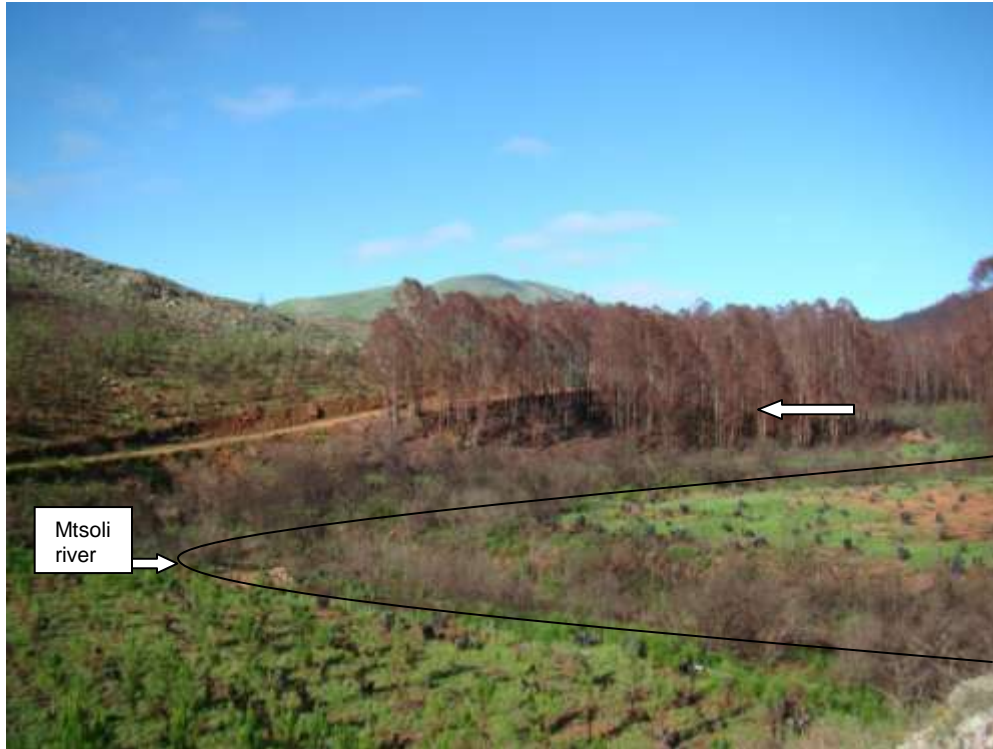
Fig. 87: A20B as seen from the east (A21) is located between the bluegum trees.

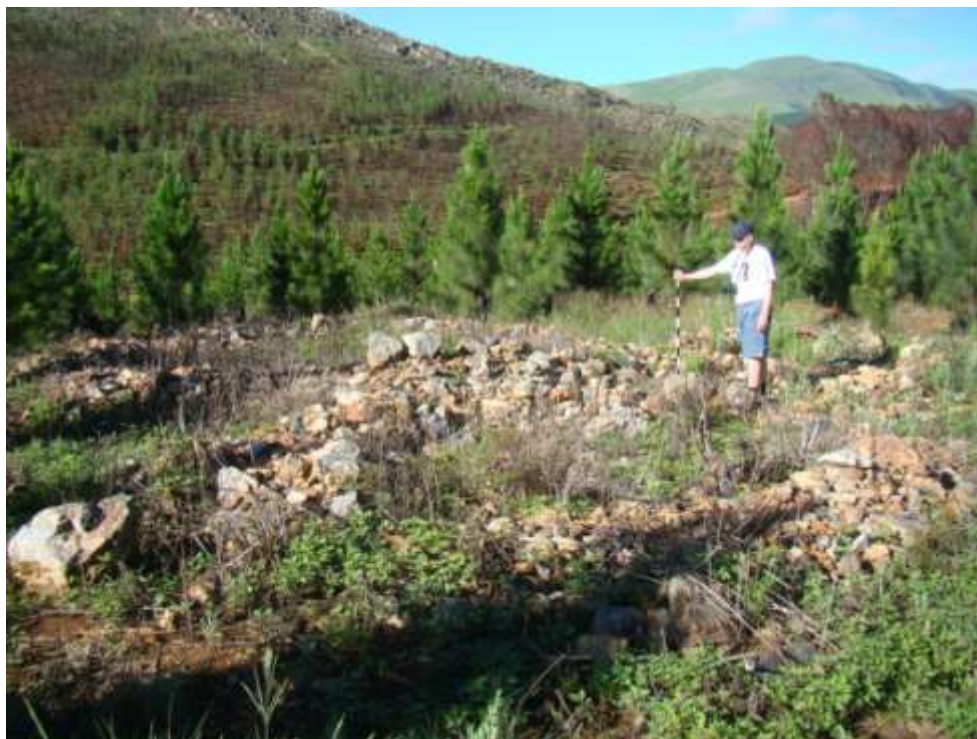
Fig. 90: Three units are together, on top of the ridge. There are tracks going towards and away from these units. The area has been disturbed by plantation activities.

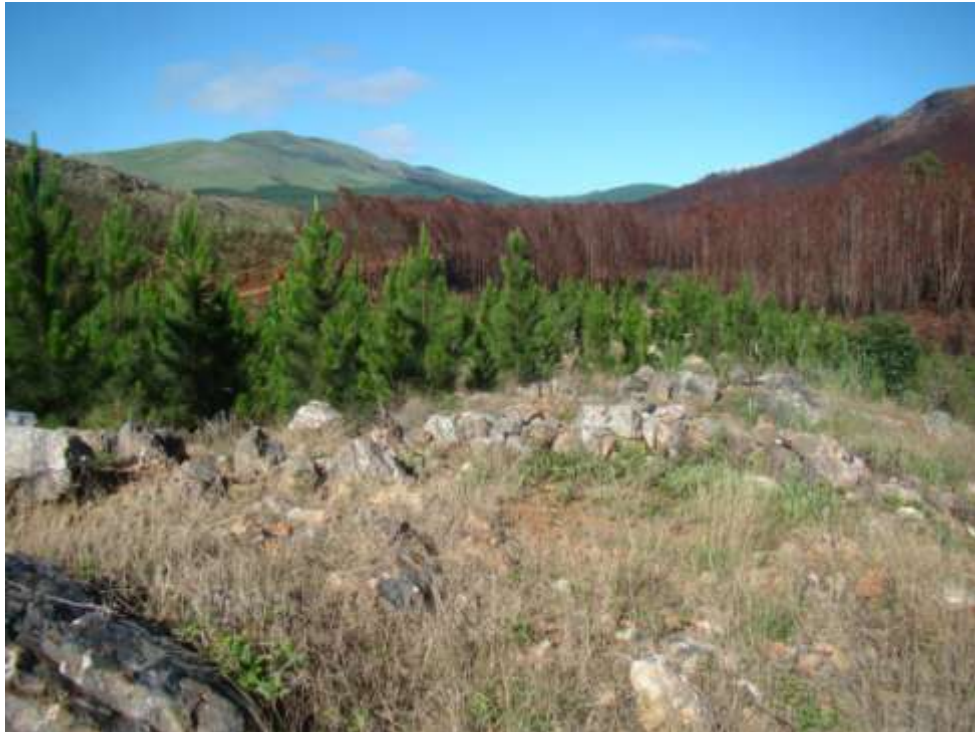
Fig. 91: A perimeter wall to the west of the three units, mark the edge of the ridge.

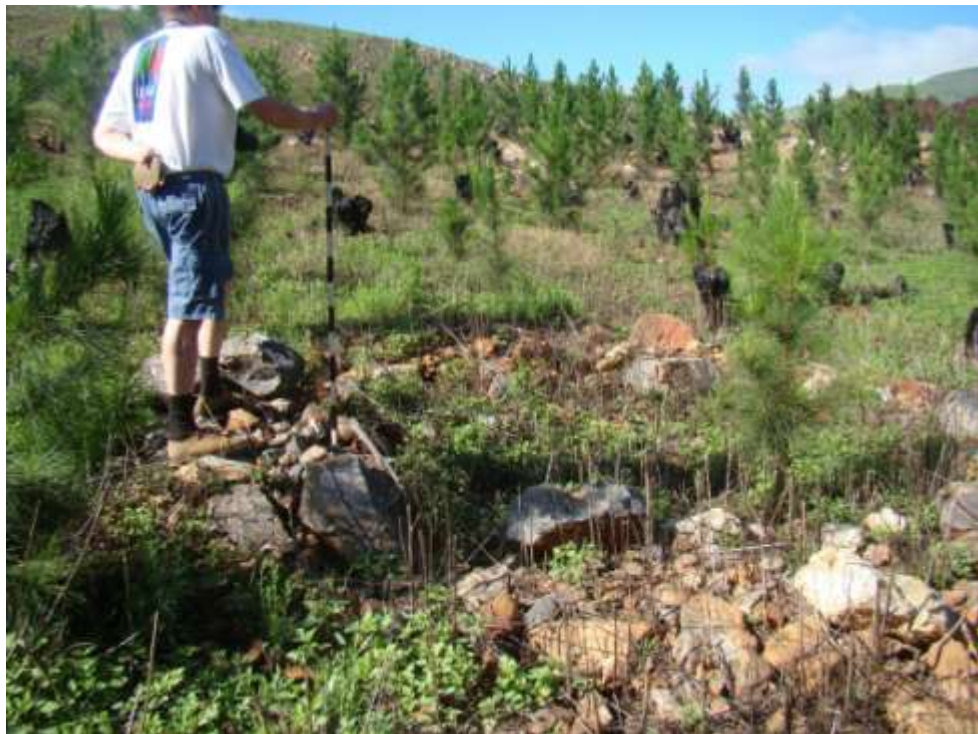
Fig. 98: Another deteriorated unit in section A21.

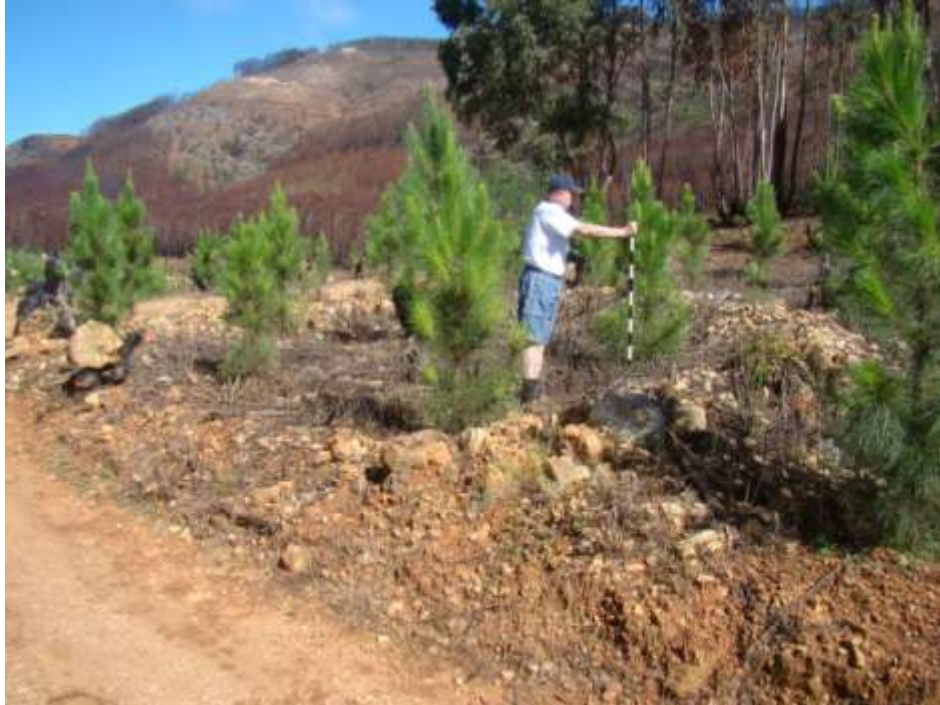
Fig. 101: A circular unit with a smaller unit connected to it, is located on a slope. This section is situated between two plantation roads, and is already extensively disturbed.

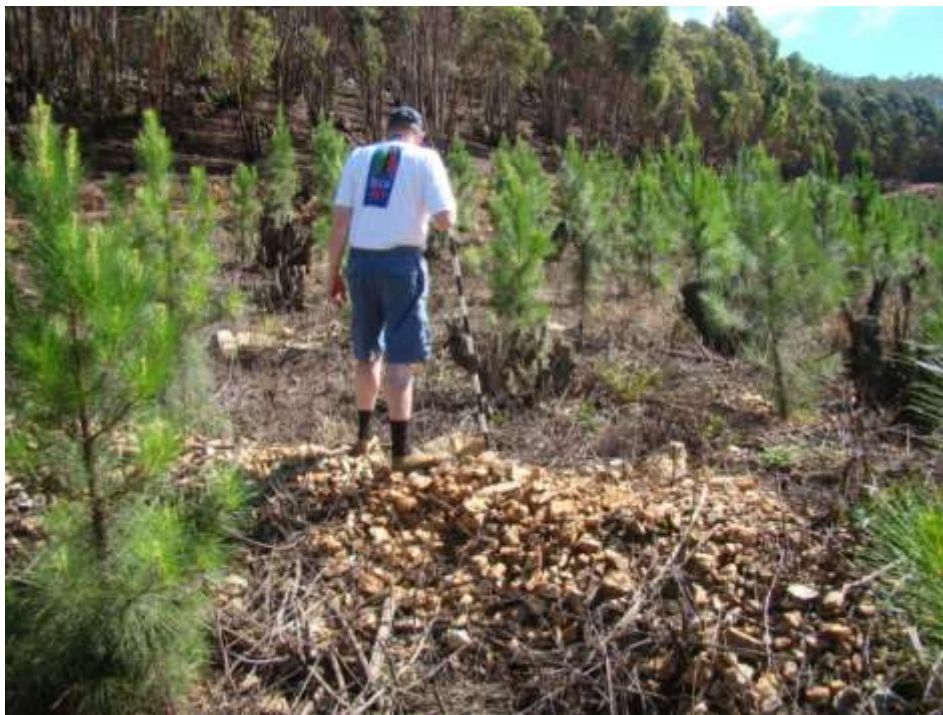
Fig. 102: Very indistinct remains of circular units, directly east of the above units. The section is extensively disturbed by plantation activities.

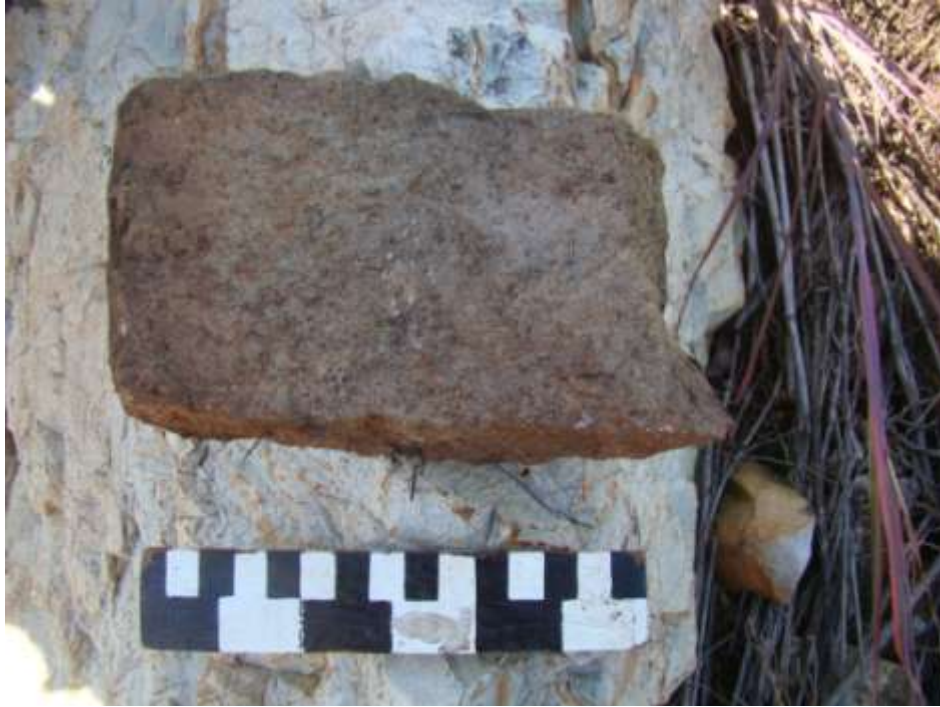
Fig. 105: A fragment of a lower grinder was observed directly east of the above unit.

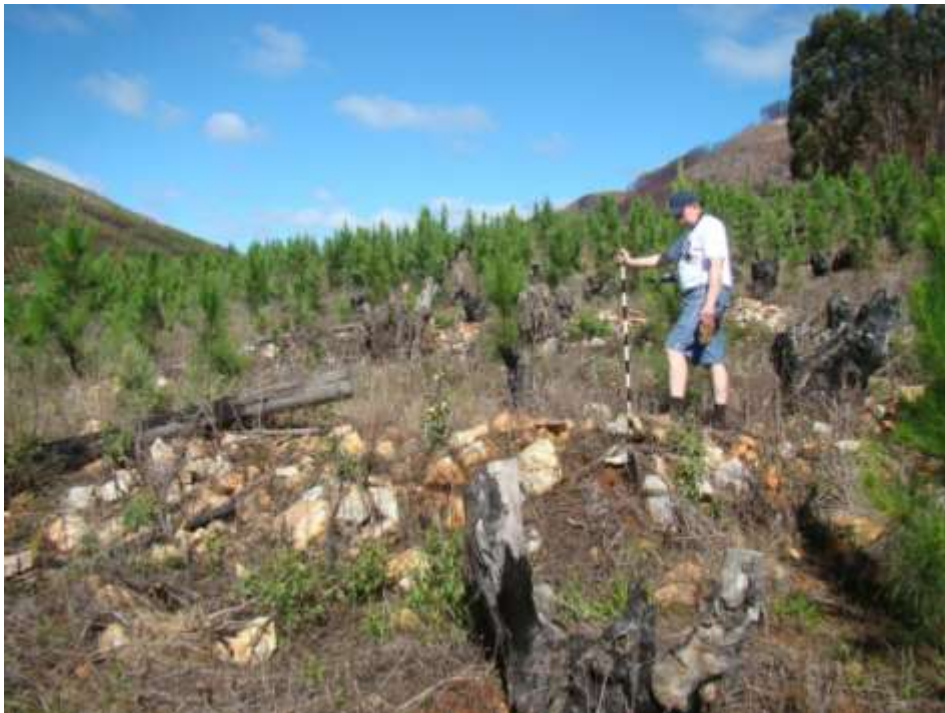
A31 - 4	Circular stone wall	A large circular unit of approximately 15m in diameter was observed towards the west of the above units. This unit is extremely disturbed by plantation activities.	Elev: 1239m S25° 54' 42.22" E30° 55' 30.89"

Fig. 106: A large circular unit of approximately 15m in diameter was observed towards the west of the above units. This unit is extremely disturbed by plantation activities.

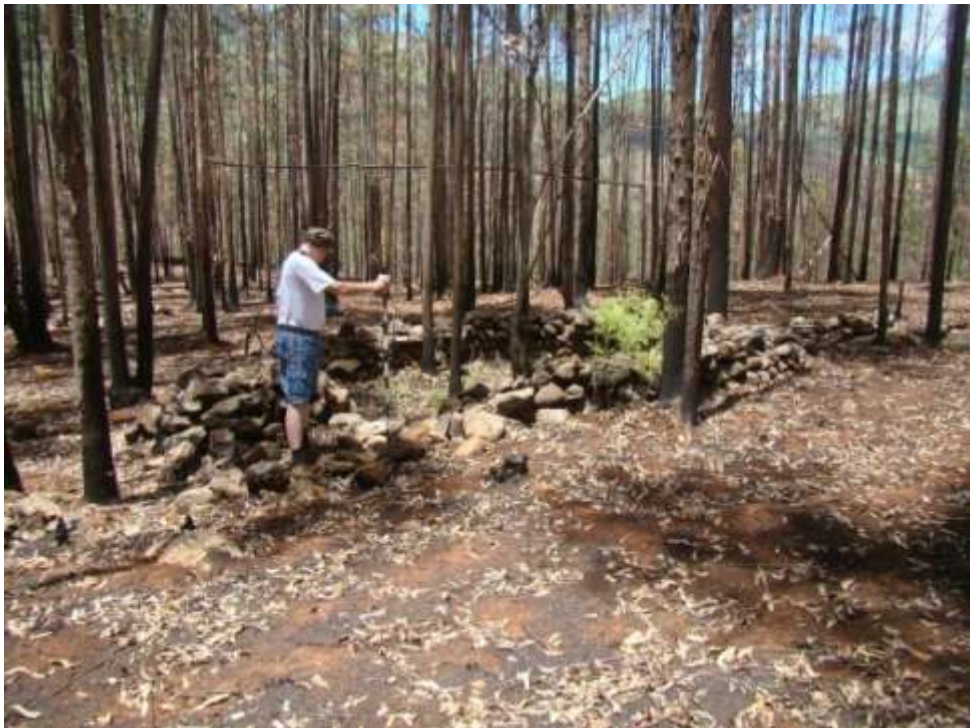
Fig. 113: A large circular stone wall, approximately 8m in diameter was observed with a distinct entrance, and a heap of stones close by. The units are located above a ridge

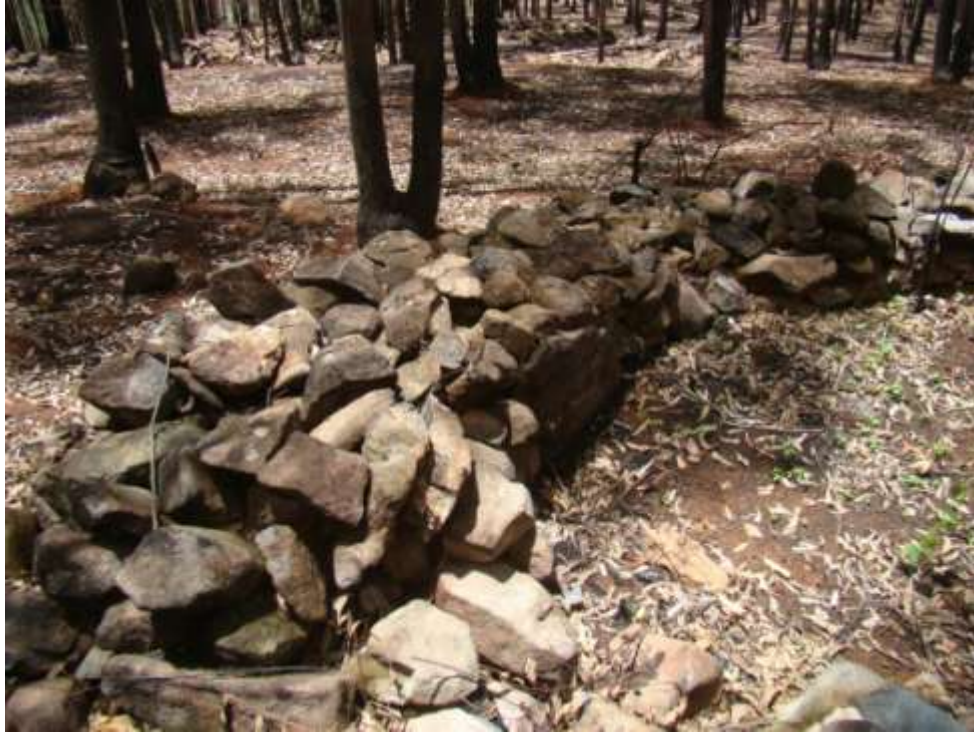
Fig. 114: Detail of the condition of some of the walls.

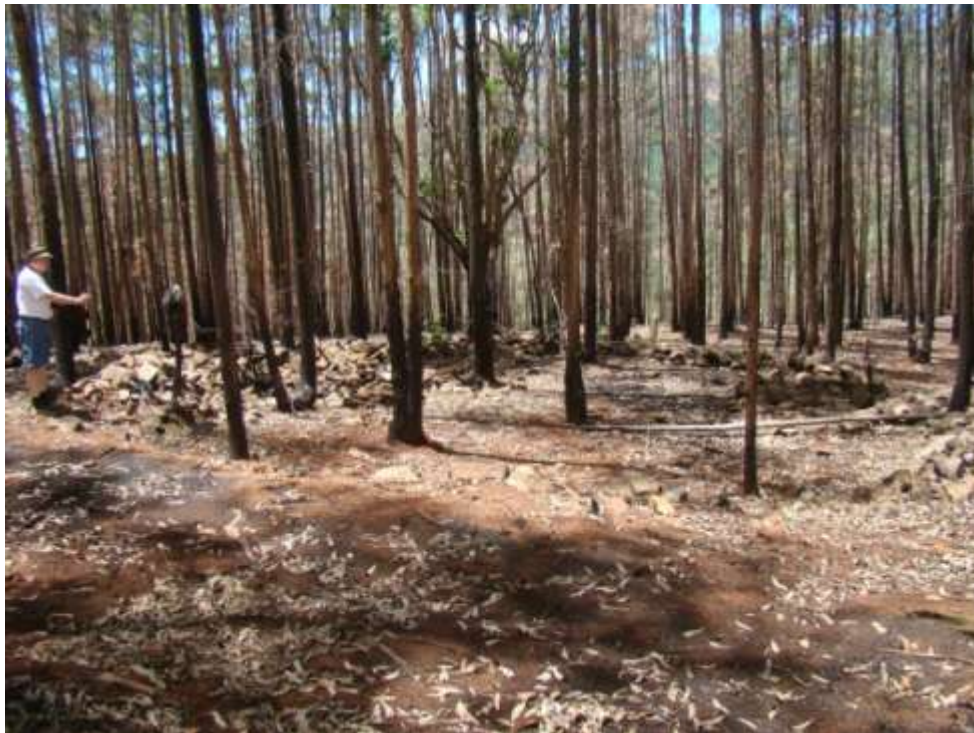
Fig. 115: A large circular stone wall (approximately 9m in diameter) with a wall inside the unit as well as traces of a wall outside the unit, were observed above the ridge.

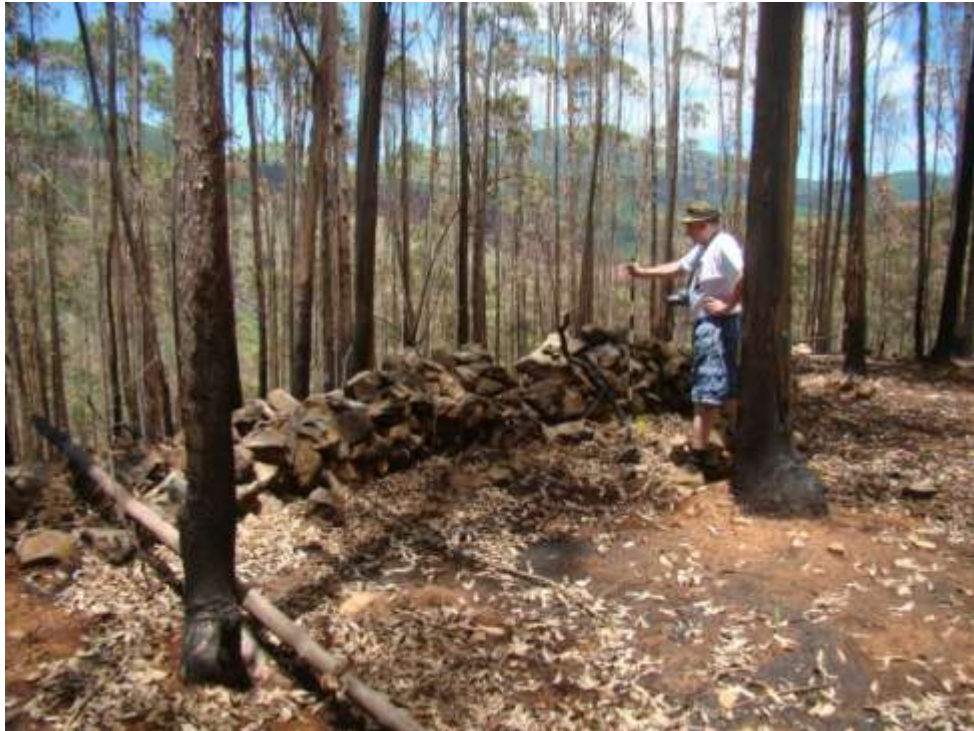
Fig. 117: A perimeter wall which was constructed on the edge of a ridge to protect the settlement above.

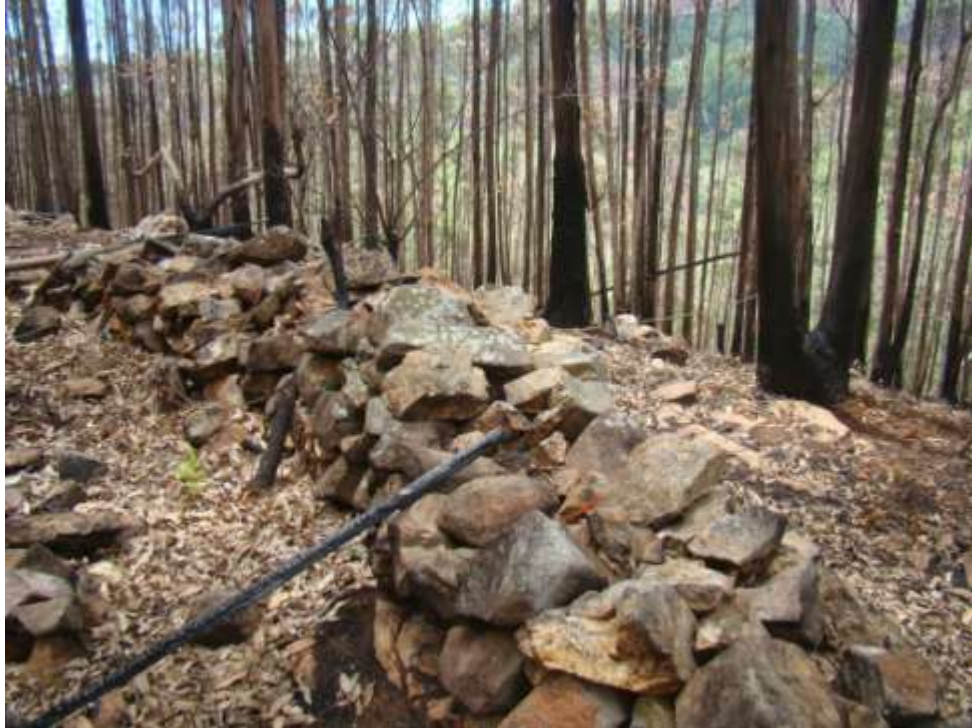
Fig. 118: Detail of the perimeter wall.

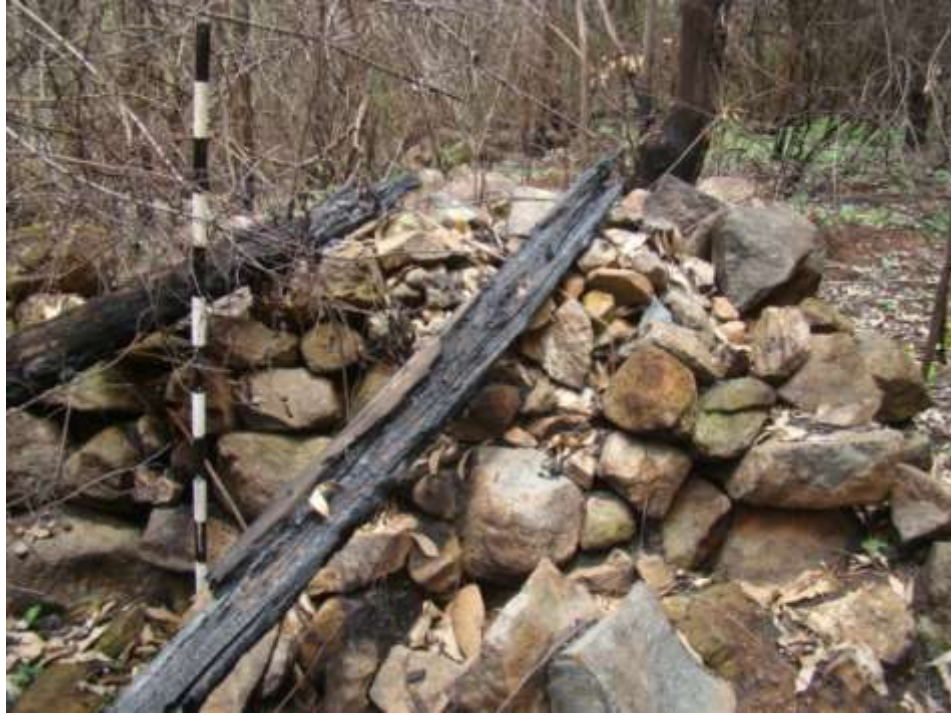
Fig. 123: Detail of the wall of the sheep kraal.

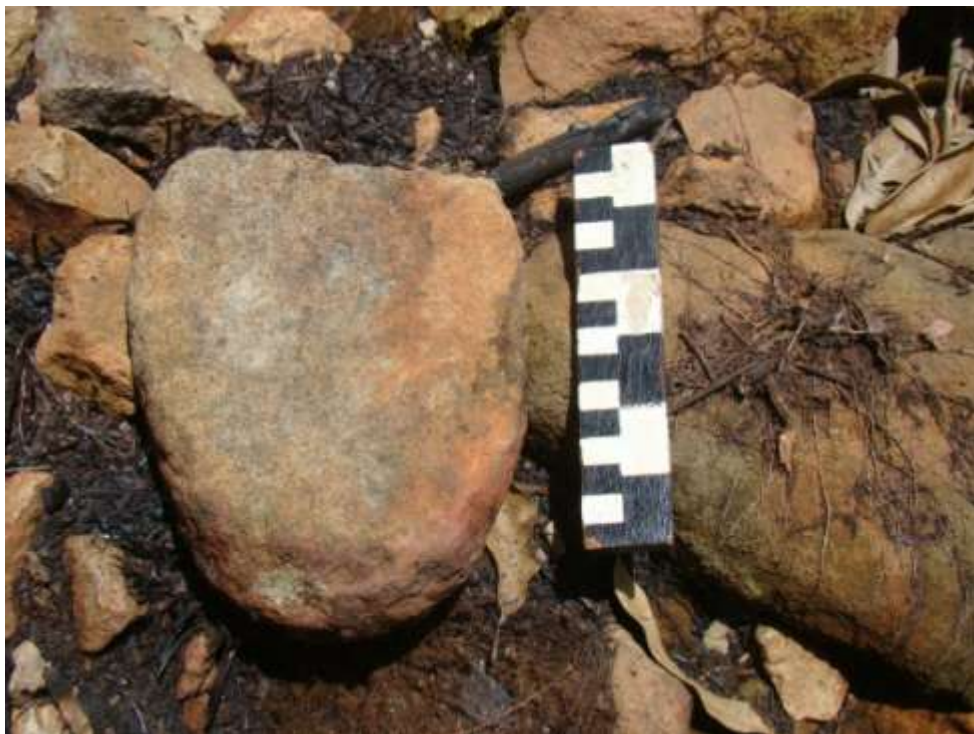
Fig. 127: Broken upper grinder.

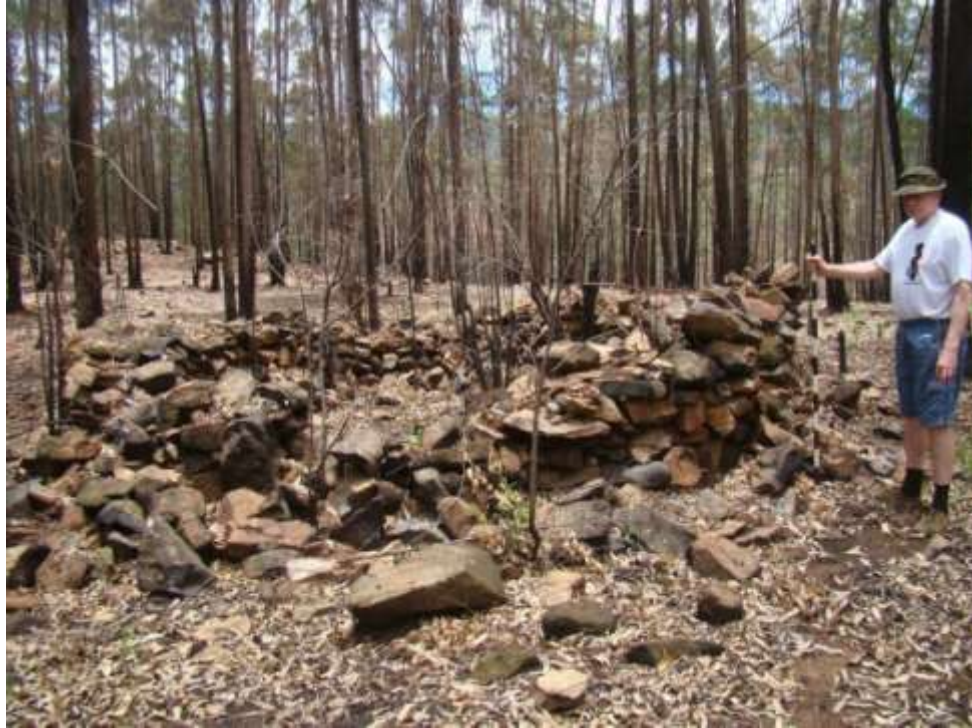
Fig. 130: 2 x circular units connected to each other are in an exceptionally well condition, and worth preserving. The walls are in the region of 1000mm \leq .

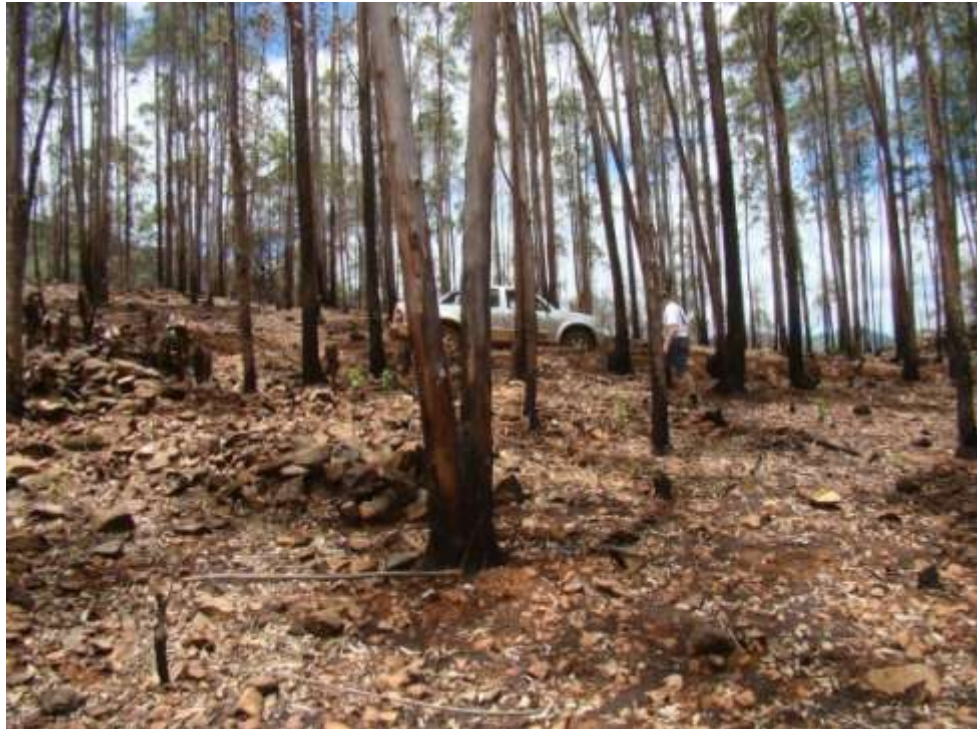
Fig. 133: An indistinct stone wall on the opposite side of the road. It has been disturbed by the road infrastructure and plantation activities.

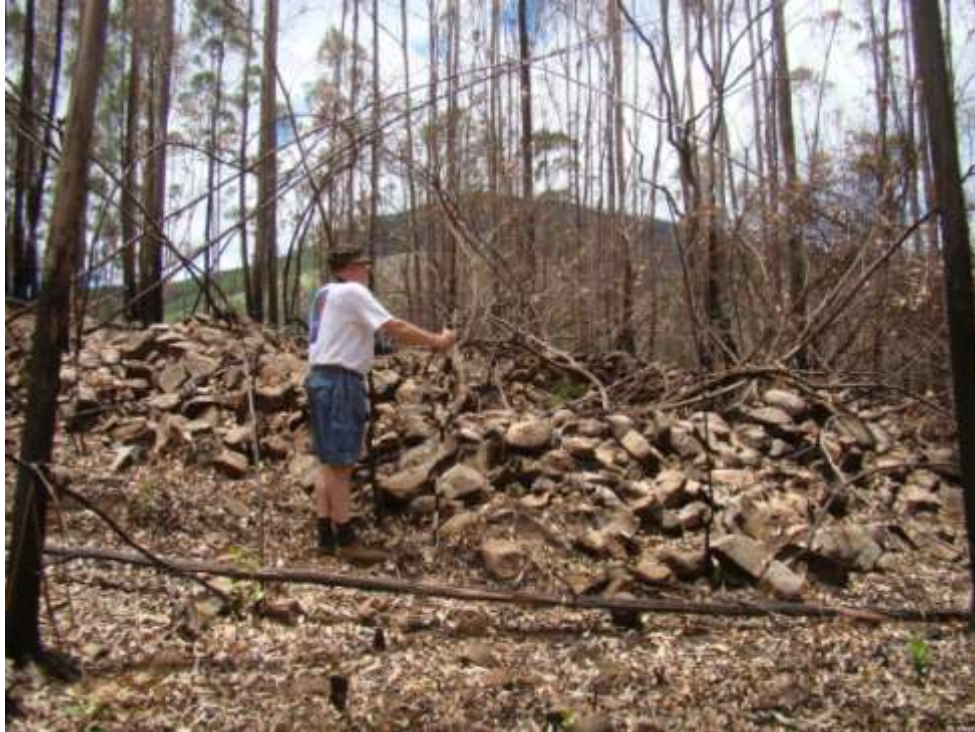
Fig. 136: Two distinct stone walled units were identified on the steep downhill (southern section). One unit has two sections.

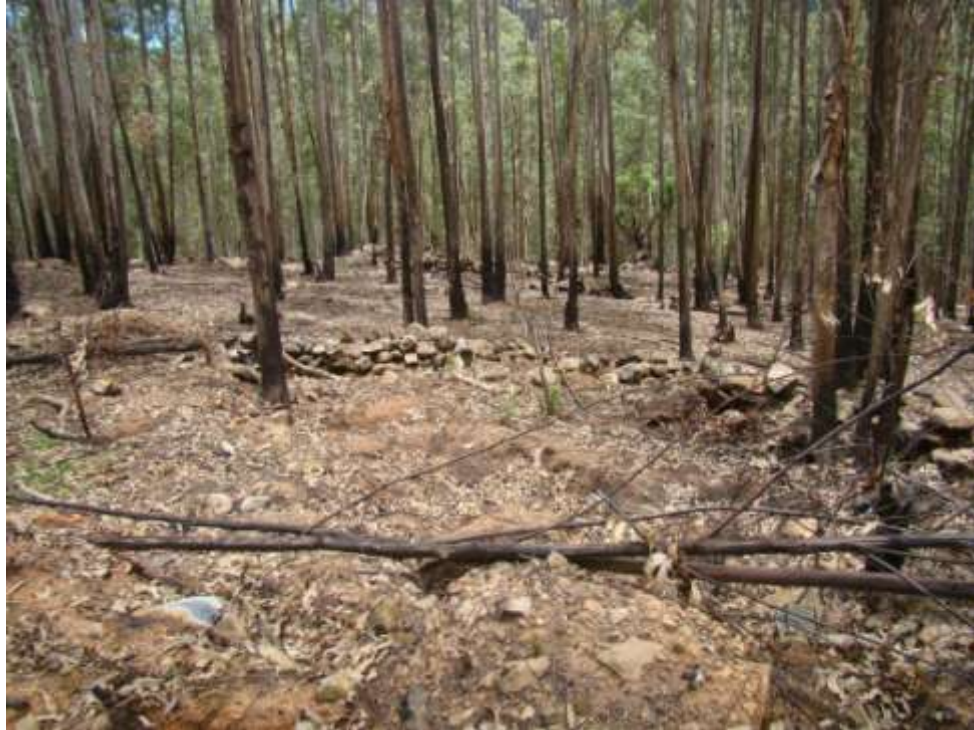
Fig. 138: Units down the southern slope.

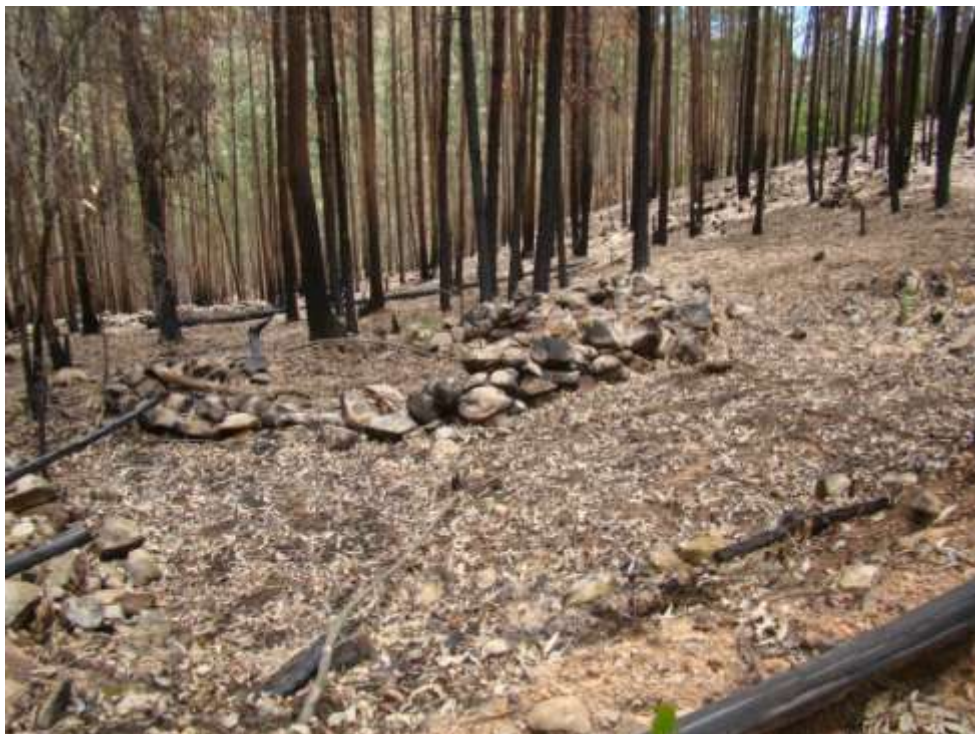
Fig. 139: Units down the southern slope.

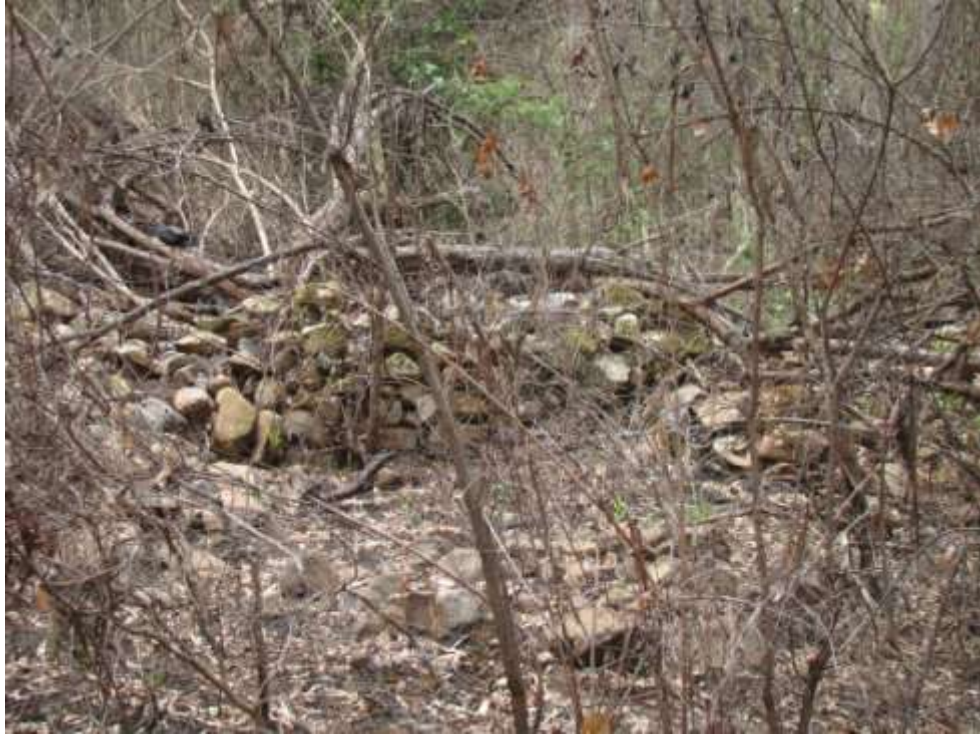
Fig. 140: Units down the southern slope.

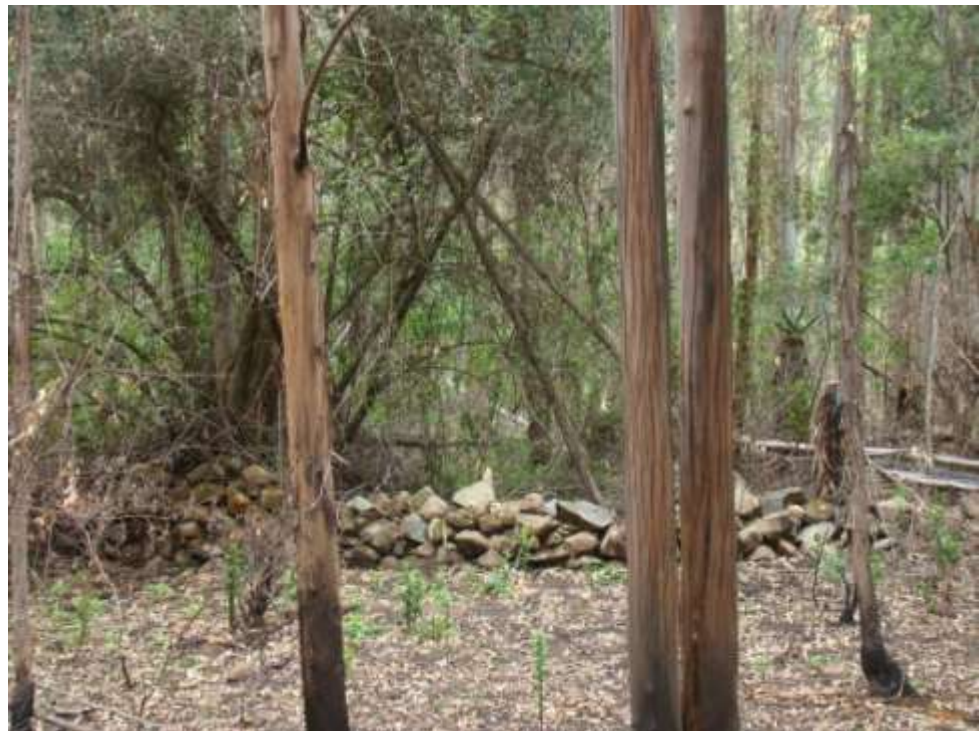
Fig. 141: Units down the southern slope.

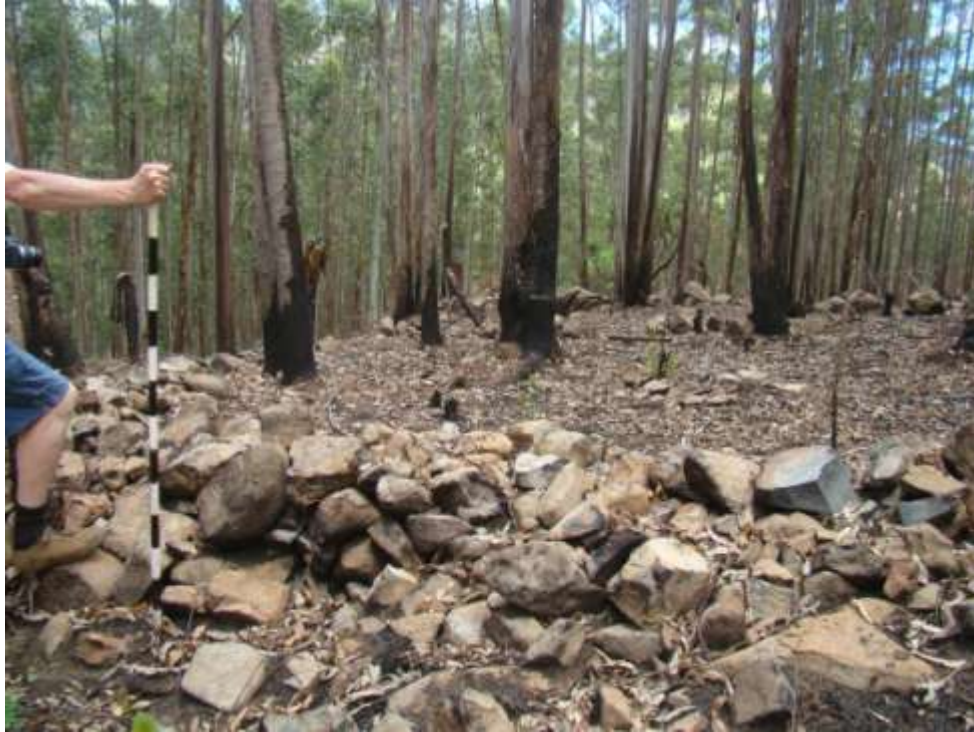
Fig. 142: The units down the southern slope are badly deteriorated.

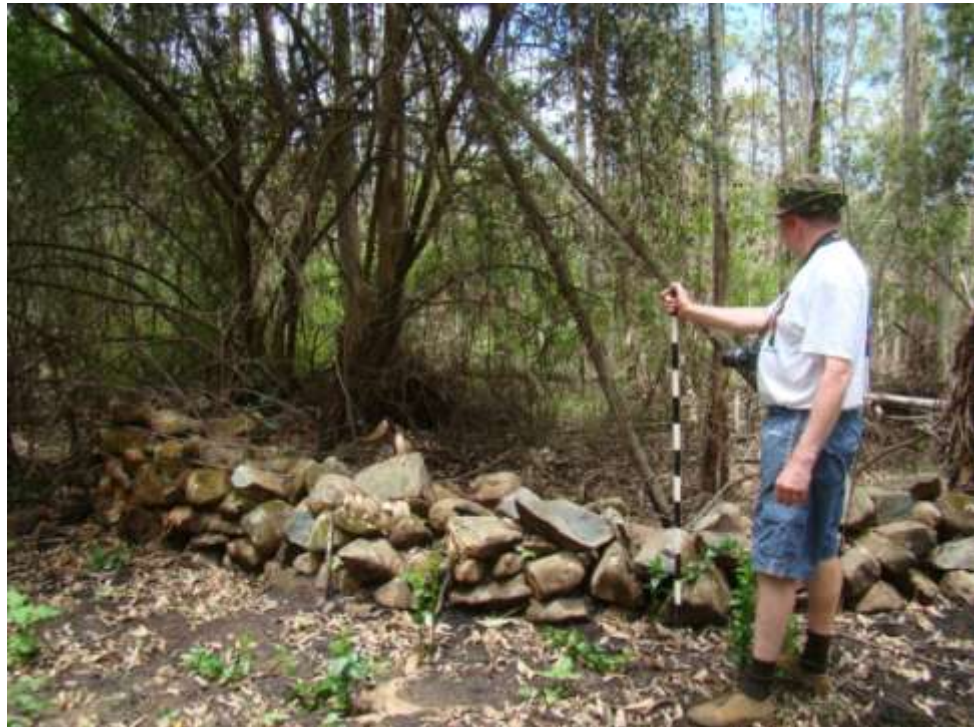
Fig. 143: A small section which is still in good condition.

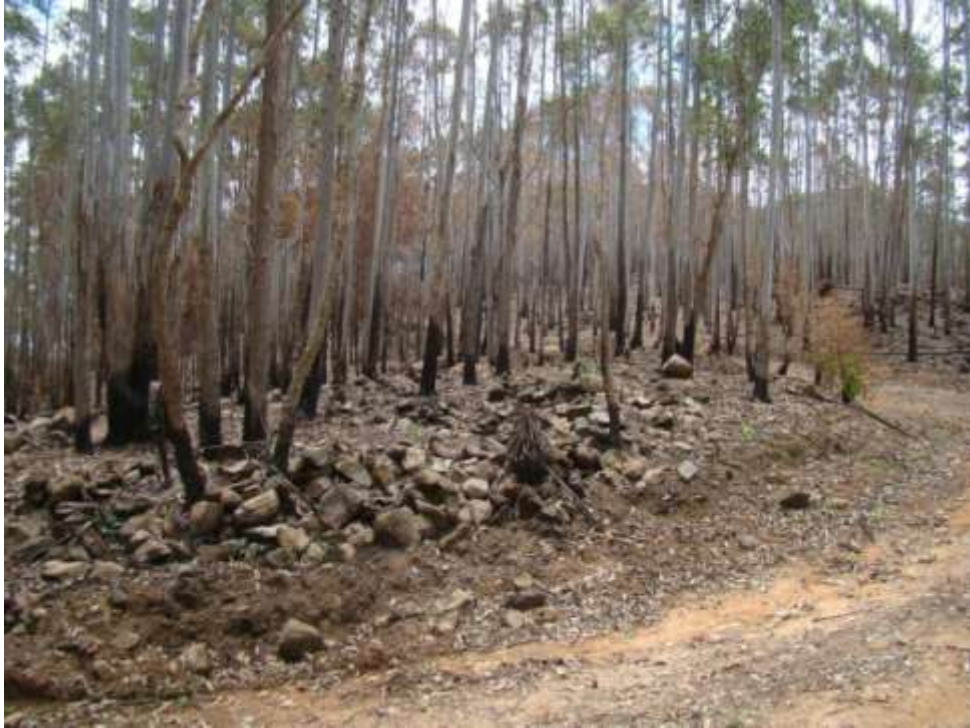
Fig. 144: Most of the units in the southern slope section are damaged by plantation and road activities.

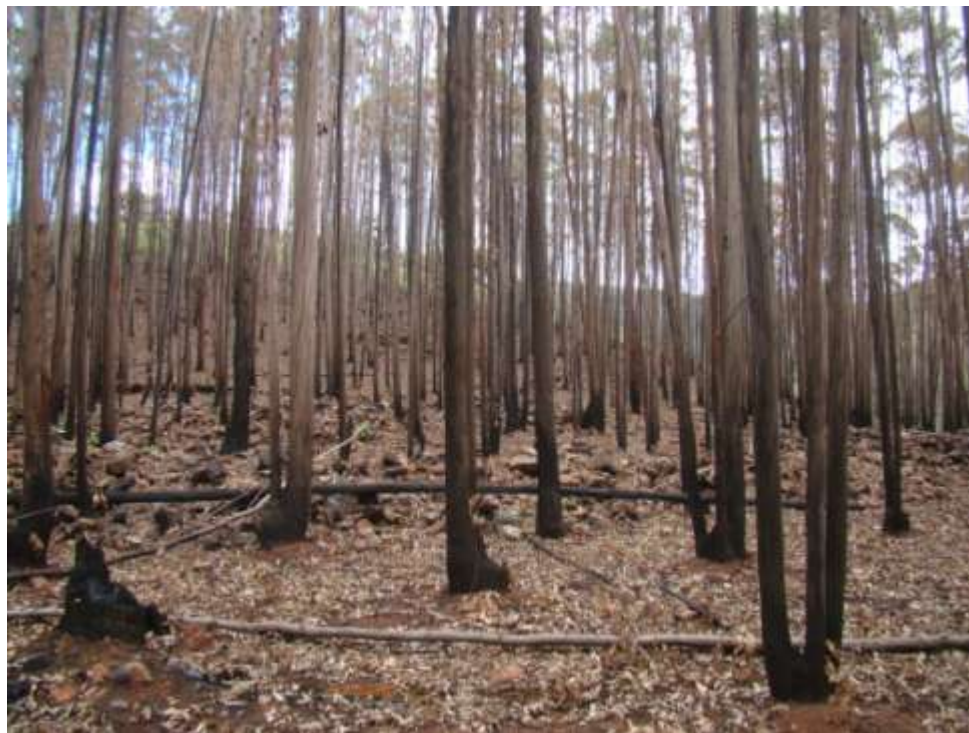
General comments C25: This compartment is marked as an ASI – “Indo African Ruins.” This section is within a bluegum plantation which has burnt recently. Visibility was good. This section is a good example of a layout pattern and worth preserving.

Fig. 145: The units are in a bluegum plantation and are interlinked.
