SPECIALIST REPORT

A PHASE 1 ARCHAEOLOGICAL AND HERITAGE IMPACT ASSESSMENT OF THE
STONE WALLED SETTLEMENTS ON TAURUS PLANTATION, BARBERTON
DISTRICT, MPUMALANGA PROVINCE

**REPORT PREPARED FOR
YORK TIMBERS**

APRIL 2015

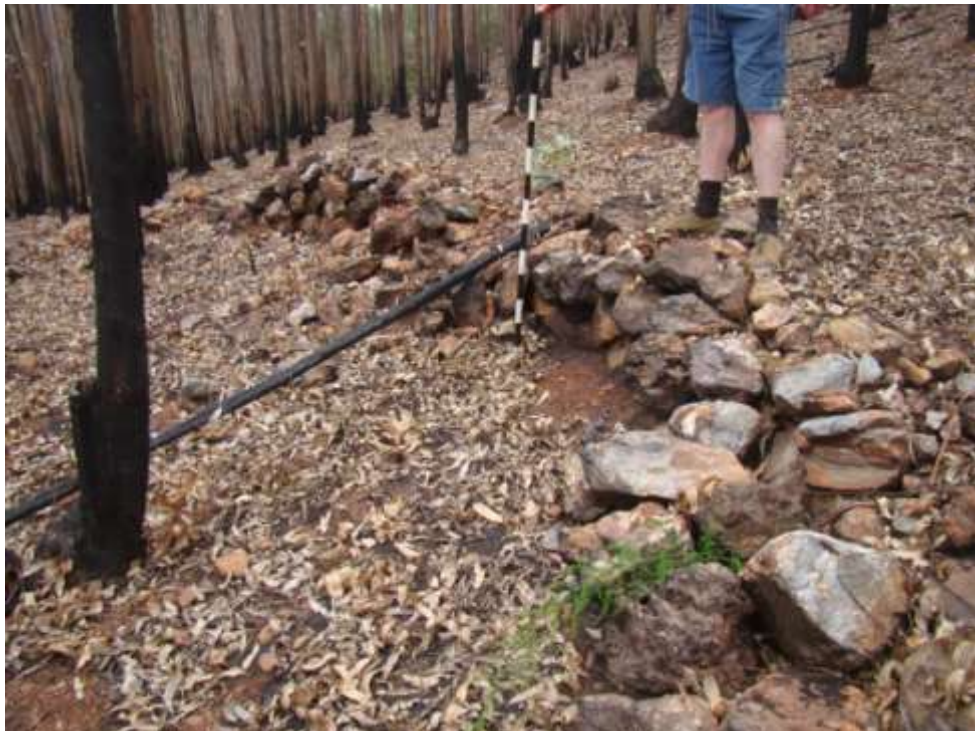
Fig. 147: Some of the terrace walls.

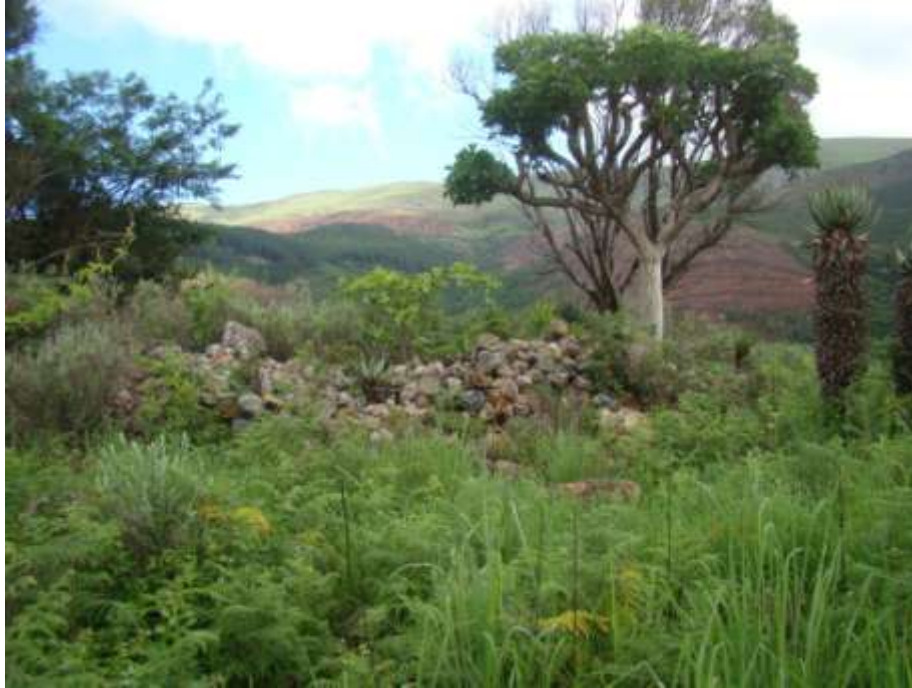
General comments: Z46: The stone walls are located on a hill, overlooking the valley and river below. Vegetation cover was restricting visibility and no clear pattern could be identified. The stone walls are in a natural section. They are not very high – approximately 600 – 800mm in sections.

Fig. 152: Some of the walls were fairly high (600mm – 800mm) but visibility was restricted due to dense vegetation cover.

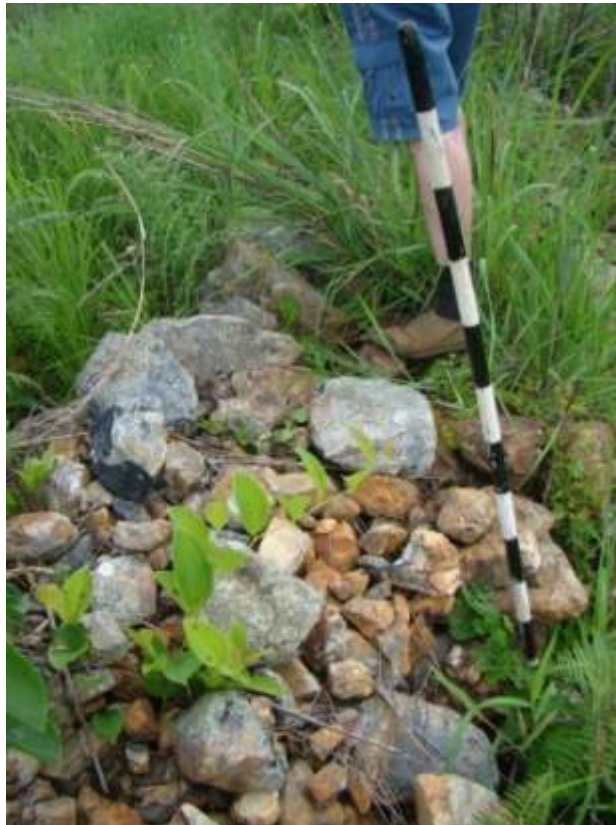
Fig. 153: Detail of the wall in this section.

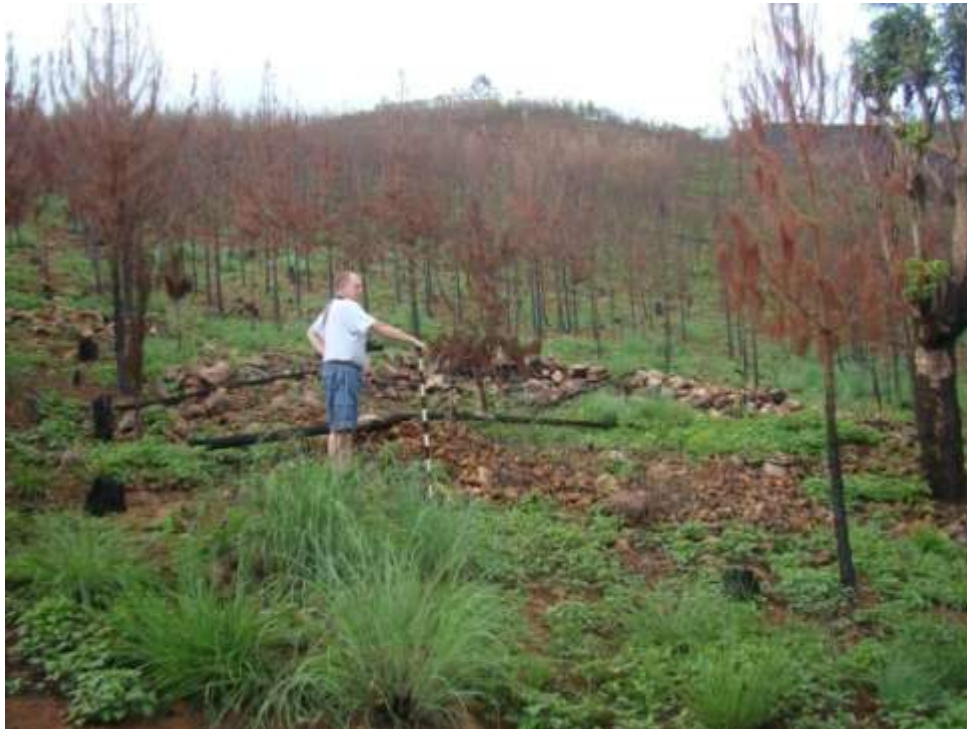
COMPARTMENT BLOCK: B34C			
No:	Heritage feature	Description / Comment	Site Location
B34C	Circular stone wall	One circular stone wall directly north of the grave site. The unit is deteriorated and damaged by plantation activities.	Elev: 1286m S25° 54' 27.4" E30° 56' 34.9"

Fig. 154: This unit is located north of the graves (B35B), and is deteriorated and damaged by plantation activities. It is situated on a slope.

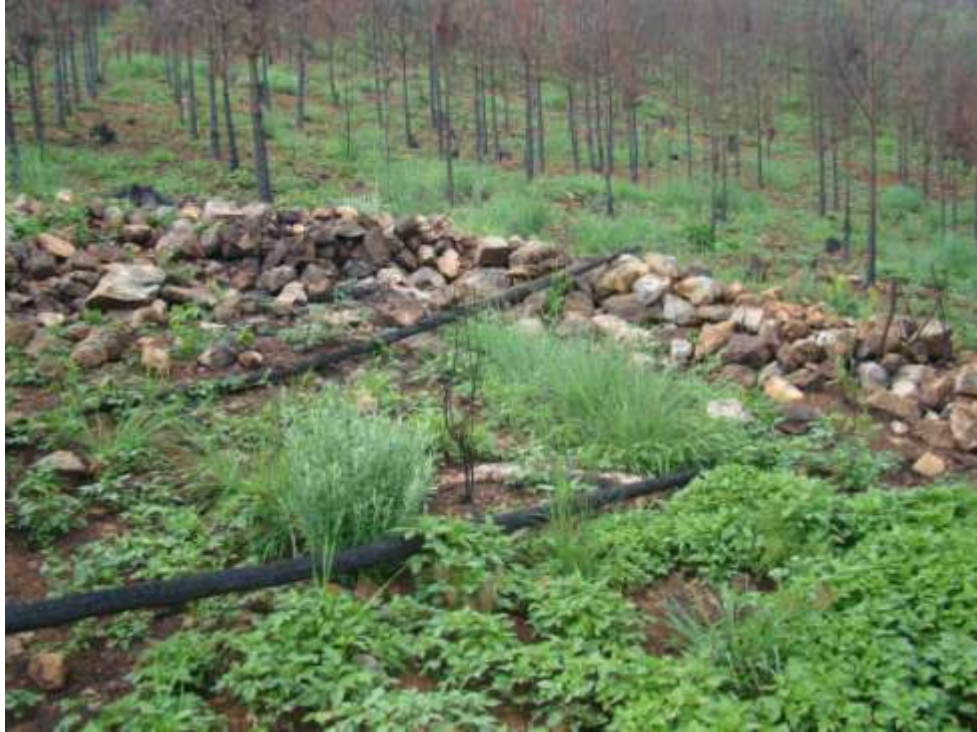
Fig. 155: Detail of the stone walls in this section.

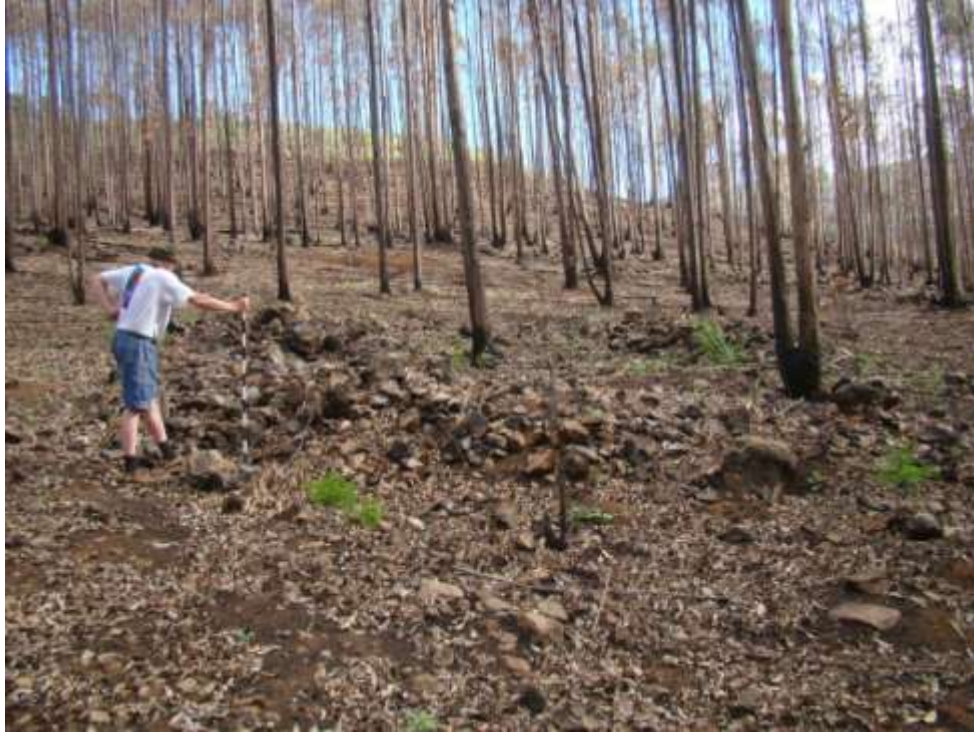
Fig. 156: A distinct circular unit was identified with a cattle track close by. An upper grinder was noted close to this unit.

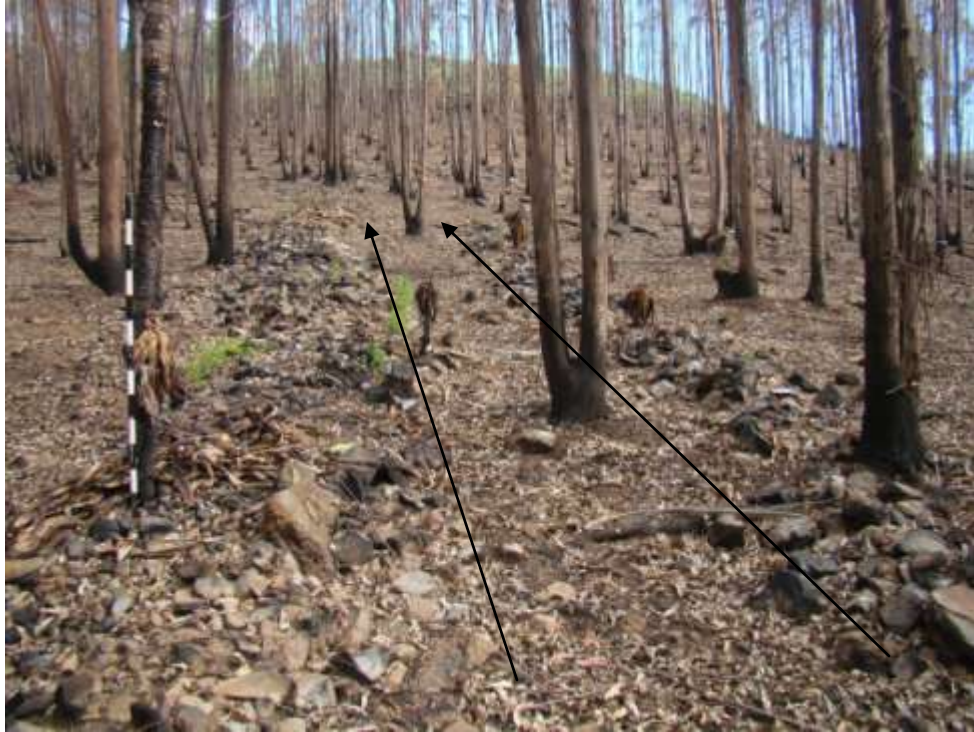
Fig. 158: A distinct cattle track was identified which runs from B35C – 2, in a southern direction up the slope.

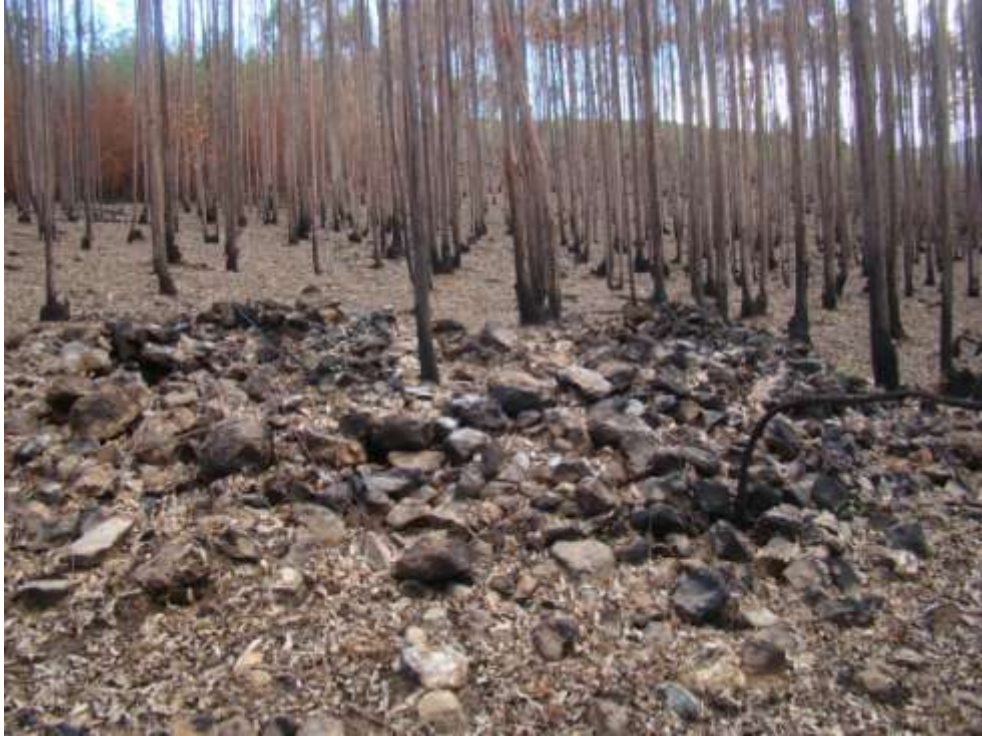
Fig. 166: Close up to show the condition of one of the circular units.

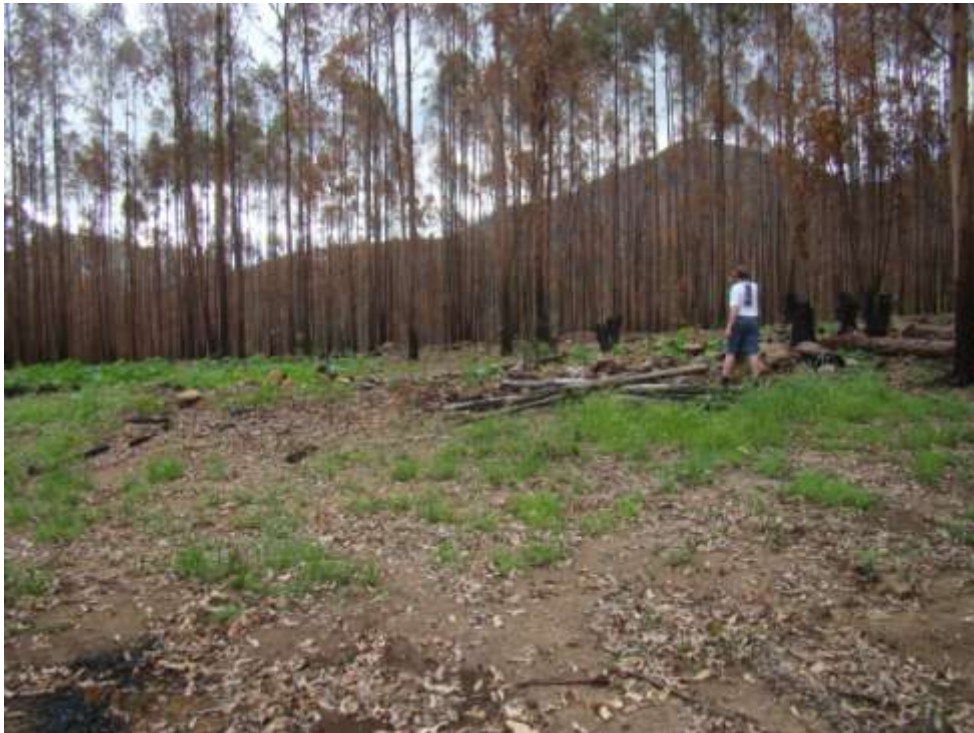
There is a wood depot next to the large unit and some of the wood damaged the walls. The section towards the south has many distinct and indistinct units, terraces and tracks visible. This section B35B continues on the other side of the road (east), into block B35A. B34C and B35C also form part of this large settlement.

Fig. 168: This is a very large unit connected to another unit (approximately 20m in diameter).

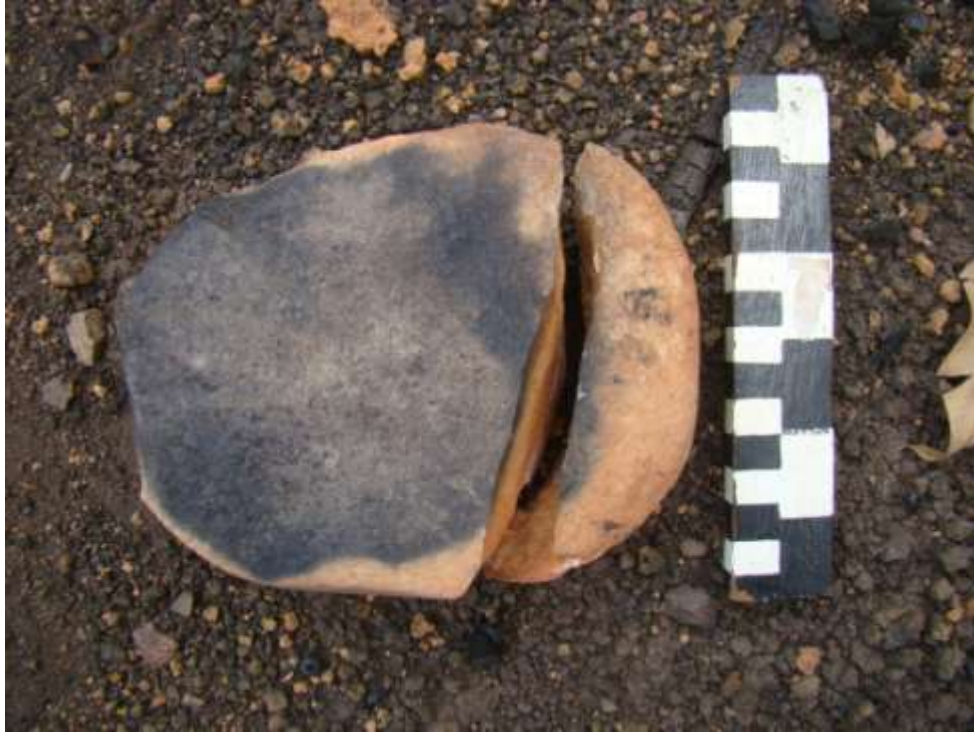
Fig. 169: An upper grinder which has broken due to the recent fire.

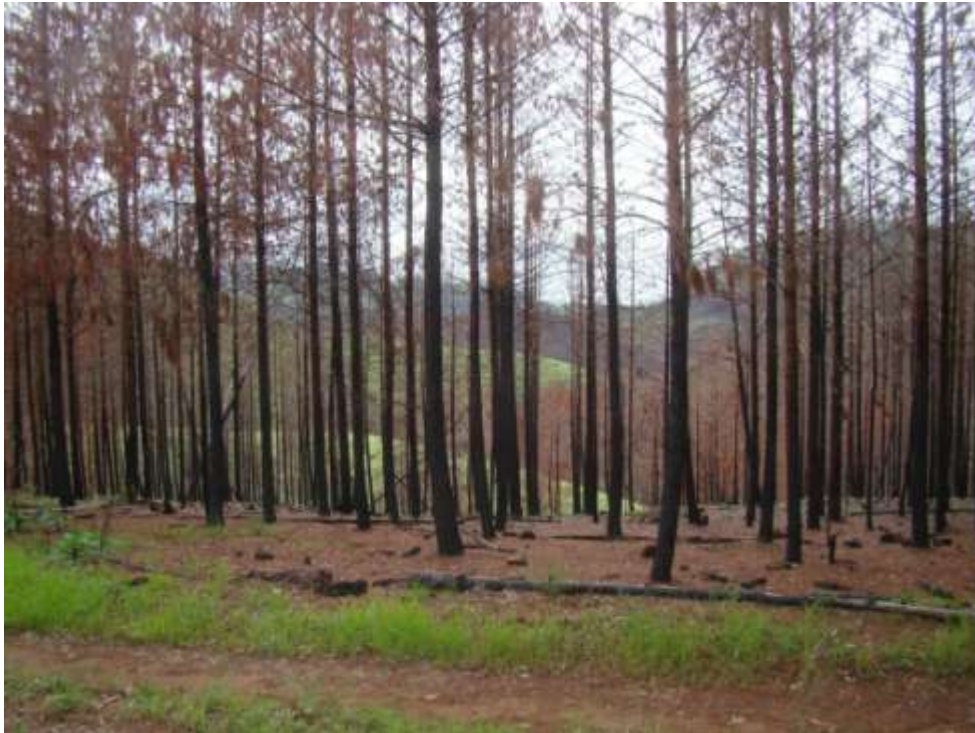
Fig. 170: The general view of this area. This settlement overlooked the valley below (before the establishment of the plantations).

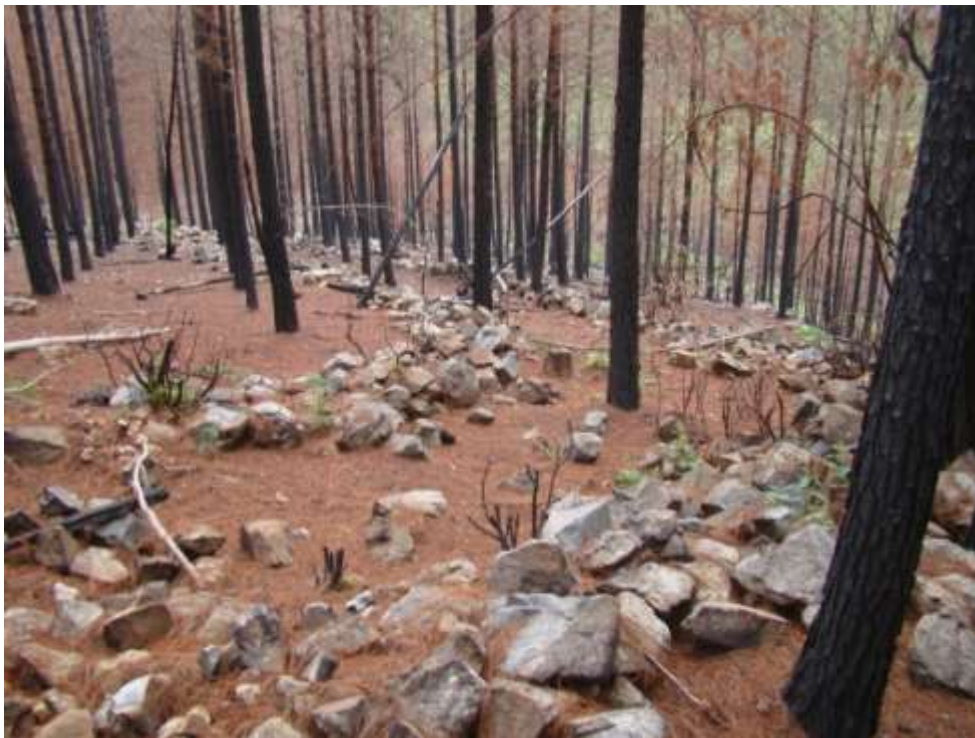
Fig. 172: The cattle track continues in the south down the slope towards the river.

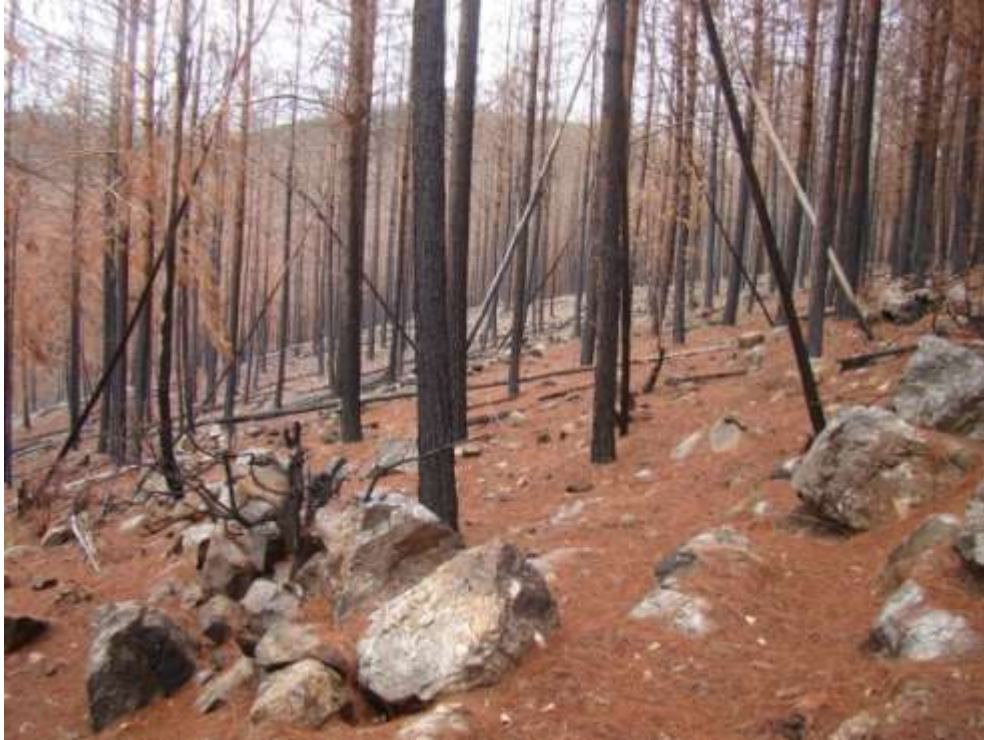
Fig. 173: Terrace walls are visible on the southern slope.

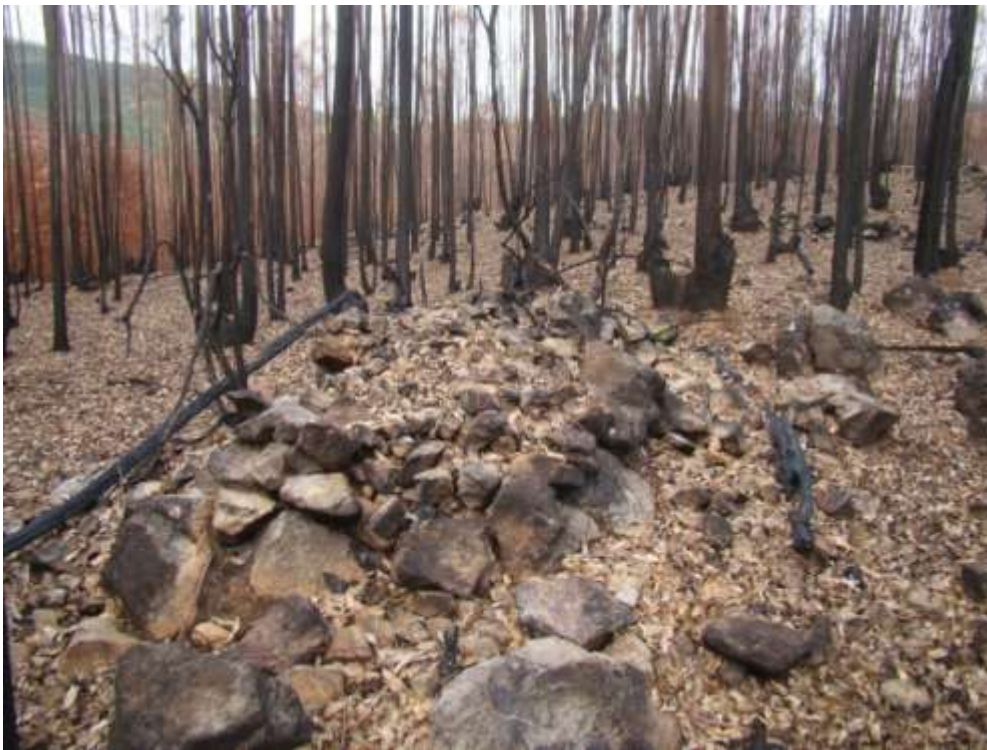
Fig. 178: The stone walls are typically outlined with larger stones and filled in with smaller stones.

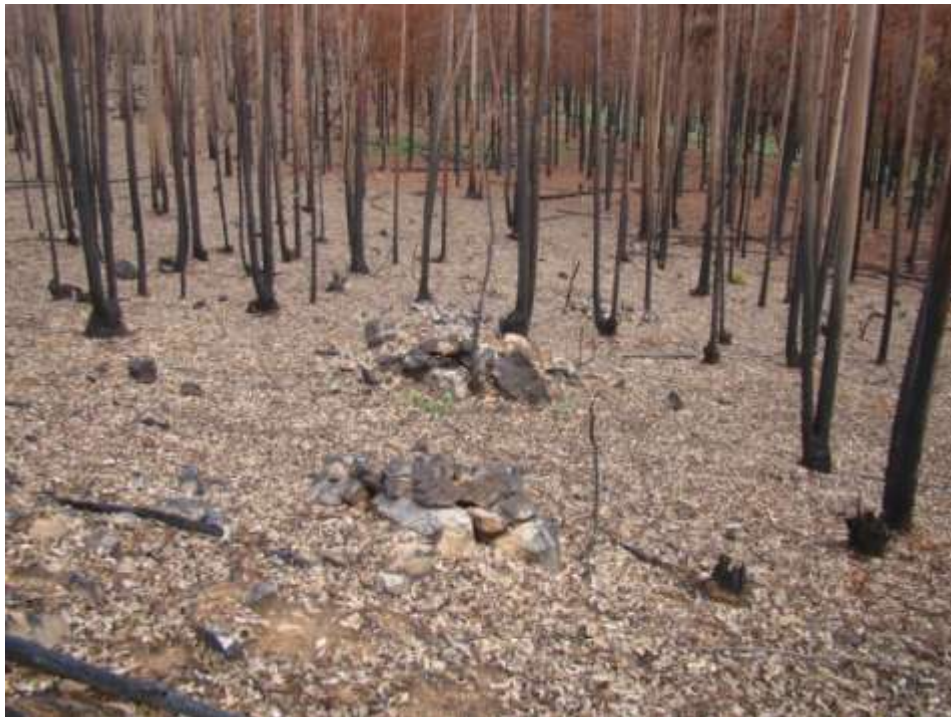
Fig. 180: Small stone heaps are visible in this section. It is not clear if this formed part of the initial stone walled settlement.

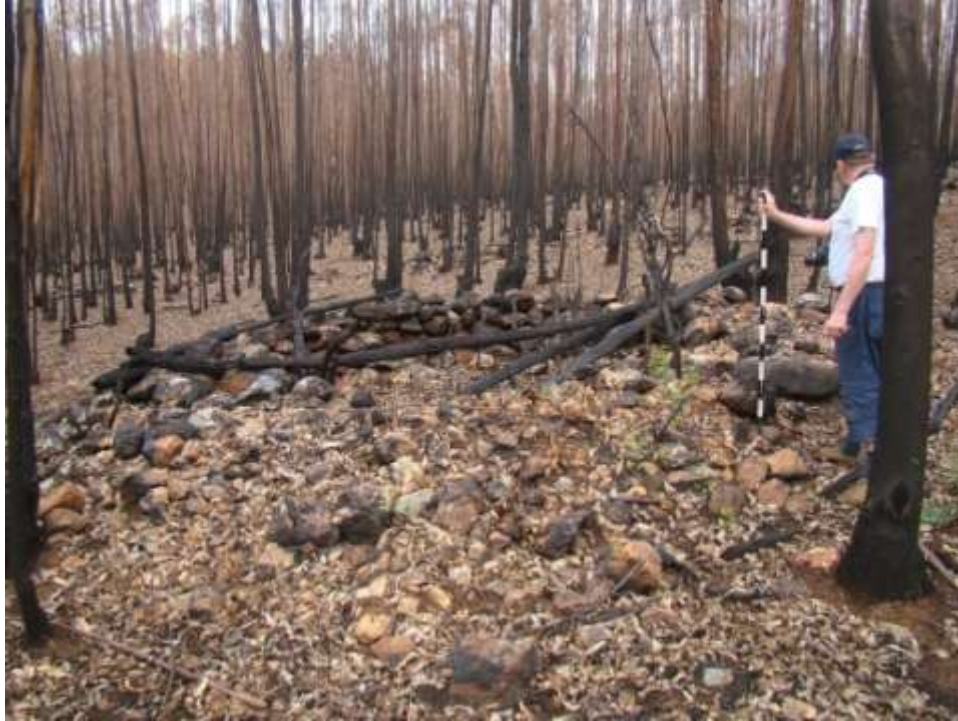
Fig. 183: One of the walls on the northern slope is still in a fairly good condition.

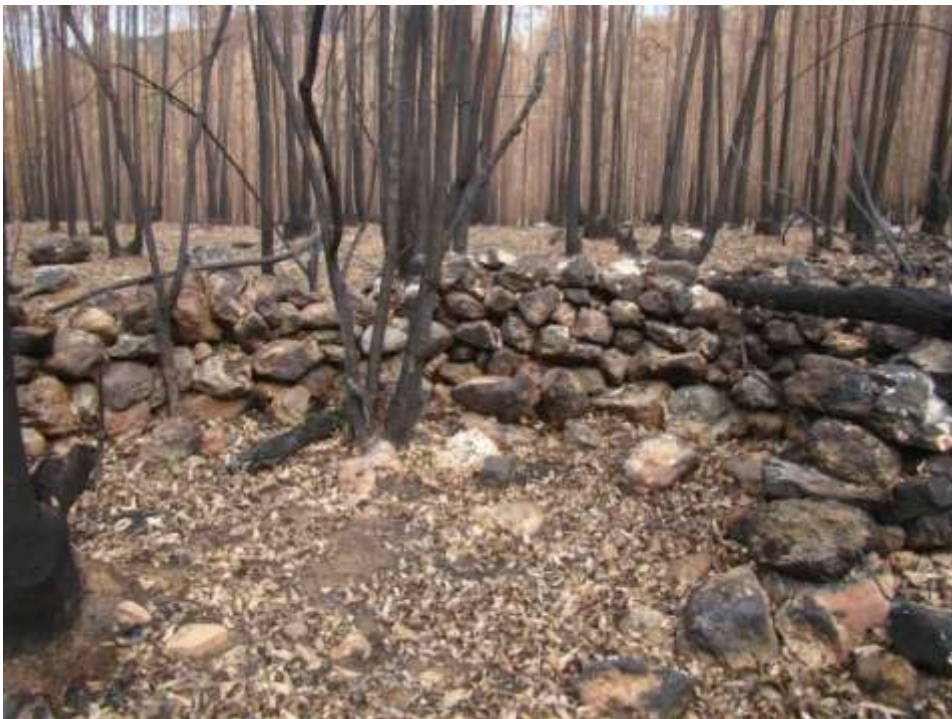
Fig. 186: Condition of a wall in this section.

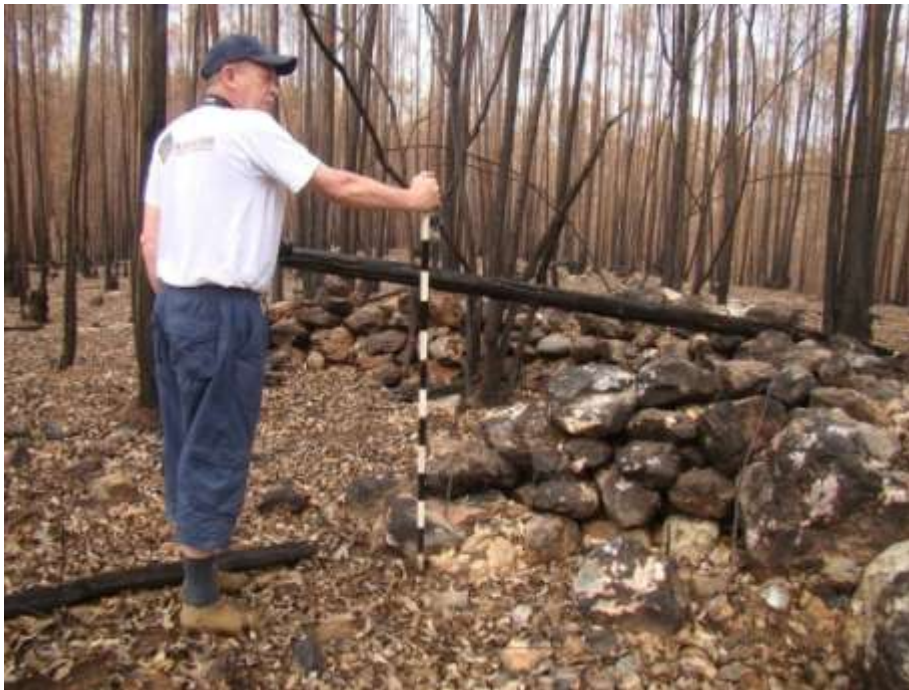
Fig. 188: Another wall in this section.

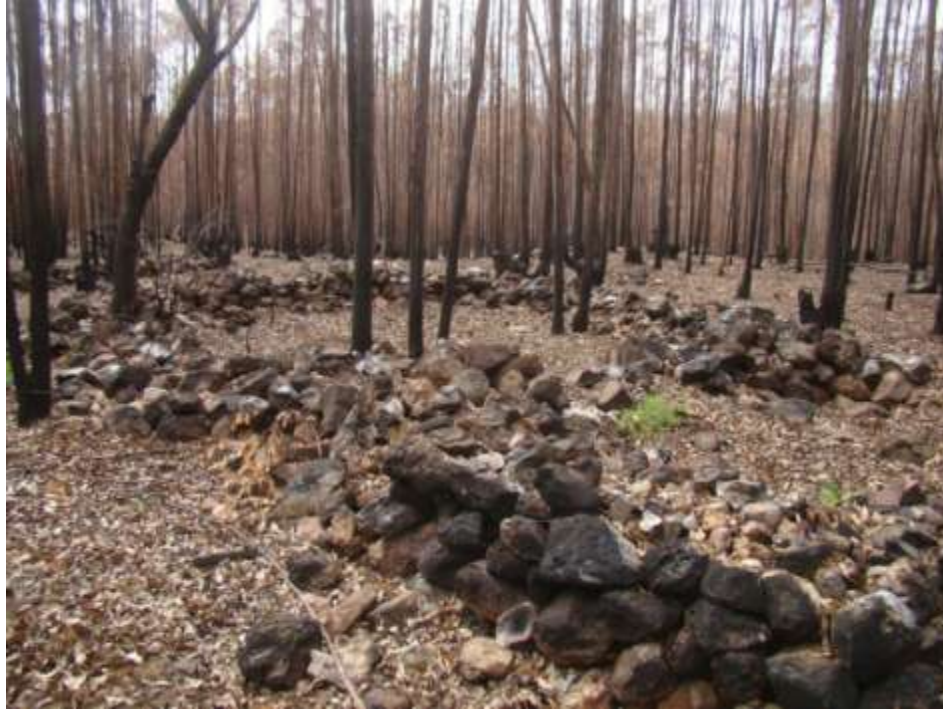
Fig. 189: Circular units in a very good condition.

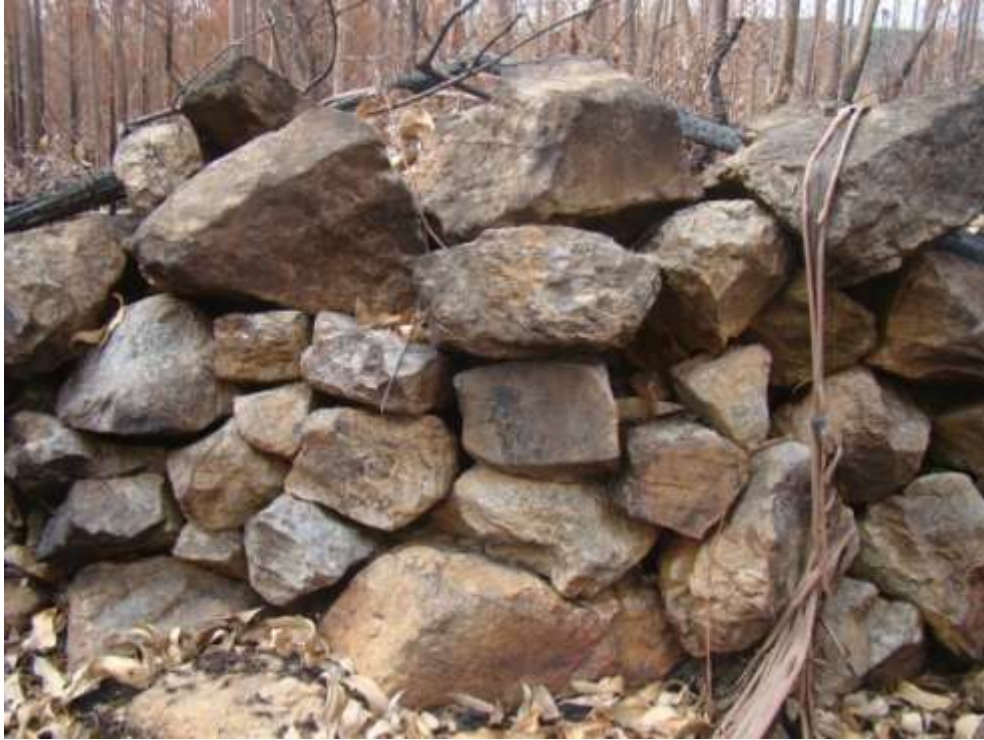
Fig. 193: An example of the walls.

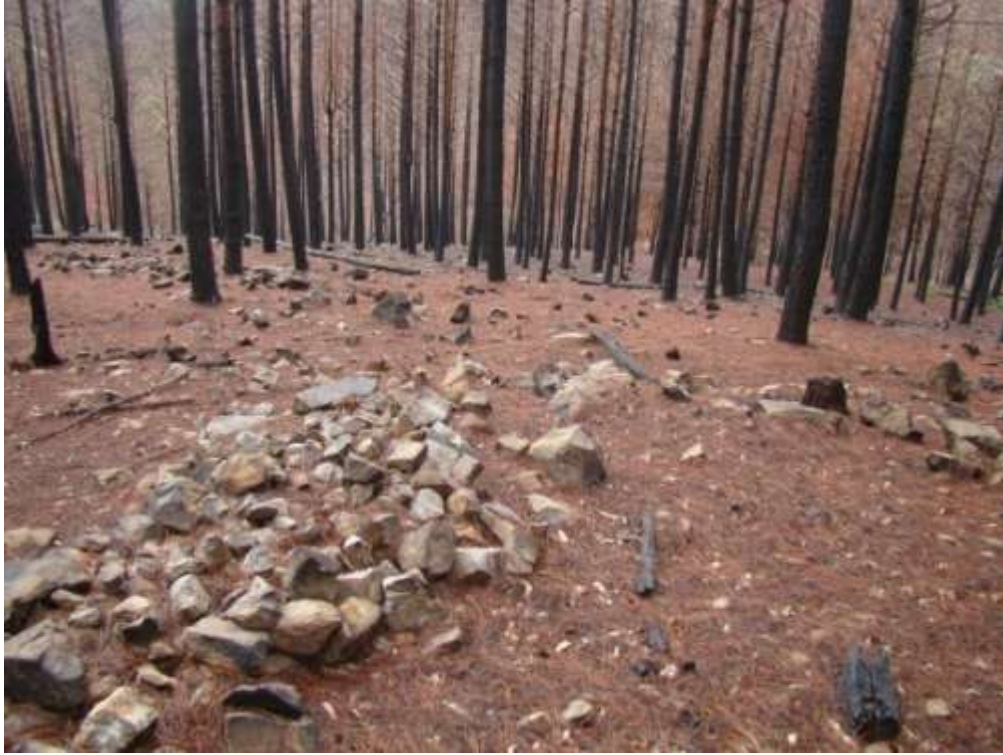
Fig. 195: Most of the walls are low and covered with pine needles.

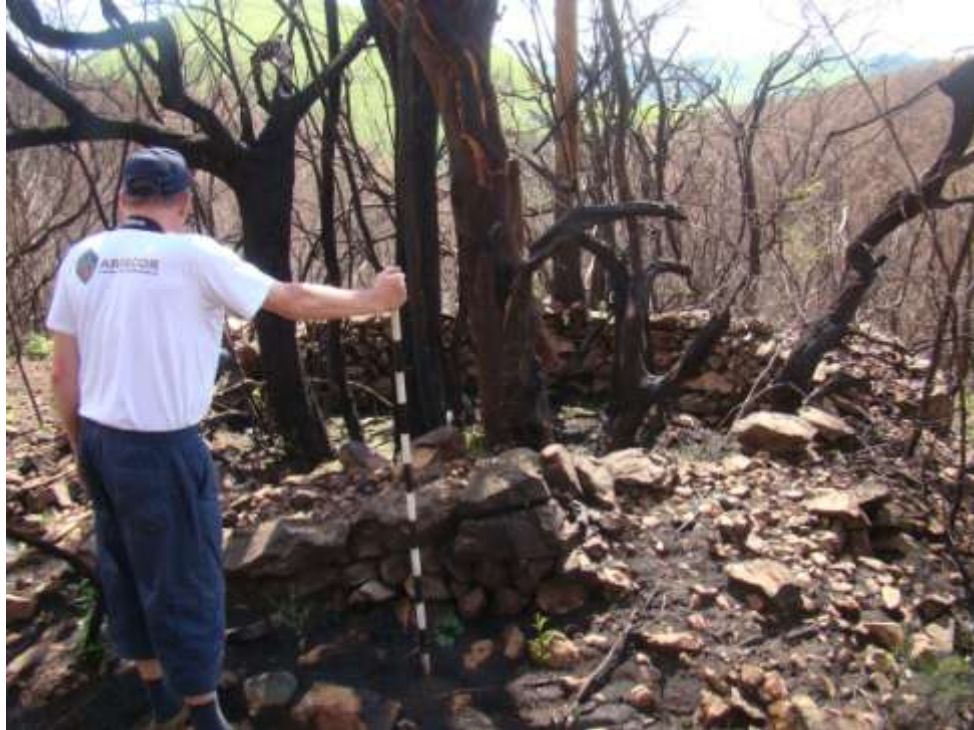
Fig. 198: One unit on the edge of the valley is in a fairly good condition, but natural vegetation is growing inside the wall.

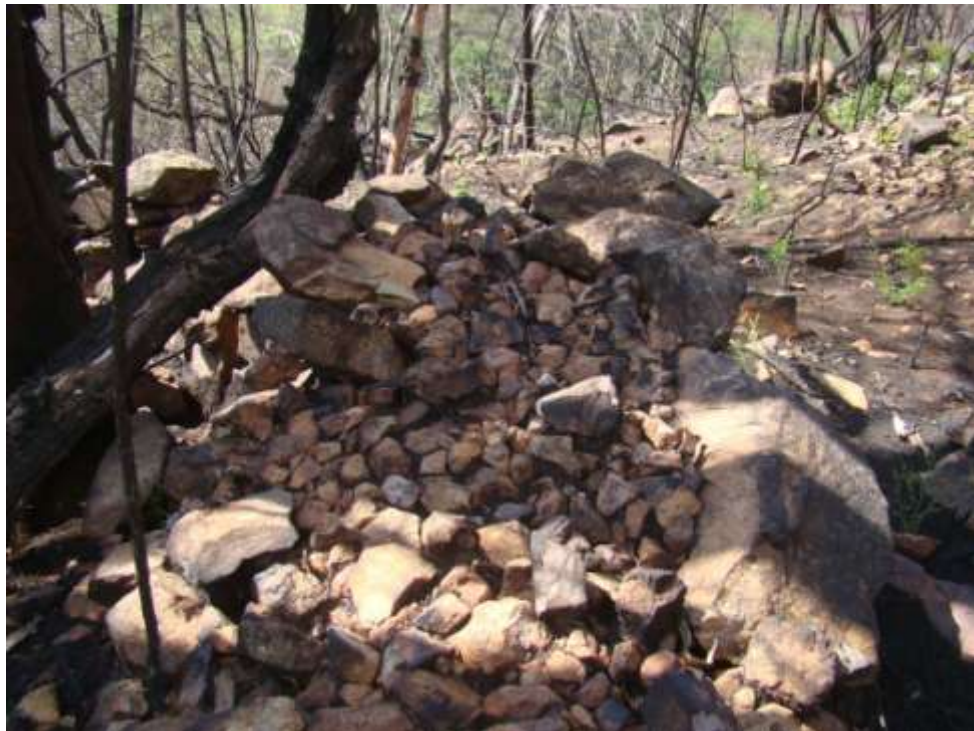
Fig. 199: A close-up of the wall of this unit.

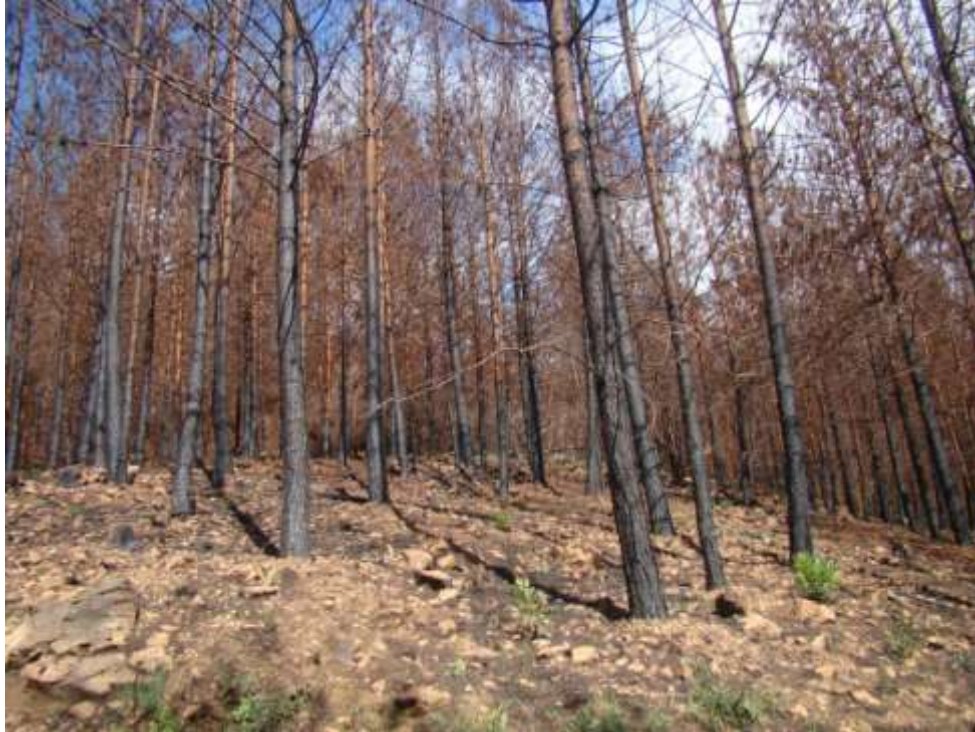
Fig. 200: Faint remains of stone walls are visible in the plantation on the western side of the road.

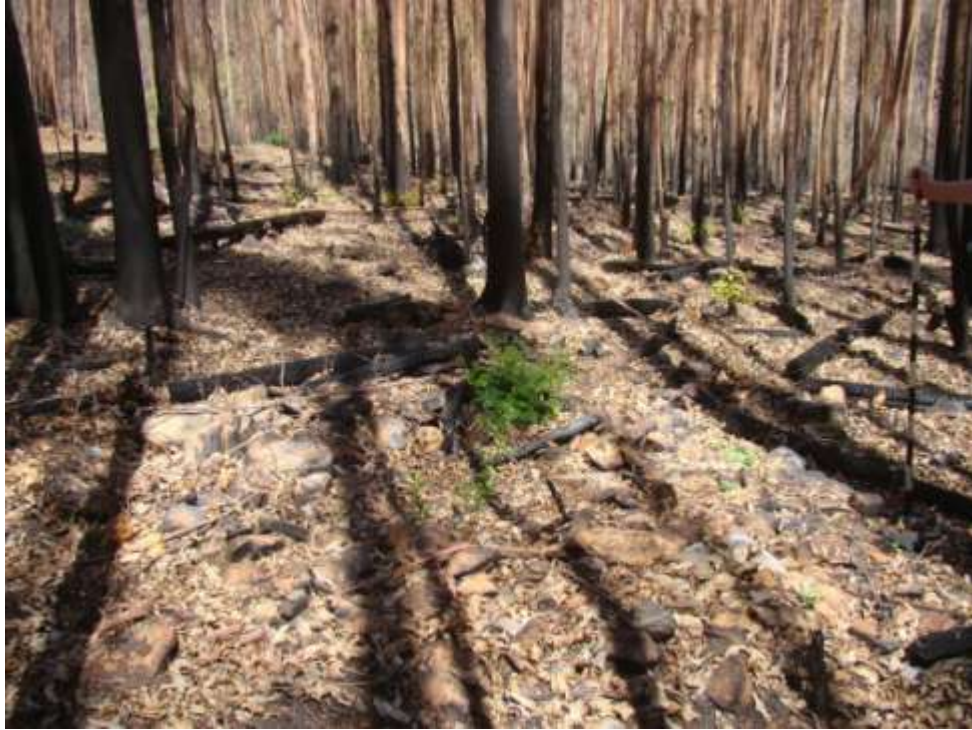
Fig. 201: A small unit that is indistinct and disturbed. There are other stone wall remains in the area.

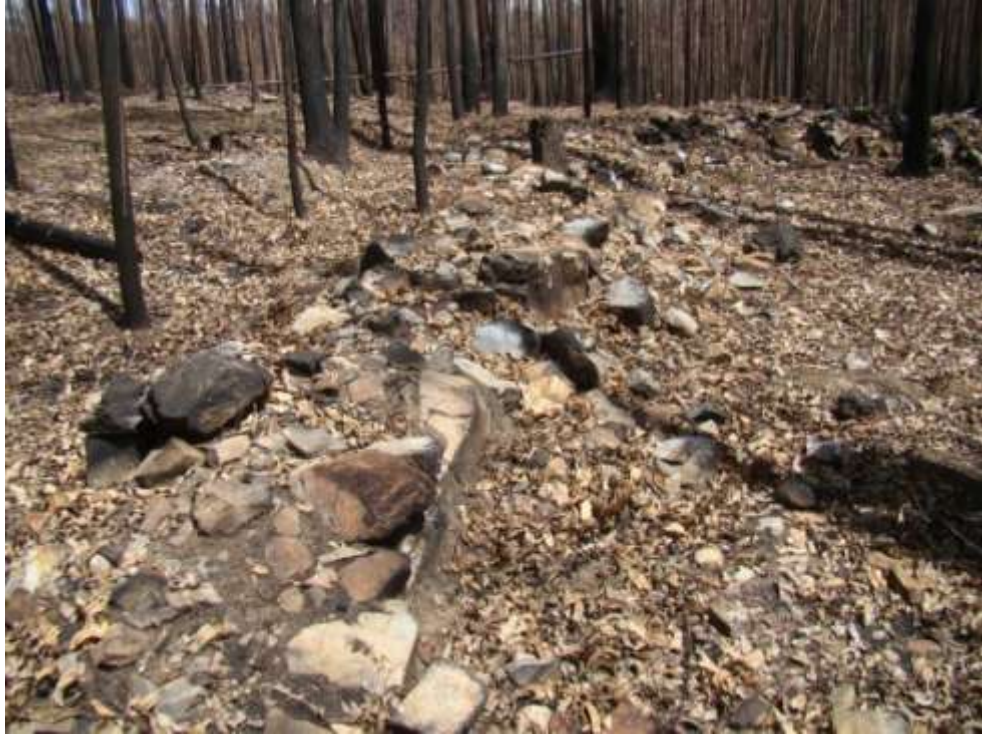
Fig. 205: A close up of one of the walls.

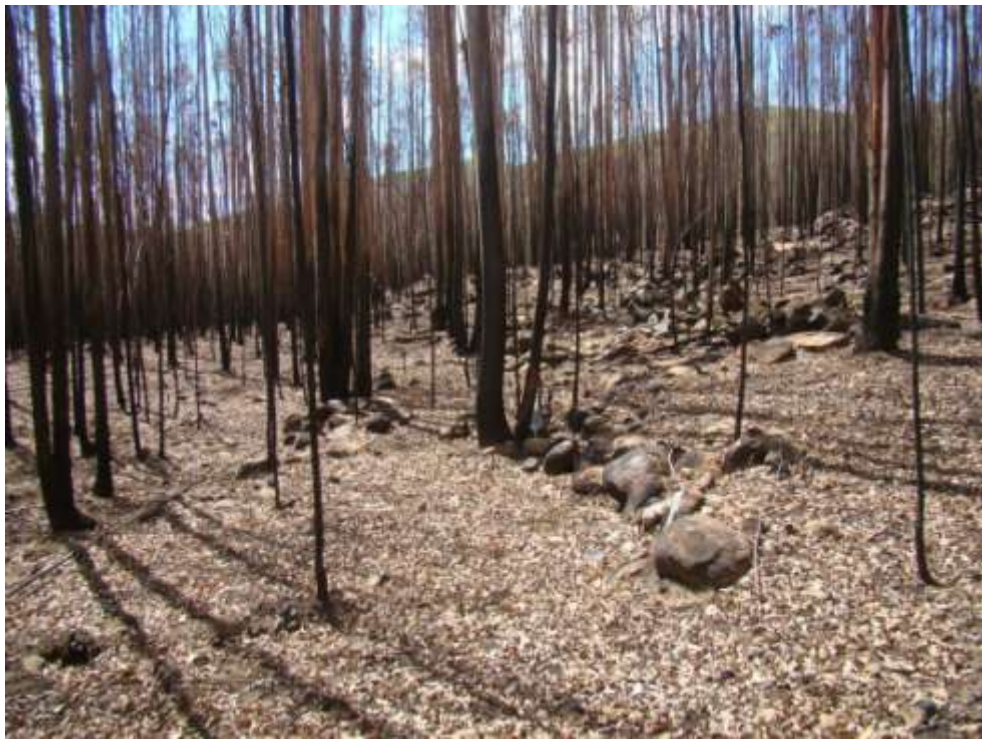
Fig. 206: A general view of the terrace walls in this section.

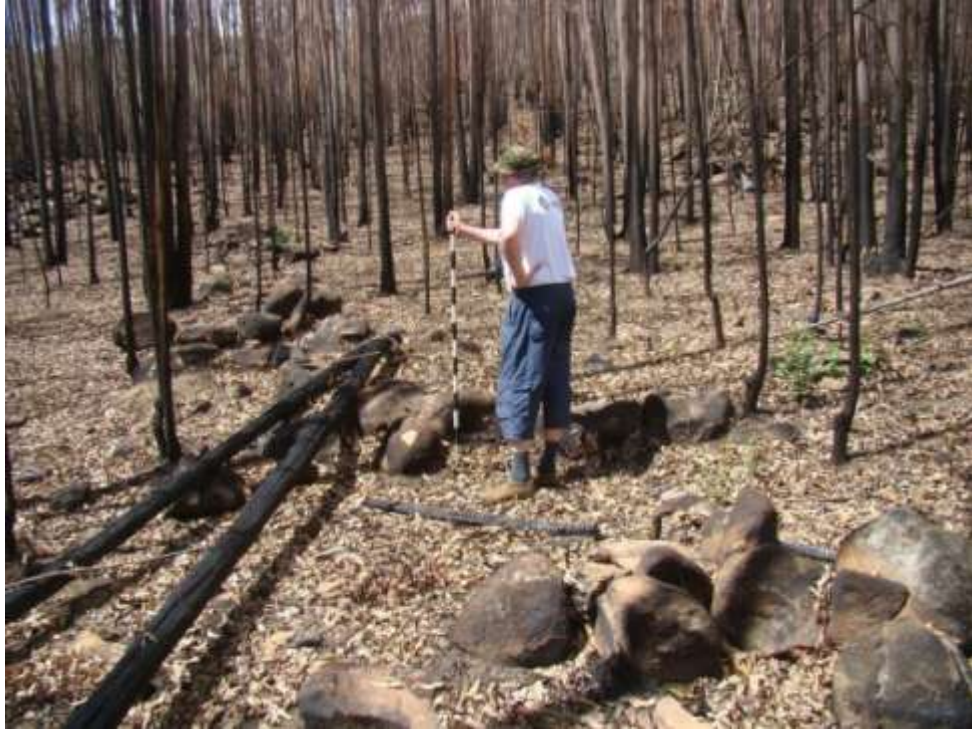
Fig. 207: The terrace walls which are situated next to the road.

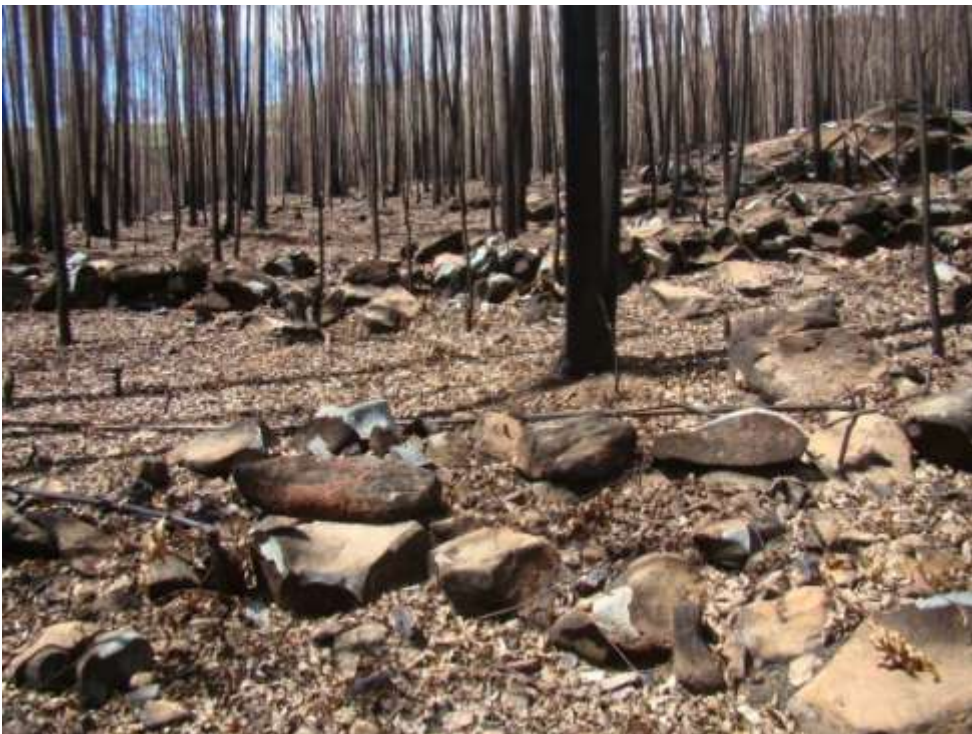
General comments C28: C28 - 1 Terrace walls in this area are built with exceptionally large stones. There are traces of indistinct walls and terrace walls on both sides of the main access road. It has recently burnt and most of the large stones were damaged by the fire. Visibility was good. No archaeological material was observed in this section.

Fig. 208: Terrace walls which were built with exceptionally large stones.

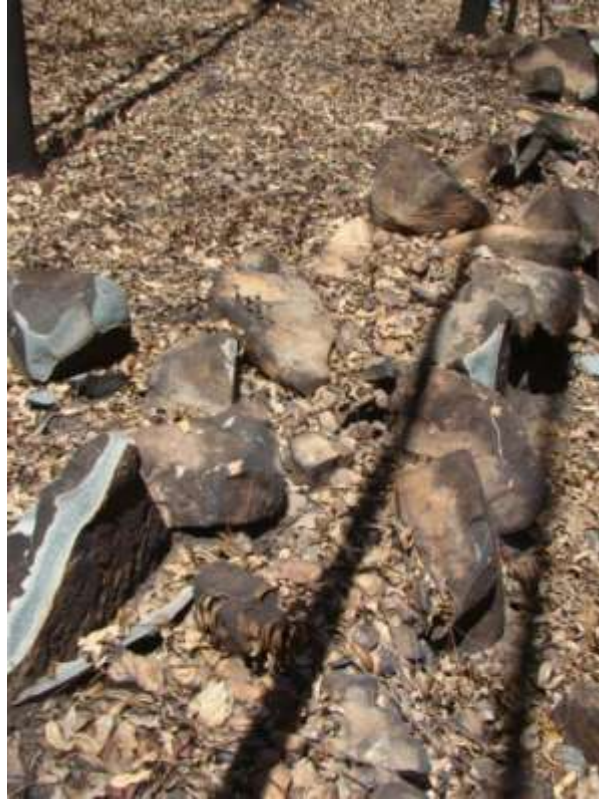
Fig. 209: One of the walls of the circular unit. The recent fire has damaged the stones.

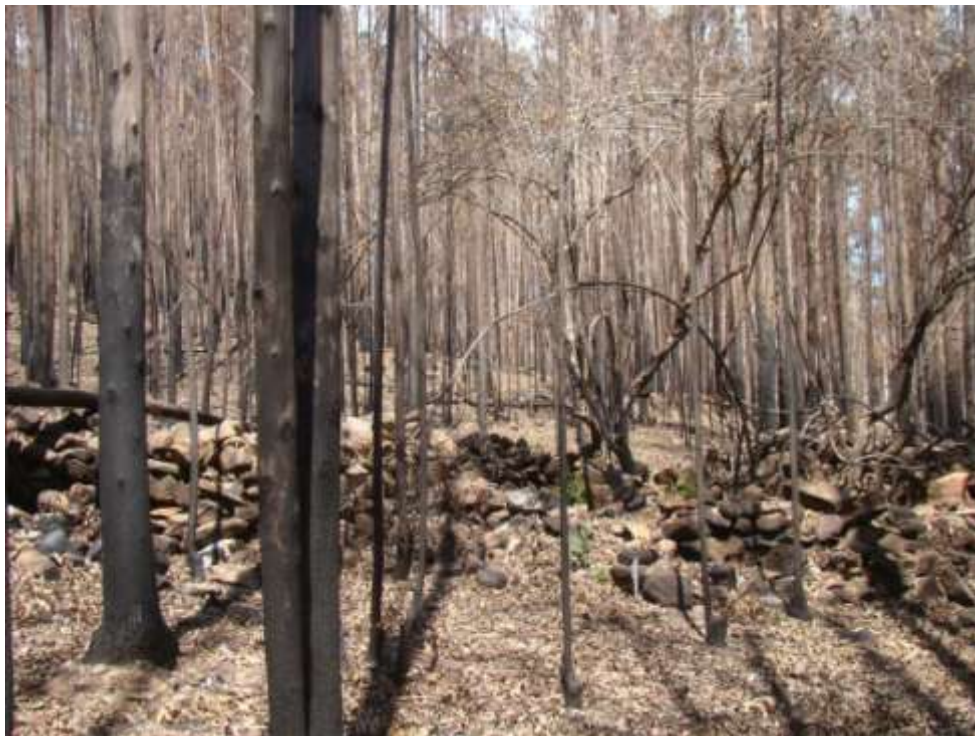
Fig. 210: 4 x units which are interlinked with walls. There are terrace walls and tracks below (north).

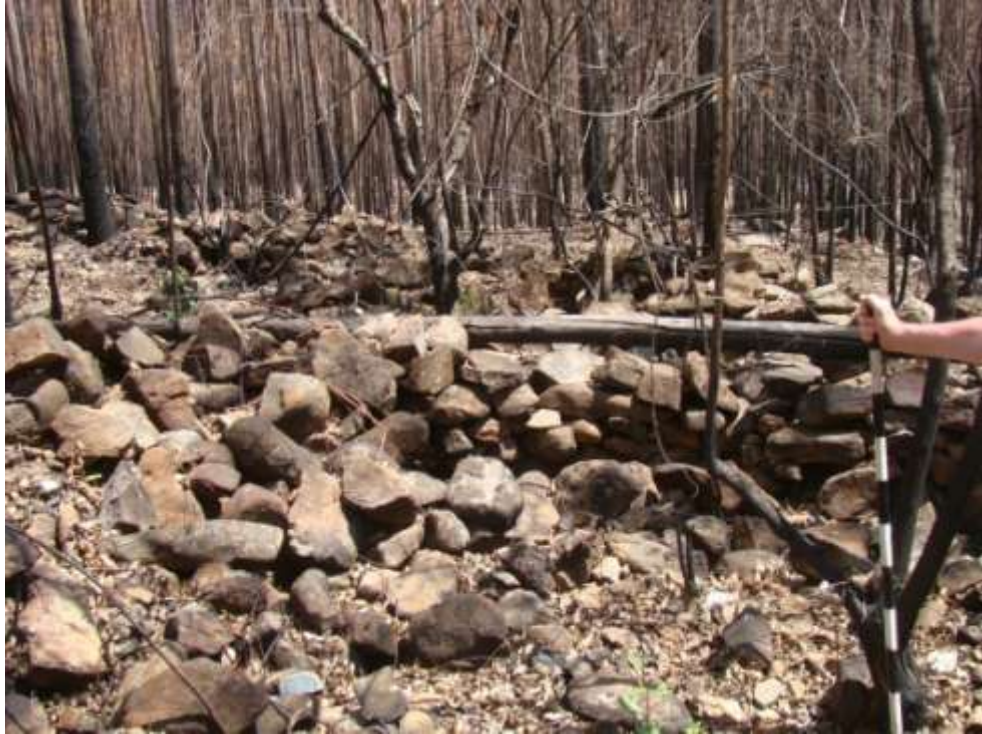
Fig. 211: Detail of the above units.
