SPECIALIST REPORT

A PHASE 1 ARCHAEOLOGICAL AND HERITAGE IMPACT ASSESSMENT OF THE
STONE WALLED SETTLEMENTS ON TAURUS PLANTATION, BARBERTON
DISTRICT, MPUMALANGA PROVINCE

**REPORT PREPARED FOR
YORK TIMBERS**

APRIL 2015

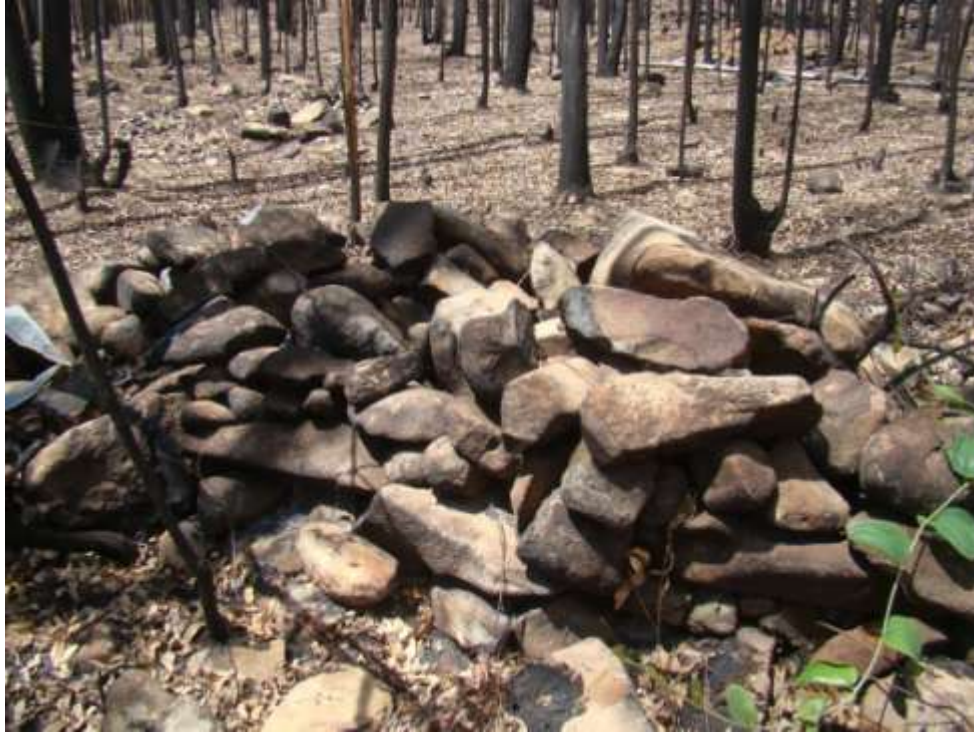
Fig. 213: A close up of one of the walls in the 4 interlinked units.

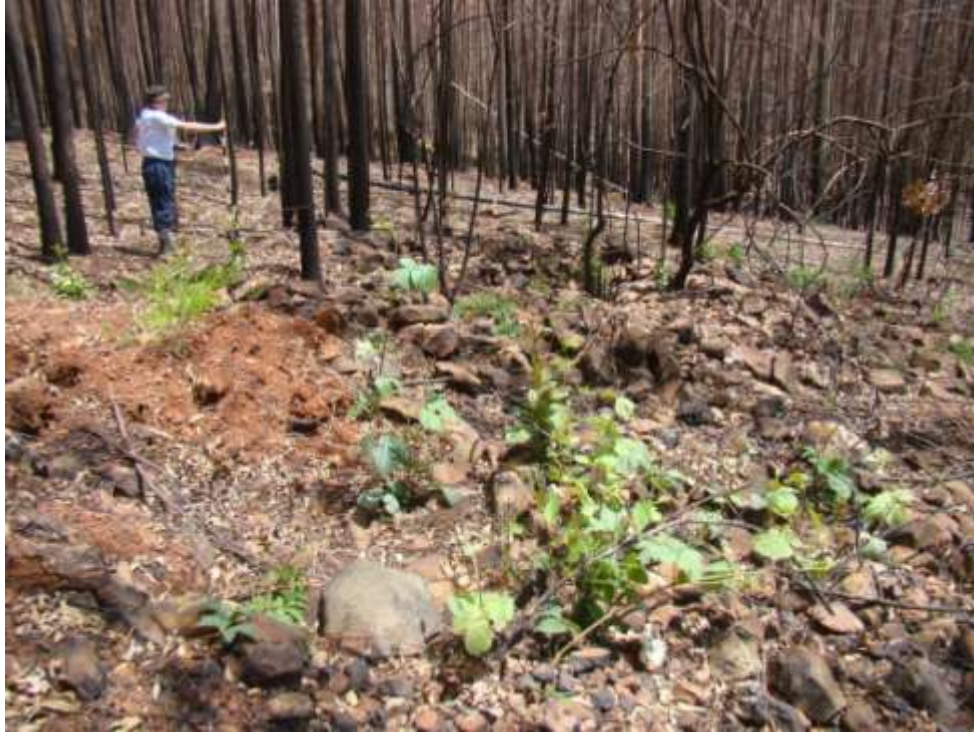
General comments D01: D01 is situated in a bluegum plantation which has recently burnt. Visibility was good. The units are damaged by road and plantation activities, and are on the edge of a drainage line. Archaeological remains were observed in this section between D01 -1 and D01 - 2.

Fig. 214: Two circular walls are joined together with a very small circle attached to it. These walls are in a fairly good condition although it has been damaged by road and plantation activities.

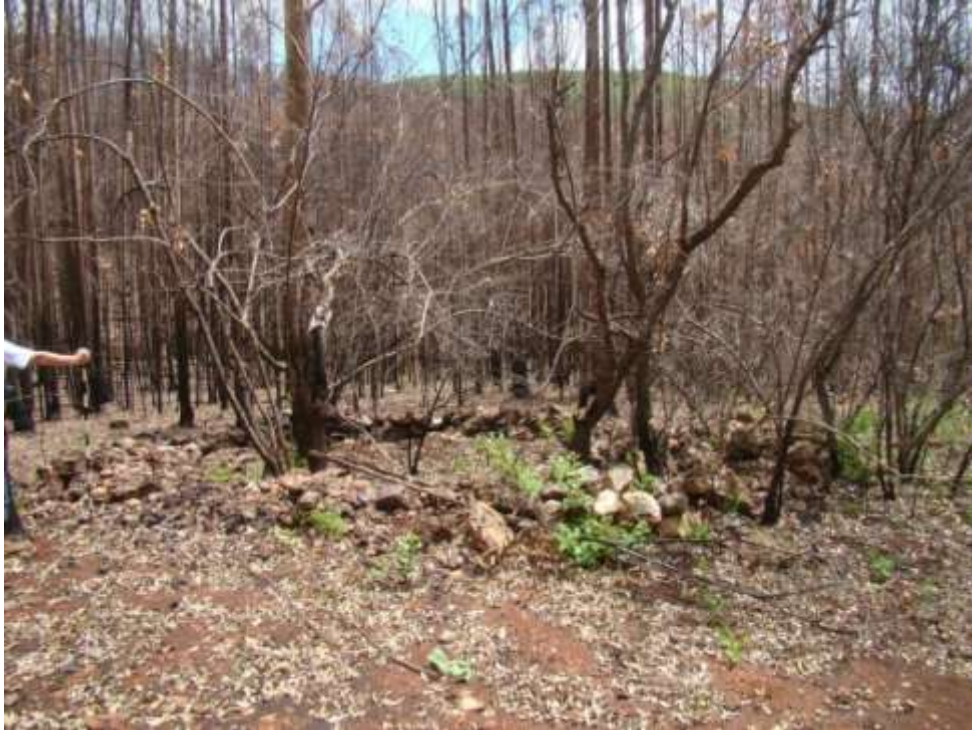
Fig. 218: A good example of a stone wall is found approximately 30m north of D01-1.

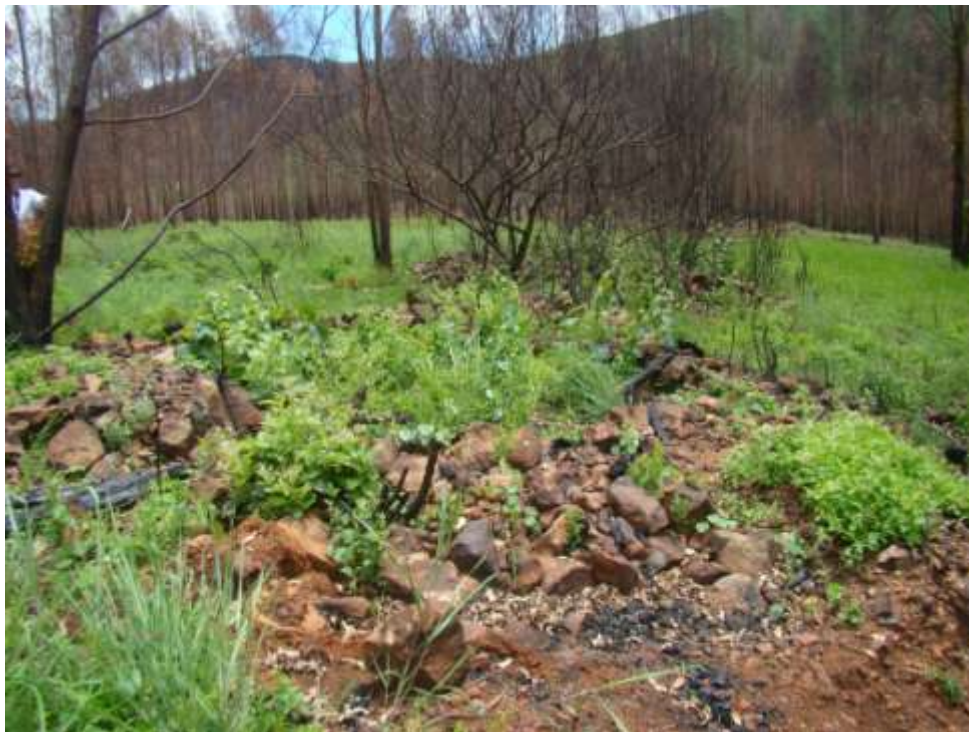
General comments Z40: These units are situated on a flat section near the main access road. The general condition of the units is not good. Vegetation cover was thick at the time of the visit and visibility was restricted. The units are close together. No archaeological finds were observed.

Fig. 223: Two large units with a division in the one unit. Vegetation cover was thick and visibility restricted.

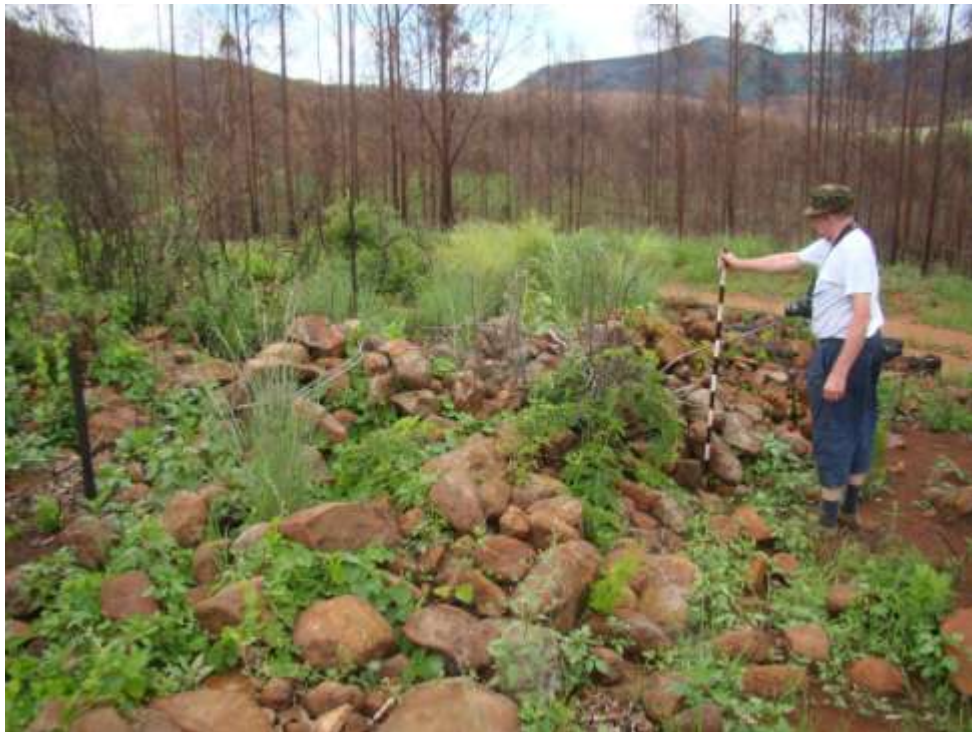
Fig. 225: Three smaller units connected by straight walls. Vegetation cover was thick and visibility restricted.

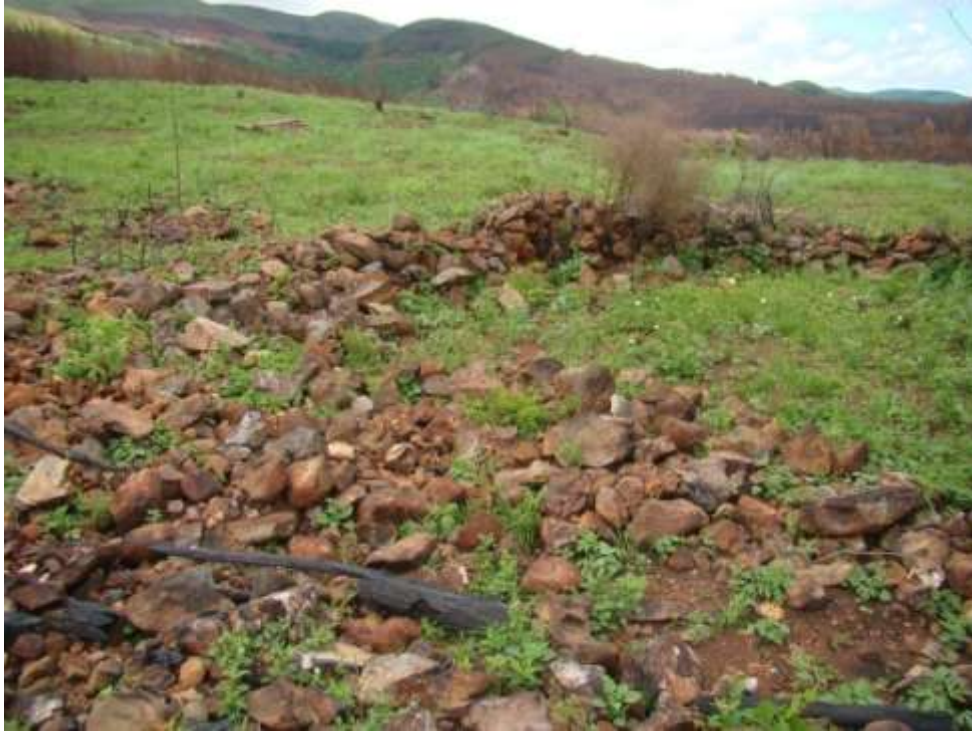
General comments Z32: The area has burnt recently but is now overgrown with vegetation and visibility was not good. A burnt tree has damaged Z32 -2 as well as a vehicle which was driven onto the walls. No archaeological material was observed.

Fig. 227: A circular unit connected to another unit. It is overgrown with vegetation and visibility was not good.

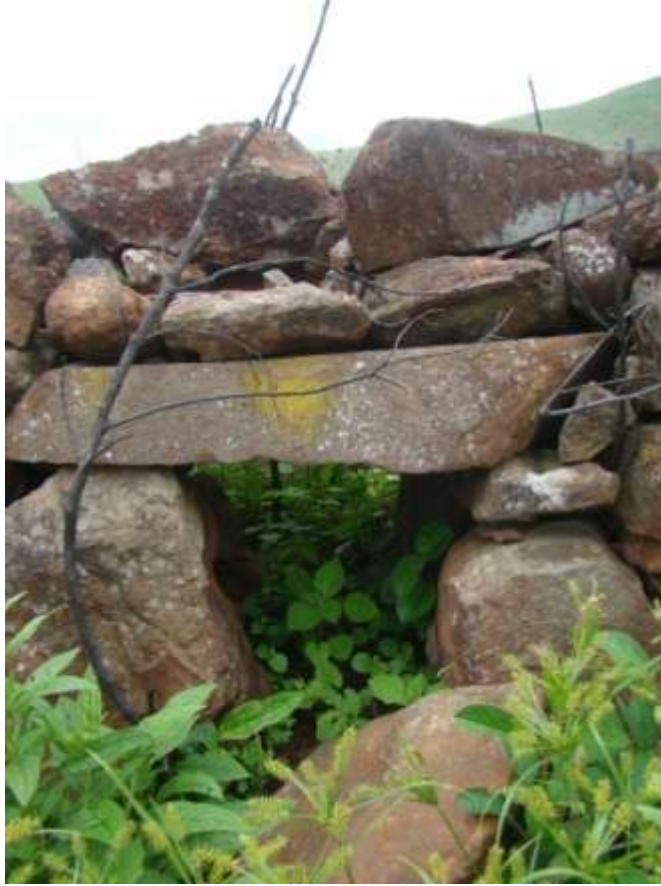
Fig. 229: Entrance opening with a stone lintel.

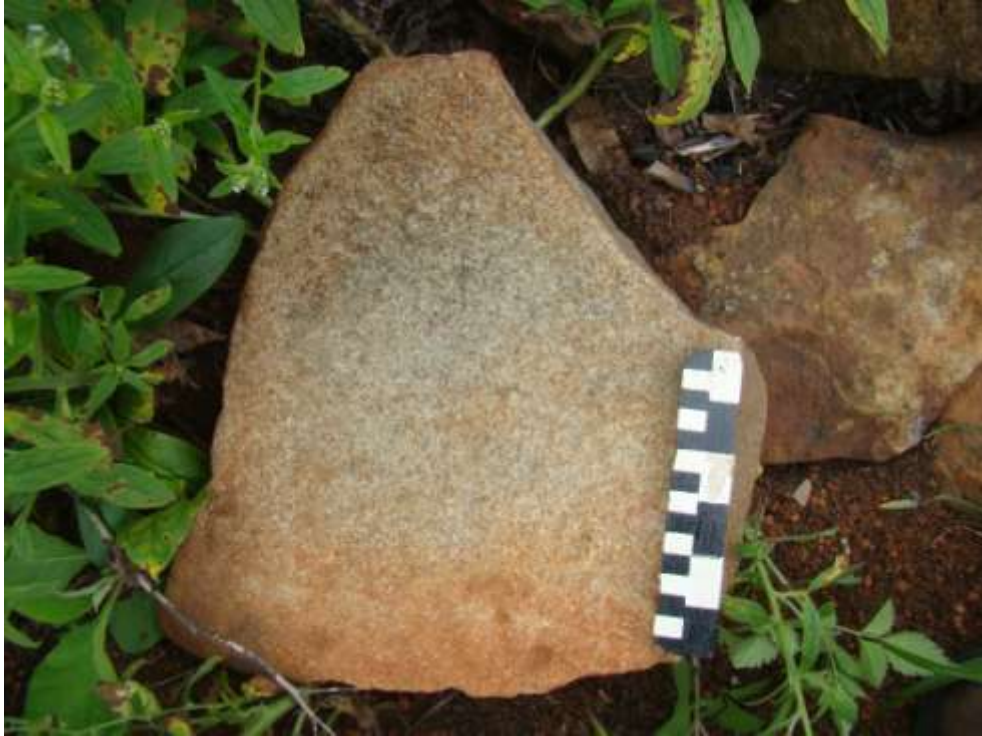
Fig. 231: A broken lower grinder which was found inside the enclosure.

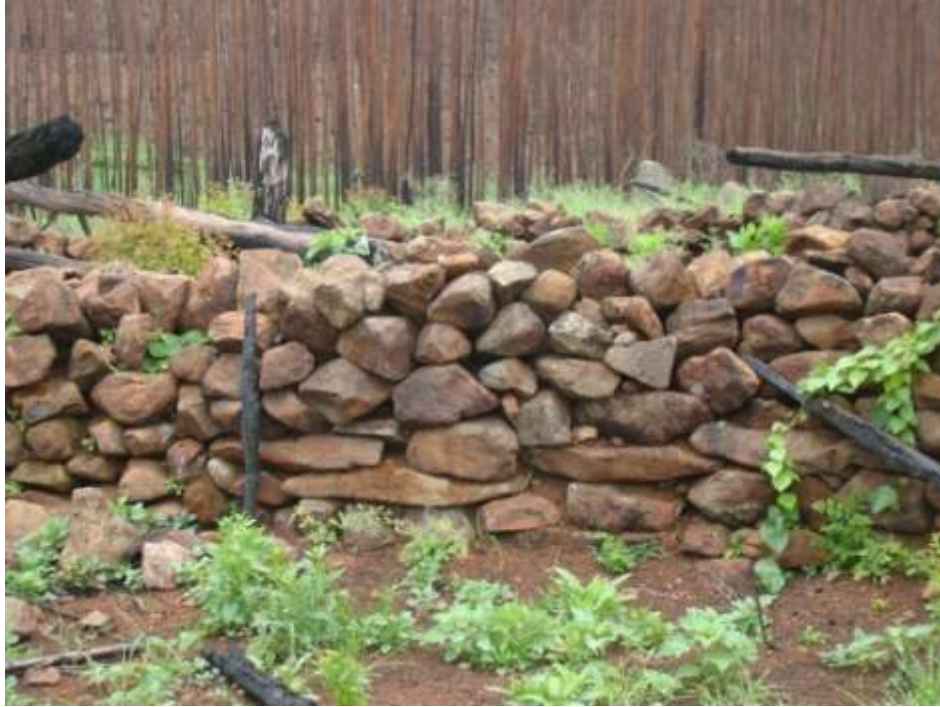
Fig. 233: The walls of the enclosure are still in a good condition.

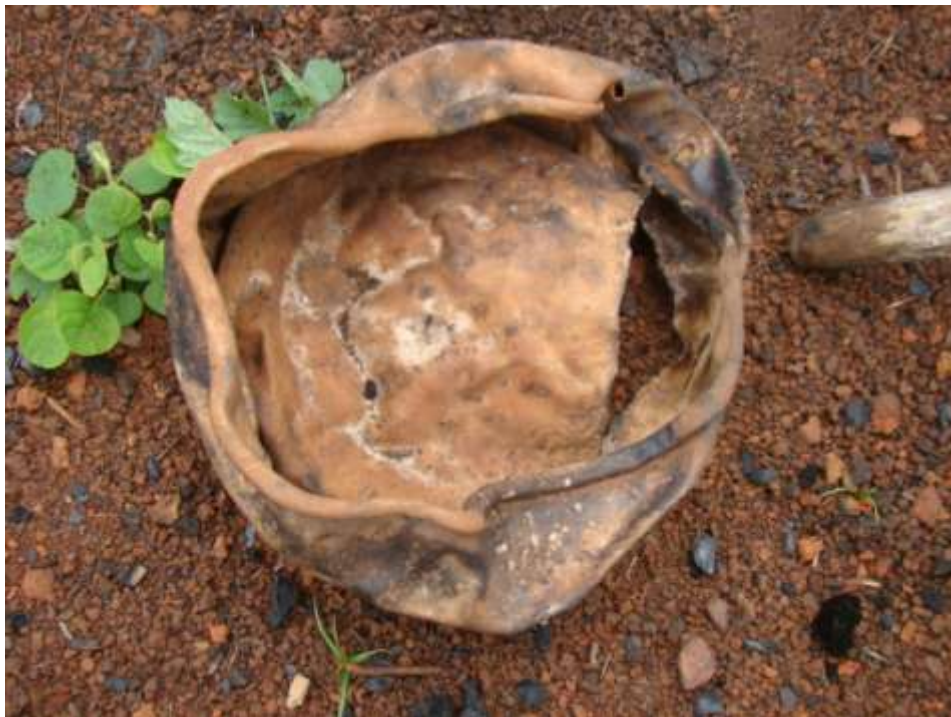
Fig. 234: A cooking pot which was found in the enclosure, was damaged by the recent fire.

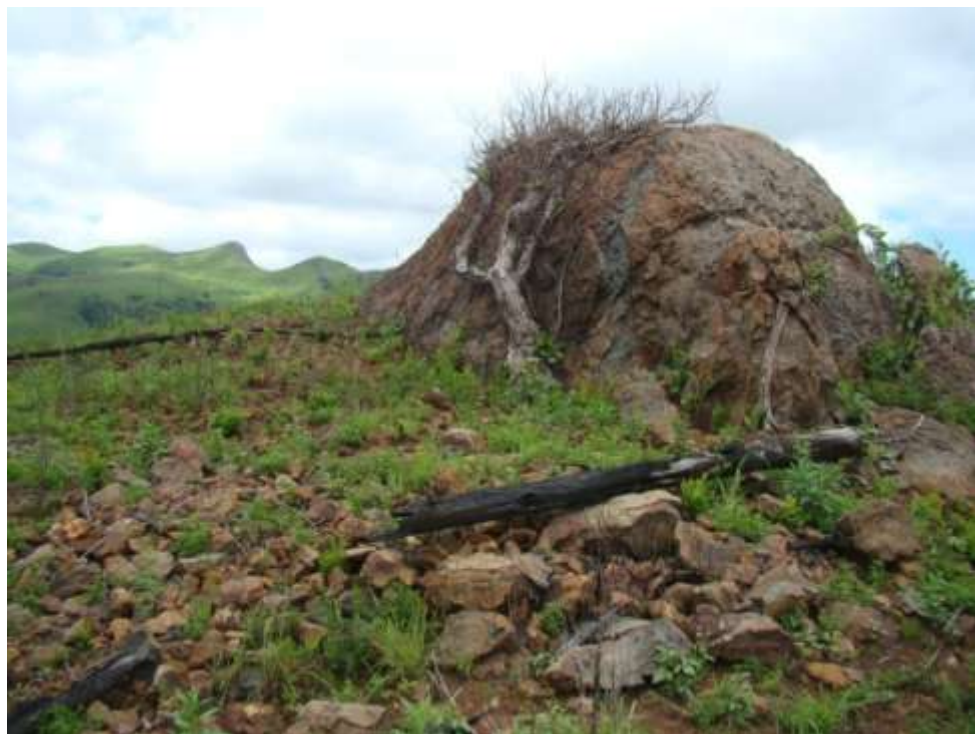
Fig. 241: A natural rock which may have been used as part of a possible enclosure.

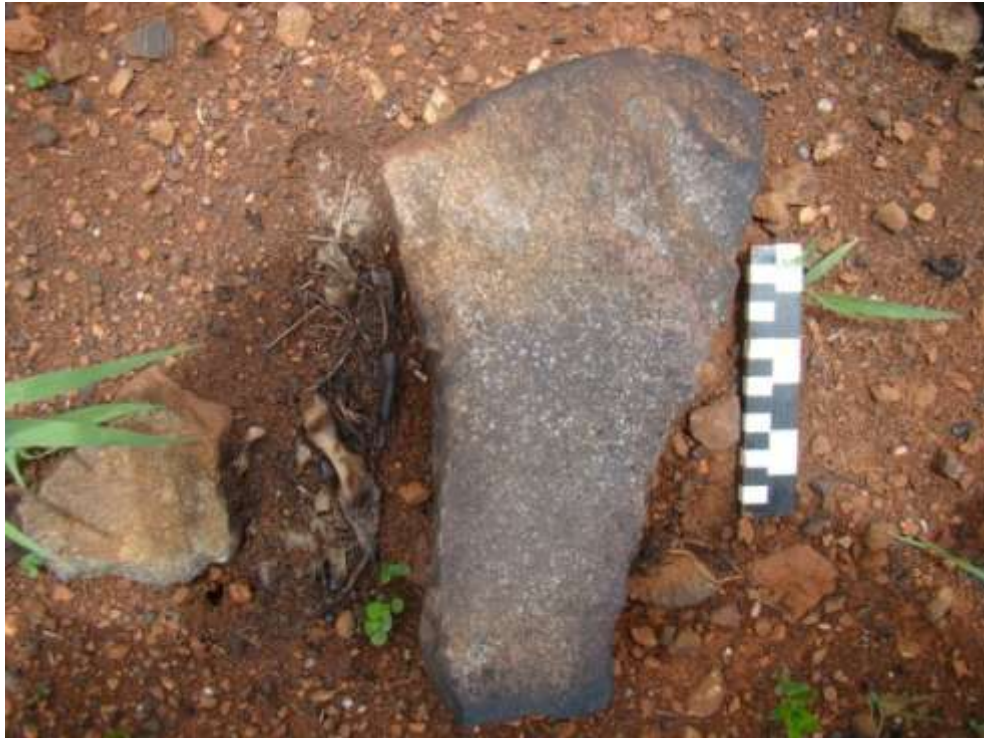
Fig. 242: Broken lower grinder near a natural rock which may have been used as part of a possible enclosure.

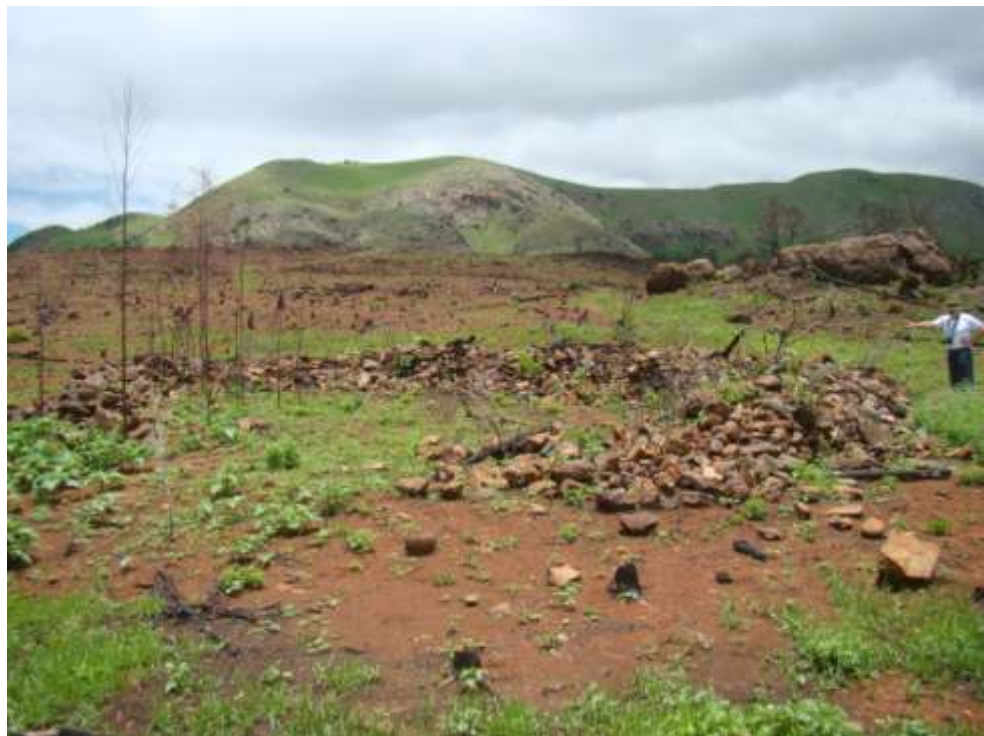
Fig. 243: A large circular unit (approximately 20m in diameter) is east of C22 – 3. The walls are in the region of 800mm high.

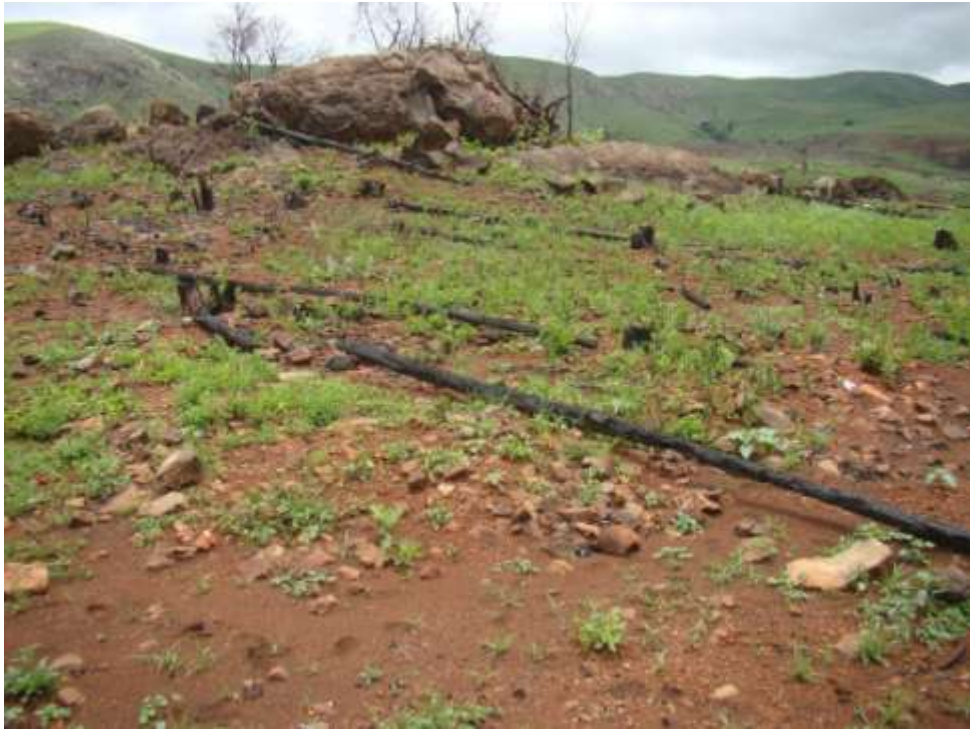
Fig. 244: Small circular unit between the large unit (C22 – 4) and the natural rock and possible enclosure.

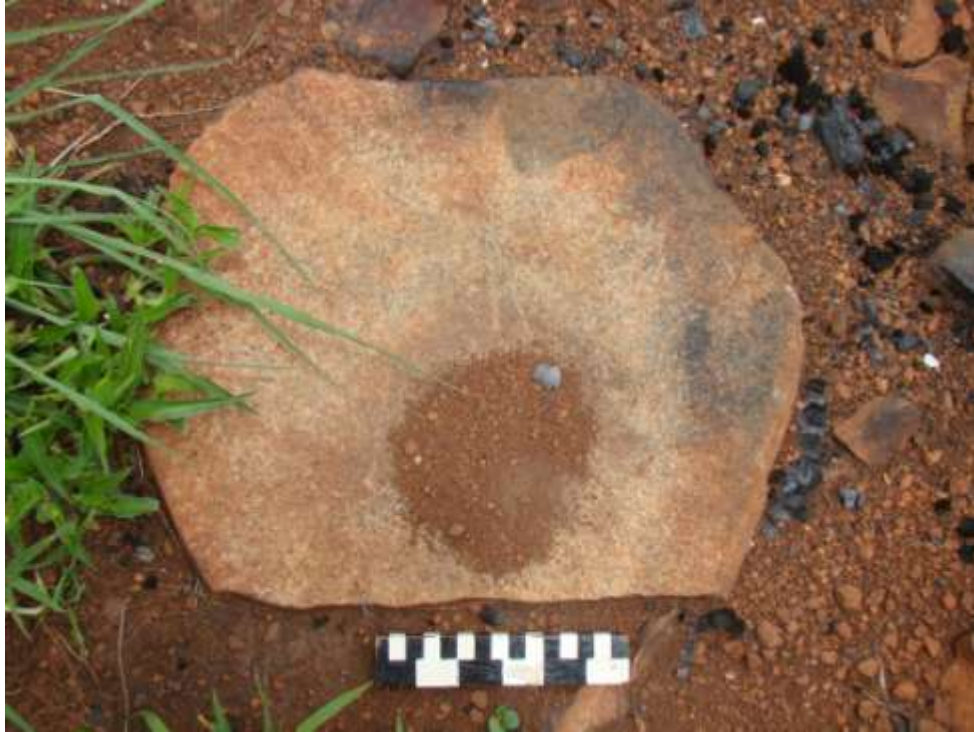
Fig. 246: The other one of two broken lower grinders inside C22 – 3.

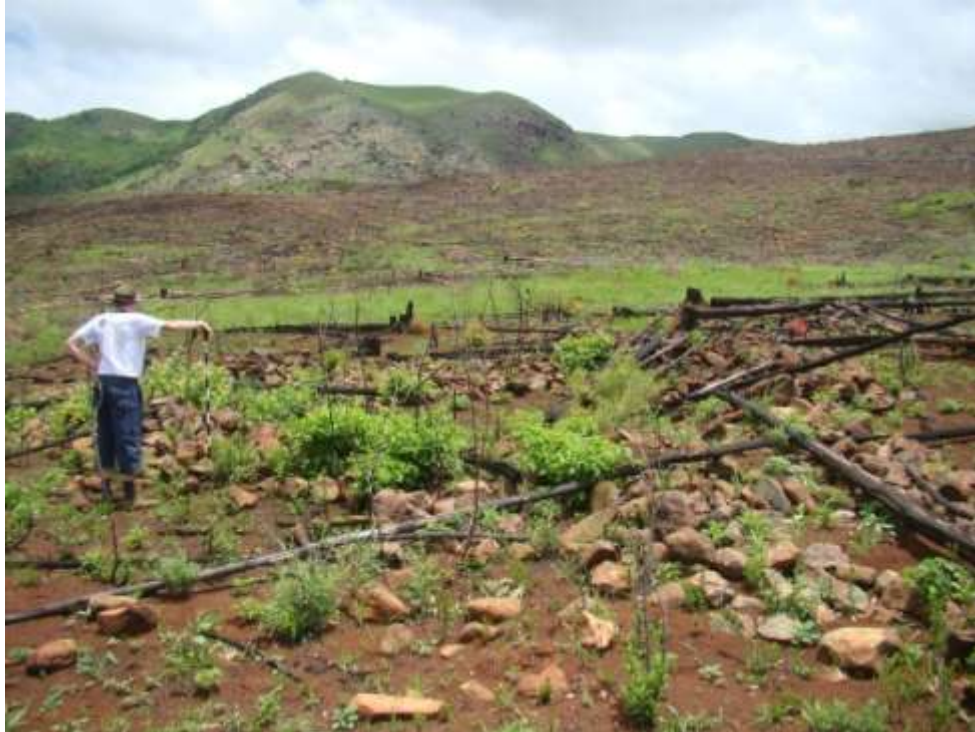
Fig. 248: Two Circular units next to each other. Units C22 – 7 has visible divisions inside. There are also low stone wall connected to the units and which leads away from them.

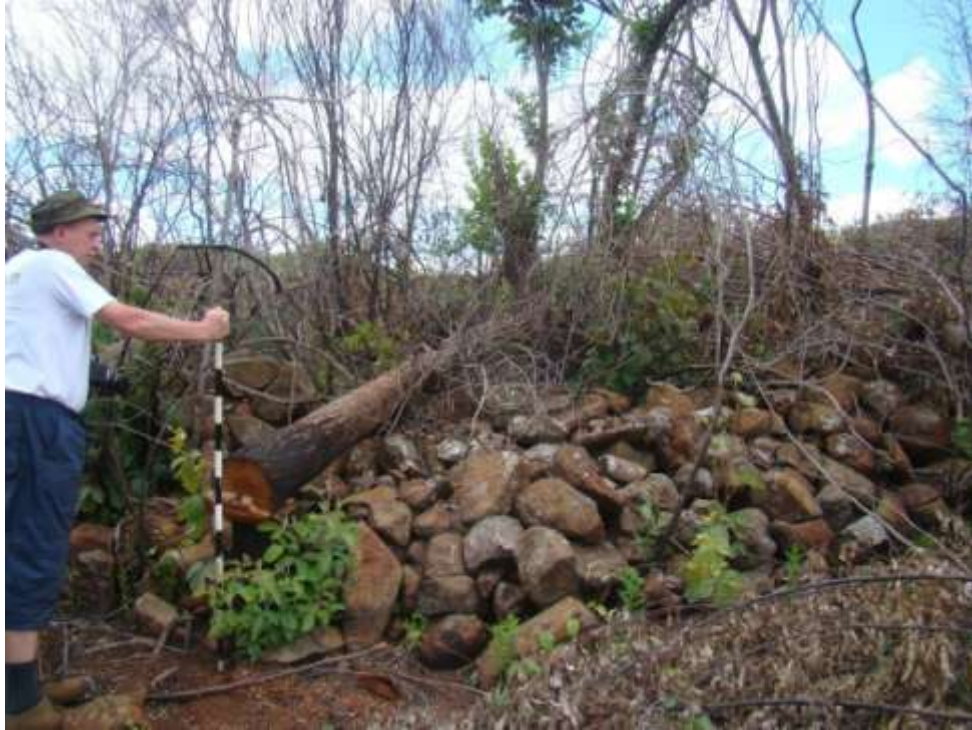
General comments C22: C 22 is situated over a widespread area, and it seems as if road and plantation activities have destroyed sections. Unit C22 – 8 is still in a good condition and worth preserving.

Fig. 250: C22 – 8: A circular wall on the northern side of the main access road is still in a very good condition, but damaged by a felled tree. The walls are in the region of 1000mm high.

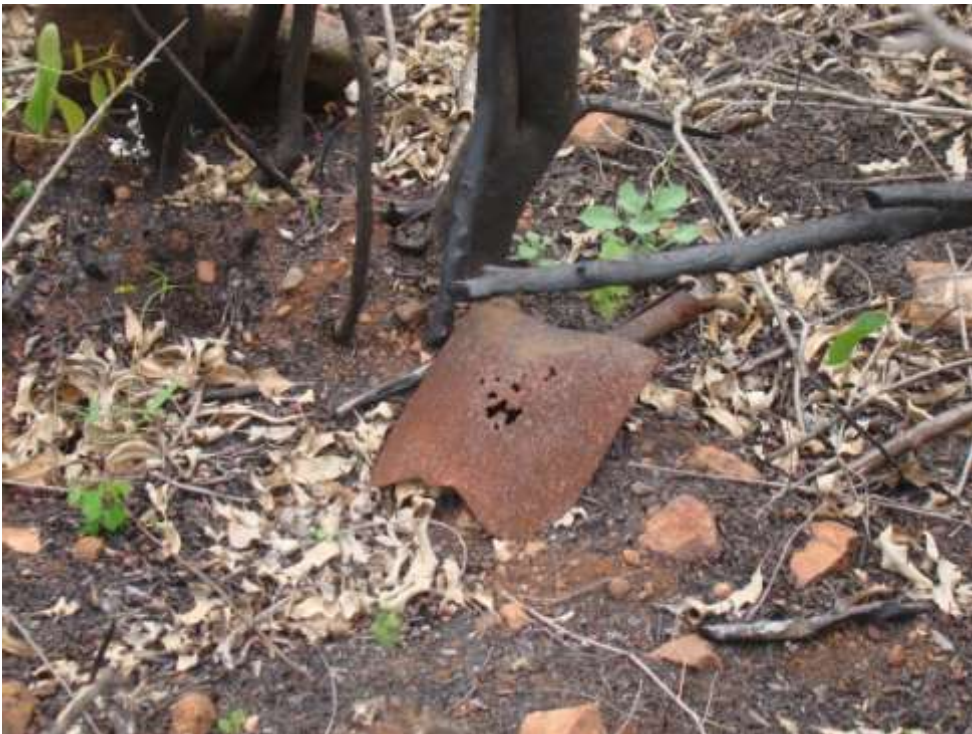
Fig. 251: C22 – 8: A recent metal spade inside the unit. This unit is worth preserving.
