Heritage Impact Assessment of the proposed Amakhala-Emoyeni Wind Energy Facility, Cookhouse District, Eastern Cape.

Savannah Environmental (Pty) Ltd

October 2010

Dave Halkett, Lita Webley, Jayson Orton and Hugo Pinto

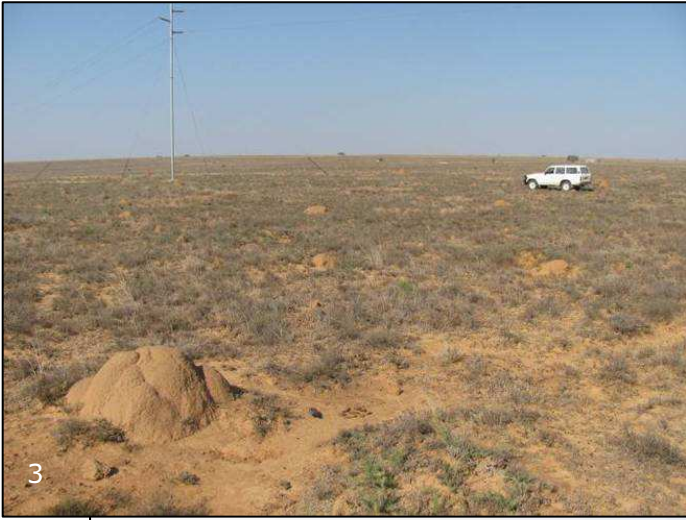
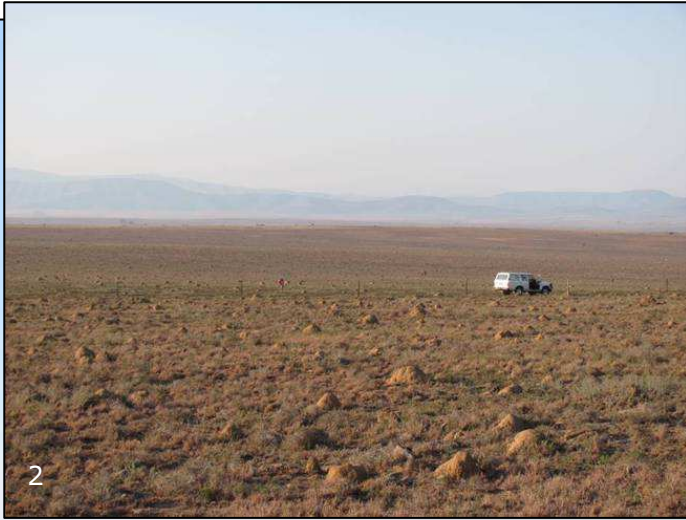
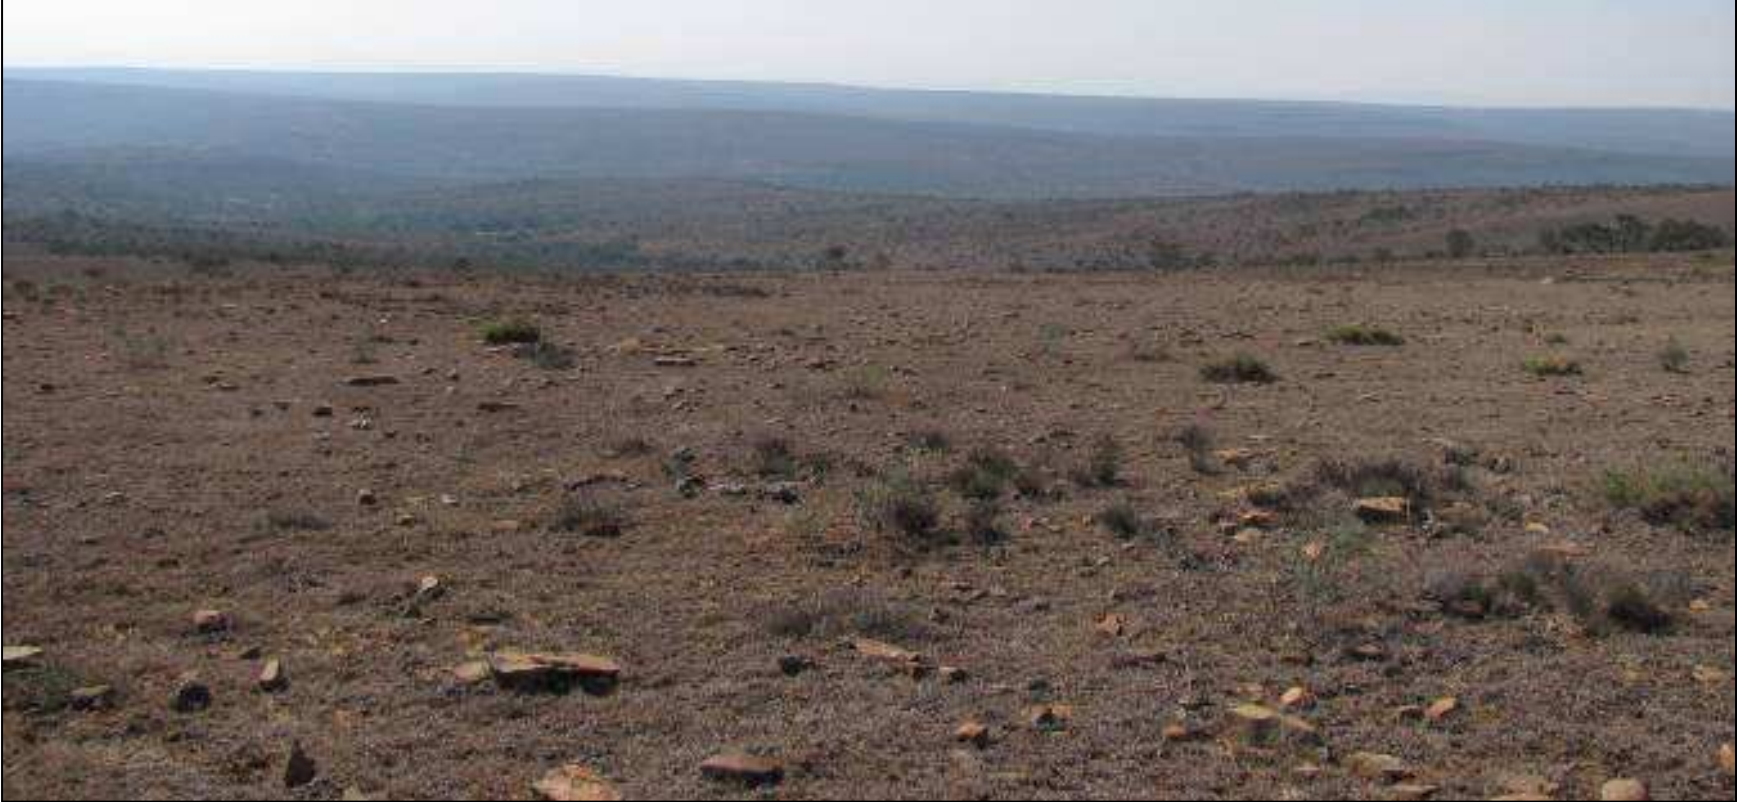
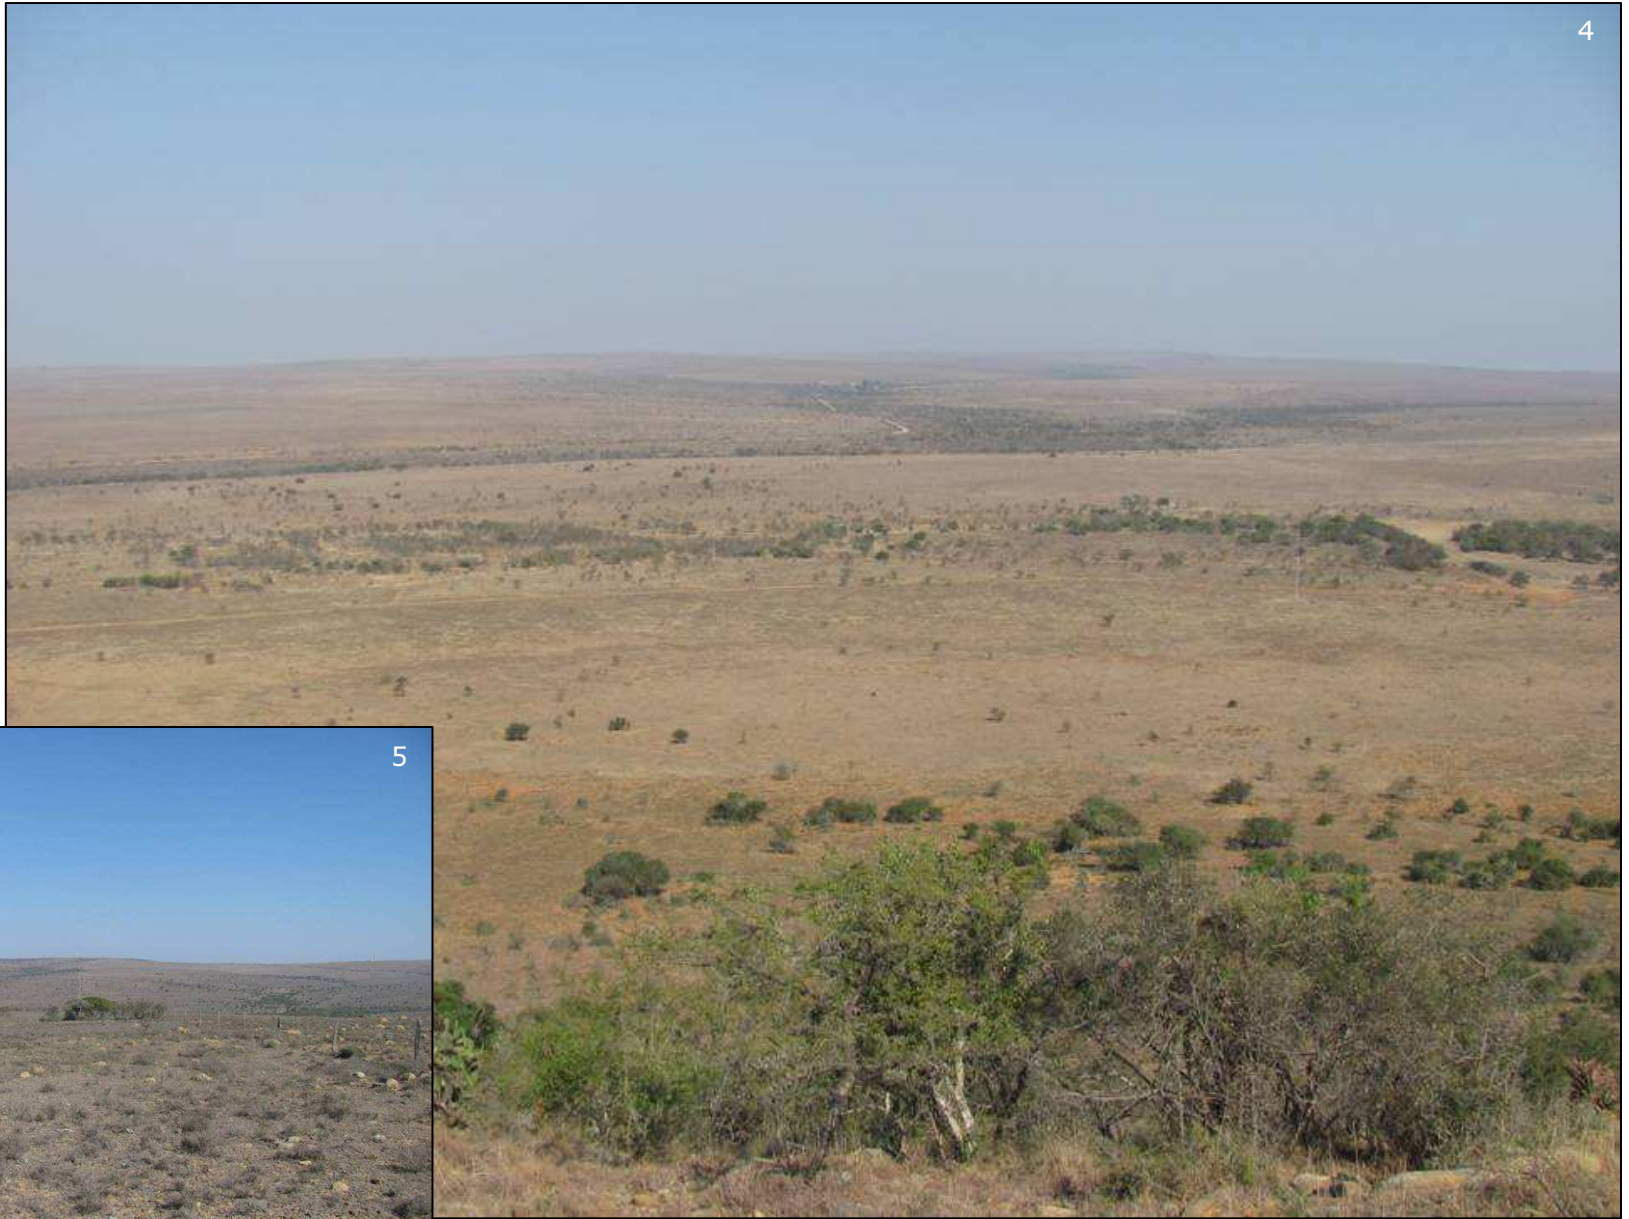
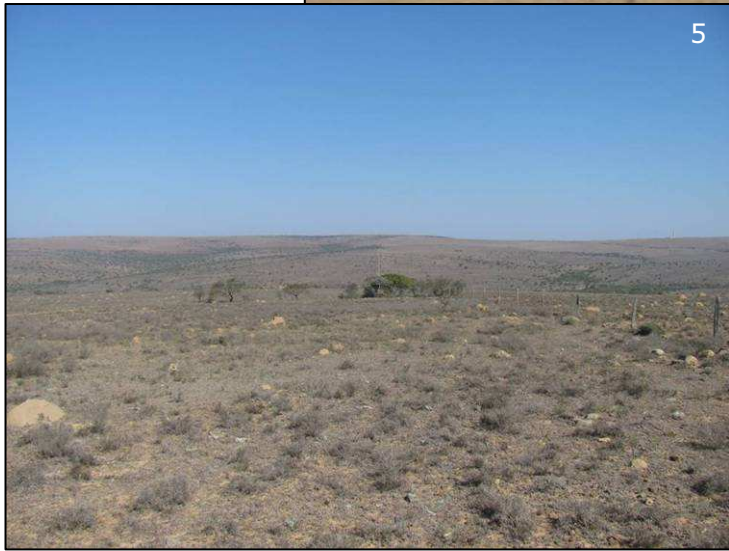
- 1.** View NE from T063 on Olive Woods Estate
- 2.** View NE from T283 on Kop Leegte
- 3.** View E on Farm 260

- 4.** View S from T020 on Farm 260
- 5.** View S from T179 towards T200 on Olive Woods Estate

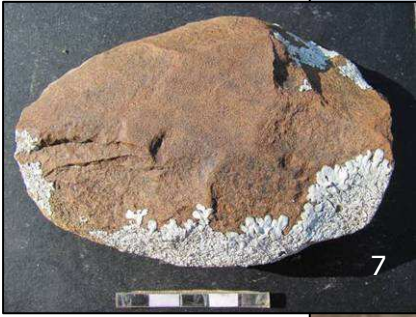
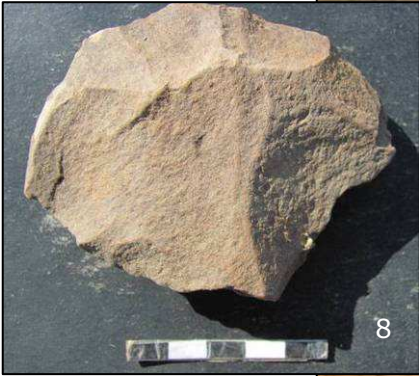
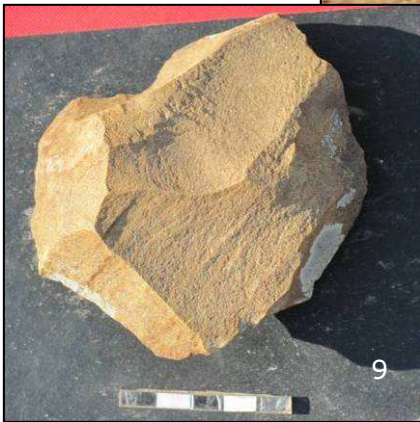
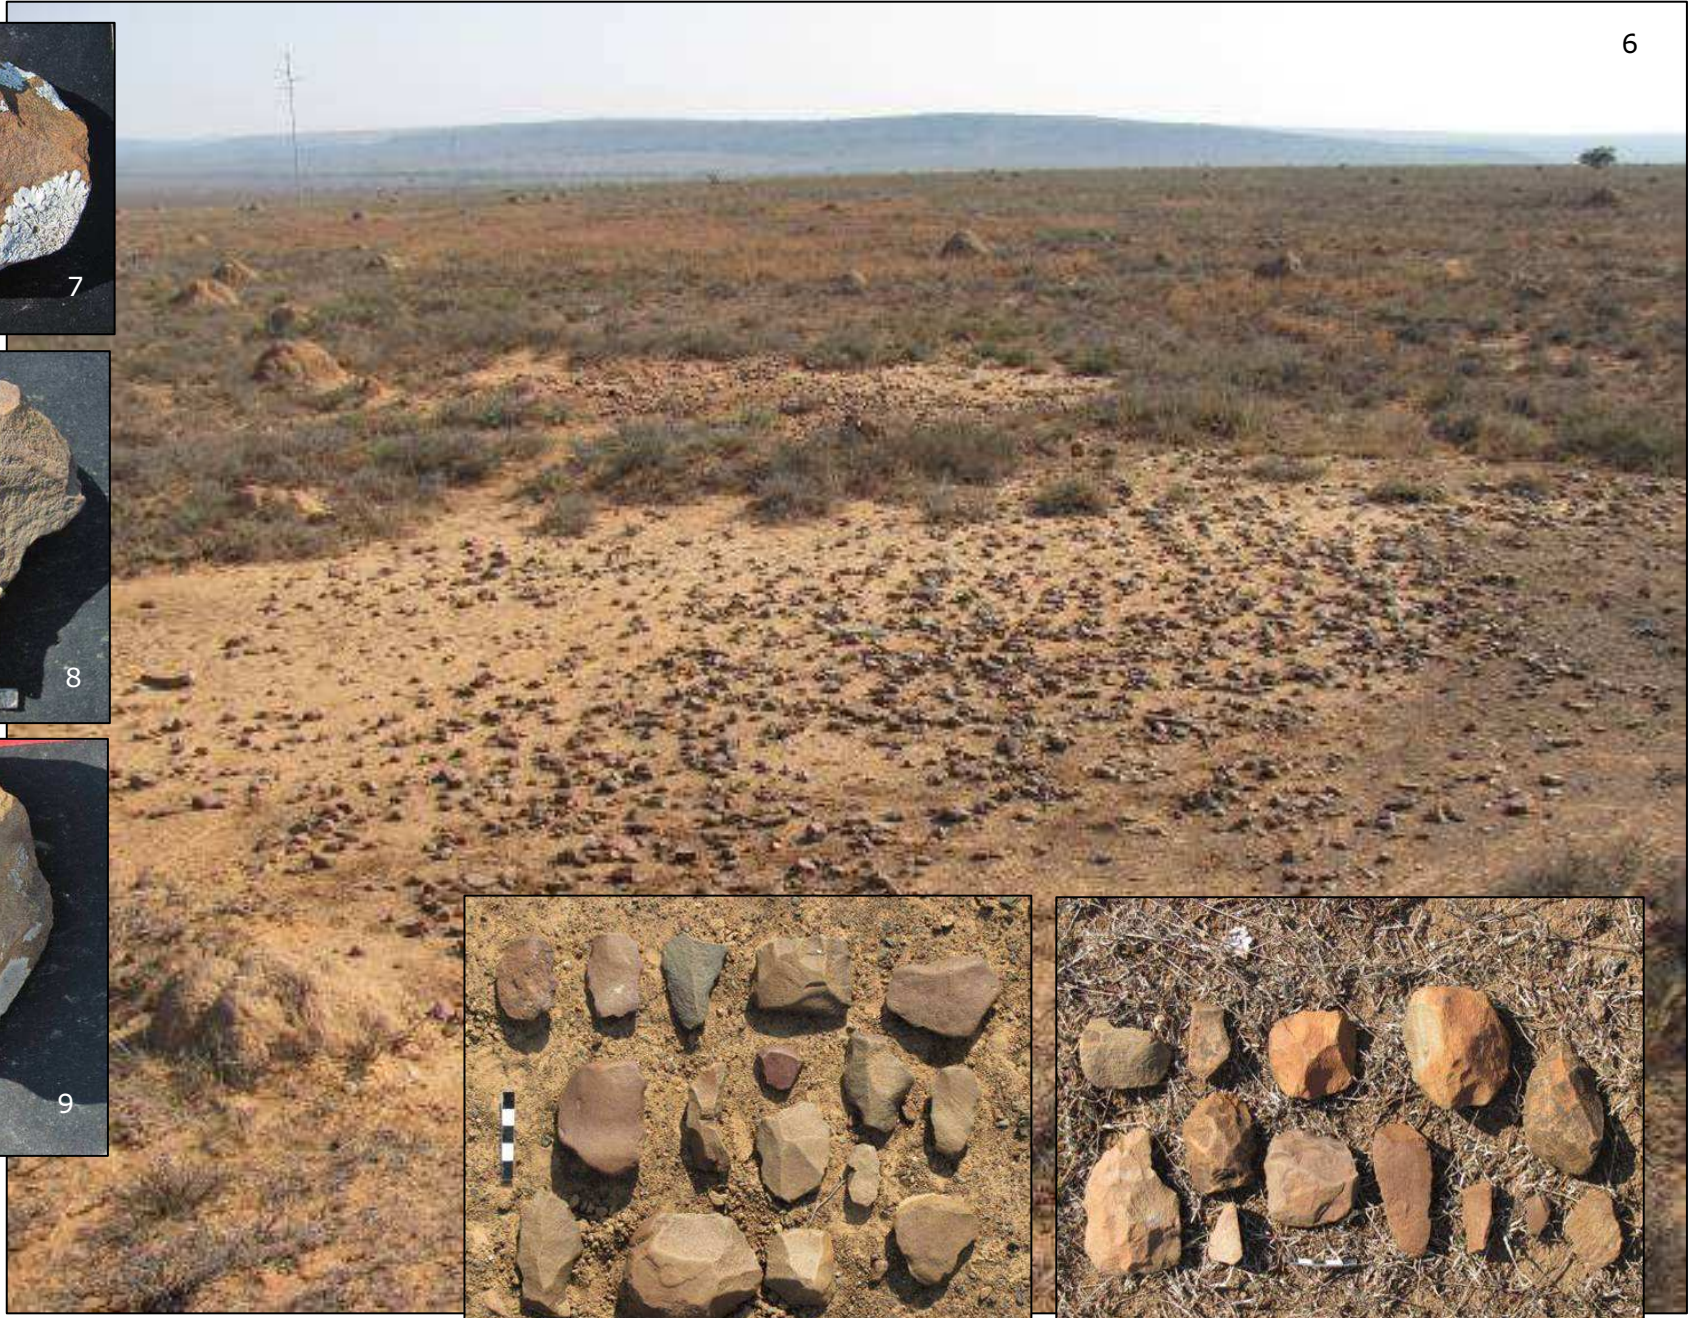
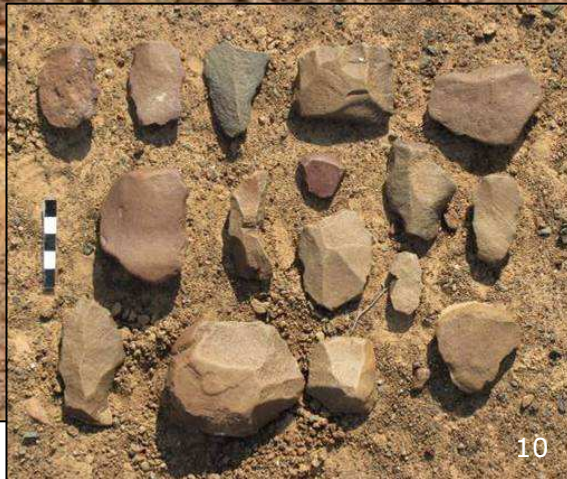
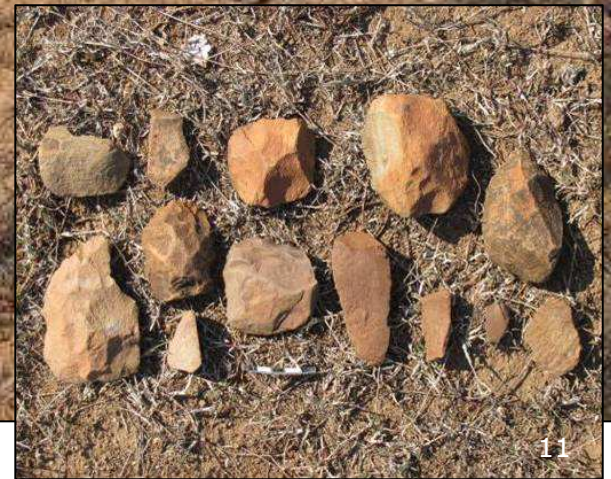
- 6.** F260/14 Concentration of ESA in deflation in saddle area. (similar to F260/13)
- 7.** F225/14 ESA hand-axe made on flake, broken and possibly unfinished.
- 8.** F225/25 ESA weathered flake
- 9.** F225/24 ESA Quartzite core
- 10.** F260/14 Selection of ESA artefacts
- 11.** OWE/23 Selection of ESA flakes and retouched artefacts on top of hill near an outcrop of boulders

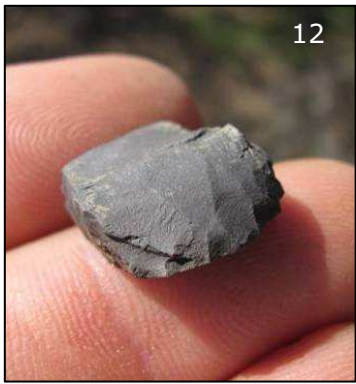
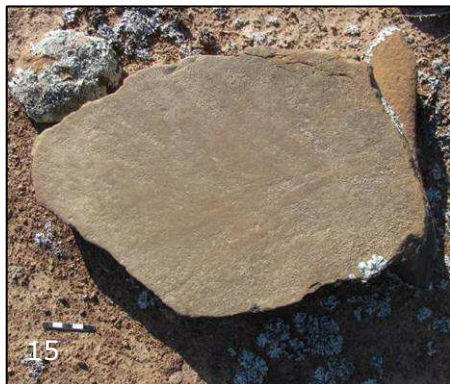
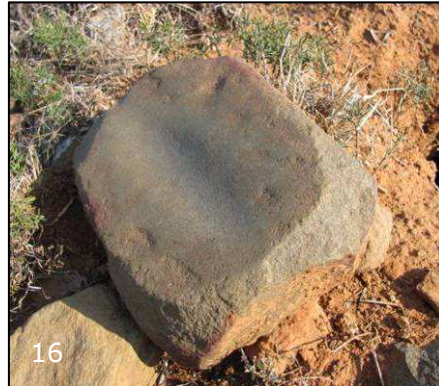
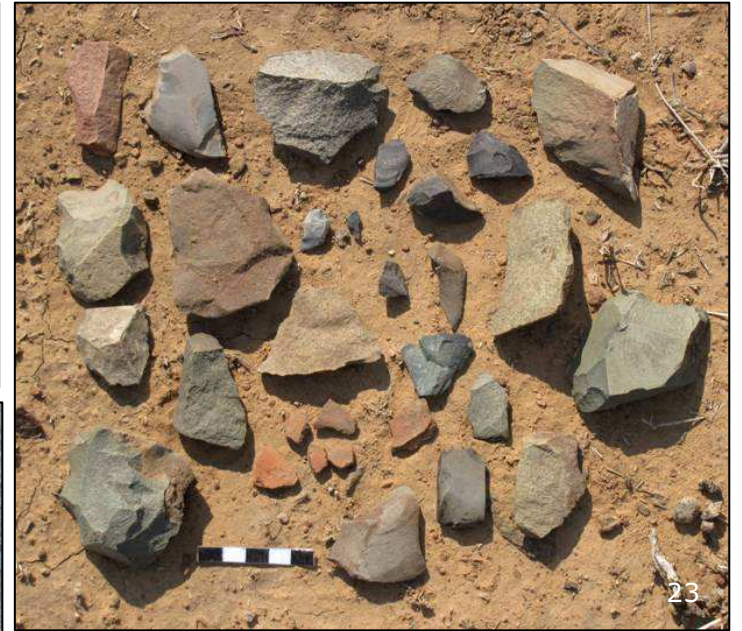
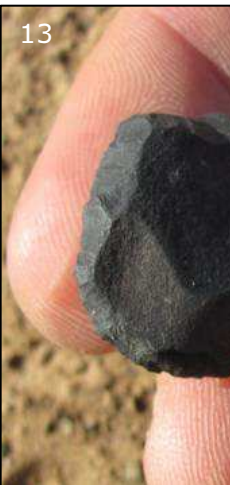
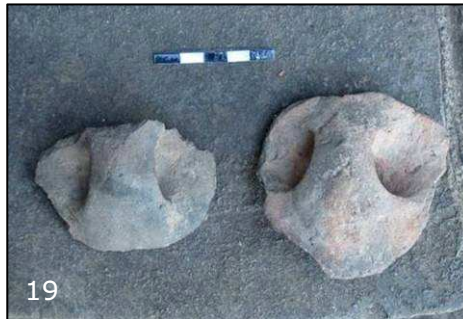
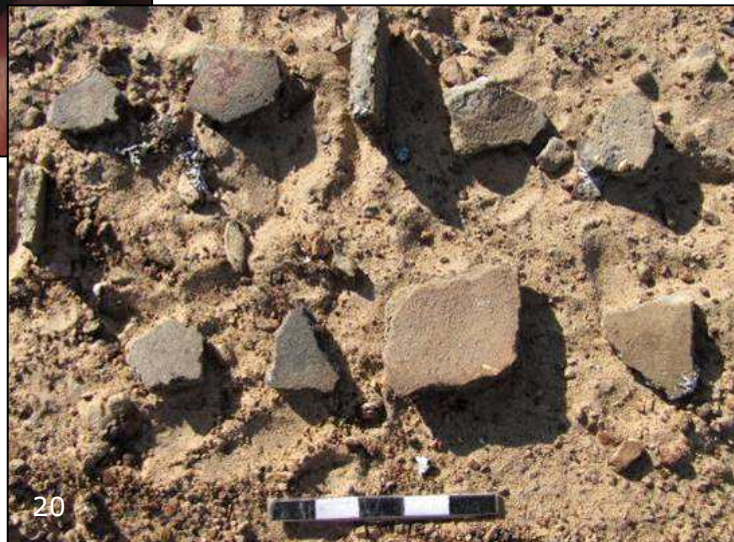
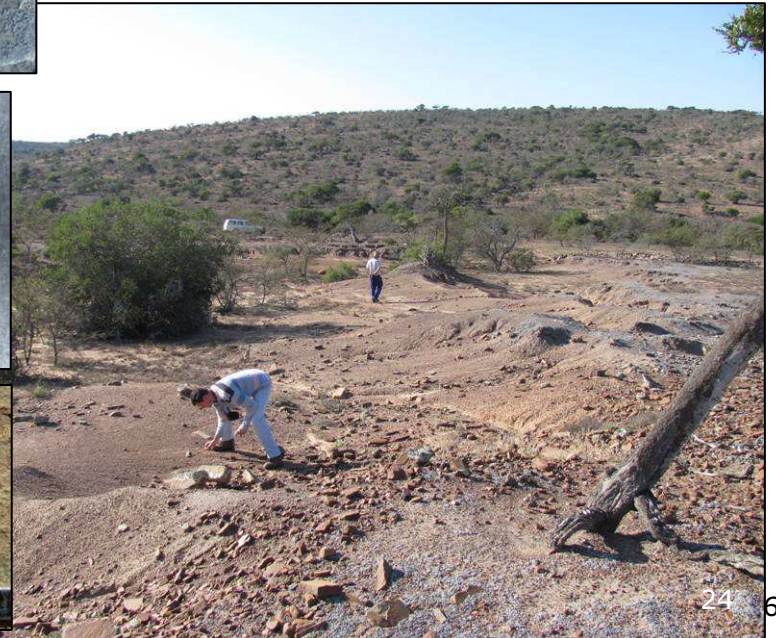
- 12.** OWE/16 LSA scraper made on hornfels
- 13.** OWE/5 LSA scraper made on hornfels
- 14.** OWE/5 LSA scraper made on ?silcrete
- 15.** PK2/2 LSA Lower grindstone made on local stone slab
- 16.** F260/9 Lower grindstone found on a grave.
- 17.** OWE/19 Upper grindstone on extensive low density scatter, LSA
- 18.** PK2/2 One of several upper grindstones found on this LSA site
- 19.** PK2/7 Two pot lugs, horizontally-pierced, collected from this site by farmer and kept at house.
 - 20.** PK2/2 Fragments of LSA pottery
 - 21.** PK2/9 Decorated LSA pottery
 - 22.** PK2/4 Broken bored stone collected by farmer
 - 23.** GKF/15 Stone artefacts and pottery fragments
 - 24.** PK2/4 Typical location for LSA sites in valleys

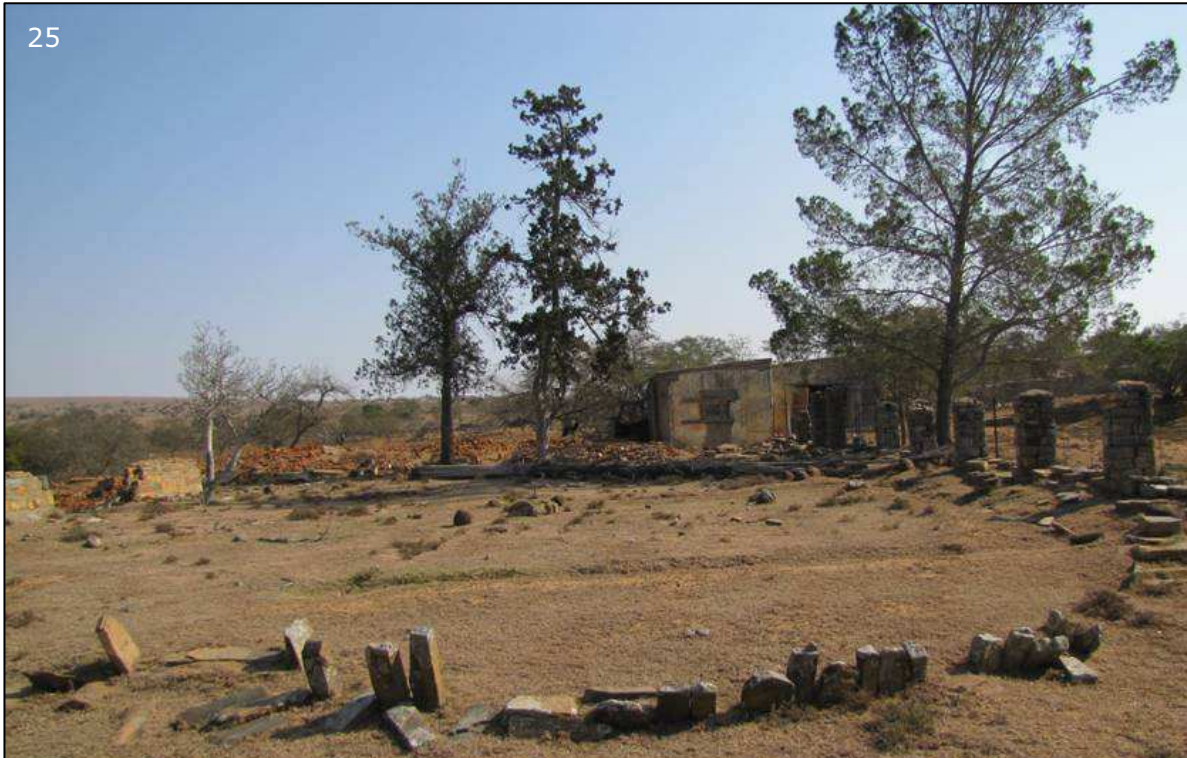
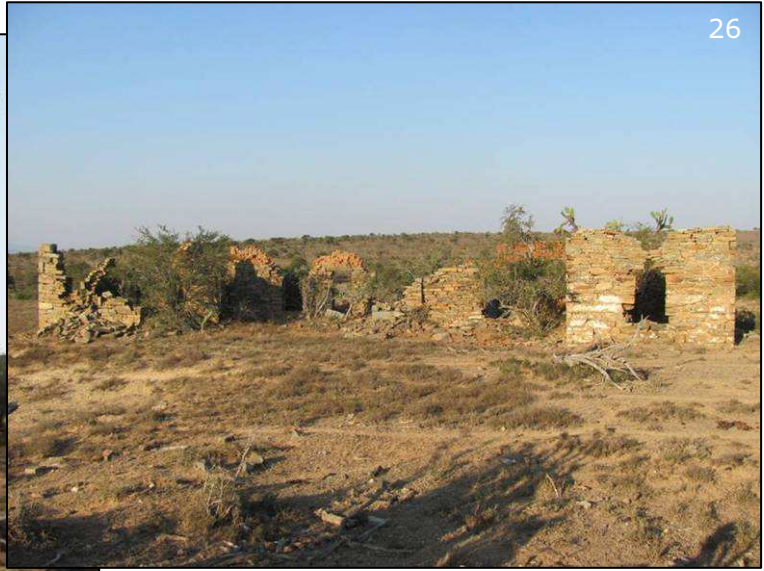
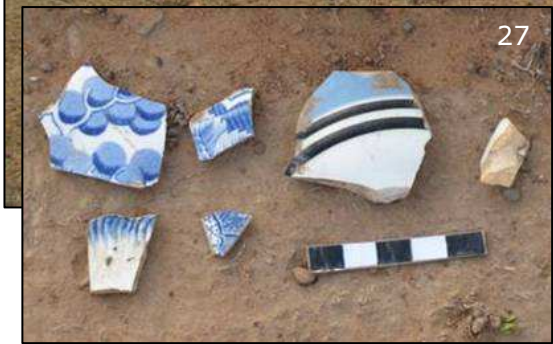
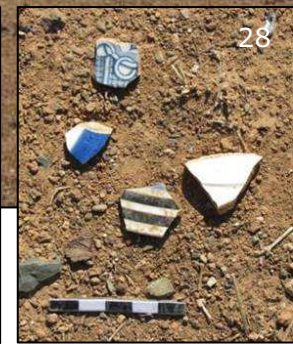
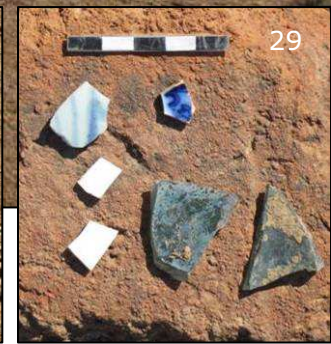
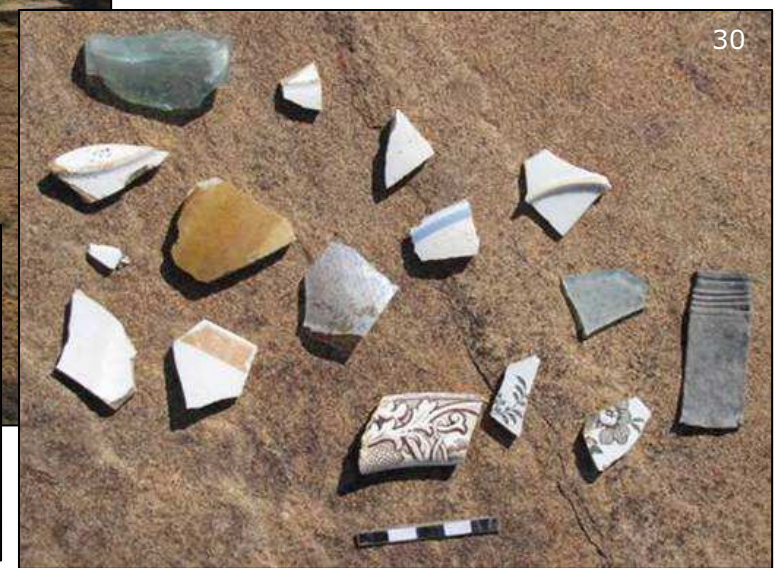
- 25.** GKF/3 remains of a trapvloer (threshing floor) at abandoned farm settlement
- 26.** LF/5 Ruined farm building
- 27.** F260/24 19th century ceramics all refined earthenware with typical decoration (incl shell edged pearlware and annular ware)
- 28.** TF/14 19th century ceramics all refined earthenware with typical decoration (incl annular ware)
- 29.** TF/10 19th century ceramics
- 30.** TF/11 19th century ceramics and glass from a dump next to a road (incl a flattened brass Martini Henry cartridge)
