INSPECTION REPORT OF DAMAGED PEDESTRIAN SUSPENSION (CABLE STAYED) BRIDGE CROSSING THE MSUNDUZI RIVER JUST WEST OF CHIEF ALBERT LUTHULI BRIDGE (S1 – 36), PIETERMARITZBURG.

Report by: AJ Bresler PR.ENG. As requested by Msunduzi Manager O&M (Bheki Sosibo)

Date: 17 November 2022.

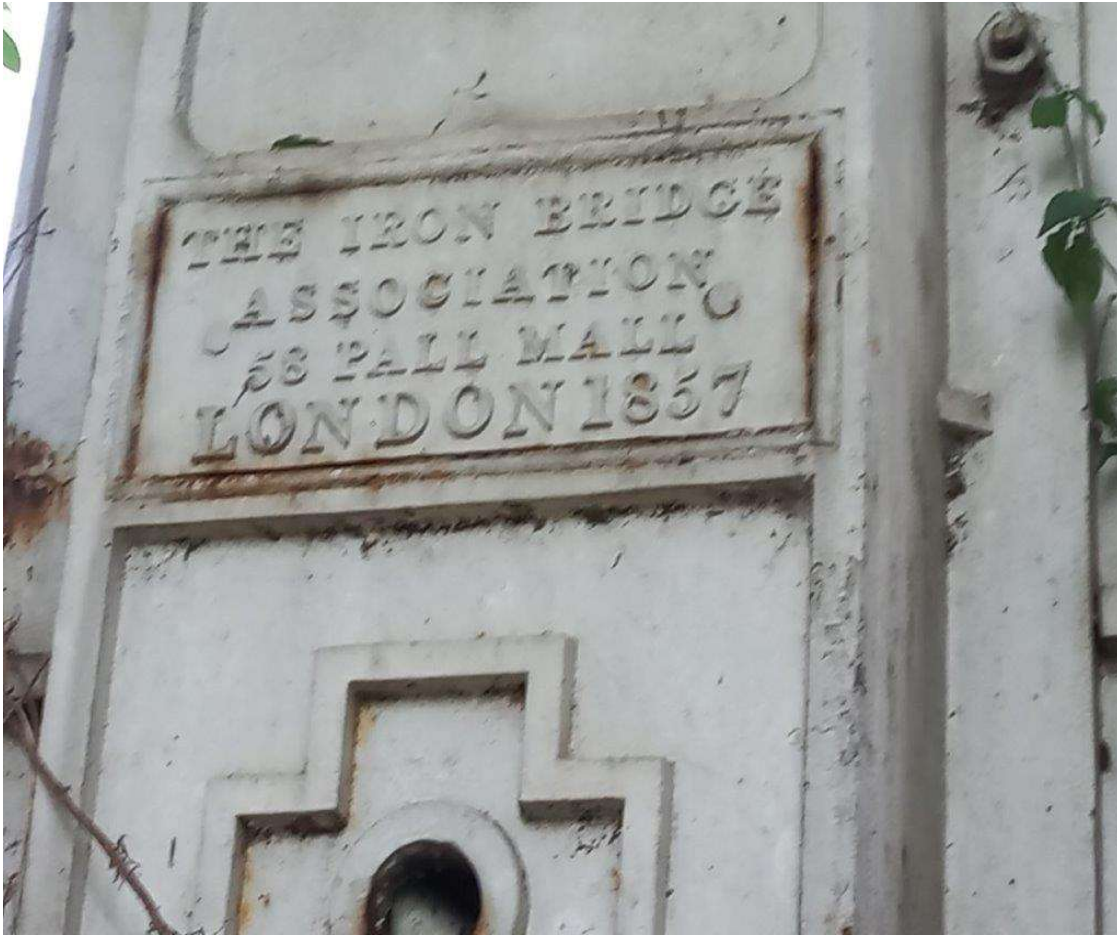
1. The bridge has a very unique and sound design. Generally speaking, except for the damages occurred on the 9th November, and some vandalism to some of the components of the parapet, the bridge is still in a very good condition, with very little signs of corrosion.
2. The bridge also has a plaque which connects it to the Iron Bridge Association, 58 Pall Mall, London 1857. If well-kept the bridge has special value as a historic structure and is a tourist attraction. (Picture 10)
3. Lastly the bridge has value because it enables pedestrians to cross the Msunduzi River without being exposed to the safety risk by making use of the sidewalk of the very busy Chief Albert Luthuli Bridge, when crossing the Msunduzi River.

Picture 10 – plaque connecting the bridge to “THE IRON BRIDGE ASSOCIATION”
