An inspection of the buildings in Church Street, Tulbagh, was done on behalf of the N.M.C. by Kirstin Van Tonder and Gwen Fagan on the 12th and 13th November, 1997. The following report summarises the legal and illegal changes which were found and provisional recommendations on how these might be addressed and the general image of the street be enhanced.

Kerkstraat in't Land van Waveren

GENERAL ISSUES:

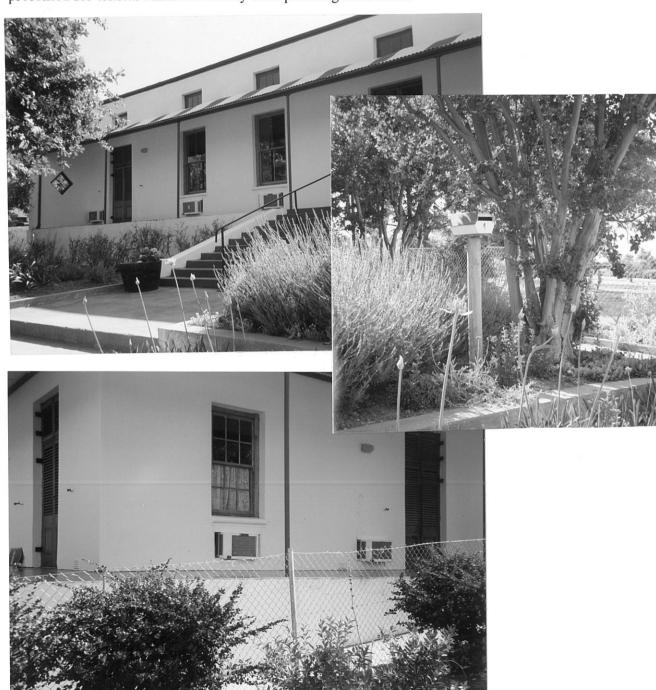
Walls have been partially demolished in three rooms.

Inside walls have been painted ochre.

A new window has been built into the front right room.

A new floor consisting of large modern clay tiles interlocked with small green ones has been laid in the back half of the central room.

Air-conditioning units have been installed on the two street facades after holes for them had been broken through the original walls.

French doors on the east facade have been replaced by a sash window.

Outbuilding doors are in a poor condition and lack paint.

As all changes were made without the approval of the N.M.C., plans and motivations should be presented for critical consideration by their planning committee.

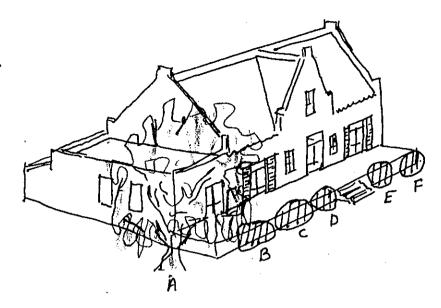
ⁱ		
~• (
7	HOUSE NO 6	
	The house is in a good condition and unchanged. A swimming pool and other built walls have been added in the back yard.	
	RECOMMENDATIONS:	
	As permission for the yard changes have not been obtained, plans of these should be presented, with motivations, to N.M.C. for consideration by their planning committee.

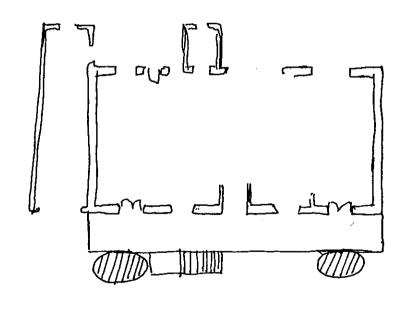
A second toilet has been added between the front and back portion of the house.

Various random garden walls have been built and white-washed.

A wide high garage shelter very visible from the street, has been constructed against the old monopitch thatched-roofed outbuilding.

Drawings of these changes with photos and motivations are to be presented to the N.M.C.'s planning committee for consideration.

The front garden needs to be upgraded to contribute to the historical atmosphere of the street.

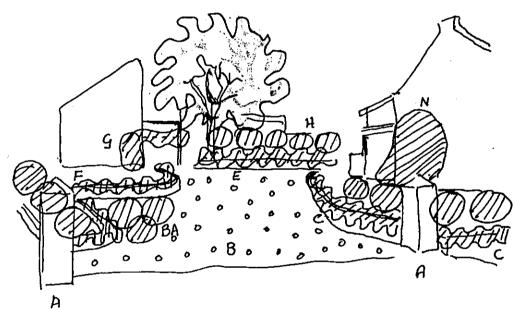
Wallpaper has been used in several rooms.

An outside baking oven has been constructed in the back yard.

A large thatched summer house has been constructed in the back yard.

Terraces have been made and levelled surfaces finished with a peach-pip clay mix. No precedent for this was found in Church Street.

A stone "braai" has been constructed in the back yard.

A large pile of bricks next to the house is to be used to construct a new horse-mill in the back yard.

A metal handrail has been erected in the centre of the front steps.

None of these changes have been presented to the N.M.C. for approval.

It is felt that the museum should set an example to the rest of the street owners by following the correct procedures when contemplating any changes to their properties.

Plans, photographs and motivations for all structures already built and planned, should be presented to the N.M.C. for consideration by their planning committee.

The front garden could be upgraded to lend atmosphere to the rest of the street.

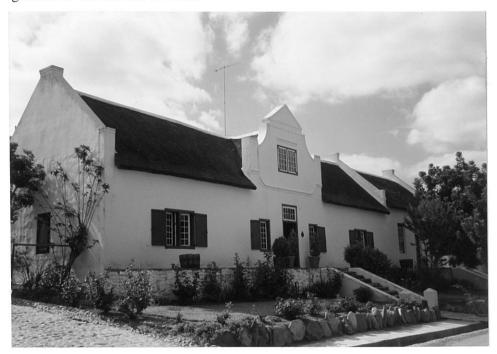
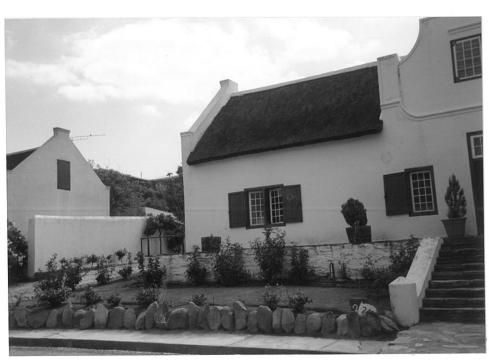
This house and outbuilding is unchanged and in a reasonable state of repair. The garden is unattractive as a result of the stone edging where all the stones are balanced on their short ends, and a lack of suitable planting.

The garden could be made much more attractive if the stones standing on edge on the street boundary were laid flat in a low loosely packed retaining wall. At present the beds are rather bare and contain a few unsuitable plants. It is suggested that the owners be provided with a plan which would enhance the street image. Low maintenance, low water requiring plants and ground covers should be used.

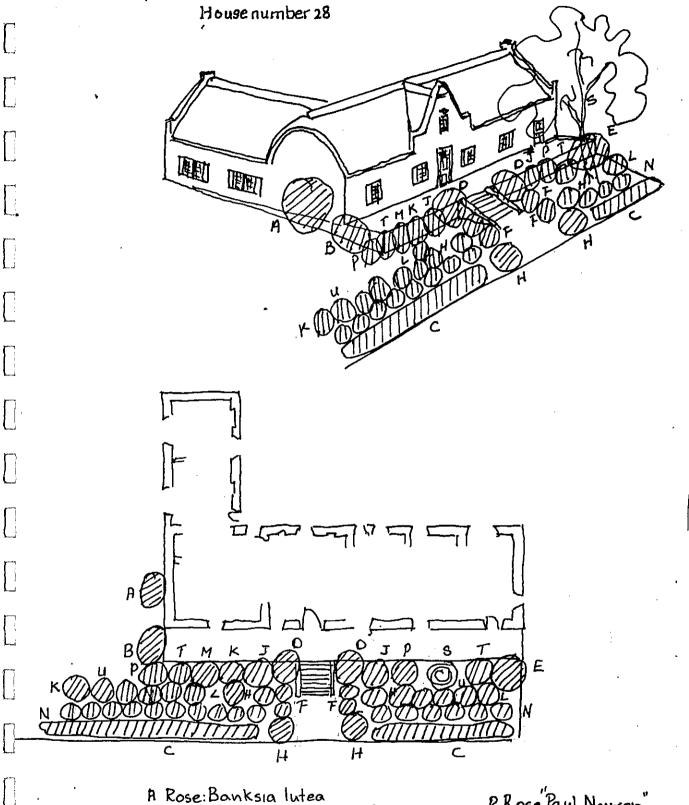
The front garden contains exotics which do not provide the right kind of atmosphere to the house or street in general. A new planting plan is suggested.

As the owner was in a great hurry to bring about the changes, he was advised that there was a moratorium on changes in Church street properties pending this report to the N.M.C. It was explained to him that old walls should be left intact and that the slight inconvenience of a longer walk to the bathroom should be endured. The bathroom can be ventilated artificially.

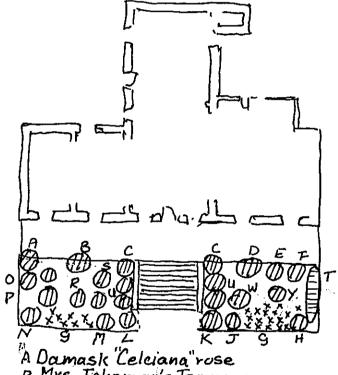
Γ	HOUSE NO 30				
	The previous owner put wall-to-wall carpeting onto yellow-wood floors in the two front rooms and painted one yellow-wood ceiling white.				
	A small cottage in one corner of the garden has been added after approval by the N.M.C.				
	RECOMMENDATIONS: The present owners wish to remove the carpets and restore the floors. As the painted ceiling				
	The present owners wish to remove the carpets and restore the floors. As the painted ceili may now be difficult to clean properly, it should be left as it is for the meantime.				
	The garden needs some attention to enhance the general street atmosphere.				
61

A Damask Celciana rose
B Mrs Johnman's Tea rose
C Fellemberg rose
D Berberis thunburghii atropurpurea
E Gloire des Rosomanes
F Viburnum opulus stevile.
White agapanthus (large)
H Cistus (small pink)
J Parson's Pink China rose
K Rose Boule de Neige
L Red China rose
M Rose "Mm. Plantier"
N Rose Multiflora nana
O Moss rose: Chapeau de Napoleon"

P Gloire des Rosomanes rose R'Mme Hardy rose u Rose "Maggie" W'Mme Lombard" vose y "Céline Forestier "rose

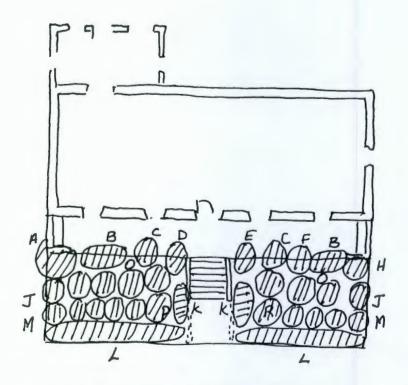
House number 38

The floors in the front rooms have been finished in unsuitable cut slate tiles, which were not found anywhere in the street.

A Berberis thunbergia atropurpurea
BRose multiflora unknown pink
CRose "Baron Prevost"

DHoneysuckle (Lonicera xamericana) RRose "Homer
ERose "La Reine"
F Golden Privet
HRose "Variegata di Bologna"
JRose "Hugonis"
KLavender hedge "Hidcote blue"
M Selection China roses
L Pink yarrow edging

All changes were made without the approval of the N.M.C. and plans together with a full motivation and photos should be presented to the N.M.C. planning committee.

The garden should be upgraded to lend an historical atmosphere to the house and street.
