KLEREFONTEIN FARM SQUARE KILOMETRE ARRAY (SKA), KAROO

by MAYAT HART ARCHITECTS & HERITAGE PRACTITIONERS

2023

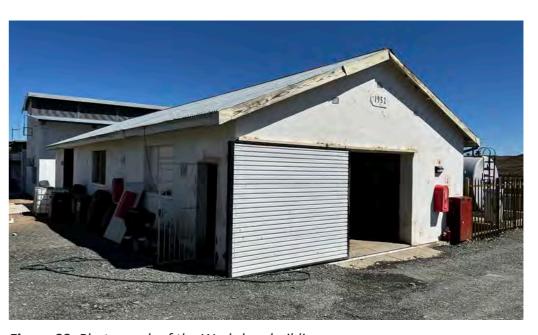
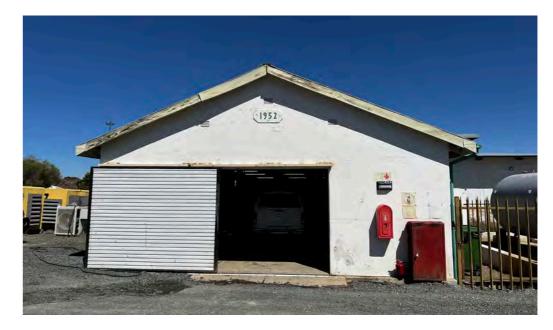
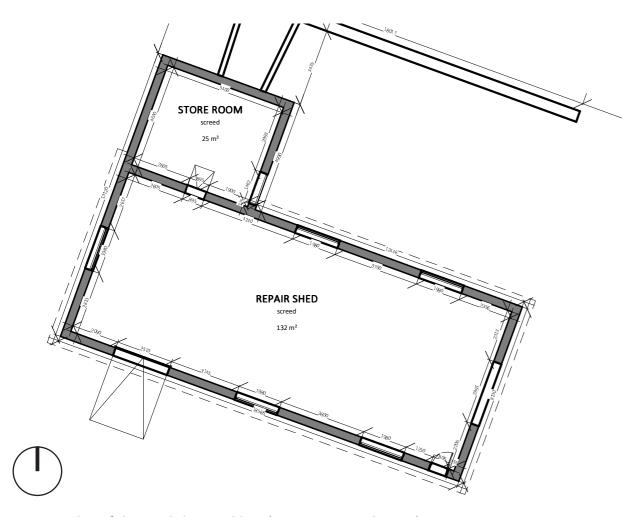
Figure 33: Photograph of the Workshop building

Figure 34: East elevation of the Workshop building with date of construction (1952)

Figure 35: Plan of the Workshop Building (Mayat Hart Architects)

The workshop building is a functional barn like structure with an attached lean to store room. The structure presumably dates from 1952 from the date on the gable as well as its method of construction. It is located next to the earlier kraal. The building would likely originally have functioned as a workshop and equipment store with the lean to structure used for sheep. The conversion of the building by SARAO in circa 2010 upgraded it internally and converted the former lean to structure for sheep into a tool store room.

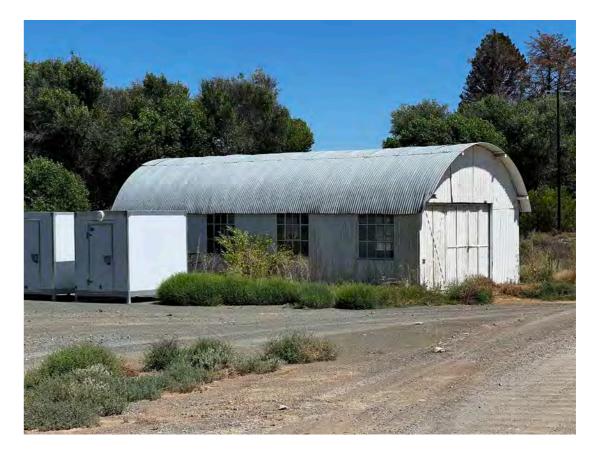
The barn is a corrugated iron building located to the north of the farmhouse. Its method of construction suggest that the building dates from circa 1930 – 1940, predating the workshop building.

Figure 36: Photograph of the Barn

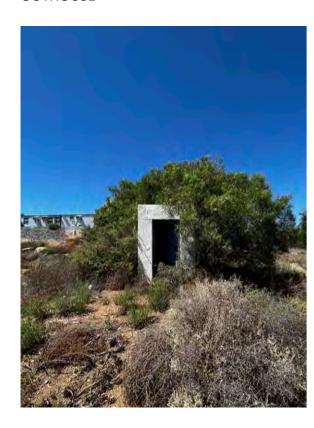
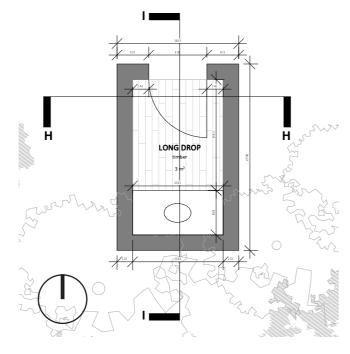
Figure 38: Photograph of the Outhouse

Figure 39: Plan of the Outhouse (Mayat Hart Architects)

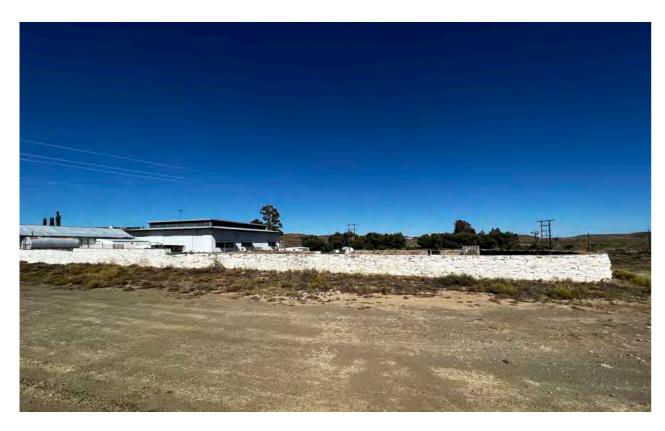
Figure 45: Photograph of the Kraal

- The kraal is a good example of an early stone type kraal dating from the 19th century
- The kraal is in a fair state of repair but is showing ome damage/collapse in places.
- The relationship of the kraal to the other original building is of significance. Some of the significance of the relationship of the kraal to the farmhouse has been lost due to the construction of the new support base building.
- The kraal is significant as part of the collection of buildings and structures of the Klerefontein farm werf.
- The location of the kraal, particularly as viewed from the main road and its association with the farmhouse behind is of significance.
- In isolation the kraal has a Grade 3C grading. Due to its association with the farmhouse and werf it should be treated as having a grade 3B grading as per the farmhouse.

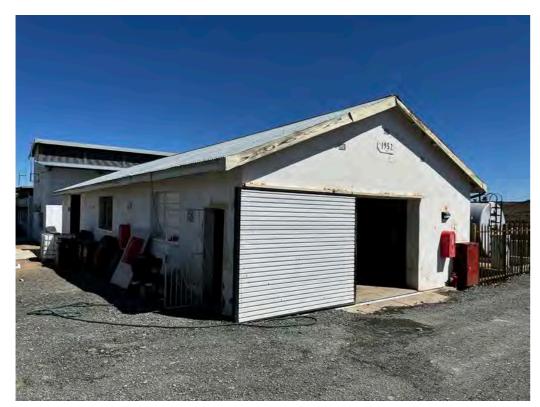
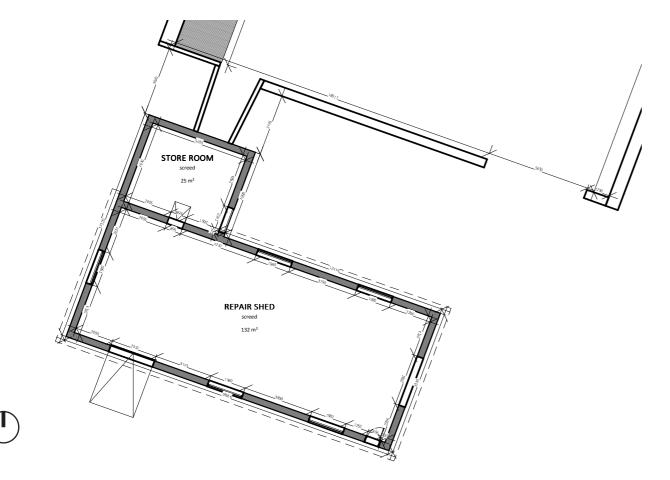
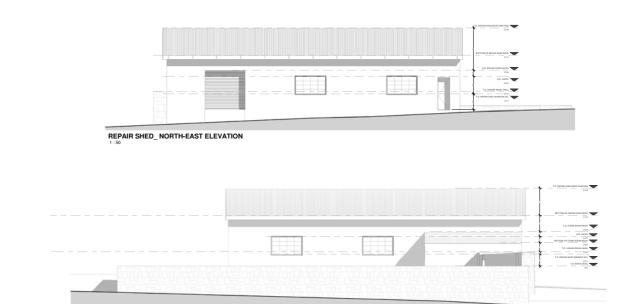
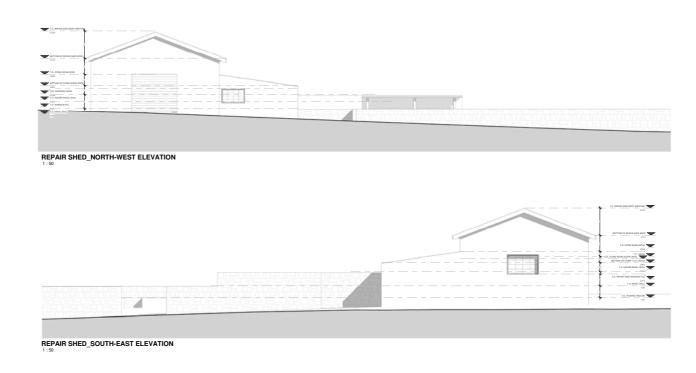
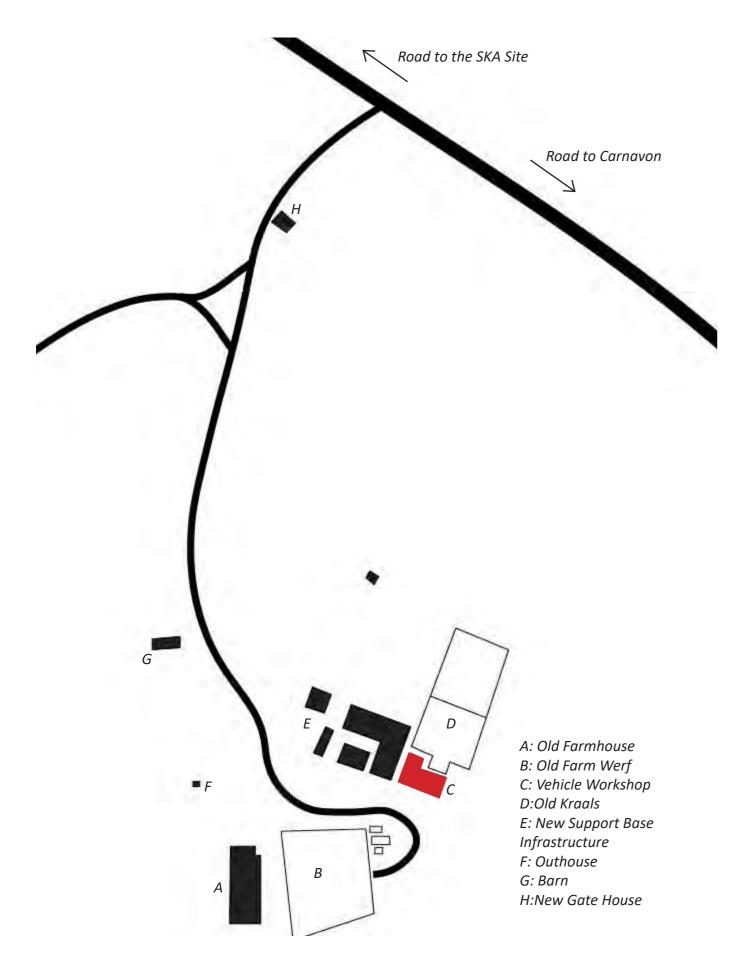
Figure 68: Klerefontein Workshop

- The workshop building is a typical example of a utilitarian farm building from the mid 20th century.
- The building has been substantially altered internally for its current function. It is in a good state of repair.
- The relationship of the workshop building to the other original building is of significance.
- The building is significant as part of the collection of buildings and structures of the Klerefontein farm werf.
- In isolation the workshop building does not meet the criteria for grading. Due to its association with the farmhouse and werf it should be treated as having a Grade 3C grading.

• Gutters and downpipes to be checked annually for maintenance, repairs and clearing.

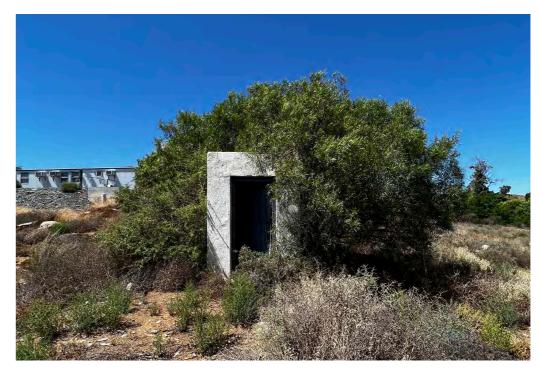
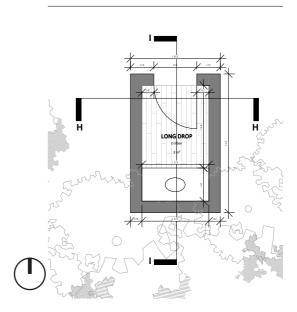
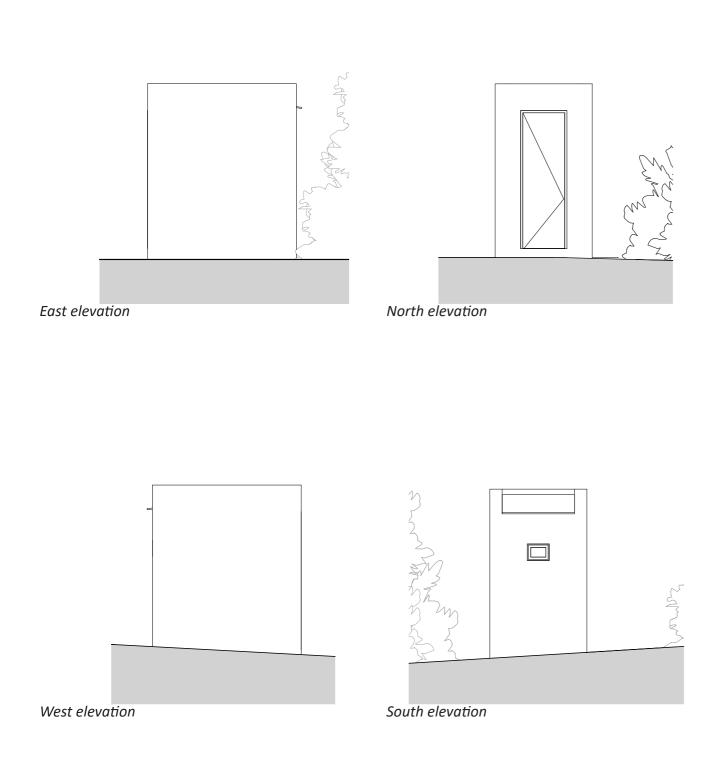
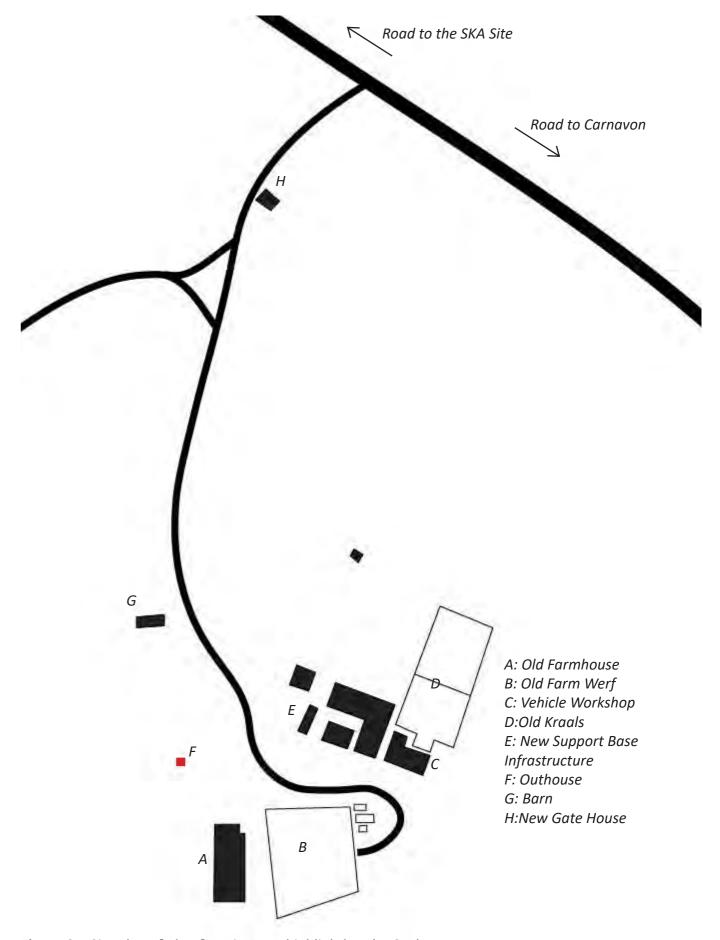
Figure 75: Front elevation of Outhouse

- The outhouse building is a typical example of a utilitarian farm building from the late 19th to early 20th century.
- The building is original with no notable changes. It is in a poor state of repair.
- The relationship of the outhouse and the farmhouse is of significance.
- The building is significant as part of the collection of buildings and structures of the Klerefontein farm werf.
- In isolation the outhouse does not meet the criteria for grading. Due to its association with the farmhouse and werf it should be treated as having a Grade 3C grading.

- The building should be photographically documented annually and checked for changes in relation to the previous year's photographs
- The building should be inspected biannually and after rain storms, fire and high winds.
- The individual in charge of inspections must be familiar with the site and have access to the photographs taken regularly of the site as part of the inspections, have access to the CMP report and, where possible have experience in building maintenance and repair.
- The intention is that this person will raise the alarm should there be change or deterioration in the building.

External Doors and Windows	•	Annually check all timber doors for maintenance and repairs.
Roofs, gutters and downpipes	•	Roof sheeting to be checked annually for maintenance and repairs.

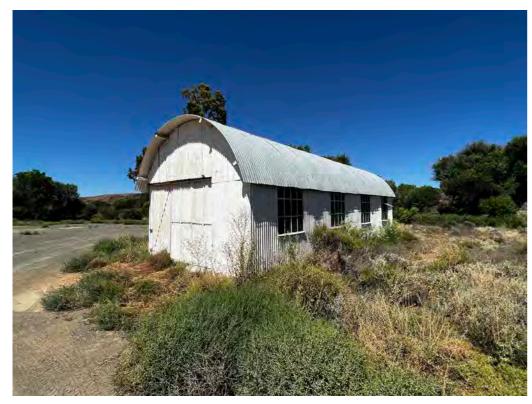
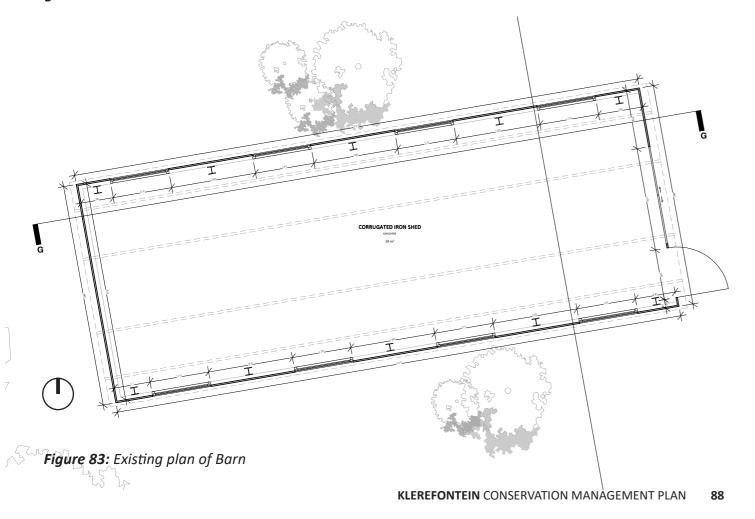
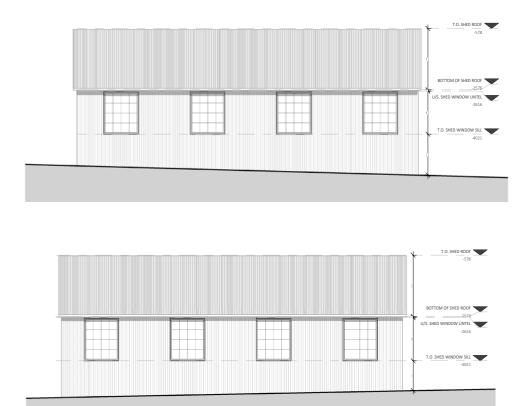
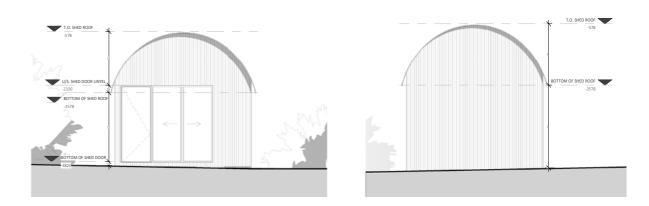
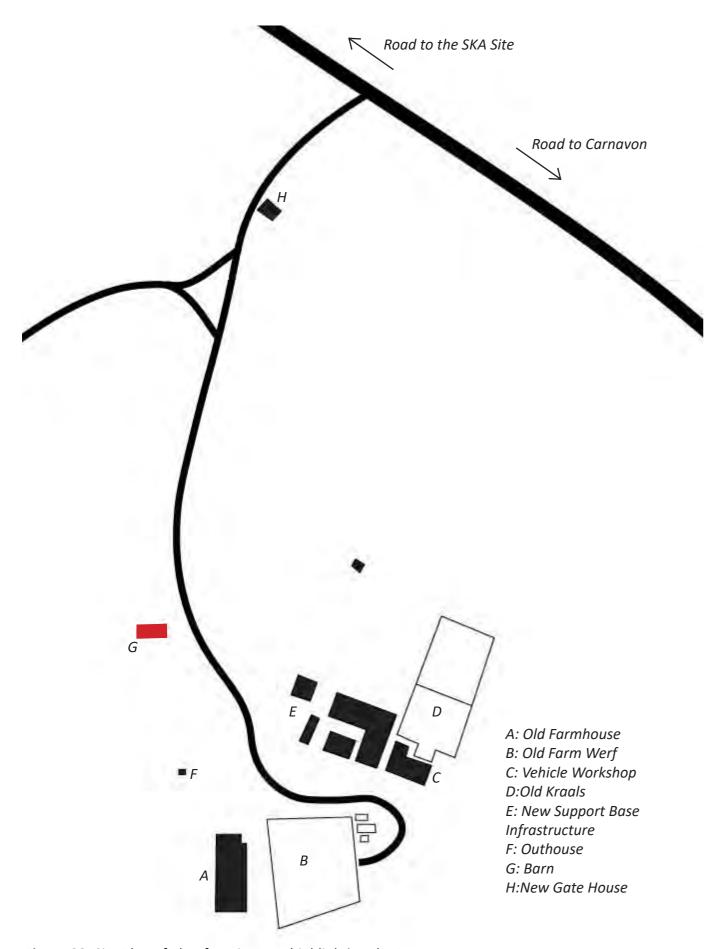
Figure 82: Barn

- The barn building is a typical example of a utilitarian farm building from the early to mid 20th century.
- The building is original with no notable changes. It is in a fair state of repair.
- The relationship of the barn building to the other original building is of significance.
- The building is significant as part of the collection of buildings and structures of the Klerefontein farm werf.
- In isolation the barn building does not meet the criteria for grading. Due to its association with the farmhouse and werf it should be treated as having a Grade 3C grading.
