Heritage Impact Assessment: Ship Repair Facility, Port of Mossel Bay

Transnet National Ports Authority

2 October 2018

Final Report

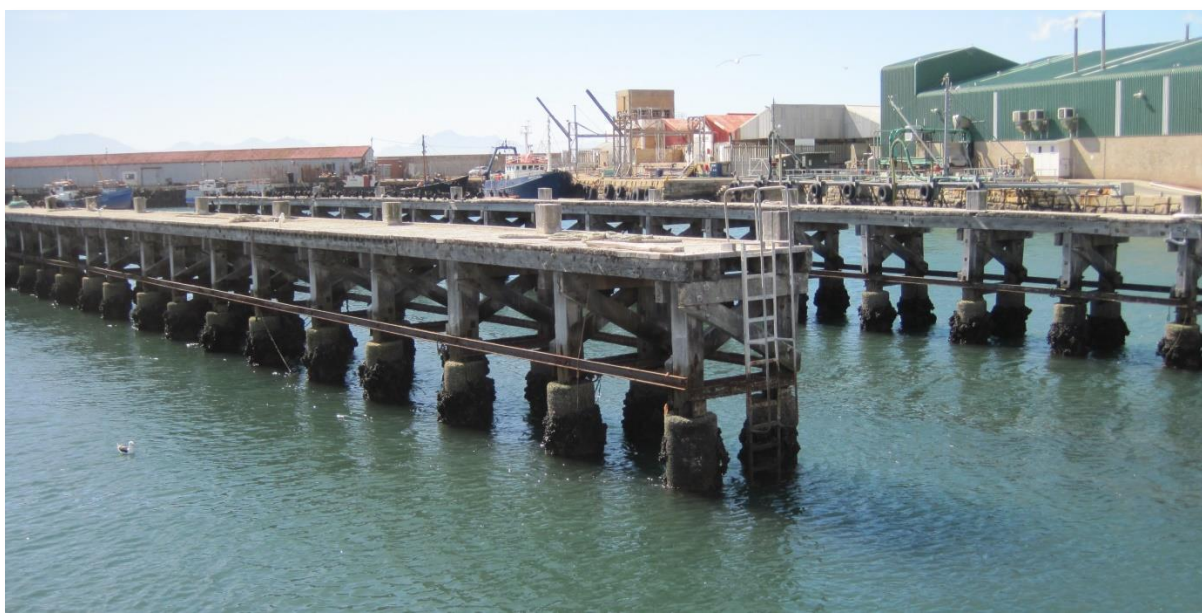
The lead-in jetties for the ship repair facility are parallel wooden structures approximately 62m long and supported on wooden piles (**Plate 8**). The slipway runs structure runs between the two jetties.

Plate 8: Lead-in jetties looking seaward.

A structural assessment of the lead-in jetties in the TNPA Feasibility Study Report (March 2018) indicates that they are in a poor condition with major deterioration of both the pile supports and superstructure. There is concern that any impact by vessels could result in a catastrophic structural failure of the jetties.

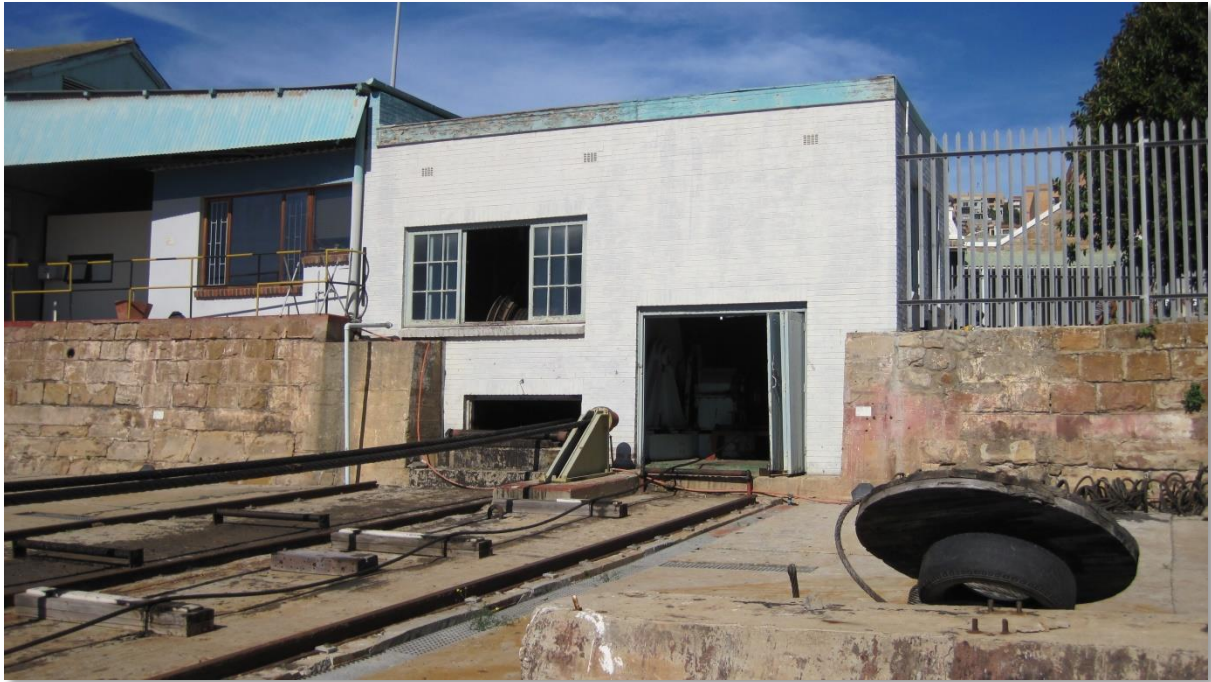
The winch house is located at the top of the slipway, in a cut made into the historical seawall that forms the landward edge of the slipway (**Plate 16** and **Plate 17**) and houses the machinery for the end haul slipway system. The 1931 plan of the harbour (**Figure 3**) shows an engine room where the winch house stands, and the current building appears to be a

Plate 16: Winch house from the slipway, showing the cradle rails and the winch cable entering the building through the horizontal opening to the left of the door.

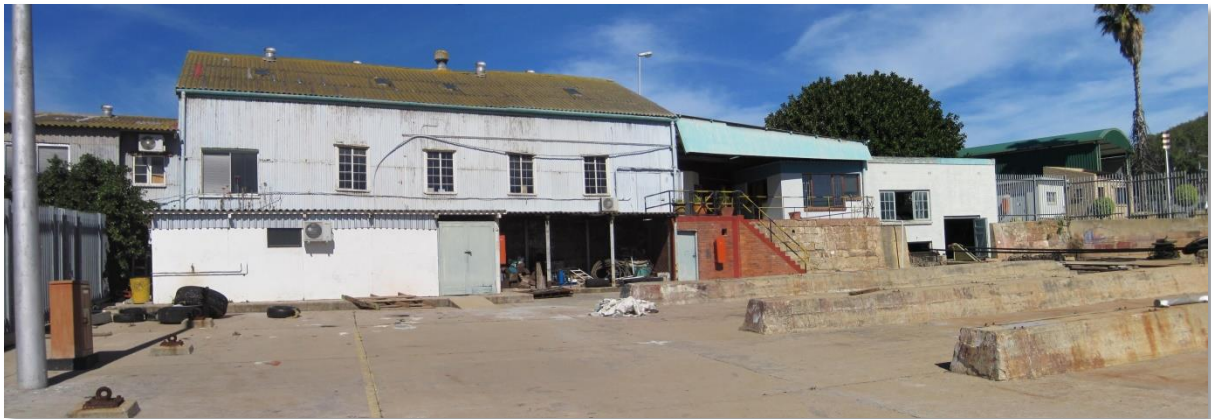
Plate 22: View of the seaward side of the administration buildings: the grey building at centre and the building on the extreme left of the photograph (see **Plate 23** below). The winch house is on extreme right with a modern infill building between. Lean-to storerooms obscure the seawall below the larger of the administration buildings.

As stated earlier, the buildings described above, with the exception of the winch house, are built above and behind the seawall which was constructed 1895. The seawall appears to be in good condition and is largely intact, although somewhat obscured below the main administration buildings by a series of lean-to storerooms built against it (**Plate 22** and **Plate 32**).

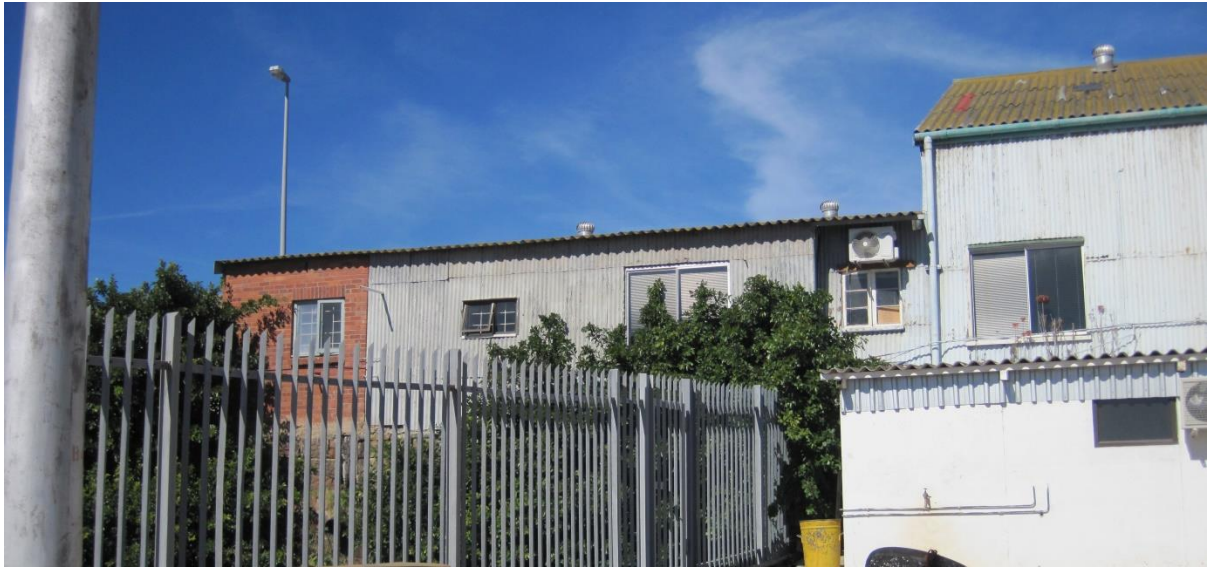
Both administration buildings have been altered from their form shown in **Plate 25**. Windows have been added in both, they have been linked by a corrugated iron infill, and the building shown in **Plate 23** has had the corrugated iron replaced by brick walling on its eastern corner.

Plate 23: The second administration building with a corrugated iron infill between the two buildings and a brick addition on the left.

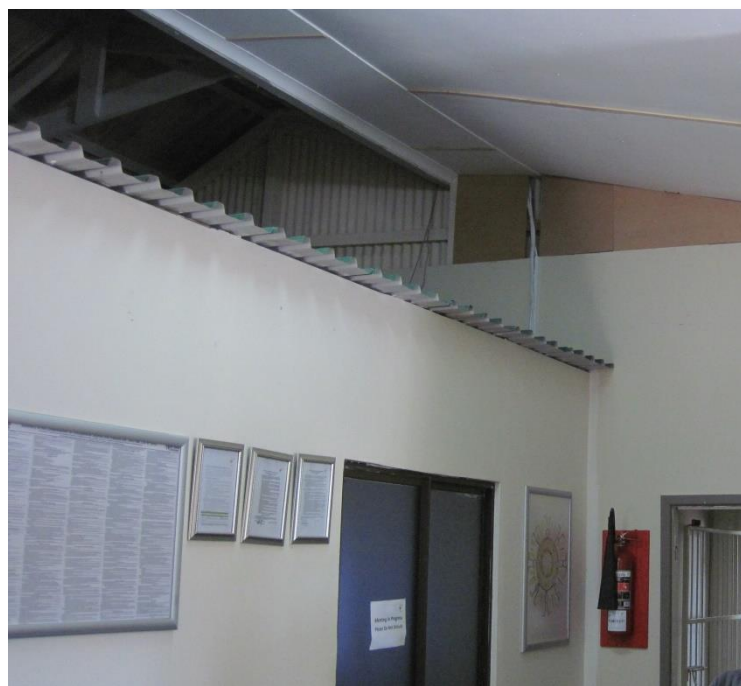
Internally both buildings have been subdivided into offices and workshops. Most of these subdivisions are lightweight drywalls (**Plate 26**). Portions of both buildings are open to the roof which is asbestos sheeting (**Plate 27**).

Plate 26: Internal prefab office divisions in the smaller of the two administration buildings.

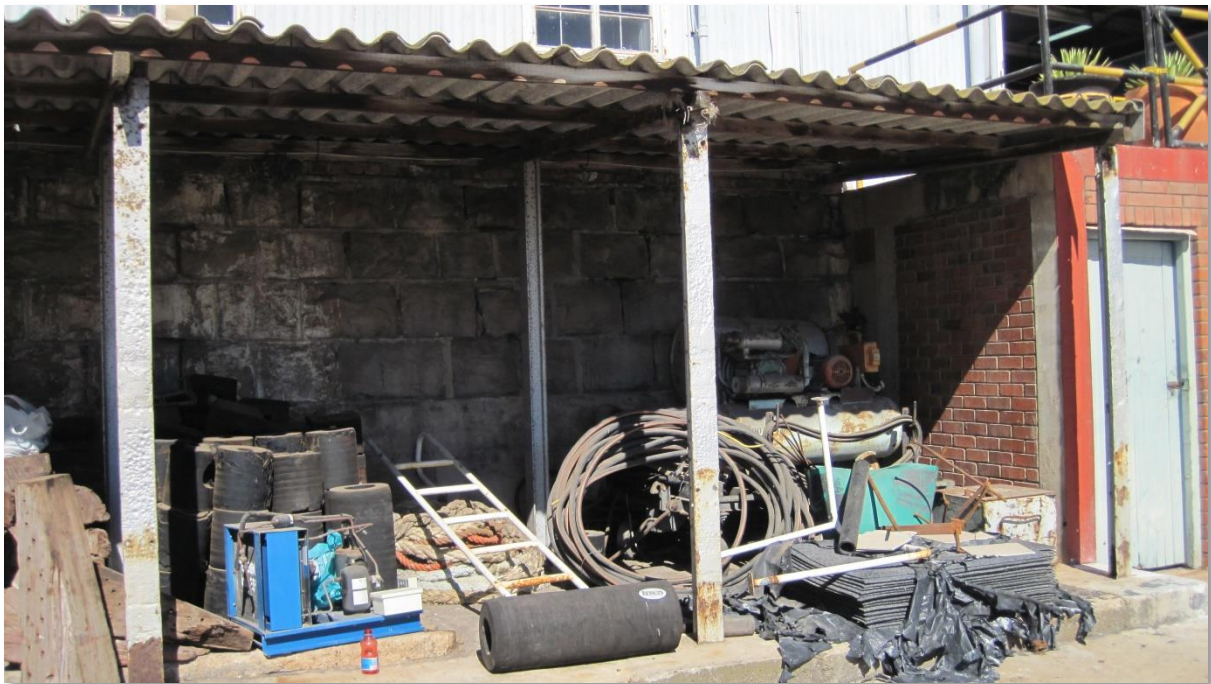
Plate 32: Lean-to structure with seawall behind.
