NAS II Robben Island Report

22 February - 10 March 2010

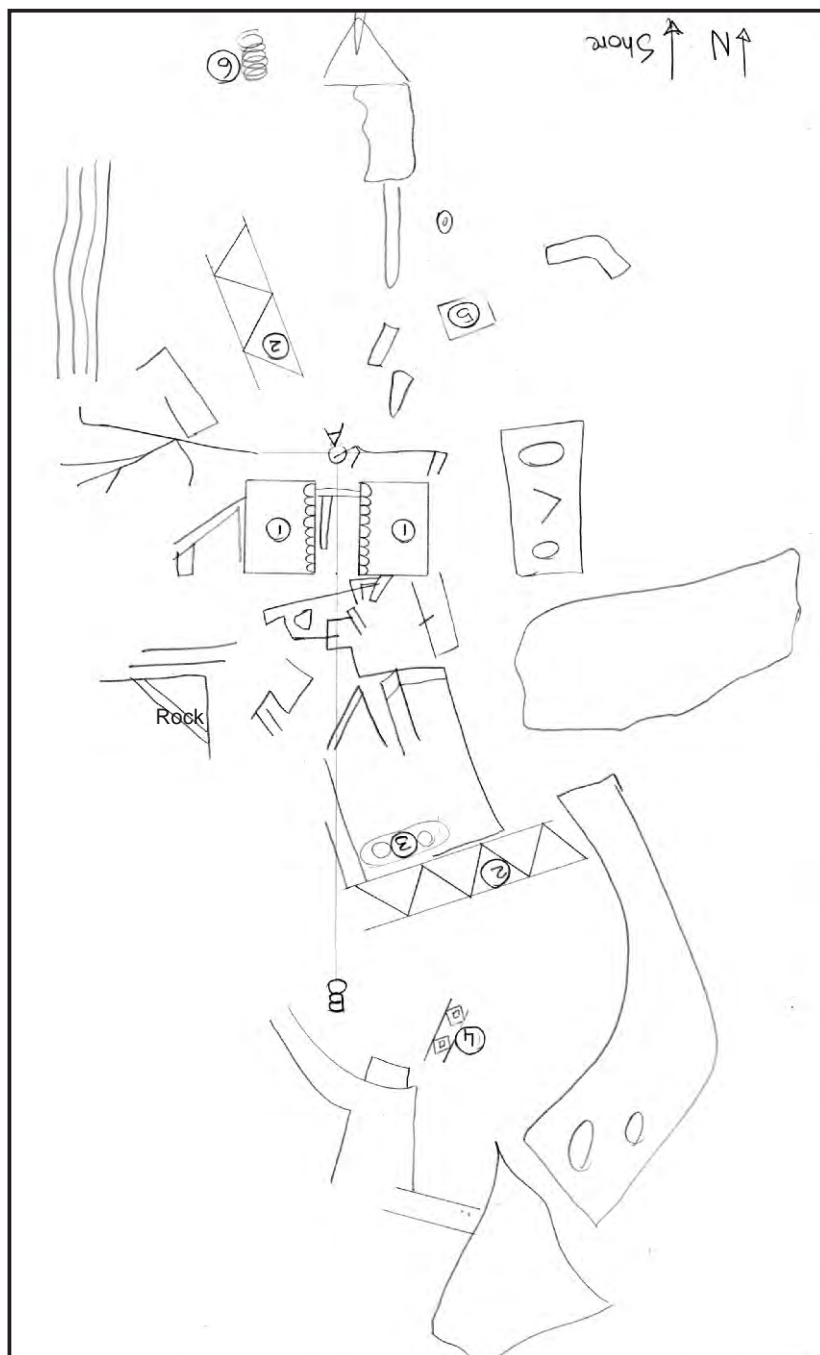
Figure 49: Compiled site map of the *Goel No. 1*.

The following day, two groups returned to the wreck and made some site sketches. These, together with the sketches from the previous four dives, have been compiled into a site map. This is vague and gives little indication of the extent or details of the wreck. All the field sketches are in Appendix C.

- A. Buoy line
- B. End baseline
- 1. Engine block
- 2. Girder
- 3. Tank
- 4. 'Wheel'
- 5. Plating
- 6. Cabling

The ship's iron hull has degraded rapidly due to its proximity to oxygen enriched surface water. The powerful surge and storm action also accelerates deterioration. At present, the majority of the wreck consists of large, structurally sound sections; the stern, engine block, winch housing and hull plating. These sections assist in orientating fieldworkers on the wreck. Less robust remains survive under a substantial layer of marine growth.

We recommend the wreck of the *Goel No. 1* be left undisturbed so that underwater archaeologists can use the site for educational and analytical purposes. A complete site survey should be undertaken and repeated every ten years. An analysis, over time, of the deterioration and dispersion of the iron wreck in a high impact zone, will assist in understanding site formation processes of similar wrecks.

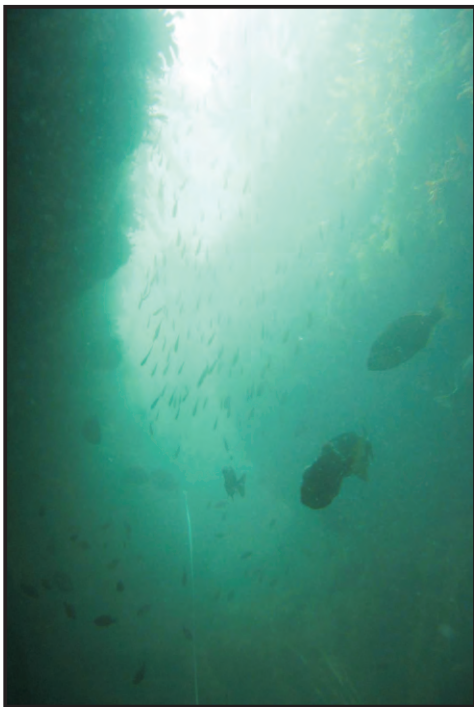
Today, ironically, the *Goel No. 1* hosts a higher density of abalone (*Haliotis midae*) and west coast rock lobster (*Jasus lalandii*) than the surrounding area. This is due to the increased shelter provided by the wreck. A good example is the two “engine blocks” that shelter a west coast rock lobster nursery, huge abalone and shoals of juvenile fish.

Figure 53: The *Goel No. 1* provides a safe haven for juvenile fish. (Photo: du Plessis 2010)

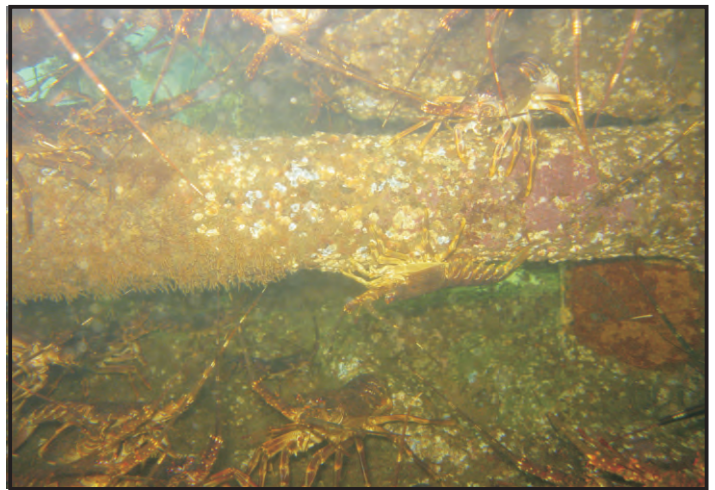
Figure 54: West coast rock lobsters in the wreck. (Photo: du Plessis 2010)

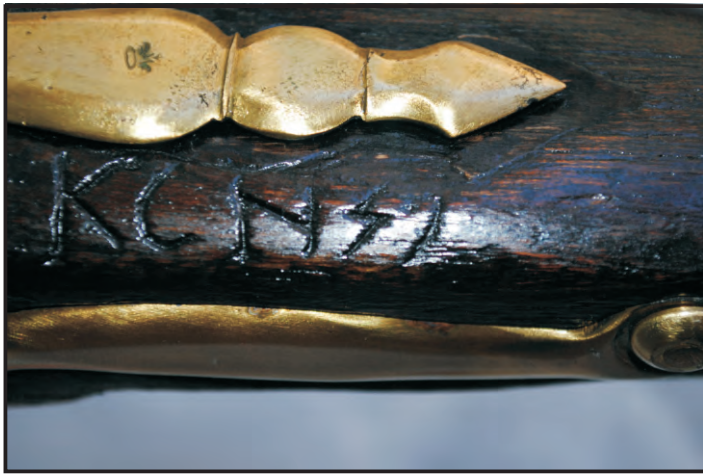
Figure 57: Close-up of the crown stamp on the trigger guard of G. Raynor's restored musket. The stock has been carved, meaning unknown. (Photo: Maitland 2011)

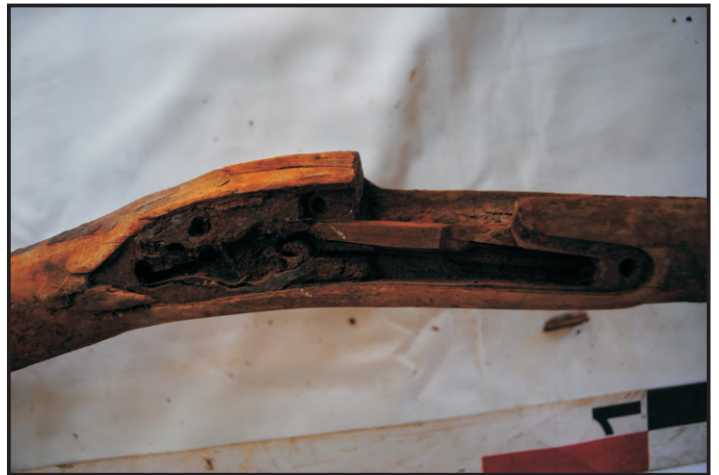
Figure 60: Musket stock, not conserved or restored from C. Byrnes. The remains of the metal lock are visible. (Photo: Maitland 2011)

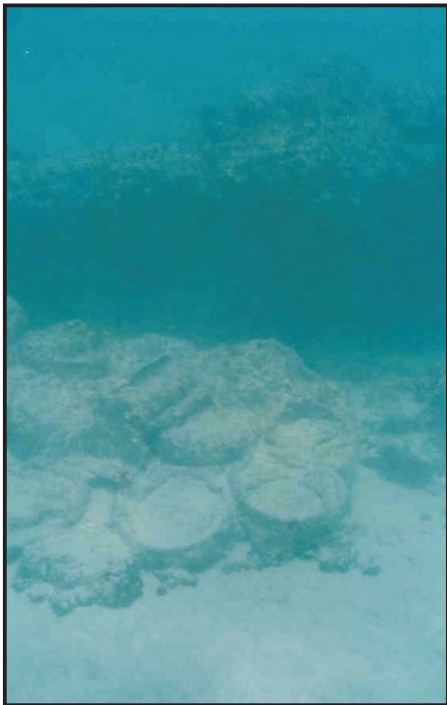
Two types of barrels are on the wreck site (Fig. 67 - 68). The first are half-barrels and the second full barrels. Throughout history barrels were used to transport a wide variety of products. These include, peppercorns, pitch, paint, cement, wine, beer, etc. The barrels on the site require more detailed analysis of their type and contents before any conclusions can be drawn.

Figure 67: A pile of half barrels, these are now scattered over the site. (Photo: Shapiro c.1980)

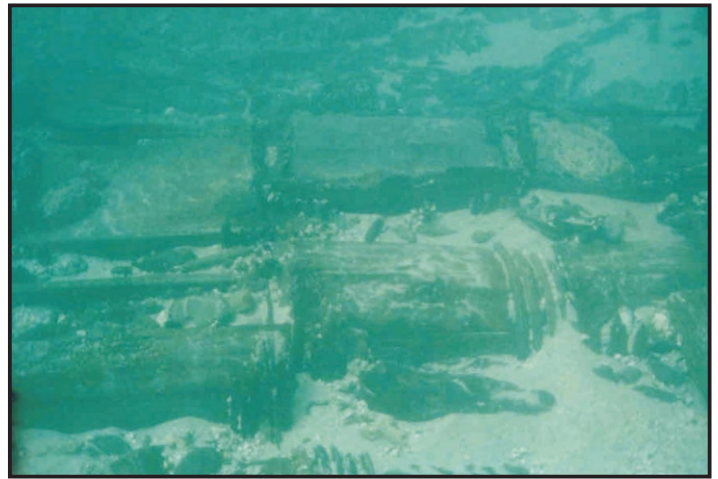
Figure 68: Full barrels in-situ. The staves and hoops are visible. (Photo: Shapiro c.1980)

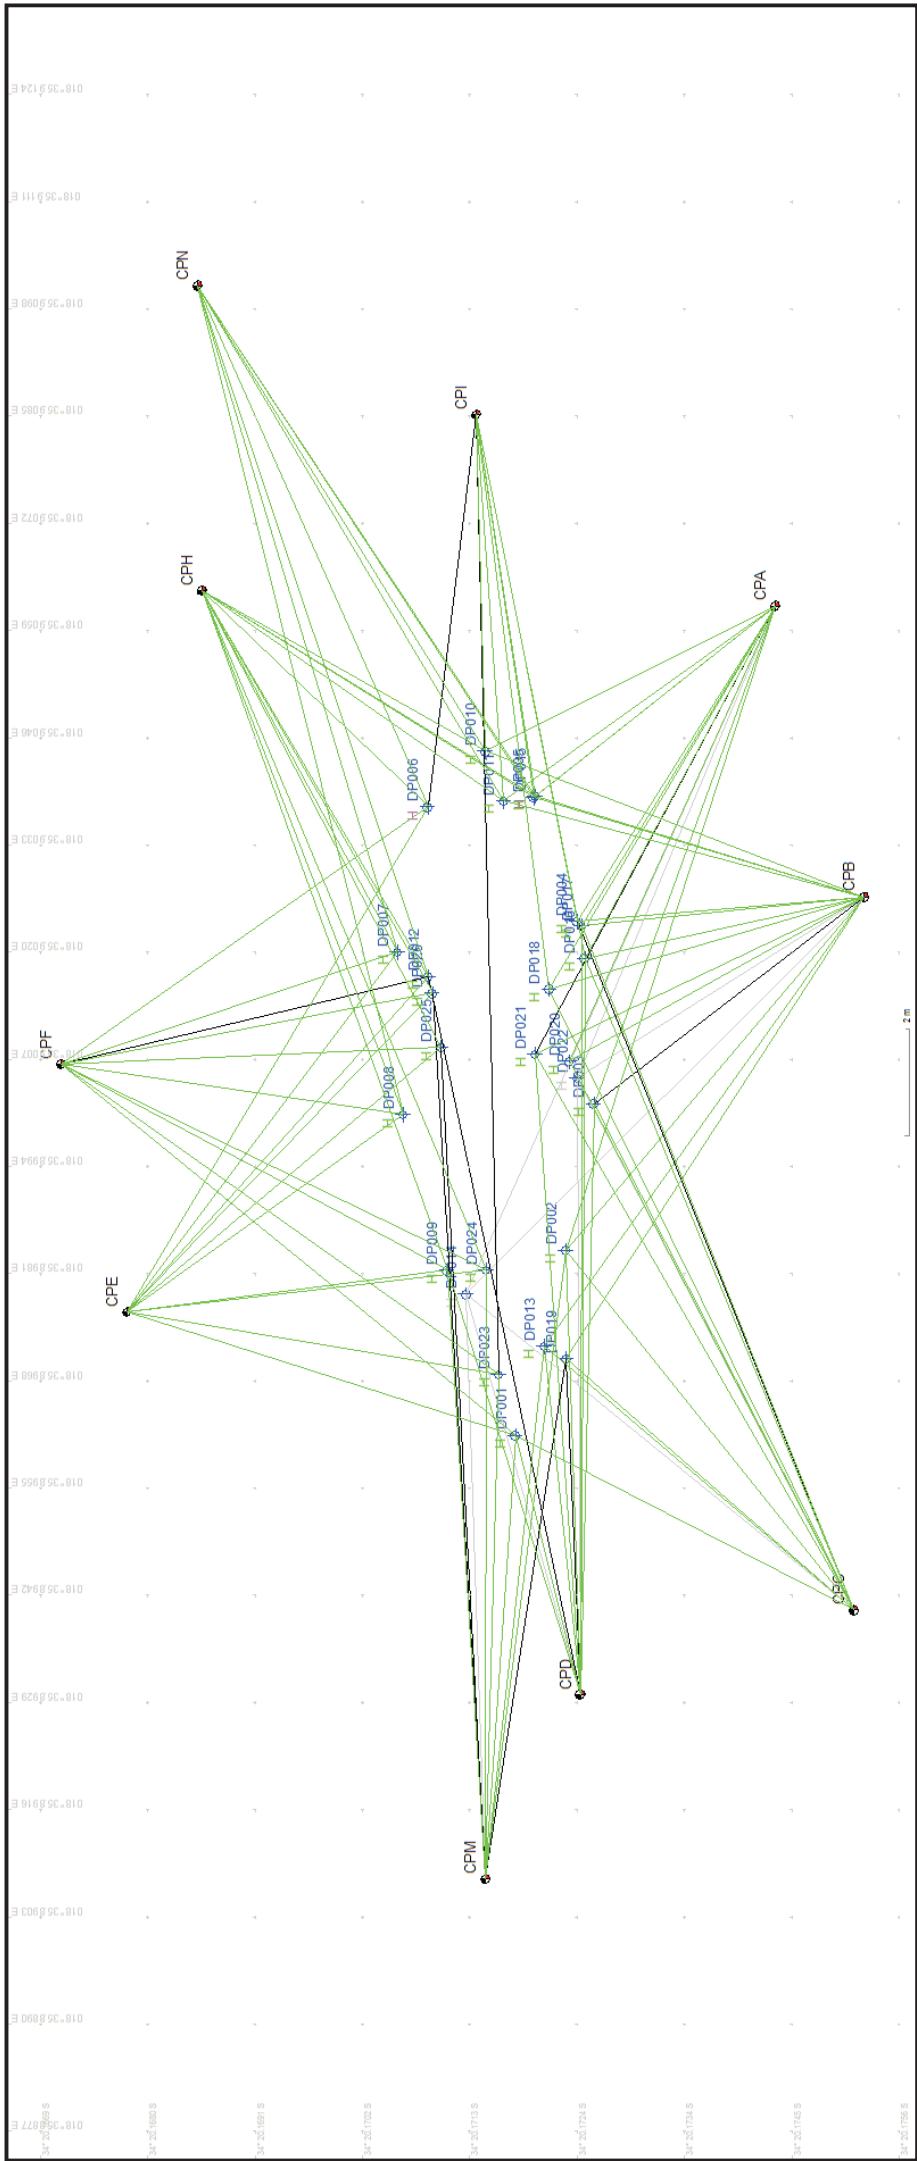
Figure 75: Site Recorder plan of the Chanson de Mer. (Winton 2010)

The *Chanson de la Mer* lies on the north west coast of the Island, 100 meters from the rocky shore.

The wreck is not of national maritime importance, but it is relevant to the maritime history of the Island. We would recommend that the *Chanson de la Mer* be recorded on the Island maritime database and be conserved as such. The site should be included in tours. The wreck can be used to teach scholars about maritime history.

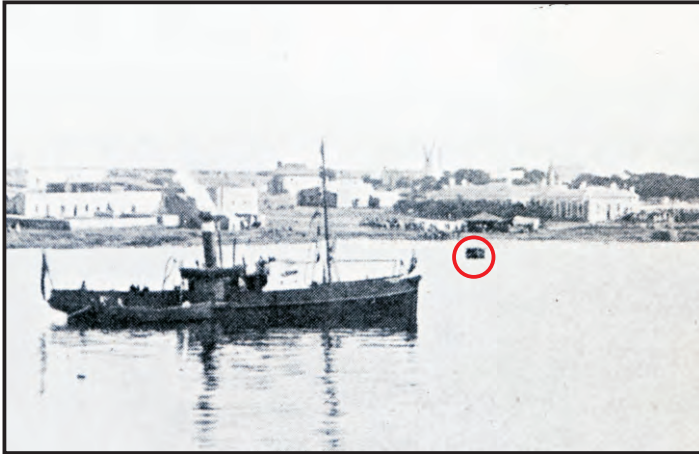
The seabed was undulating silt. Approximately 100 metres east of the west quay, a rocky outcrop covered in kelp, was found. Embedded in this area, were two heavily encrusted and corroded, medium-sized admiralty anchors. The survey was done largely by touch and there seemed to be large quantities of chain attached. We think the anchors may have been part of a mooring system.

Figure 78: This photograph from 1896 was apparently taken from the site of the present harbour (de Villiers 1971: 40). The item circled may well be a mooring buoy and the position corresponds with the anchors found in the harbour.

The historical importance of the site could not be ascertained within the available time. The anchors were left in situ and there are no plans to raise the artefacts. Although they may need to be removed if they become a shipping hazard. GPS coordinates were not recorded.

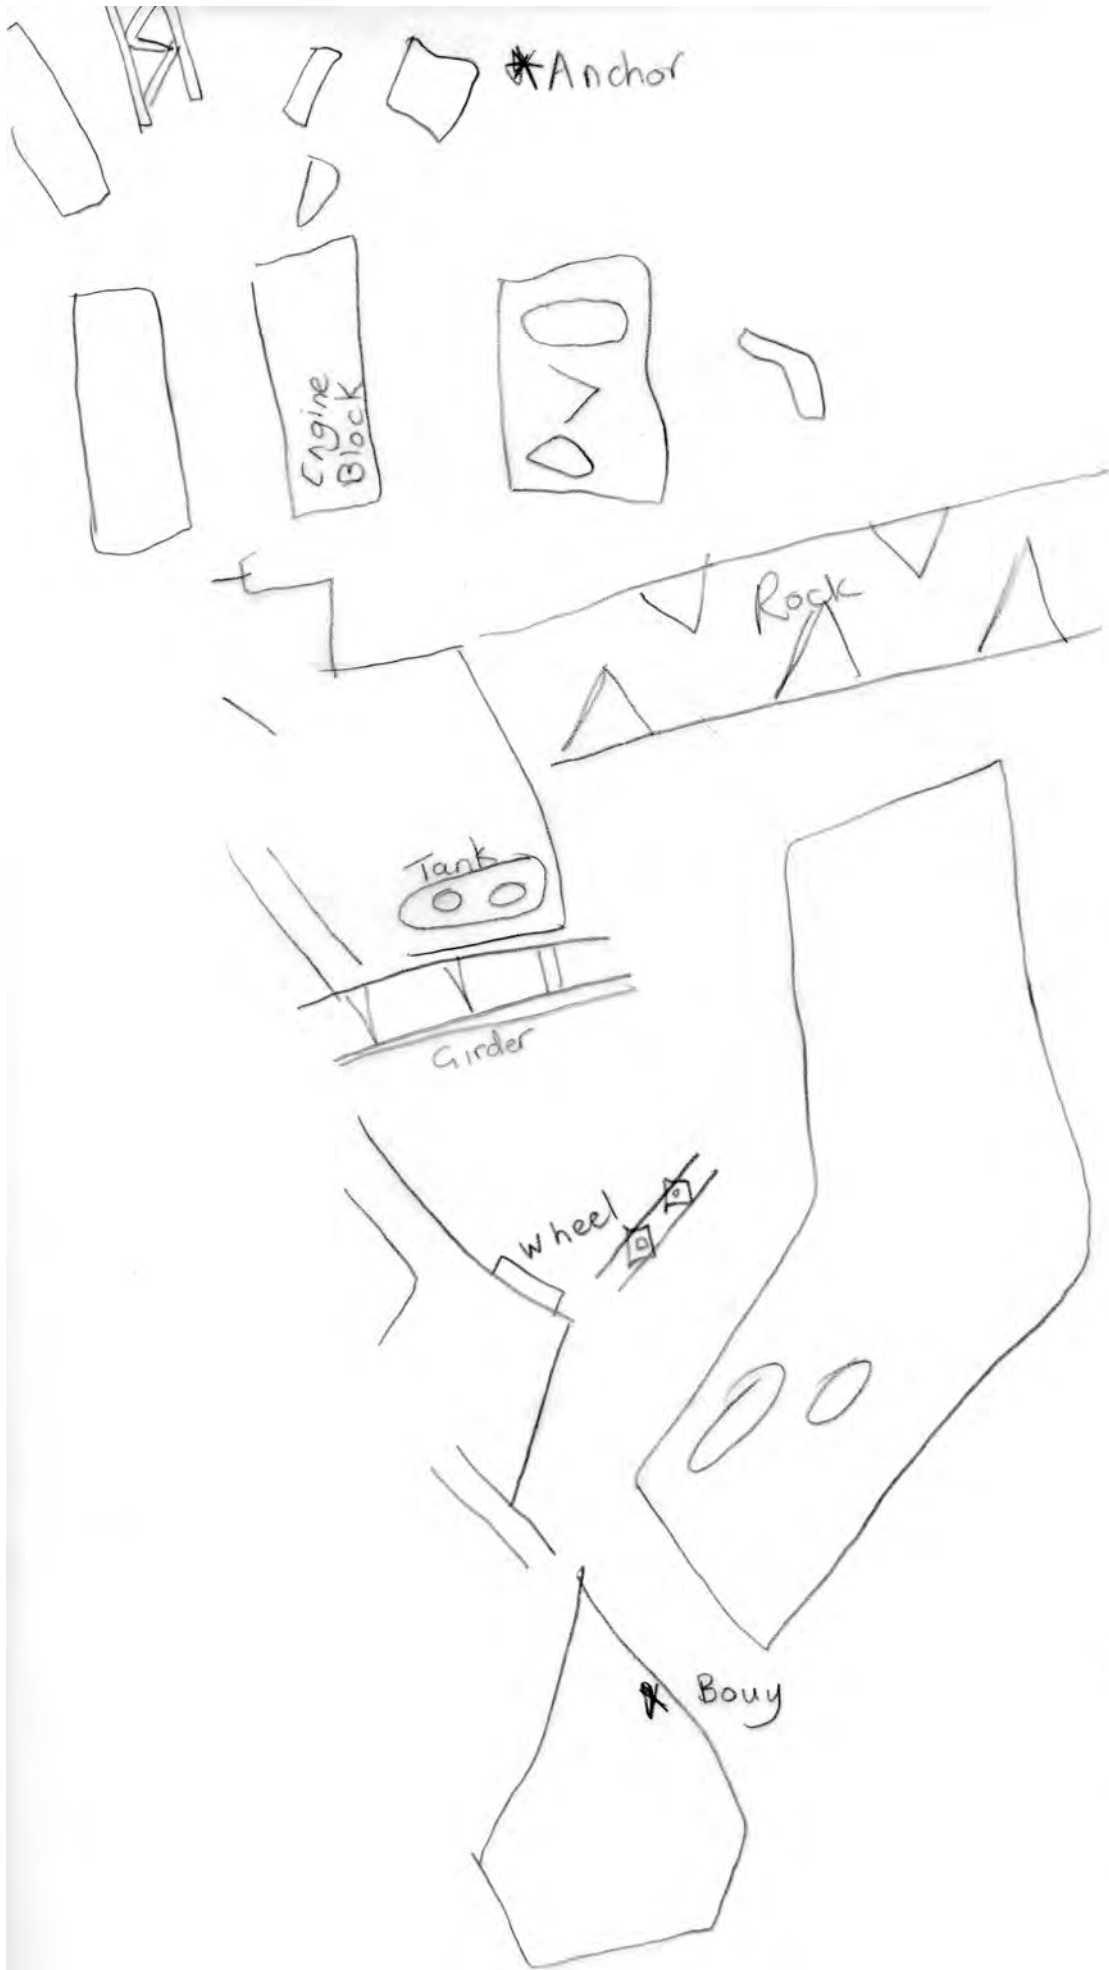
M.V. Goel No. 1

Thursday Group 4

Shore
 ↓
 Grp 1
 Jake
 Friday.

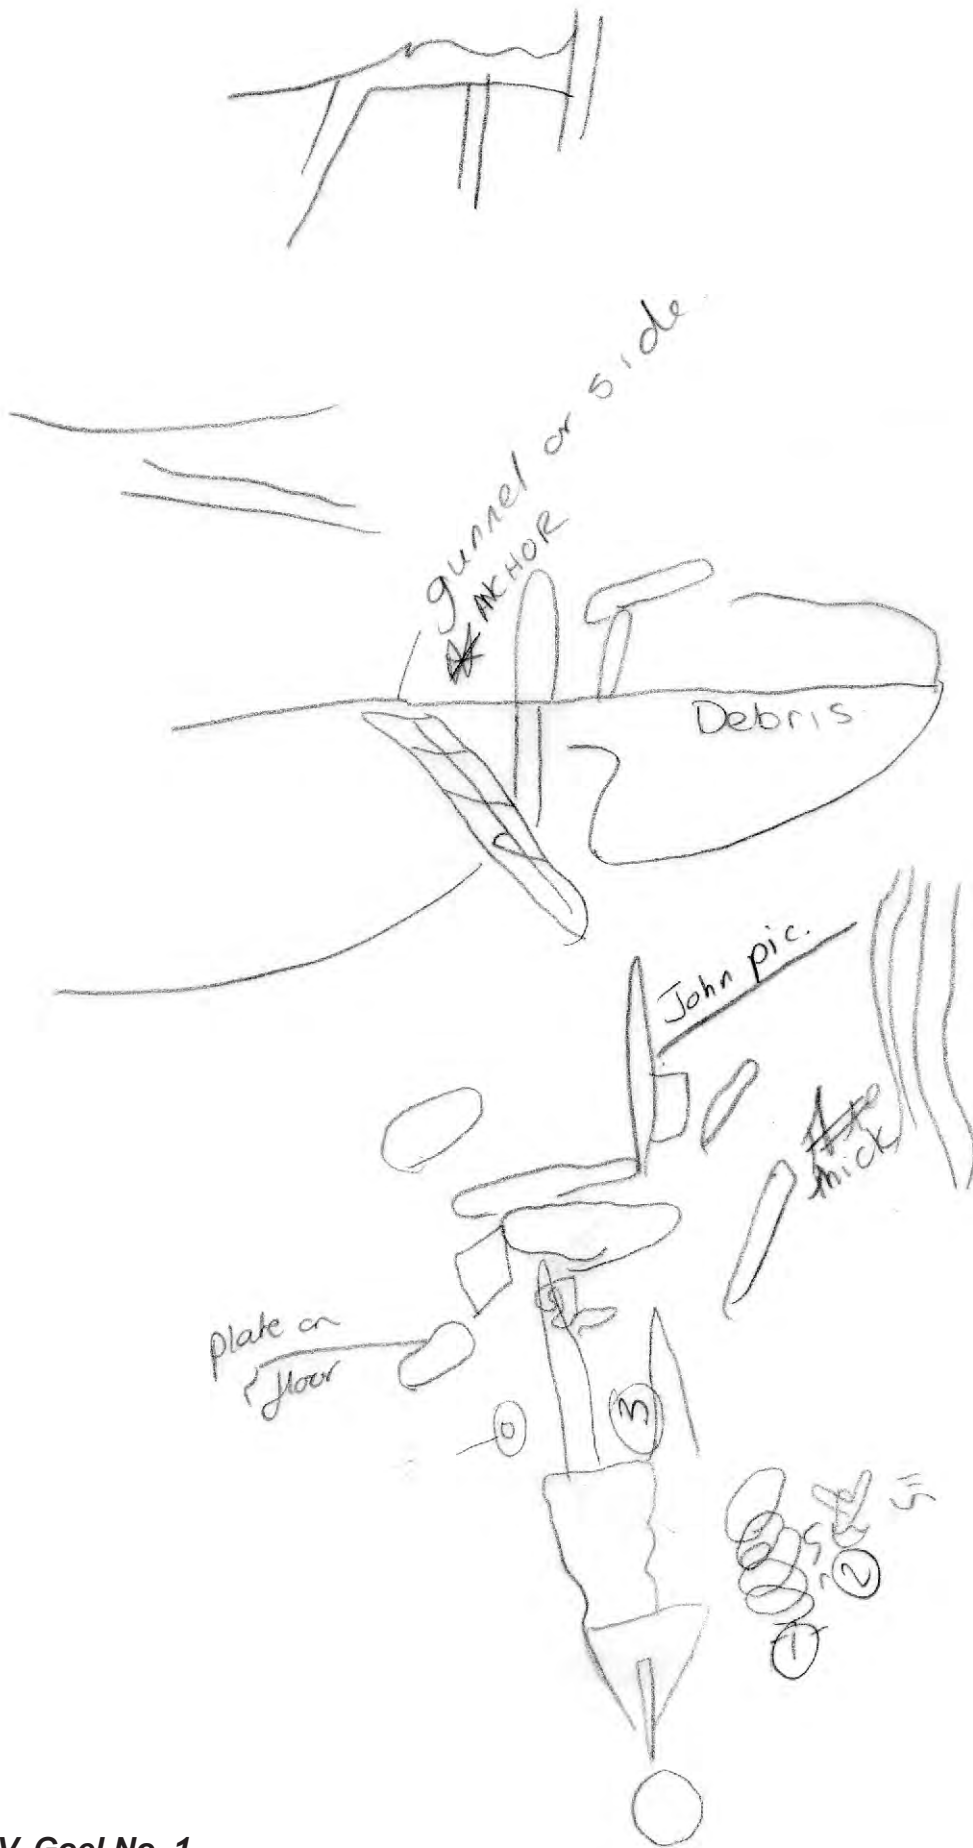
M.V. Goel No. 1

Friday Group 2

Grp 2
Fri.

A) B/L O/S.

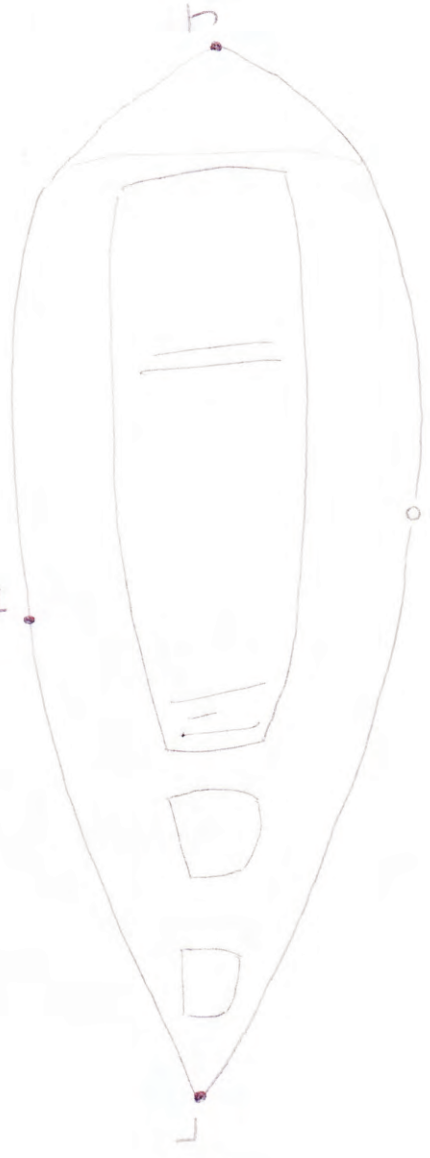
Sketch of yacht - Detail Points (South side of yacht)
rough side view. L1-15; 10; 13-18; 11.
2/3/10

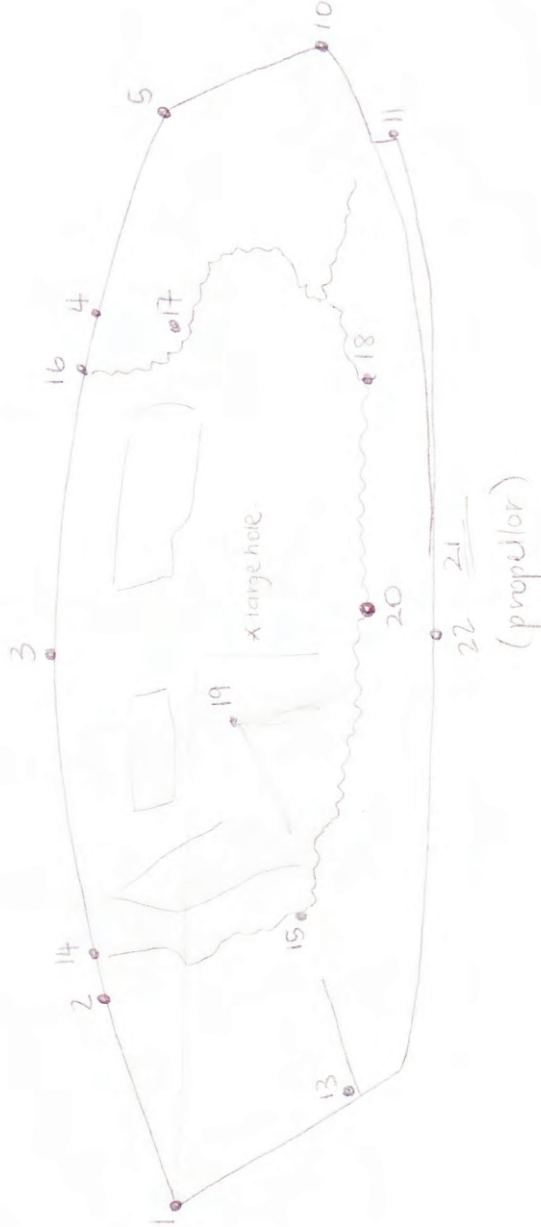
Side plan sketch of yacht seen from north-side.

(DPS 1; 6-12)
2/3/10
