# PHASE 1 HERITAGE MITIGATION FOR THE NMPPP PIPELINE

FOR TRANSNET

DATE: July 2009

By Gavin Anderson

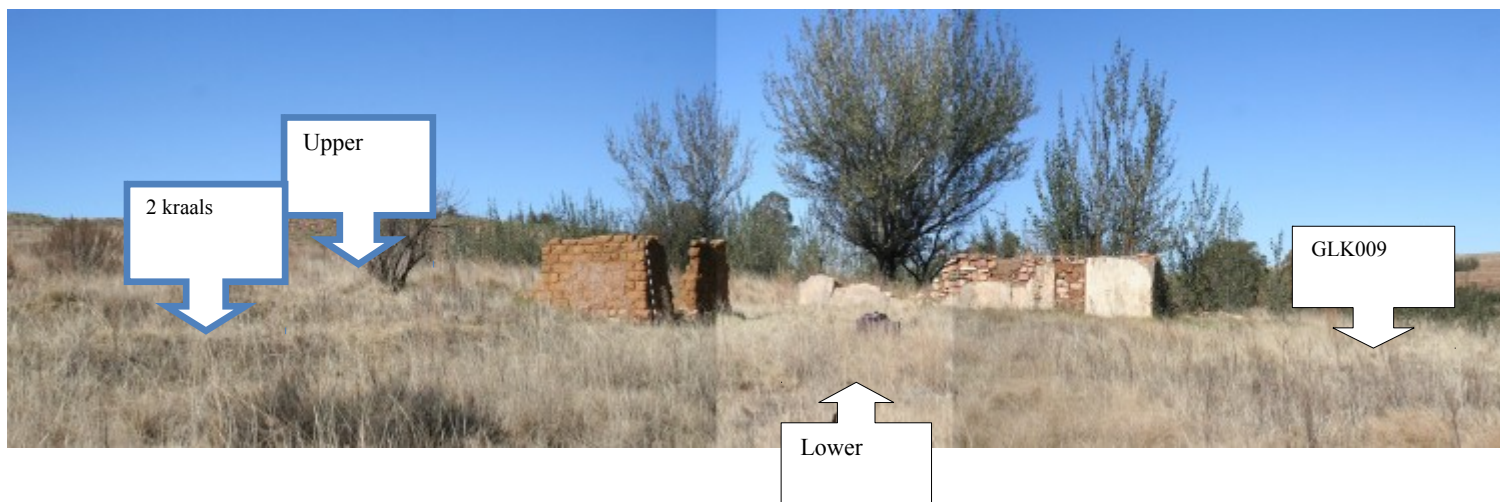
FIG. 1: SITE MAP OF GLK008

GLK008 was divided into two areas: on top of the hill, and below the hill (fig. 1). The lower part of the site consists of two small kraals (fig. 2) approximately 80m southeast (and upslope) from the two houses. These kraals are at right angles to each other and are 5m x 3m in diameter. The pipeline passes between these two kraals and the house. The houses consist of two rectangular houses and a long low stone wall. The smaller house is a mud-brick construction with some mud plaster on both sides of the wall. The main house is a built from sandstone blocks with a mud plaster on both sides of the wall (fig. 3). The interior dividing walls do not appear to have plaster, although this may have disintegrated. Only two exterior walls, and a small section of one interior wall, of the main building, remain. The rest of the building has collapsed. The main entrance has been filled in, and presumably relocated to another part of the building. Figure 4 illustrates the site.

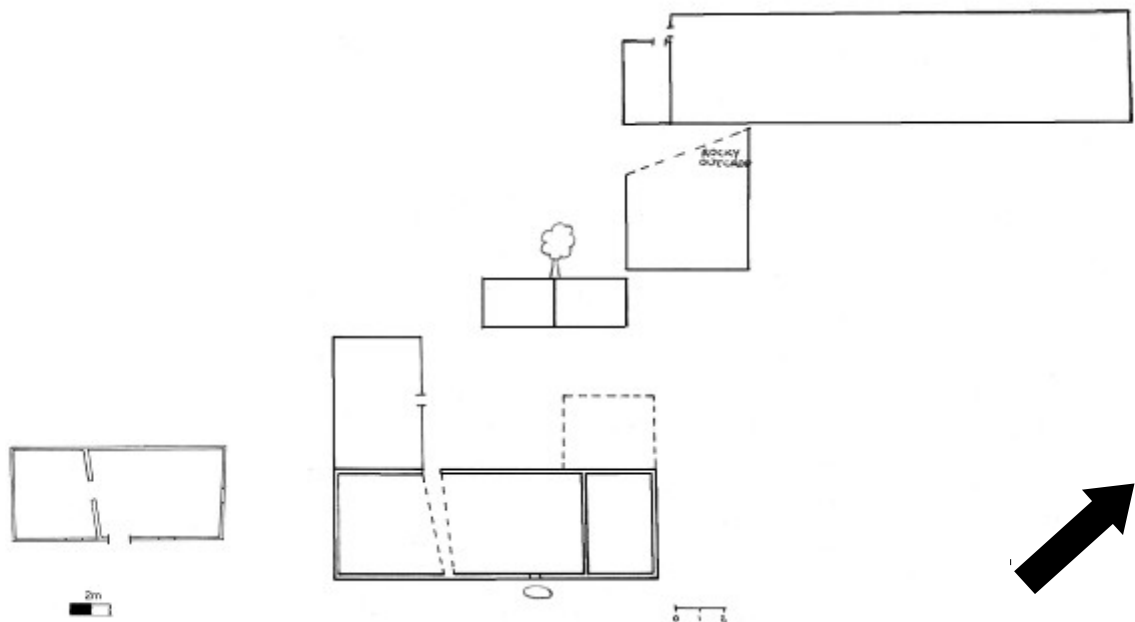
**FIG. 11: SITE PLAN OF GLK009**

in size. All of these use the natural rock outcrop as part of the walling. Figure 11 illustrates these houses.

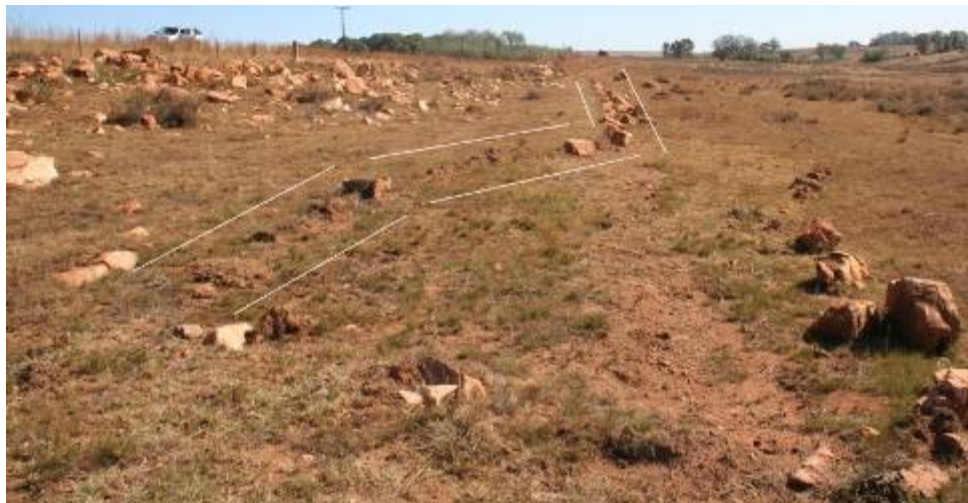
**FIG. 14: CONNECTING WALL BETWEEN THE HOUSES AT GLK0010<sup>3</sup>**

GLK0010 was mapped and photographed. The site consists of two stone walled houses ~120m apart (fig's 12 - 13). There is a low wall, or terrace that connects the two houses (fig. 14). The northern house consists of a main house with a dividing wall. There are two rooms added to the north eastern and southeastern part of the house. Only parts of the main house are intact, while the other rooms have collapsed. There is a small stone cairn to the north of the extended room: this is unlikely to be a grave.

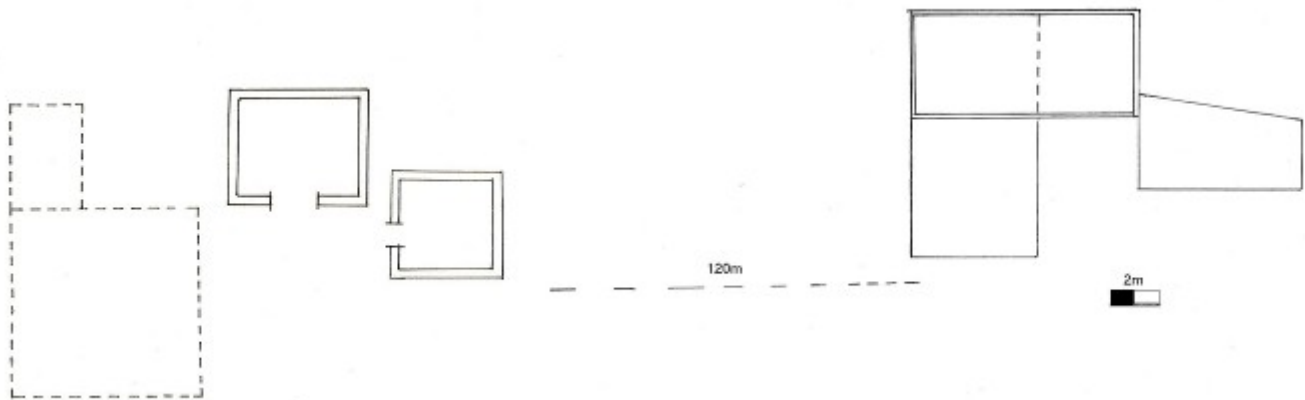
FIG. 15: SITE PLAN OF GLK0010

The southern house (fig. 13) consists of two buildings and a large area of basal foundations. The two rooms have doors that face each other. Figure 15 illustrates GLK0010.

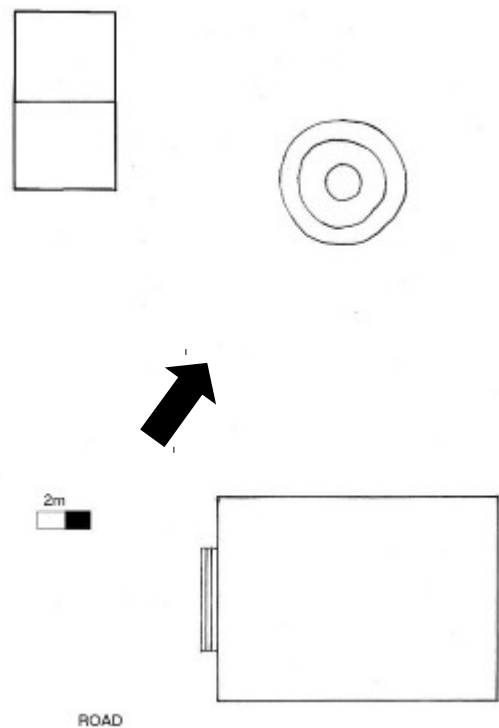
**FIG. 17: SITE PLAN OF GLK0012**

northern wall. The building consists of a stone foundation and a double row of bricks in an English Bond for the wall. To the northeast of the buildings stairs, are the foundations of two rooms and these are possible toilets. Between these two buildings is a three-tiered circle that was presumably a flowerbed. There is a small stone cairn ~16m northwest of the school building. Figure 17 illustrates this site.

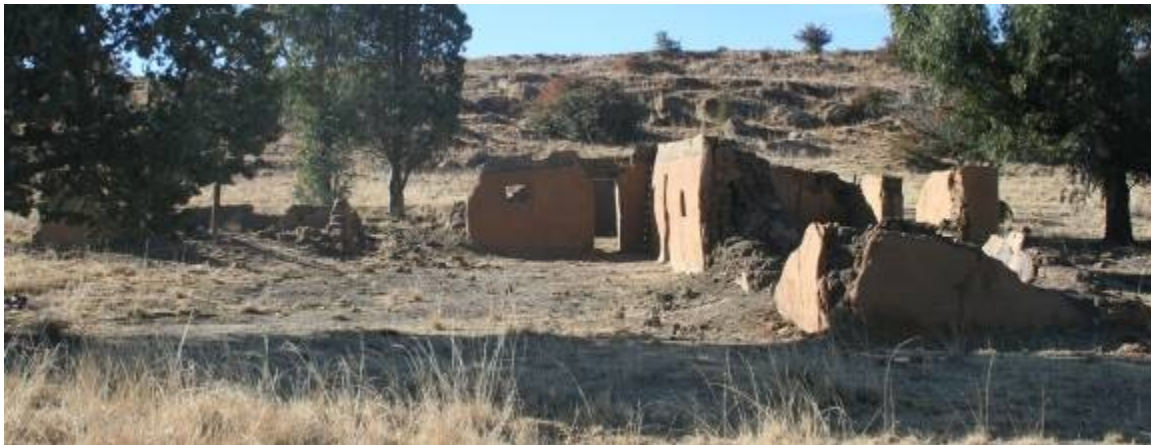
**FIG. 20: VIEW OF RECENT HOUSE AT GLK0015**

GLK0015 was photographed and mapped, and the area was resurveyed. The pipeline will not directly affect the site. The site consists of two households with similar architectural designs. The southern household is built in the 'wattle and daub' style, with some mud-bricks (fig. 20). Several items have been placed within the daub to strengthen the structure. This includes, glass, wire, metal rods and plastic. The main doors face north, although one faces west. Some of the rooms have interconnecting doors, while others can only be entered via the outside. There is a separate house next to the main house. The interior and exterior walls are plastered and decorated with *ilemba*. It is interesting to note that the plaster consists of several coats, and each coat has *ilemba* on it. This suggests that the plaster is not pasted in one episode, but repeatedly over several years. The plaster in fig. 21 has at least six layers.

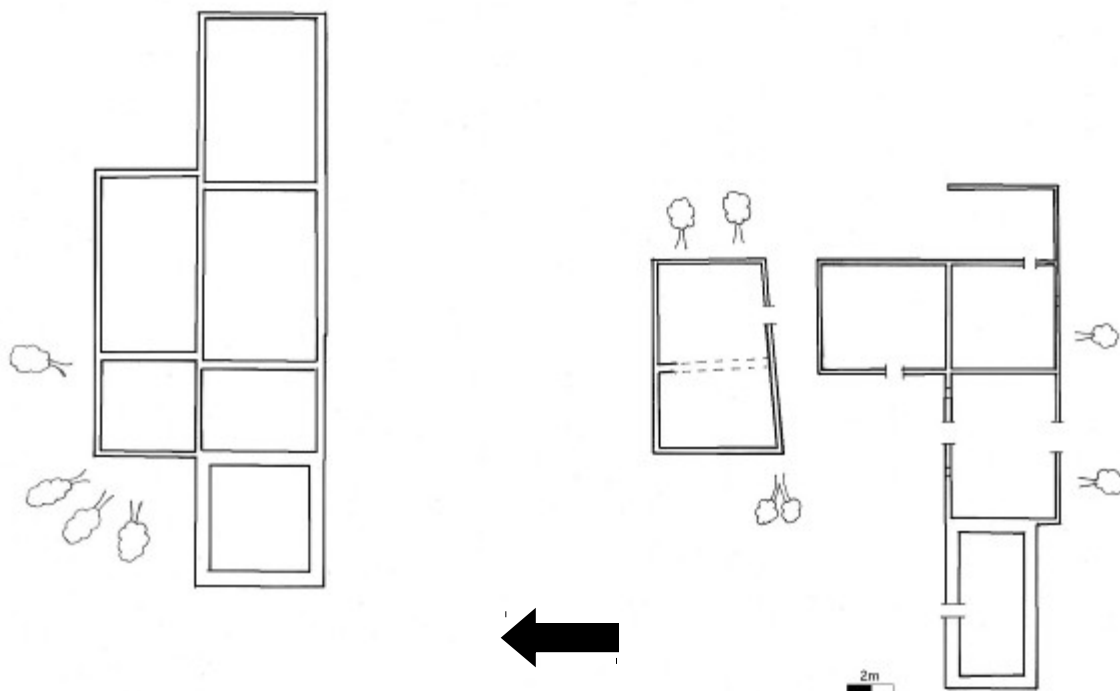
FIG. 23: SITE PLAN OF GLK0015

The northern household is much older than the southern house, and only the foundations are visible. This house is made from mud-bricks. The walls have collapsed and nearly disintegrated. This household consists of a double row of rooms with extended rooms at the east and western sides of the house. No entrances were visible. The entire settlement is illustrated in figure 23.

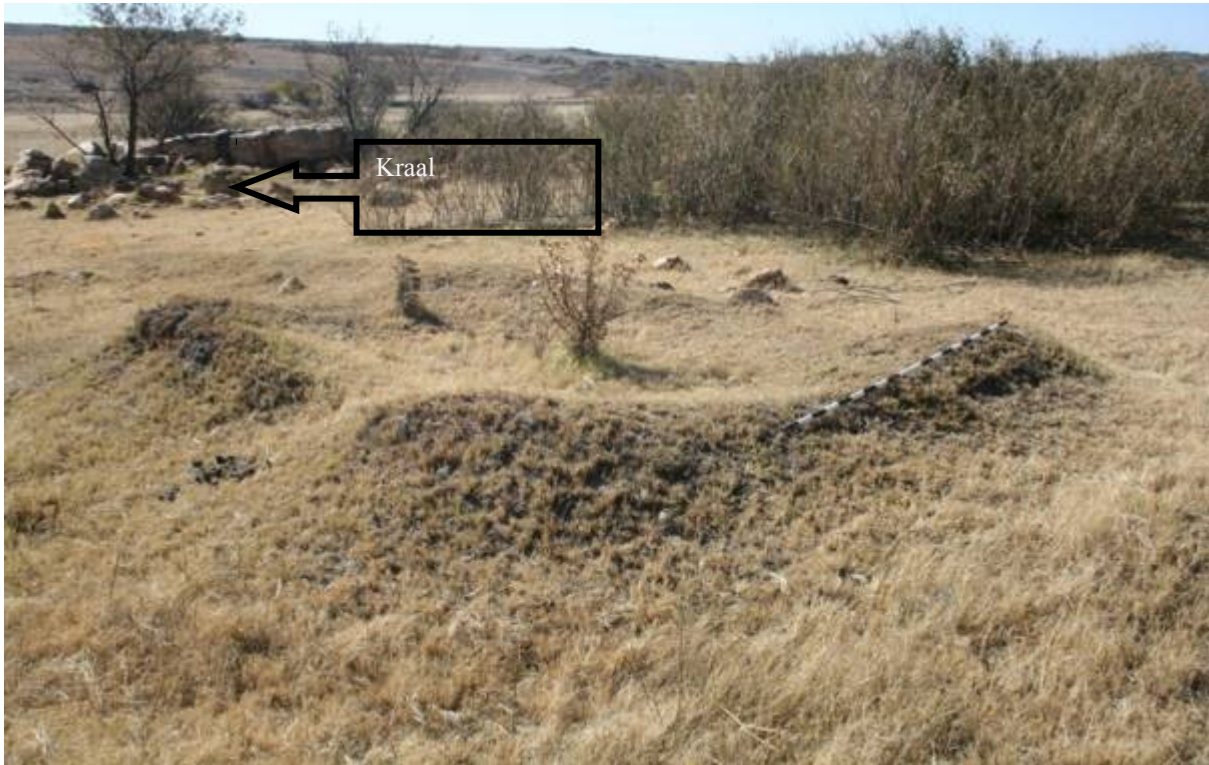
**FIG. 24: HOUSE REMAINS AT GLK0022**

GLK0022 is located on the border of the 100m mark. Since the settlement is fairly recent and unlikely to be affected by the pipeline, we only photographed it. The settlement consists of four unattached mud-brick houses that have collapsed and are now covered with grass (fig. 24). There is a small stone walled kraal at the northeastern part of the settlement. The kraal consists of a double row large stones that have a "rubble" infill.

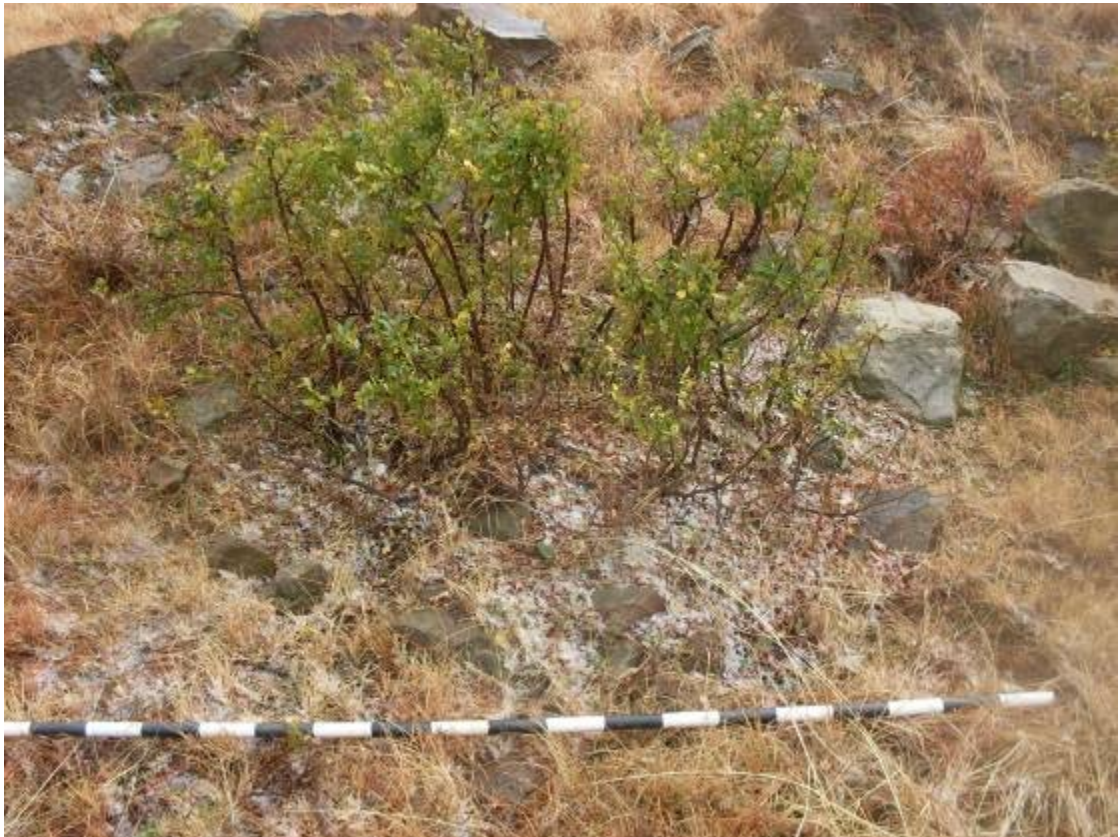
FIG.  
27:

The kraal is a large rectangular kraal (21m x 17m), with a small secondary kraal (5m x 7m) attached to it (fig. 26). There is a small semi-circular kraal within the main wall and abutting the northern wall. This small kraal is ~1.7m in diameter (fig. 27). The main kraal consists of a double row of large boulders with a small stone infill (fig. 28). The kraal probably relates to the colonial occupation of the area; however, it will be difficult to date. Figure 29 illustrates the site.

OUTLINE OF SMALL KRAAL AT GLK0035A

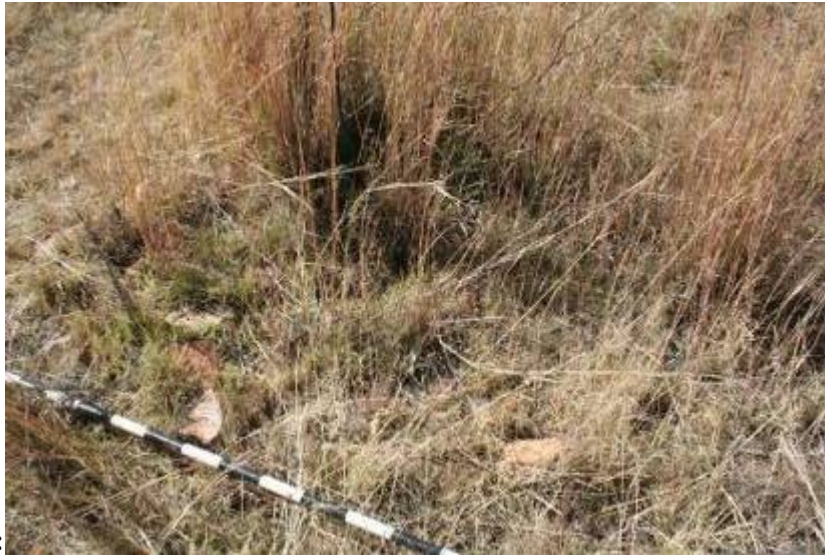
**FIG. 31: POSSIBLE GRAVE AT GLK0025**

The site consists of several stone features that are now more visible due to the shortened grass. The pipeline occurs ~50m away from these features, and on the western side of the rocky outcrop. We re-assessed the area for graves, and concluded that there is only one possible grave (fig. 31), while the other two

possible graves are related to collapsed walling. The possible grave was demarcated with coloured fence droppers (fig. 32).

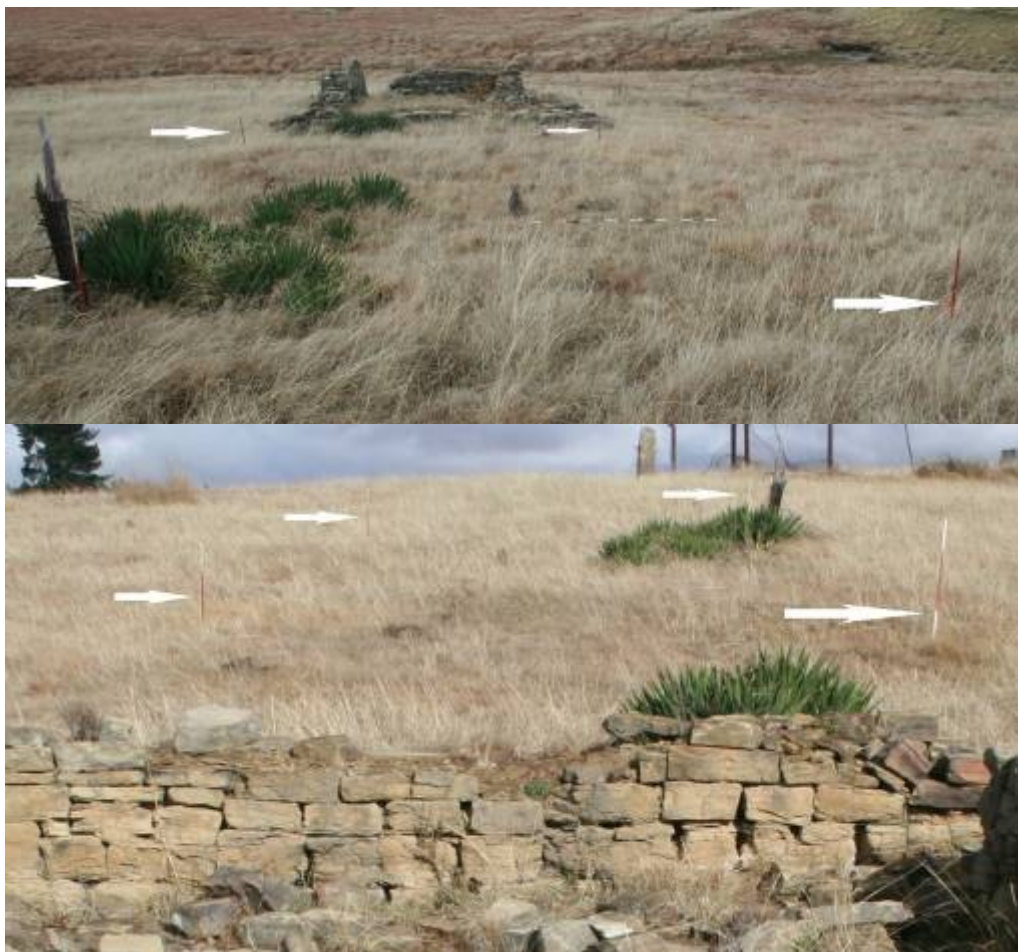
**FIG. 34: EXTENT OF UNAMRKED GRAVES AT GLK0040B**

The pipeline passes the main cemetery by ~20m to the west. The main cemetery belonging to the Wessels family is clearly demarcated with a large fence and poles (even if it is in disrepair). The more recent possible graves occur ~70m to the east of the pipeline. These were not clearly visible and we have demarcated the area of the two graves with coloured fence droppers (fig. 34). We also re-photographed the Wessels' graves and the sheep dip.

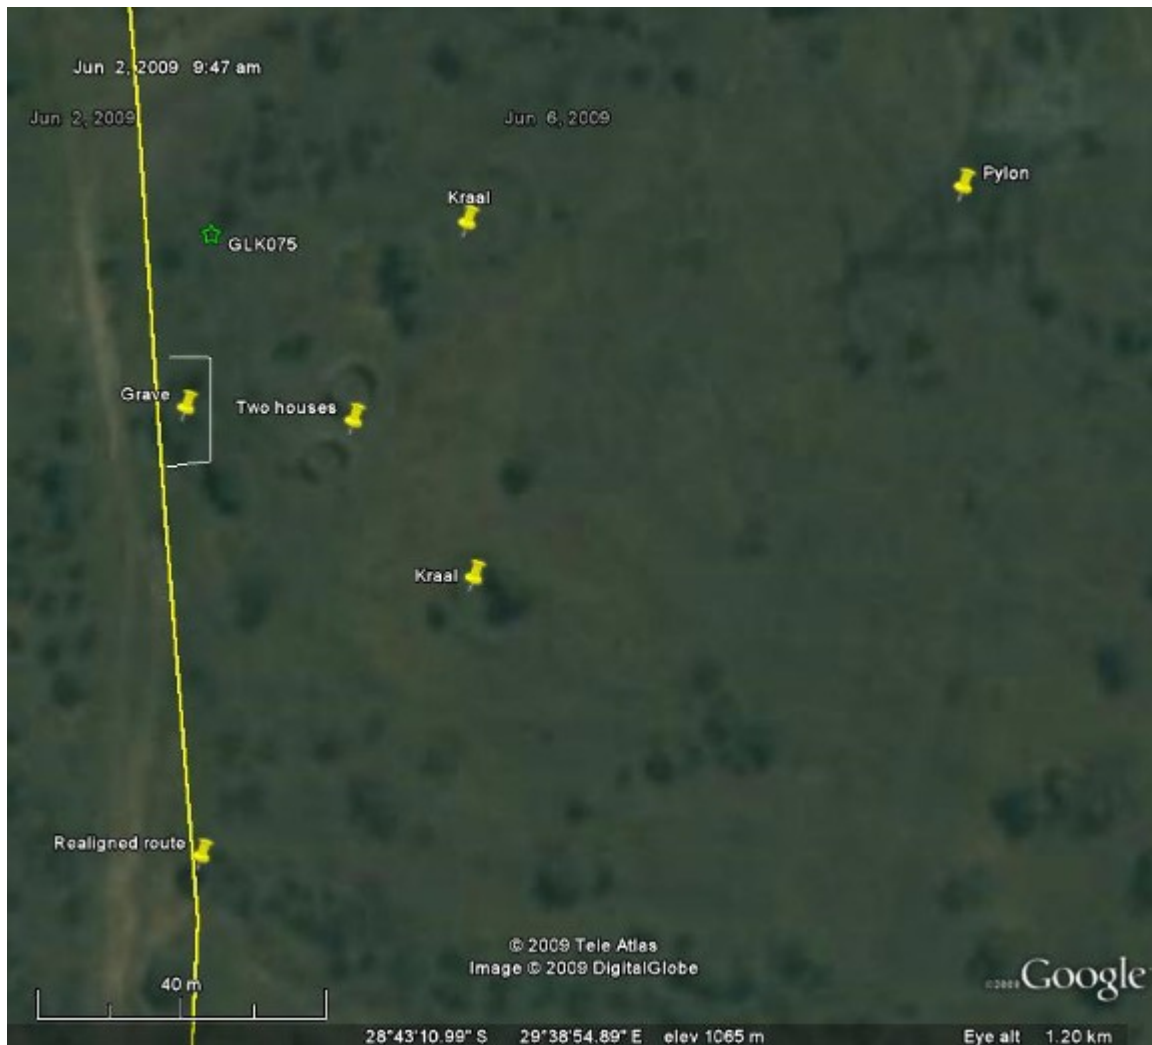
FIG. 37: EXTENT OF UNAMRKED GRAVES AT GLK075

The site was photographed and the grave was demarcated (fig. 36). The vegetation was less dense during this field trip and we noted two stone walled kraals to the northeast and southeast of the two houses. The houses and kraals were photographed. The houses are made in the 'wattle and daub' design and are both ~ in diameter. The kraals are large (~12m in diameter) and consist of two large stone rows with small pebbles used as infill. The latest route re-alignment (i.e. after the site was photographed and demarcated) places the pipeline within 2m of the graves. The pipeline will need to be moved either to the west (i.e. closer to the fence), or between the stone walled kraals and 'wattle and daub houses'. Figure 37 indicates the locations of these structures.

We were denied access to the site by the landowner, and thus could not demarcate the grave. This will need to occur at a later stage.

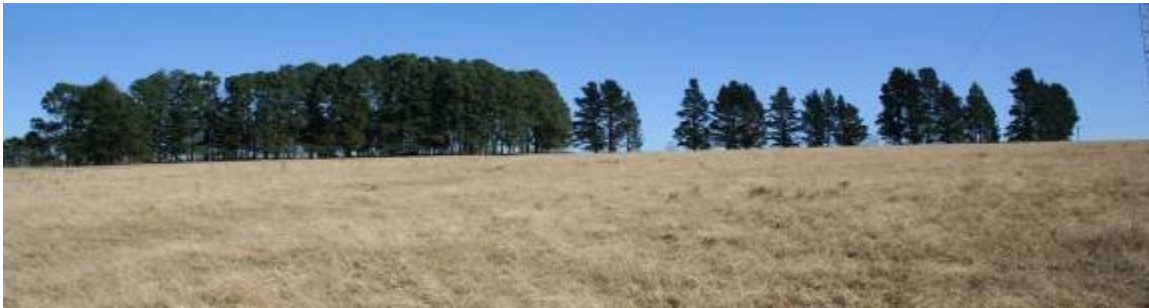
**FIG. 40: WIDE ANGLE VIEW OF THE TREE BOUNDARY**

The pipeline was re-aligned to have no impact on the trees, and is now 30m – 120m east of the trees (fig. 39). The tree boundaries were photographed (fig.40).

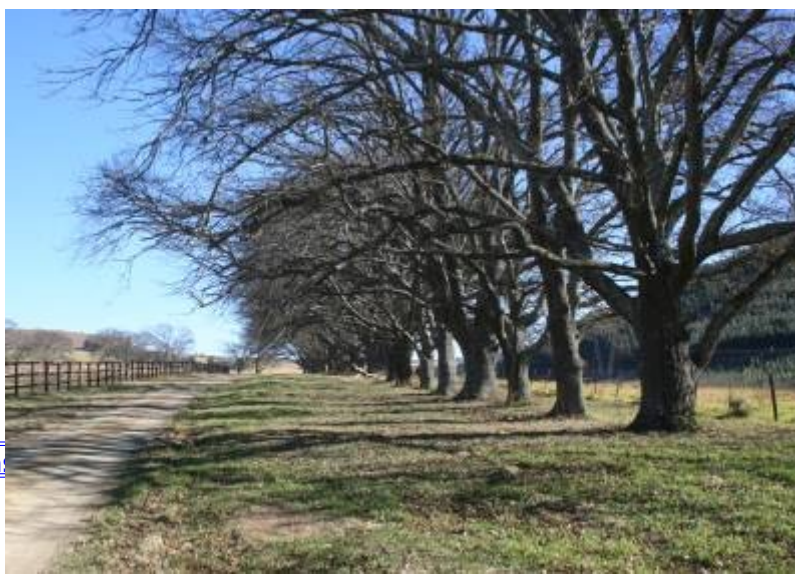
**FIG. 42:  
THE TREE**

The pipeline was re-aligned to have no impact on the trees, and is now 30m – 90m away from the trees. The rows of trees were photographed from various angles. Fig. 41 show the line of trees in relation to the pipeline, while fig. 42 indicates the row of trees
