AN ARCHAEOLOGICAL WALKTHROUGH SURVEY OF THE FINAL LAYOUT OF THE PROPOSED NOJOLI WIND ENERGY FACILTY NEAR COOKHOUSE, BLUE CRANE ROUTE LOCAL MUNICIPALITY, BEDFORD DISTRICT, EASTERN CAPE PROVINCE.

Date: April 2014

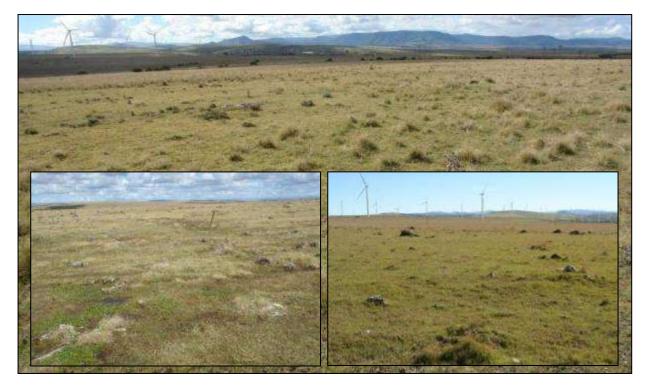
Figure 2.Views towards turbine positions 4, 5 (left insert), 8 (main image) and turbine positions 6 and 7 near the Poseidon Substation (right insert).

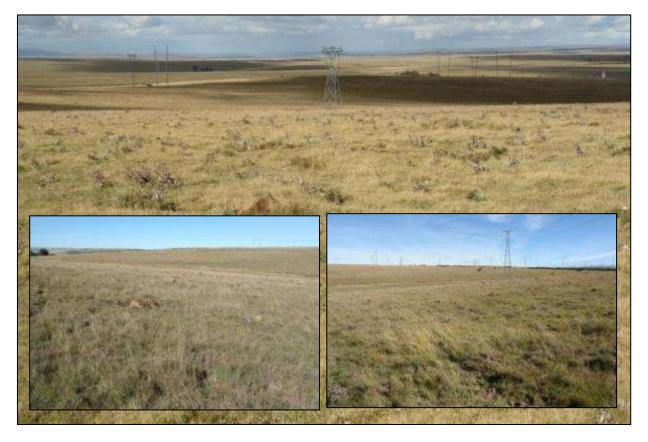
Figure 3. A view from turbine position 8 towards positions 9-13 in a north-easterly direction (main image) and reverse view towards turbine positions 9-11 from the south-west (inserts).

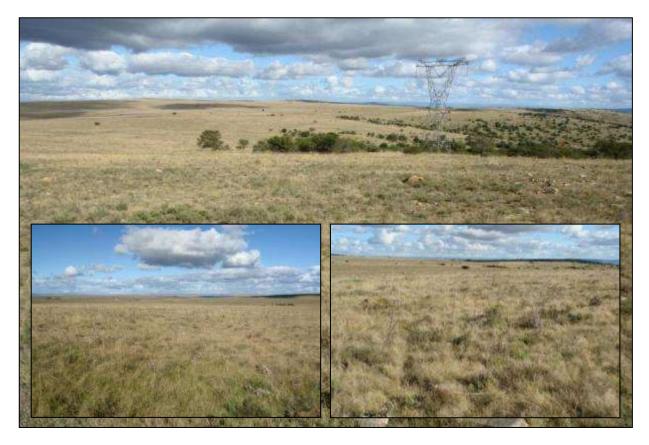
Figure 4. A view from turbine position 3 towards positions 16-18 (main image and left insert) and positions 19-21 (right insert).

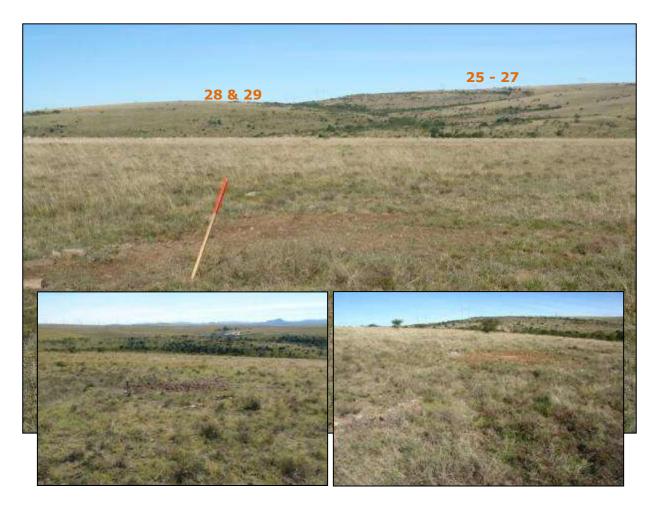
Figure 5. A view from turbine position 15 towards positions 25-29 (main image), a reverse view from position 29 towards the northern section (left insert) and a view of position 28 and towards the middle section (right insert).

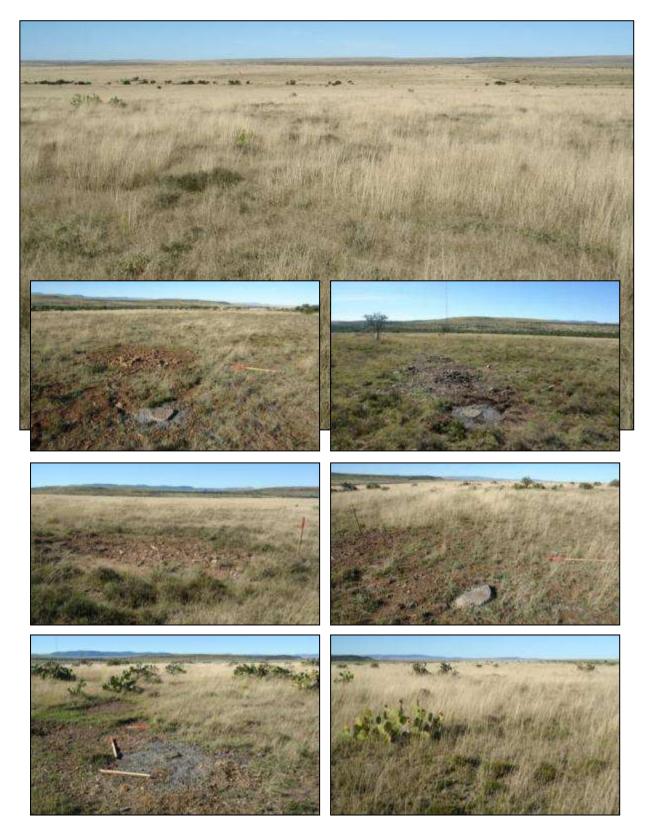
Figure 9. General view of the southern section (main image), turbine position 35 (top left insert), position 38 (top right insert), position 39 (middle left insert), position 42 (middle right insert), position 40 and a view towards positions 44 (bottom inserts).
