MEYER AND DU TOIT FARMSTEADS

Phase 2 – Heritage Impact Assessment Report

Issue Date: 27 May 2020

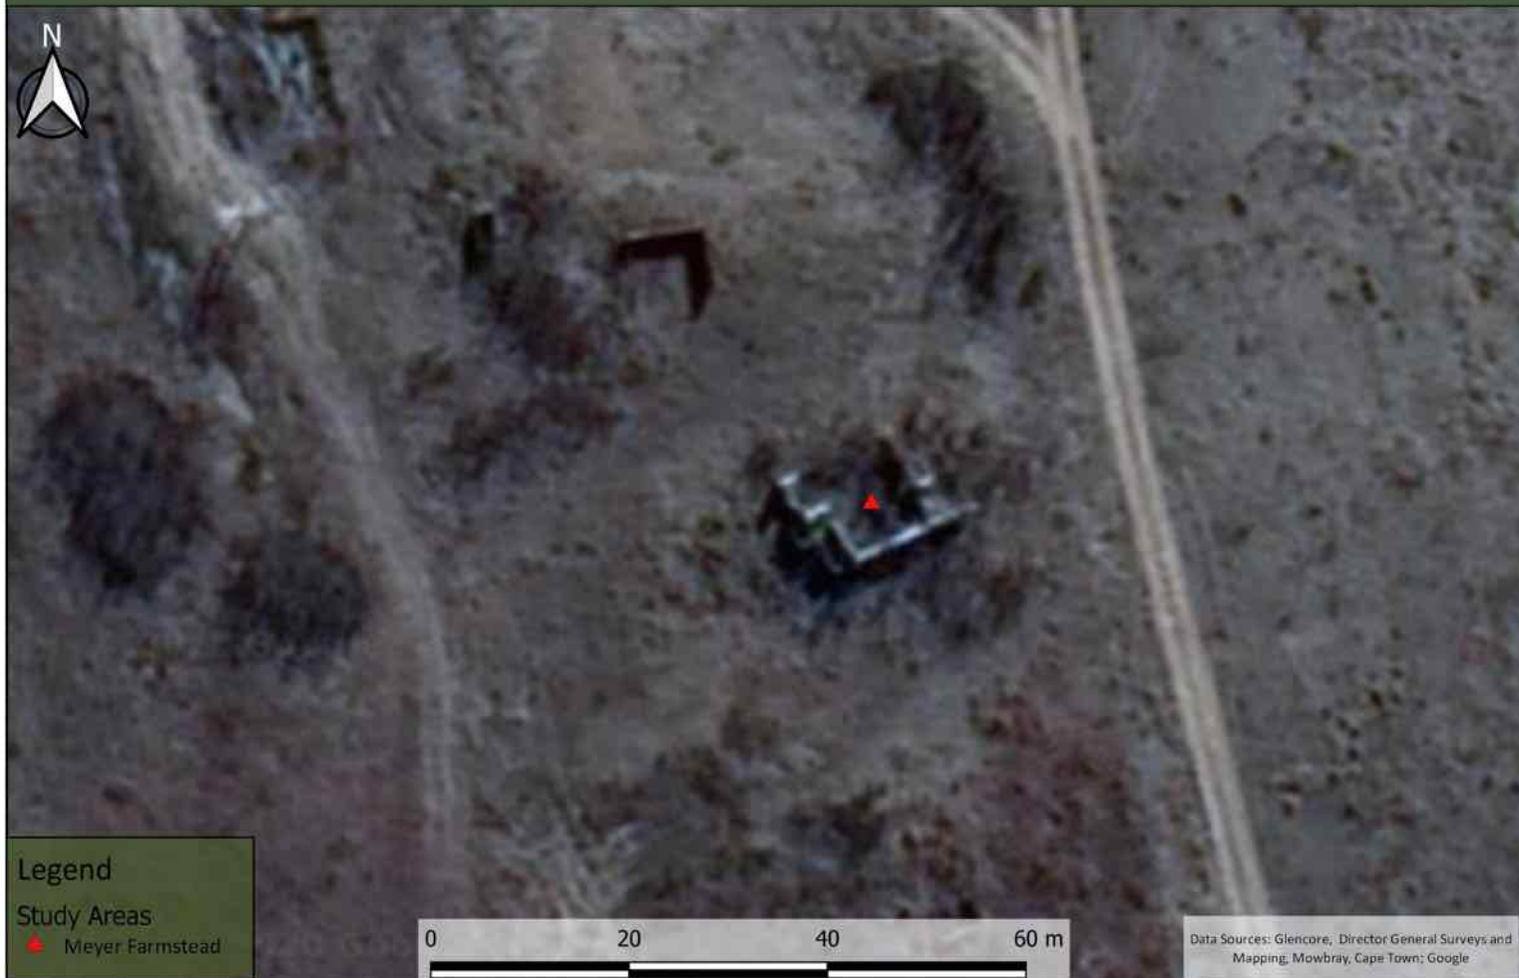
Figure 3 - View of the Meyer Farmstead

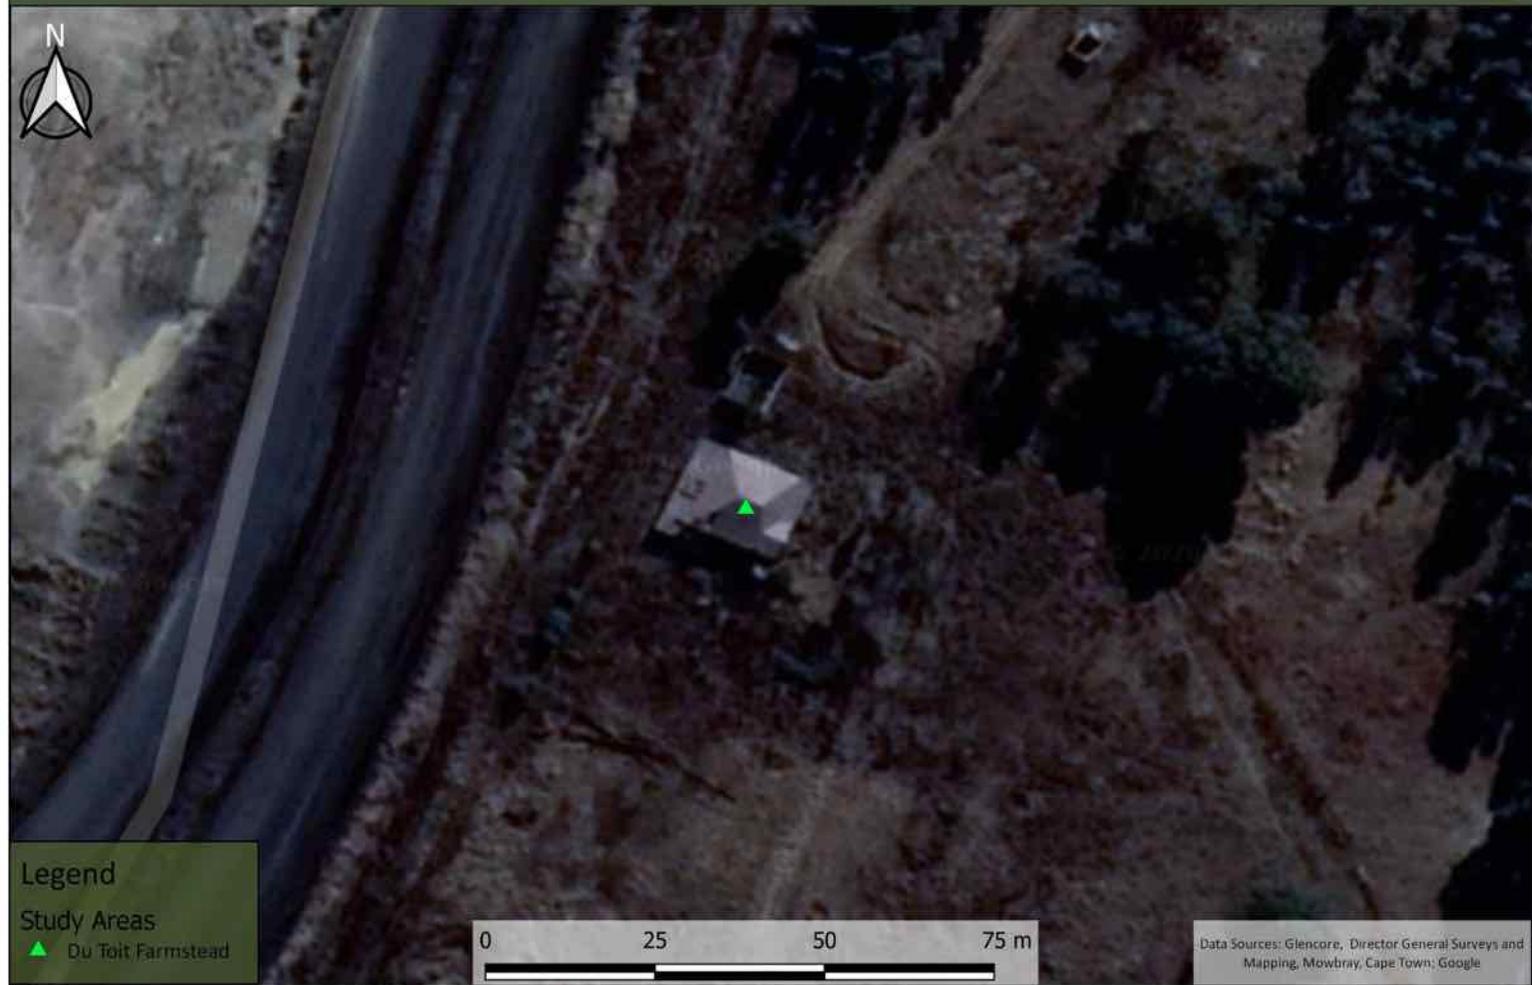
Figure 4 - View of the Du Toit Farmstead

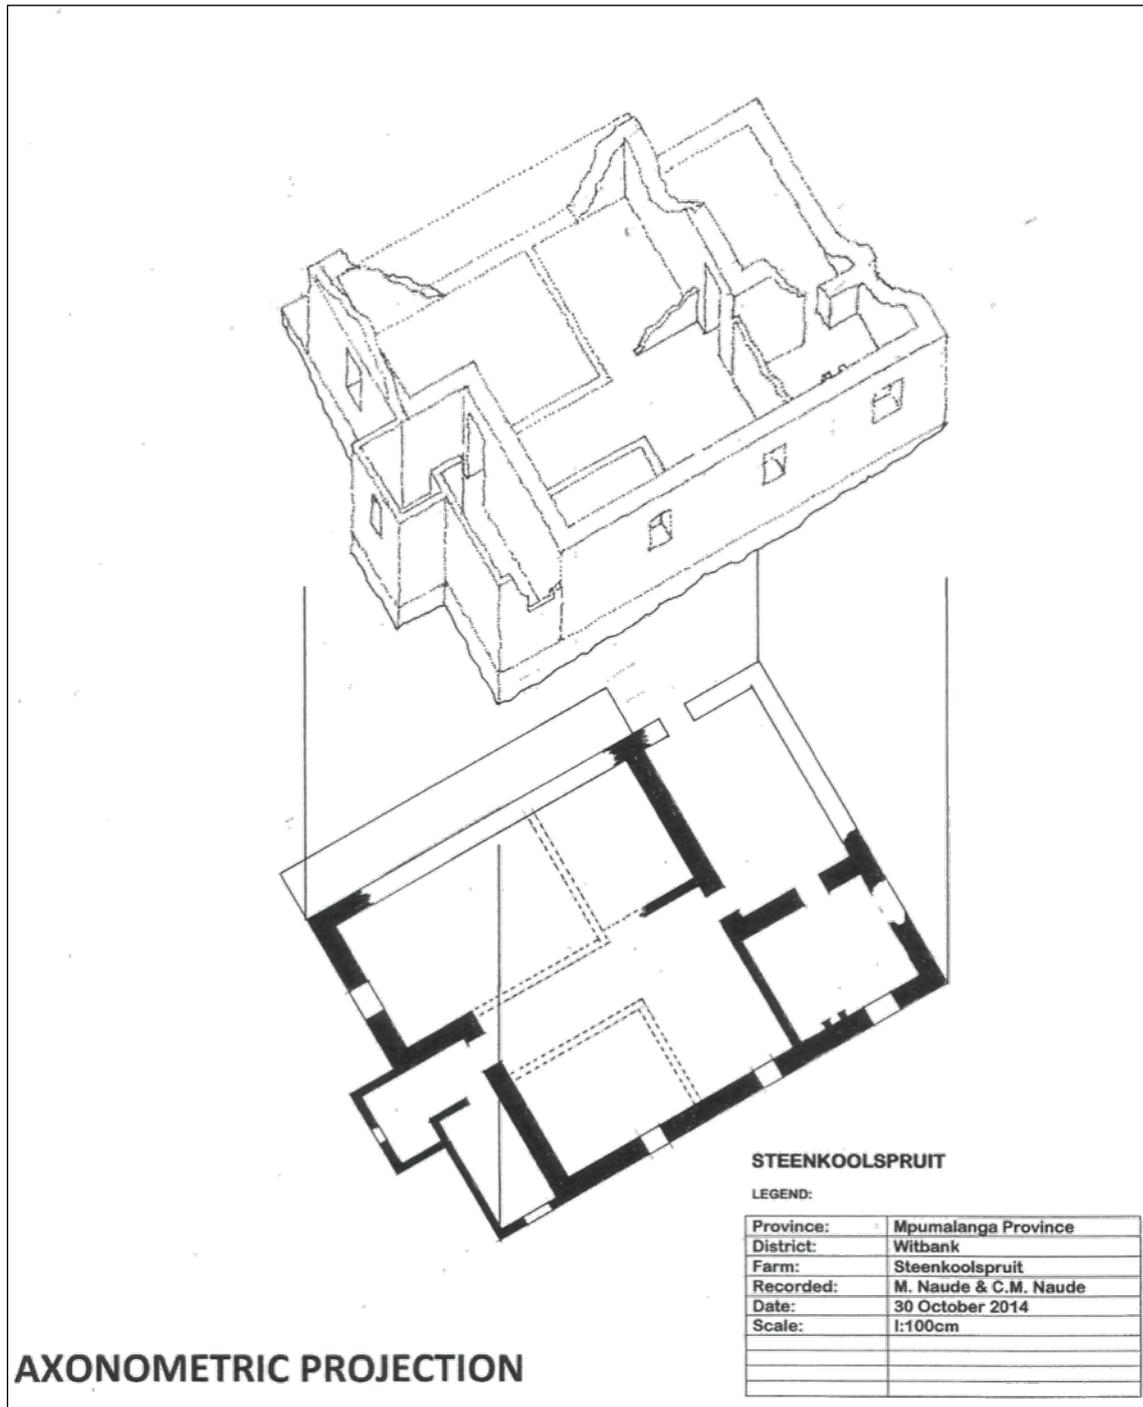
Figure 29 - Axonometric view of the ruin indicating the floor plan layout and condition of the dwelling. Drawing appeared in the recording report of Mauritz Naudé (2014:3).

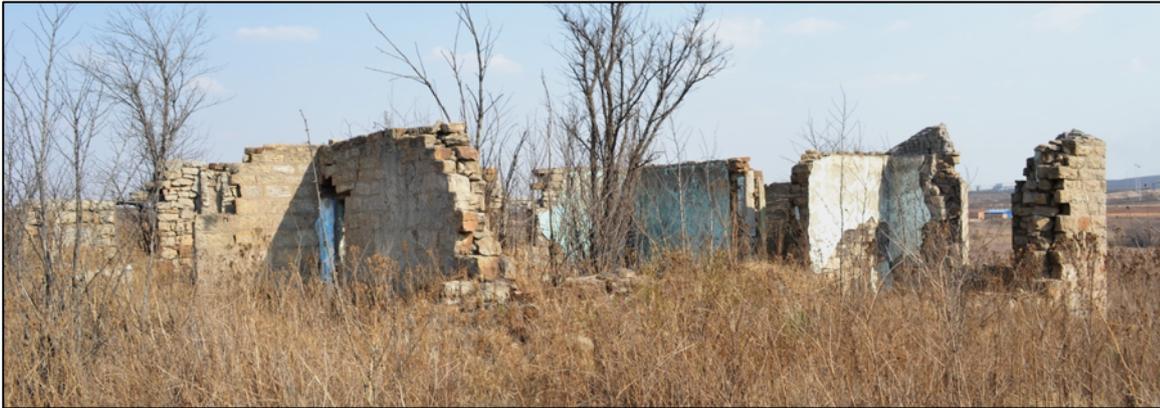
The building is not orientated according to the exact north-south axis but is set slightly off this axis. Almost the entire façade has been demolished and no evidence is available in the structure to reconstruct the elevation.

Figure 31 - North-western elevation (Photograph by Mauritz Naudé).

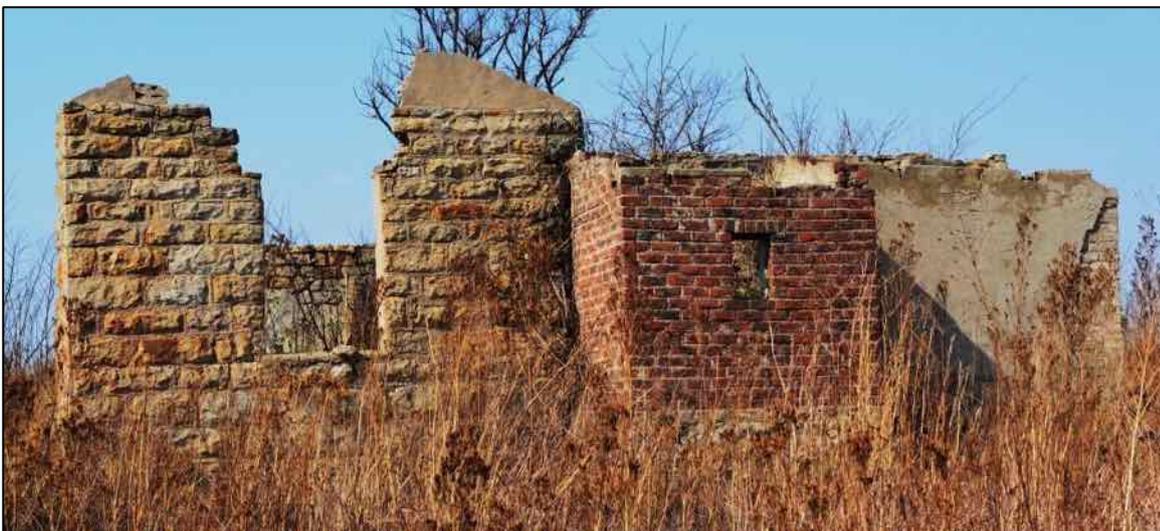
The façade seems to have been the principal façade of the dwelling and faces downhill towards the Steenkoolspruit valley and flood plain. The most significant feature is the original protruding sandstone gable and the red brick toilet which is a later addition. This façade was originally defined by the sandstone gable and a small verandah to its right. The verandah was later closed with walls (red brick and plastered section in the picture) to create a bathroom and toilet.

Figure 32 - South-eastern facade with gable and more recent toilet and bathroom additions done in red bricks (Photograph by Mauritz Naudé).

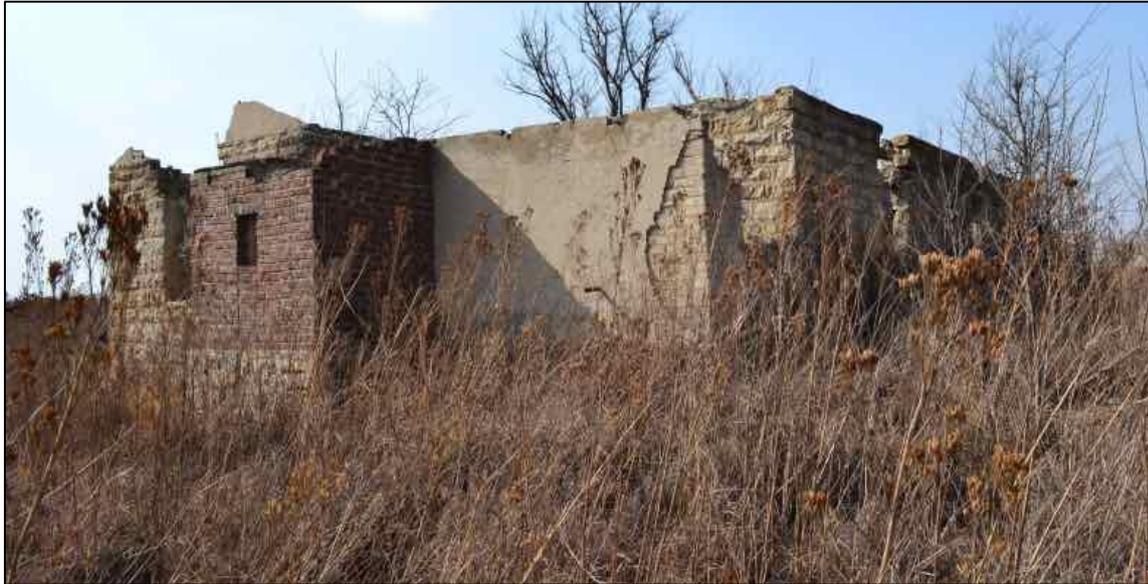
Figure 33 - This used to be the principal facade with gable and stoep where the red brick and plastered room were added to form the bathroom and toilet (Photograph by Mauritz Naudé).

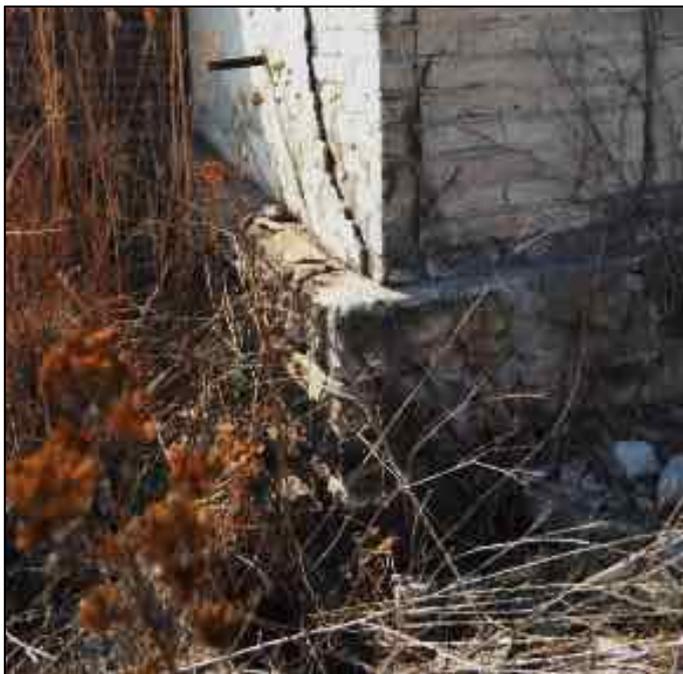
Figure 35 - Plinth where the original stone foundation of the stoep was used as a base for a later addition (Photograph by Mauritz Naudé).

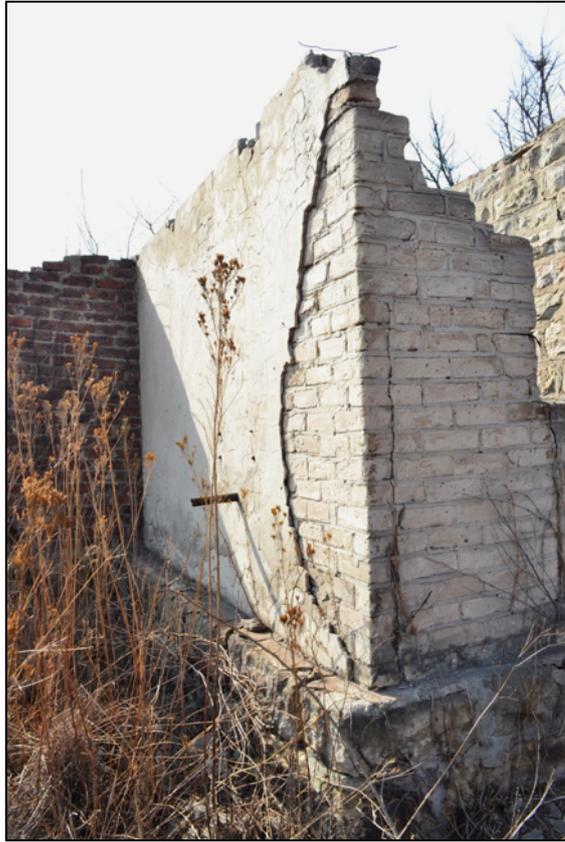
Figure 41 – Exposed sun-dried bricks after the plastering had washed off on the addition along the south-western façade of the dwelling (Photograph by Mauritz Naudé).

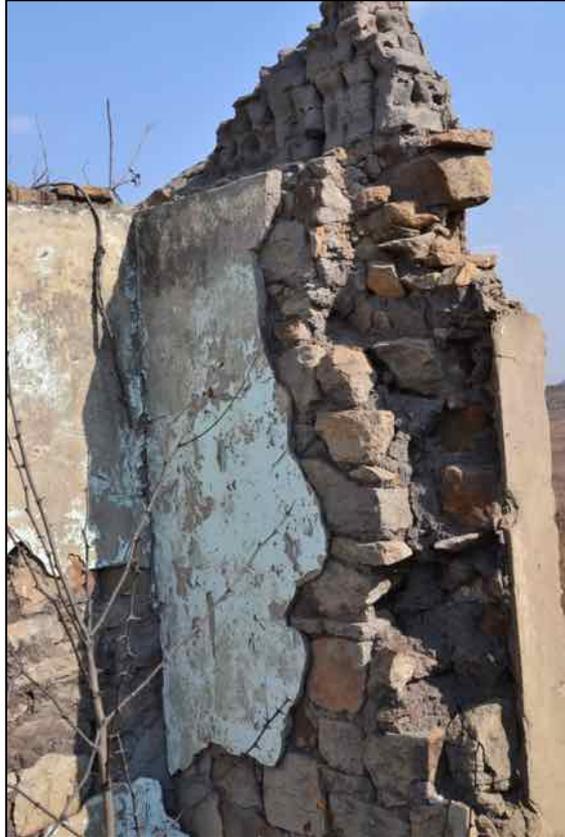
remained on top of the sandstone walling. It may also imply that the gable was a later addition. The bricks used for the gable were laid as a single course four inches wide, rendering the gable rather flimsy. An outstanding element is the presence of a large protruding sandstone window sill in the eastern façade. For such a simple dwelling this sill is quite monumental and indicates some level of sophistication in the masonry. The dwelling reflects no other decorative elements except for this detail. Some effort has been made with the stone window sill. All the lintels were done with timber. No lintels were done with sandstone.

Figure 42 – Sun-dried clay bricks on top of the sandstone wall define the triangle of the remains of the gable (Photograph by Mauritz Naudé).

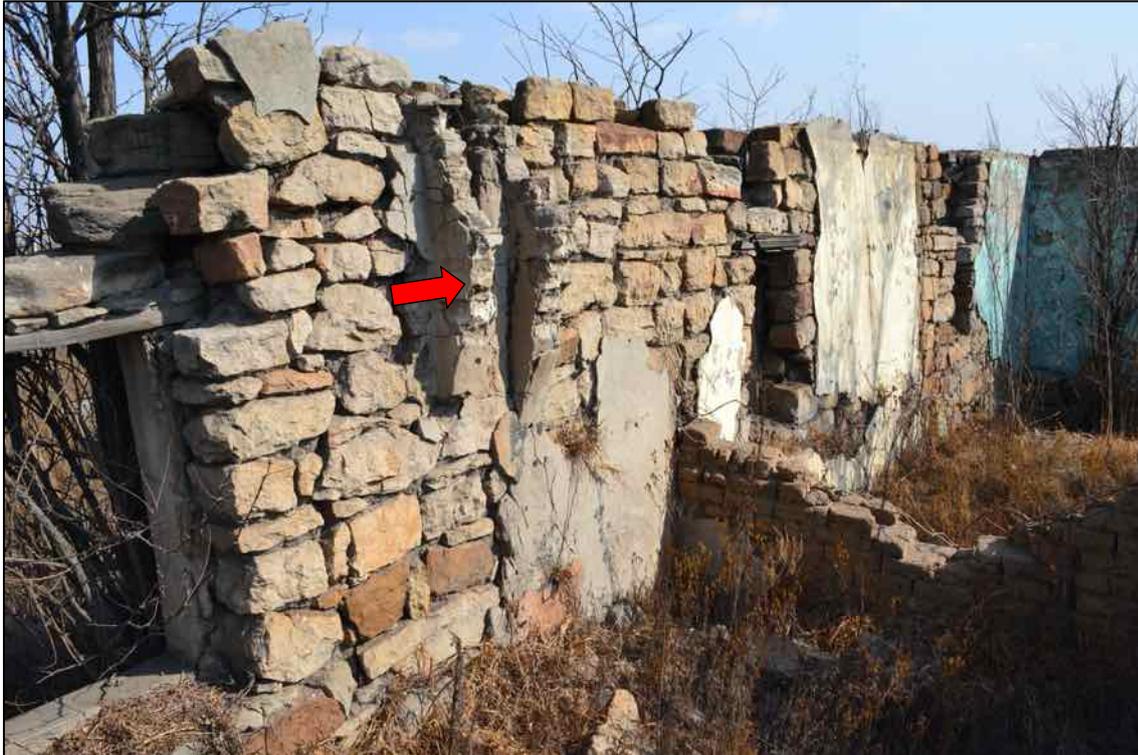
No formal hearth was identified in the floor plan but the remains of a chimney sheath defining the exit of a chimney for a coal stove or slow combustion stove was identified in what could have been the kitchen.

Figure 43 - Remains of plastered brick chimney fluting (see red arrow) guiding the round metal chimney pipe of a coal stove (Photograph by Mauritz Naudé).

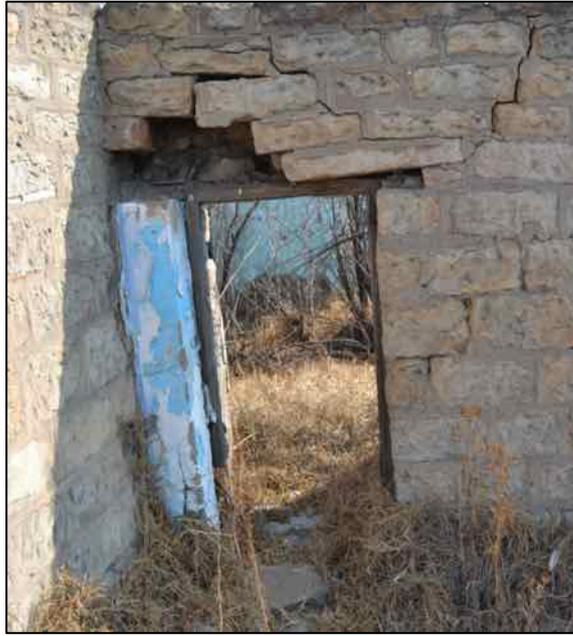
No doors have been left in the building and all the door frames have been removed. A single door frame has been left intact.

Figure 44 - Remains of a single door frame (Photograph by Mauritz Naudé).

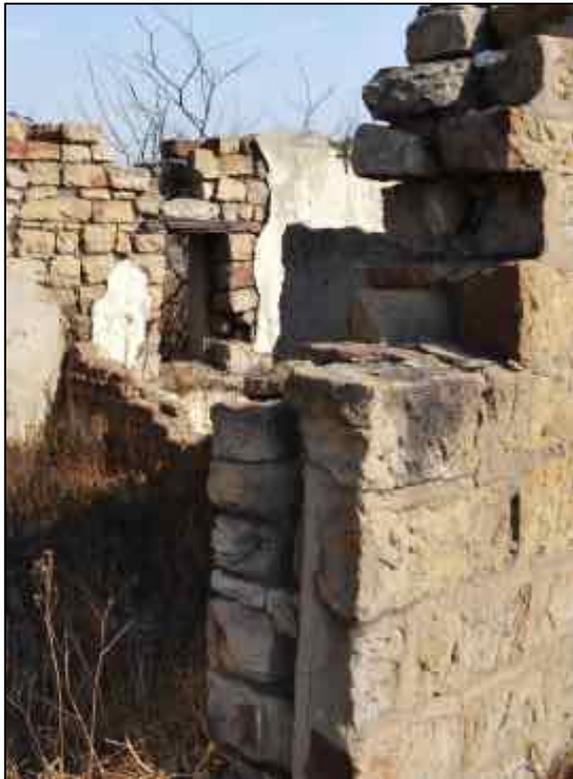
Figure 45 - Remains of a door where the frame has been removed (Photograph by Mauritz Naudé).

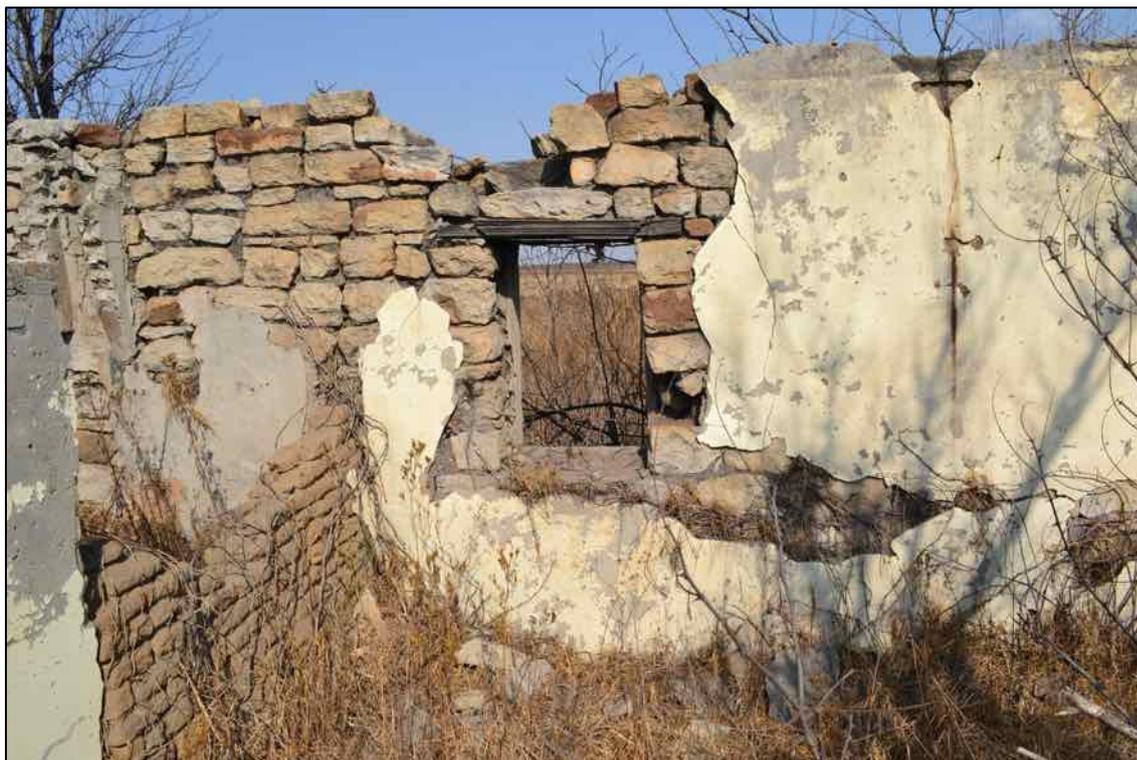
The windows from the dwelling had timber frames and timber lintels. Some have remained intact while others have disappeared after being exposed to the sun and rain. It is assumed that some timber frame windows were replaced with steel frames and these were also removed.

Figure 46 - Window with lintel and a short section of the top part of the architrave intact (Photograph by Mauritz Naudé).

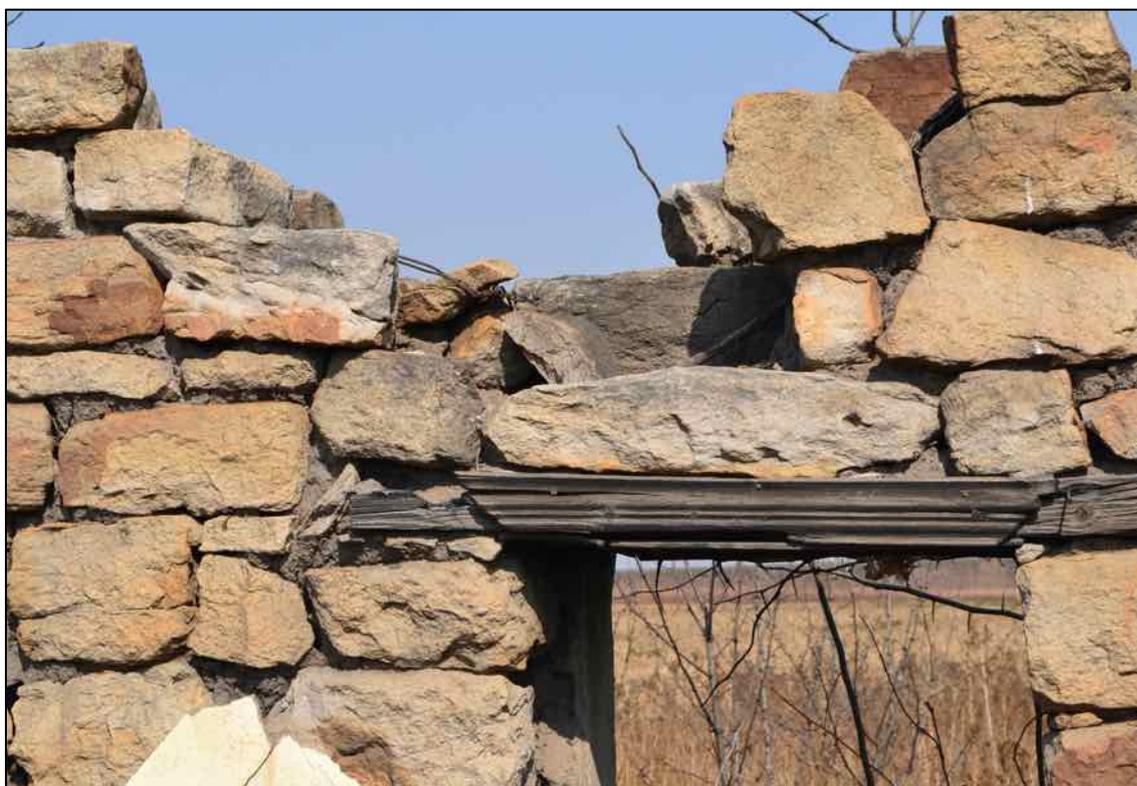
Figure 47 - Window with lintel and architrave intact (Photograph by Mauritz Naudé).

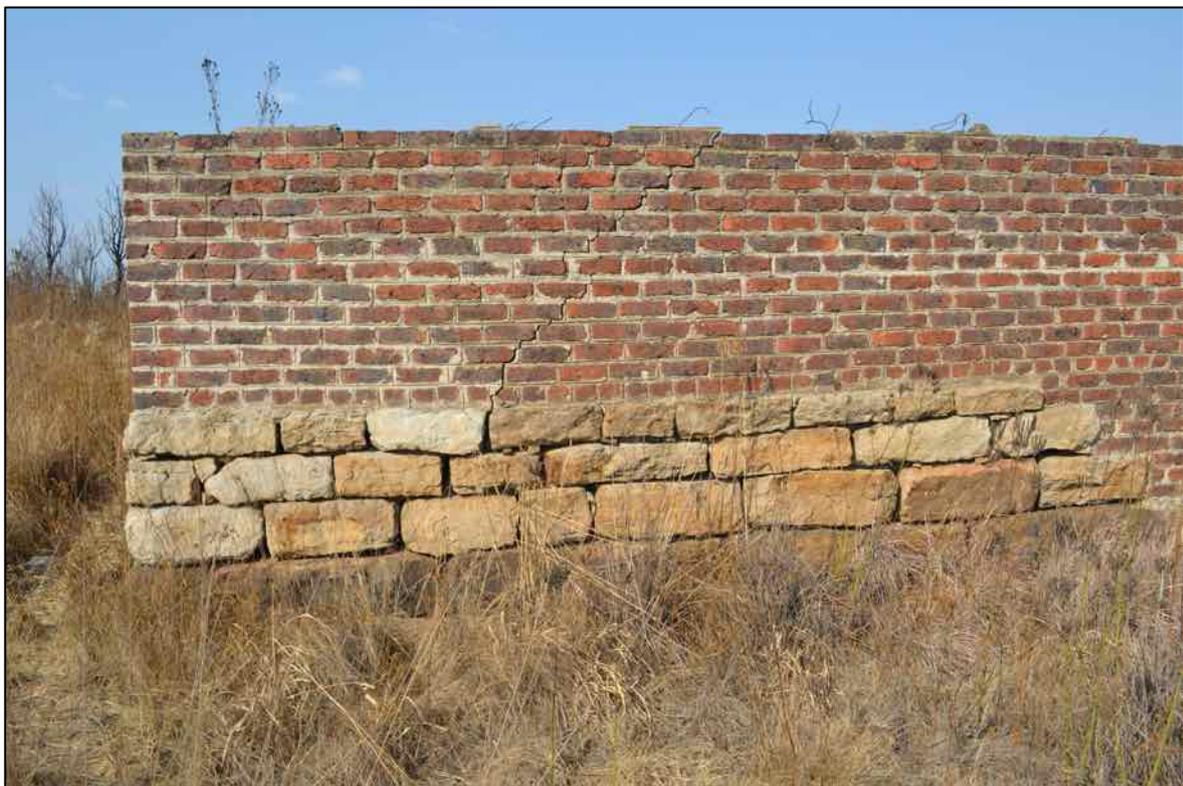
A garage for two standard motorized vehicles is located here. The building is the size of a double garage for standard vehicles. It was constructed with red stock bricks but never plastered. The most northern corner was constructed with dressed sandstone blocks using simple coursework. The entire roof has been removed.

Figure 51 – Exterior wall of the garage indicating the various building materials that were used for the construction (Photograph by Mauritz Naudé).

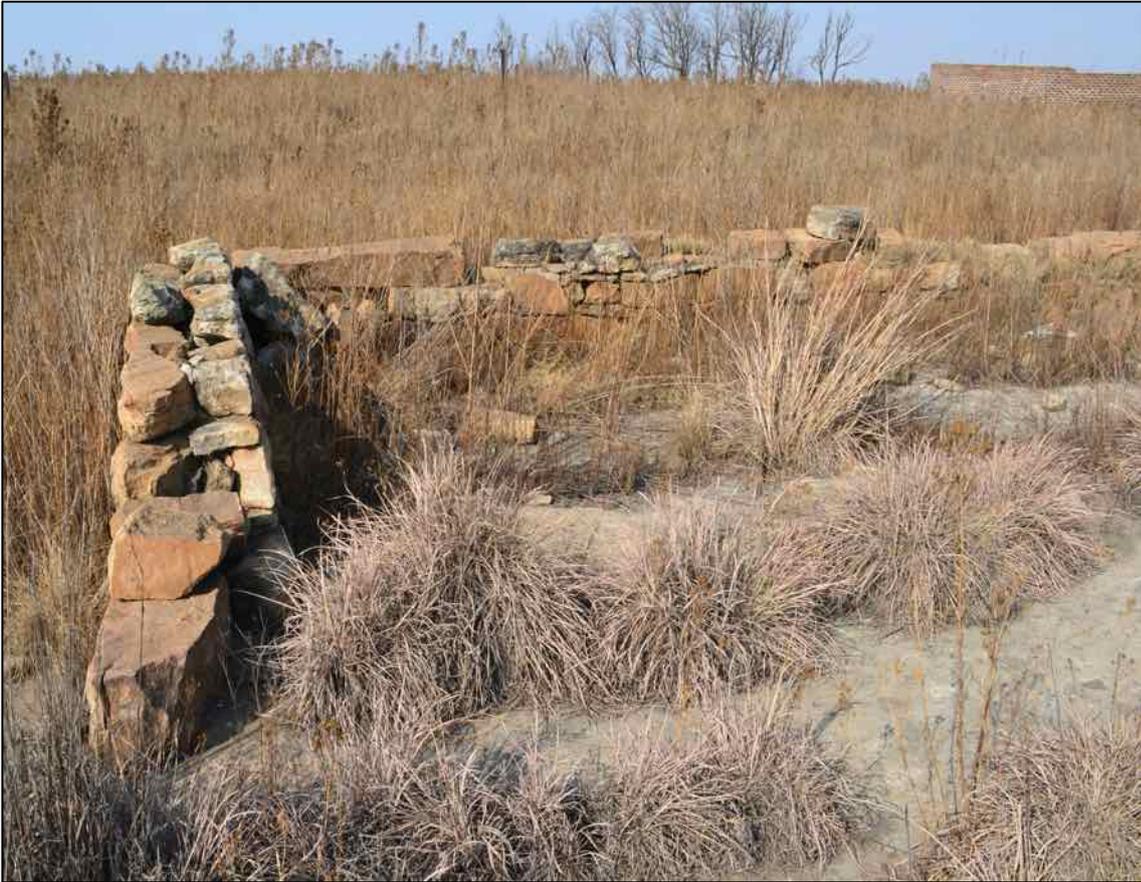
The remains of a sandstone livestock enclosure was identified here. This structure was constructed in a relatively crude manner with dry stacked walling.

Figure 53 – The remains of a livestock enclosure identified some distance from the farm dwelling. The structure is set along the vertical slope of a stone outcrop (Photograph by Mauritz Naudé).

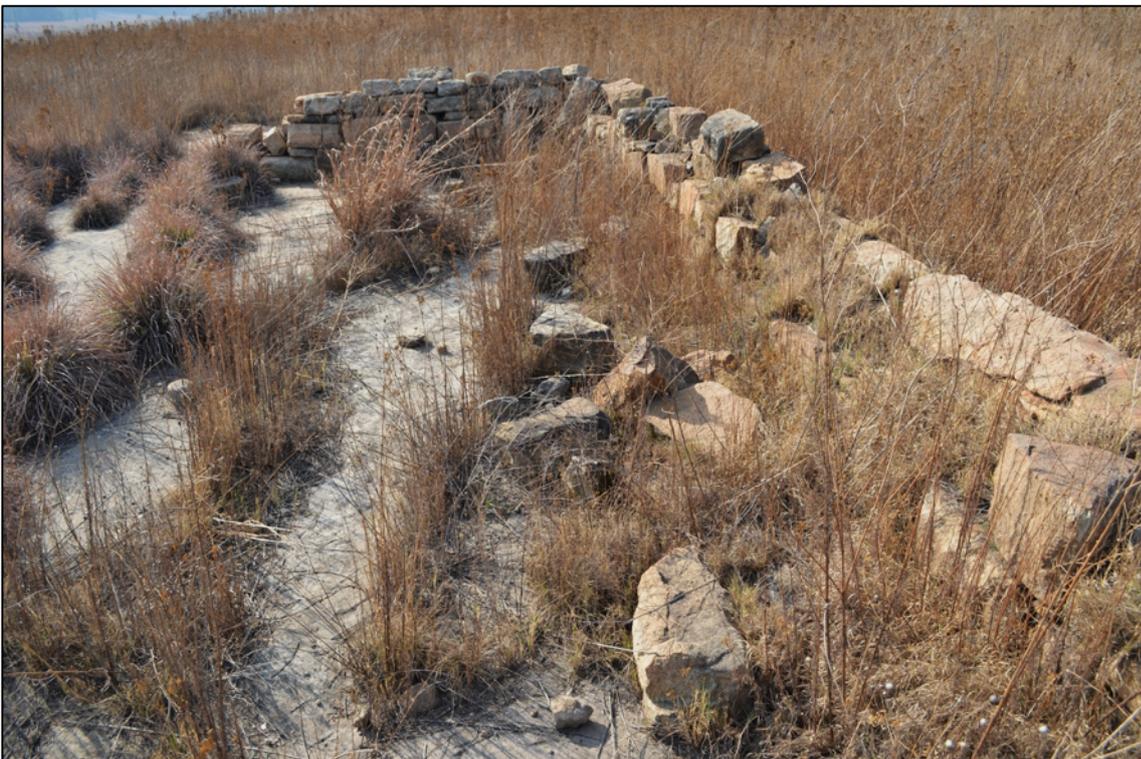
Figure 54 – Another view of the remains of a livestock enclosure identified some distance from the farm dwelling (Photograph by Mauritz Naudé).

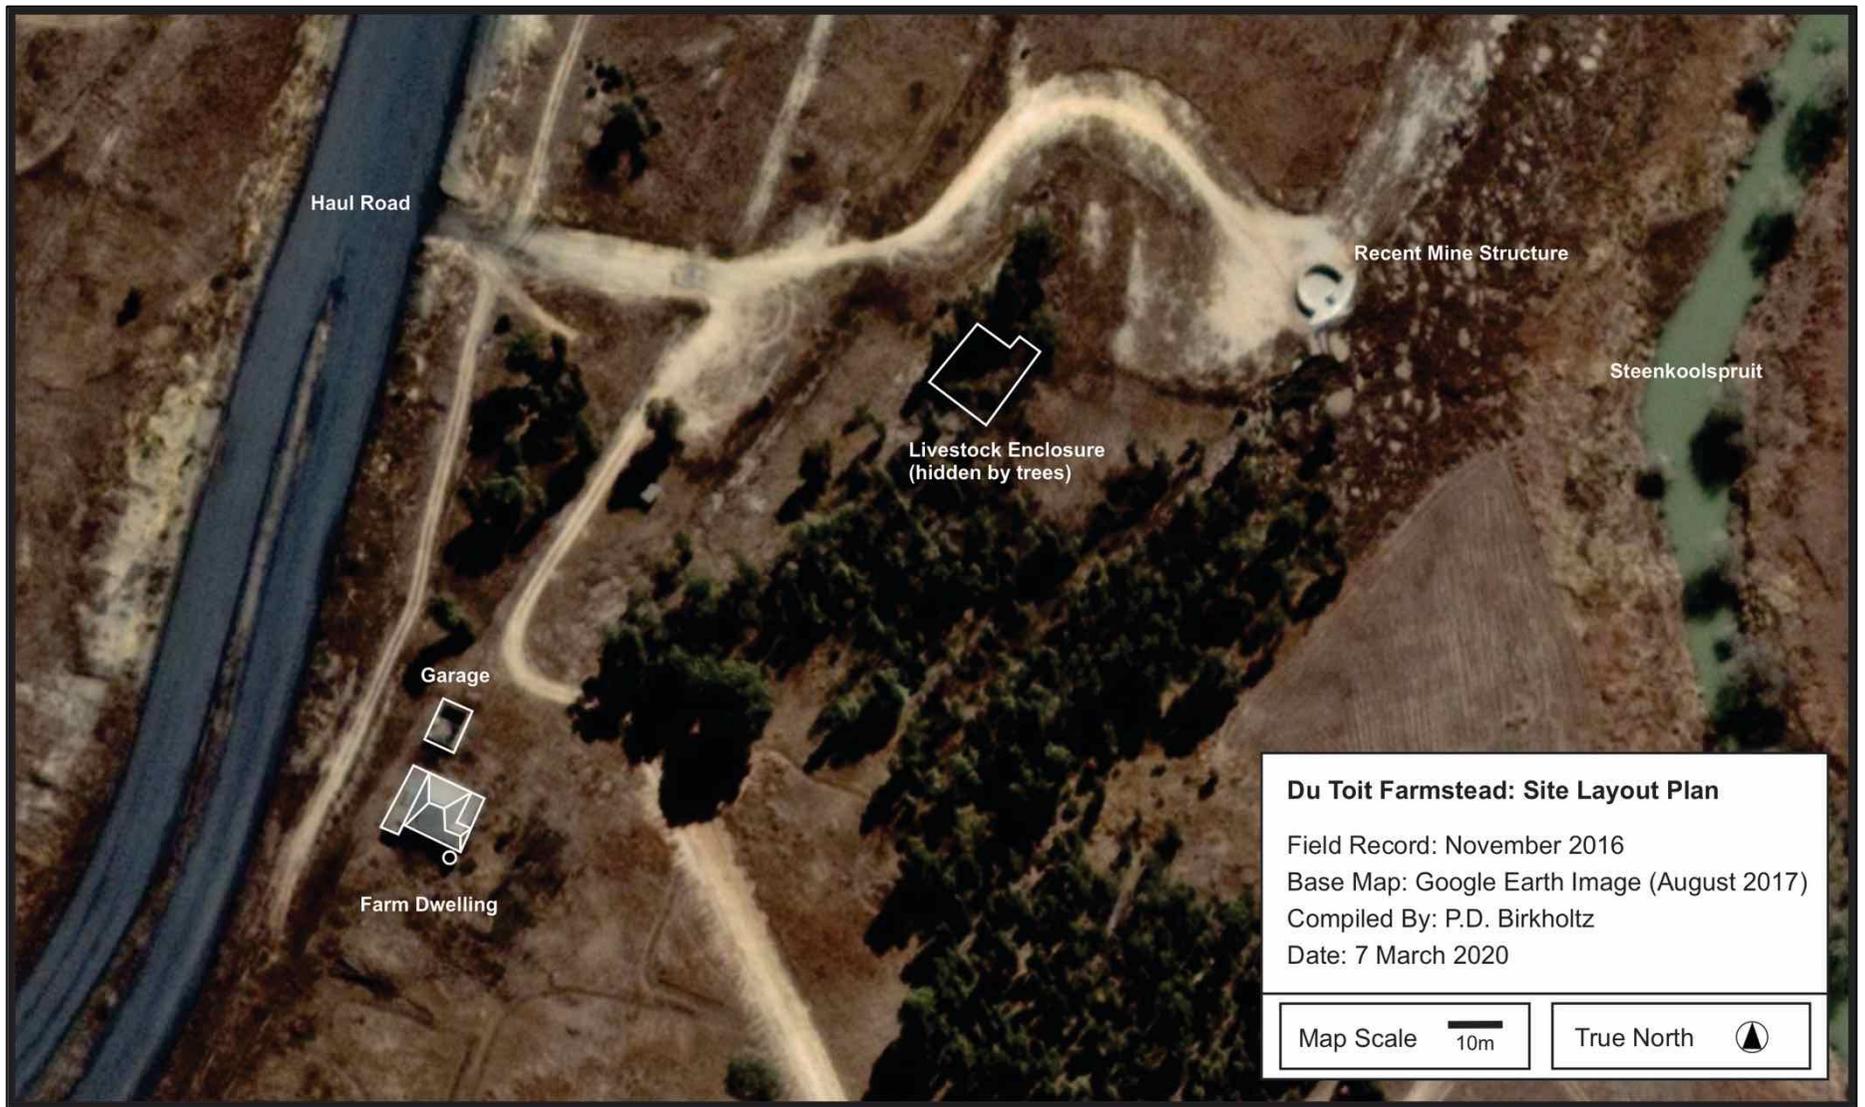
Figure 55 – Site layout plan for the Du Toit Farmstead.

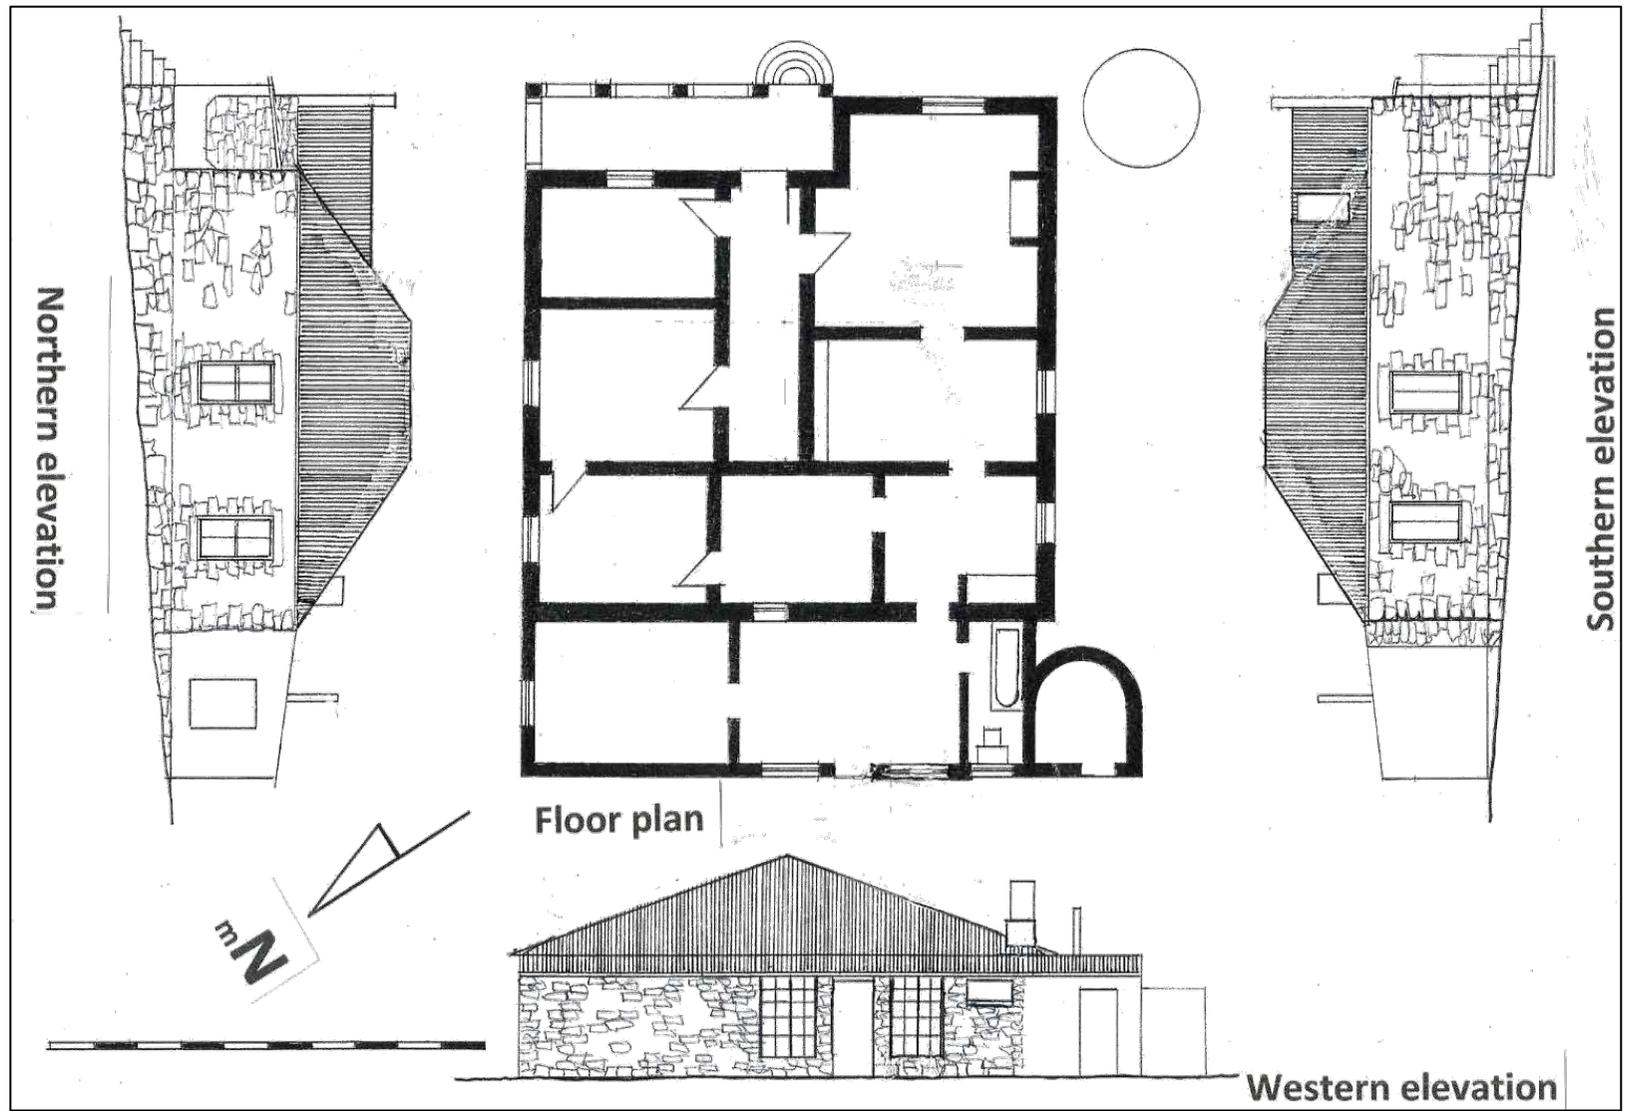
Figure 56 - A floor plan of the original dwelling with the northern, southern and western elevation. It appeared in the recording report of Mauritz Naudé (2016:3).

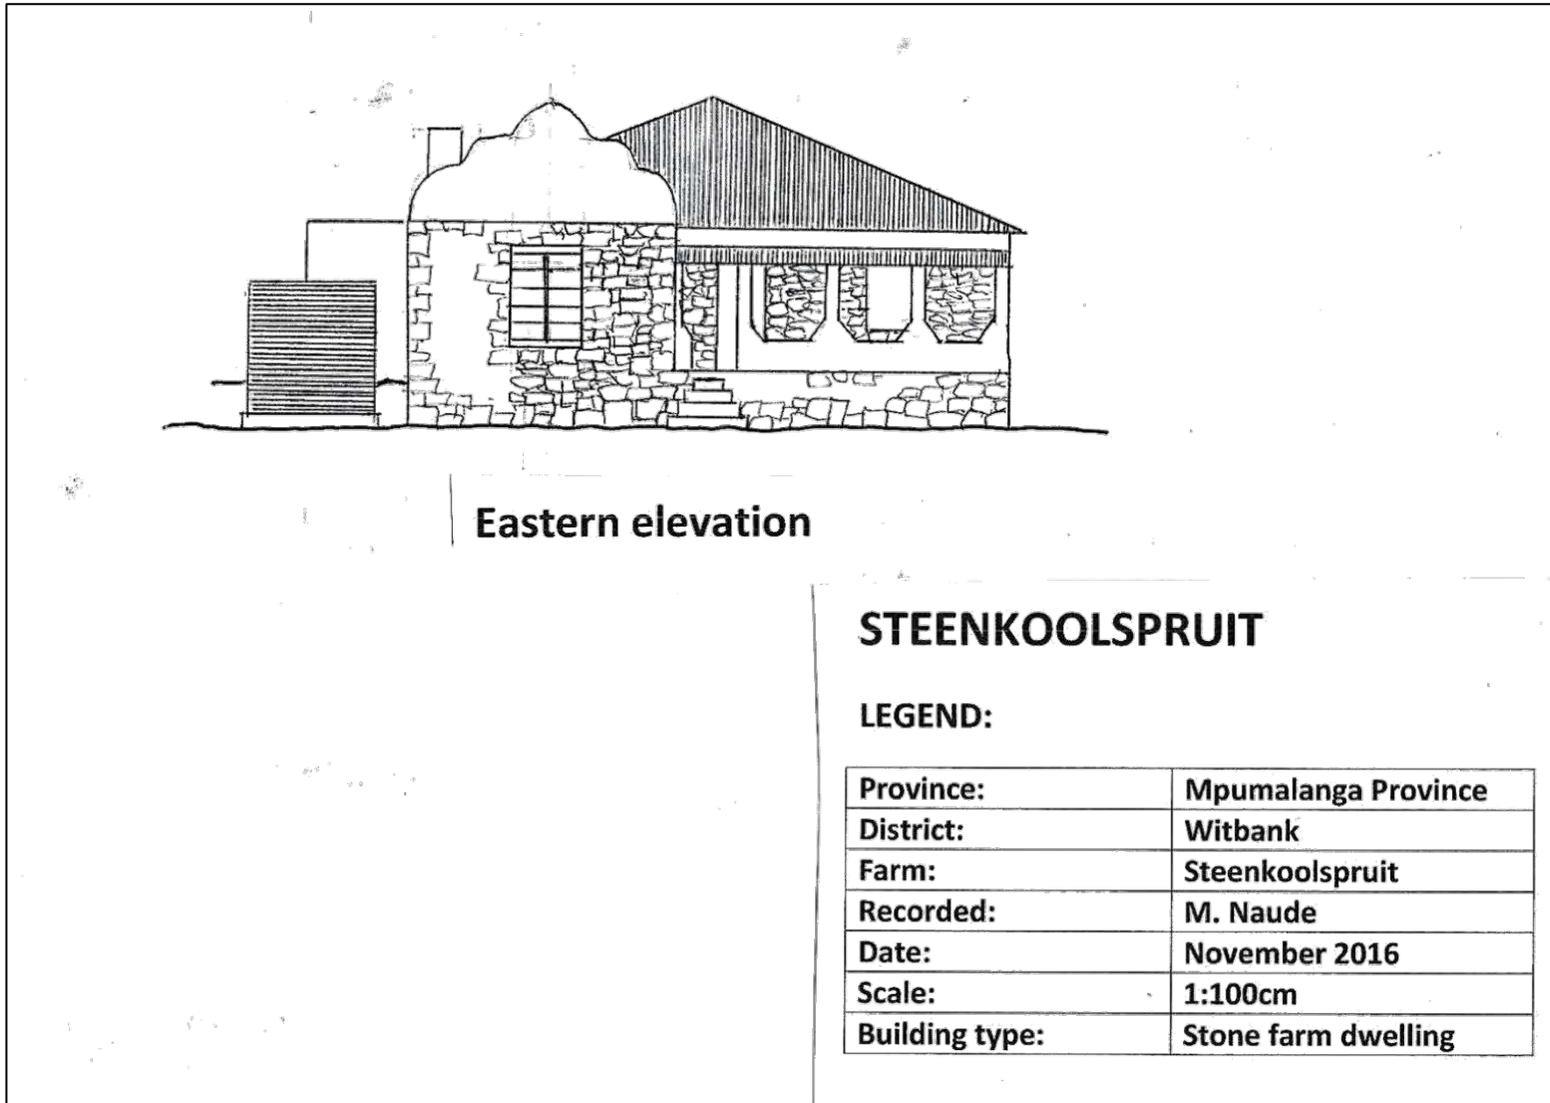
Figure 57 – The eastern elevation of the farm dwelling. This drawing appeared in the recording report of Mauritz Naudé (2016:4).

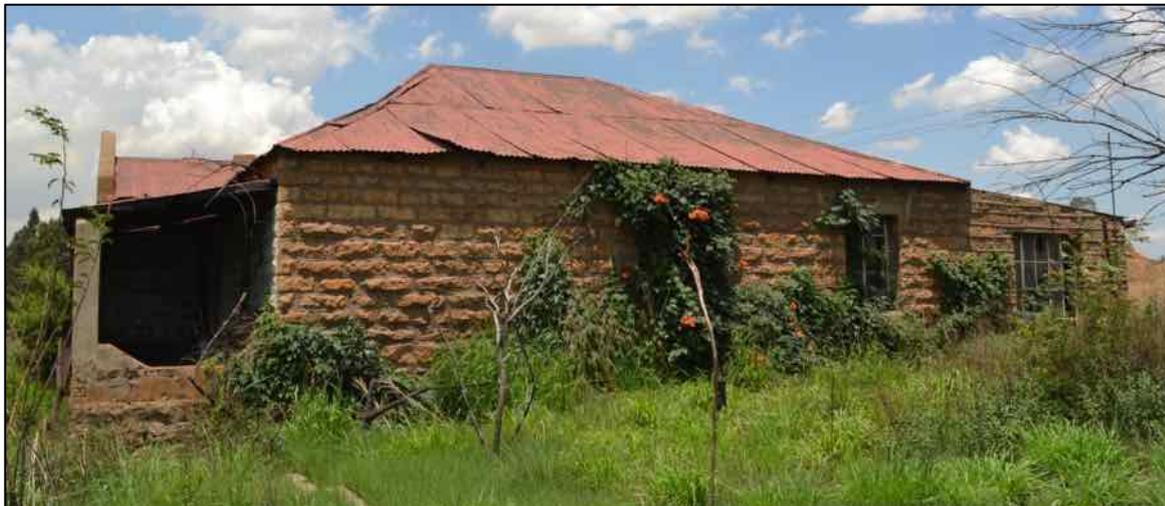
This elevation only contains two windows in the core of the structure and a single steel frame window in the lean-to.

Figure 58 - Northern Elevation (Photograph by Mauritz Naudé).
