MEYER AND DU TOIT FARMSTEADS

Phase 2 – Heritage Impact Assessment Report

Issue Date: 27 May 2020

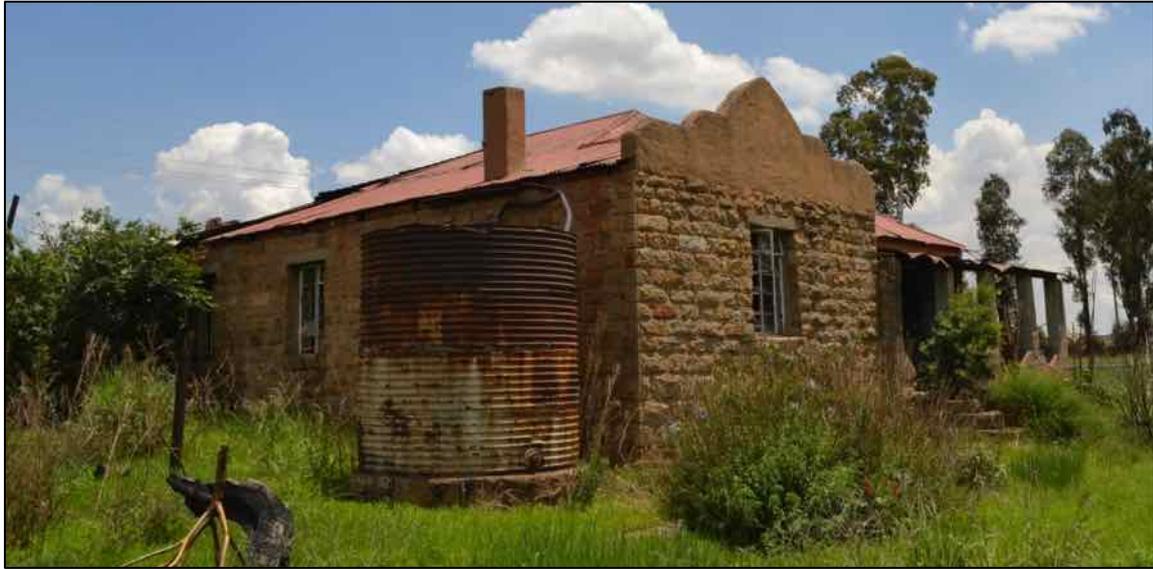
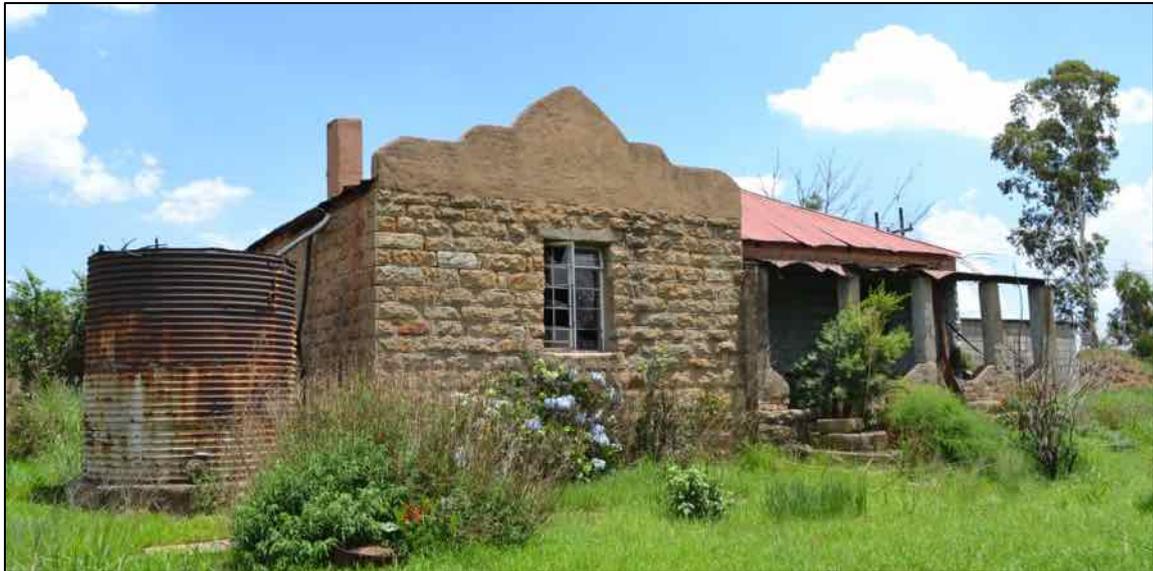
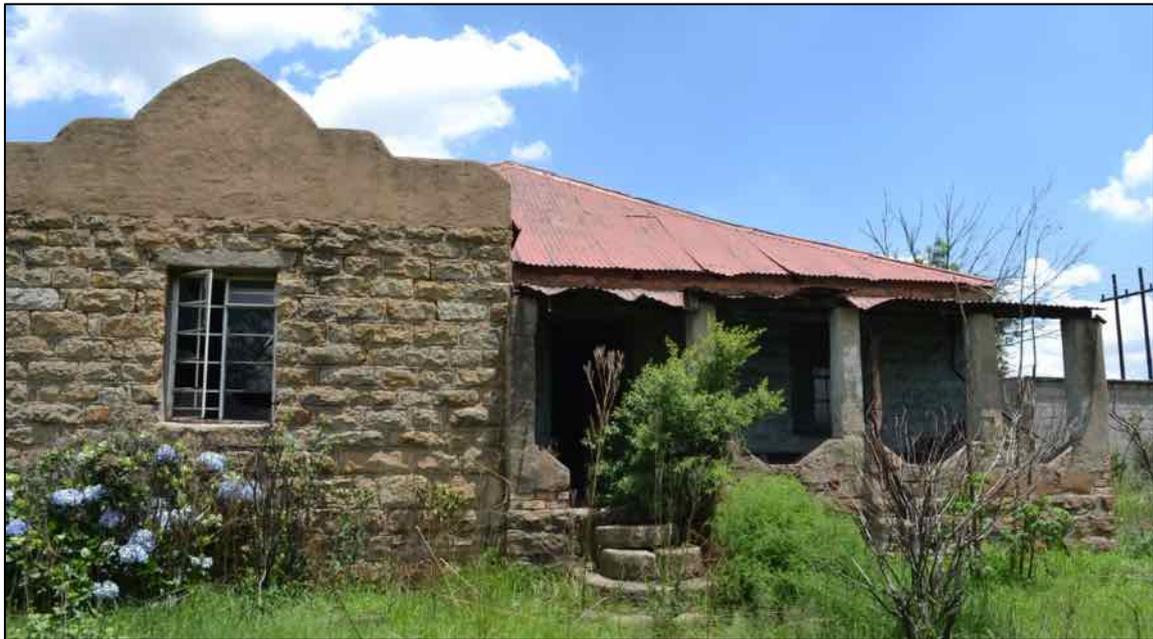
The veranda originally had a timber support structure for the roof which was later replaced with plastered brick columns. This may have been altered during the 1920s or 1930s.

Figure 59 - Eastern Elevation (Photographs by Mauritz Naudé).

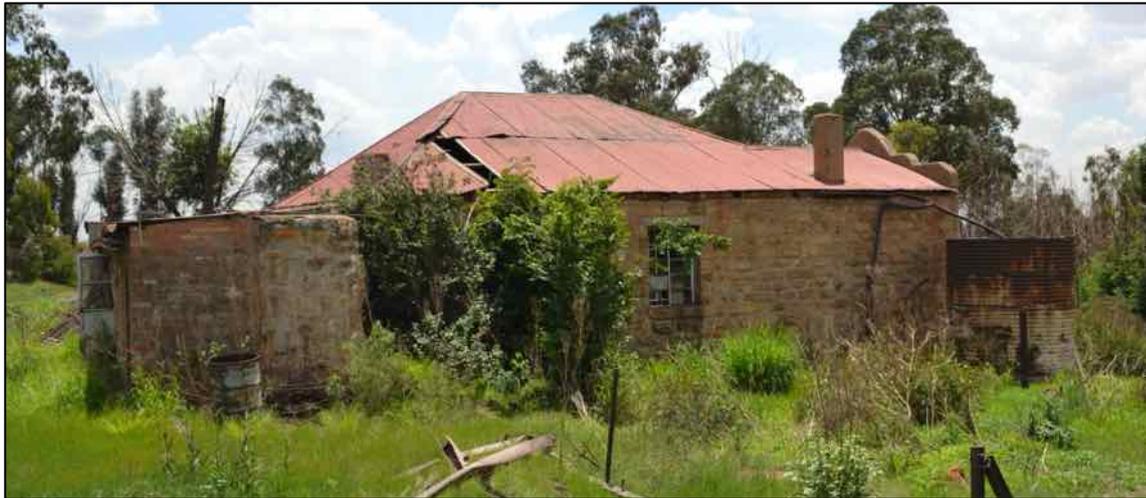
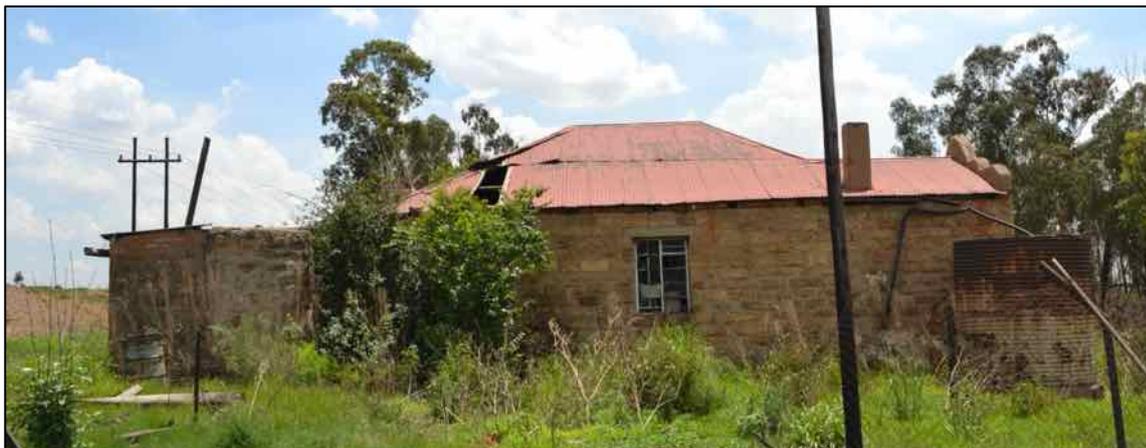
This elevation contains no entrances. The entire elevation was constructed with sandstone. The only extension to this elevation is a small room. Where the 'donkie' (the hot water tank and hearth) was located. Two steel frame windows occur in this elevation.

Figure 60 - Southern Elevation (Photographs by Mauritz Naudé).

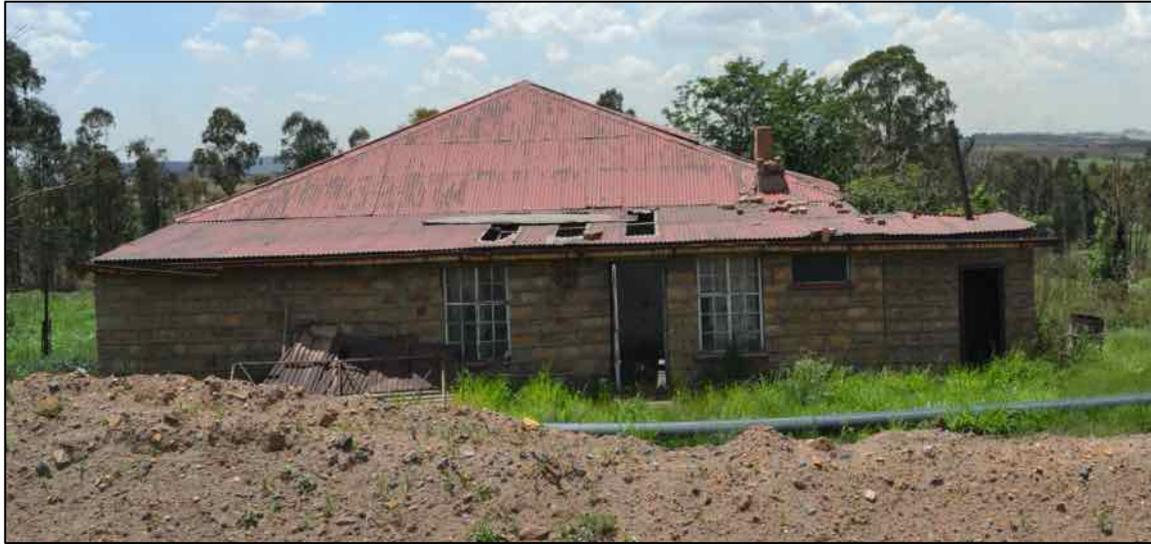
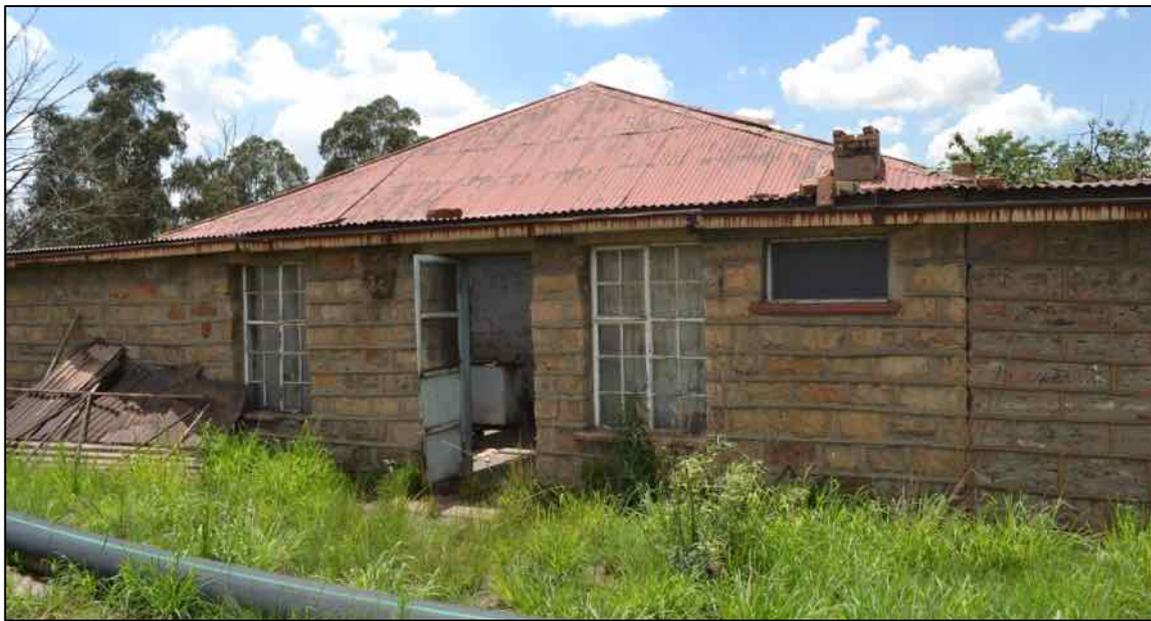
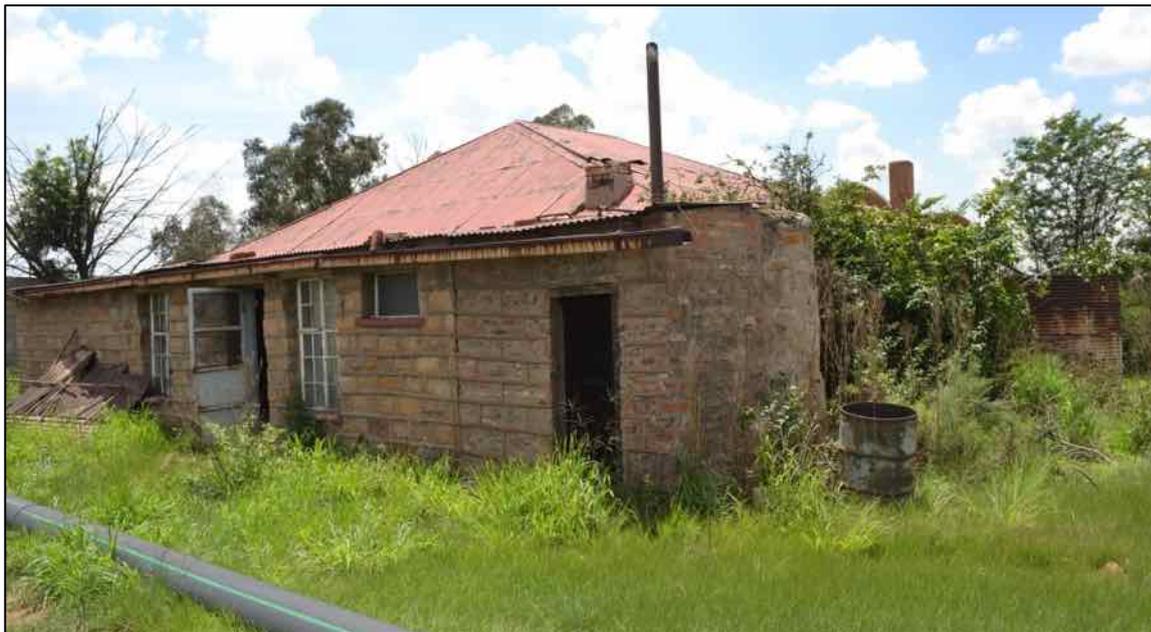
The entire western elevation has been extended with the lean-to section. This lean-to was first added as a back stoep and veranda and the space created was closed-off in sections over time. A central part of the stoep was left as a veranda while an additional bedroom was added on the northern side and a bathroom and toilet were added on the southern side. The veranda was later closed-off with walls and became a dining room.

Figure 61 - Western Elevation (Photographs by Mauritz Naudé).

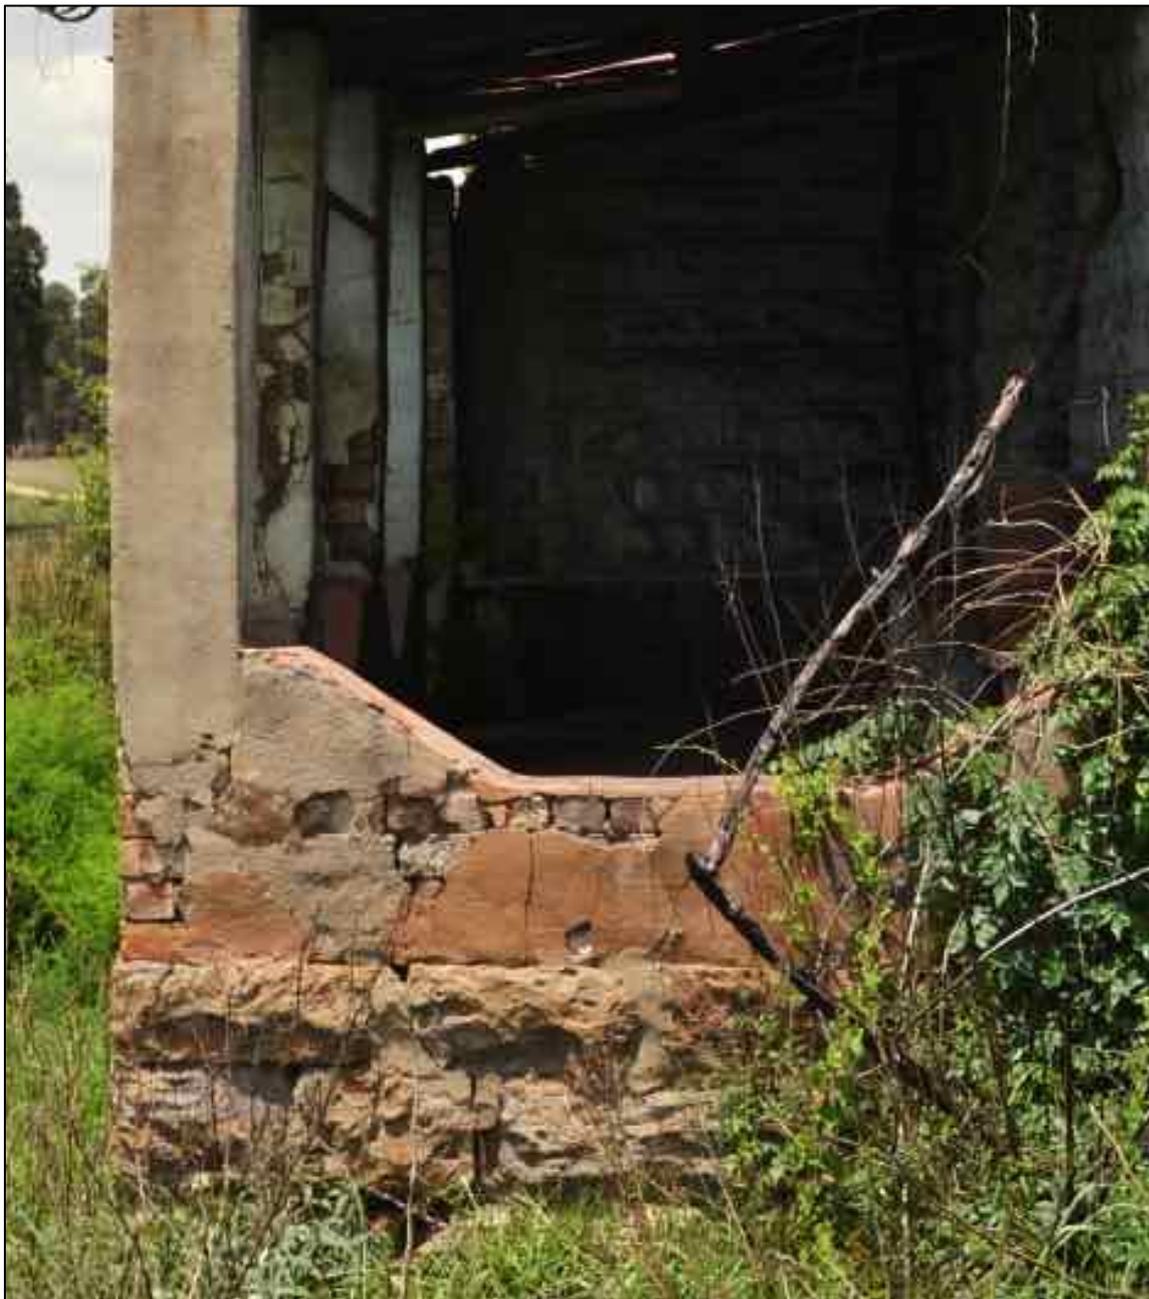
Figure 62 - View of the original stone foundation (Photograph by Mauritz Naudé).

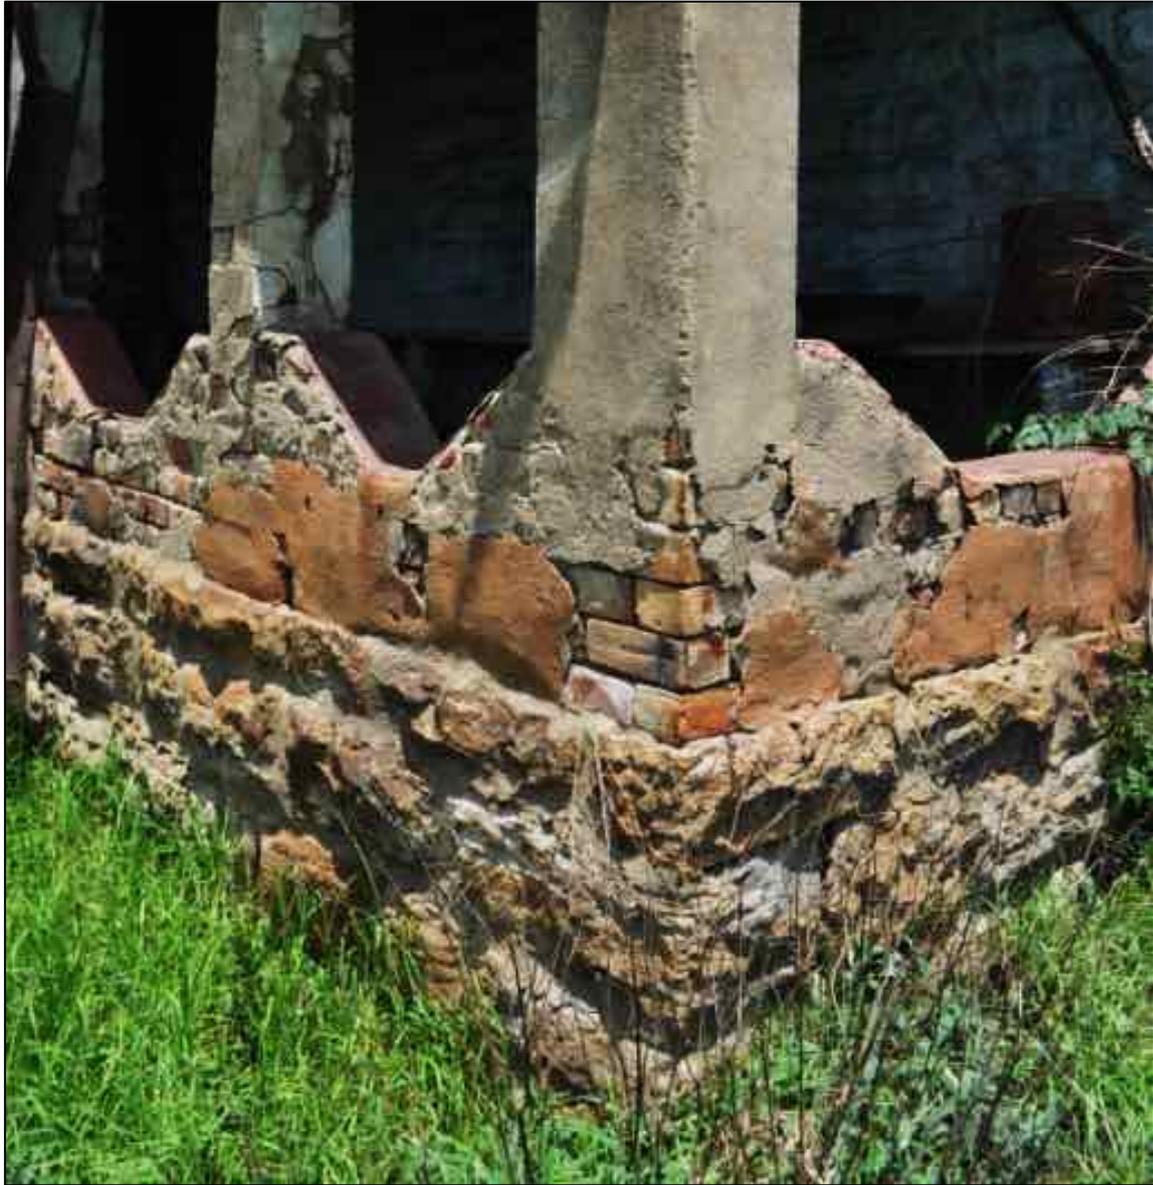
Figure 63 - Exposed sandstone base of the front veranda indicating the difference between the sandstone base of the structure and the more recent introduction of baked bricks for the low veranda wall and supporting columns (Photograph by Mauritz Naudé).

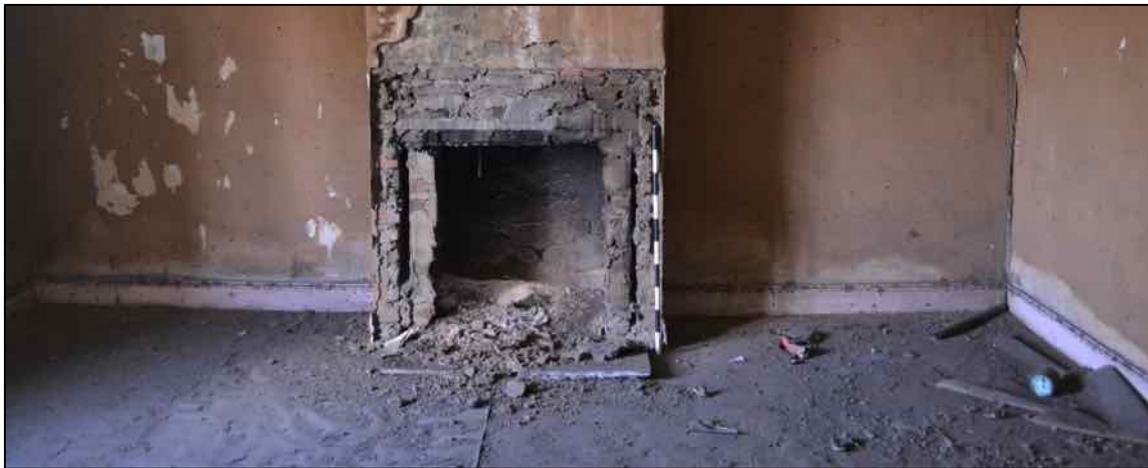
Figure 65 - Floor of the lounge with wooden skirting boards (Photograph by Mauritz Naudé).

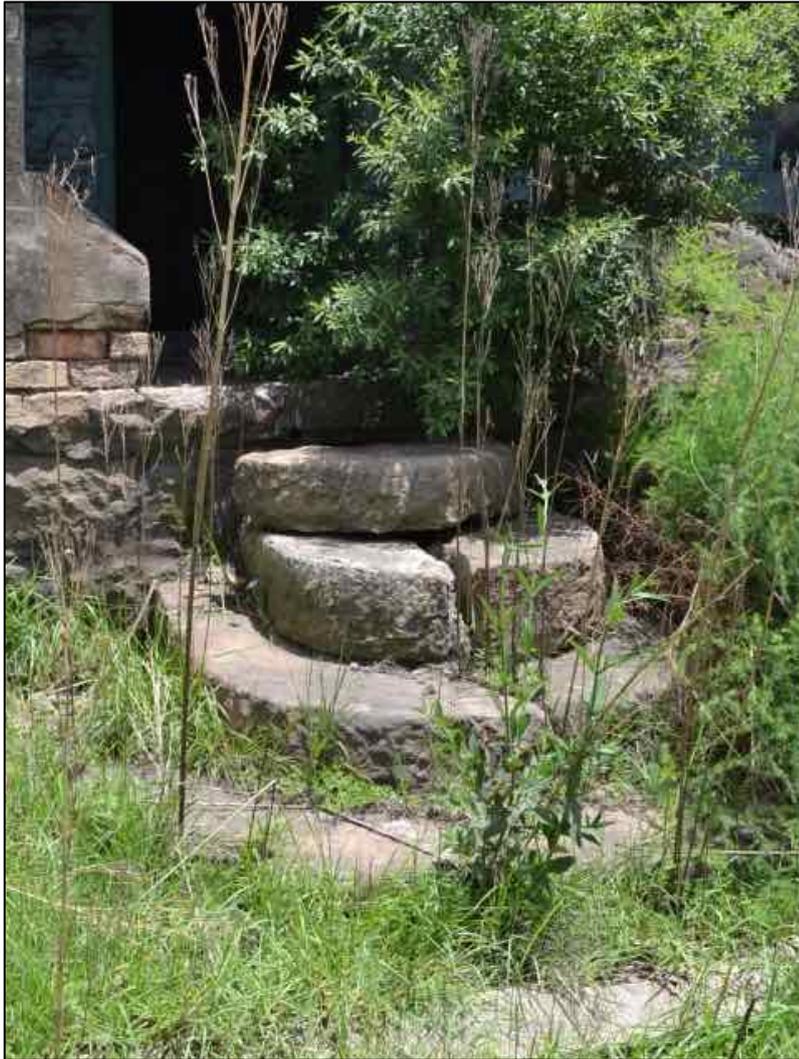
The stairs leading to the stoep level are unique as they do not form part of the foundation either part of the stoep floor. They were constructed with large semi-circular granite slab-shaped blocks. Four layers of granite define the height of the staircase – rising into a staircase with each layer smaller than the original.

Figure 66 - Stacked granite blocks shaped to serve as stairs towards the front stoep (Photograph by Mauritz Naudé).

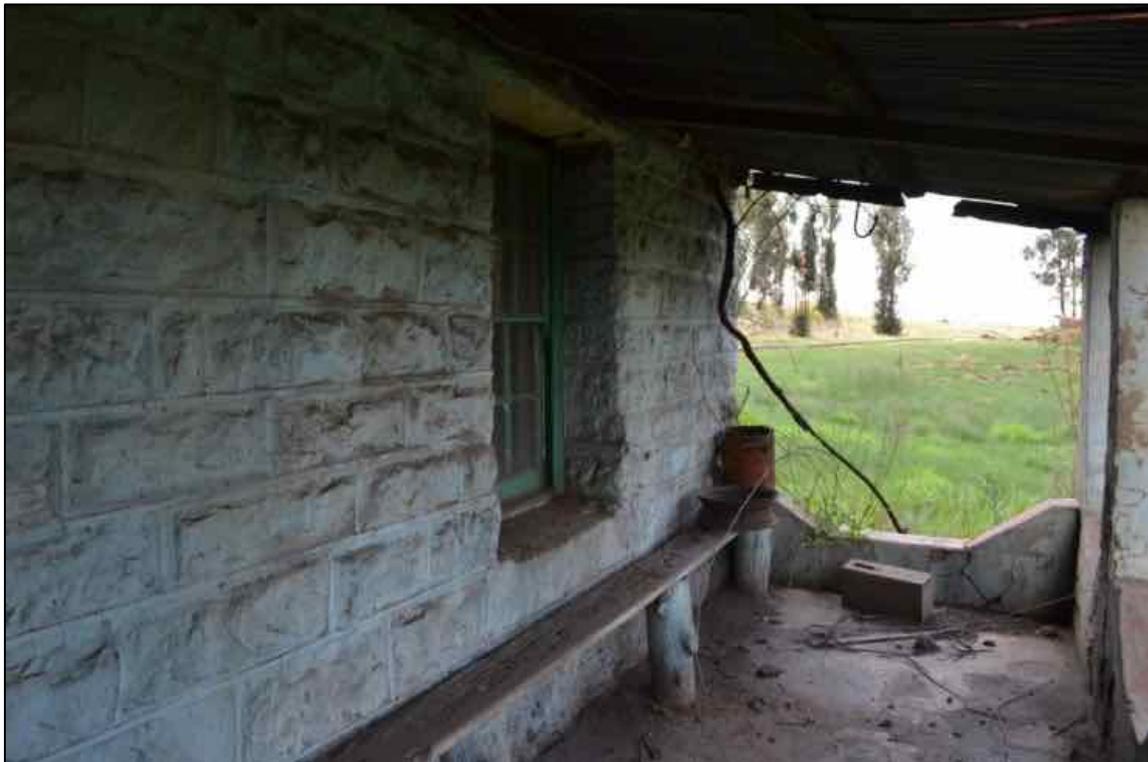
Figure 68 - View on the front veranda (east elevation) with whitewashed exterior sandstone walling (Photograph by Mauritz Naudé).

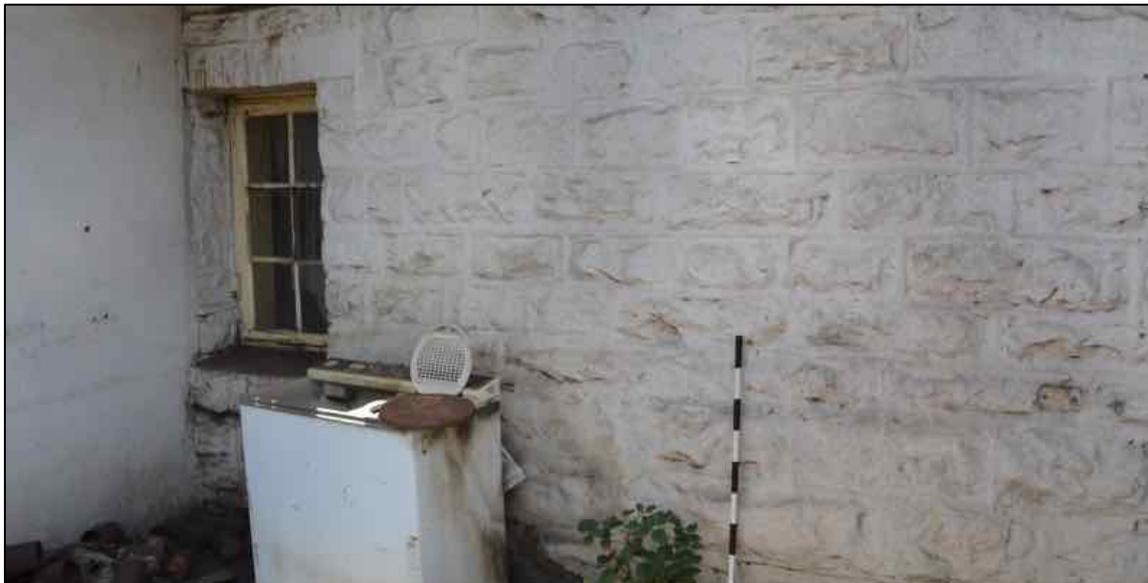
Figure 69 - Whitewashed sandstone wall at the back of the dwelling where a veranda was later added (Photograph by Mauritz Naudé).

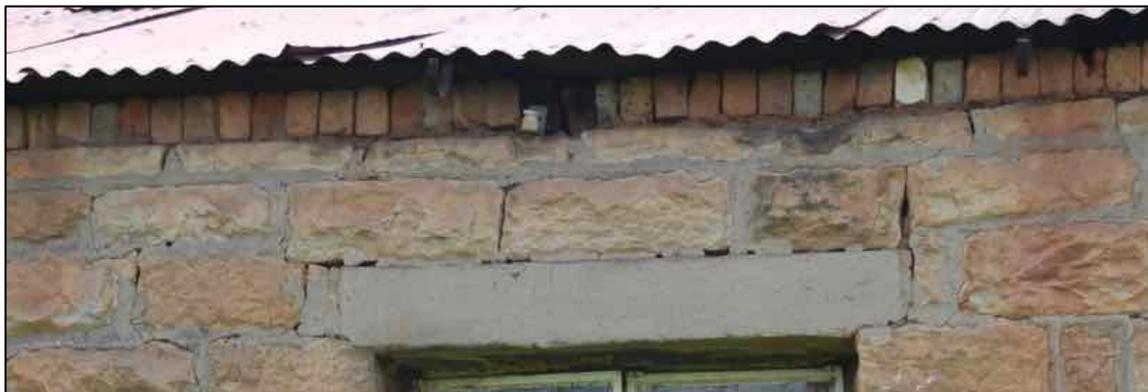
Figure 70 - In-fill row of bricks directly underneath the roof, suggests some alterations to the walling to accommodate the roof (Photograph by Mauritz Naudé).

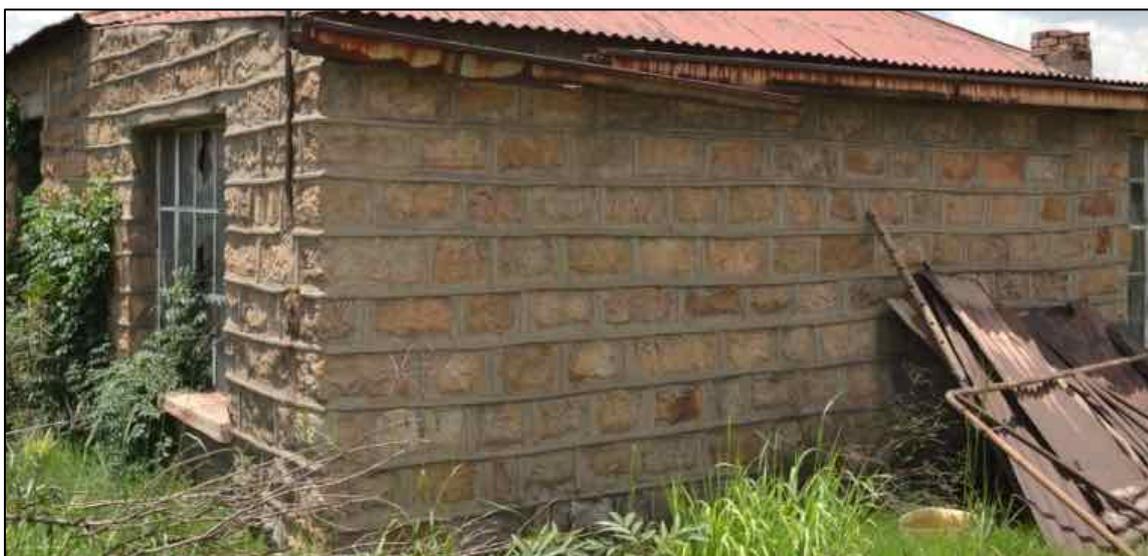
Figure 71 - One way to distinguish between the sandstone masonry of the core dwelling and that of the more recent additions is the prominent pointing of the more recent walls.

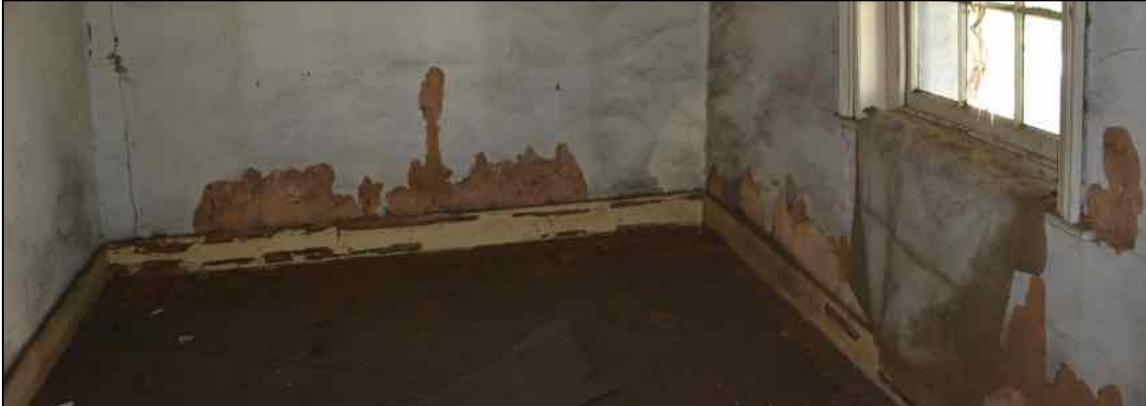
Figure 72 - Rising damp in the room adjacent to the front veranda (Image by Mauritz Naudé).

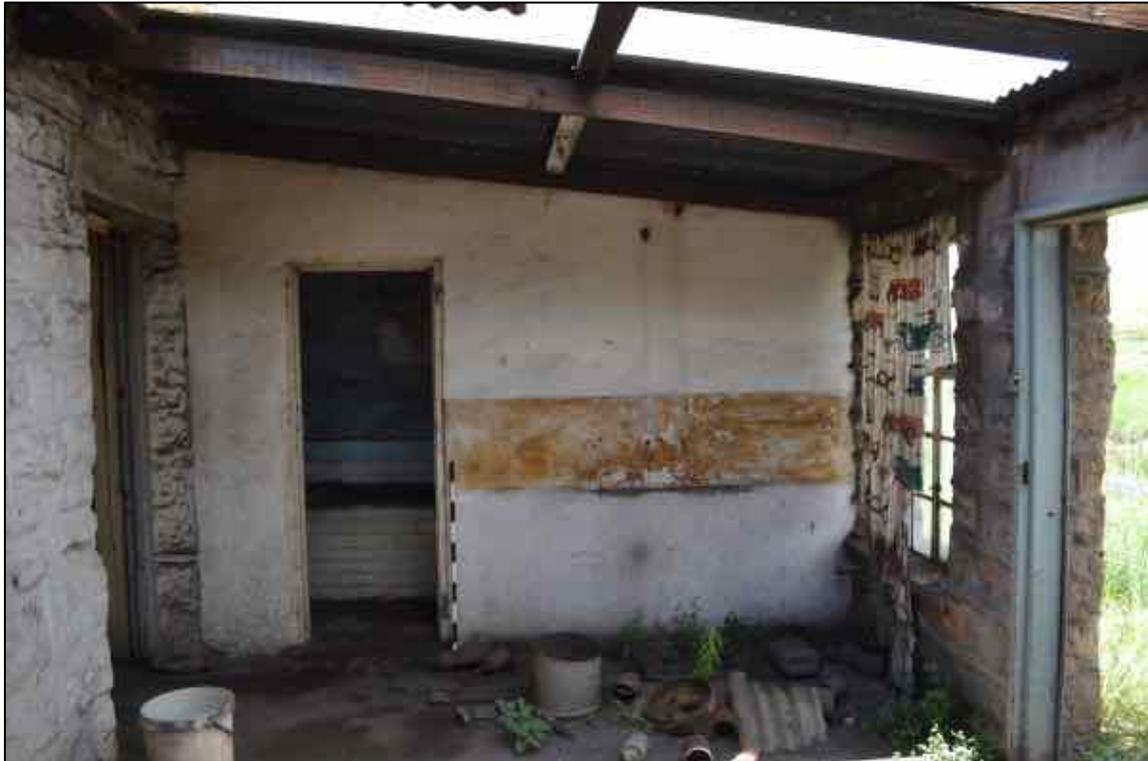
Figure 74 - The back veranda was eventually closed in to accommodate a bathroom and an additional bedroom. These walls were constructed with plastered brick walling (Photograph by Mauritz Naudé).

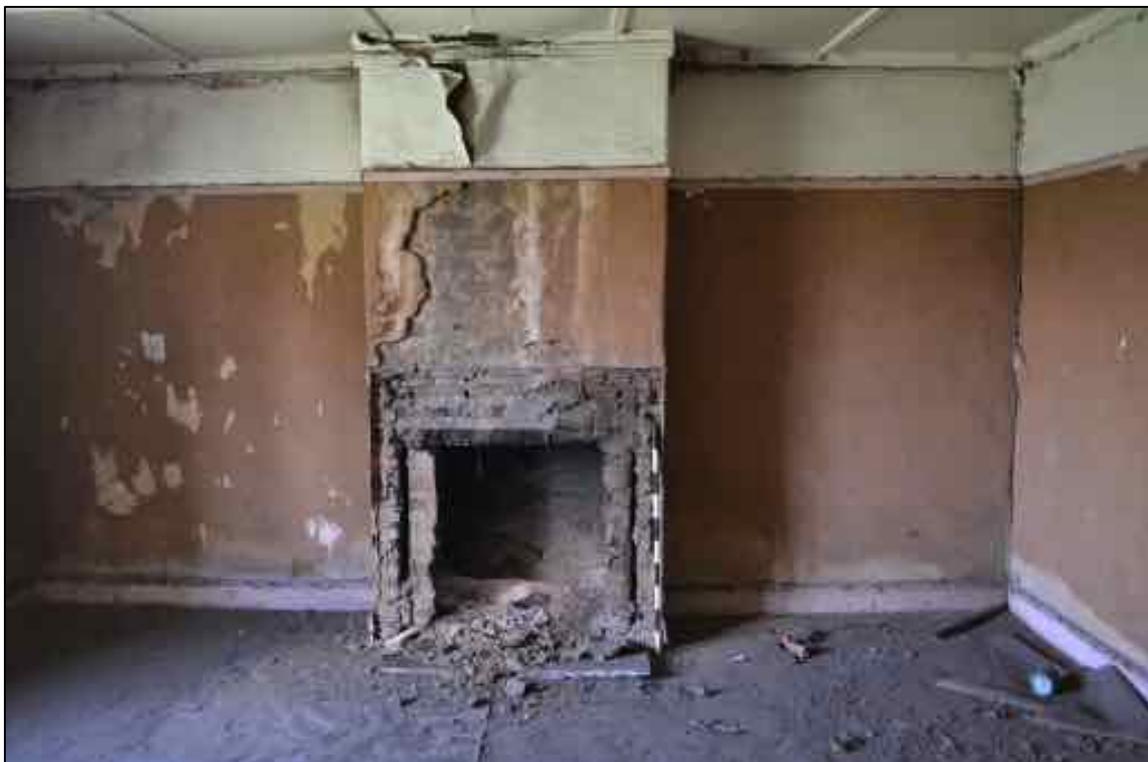
Figure 75 - Interior of the lounge with clay plastered walling (Photograph by Mauritz Naudé).

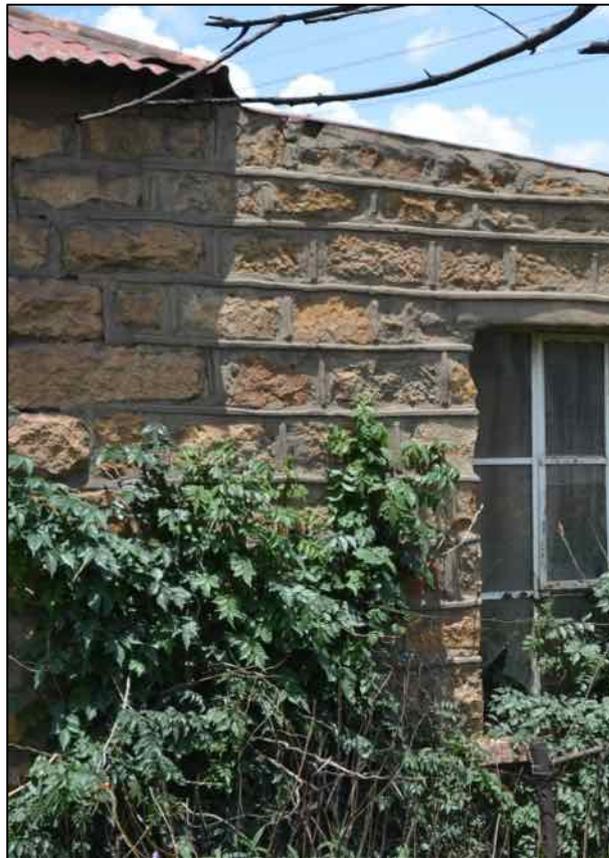
Figure 76 - Careful effort to blend the more recent sandstone extension (right) with the original sandstone walling (left) (Photograph by Mauritz Naudé).

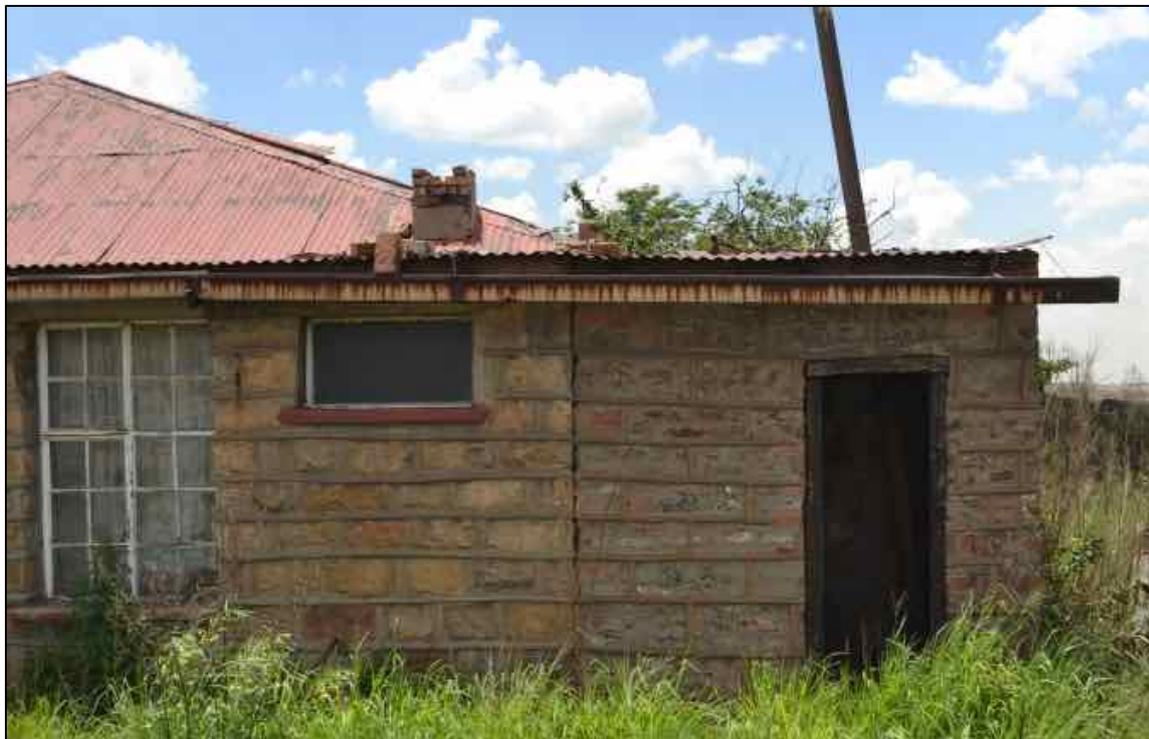
Figure 77- The most recent addition was this boiler room. The small extension was also constructed with stone but applied in a different style. The new room was demarcated but the pointing was applied to blend with the pointing of an earlier addition (Photograph by Mauritz Naudé).

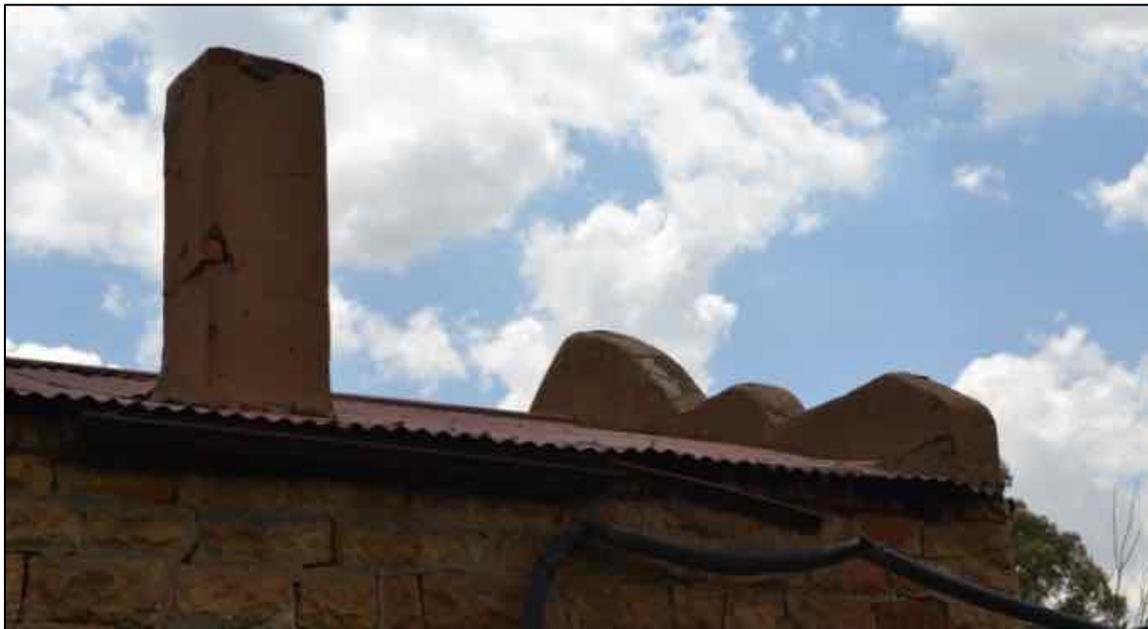
Three chimneys are visible above the roof level. The fireplace in the lounge is best defined in the building. The mantelpiece and fireplace front cover has been ripped from the wall and no evidence of what it looked like, exists. Its chimney is a plastered brick structure – similar to the parapet gable wall. The second fireplace is located in the kitchen and consists of a small floor area that is raised about 100mm from the kitchen floor with a half brick low wall directly next to the kitchen entrance from the backdoor. This area must have contained a coal stove with a cylindrical galvanized sheet iron chimney leading towards a large funnel-shaped exit where the chimney entered the ceiling cavity. The chimney was constructed with plastered brick but has deteriorated extensively.

Figure 78 - Simple plastered brick chimney leading from the fireplace in the lounge (Photograph by Mauritz Naudé).

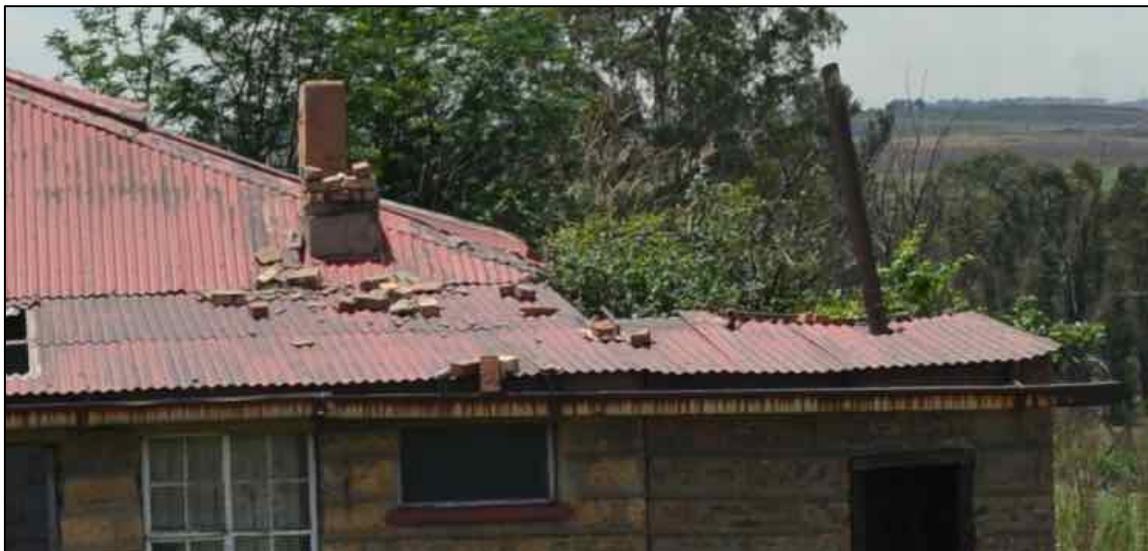
Figure 79 - General position of the three chimneys and chimney pipes (Image by Mauritz Naudé).

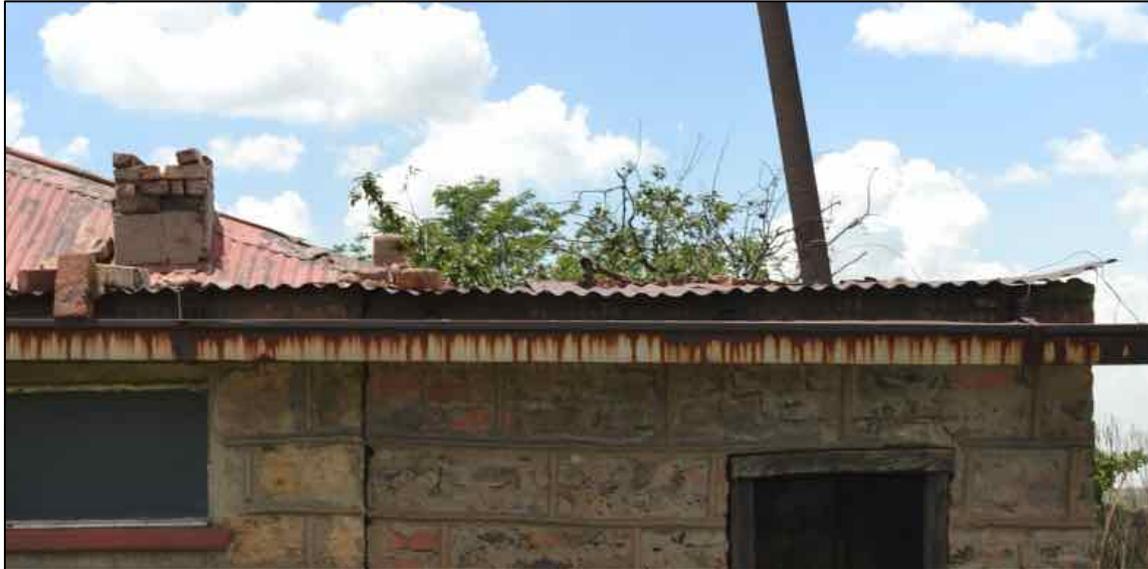
A third chimney occurs at the most south-western corner of the building - penetrating through the roof of the boiler room – a small room that was entered only from outside. The chimney pipe projects about 1.5m above the roof.

Figure 80 - Sheet iron chimney pipe leading from the boiler room (Photograph by Mauritz Naudé).

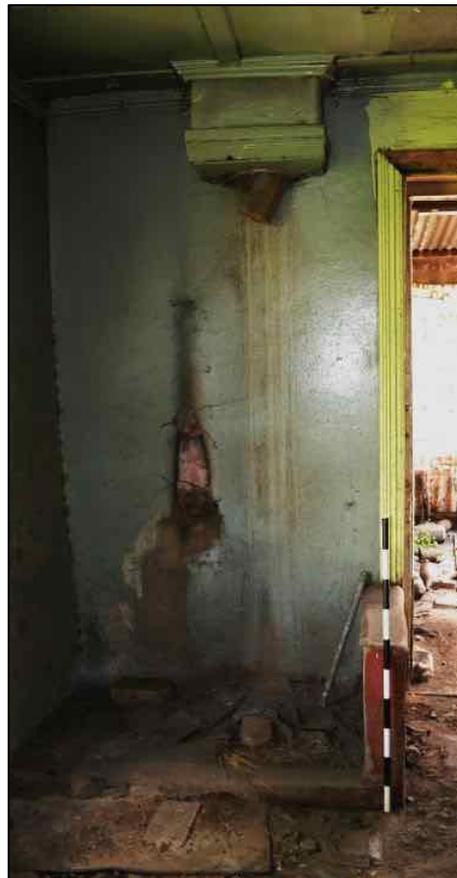
Figure 81 - Remains of the small alcove created for the coal stove in the kitchen. The stove has been removed, but the funnel leading the chimney out of the kitchen is still in situ (Photograph by Mauritz Naudé).

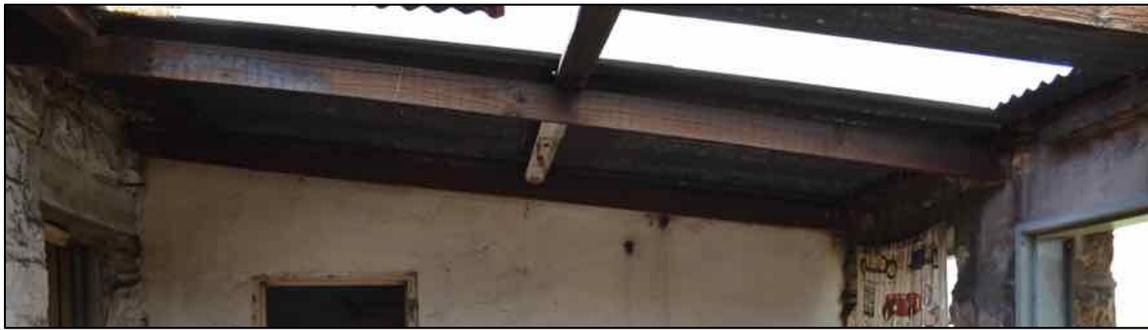
Figure 84 - The roof of the back veranda has no ceiling and transparent glass-fibre sheeting was installed to allow light into the closed area (Photograph by Mauritz Naudé).

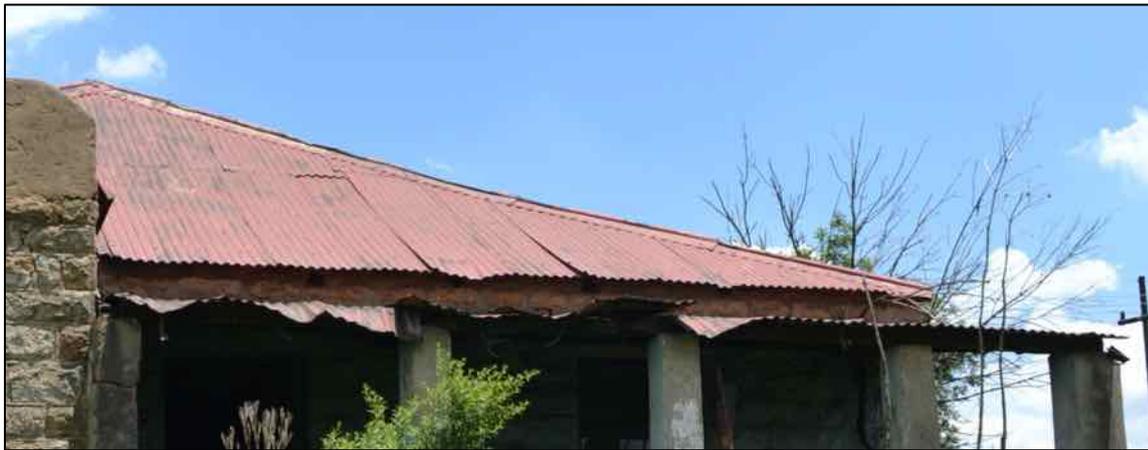
Figure 85 - The corrugated iron sheets were loosely mounted on a simple timber frame for the front veranda (Photograph by Mauritz Naudé).

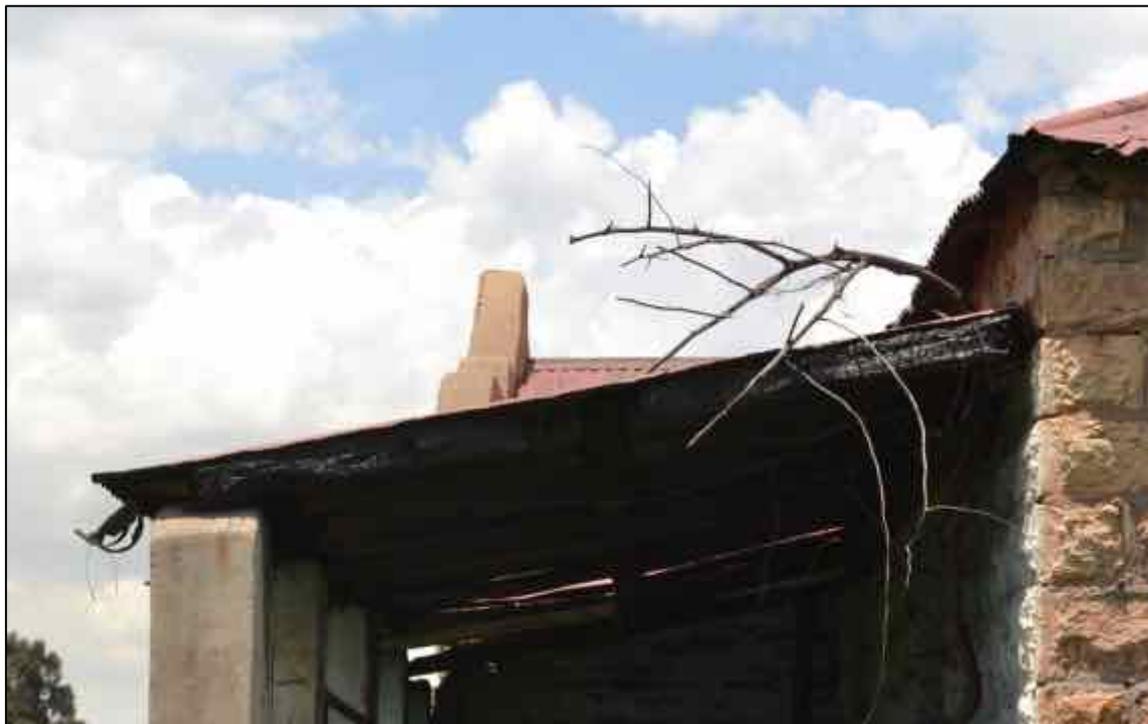
Figure 86 - Side elevation of the front veranda roof indicating its 'lean-to' character (Photograph by Mauritz Naudé).

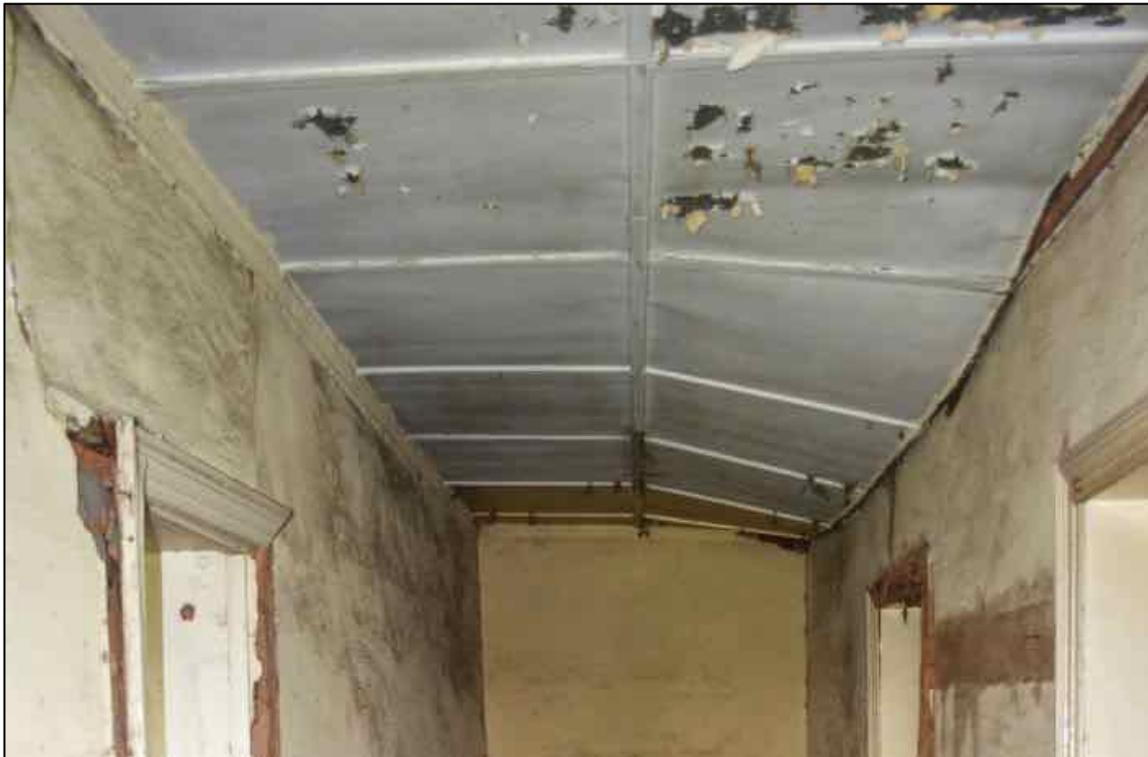
Figure 88 - Gypsum boarding mounted in the passage, with pine planking in the foyer (Photograph by Mauritz Naudé).
