MEYER AND DU TOIT FARMSTEADS

Phase 2 – Heritage Impact Assessment Report

Issue Date: 27 May 2020

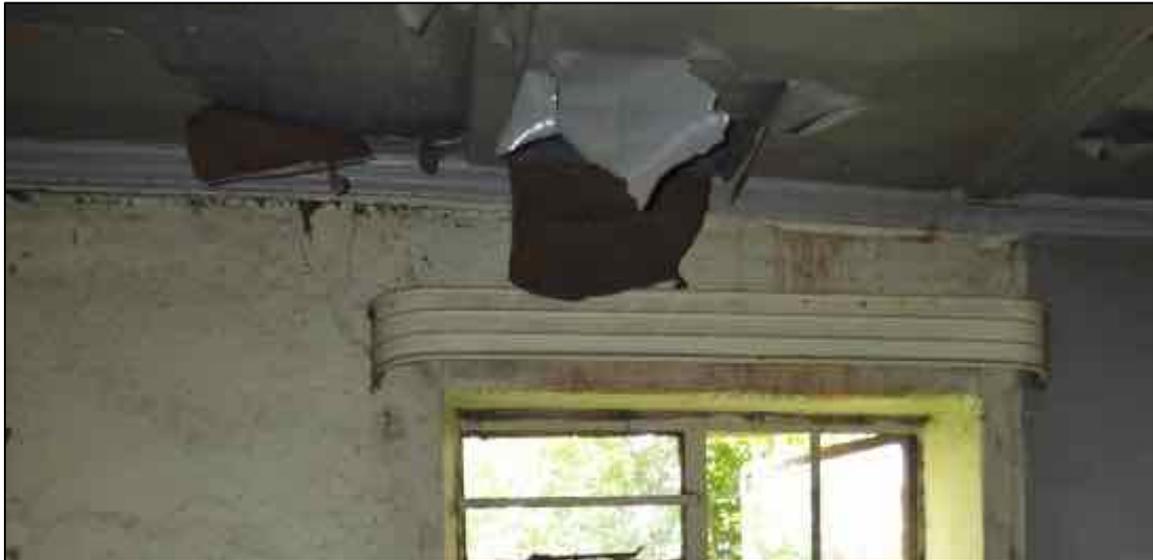
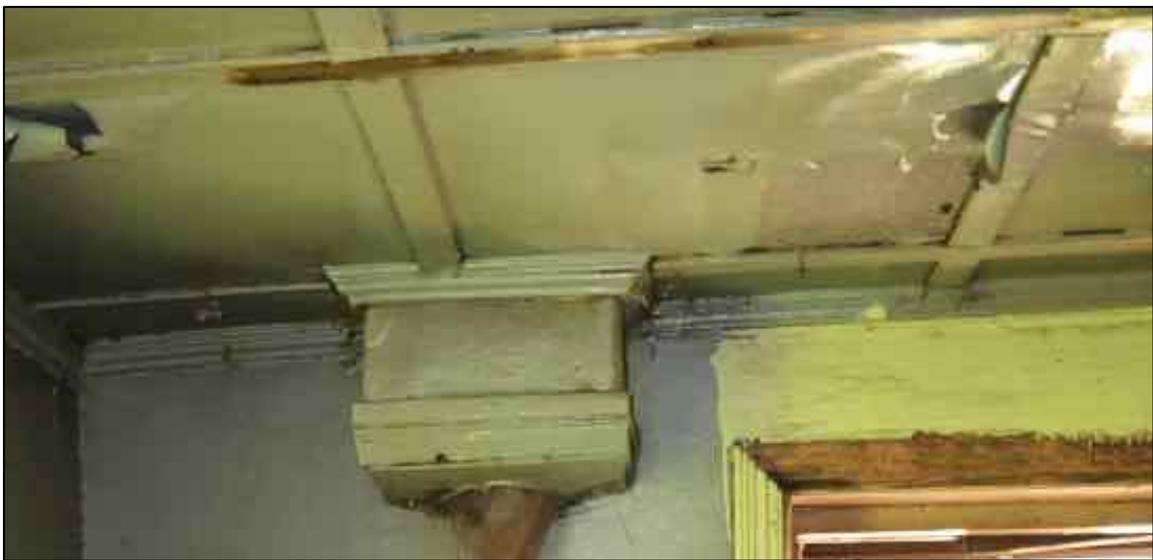
Figure 89 - Gypsum boarding mounted with pine planking in the kitchen (Photographs by Mauritz Naudé).

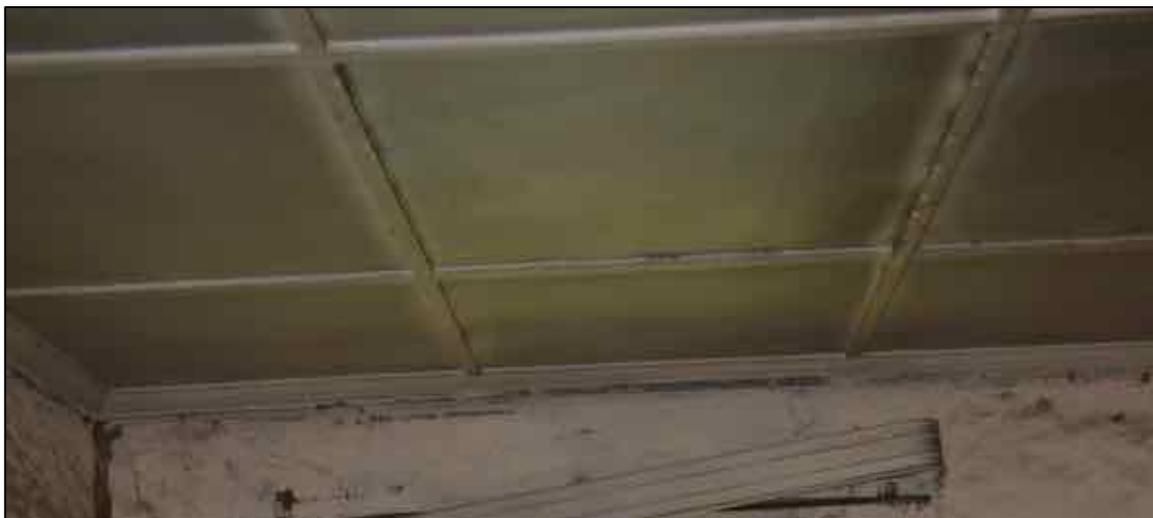
Figure 90 - Gypsum boarding with pine planking in one of the bedrooms (Photograph by Mauritz Naudé).

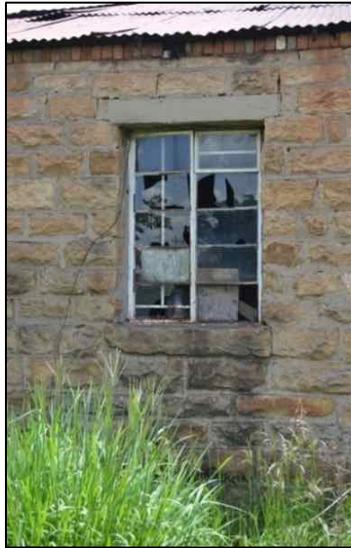
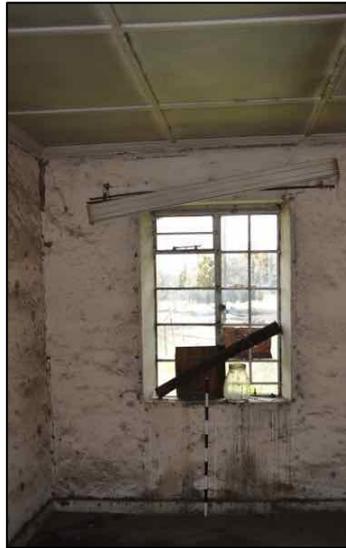
Figure 93 - Steel frame window in the pantry cum breakfast room (Photograph by Mauritz Naudé).

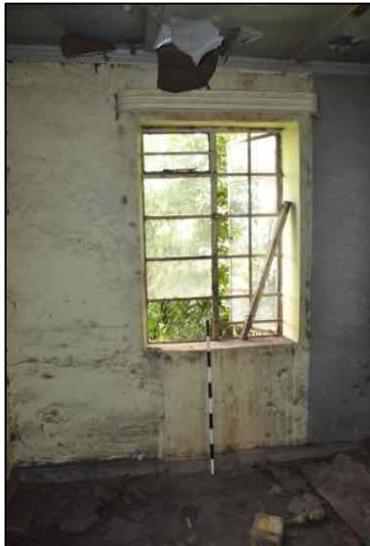
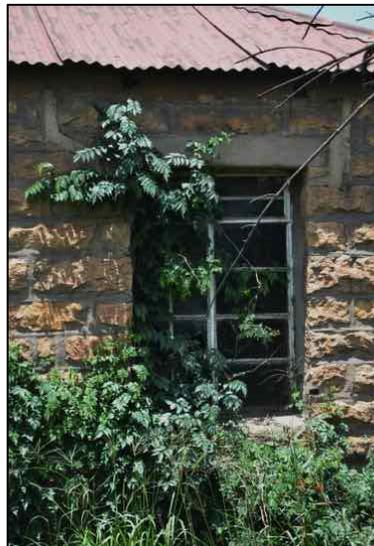
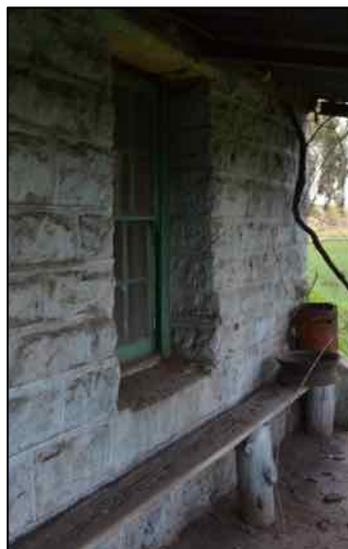
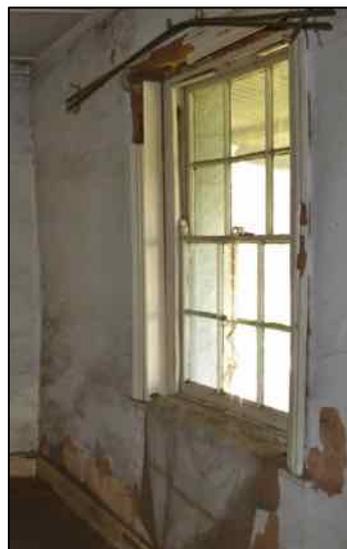
Figure 94 - One of the original wooden frame sash windows - room facing the eastern elevation with the window on the stoeep (Photograph by Mauritz Naudé).

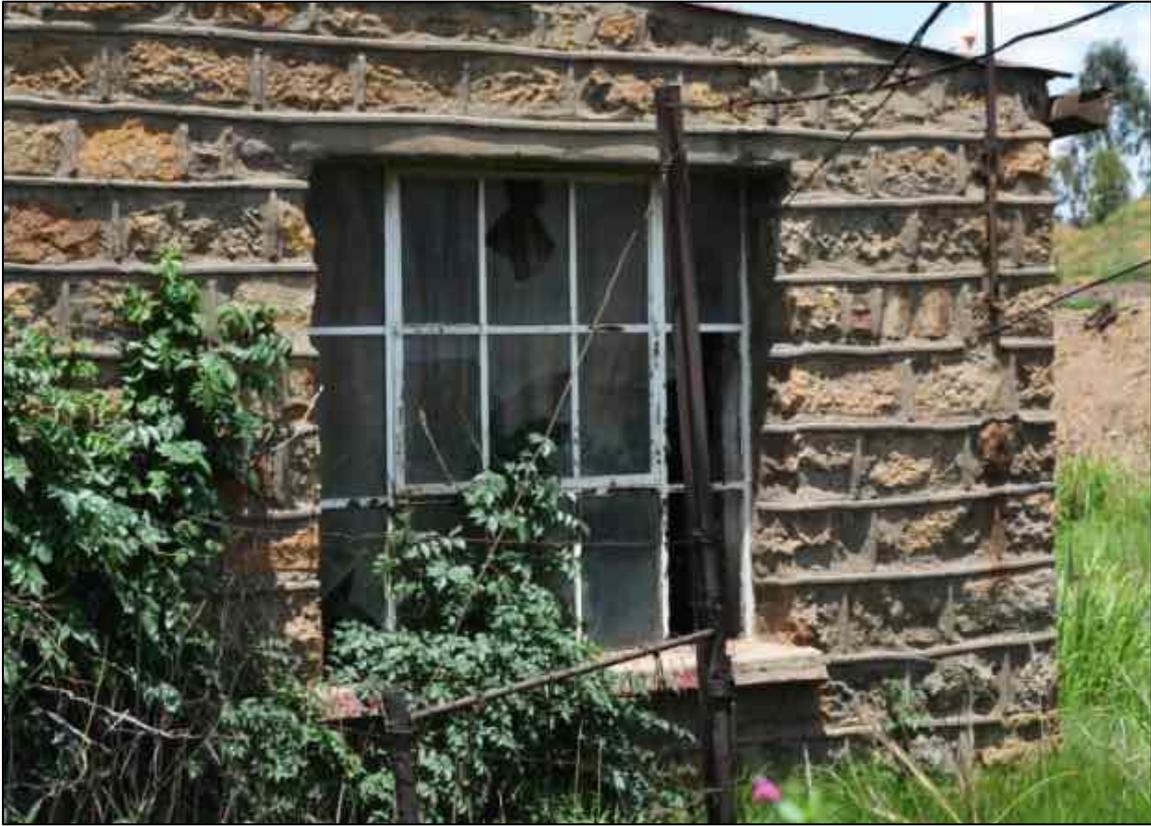
Figure 95 - Fifteen pane steel frame window in the stoepkamer along the western elevation (Photograph by Mauritz Naudé).

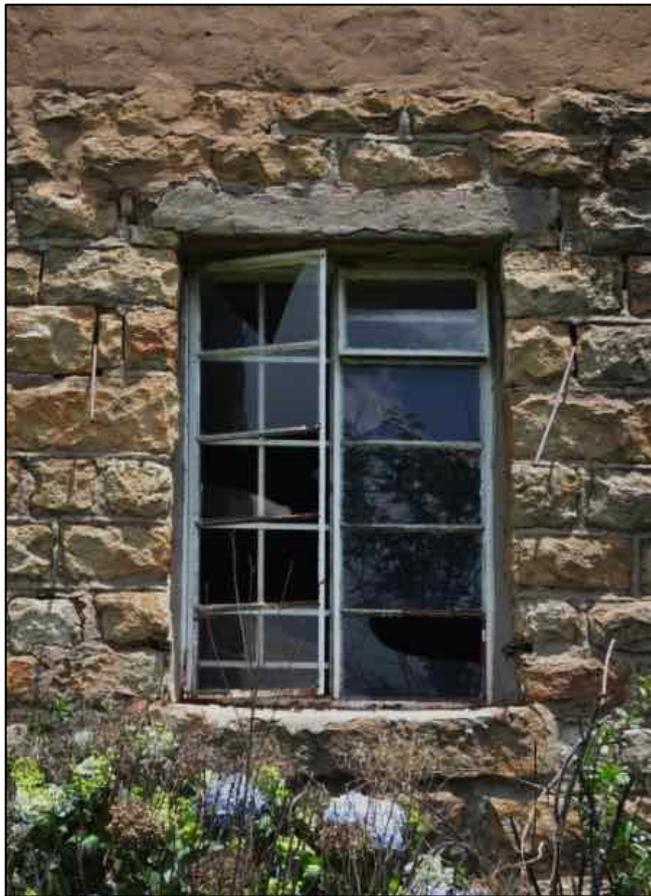
Figure 96 - Steel frame window in the lounge, facing east (Photograph by Mauritz Naudé).

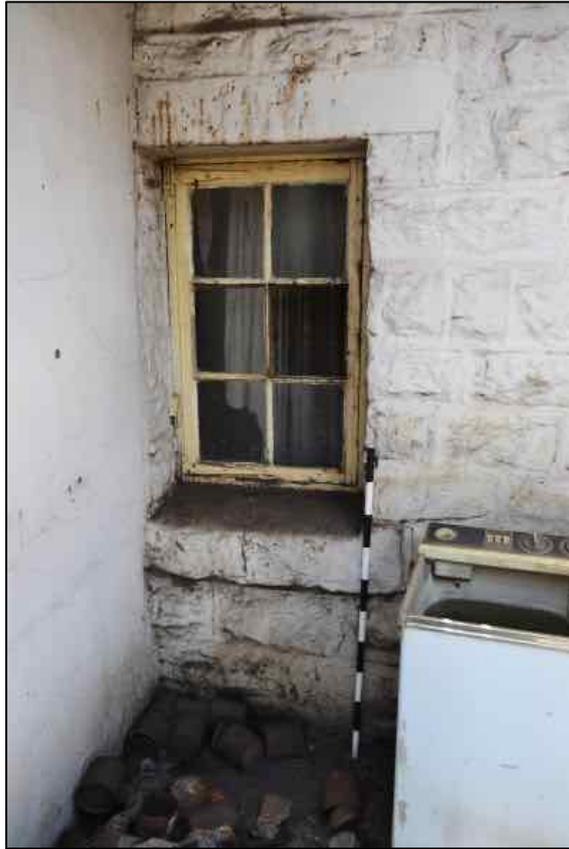
Figure 97 - One of the original wooden frame windows that remained intact at the back veranda (Photograph by Mauritz Naudé).

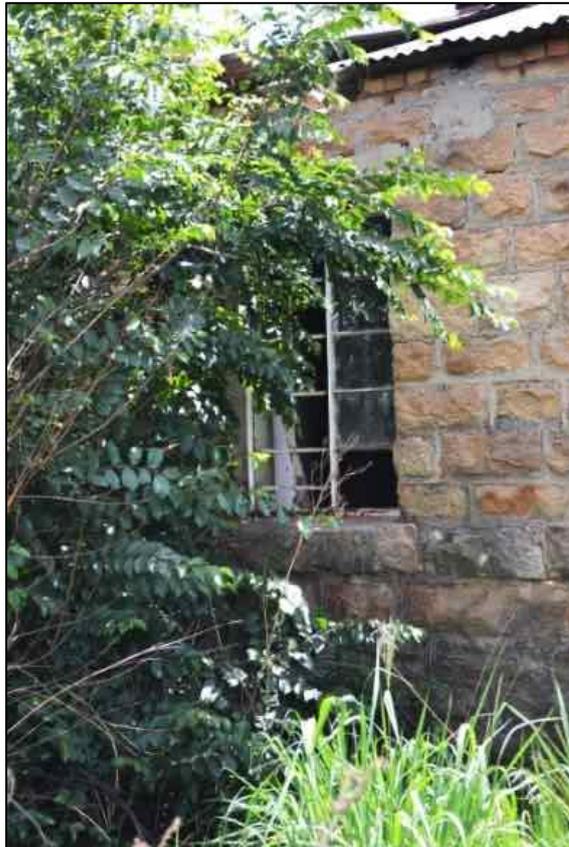
Figure 98 - Steel frame window in the southern elevation (Photograph by Mauritz Naudé).

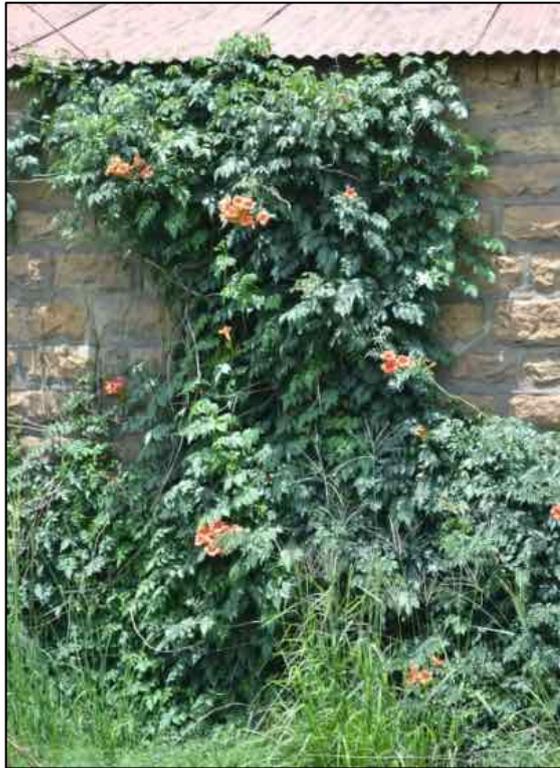
Figure 99 - Steel frame window is hidden behind a creeper in the northern elevation (Photograph by Mauritz Naudé).

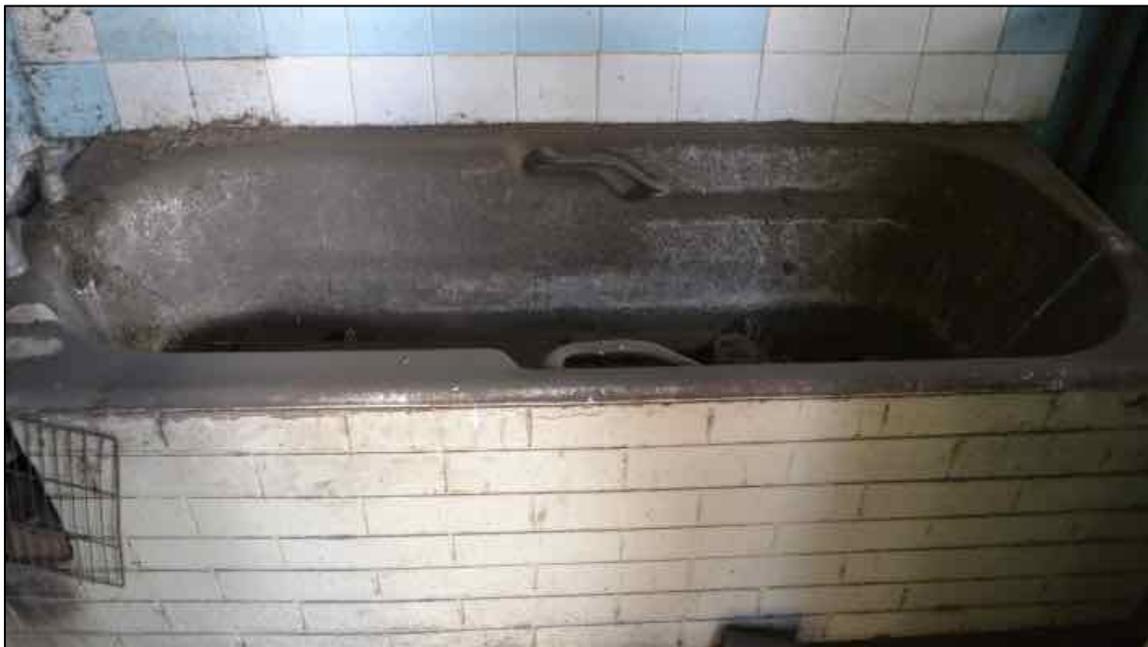
Figure 100 - Bathtub - now covered in black coal dust (Photograph by Mauritz Naudé).

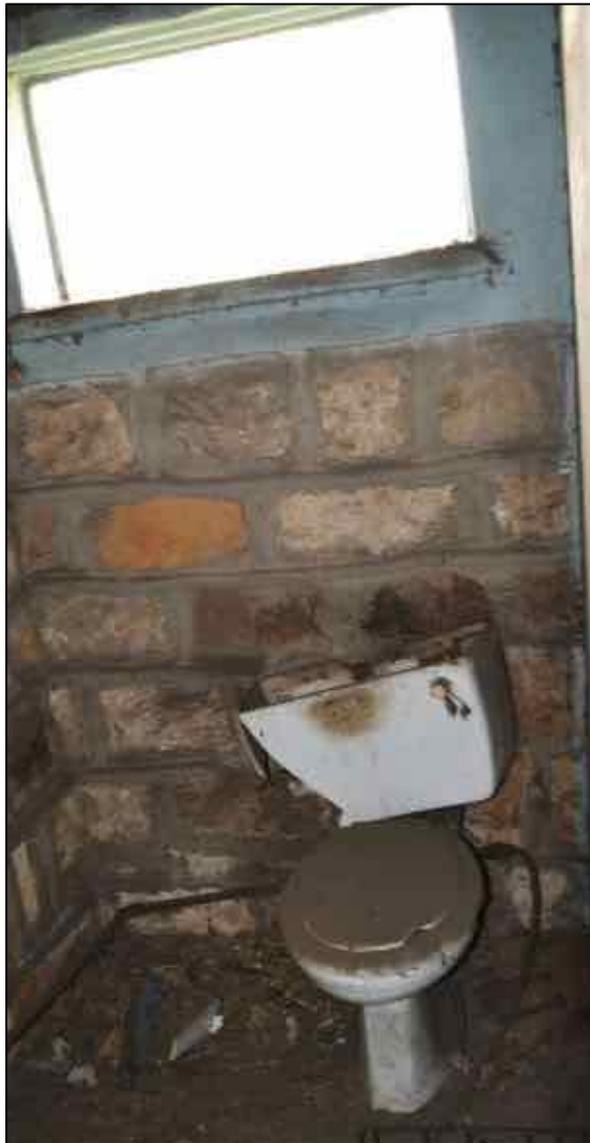
Figure 101 - Porcelain toilet mounted along the exterior wall (Photograph by Mauritz Naudé).

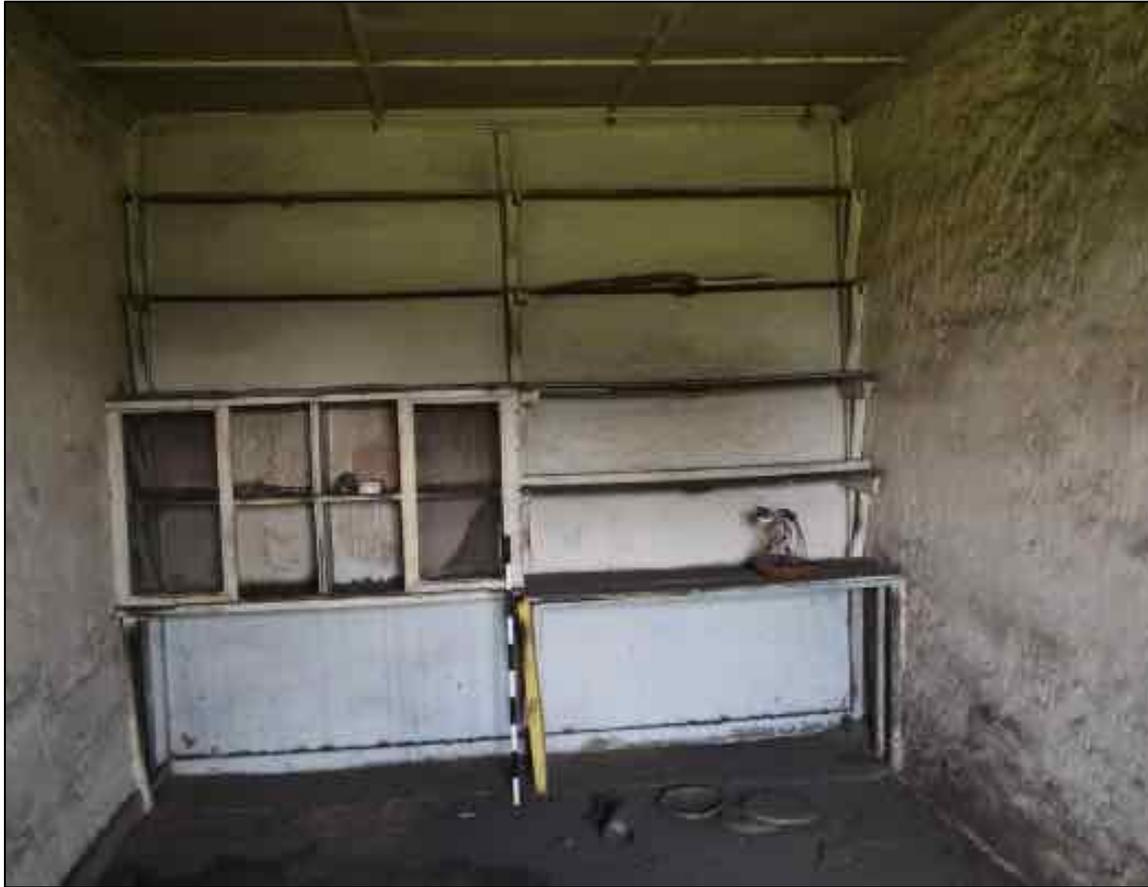
Figure 102 - Shelving and racking in the pantry. This room may have been used as a breakfast room (Photograph by Mauritz Naudé).

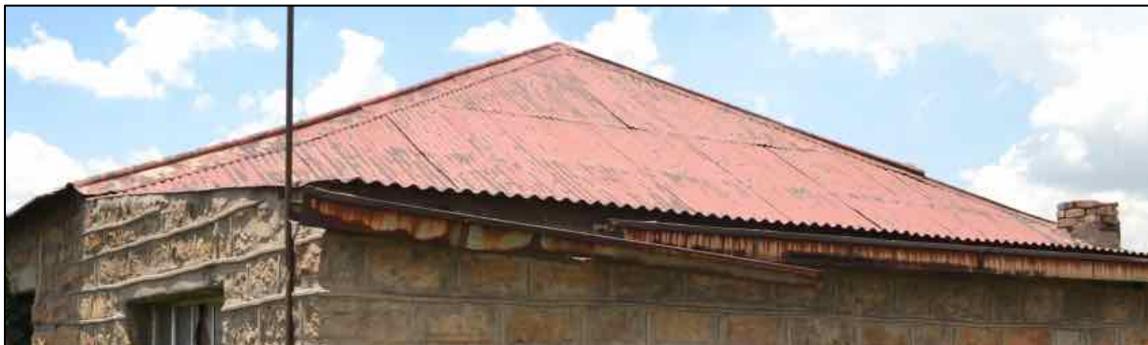
Gutters were mounted along the roof of the western extension. No downpipes were installed. A gutter was also installed along the southern elevation and the water drains into a large circular corrugated iron water reservoir.

Figure 103 - Some effort was made to mount gutters but without downpipes. Water was directed to a single detached corrugated iron water reservoir (Photograph by Mauritz Naudé).

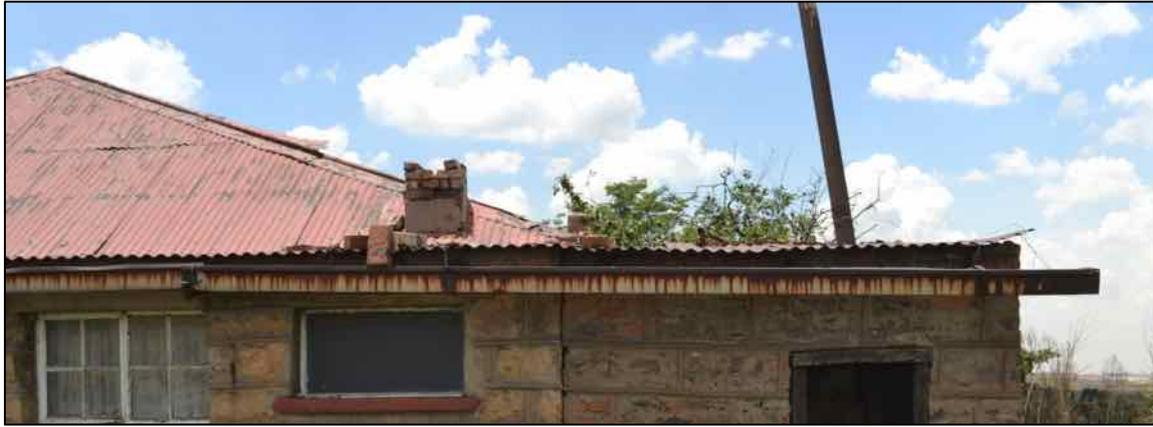
Figure 104 - Box gutter along western elevation and extension (Photograph by Mauritz Naudé).

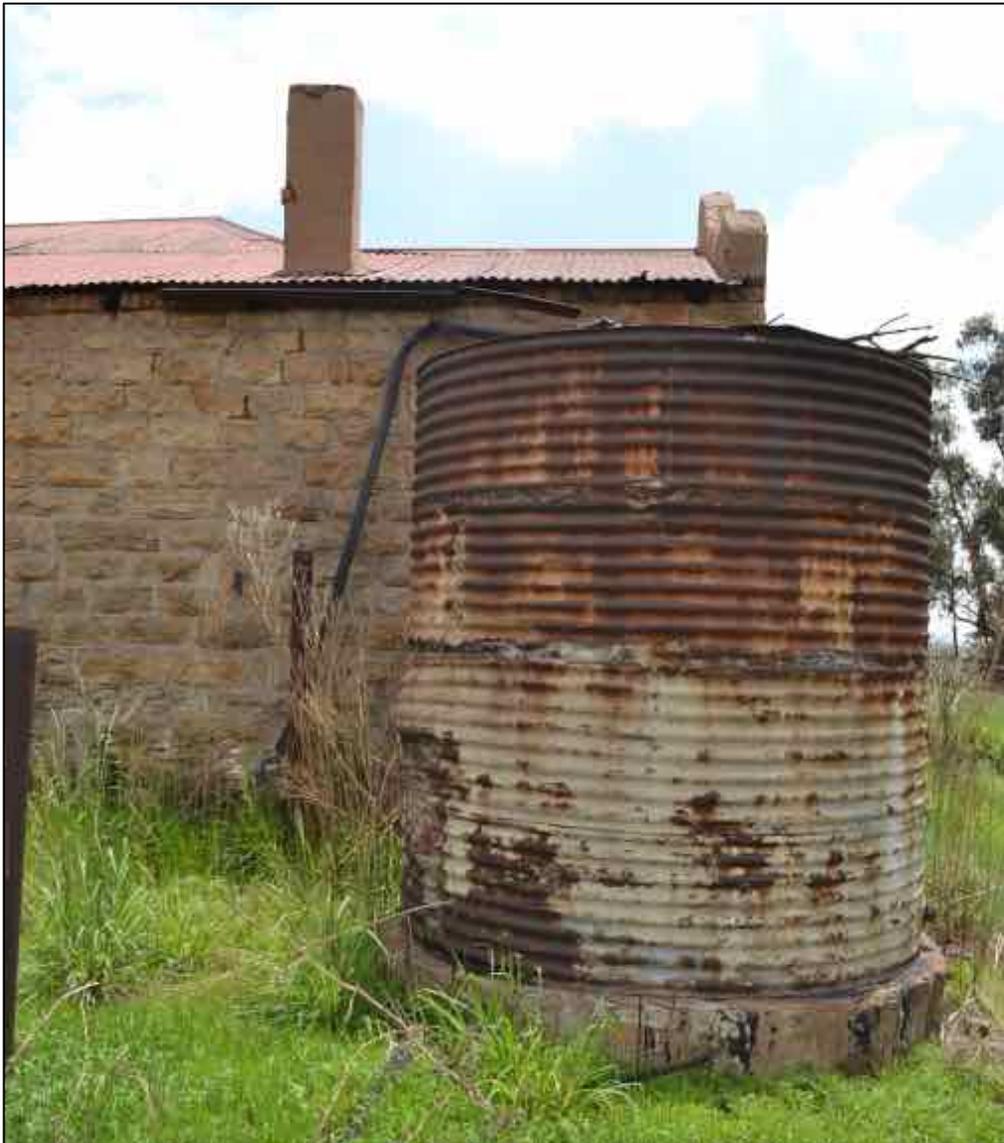
Figure 106 - View of the water reservoir (Photograph by Mauritz Naudé).

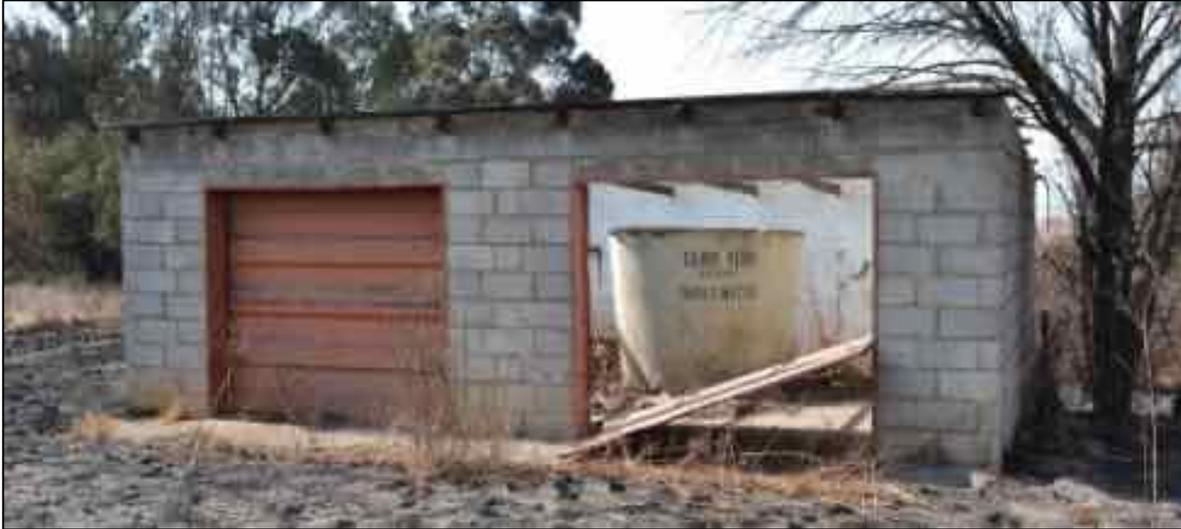
A garage is located here. The structure was built with cement bricks and it would have had a corrugated iron roof. At the time of the fieldwork, the roof was missing.

Figure 107 – General view of the garage (Photograph by Mauritz Naudé).

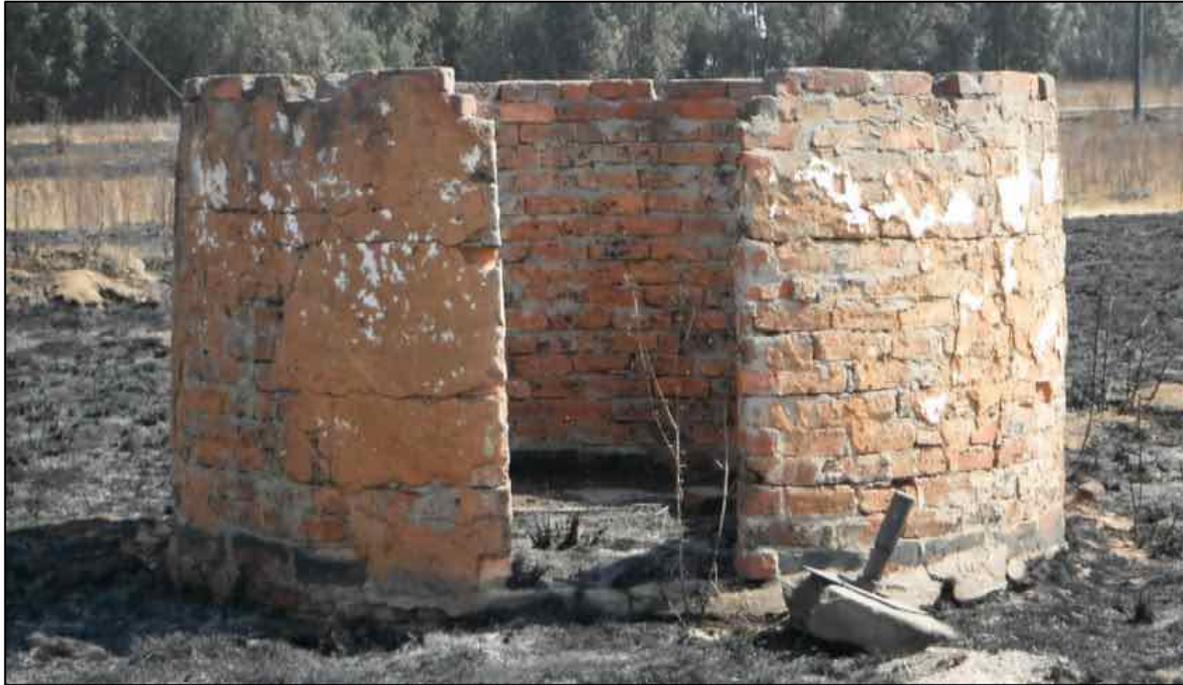
In the first report undertaken in 2012, the building was indicated to be of Low Significance. The building was subsequently destroyed during the construction of a haul road.

Figure 108 – General view of the rondavel. This structure was assessed to be of Low Significance in a previous report and was demolished in c. 2015 (Photograph by Mauritz Naudé).

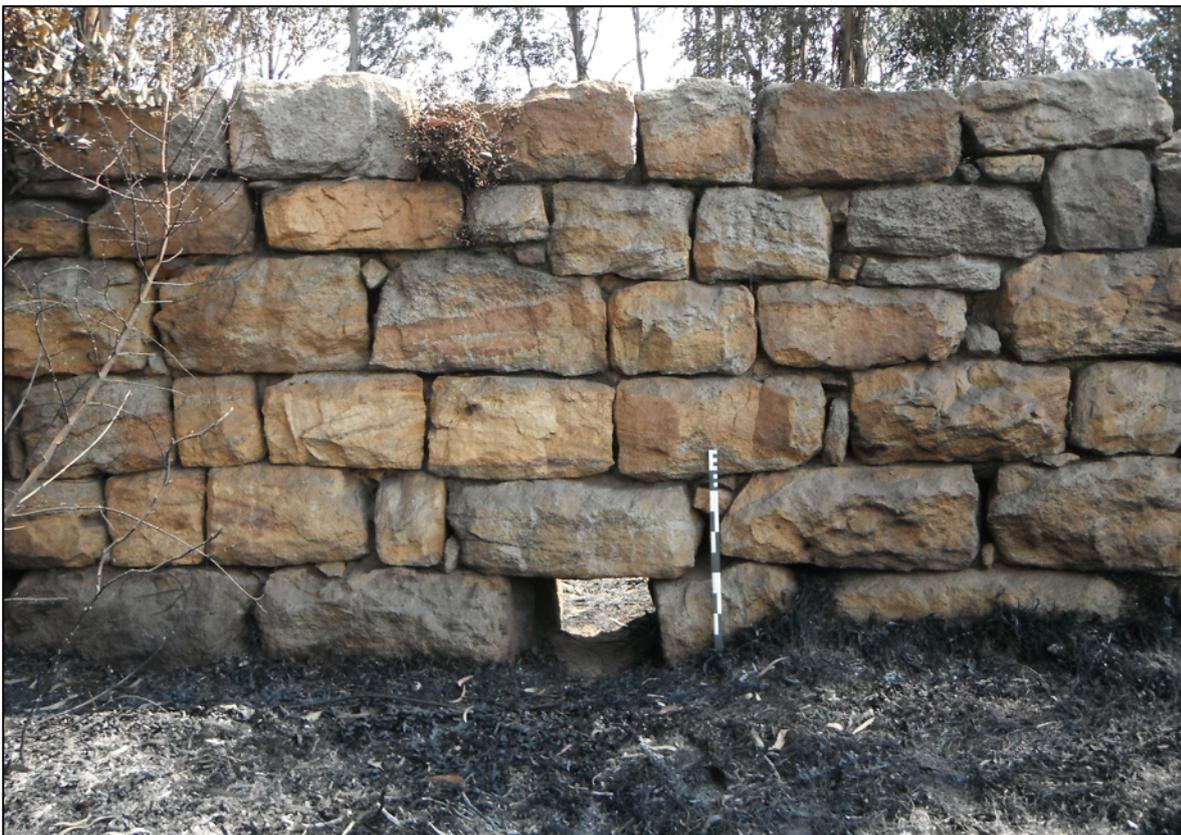
In the Heritage Assessment undertaken in 2012, it was recommended that the livestock enclosure be retained. Unfortunately, the structure may have been demolished a few years ago.

Figure 110 – Closer view of a section of the eastern wall of the livestock enclosure. Note the well-built drainage hole (Photograph by Polke Birkholtz).
