Matakoma Consultants

**PERMIT APPLICATION FOR THE DESTRUCTION OF HISTORICAL SITES LOCATED WITHIN
PHASE 1 OF THE GARDENER ROSS GOLF AND COUNTRY ESTATE ON THE FARM
KNOPPIESLAAGTE 385 JR, GAUTENG PROVINCE**

ANNEXURE 3 - DOCUMENTATION OF HERITAGE SITES FOR APPLICATION

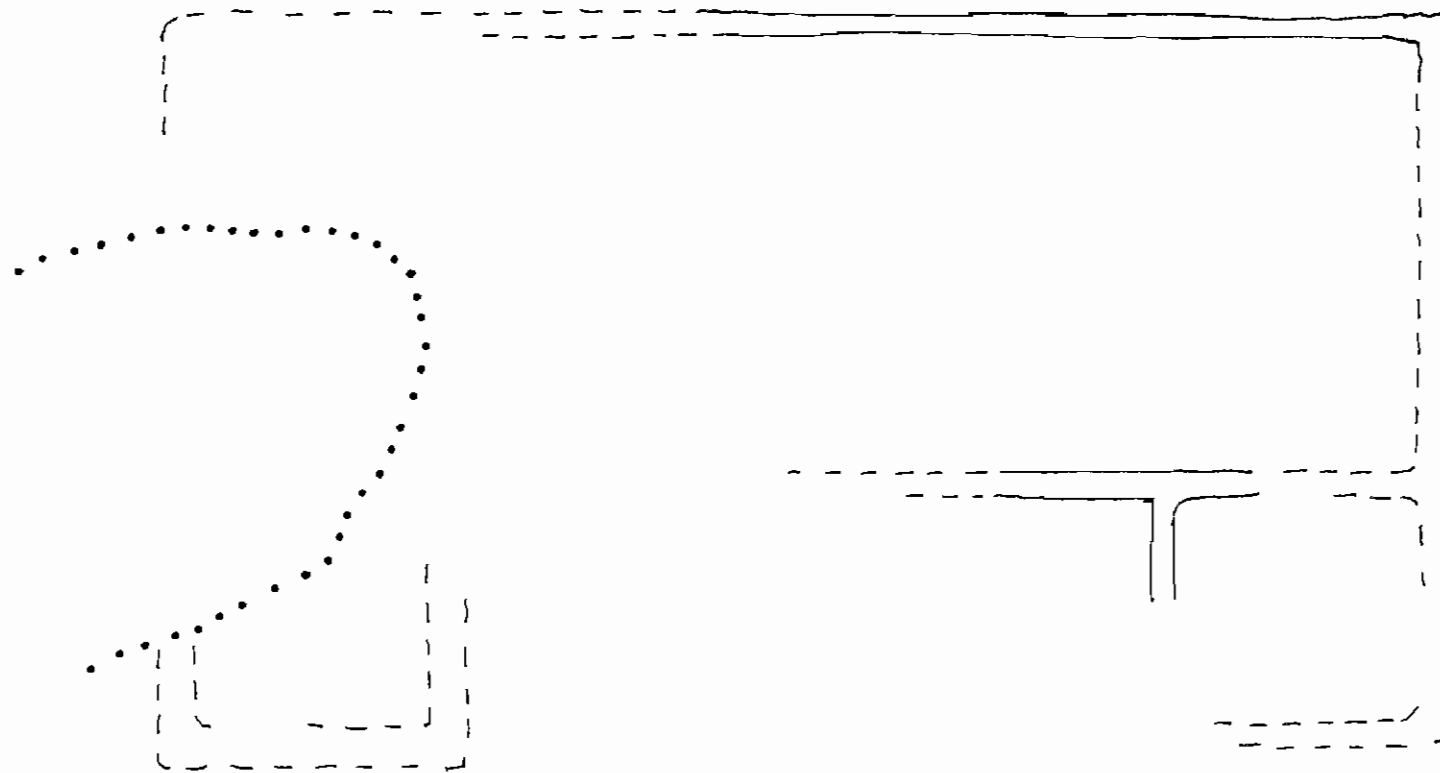
Floor plan

Almost nothing of the structure is left. According to the floor plan it must have been a farm workers dwelling. The scanty remains of the footprint of the structure suggests that it consisted of one large space in front with two smaller spaces, probably lean-tos at the back. The structure faced down hill and part of it has been destroyed by a grader (southern side). The best preserved remains are the single row of foundation stones along its eastern facade. It is assumed that it had a compacted clay floor. Some of the clay walls have remained but were pushed over by the grader and are lying around on the site.

According to the site features the structure was not used as a dwelling for white farmers as no trees or other planted vegetation occur around the structure. No other outbuildings were erected on the site.

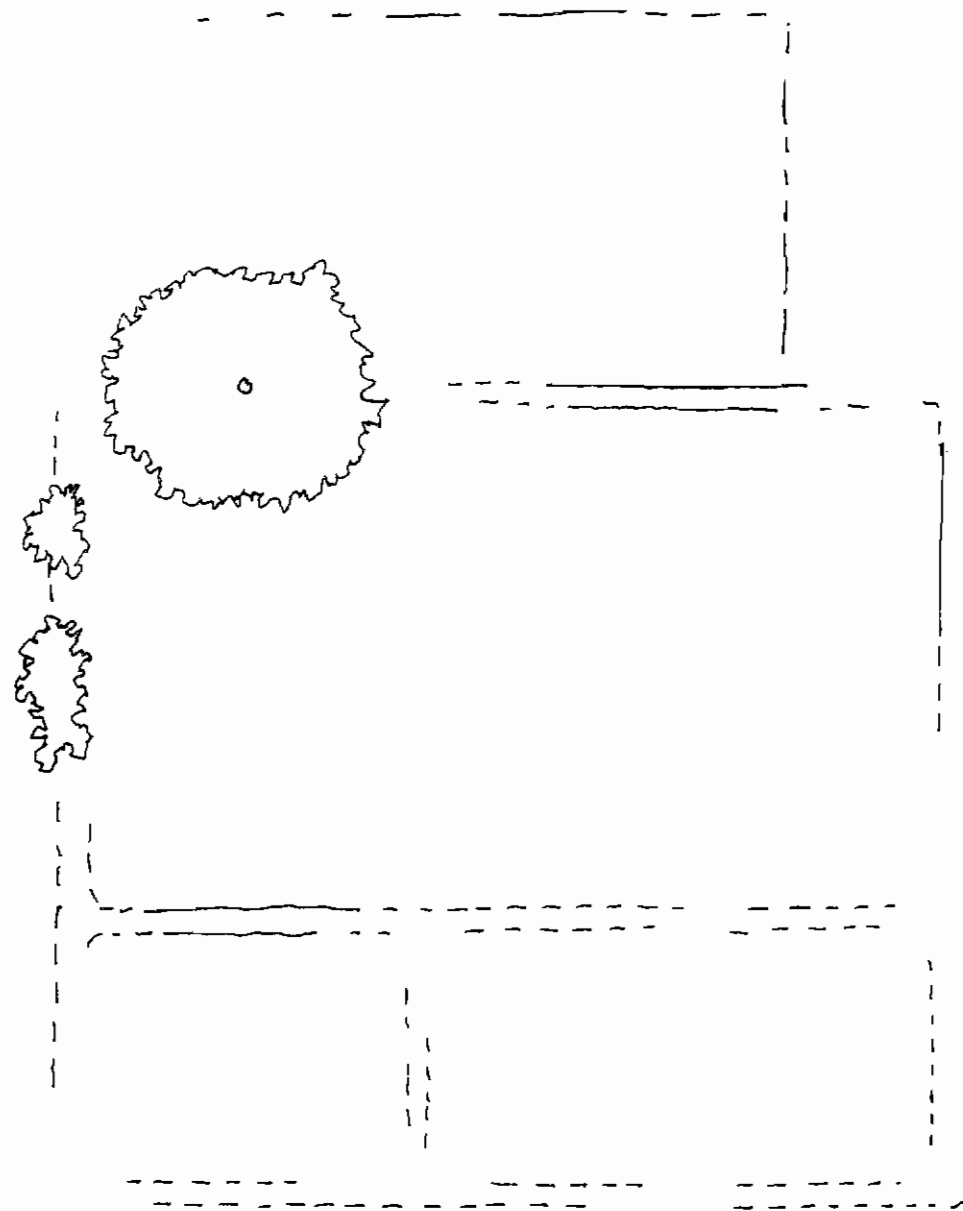
Floor plan

Very little of the structure is left. According to the floor plan and the little physical fabric left it must have been a farm workers dwelling. According to the remains of the walling, it seems as if it consisted of three closed spaces: one large space with two smaller spaces behind it. The remains of what could have been a low lapa wall, constructed with loose stacked stones are located on the northeastern side of the dwelling. Small stones were used as foundation. A thin concrete surface is located in front of the dwelling and it is assumed that the rest of the dwelling had a compacted clay floor. The structure was constructed with sundried clay blocks and plastered with clay. The soft nature of the material caused it to decay quickly and almost none of the walls have survived.

The site does not reflect typical characteristics of white settlement with extensive planting of trees and extended outbuildings and structures

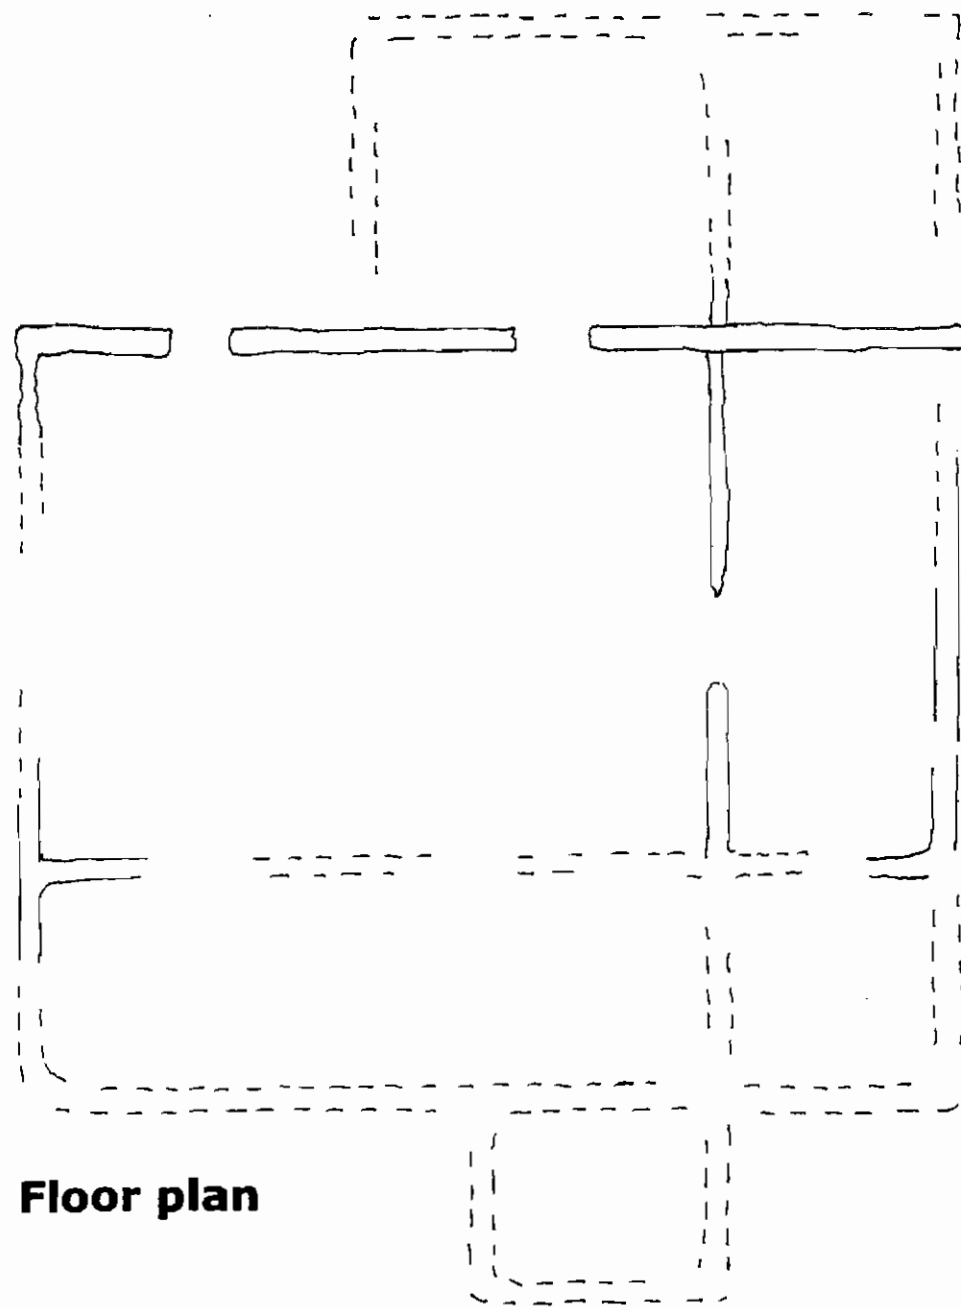
Floor plan

The structure used to be a dwelling of a farm worker and has lost its purpose over time. Very little of the structure is left. The footprint suggests that it consisted of seven spaces, each one linked to a central space. It is assumed that the floors consisted of compacted clay. The walls have been constructed on a thin foundation consisting of small stones and clay mortar. Walls were constructed with sundried clay blocks that were plastered with several layers of clay. No doors or windows were left. The structure faced downhill towards the spruit and the nearest other manmade feature is a diesel (mechanical) water pump, located about 30m downhill from the structure.

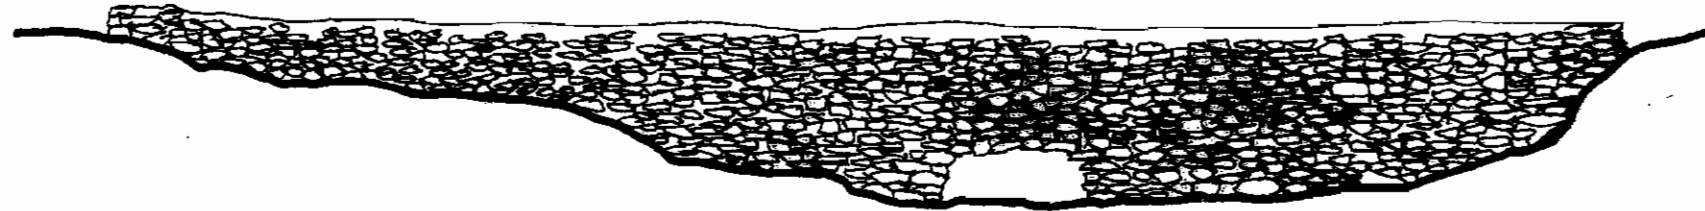
South elevation

The bottom part of the weir is open and it seems as if the river bed has been washed away and that the weir walling have remained intact.

The structure can now only be described as a pedestrian bridge as it has lost its ability to contain water in the same way a weir or dam wall would. It was originally constructed the same way as the other weirs in the spruit - with stone and concrete. It uses the rocks in the flow bed as foundation and no other buttressing was used for supporting the wall. The top of the wall was also covered with a thin layer of cement to seal the top. At some stage in its history the lowest part of the wall must have disintegrated and slipped from underneath the wall allowing water to drain through without any resistance.

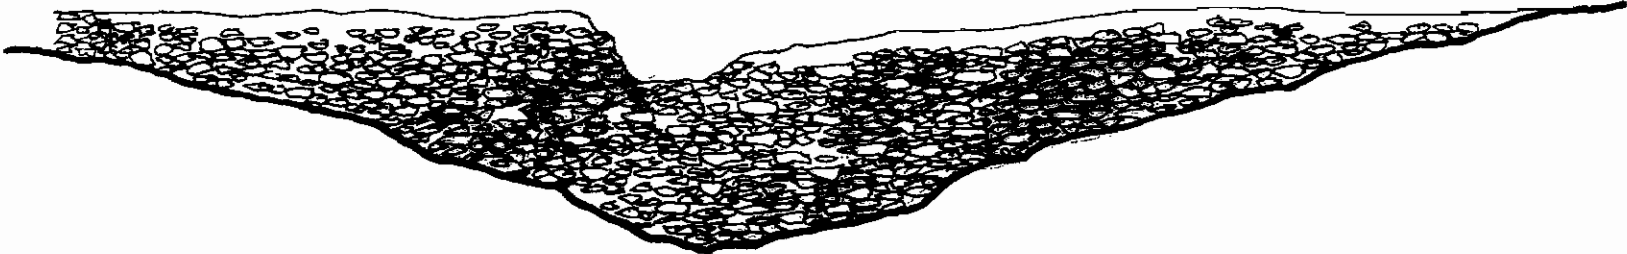
Southeastern elevation

Dam wall or weir with a broken top supposed to operate as an overflow for flood water.

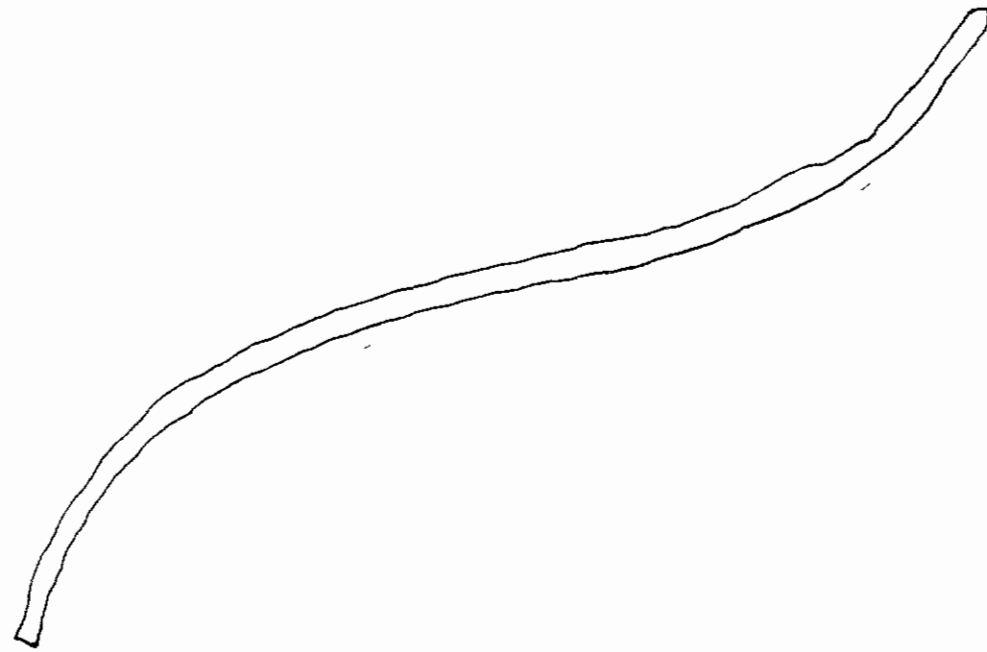
Floor plan

It consists of a curved wall erected as a weir in the spruit and is about 30m long and about 600mm wide. Although it probably served as a low dam wall the overflow, has over time, been broken down by water and the weir is not holding water anymore. The overflow is located on the southern end of the wall. The curved wall will merely operate as a break in case of a flood towards the larger and more 'formal' dam located down stream. No water furrow could be identified linking the weir to lower lying irrigation fields or a farmstead. At its highest point it reaches a height of about 1,3 m. It is constructed with cement and stone with a cement topping rendering it smooth.
