TEST EXCAVATIONS OF OLD KLIPTOWN ROAD, FOR THE WALTER SISULU SQUARE OF DEDICATION

A Phase-2 report prepared for the Johannesburg Development Agency

MH Schoeman

May 2005

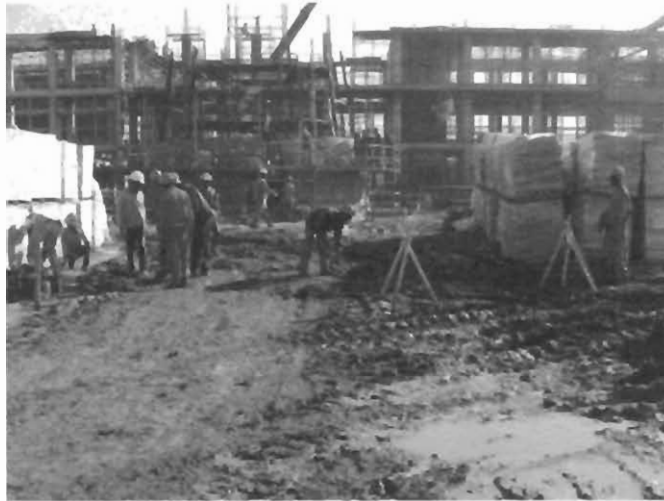
Area II was dug approximately midway between the two parallel buildings, currently under construction. The trench was approximately 14.5m from the southern edge of the memorial. The Area II team was lead by Dr Cain.

Figure 6. Photograph showing Area II prior to excavation.

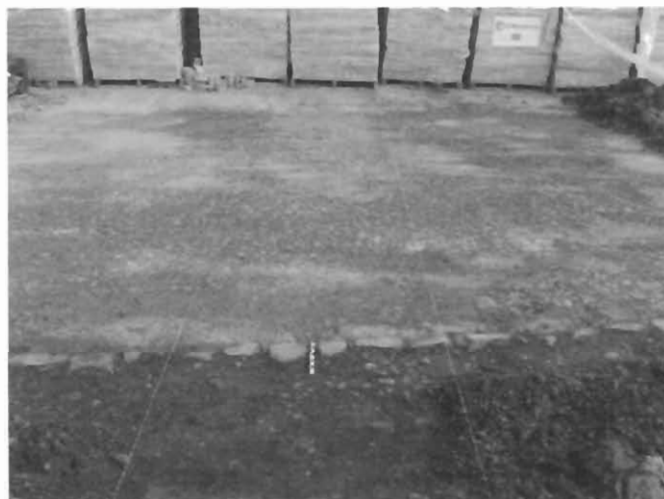
Initially a one meter wide test trench was excavated into Area II. It was aligned roughly parallel to the buildings under construction. This trench exposed both road edges and was approximately 8.5m long. On completion of the initial test trench two 2.5m wide areas were cleared on both sides of it (Figure 7).

Figure 7. Photograph of Area II at the completion of the excavation.

On the western edge the excavations exposed a concrete surface stretching towards the demolished building area. Moving east a tarred surface was found 0 to 5 cm below the current surface. A tarred curb slopes down for about 40cm after which the road flattens out. The preservation of the road varied. In some areas the tar was intact, in others the crusher stones were exposed (Figure 8) and backhoe marks scar the surface (Figure 9). The crusher stones were 3 - 8cm in diameter.

The road was 5.9m wide. The tar was mostly intact on the western half of the road, however the crusher stones were exposed on the eastern half. The edge of the road was marked with edging stones, which ranged in size from 10 –25cm in length (Figure 15). A mixture of rubble and cobbles was found from the curb to the end of the trench.

The simple mitigation measures were sufficient to recover useful data. We established the road alignment, edges, depth below surface and condition of the road. It seems that extensive preparation of the road substrate will not be necessary as the original is still in tact and that little road repairs would be needed, except at the junction with Union road. The road surface, however, does need to be stabilised as the original tarmac has been eroded.

We recommend that such treatment take into account to the edging stones on the eastern side, which seems to be a unique feature of the road.
