**Historical and Architectural Impact Assessment Report for the
Port Durnford State Forest, Umhlatuze, Uthungulu District
Municipality**

Historical and Architectural Impact Assessment Report for the Port Durnford State Forest, Umhlatuze, Uthungulu District Municipality

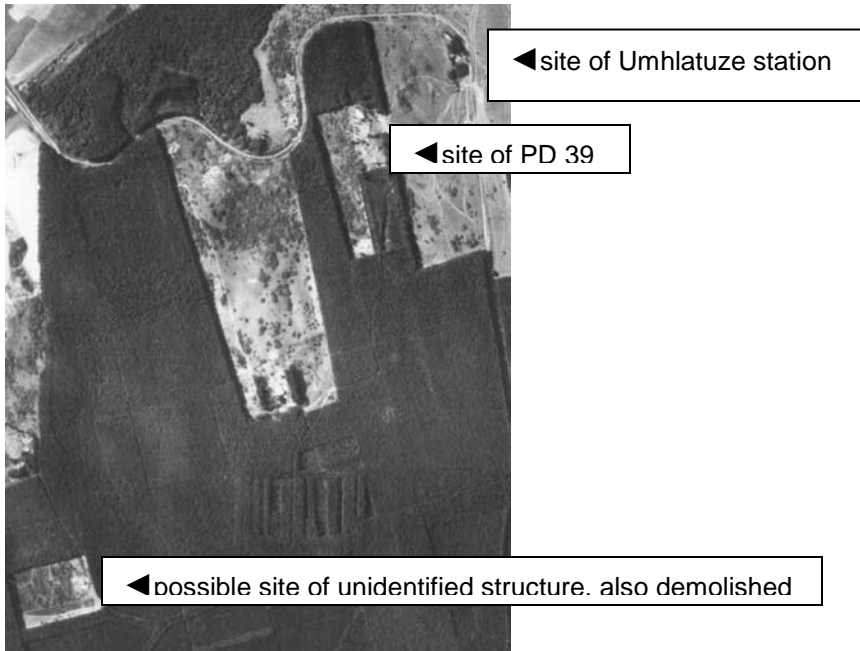
Fig 7: 1937 Aerial photo showing sites correlating to 1930 map in fig 1.

In any event, structures that were demolished and bulldozed on the site date back to pre-1937 (being evident on the photo's) and should not have been demolished without a permit from either *Amafa*, or its progenitor, the National monuments Council.

Condition of site: ruin

Recommendations: since this seems to be the oldest habitation site, the presence of an archaeologist during site clearing is recommended.

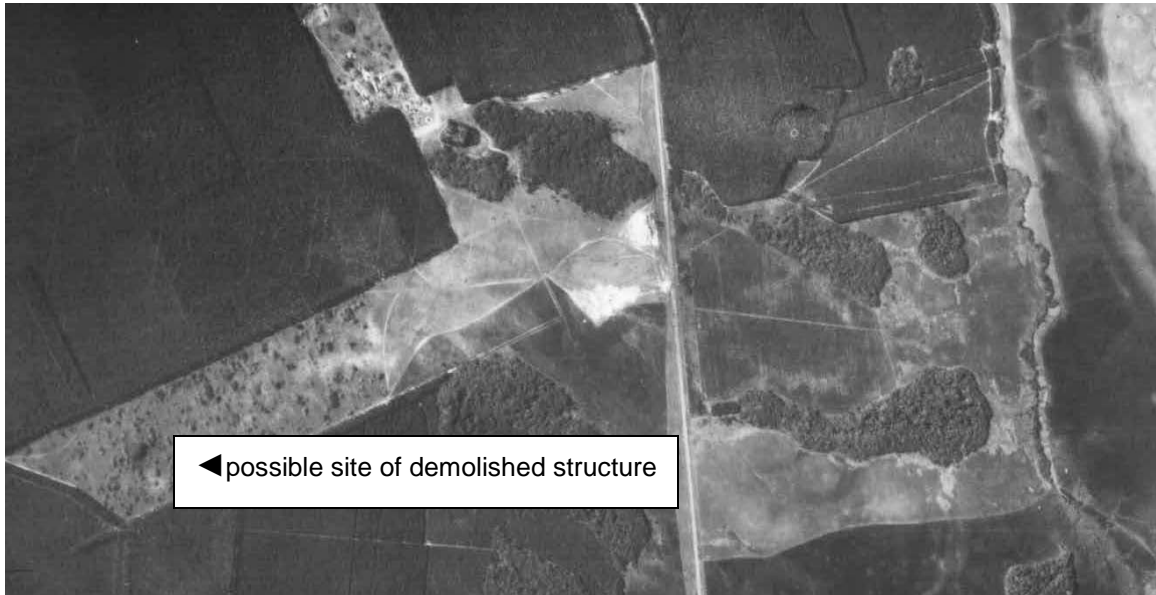
Fig 8: 1937 Aerial photograph showing possible site of PD27

The remains of a dwelling, and concealed rainwater tanks are what is left of this site. The building has been largely destroyed, but some walls still remain to eaves level. The building is of conventional brick and mortar construction, and gauged from the occasional coursing built pre-World War II. No evidence has been found as to what this structure looked like, although its position may be seen on the 1937 aerial photo. (Fig 8)

Condition of site: ruin except for water tanks

Recommendation: none and demolition of the rainwater tanks is recommended

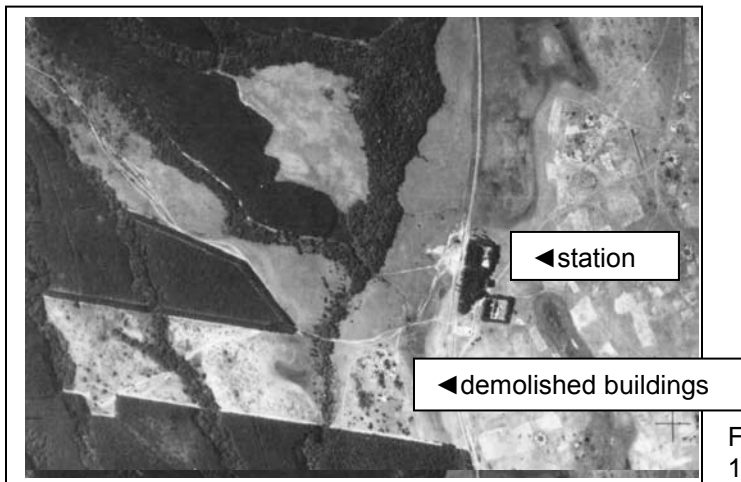
Fig 12: Showing an excerpt from the 1937 aerial photo of the site

The site of the 'sawmill' appears to have moved across the railway line from time to time. In the 1937 aerial photos, no substantial structures exist on the Port Durnford side (as opposed to the Umsingwenya plantation) which indicate that the sawmill was on this portion, yet across what was

the railway line at that time, in the 1937 photos, a distinct development is seen. Marwick notes that the first sawmill was set up at Port Durnford as early as 1915, and this was carried out by Gray Bros, the people who ran Eshowe sawmills. As the majority of these logs were 'Mdoni logs from the Umsingwenya swamp forests which were converted into light sleepers sold mostly to the sugar mills' the position of the development on the Umsingwenya side is plausible. (Marwick;1984:48) The lack of development on the Port Durnford side is also explained by the phrase; 'the firm decided to build a mill at Port Durnford and this was completed towards the end of 1938 and continued in operation until the end of 1952 when it was replaced' (ibid:50)

Evidence of the scattered buildings to the south of the old sawmill site is seen on the 1937 photo as 'demolished buildings' and this is possibly the remains of the following; 'In 1925 a contract was entered into with the Rand Mining Timber Co. for the purchase of 7000 tons of mining timber and 12 000 tons of firewood. The company laid down tracks and erected a sawbench. These were, however, badly located and were never used to full capacity.'(Ibid:48)

Recommendation: none and demolition of the loading ramps is recommended

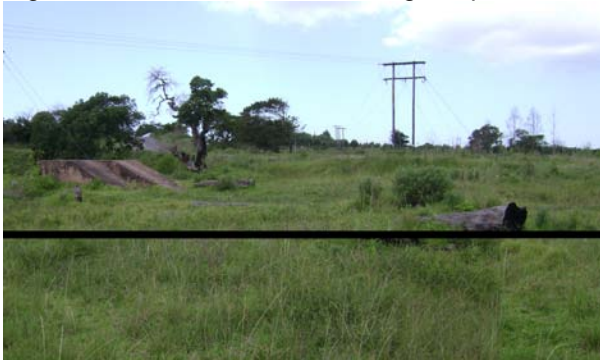
Fig 15: looking towards elevated road level

Condition of site: ruin except for loading ramps

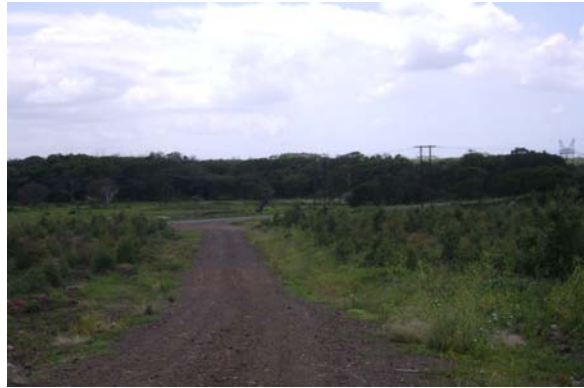
Fig 19: view back towards site of sawmill

The structures that were demolished and bulldozed on the site date back to pre-1937 (being evident on the photo's) and should not have been demolished without a permit from either *Amafa*, or its progenitor, the National Monuments Council.

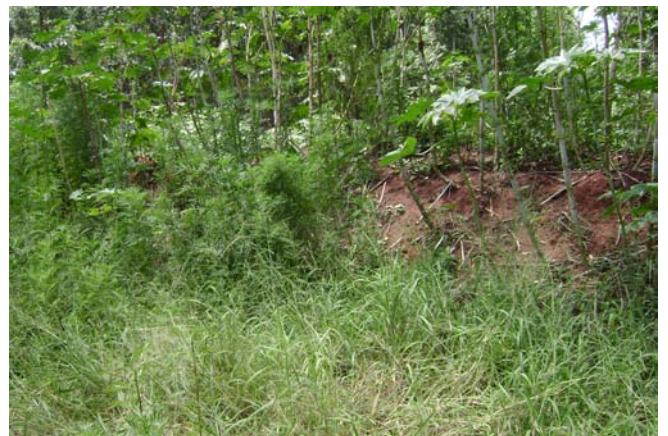
Fig 22: view from road

Condition of site: overgrown ruin

Recommendation: none

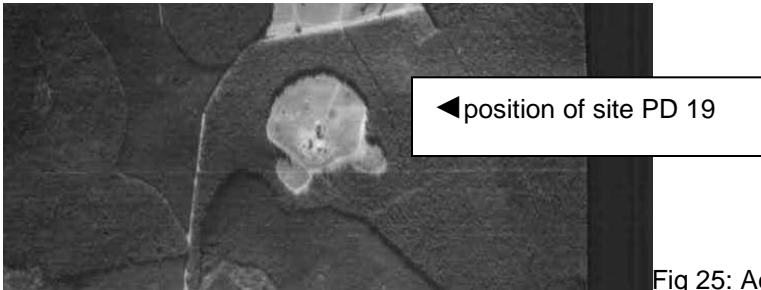
Fig 25: Aerial photo (1937) showing site

The structures that were demolished and then bulldozed on the site date back to pre-1937 (being evident on the photo's) and should not have been demolished without a permit from either *Amafa*, or its progenitor, the National Monuments Council.

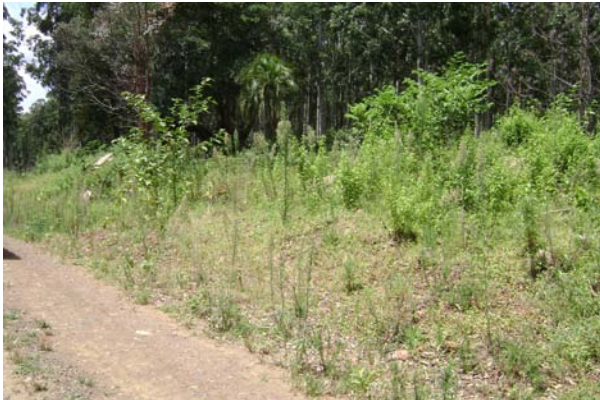
Fig 28: view of site from road

This site is identified as a Forester's encampment on the maps in Fig 2 and 3. Extensive bits of brick walling exist on the surface which has been extensively bulldozed. A water tower still stands.

Condition of site: overgrown ruin

Recommendation: none

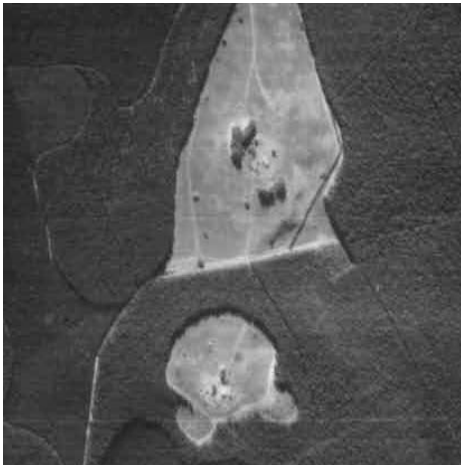
Fig 30: showing site PD 20

The aerial photo to the left (fig 30) shows site PD 19 below and the structure on PD 20 above.

The structures that were demolished and bulldozed on the site date back to pre-1937 (being evident on the photo's) and should not have been demolished without a permit from either *Amafa*, or its progenitor, the National Monuments Council.

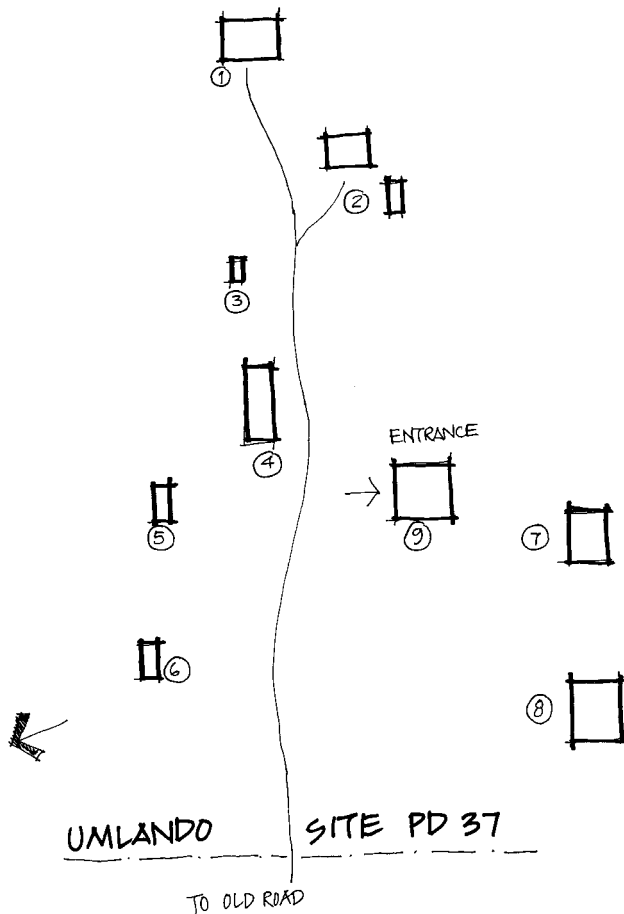
Fig 31: rough sketch showing the layout of the entrance complex

Buildings no 1, 2, 7 and 8 are enclosed housing complexes, largely of latter construction but no 7 likely to fall in within Amafa protection. Building no 3 is a small cottage, possibly built in the 1950's. Building no 4 is a garage complex and has little to merit if except for a large shed. Buildings no 5 and 6 are ill-maintained, ill-inhabited and have little merit, although they are likely to be older than 60 years.

Building no 9 is the entrance building, and is a solid brick structure under Marseille tile. It is also likely to fall within the protection of the Heritage Act no 10 of 1997.

There is no evidence of any of these structures on the 1937 aerial photos.

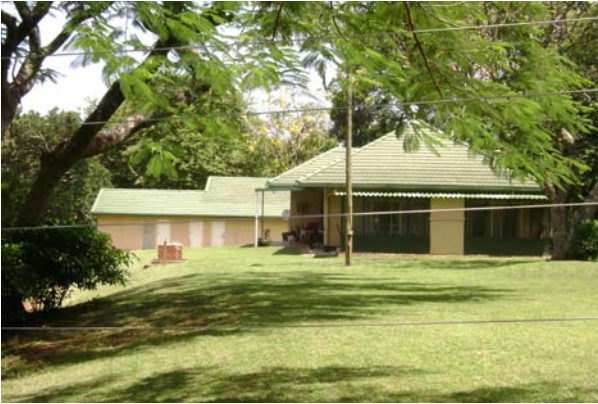
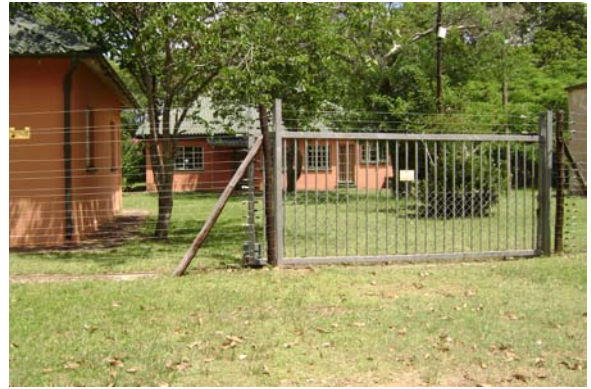
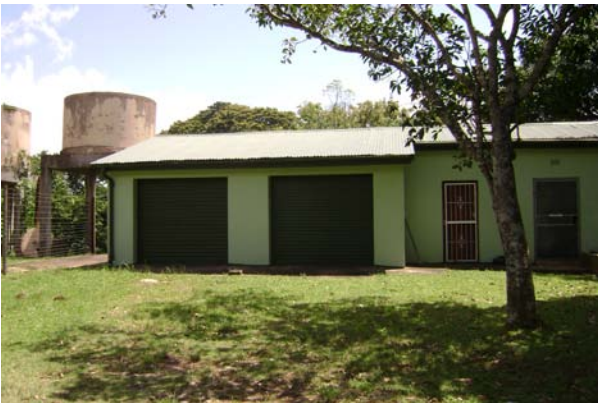
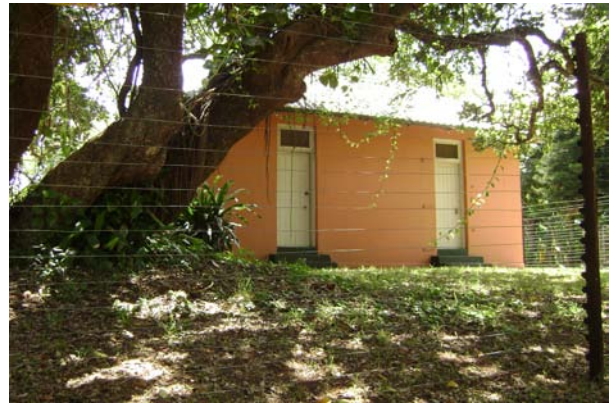
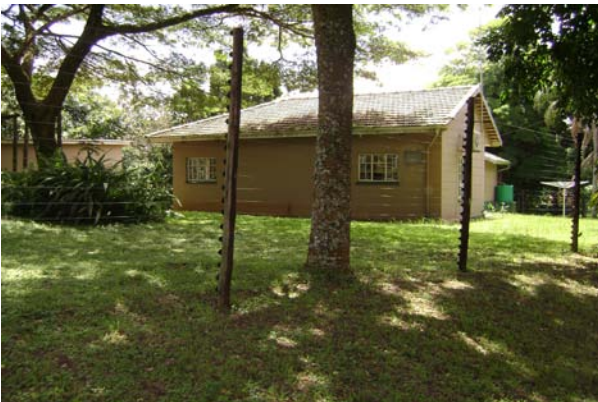
Fig 32: showing part complex 1

Fig 33: showing part of complex 2

Fig 34: showing part of complex 2

Fig 35: showing part of complex 2

Fig 36: part of complex no 2

Condition of site: the buildings are generally in good order. They are architecturally not significant, although they are good examples of functional buildings. They do not operate as a group, do not form streetscape, and are not associated with any major event nor person. They are remote from Empangeni and Mtunzini and their situation limits alternative uses.

Recommendation: should demolition be requested, this group of buildings is not significant with regards to the heritage of the province of KwaZulu-Natal.

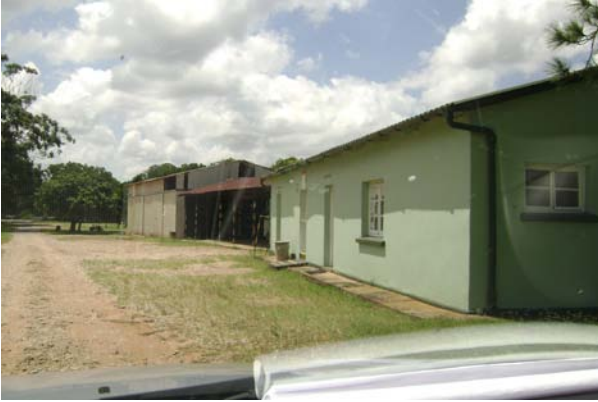
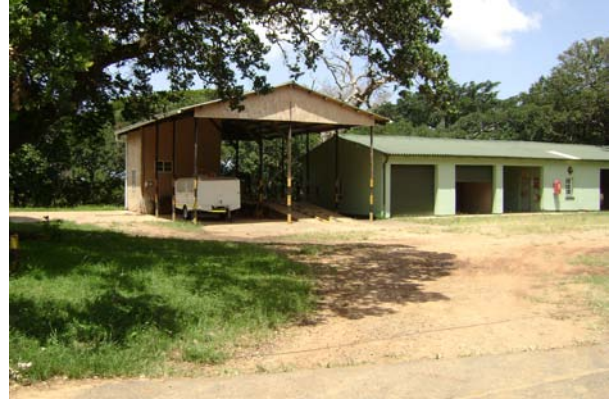
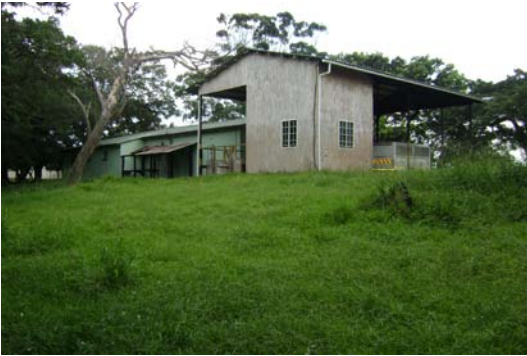
Fig 38: showing complex 4

Fig 39: complex no 4 from the south

Fig 40: showing the north western elevation of the shed in complex 4

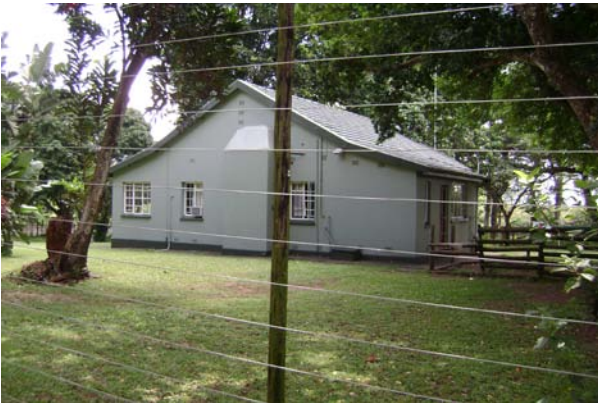
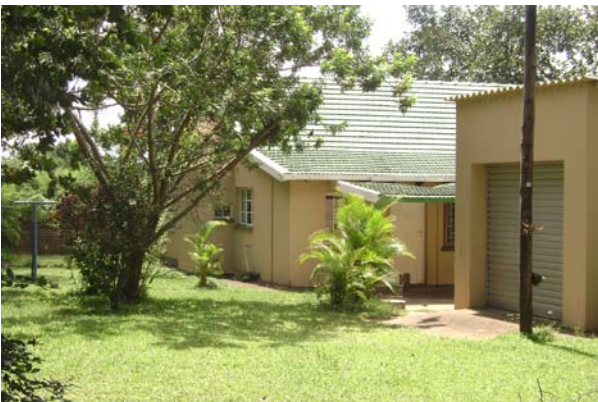
Fig 41: complex no 7

Fig 43: complex number 7

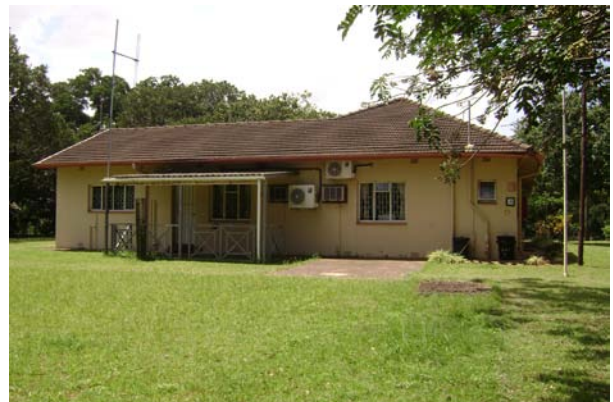
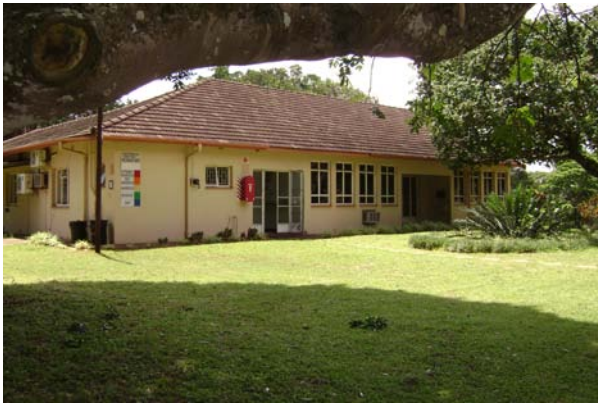
Fig 44: main entrance from the east

Fig 45: Main entrance building from North

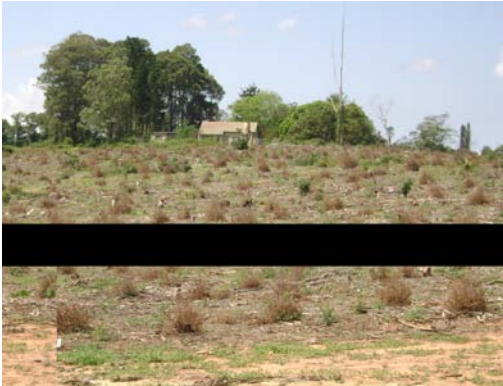
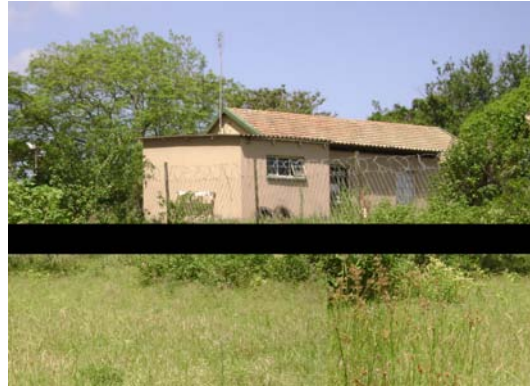
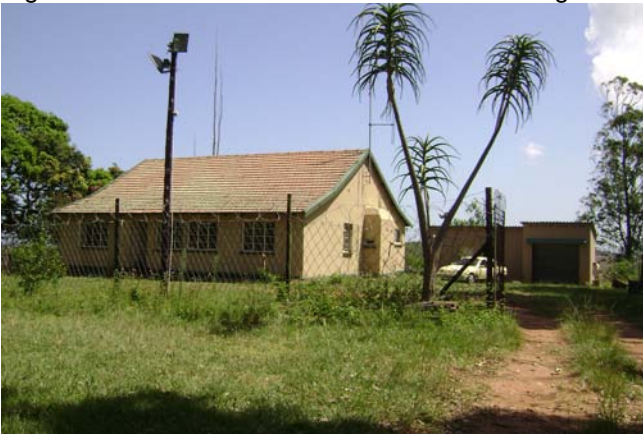
Fig 48: view from south west

Fig 49: view from dirt road

Fig 50: view from driveway

This structure was not identified in the Umlando report but does form part of the architectural impact assessment. It is of the same period as complex no 7 in the previous section, a simple tiled, saddled roof over a masonry structure. It is suspected that the building is either older than 60 years, or constructed soon after World War II.

Condition of site: the building is generally in good order. It is architecturally not significant. It does not operate as part of a group, nor does it form streetscape. It is not associated with any major event nor person.

Recommendation: should demolition be requested, this building is not deemed significant with regards to the heritage of the province of KwaZulu-Natal.

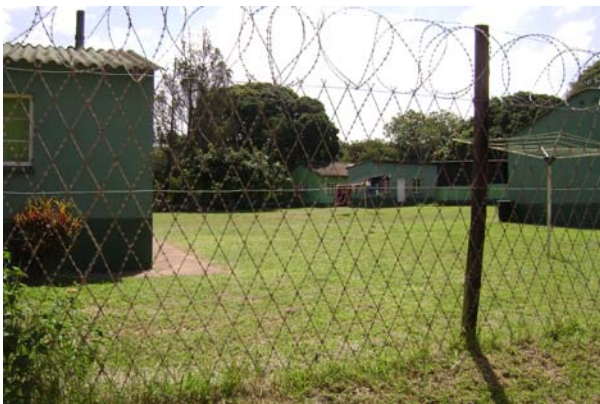
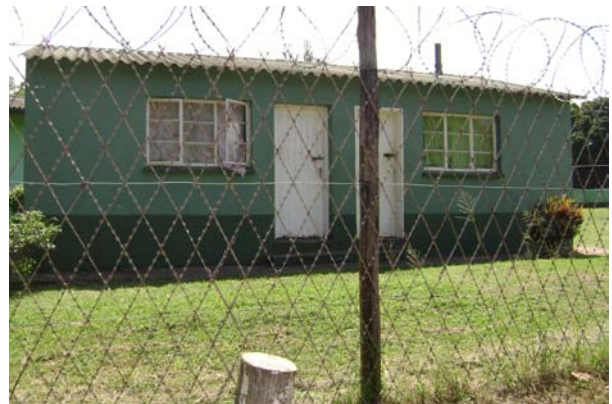
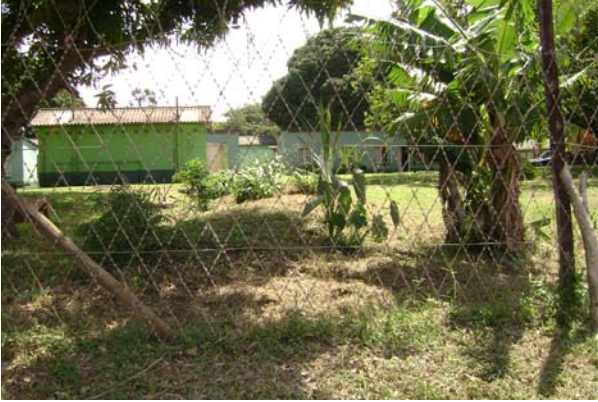
As with the previous structure, this was not identified under the archaeological impact assessment. It is a workers camp, of itinerant construction, with some of the older buildings being constructed out of asbestos sheeting. They are constructed of concrete block with steel windows.

Fig 52: view of group from road

Fig 53: view of unit

Fig 54: view of ablution block

Condition of site: the buildings are generally in good order. They are architecturally not significant, although they are good examples of functional buildings. They do operate as a group, but not as a streetscape, and are not associated with any major event nor person. They are remote from Empangeni and Mtunzini and their situation limits alternative uses. They are constructed of mixed materials, but largely concrete block and asbestos. It is suggested that they were constructed post-war.

Recommendation: should demolition be requested, this group of buildings is not significant with regards to the heritage of the province of KwaZulu-Natal.
