# Archaeological Impact Assessment of two outbuildings on the historic werf at Weltevreden Farm, Ptn 14 of Farm 1646, Franschoek

21 January 2013

**Hugo Pinto**

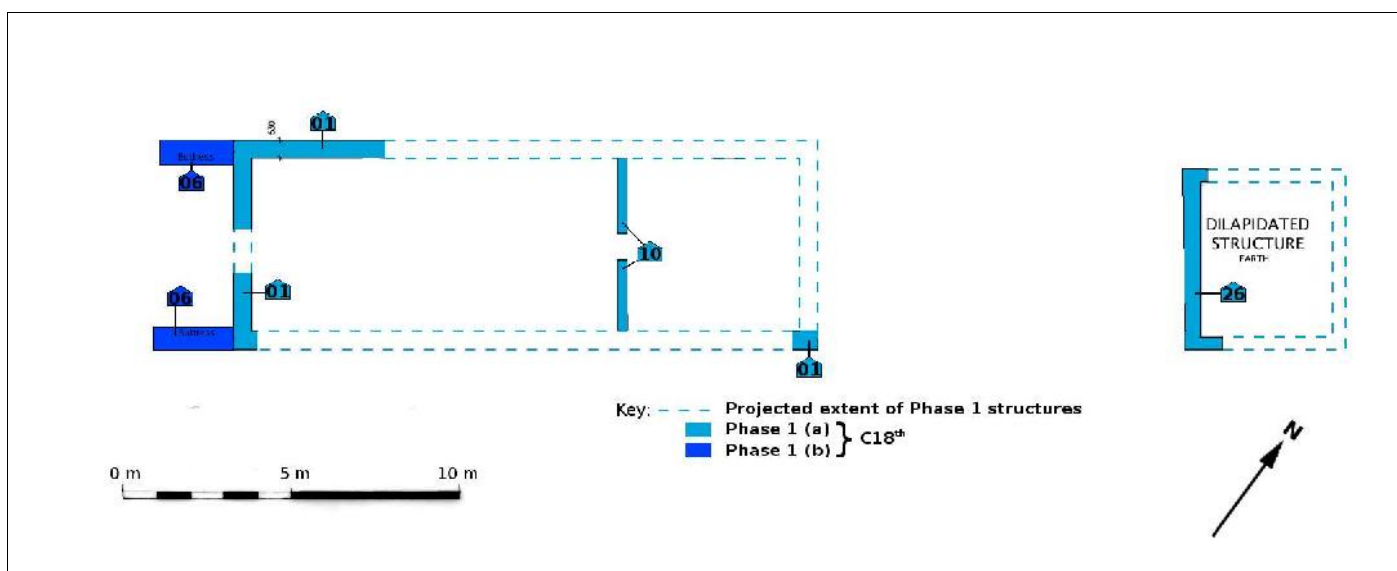
Fig. 10: Plan of West Barn Phase 1 structures.

The earliest structures in the stratigraphic sequence of the West Barn were walls 01, 06, 10 and 26 (Fig. 10). With the exception of the internal division formed by wall 10, all were originally external building walls built with irregular rounded and sub-rounded sandstone cobbles, generally uncoursed or laid in rough courses, set in a soft soil bond (comprising a dark grey sandy-silt). Internal dividing wall 10 was built with unfired (sun-dried) dark grey bricks, set in a similar dark grey soil mortar.

Wall 01 represents the footprint of a rectangular building, measuring 17.34m north-south by 6.22m east-west. The only sections of fabric from this original building that survive in the current structure

Context 26 formed the southern wall to a smaller building, situated approximately 11m north of the Phase 1 building represented by wall 01 (Fig. 10). Although the remainder of this second Phase 1 structure has subsequently collapsed, the two stone-built and keyed-in right-angle corners at the eastern and western ends of wall 26 continue to the north (Plate 1). This indicates context 26 represents the southern wall of a separate structure, rather than the northern wall of the Phase 1 building represented by wall 01. This is supported by the fact that wall 26 does not extend across the entire 6.22m width of the building represented by wall 01, as shown in section 10 (Plate 2). Assuming that the original north-eastern and north-western corners of this structure were referenced when they were re-built in Phase 5 (see below), wall 26 represents an almost square building measuring c. 5.40m east-west by 4.60m north-south.

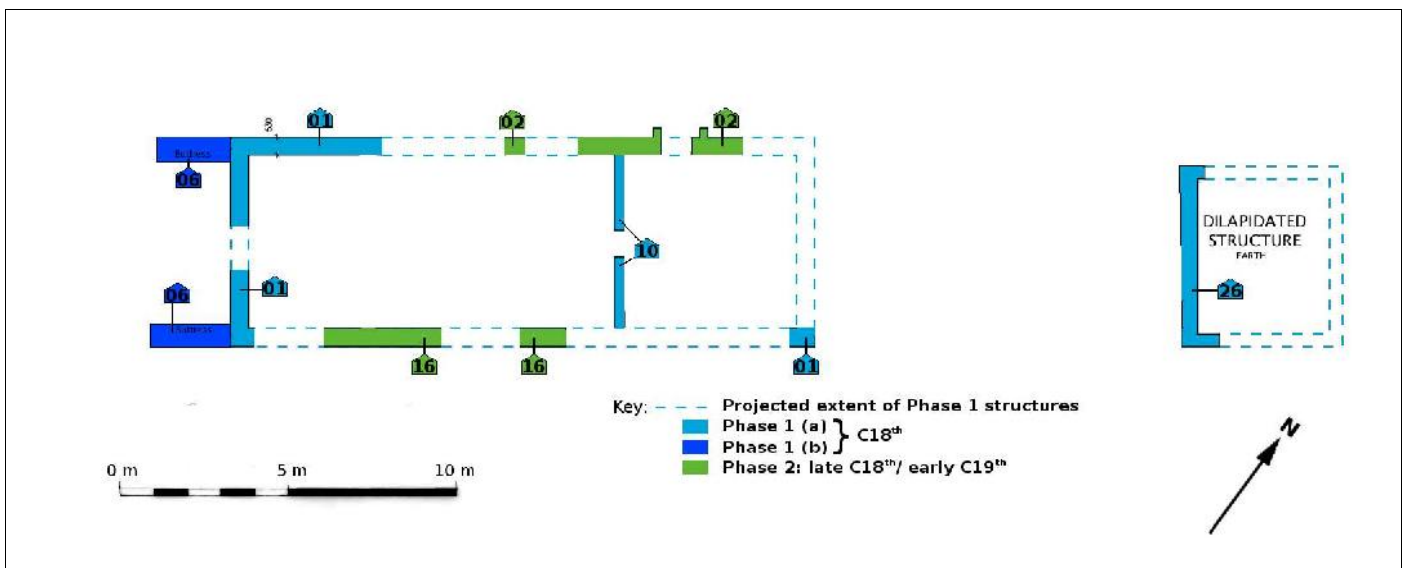
Fig. 11: Plan of West Barn Phase 2 structures.

The Phase 2 structures are represented by two contexts: wall 02 forming a tract of the building's western elevation, exposed in sections 1, 3 and 5; and wall 16 forming a tract of the building's eastern façade, exposed in section 4 (Fig. 8 and Fig. 11; section 4 was also recorded as a drawn elevation and is presented as Fig. 16).

Wall 02 was built with a combination of stone and brick coursing, set in a soft, dark grey sandy-silt mortar identical to that used in the Phase 1 structures. The lower portion of wall 02 was built with rounded and sub-rounded sandstone cobbles to a varying height of 0.76m, 0.50m and 0.57m above current internal floor level (sections 1, 3 and 5 respectively). The upper part of wall 02 was completed with pale orange, low-fired friable bricks, with occasional dark grey sun-dried bricks randomly included in the wall fabric.

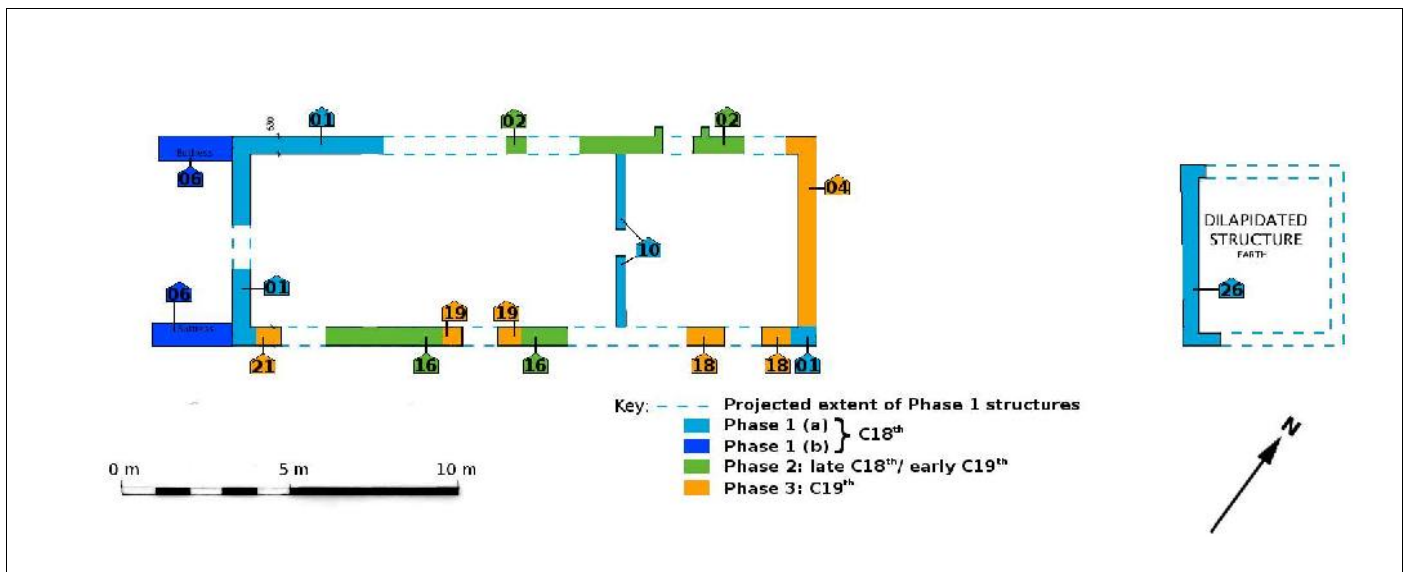
Fig. 12: Plan of West Barn Phase 3 structures.

Doorway 19 was exposed in section 4 and represents a 1.00m wide doorway inserted close to the centre of the building's eastern façade, located approximately 9.50m south of the north end gable (Fig. 12 and Fig. 15). Both northern and southern sections of this doorway truncated Phase 2 wall 16.

Context 21 represents the southern jamb of a doorway inserted into the building's eastern façade

1.47m north of the south end gable. This structure was exposed in section 6 but, as the northern jamb was not exposed, the doorway's overall width was not determined. The southern section of doorway 21 truncated the Phase 1 fabric represented by wall 01.

All of these doorways were entirely brick-built, with orange and pale orange/beige low-fired bricks and occasional dark grey sun-dried bricks, although the latter were primarily found within doorway 18, sparsely within doorway 19 and structure 21 was built entirely with low-fired orange bricks. These were set in a soft soil mortar identical to that used in structures assigned to Phases 1 and 2, consisting of a dark grey sandy-silt.

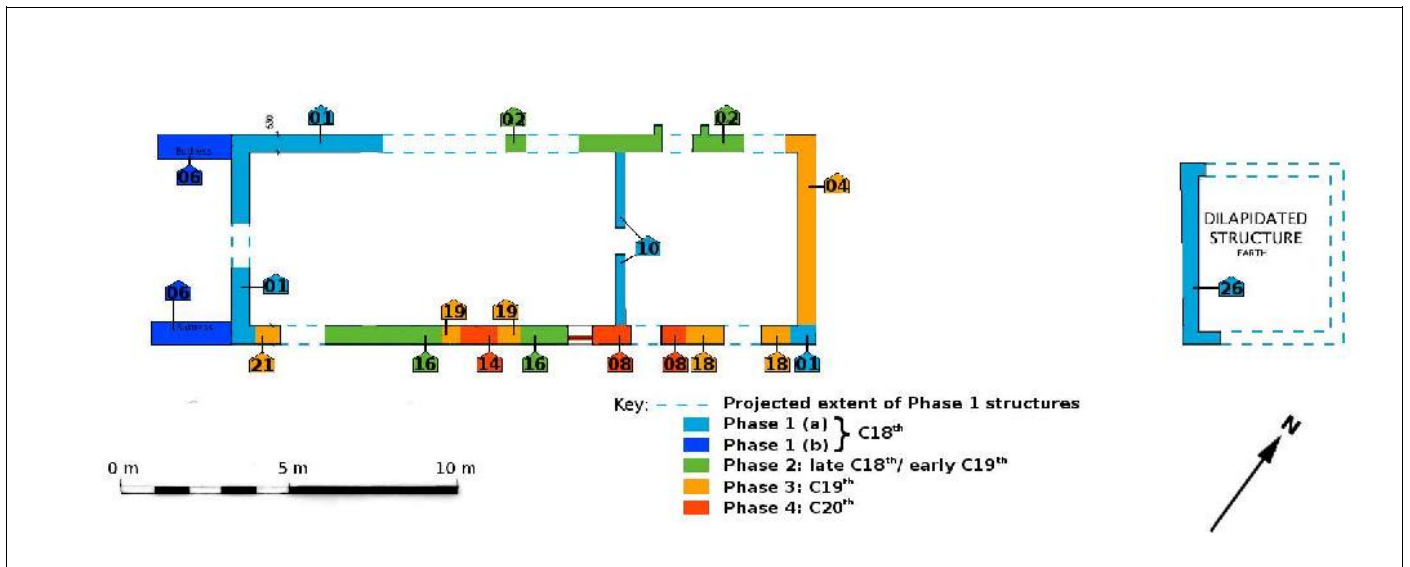
Fig. 13: Plan of West Barn Phase 4 structures.

The use of modern materials in the construction of Phase 4 structures, particularly that of a cement mortar in doorway 08, most likely dates these structures to the C20<sup>th</sup>. Cement became more readily available and affordable in South Africa after the Pretoria Portland Cement plant was established in 1892 to counter the exorbitant cost of cement imported from Europe (PPC 2011). Even after the establishment of this cement plant in the late C19<sup>th</sup>, the use of cement as a construction material on farm buildings in the Drakenstein Valley is likely to have been very limited for some time

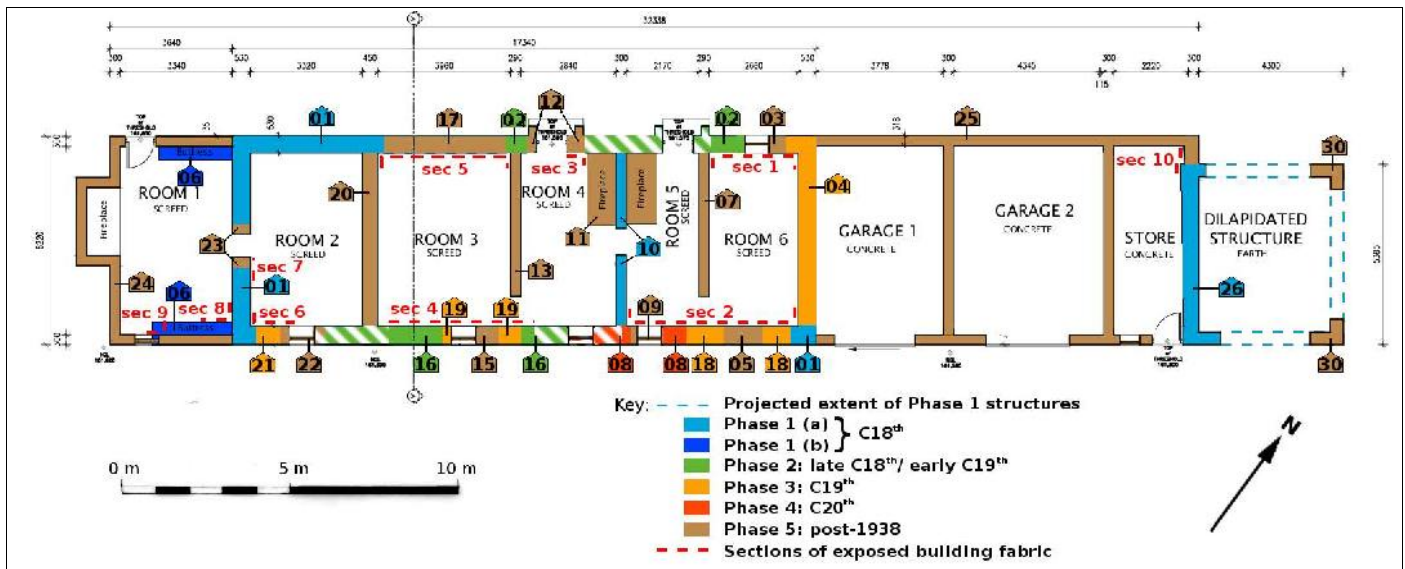
Fig. 14: Plan of West Barn Phase 5 structures.

All Phase 5 structures were built using the same construction methods and materials. These consisted of highly-fired, reddish-orange bricks with white grit inclusions. These were also factory mass-produced bricks, although slightly different in appearance and composition from bricks used in Phase 4 structures. The mortar used in Phase 5 structures reverted to a soil based composition, consisting of a pale yellow/brown silty-sand, with possibly some lime mixed in. The lime component was not evident from its appearance but would account for the mortar's relative hardness, making it a substantially more robust and less friable mortar than the dark grey soil used in Phases 1-3. All surviving internal wall faces and structures were also rendered with this

All Phase 5 structures to the south of the double garage extension represent alterations and additions that converted the southern section of the West Barn into three separate dwellings, or terraced cottages. Each dwelling consisted of two rooms, with a fireplace in one of the two rooms of each dwelling. Each room was also fitted with a window to the building's eastern façade, with the exception of Room 6 where the window was to the western façade. Each two-room dwelling was accessed through a door through the building's western façade.

The southernmost of these cottages comprised Rooms 1 and 2. The former was a newly built Phase 5 extension to the south end of the building, represented by wall 24, and fitted with a doorway through the western façade, a fireplace along the southern wall and a window to the eastern elevation. Doorway 23 was inserted into the previous south end gable wall 01 to link this room with Room 2, which had window 22 inserted along the eastern façade that also served to block-up Phase 3 doorway 21. This dwelling was separated from the central dwelling by east-west dividing wall 20 that extended across the entire width of the building (Fig. 14).

The central dwelling comprised Rooms 3 and 4, with east-west wall 13 forming the division between these rooms and a 0.85m wide door at its eastern end allowing access between rooms. Room 3 was fitted with window 15 to the eastern elevation, truncating Phase 3 doorway 19 and its subsequent Phase 4 blocking represented by structure 14 (section 4; Fig. 16). Room 4 was also fitted with a window to the eastern elevation that is likely to also date to Phase 5, although as this structure was not exposed by plaster stripping this phasing has not been assigned to the final plan; the diagonal hatching on the phased plan represents the unconfirmed phasing of this window (Fig. 14). Fireplace 11 was built in Room 4 and doorway 12 was inserted into the building's western elevation, the latter truncating Phase 2 wall 02 (section 03). The tract of the building's western elevation re-built as structure 17 (exposed in Room 3; section 5) was possibly a repair to the outer building wall that may have collapsed. Alternatively, it may have been a rebuild required after the demolition of a structural element, such as an internal wall that had been keyed-in to the building's western wall that, as a result of its demolition, damaged the building's western elevation which was subsequently rebuilt as wall 17.

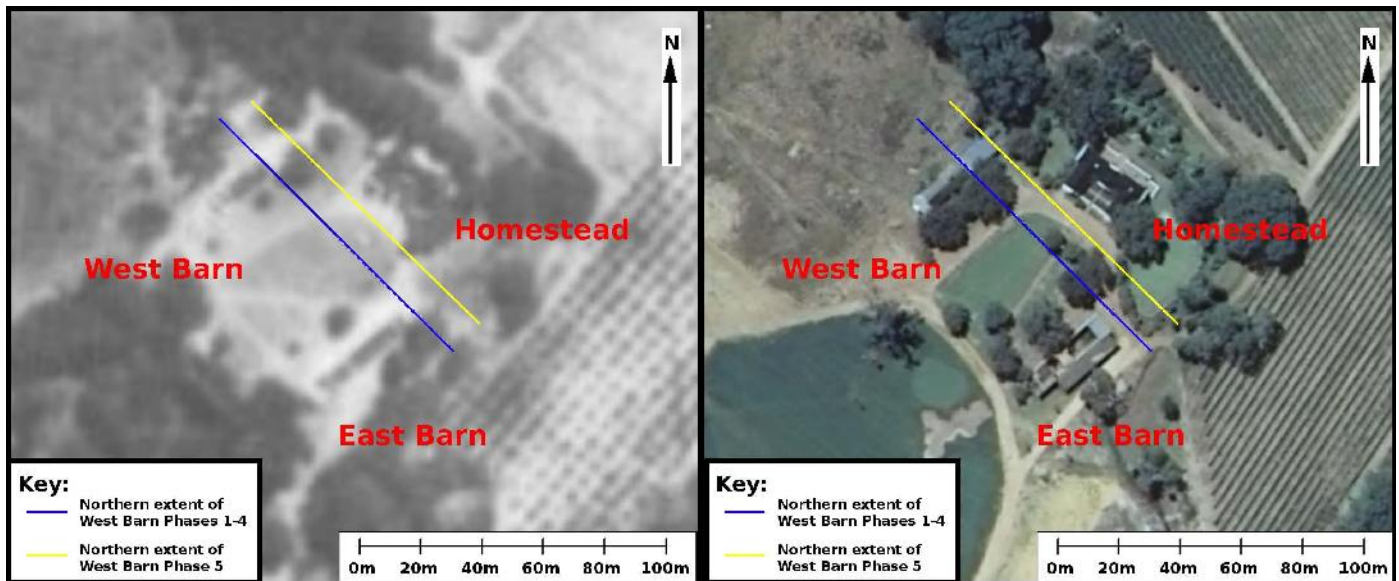
Fig. 17: Aerial photographs comparing extent of West Barn in different phases; from 1938 (left) and 2010 (right). © Chief Directorate Surveys and Mapping.

The dating of Phase 5 was primarily determined by analysis of aerial photographs. When comparing geo-rectified aerial photographs of the Weltevreden farmstead taken in 1938 to the one from 2010, there is a noticeable difference in the overall extent of the West Barn building. Although the earlier photograph has less resolution, it is still evident that the Phase 5 extension to the northern section of

the building comprising the two garages and a store room is not present in that photograph. This therefore dates the construction of these Phase 5 structures to after 1938 when the photograph was taken (Fig. 17).

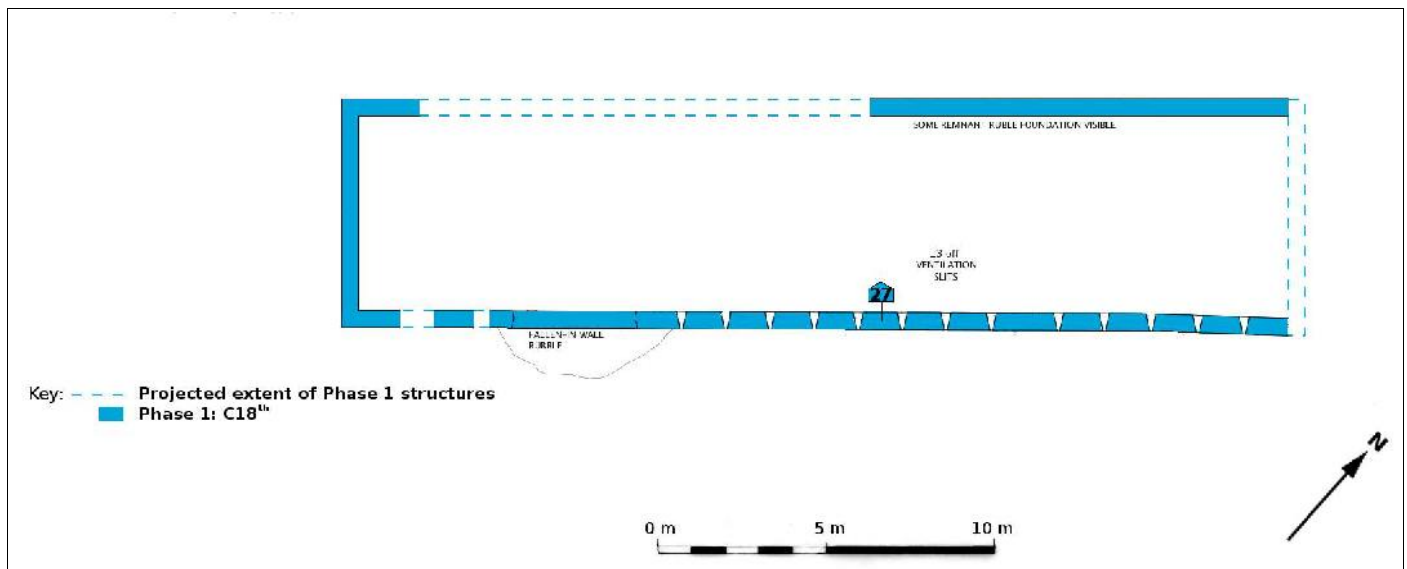
Fig. 18: Plan of East Barn Phase 1 structures.

The earliest context in the stratigraphic sequence of the East Barn was wall 27 (Fig. 18). This structure was predominantly stone-built with rounded and sub-rounded sandstone cobbles, generally uncoursed or laid in rough courses. The cobbles were set in a soft soil bond of a dark grey sandy-silt. These are identical construction materials and methods to those used in the construction of Phase 1 structures in the West Barn. Aside from the eastern building elevation, where large sections of the fabric of wall 27 have been exposed from dilapidation of the plaster render (Plate 6), this structure was also exposed in plaster-stripped sections 11, 12, 13 and 14 (Fig. 9).

The tracts of wall 27 along the southern and western elevation survive solely as a stone footing for brick-built walls of subsequent phases. The footprint of this original Phase 1 structure formed the basis for alterations and additions to the East Barn in subsequent phases.

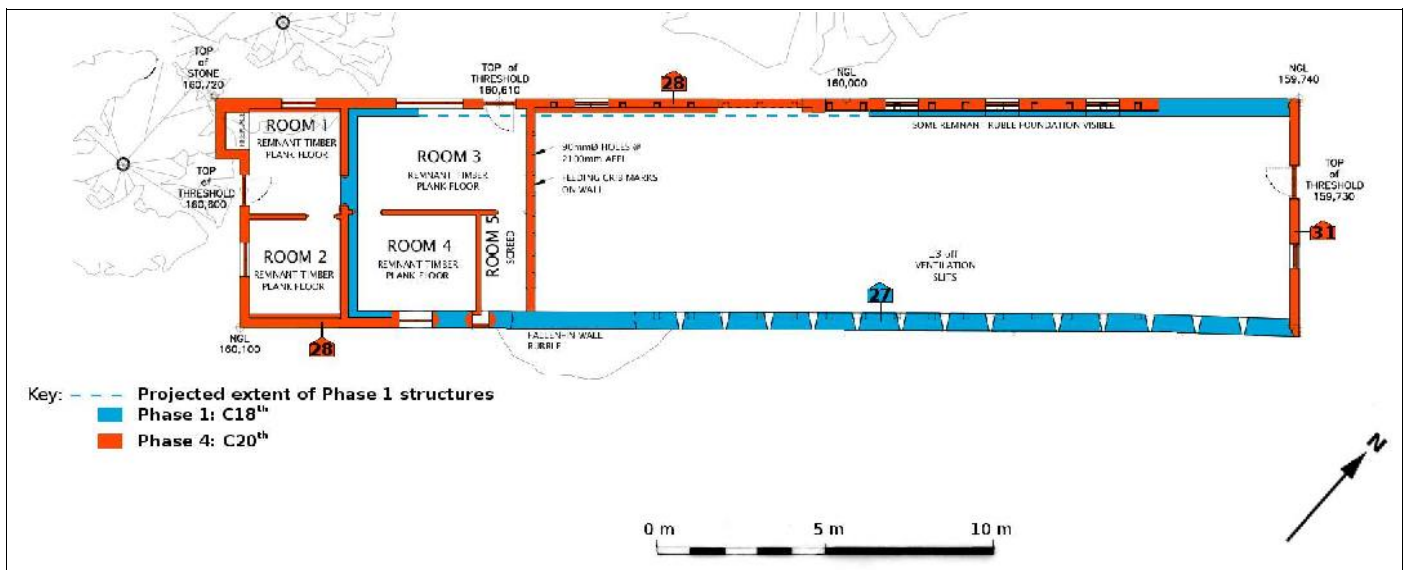
Fig. 19: Plan of East Barn Phase 4 structures.

The Phase 4 structures of the East Barn comprise contexts 28 and 31 (Fig. 19). Both were built with highly-fired reddish-orange, mass-produced factory bricks. These were set in a pale grey cement

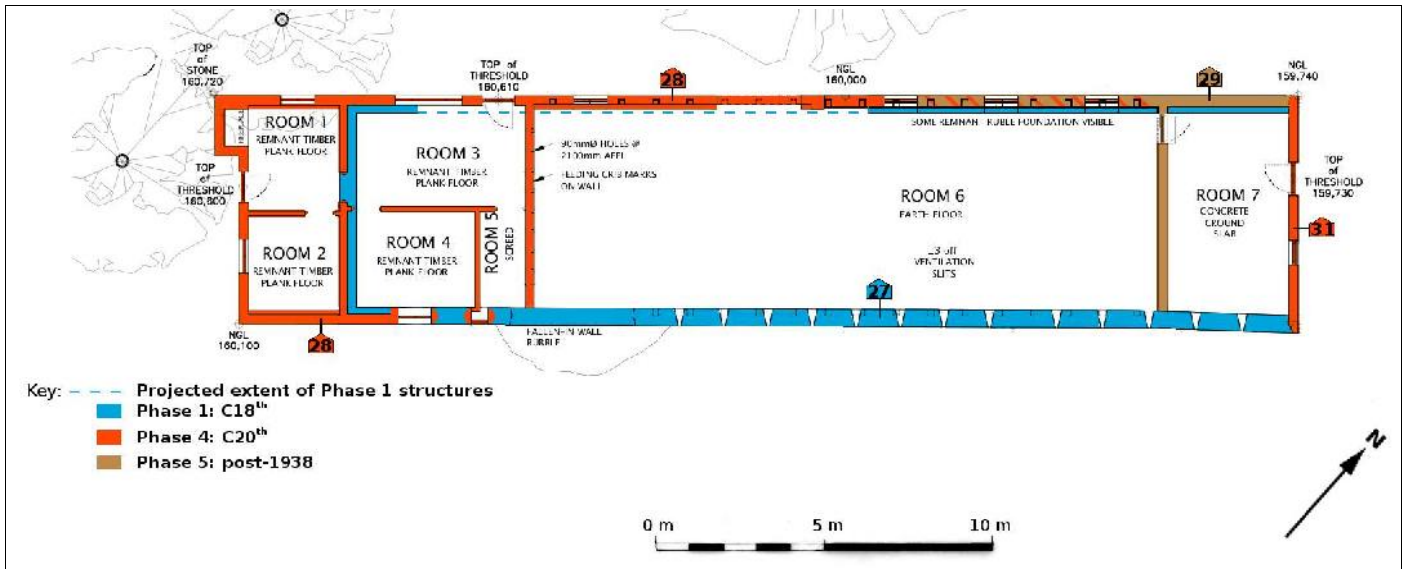
Fig. 20: Plan of East Barn Phase 5 structures.

Structure 29 represents a re-build of the northernmost tract of the East Barn's western elevation. This was keyed-in to an east-west wall that sub-divided a 4.20m long section at the north of the building from the larger open-space section in the centre of the building, recorded as Rooms 7 and 6 respectively (Fig. 20). The space divided as Room 7 during this phase was also finished with a concrete floor, as was the case with all other Phase 5 structures in the West Barn.

The continuation of structure 29 as the building's western elevation to the south of the east-west dividing wall was not confirmed with plaster-stripping. The interface between Phase 4 wall 28 and Phase 5 wall 29 along the western elevation is therefore uncertain; this is represented by the diagonal hatching of the colours representing each phase in Figure 20.

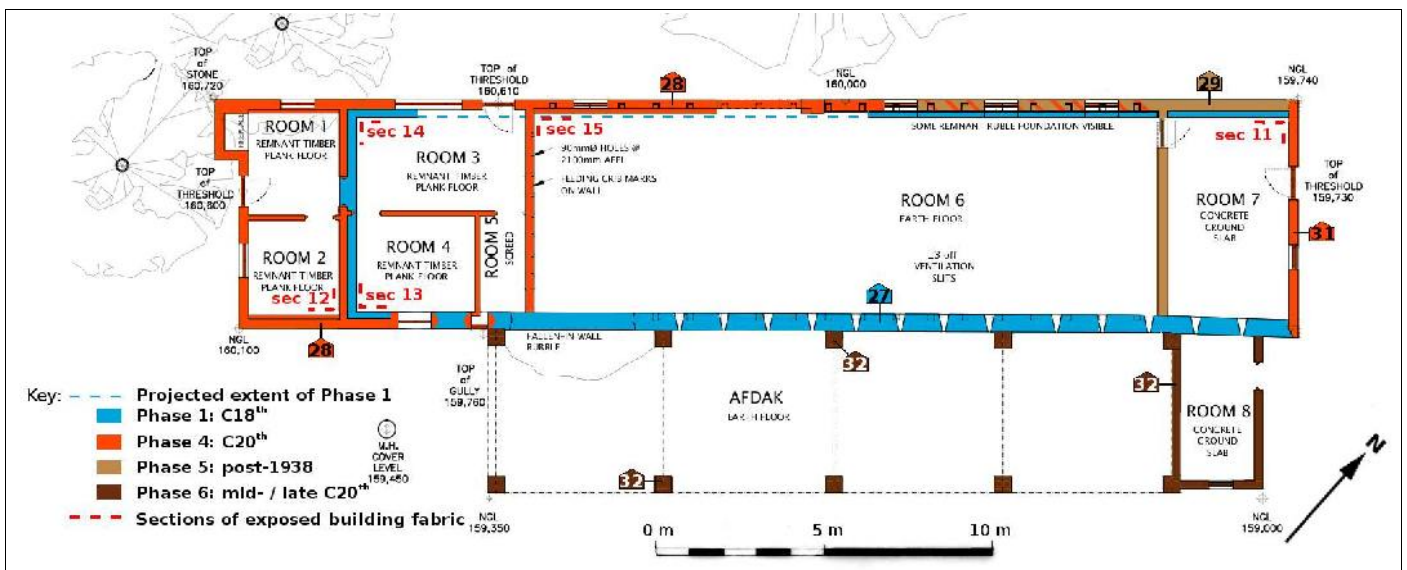
Fig. 21: Plan of East Barn Phase 6 structures.

The Phase 6 structures in the East Barn were recorded as context 32. These structures were built with highly-fired dark red, factory-produced bricks, containing common iron stone and white grit inclusions. Bricks were set in a grey cement mortar.

Context 32 comprised a rectangular room that extended the building's footprint to the east at the northern end of the East Barn, measuring 4.65m east-west by 2.72m north-south and finished with a concrete floor (recorded as Room 8; Fig. 21). Associated with this structure, and also extending the building's footprint to the east, was a lean-to structure (*afdak*) also recorded as context 32. The *afdak* comprised a set of 10 square pillars arranged in two rows running north to south: the western row build adjacent to the barn's eastern elevation wall 27 and the eastern row extending 5m to the east, with a 5m gap between pillars along each row (Fig. 21). These support a single pitch corrugated metal roof sloping down from west to east, that also extended over Room 8 at the north

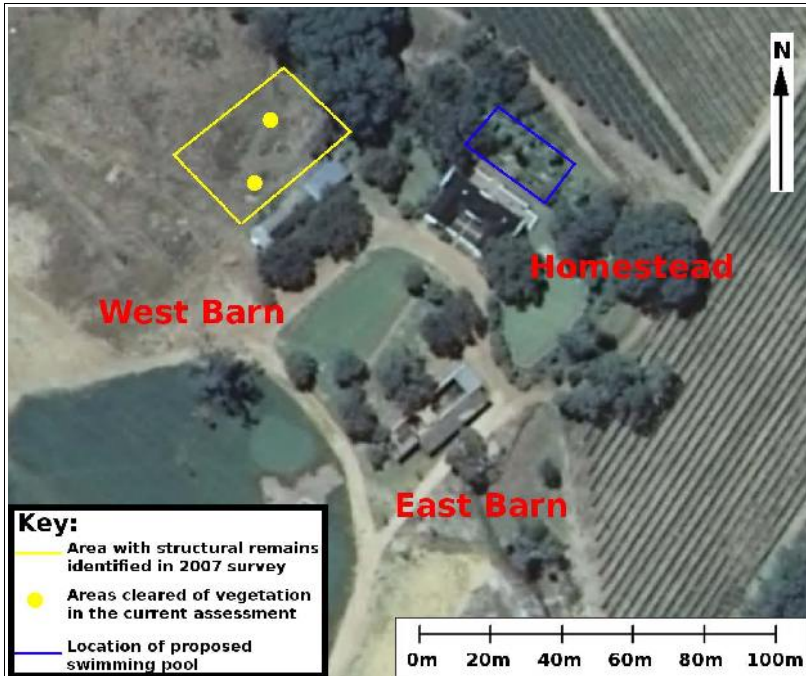
Fig. 22: Aerial photograph of werf showing area of structural remains identified in 2007 survey.

An attempt was made to identify and characterise the remains of the structure noted in the Archaeological Scoping Survey undertaken in 2007 (Patrick 2007). However, as the permit issued by Heritage Western Cape for the current investigation was solely for plaster-stripping of the two standing structures, and did not include permission to undertake sub-surface excavations, this investigation was limited to clearance of low-level vegetation (tall grass) from two small areas in the vicinity indicated by the previous scoping survey (Fig. 22). The aim was to expose the remains of this structure in order to determine its character, extent and preservation quality.

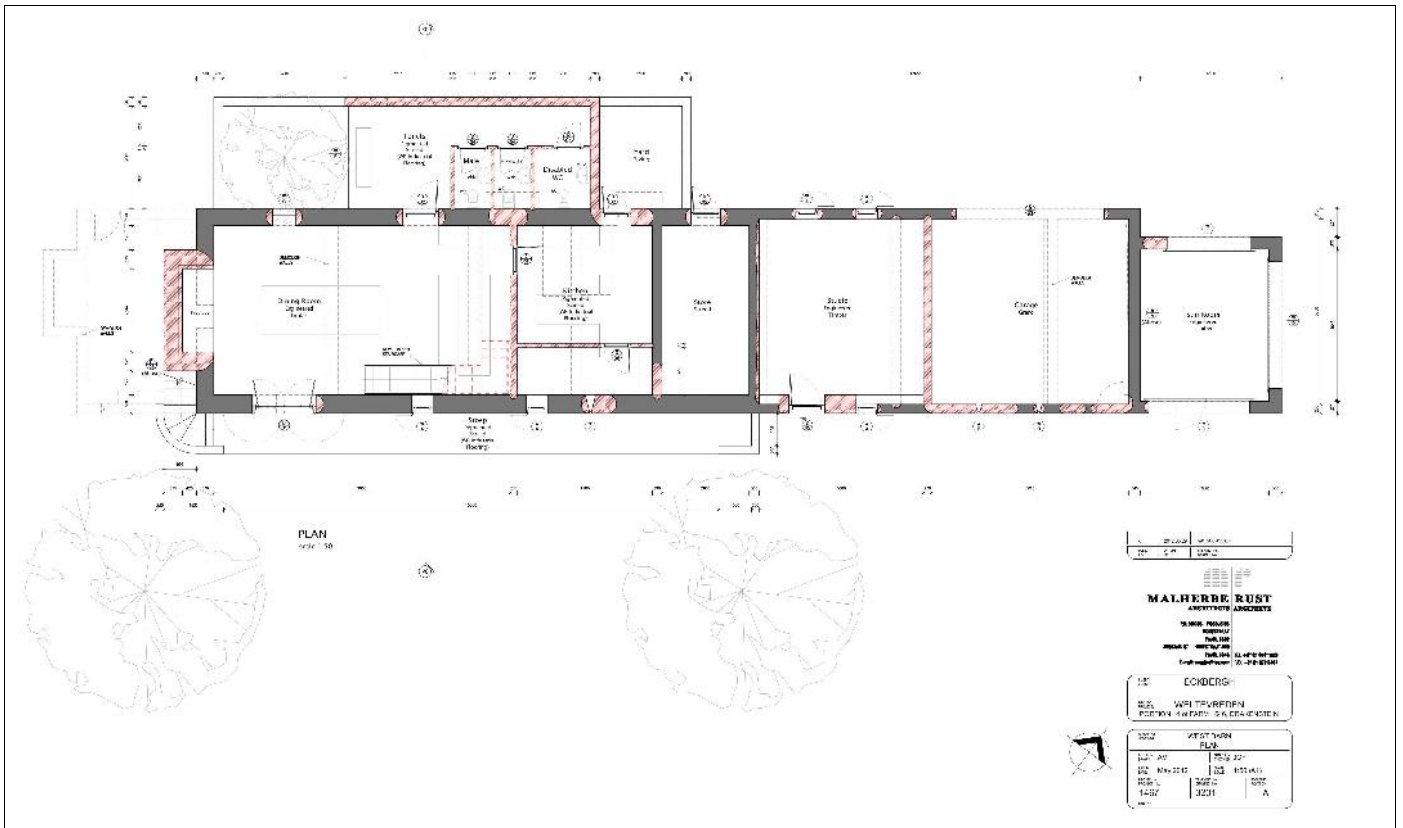
Fig. 24: Plan of proposed redevelopment of West Barn. © Malherbe Rust Architects

It should be noted that the proposed extension to the western elevation of the West Barn building (Appendix 2) is likely to impact on this possible structure. Although this extension has apparently been removed from the proposed redevelopment (Chris Fick pers. com.), if the remaining proposed redevelopments of the West Barn or surrounding *werf* will impact in any way on the area highlighted in Figure 22 (including any alteration, removal or addition of material to that area), then mitigation according to point (8) should be a condition of approval to the proposed redevelopment.

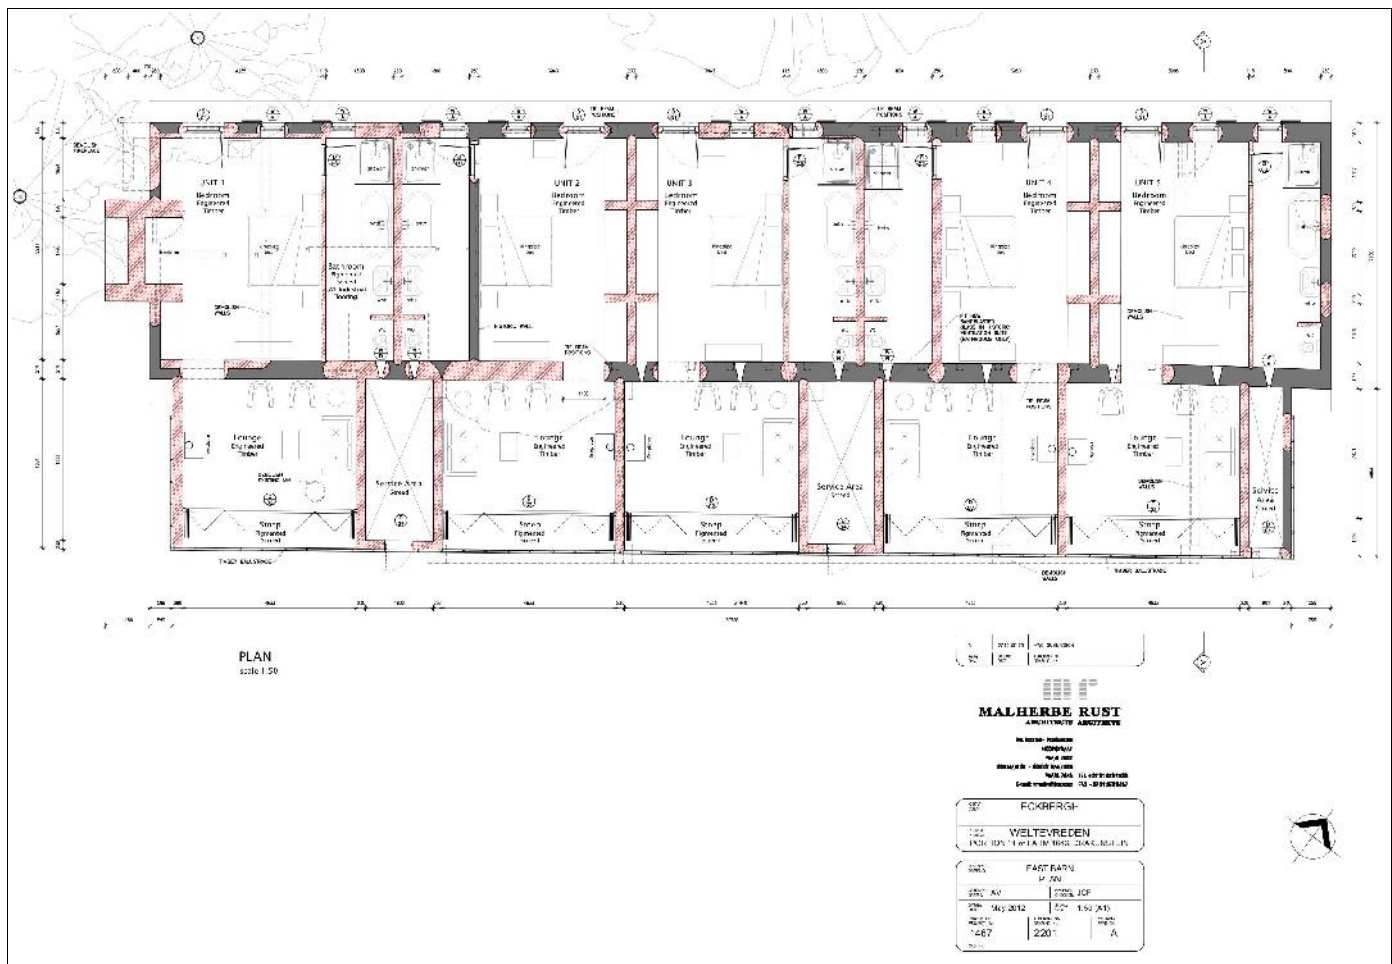
Fig. 26: Plan of proposed redevelopment of East Barn. © Malherbe Rust Architects

The proposed development plans presented in Appendix 2 will have a **Medium Impact** on the East Barn structure. In accordance with the suggested **Grade 3B** for this building and with reference to these plans, it is recommended that:

damage by exposure to the elements. The proposed plans (Appendix 2) conform to point (6) above and, subject to point (7), it is recommended that the proposed redevelopment of the East Barn be allowed to proceed as soon as possible. This will stabilise and preserve the surviving historic building fabric and ultimately result in a **positive impact** on these heritage resources.
