Bo-Kaap Erf 142718 & 142719, 38 & 38A Rose Street
**Section 34 Application to Heritage Western Cape in terms of the National
Heritage Resources Act**

**Report on Existing Housing Condition and Assessment of Recommended
Work on City Owned House in Bo-Kaap.**

**Compiled by Dieter Bossow of Architects Associated for the City of Cape Town.
June 2018.**

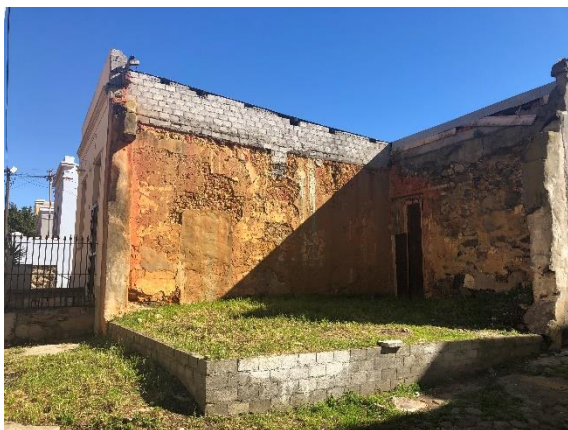
Former corner shop

The corner shop at No 38 has been demolished subsequently to the Buildings of Cape Town 1983 Report. The site area has remained open since then. The back portion remains and forms part of the dwelling at 38A.

Since demolition of corner shop walls and parapets have deteriorated badly

Remove loose plaster, re-plaster and paint, fit fascia and bargeboard to roof edge
Refurbish bedroom 1 and kitchen windows, make good plaster and paint
Make good building corners where walls had been demolished.
