Bo-Kaap Erf 141385, 4 van der Meulen Street

**Section 34 Application to Heritage Western Cape in terms of the National
Heritage Resources Act**

**Report on Existing Housing Condition and Assessment of Recommended
Work on City Owned House in Bo-Kaap.**

**Compiled by Dieter Bossow of Architects Associated for the City of Cape Town.
June 2018.**

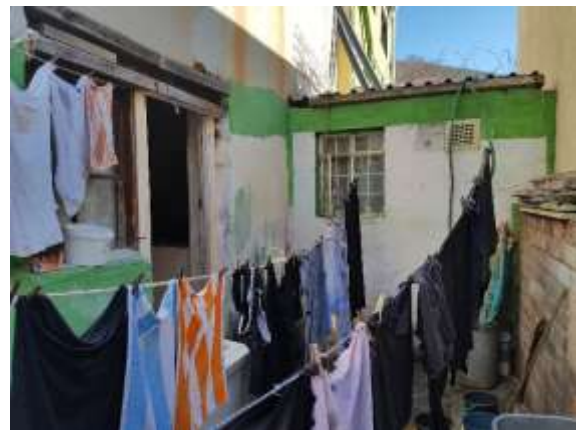
Kitchen yard

The exterior of the dwelling is generally in good condition, apart from some untidy water pipe reticulation in the yard. Walls are generally plastered and painted, apart from courtyard walls.

Increase size of bathroom as shown on the drawings, fit new sanitary ware and gully.

Replace kitchen door with side light as shown

Repair plaster around existing windows as shown and paint

Service existing windows and re-paint

Repair plaster and paint
