**ARCHAEOLOGICAL IMPACT ASSESSMENT REPORT ON THE REDAN
ENGRAVING SITE: SPRINGFIELD COAL MINING PROJECT SITUATED
BETWEEN VEREENIGING AND MEYERTON, IN THE SEDIBENG
DISTRICT MUNICIPALITY, GAUTENG PROVINCE**

Assessment conducted under Section 38(3) of the National Heritage Resource Act (No. 25 of 1999)

September 2020

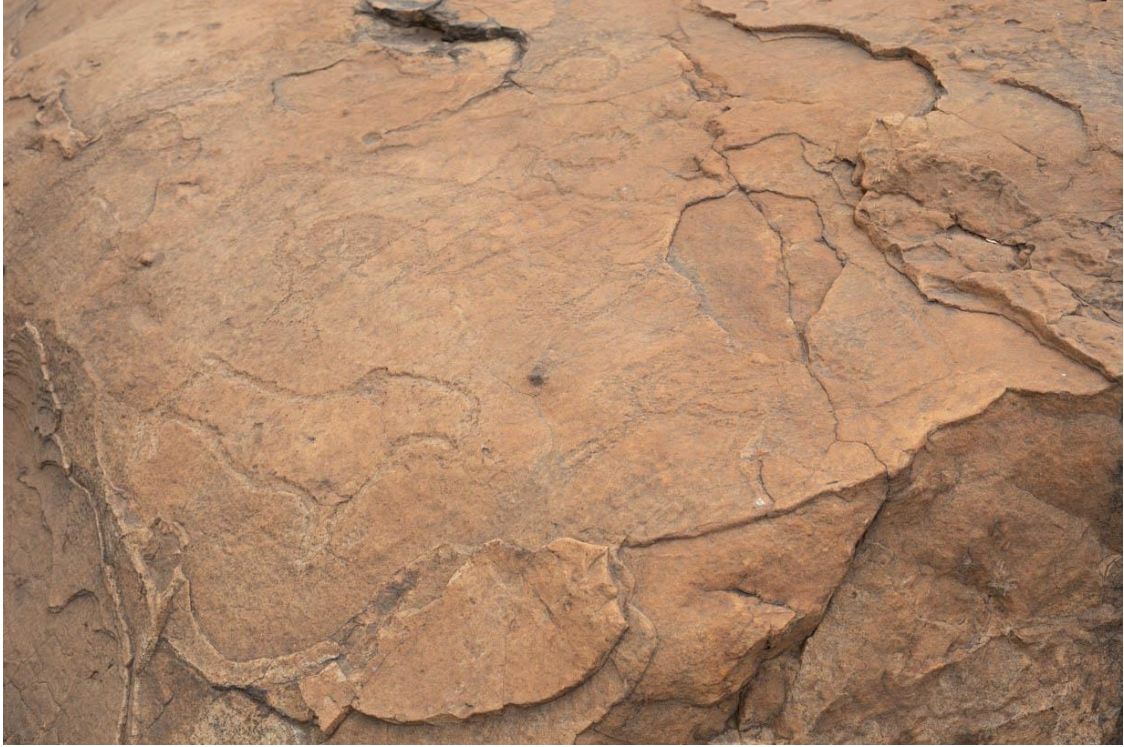
Figure 8. Possible engraving of a lion (bottom left of picture) alongside geometric designs. Rock C

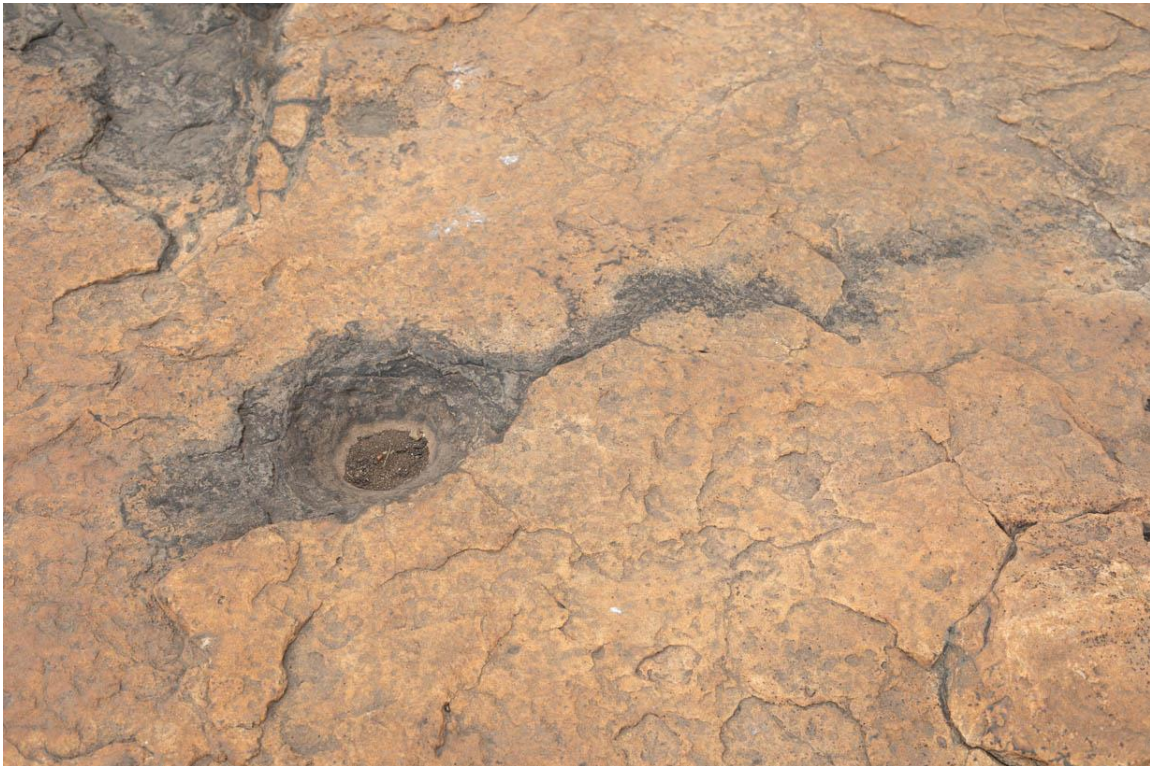
Figure 9. One of the cupules (small cavities) hollowed out by people. The dark colour of the cupule and the water trail could be staining from mineral deposits. Rock K

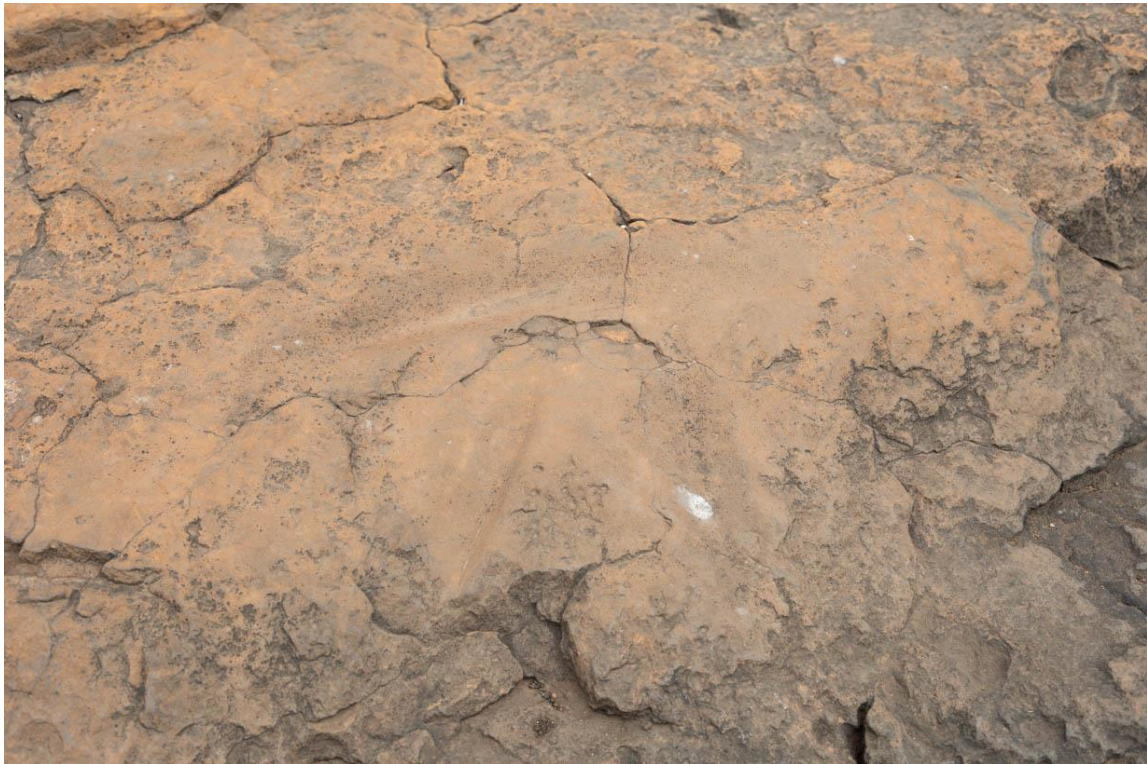
Figure 10. The rock has been smoothed friction caused by people rubbing the rock. Here people made shallow grooves by rubbing the rock with unknown objects (perhaps stone). Rock K

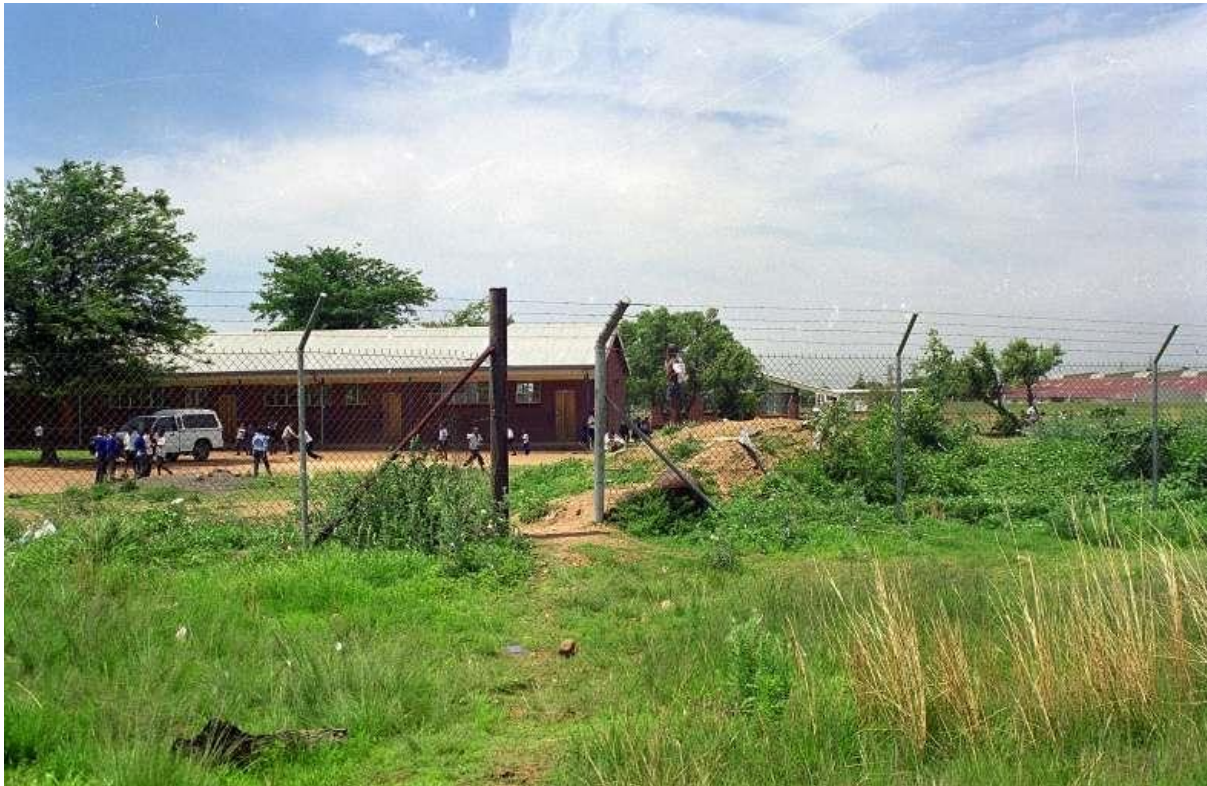
*Figure 12. This gateway at the Springfield Junior Secondary School was used to access the site in the past.
Photo credit: African Rock Art Digital Archive RSA-RED1-55P*
