## **1st Phase**

**Cultural Heritage Resources Impact Assessment for proposed rapid bus service, Paul Kruger Street, Pretoria, Tshwane.**

**June 2011**

**Report compiled by Sidney Miller and Dr. Udo S. Küsel.**

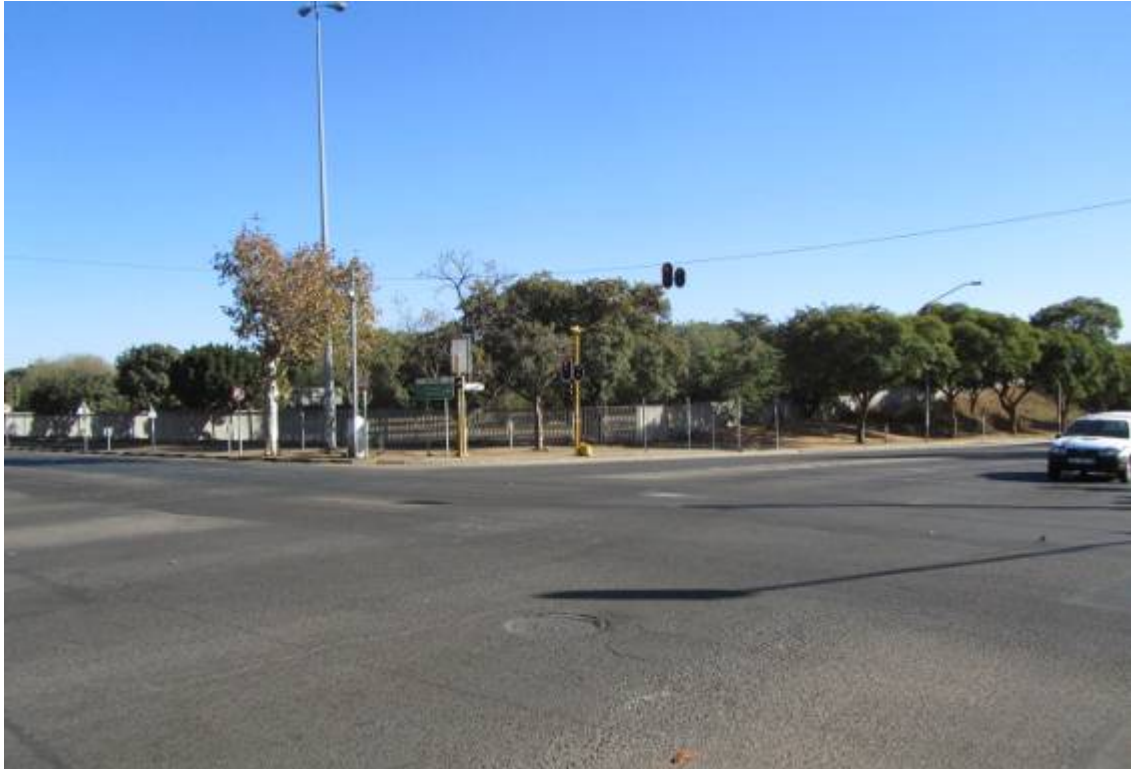
**Figure 24.** *Open land on northwest corner of Boom and Paul Kruger Street. (P805)*

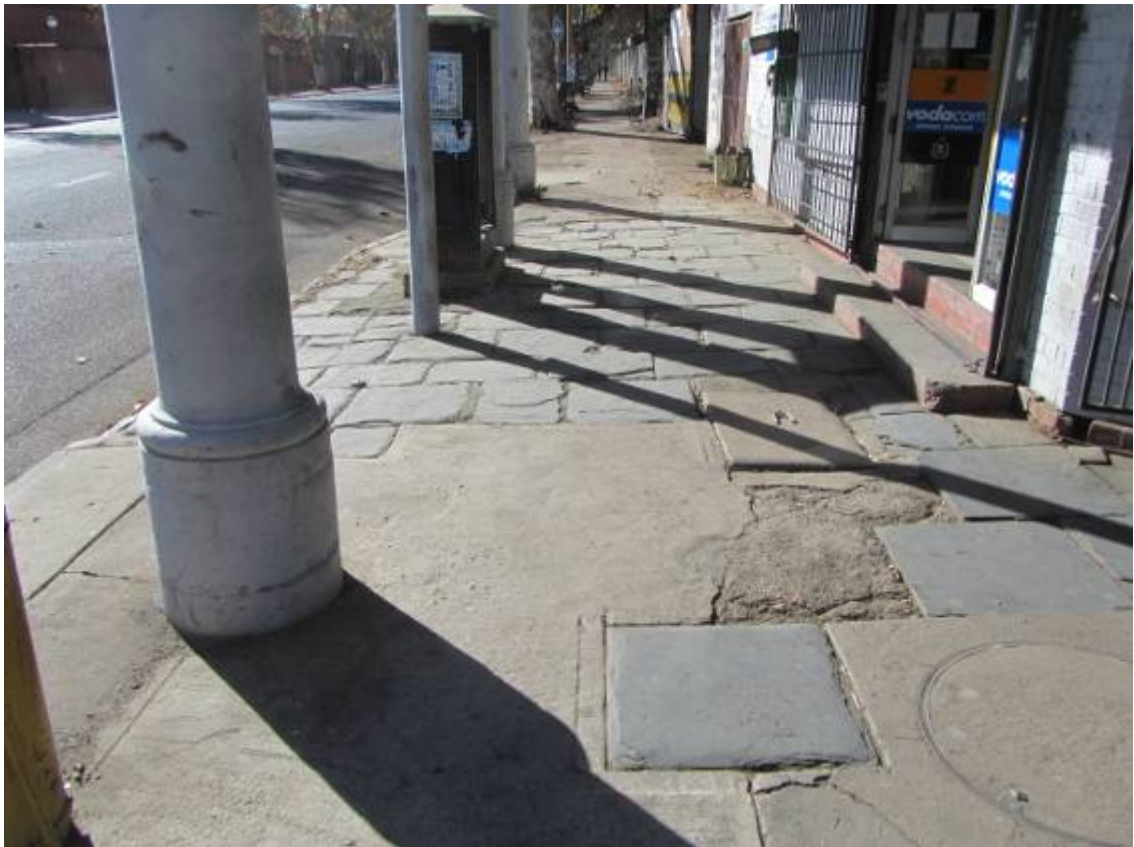
**Figure 29.** Historical slate sidewalk in front of 'protected building'. Granite curb stones, and pillars. (P802) Note services access.

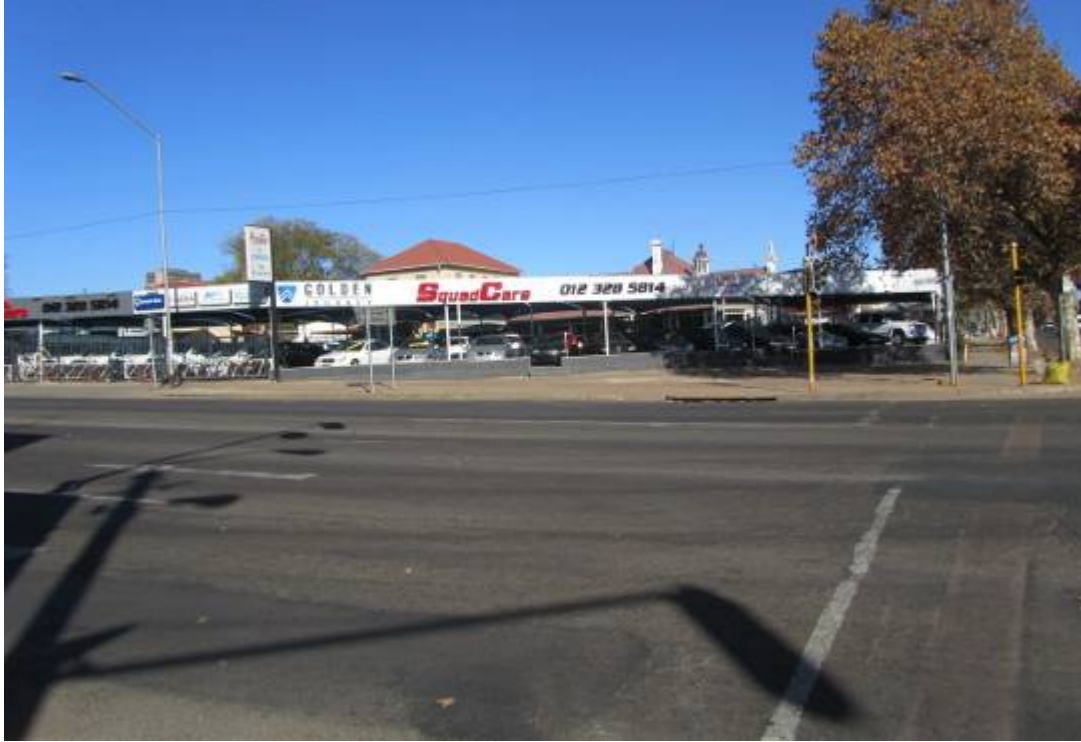
**Figure 31.** ‘Protected building’ behind car sales advertising headband. Possible ‘station’ terminus for busses in front of and including historic building. (P804). Note absence of greening.

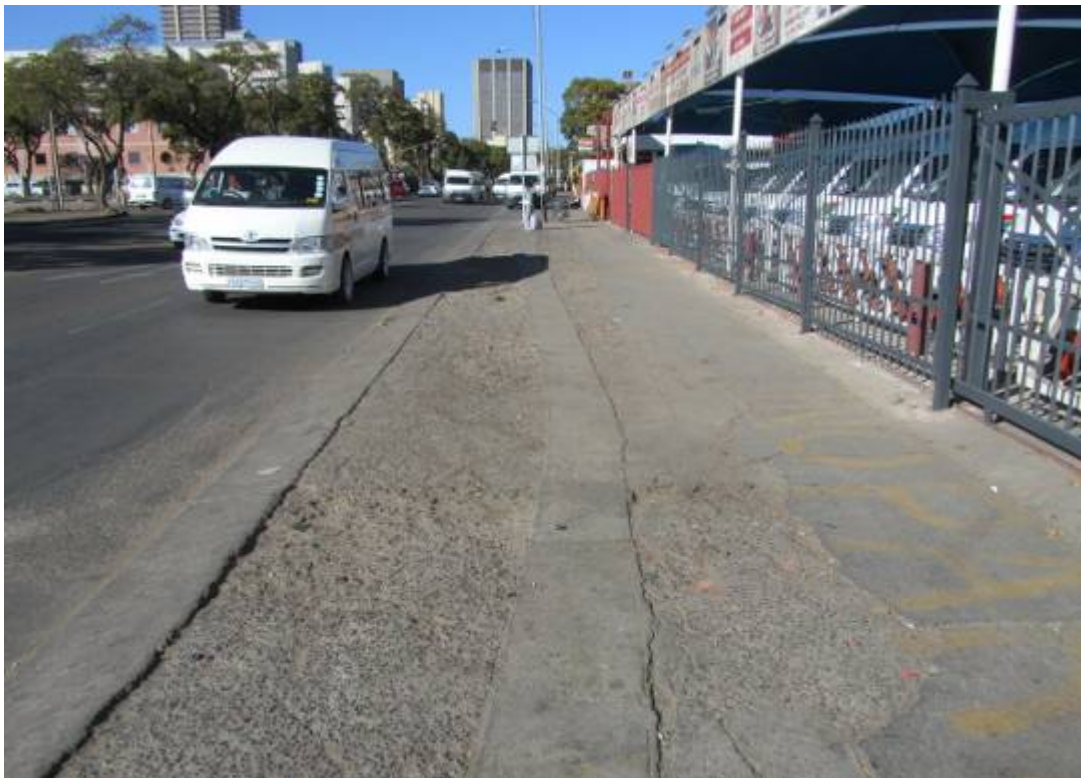
**Figure 36.** Modern sidewalk in front of ‘protected building’ (P811). As a ‘portal’ to the city this is most unsatisfactory.

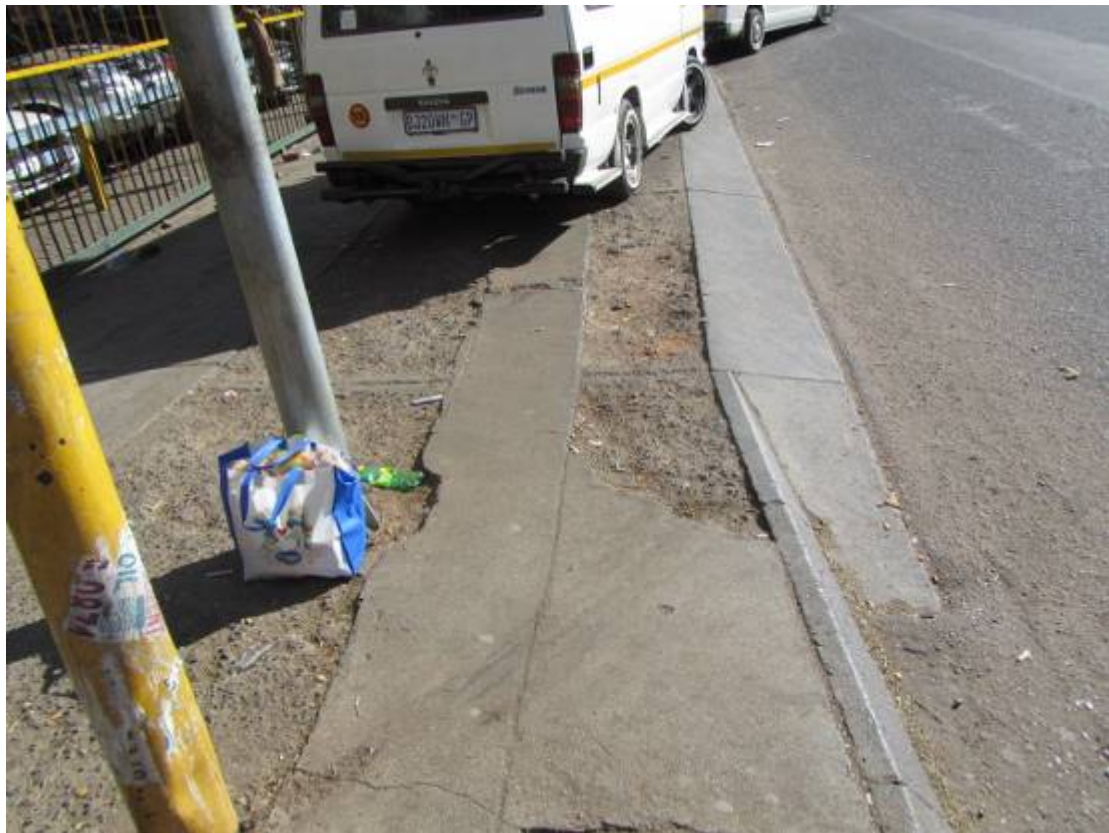
*Figure 38. Modern sidewalk and curbing. (P813)*

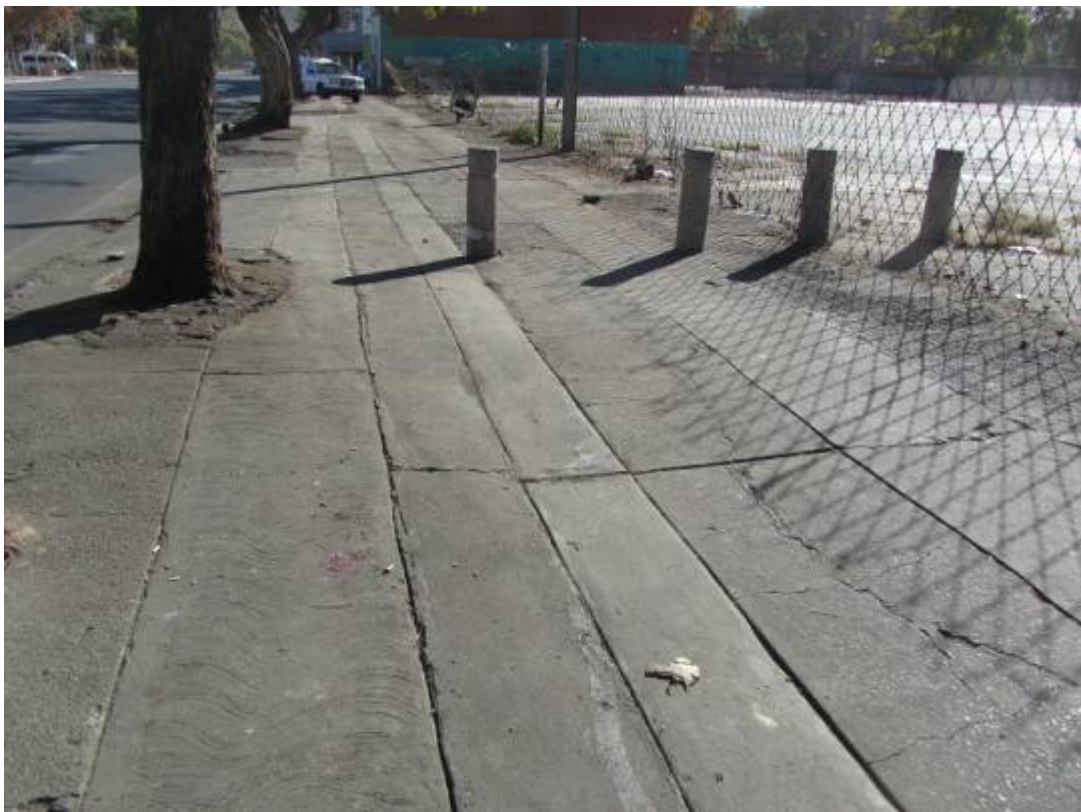
**Figure 41.** *Modern sidewalk. Services issue apparent. (P818)*

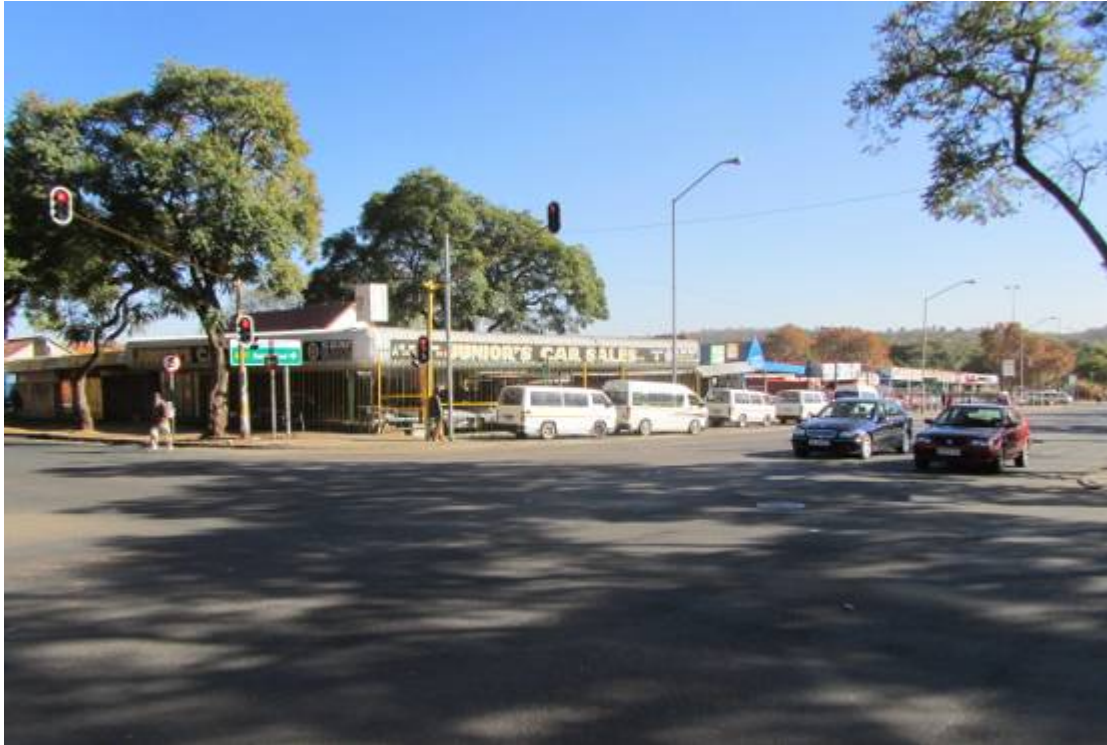
**Figure 42.** ‘Protected building’ in background although blanked out by car dealer advertising headboard. **NOTE LACK OF TREES.** (P823) Note line of taxis even early on a Sunday morning.

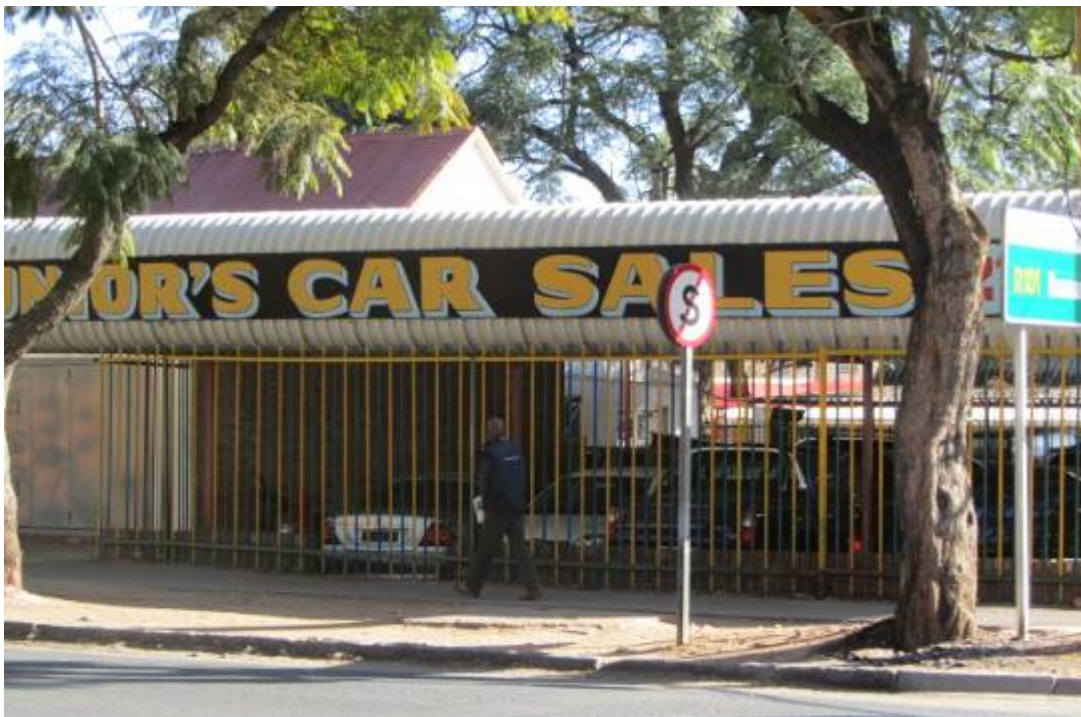
**Figure 43.** ‘Protected building’ in background although blanked out by car dealer advertising headboard. (P824)

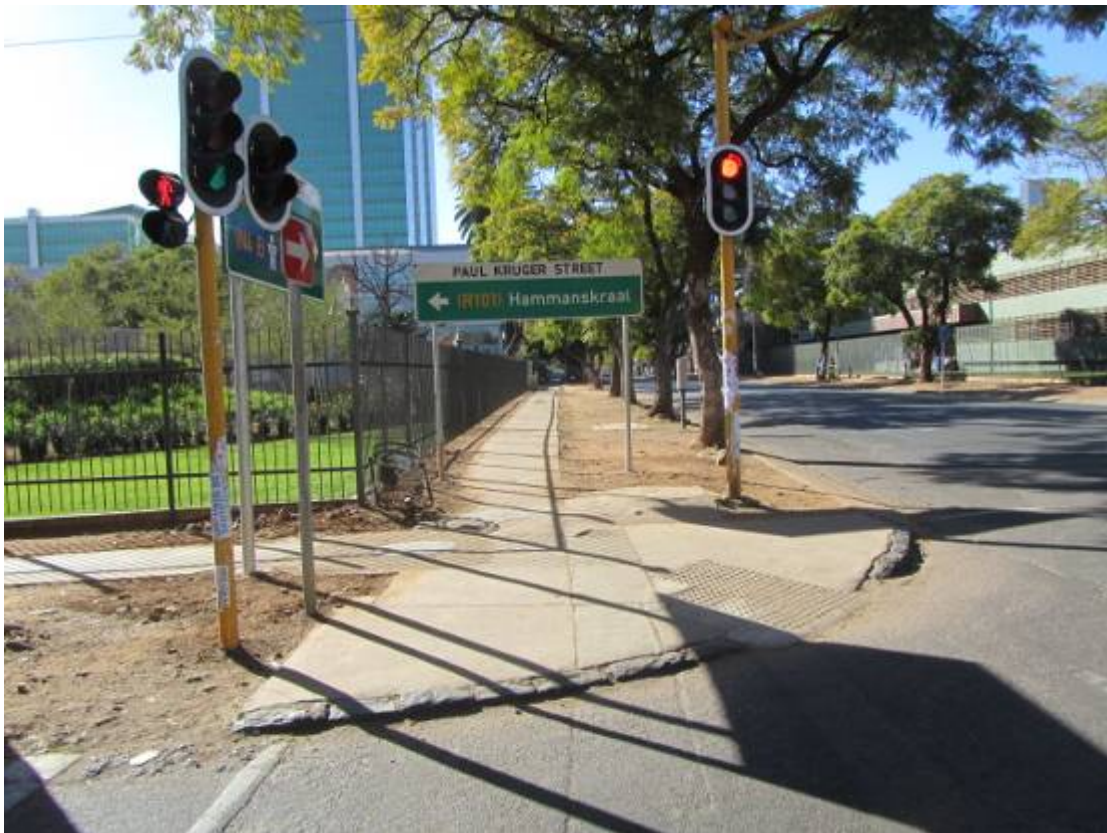
**Figure 60.** Granite curbing can and was adapted at street corners to accommodate disadvantaged people. (P 835)

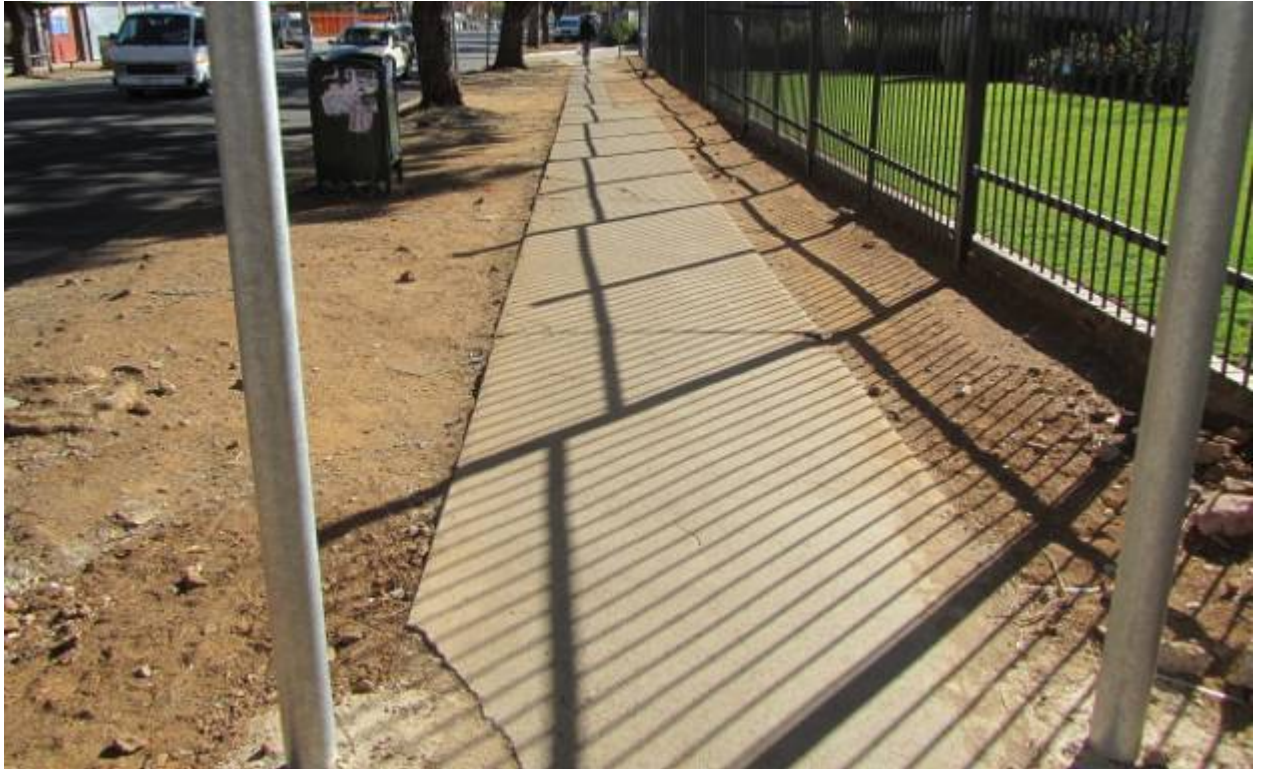
*Figure 61. Modern strip concrete paving bordered with bare earth. Granite curbing still demarcates original dimensions. The modern building to the right has a well defined green landscape that is a feature that may be incorporated in the new design. (P 837)*

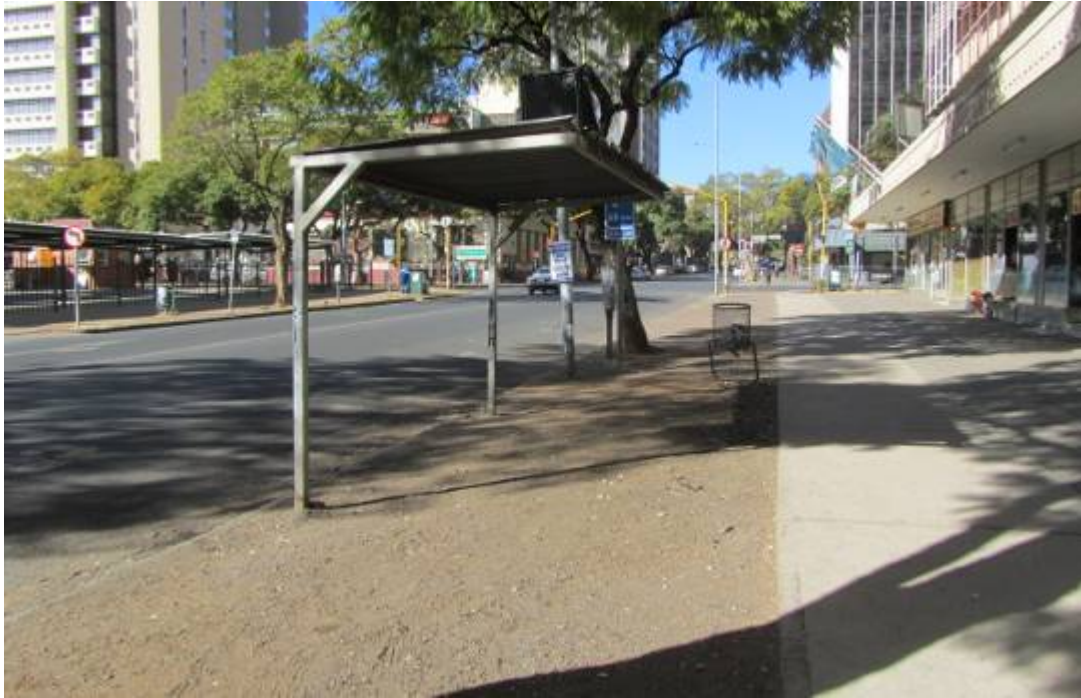
**Figure 76.** ‘. Strip concrete and bare earth sidewalk. Street furniture is endangered by illegal parking on sidewalks. Note fresh tire tracks on earth section. Note the extra set-off of this ‘modern’ building, widening an already wide sidewalk. (P 861).

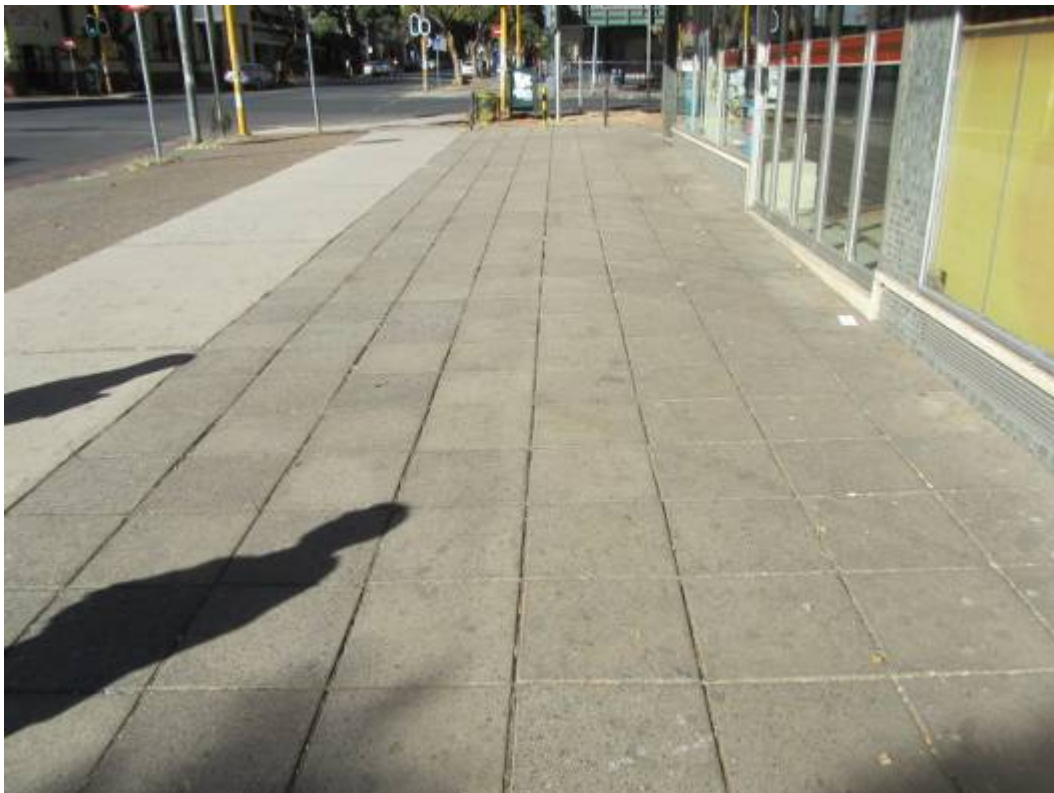
**Figure 77.** Strip concrete and bare earth sidewalk complemented with mid to later twentieth century square paving blocks. These paving blocks are practical and may be successfully re-applied in other areas. (P 863)

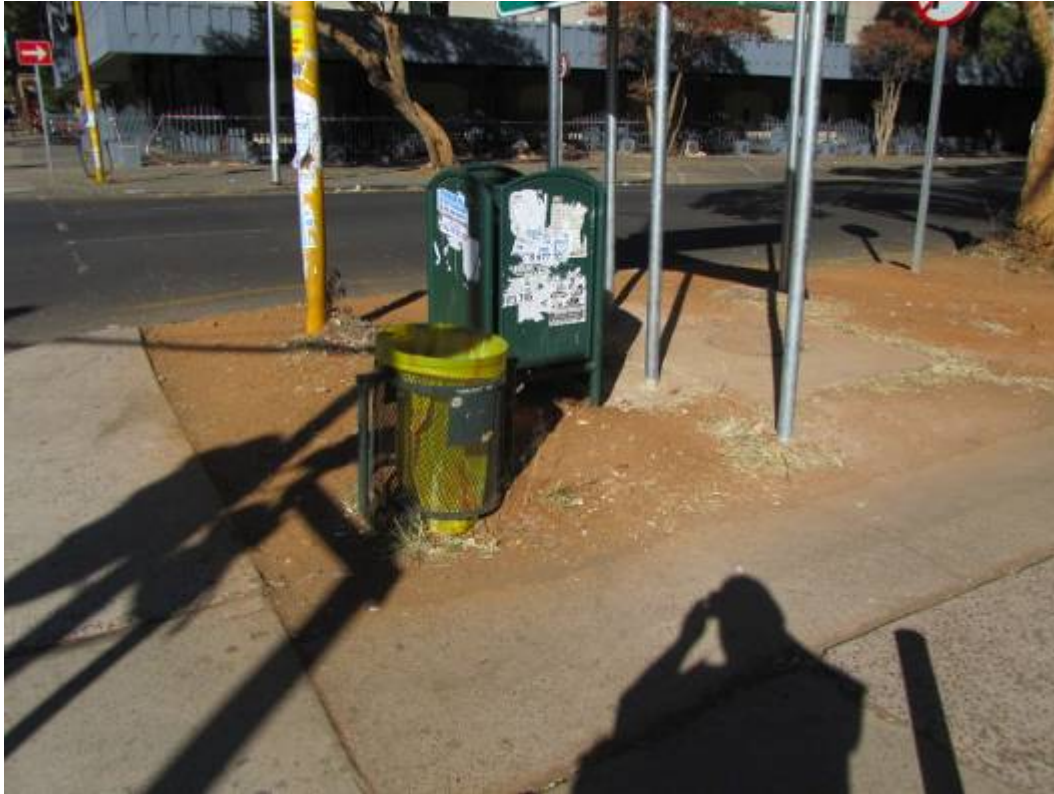
*Figure 78. A rather unsightly jumble of street furniture signage and services access points. The incessant occurrence of illegal and vulgar advertisements on street furniture do not enhance the stature of Tshwane's Capital. (P 864)*

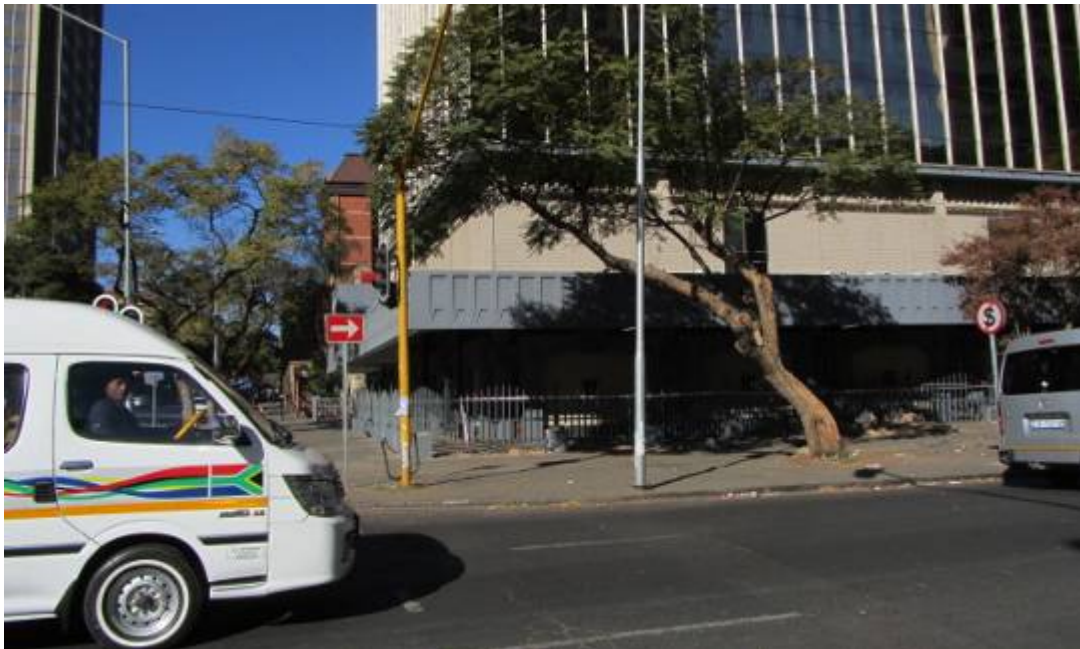
*Figure 79. Modern 'Provisionally protected building'. Although structurally protected by law the need for unsightly devils-fork fencing on the sidewalk tells another story. (P 865).*

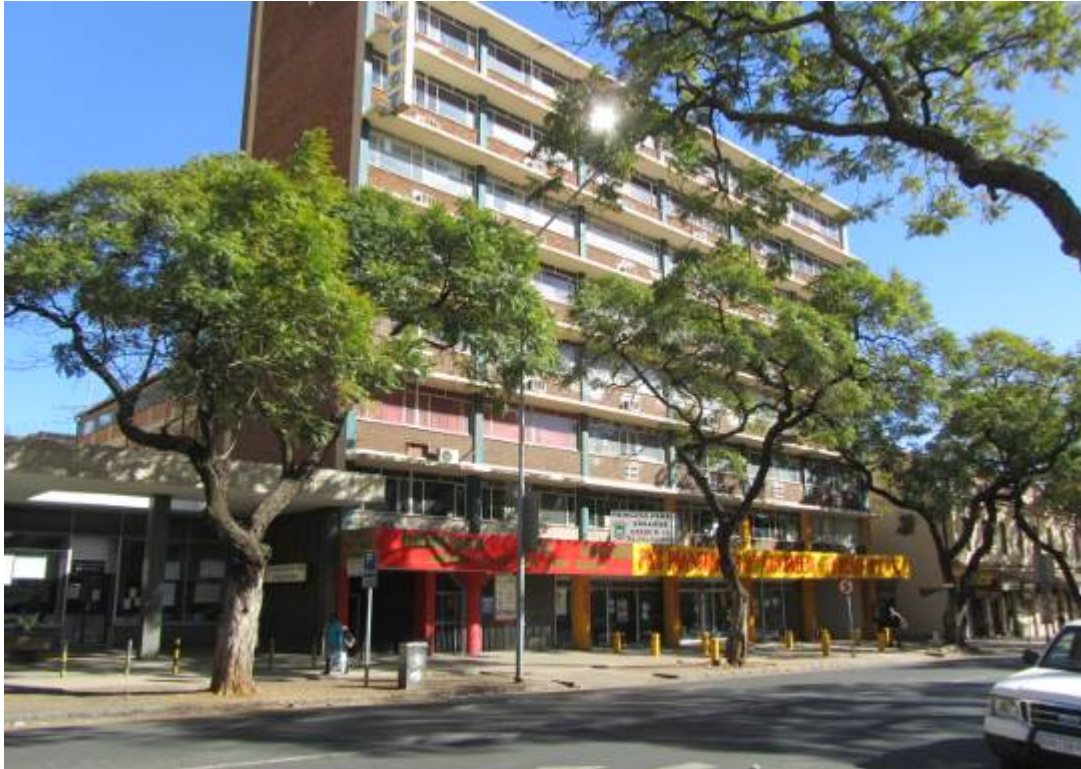
*Figure 90. The issue related to the 60 year rule for ‘Protected buildings’ is again demonstrated by this 1960’s complex. Although a good example of the period it is not protected against demolition. . (P 877).*

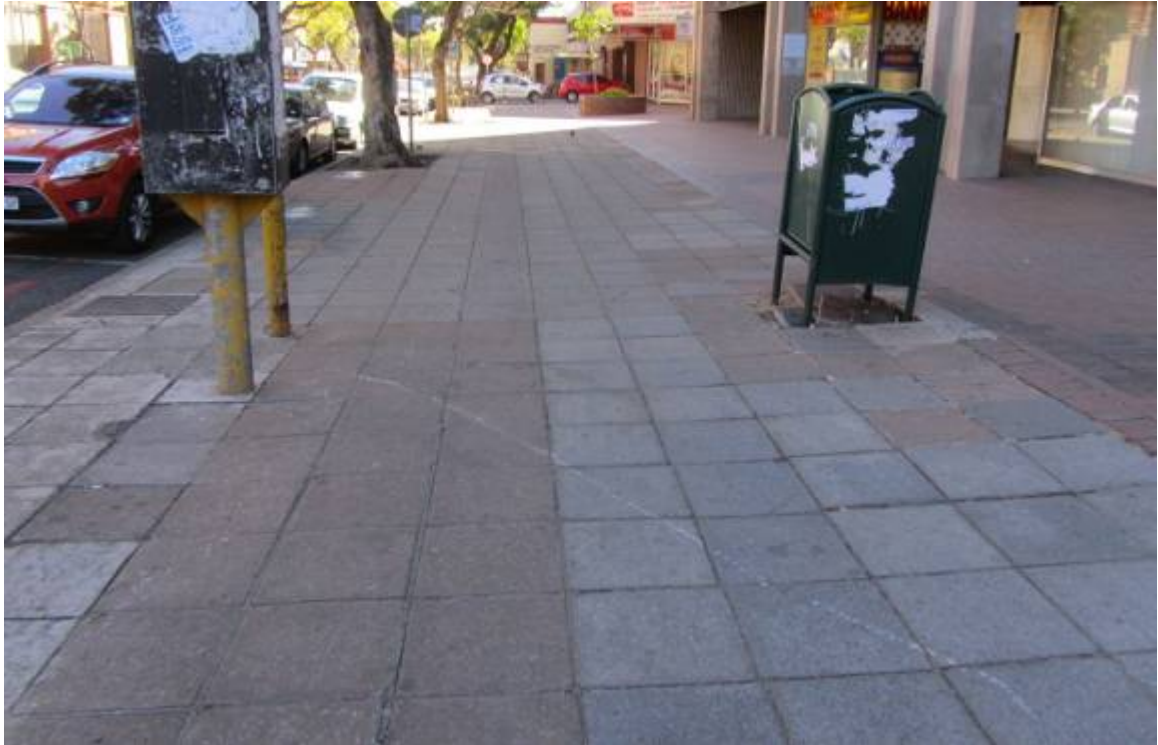
**Figure 112.** *‘The concrete block here demonstrates its adaptability to accommodate services. In the long term it will be preferred if the blocks are standardized (P 911).*

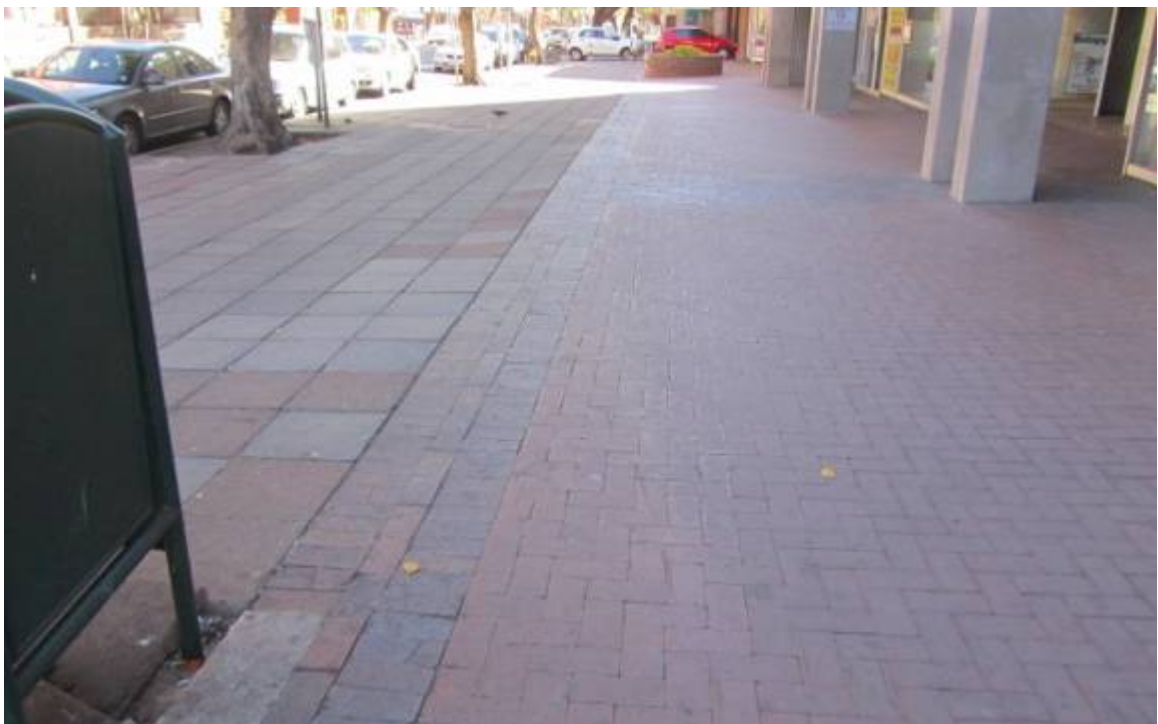
**Figure 113.** *The issue of land ownership and council ownership is illustrated by this ‘new’ paving with a ‘modern’ building.’ Provisionally protected building’. (P 912).*

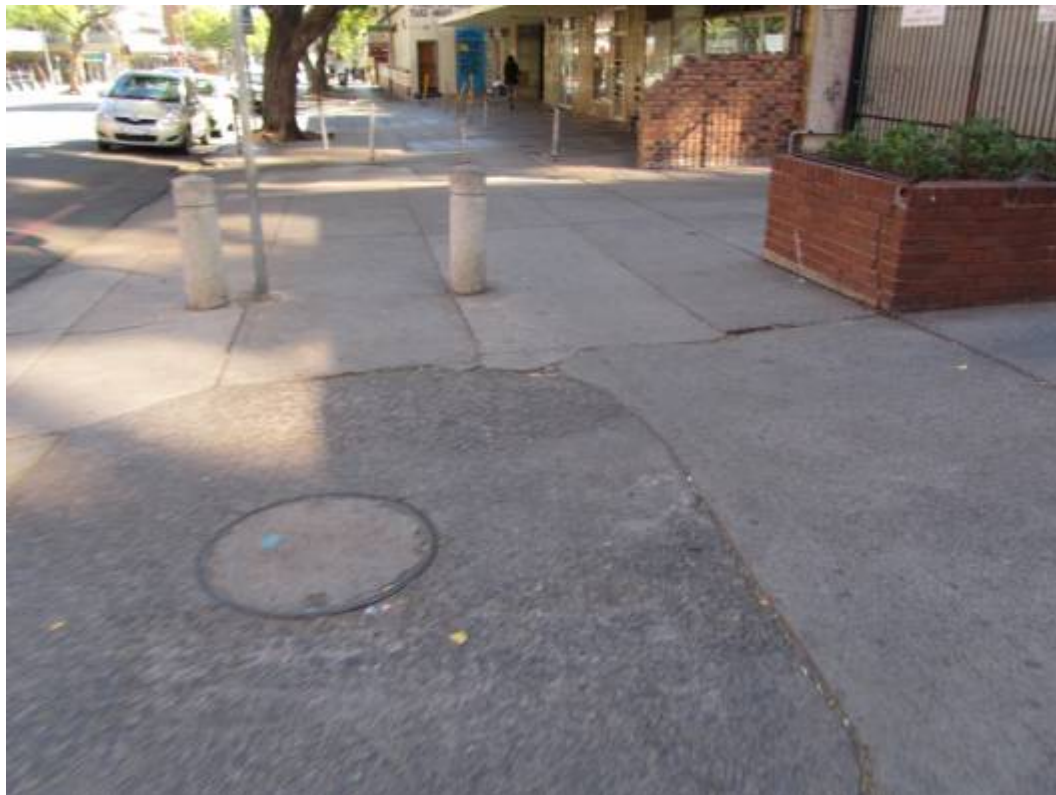
*Figure 118. 'Concrete strip interruption in cement block paving. (P 917).*

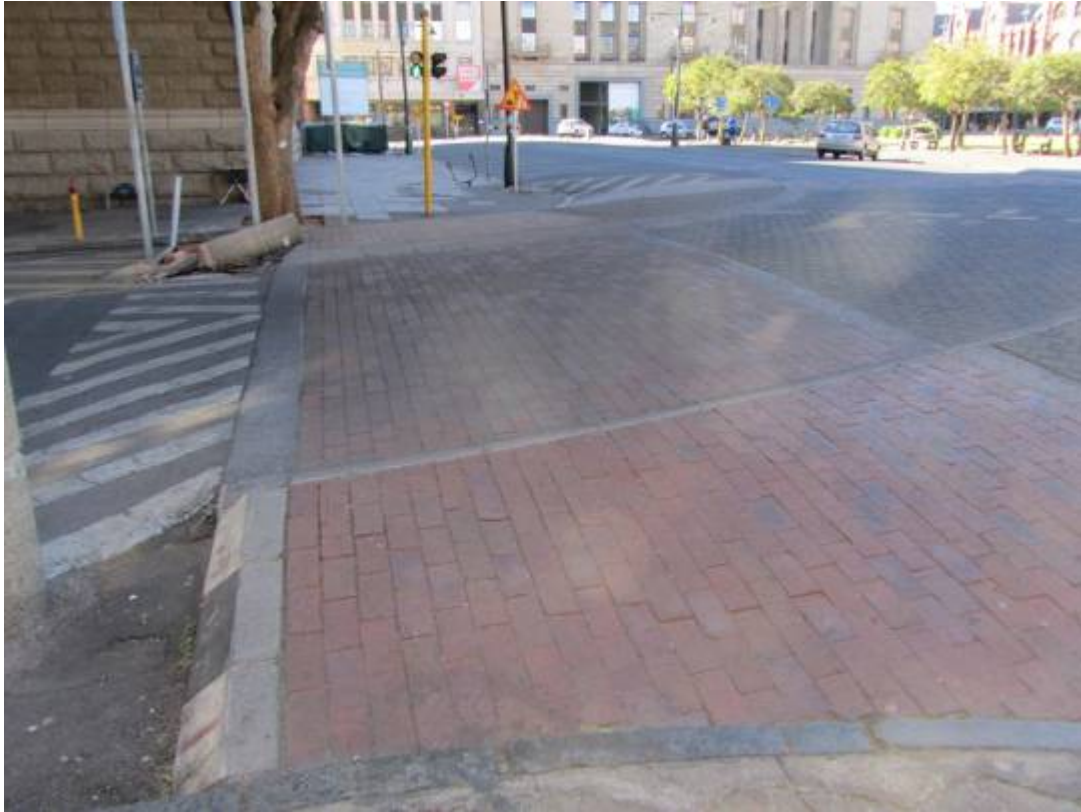
**Figure 133.** Modern traffic calming structure. (P 936).

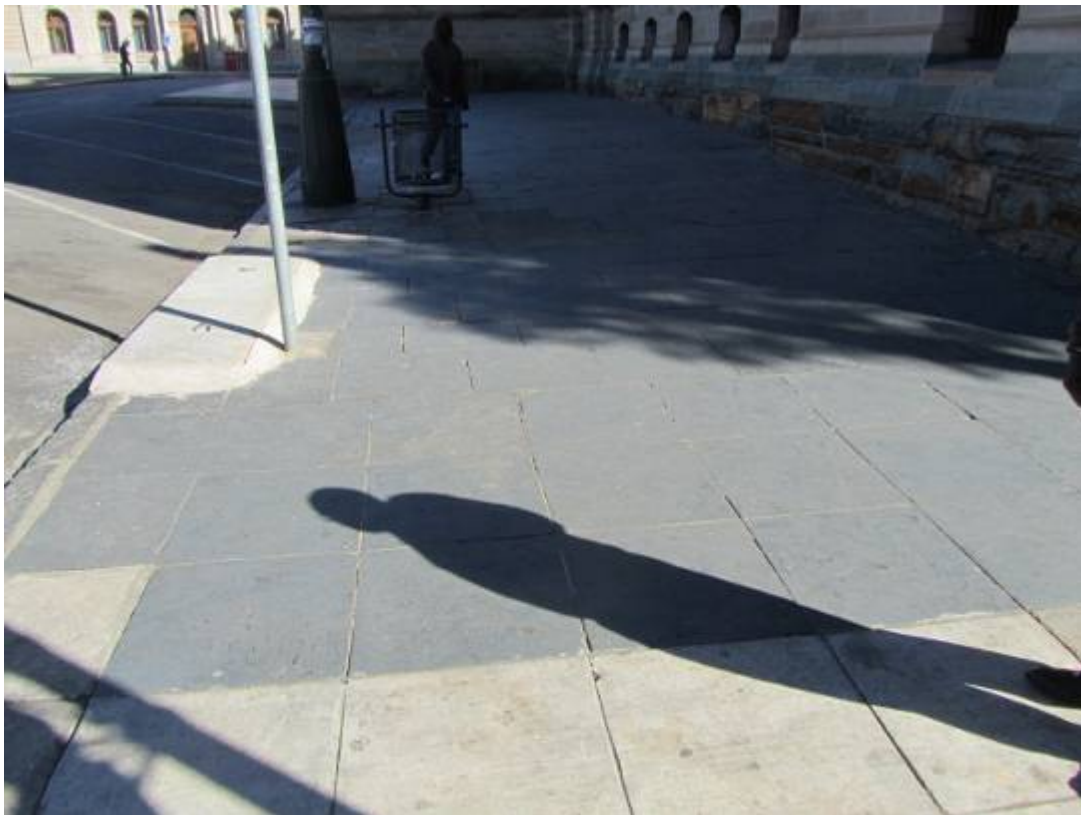
**Figure 134.** Historical slate paving adjacent to historical building. Note roadway definition with steps of historical building. (P 942).

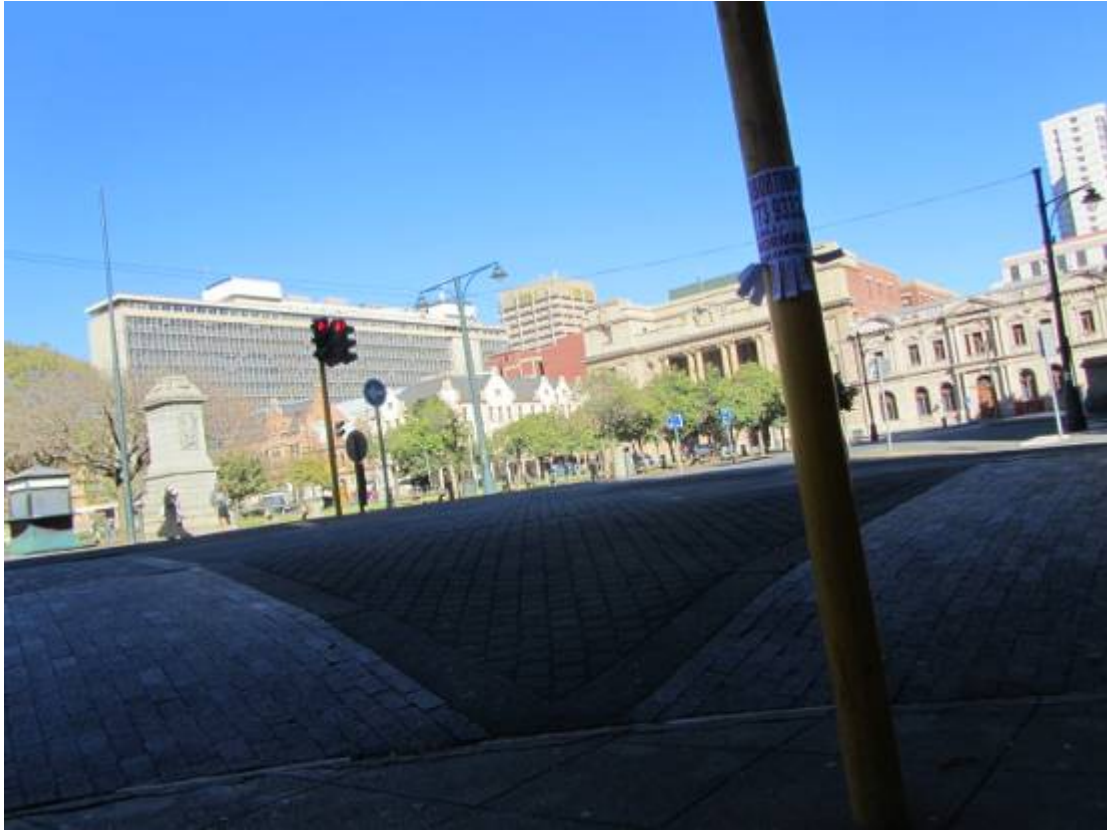
*Figure 137. Modern traffic calming structure. Note immense build-up of road surface This may be attributed to the tram lines that is suspected to be still in place. (P 945).*

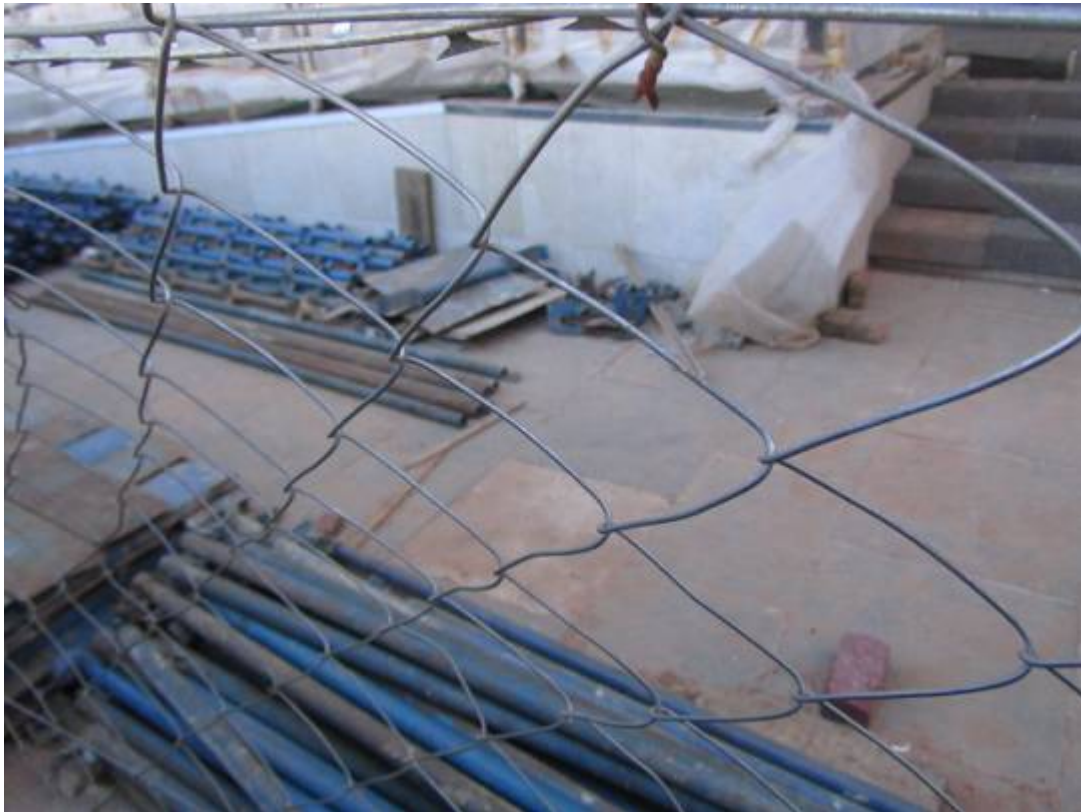
**Figure 147.** Construction work at historical building. (P 950).

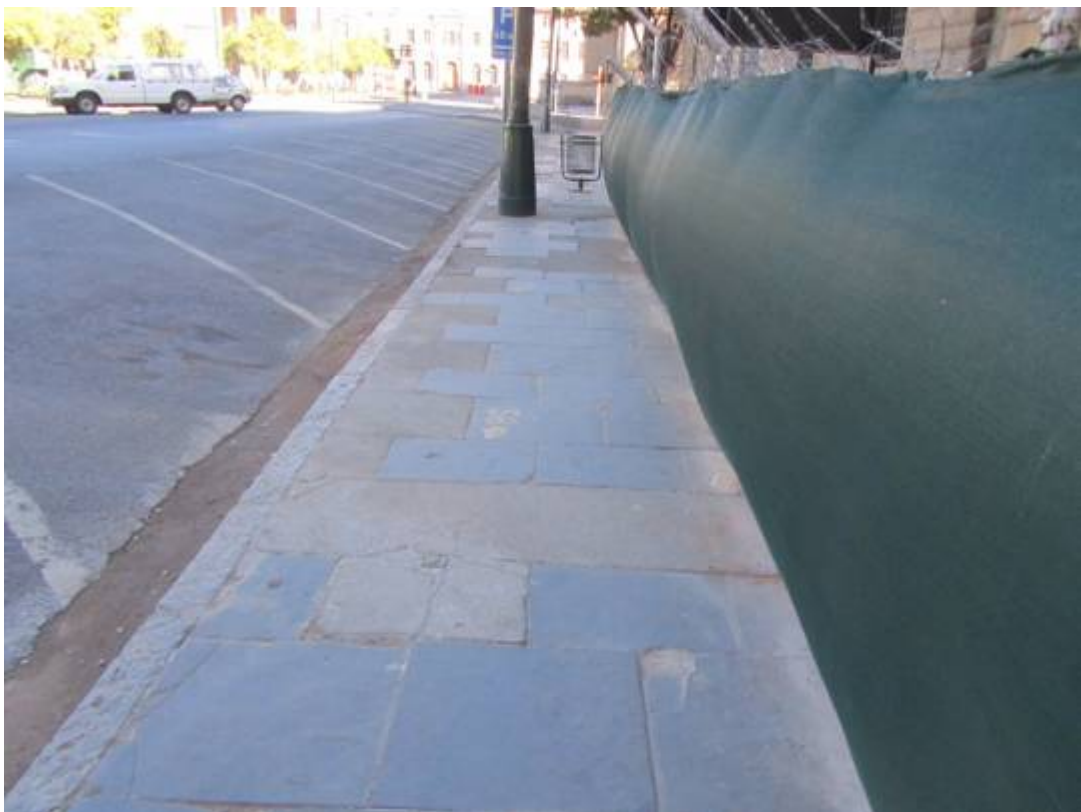
**Figure 148.** Original slate paving adjacent to historical building Construction in progress without protection. (P 951).

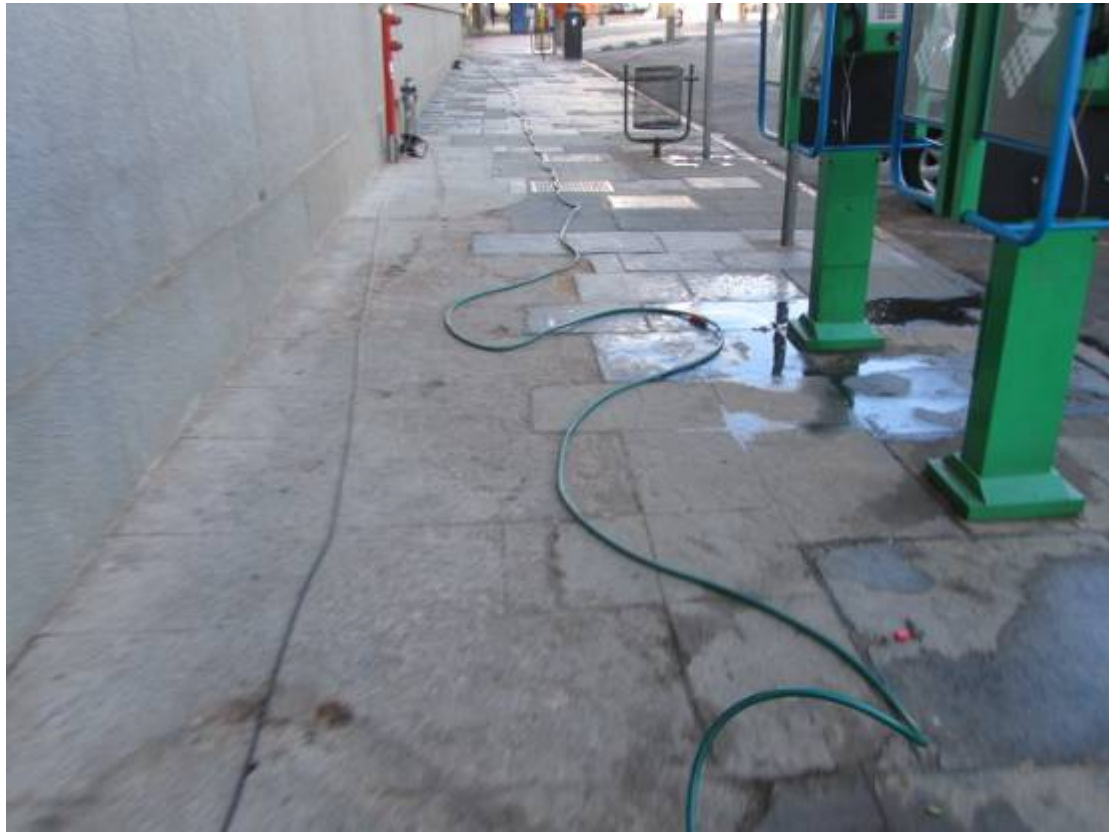
*Figure 155. Cement paving adjacent to historical building. (P 958).*

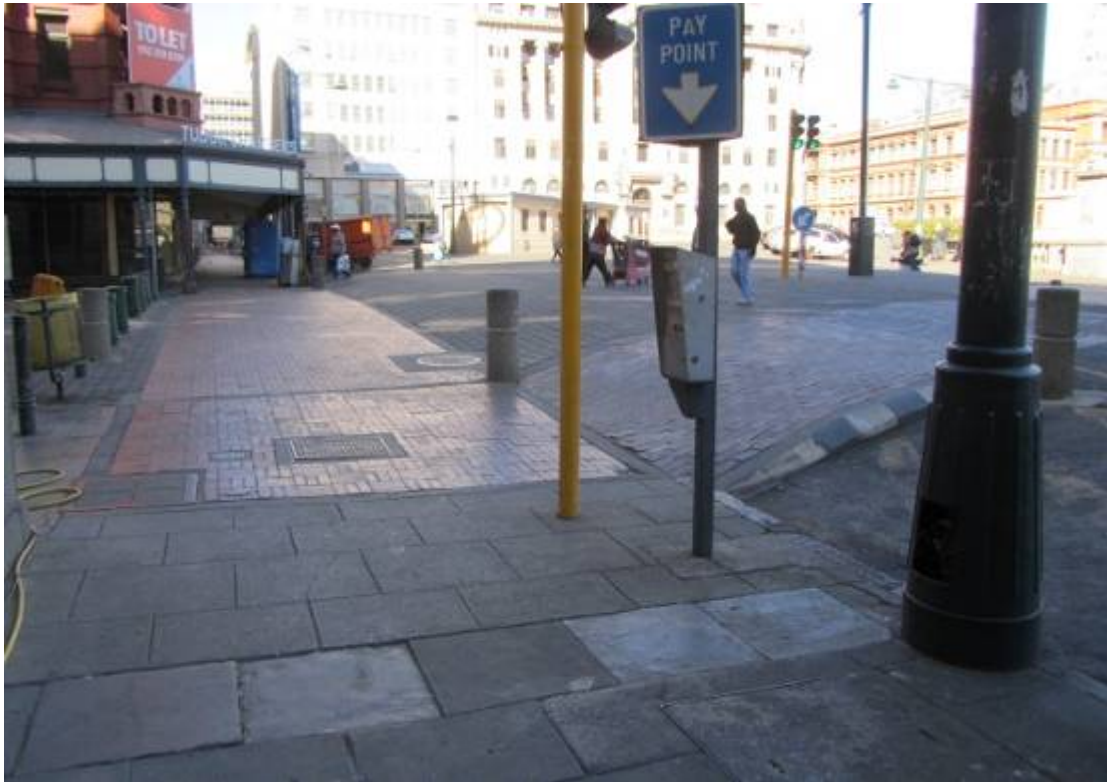
*Figure 157. Mixed old and new paving at Church Street pedestrian boulevard. Note marked difference in road level. (P 960).*
