## **1st Phase**

**Cultural Heritage Resources Impact Assessment for proposed rapid bus service, Paul Kruger Street, Pretoria, Tshwane.**

**June 2011**

**Report compiled by Sidney Miller and Dr. Udo S. Küsel.**

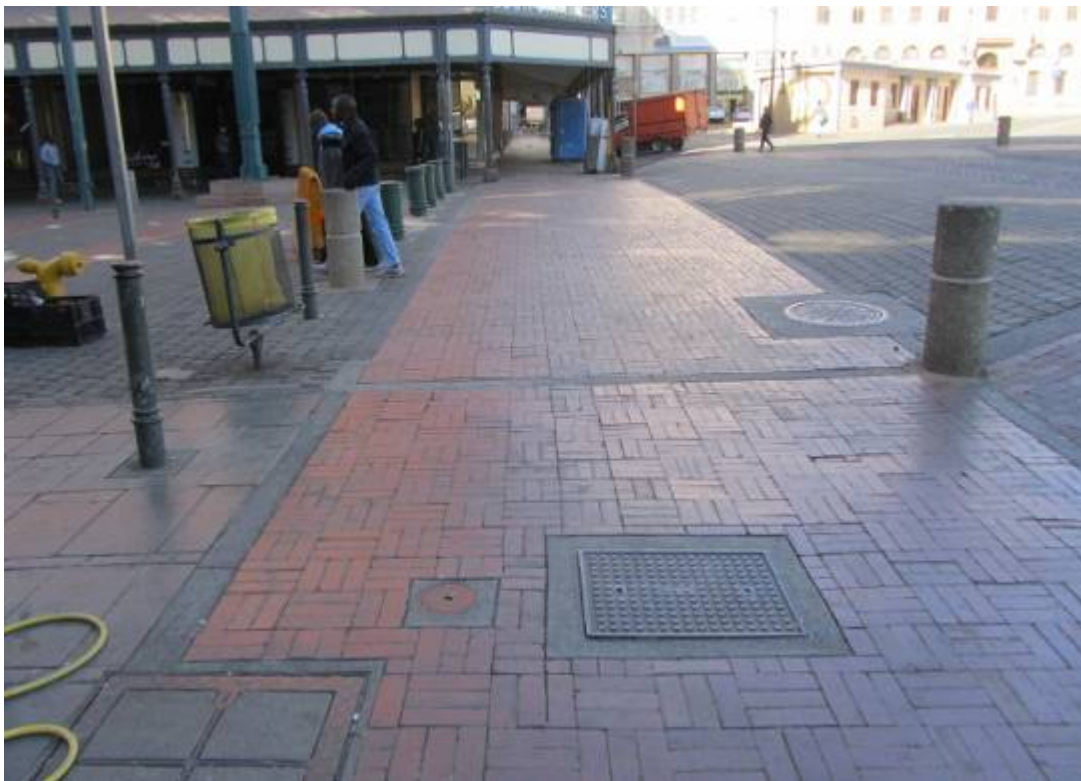
*Figure 158. Mixed new paving at Church Street pedestrian boulevard. Note marked difference in road level. Service access-covers well blended as features rather than eye-sore. . (P 961)*

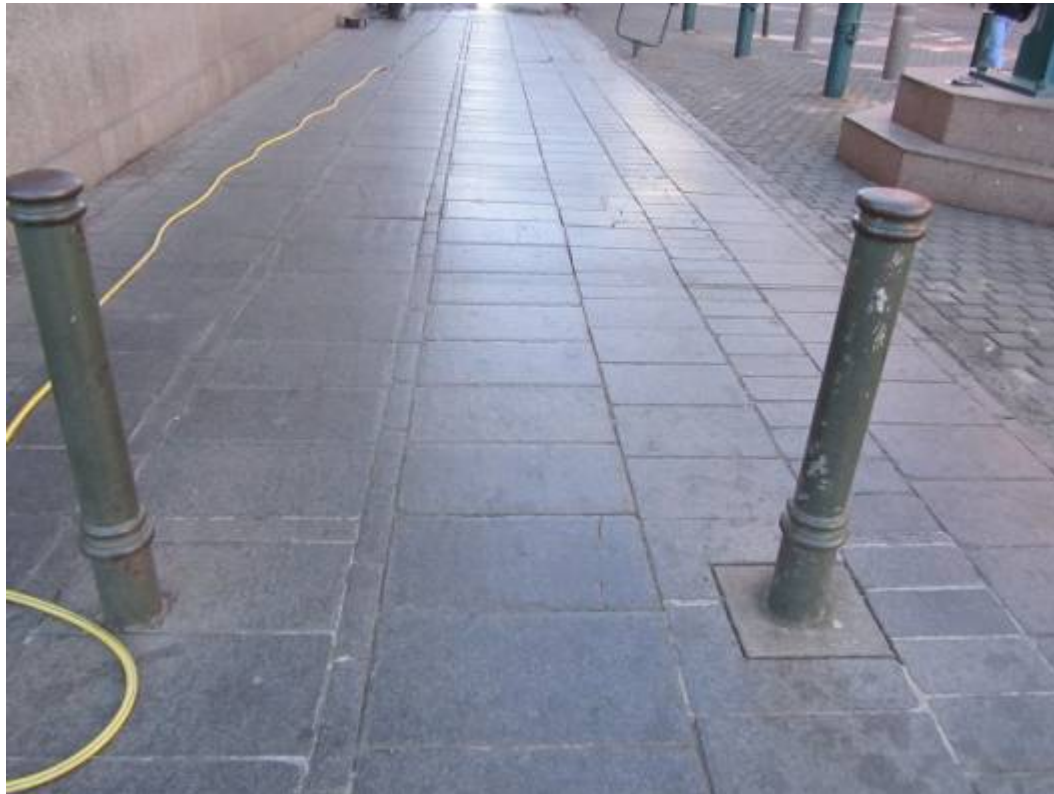
*Figure 159. The refurbished paving in the Church Street Boulevard is excellent and may well become the type pattern for the present project. (P 962).*

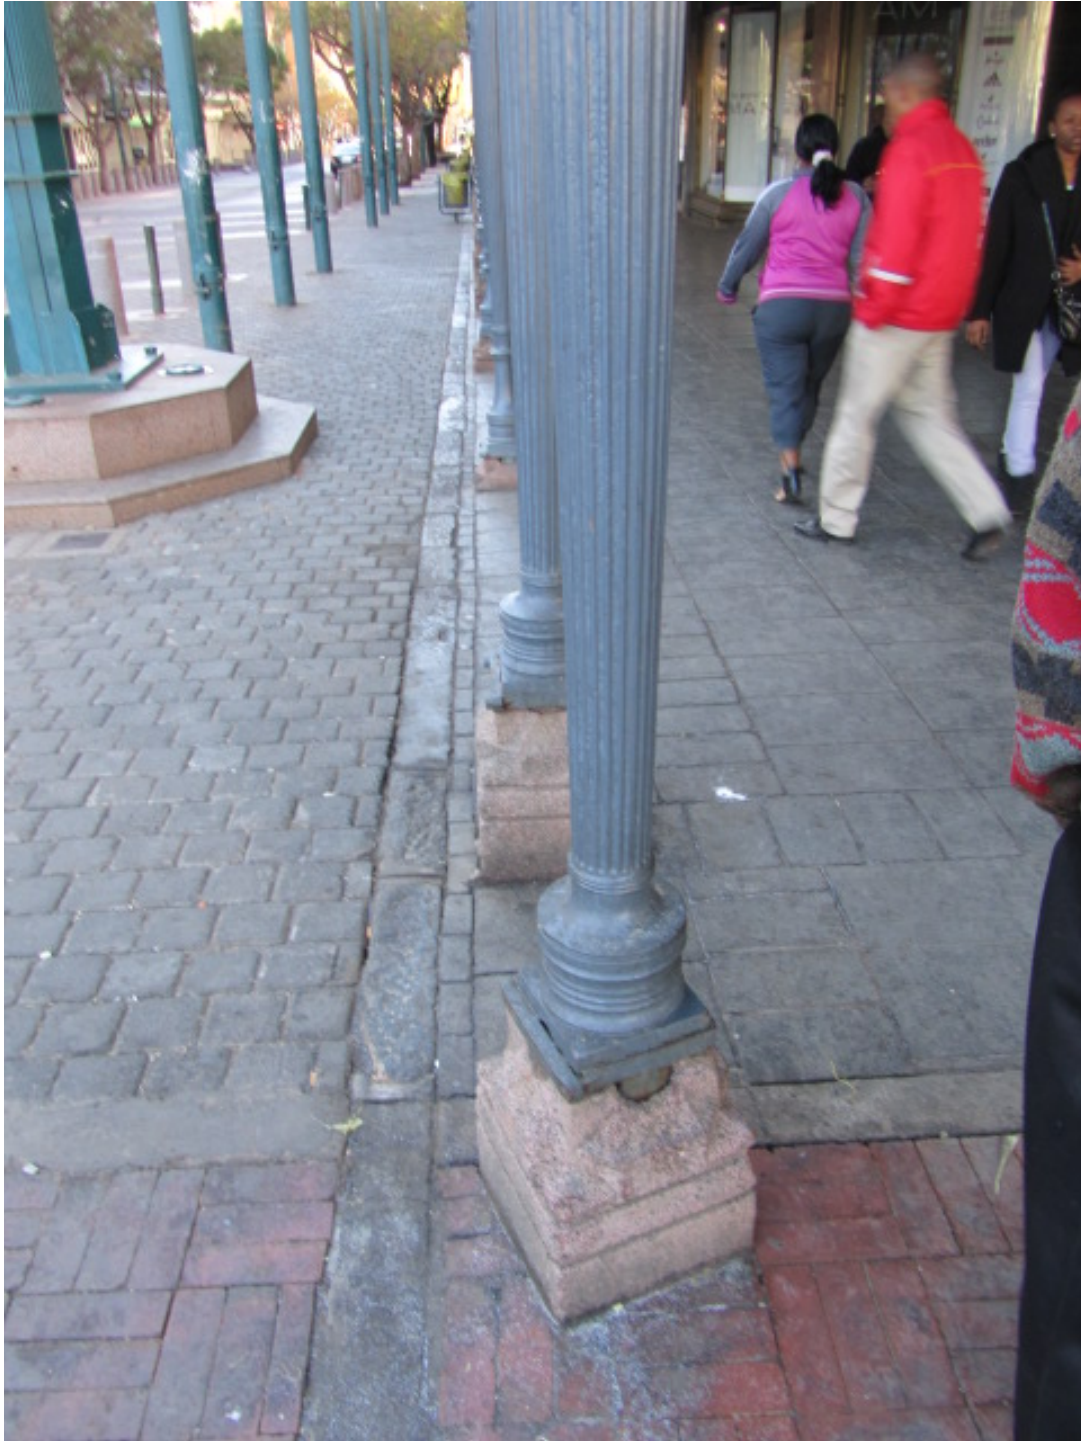
*Figure 161. The refurbished paving in the Church Street Boulevard is excellent. Note the retention of the original granite curbing stones as the 'memory' from the past. (P 964).*

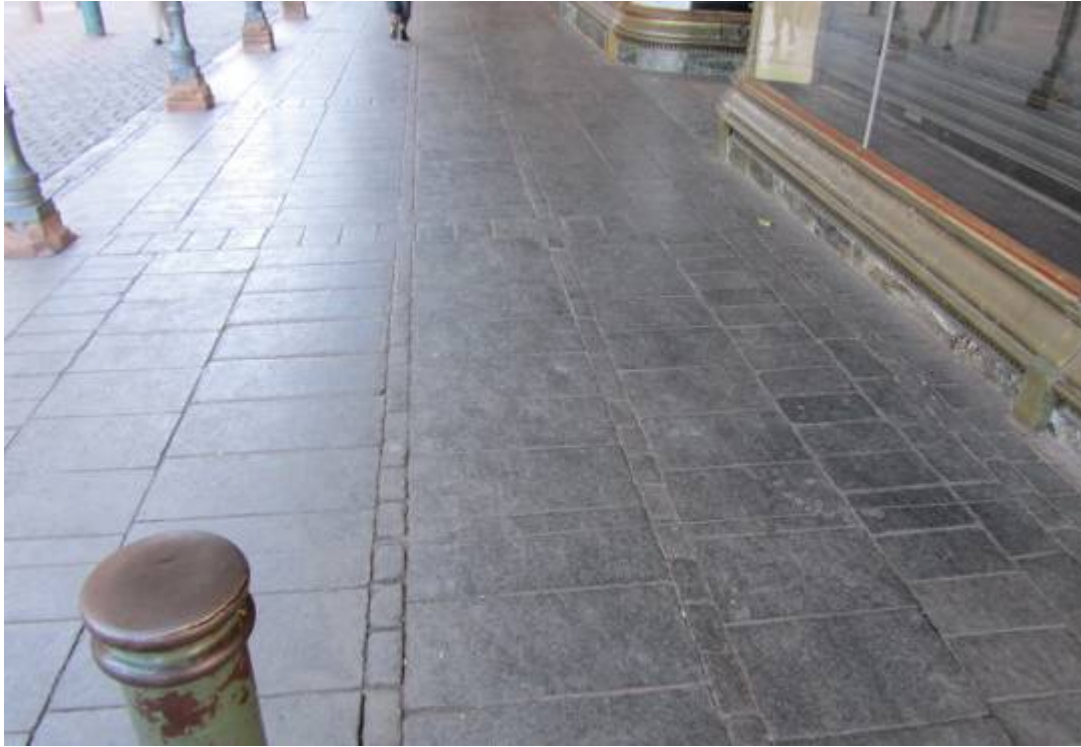
**Figure 162.** *The refurbished paving in the Church Street Boulevard is excellent. Note the fact that the Sidewalk and roadway now interface on the same level forming a far better aesthetical design. (P 965).*

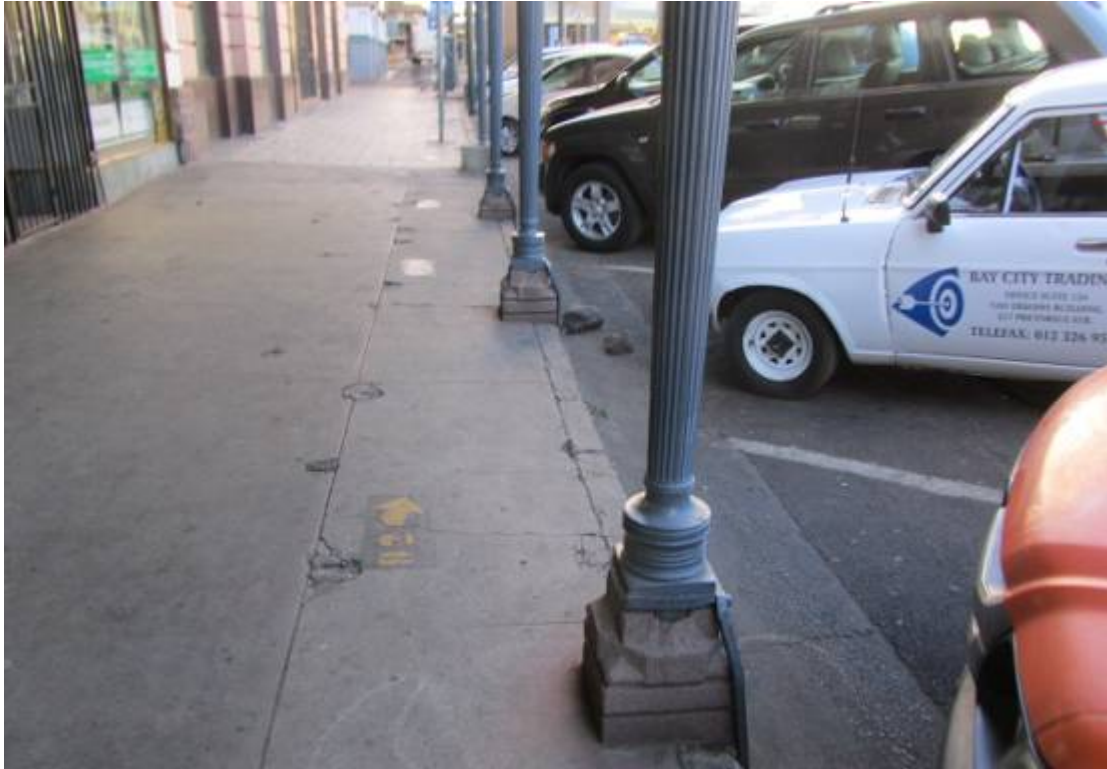
**Figure 164.** As mentioned in earlier documentation blocks, historical building's columns to support the canopy were mostly located on the street line as demonstrated here. (P 967).

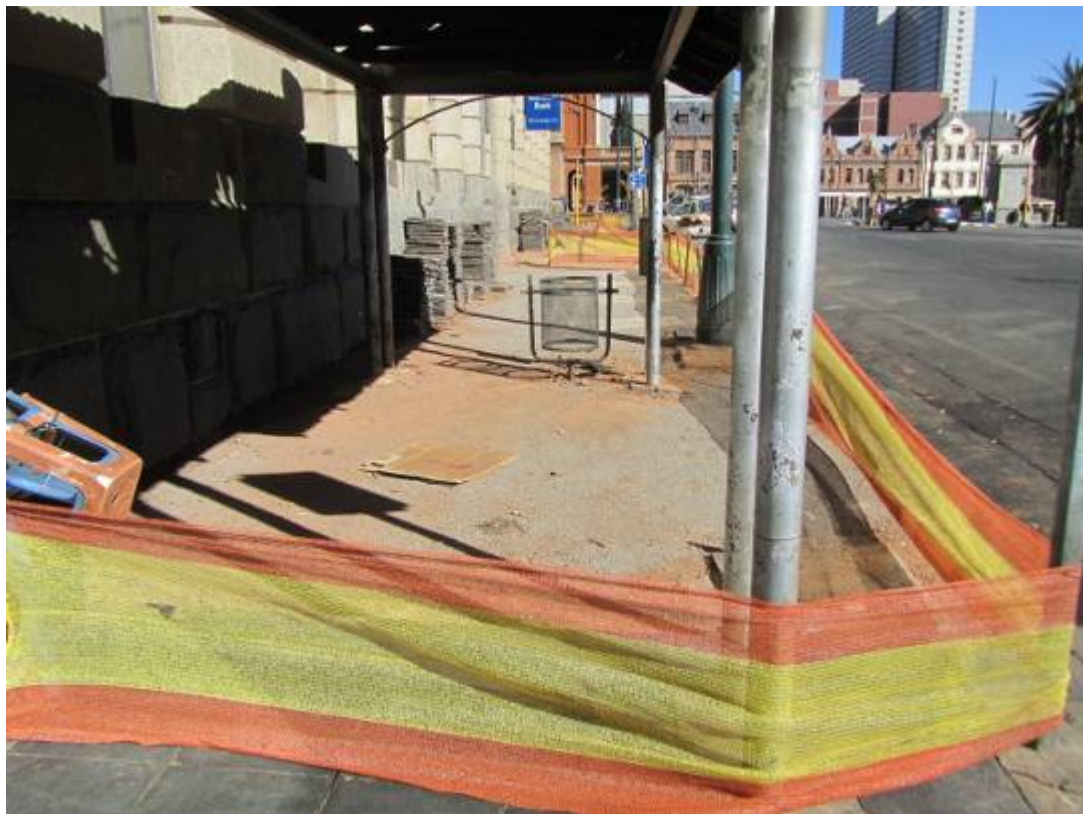
**Figure 173.** Slate paving in front of historical building being lifted. (P 976).

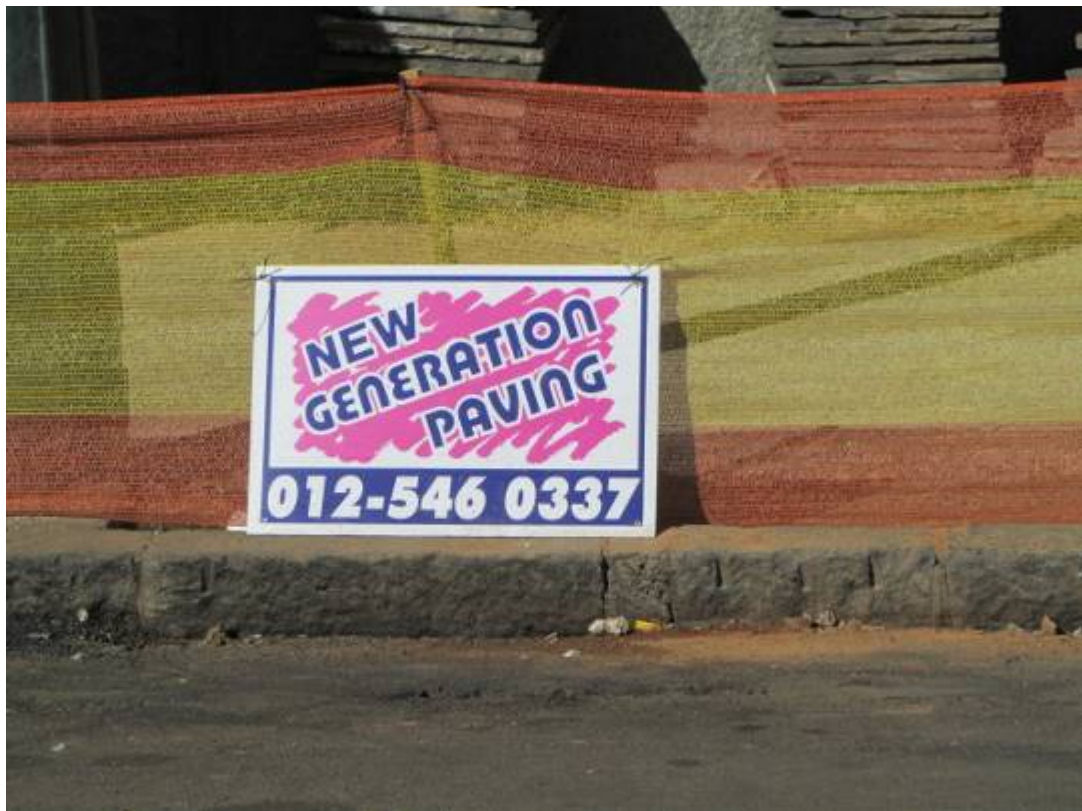
*Figure 177. Slate paving in front of historical building being lifted. (P 980).*

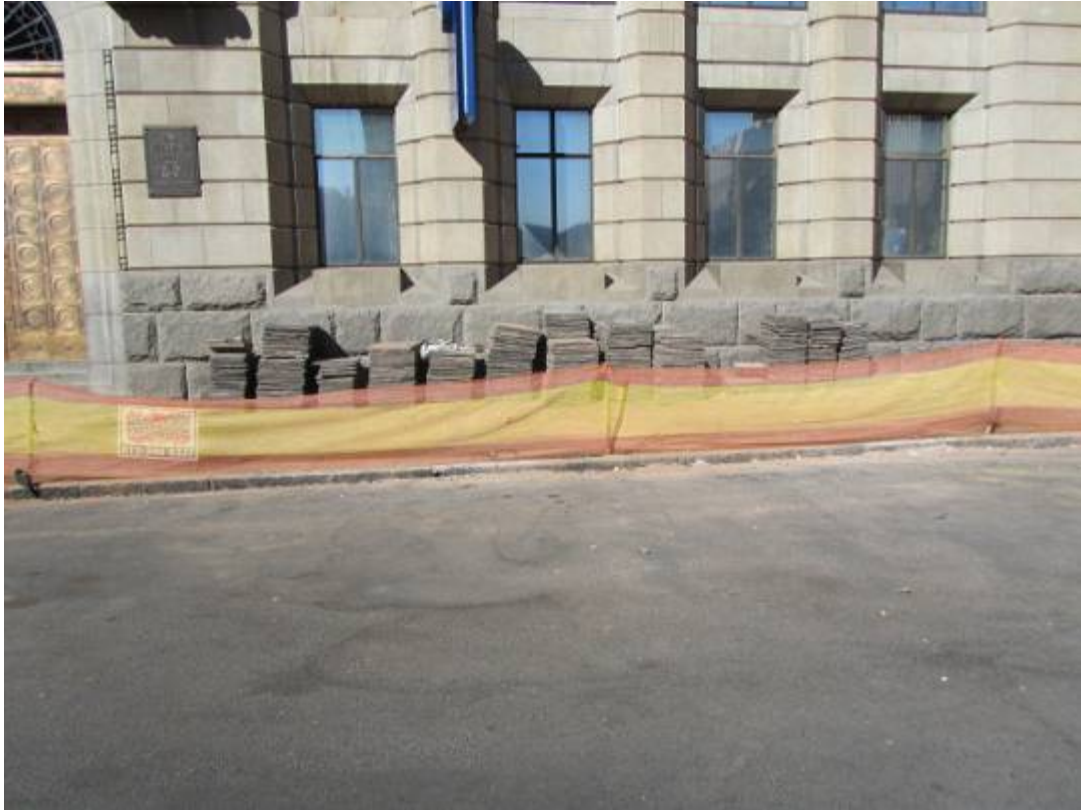
*Figure 178. Slate paving in front of historical building being lifted. (P 981).*

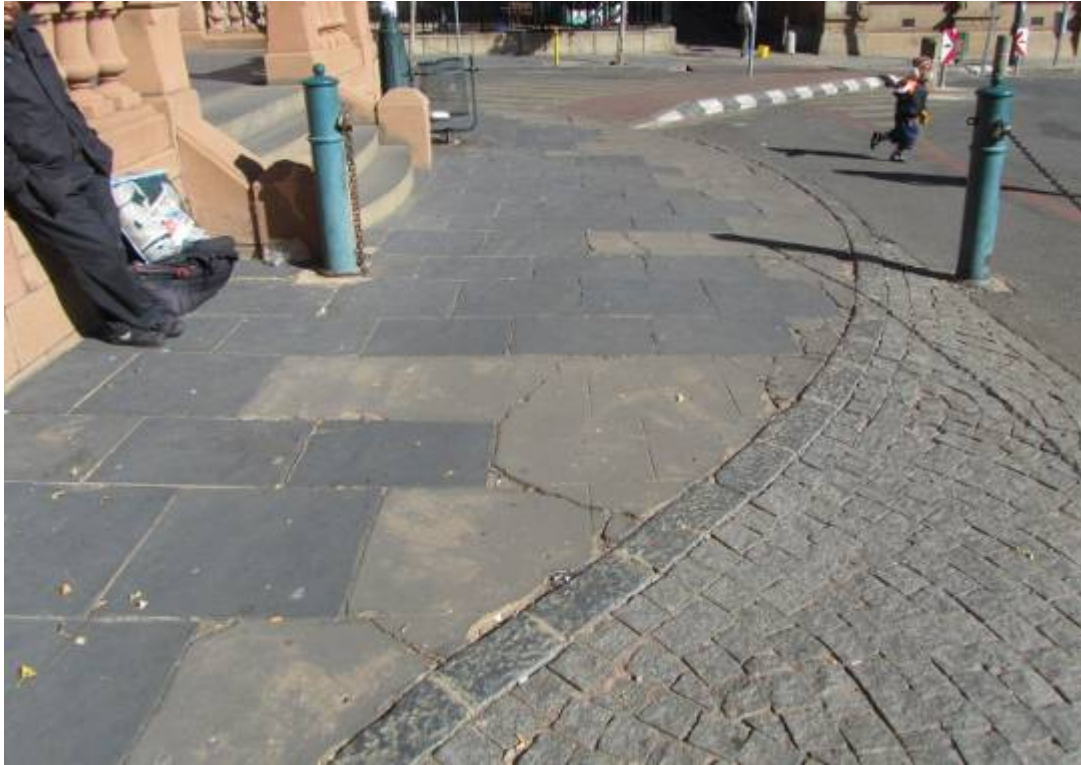
*Figure 184. An array of paving materials in front of a historical building. (P 988).*

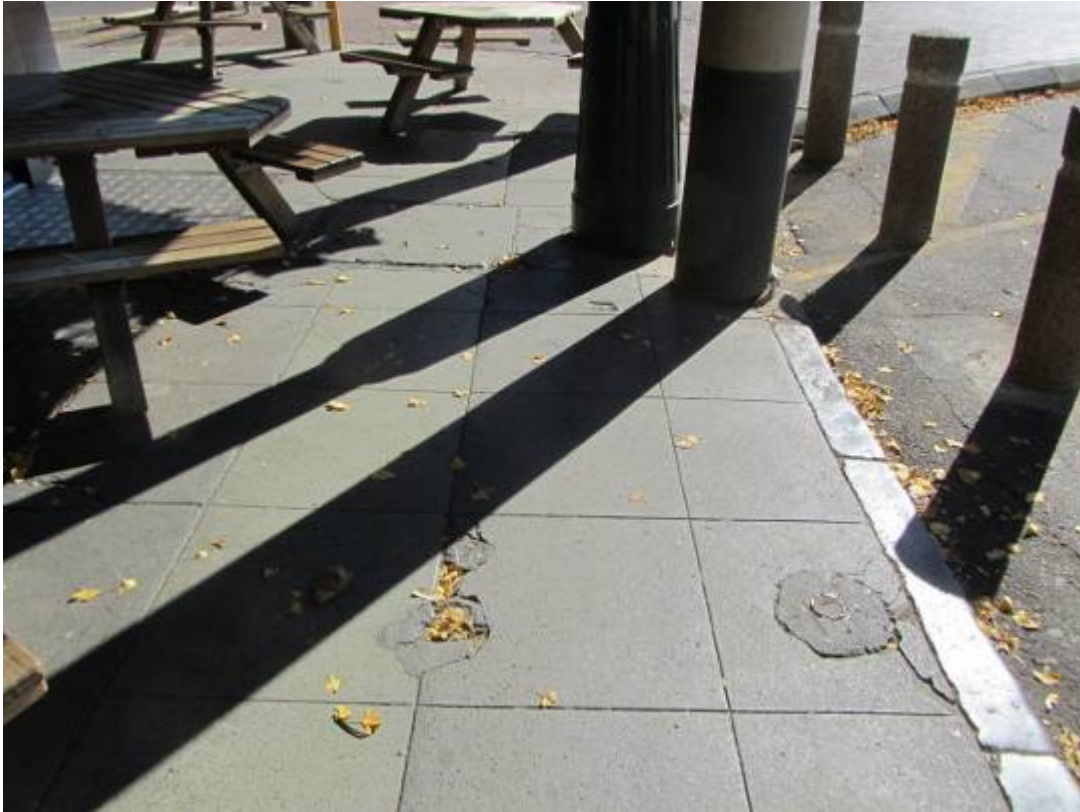
*Figure 195. Large cement blocks as paving adjacent to historical building. Pillars defining sidewalk limit. (P 998).*

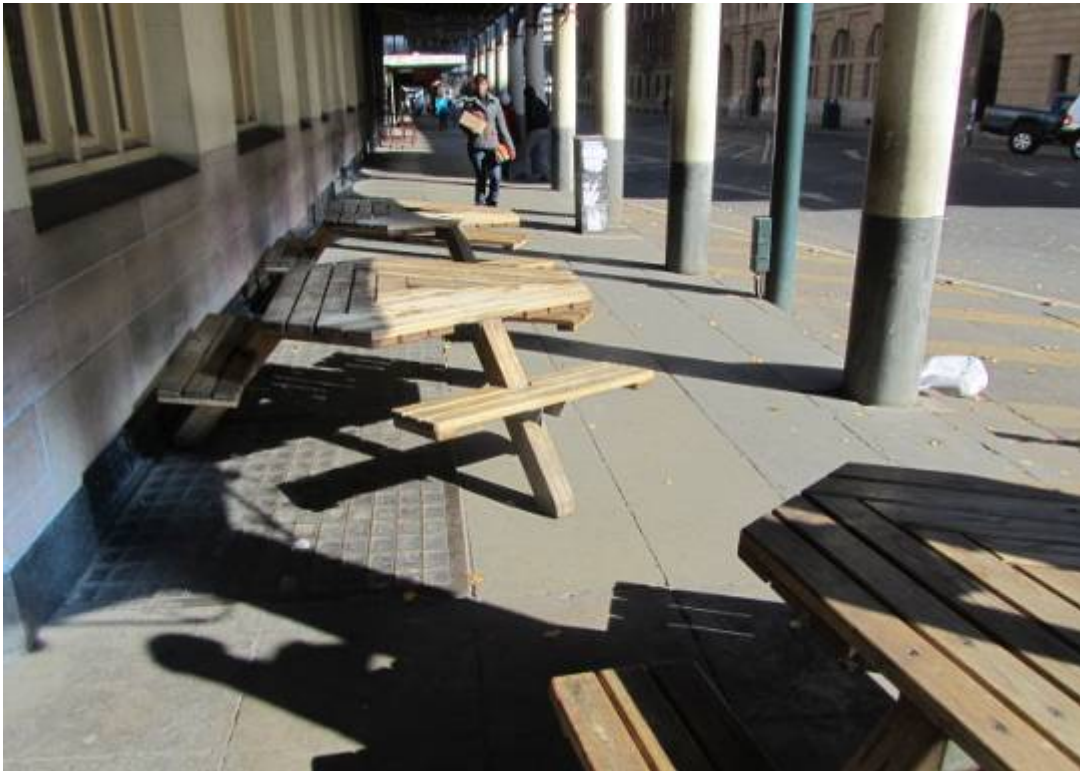
*Figure 196. Large cement blocks as paving adjacent to historical building. Pillars defining sidewalk limit. (P 999).*

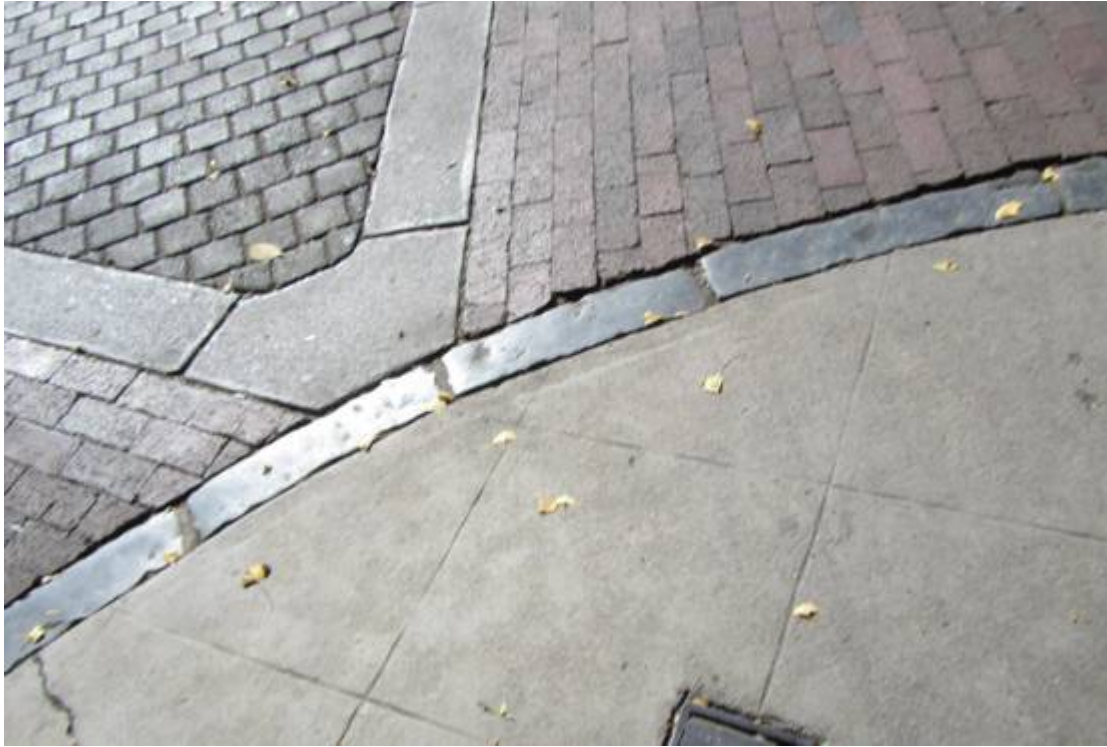
**Figure 197.** Although a number of different paving materials were used we find that the original curb stones are still in place. (P 1000).

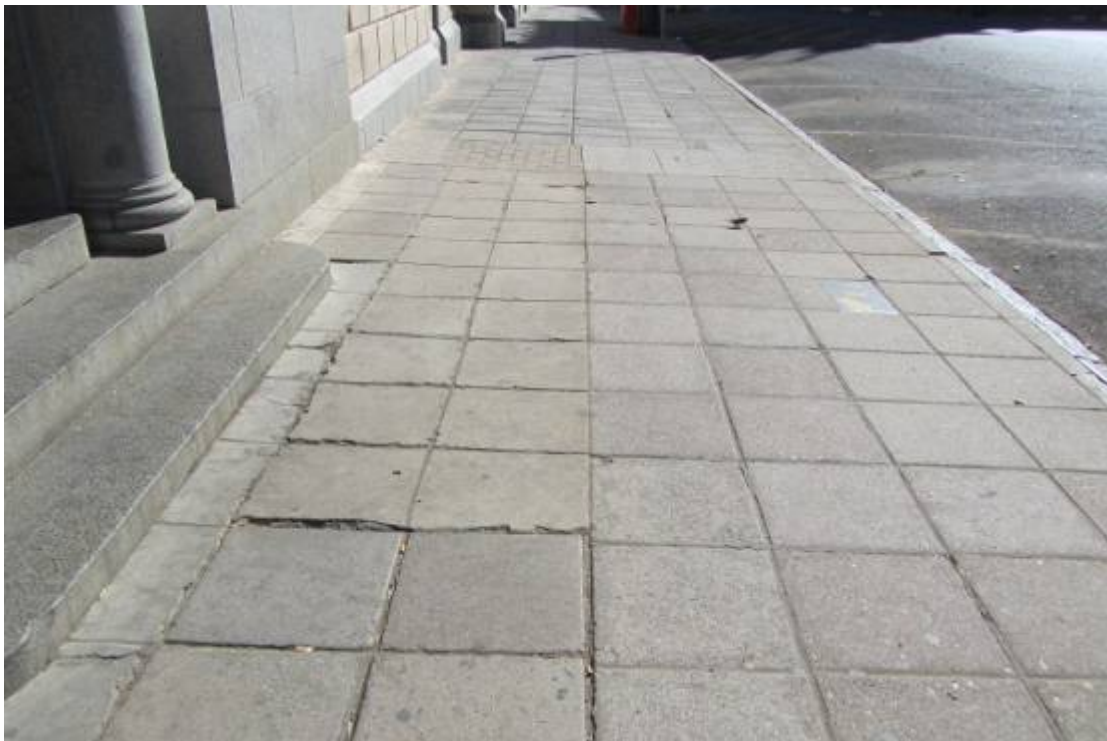
**Figure 200.** Large cement blocks as paving adjacent to historical building. Granite curbing stones defines sidewalk limit. If paving is used to retain character then the buildings should be investigated to define paving. (P 1003).

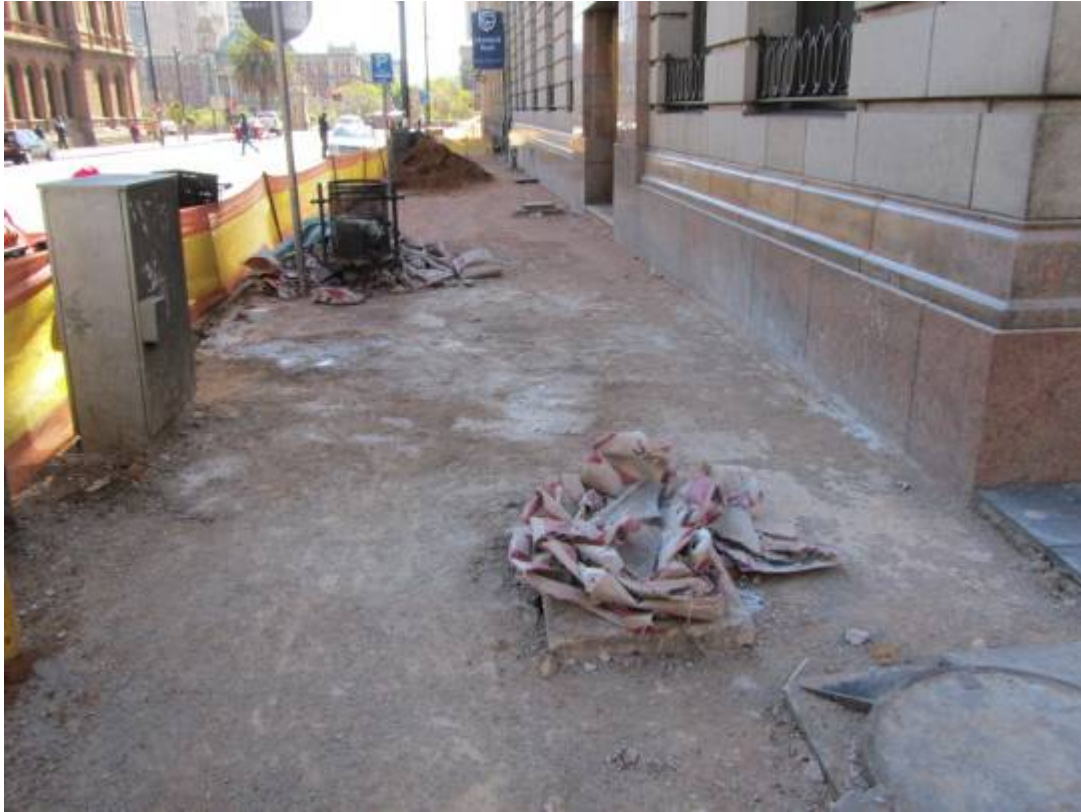
*Figure 204. Historical slate paving being lifted adjacent to historical building. Note that no excavations were undertaken to alter paving level. (P 1006).*

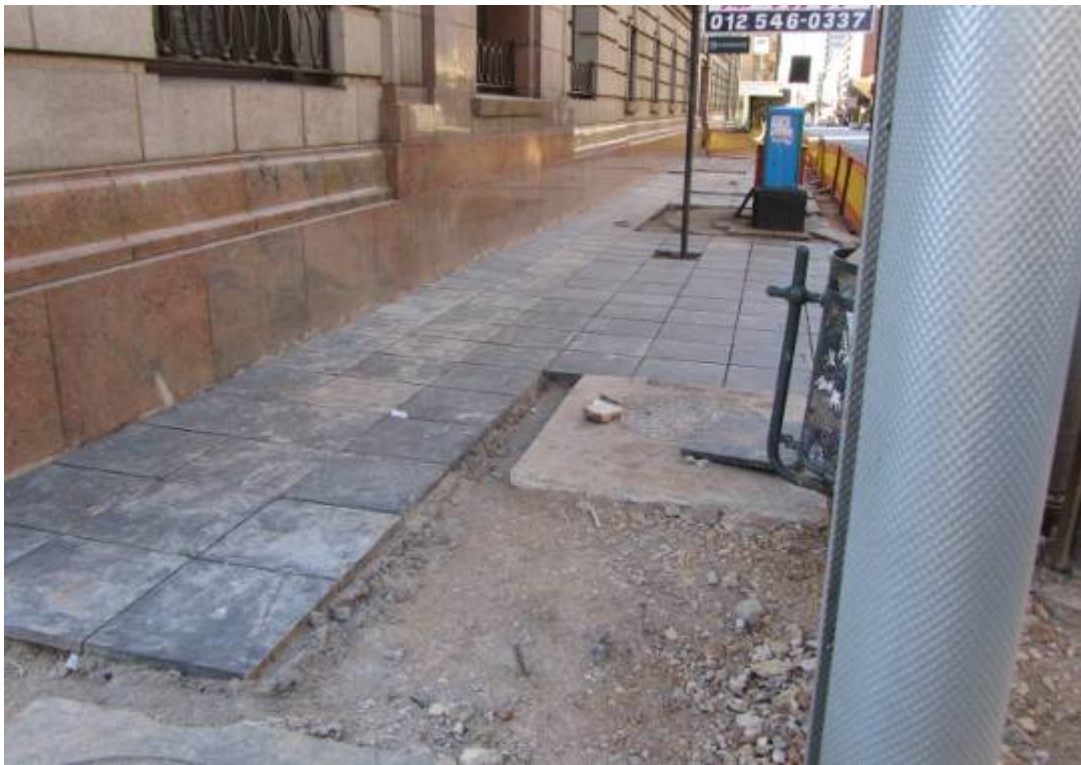
*Figure 205. Historical (?) paving r- instated. whether this is the old slate that was re-sized in unknown.. NOTE:- Matter to be investigated. (P 1007).*

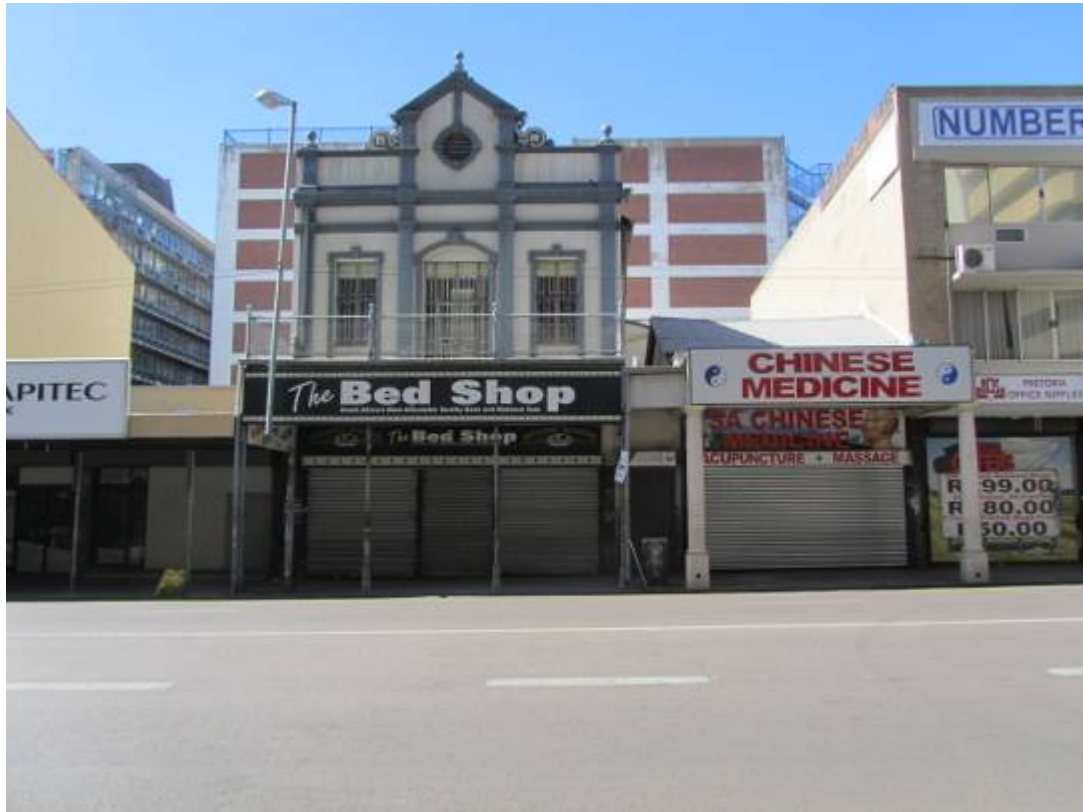
*Figure 218. Provisionally protected and protected buildings. (P 1017)*

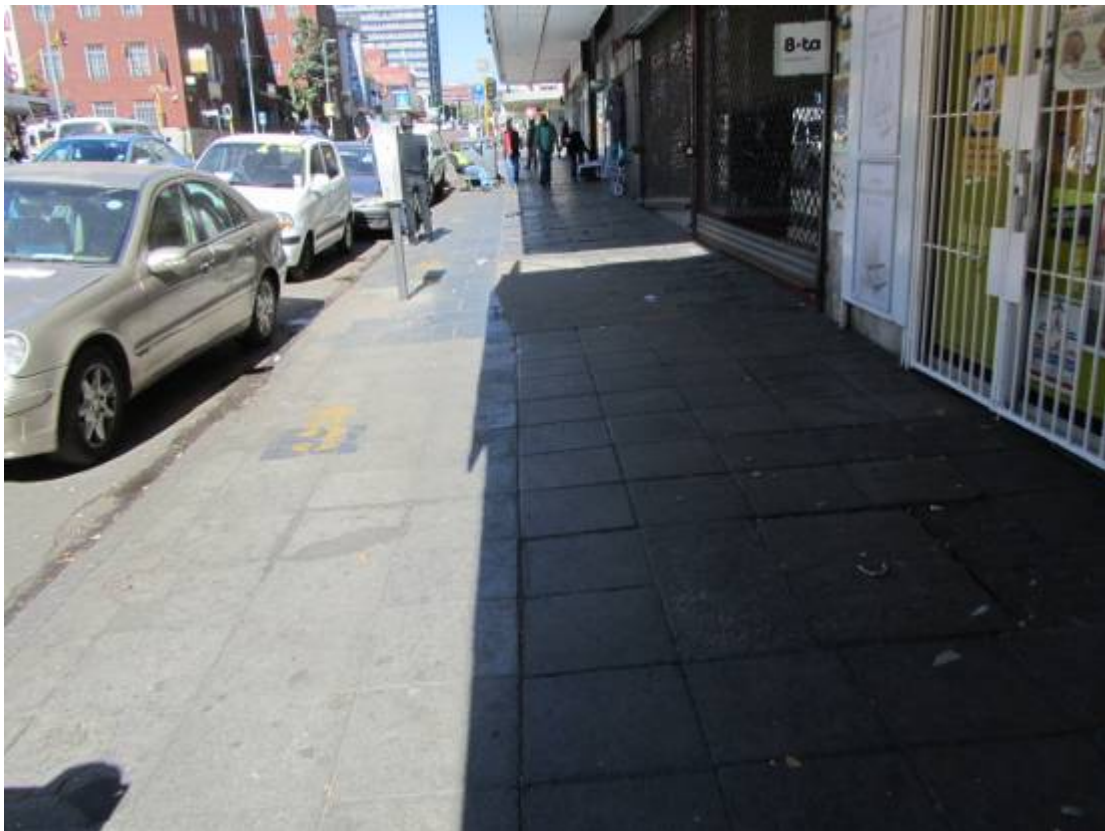
**Figure 221.** Provisionally protected buildings. (P 1021)

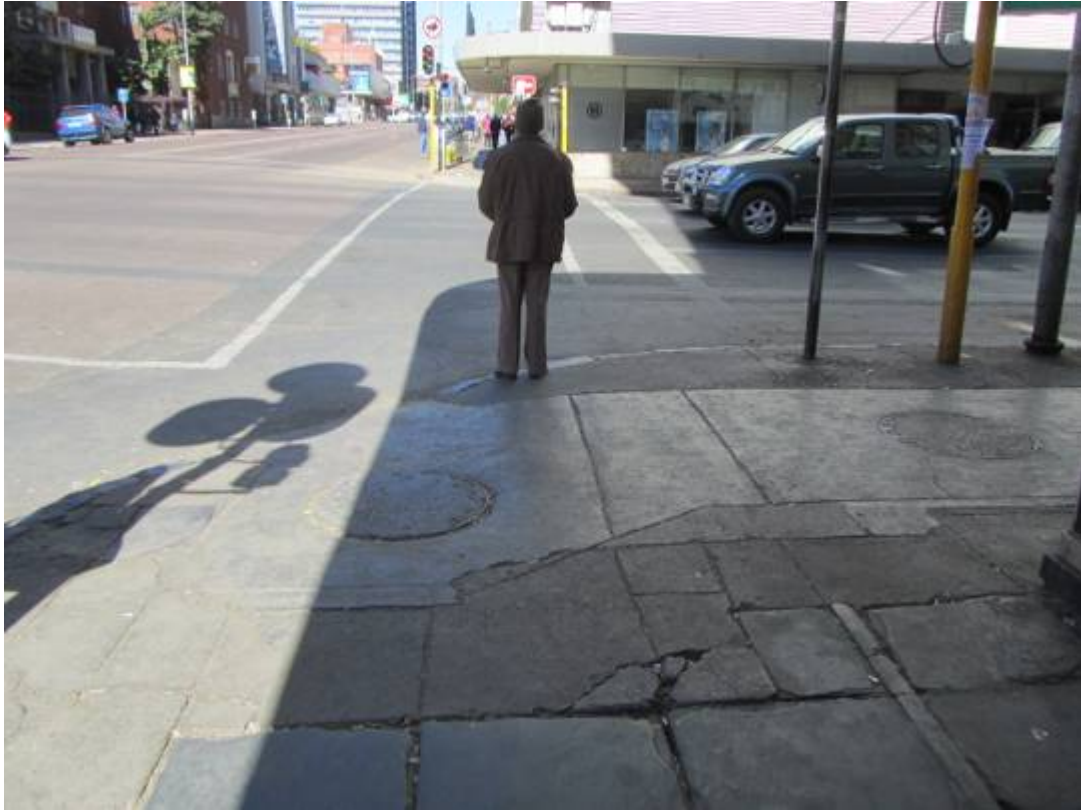
*Figure 223. Remnants of historical slate paving and granite curbing defining old roadway. (P 1023)*

13.3 All, or most of the historical curbing and paving, must be retained or replaced in-situ.

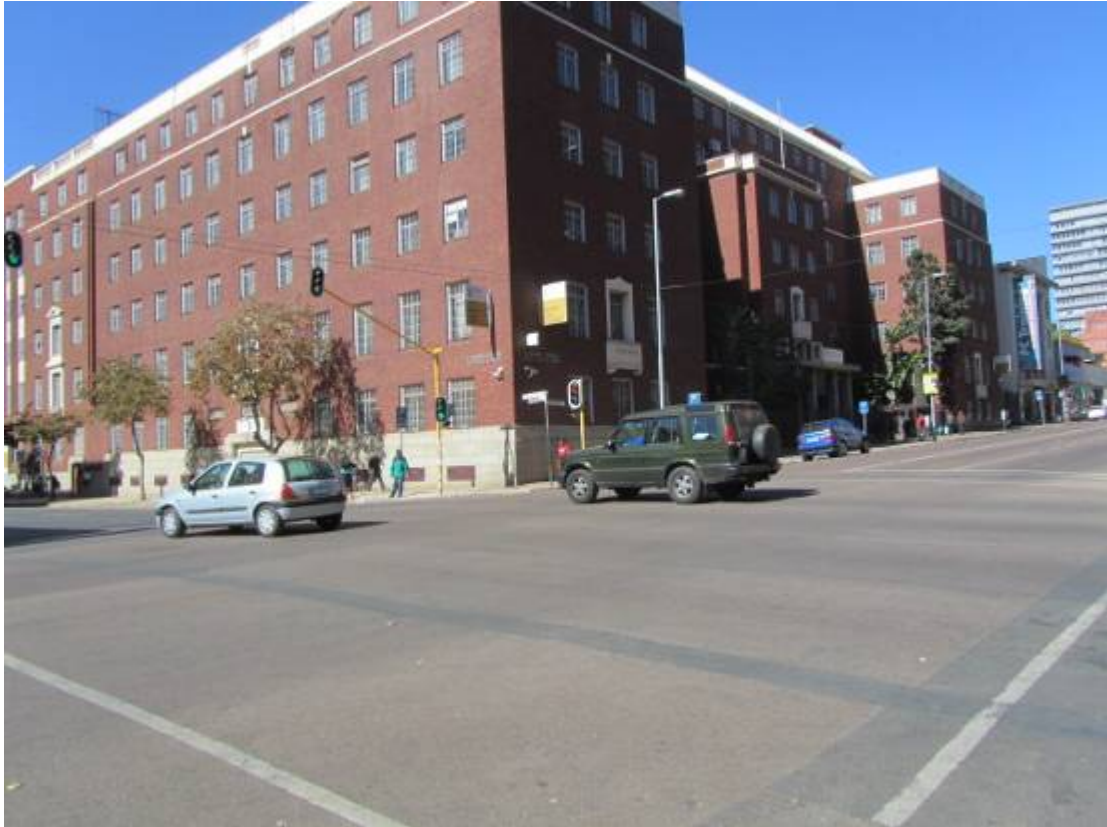
*Figure 225. Provisionally protected buildings. (P 1025)*

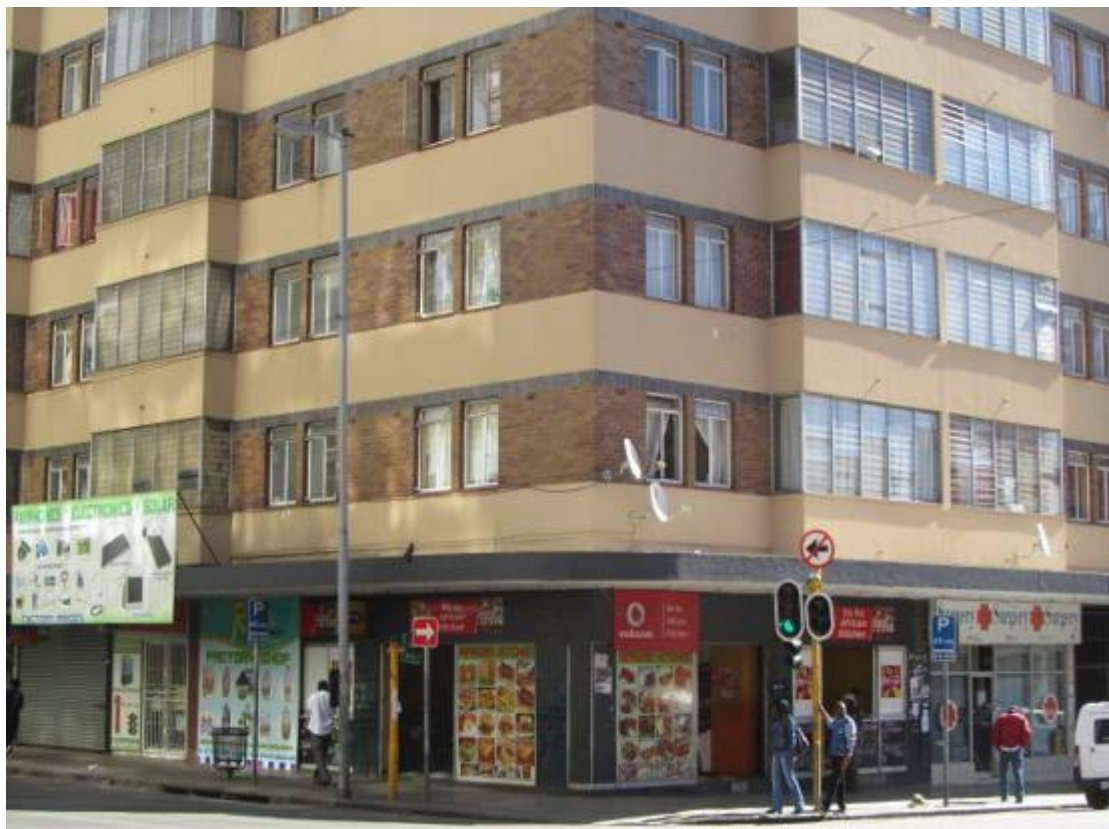
*Figure 228. Provisionally protected building. (P 1028)*

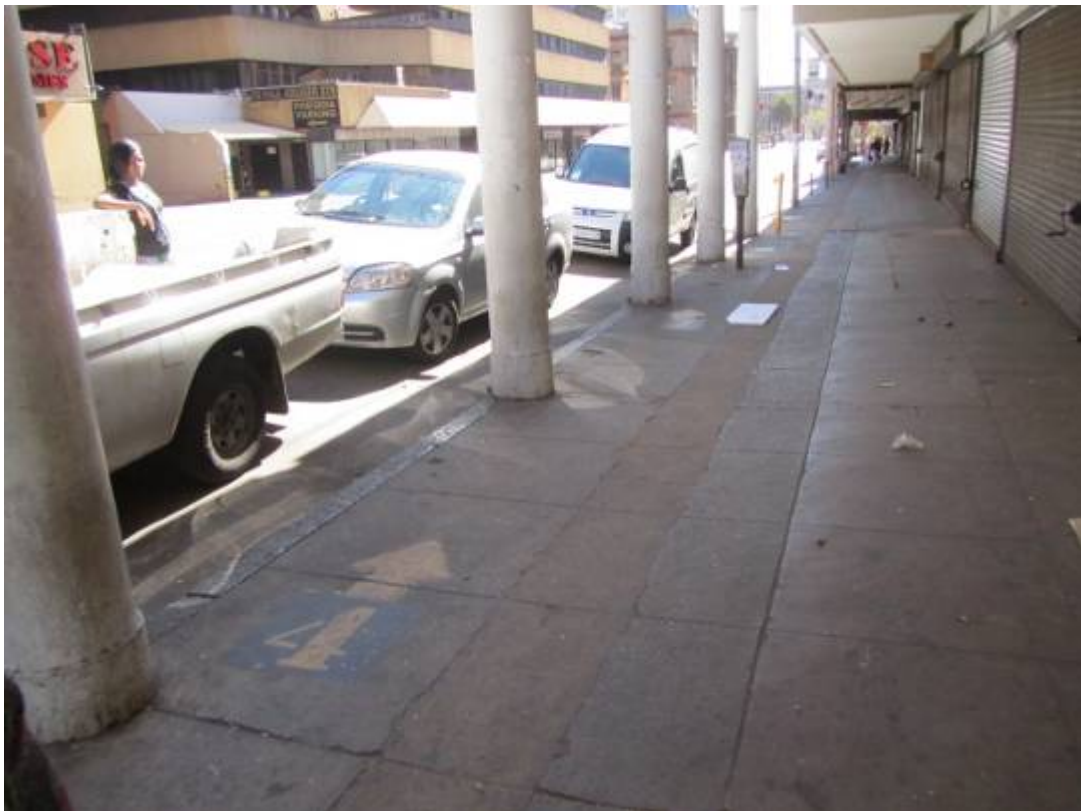
*Figure 230. Variety of paving material and historical pillar footprint. (P 1029)*

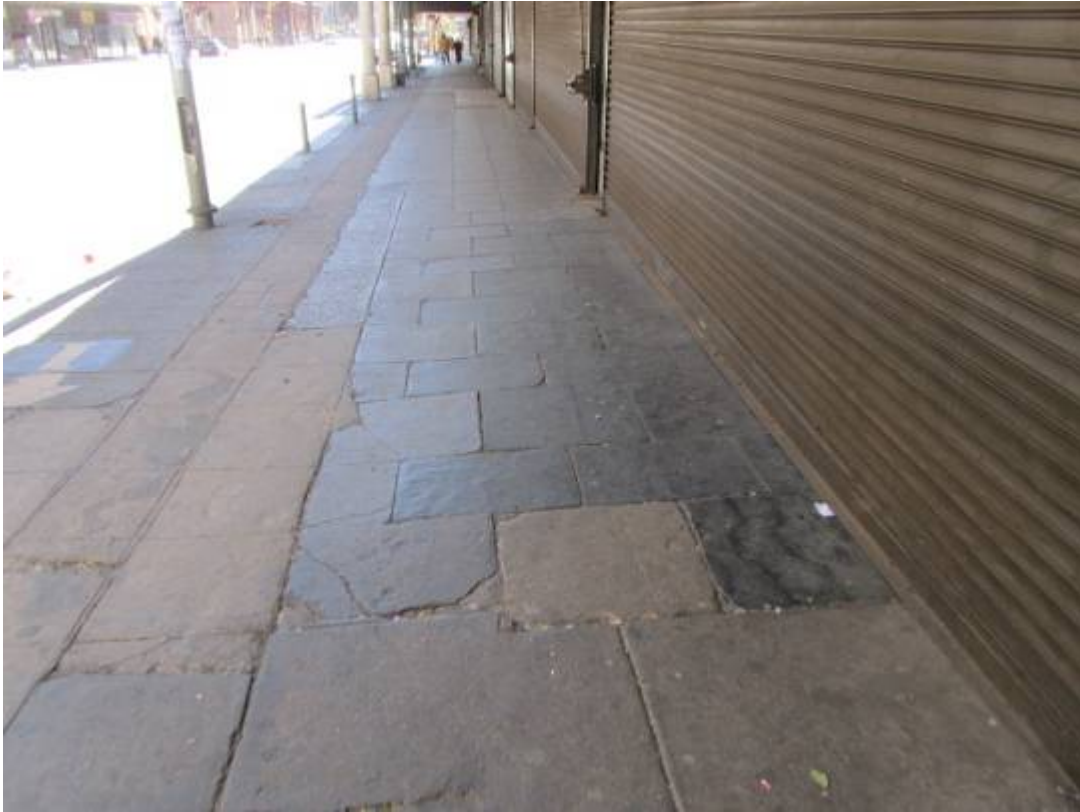
*Figure 231. Variety of paving material and historical pillar footprint. (P 1030)*

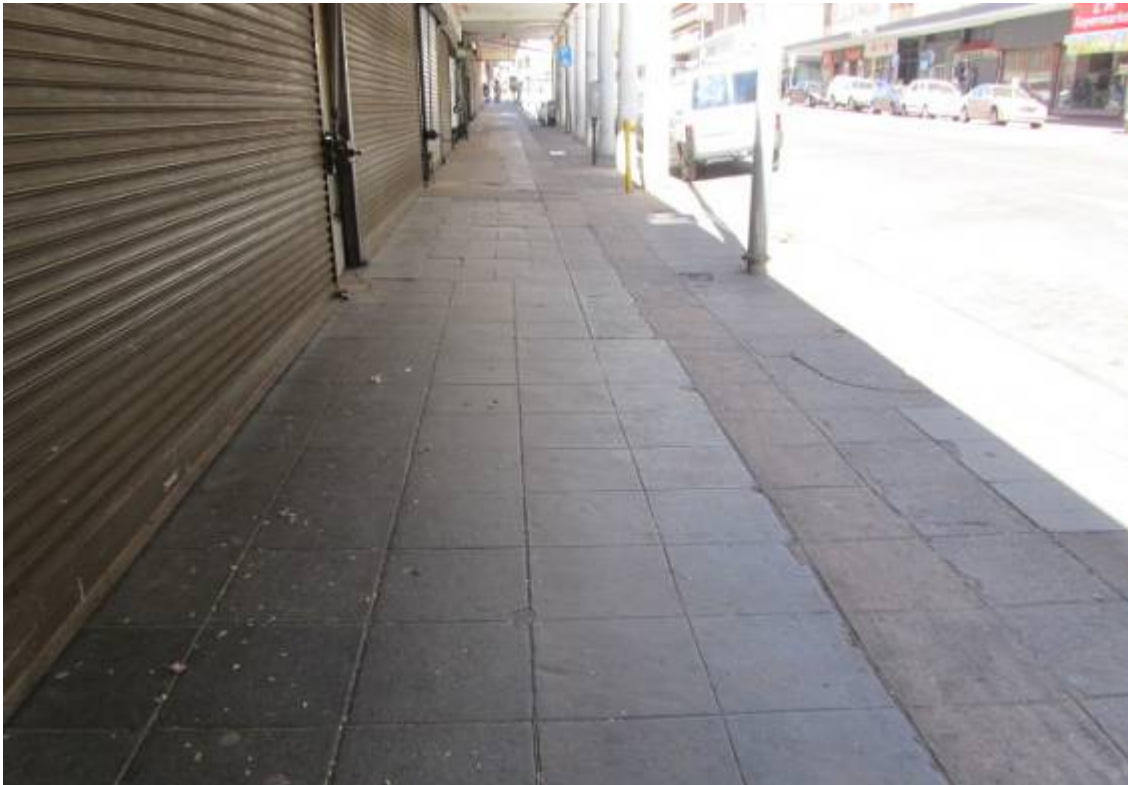
**Figure 232.** *Cement block paving, remnants of historical slate paving and granite curbing defining old roadway. (P 1031)*

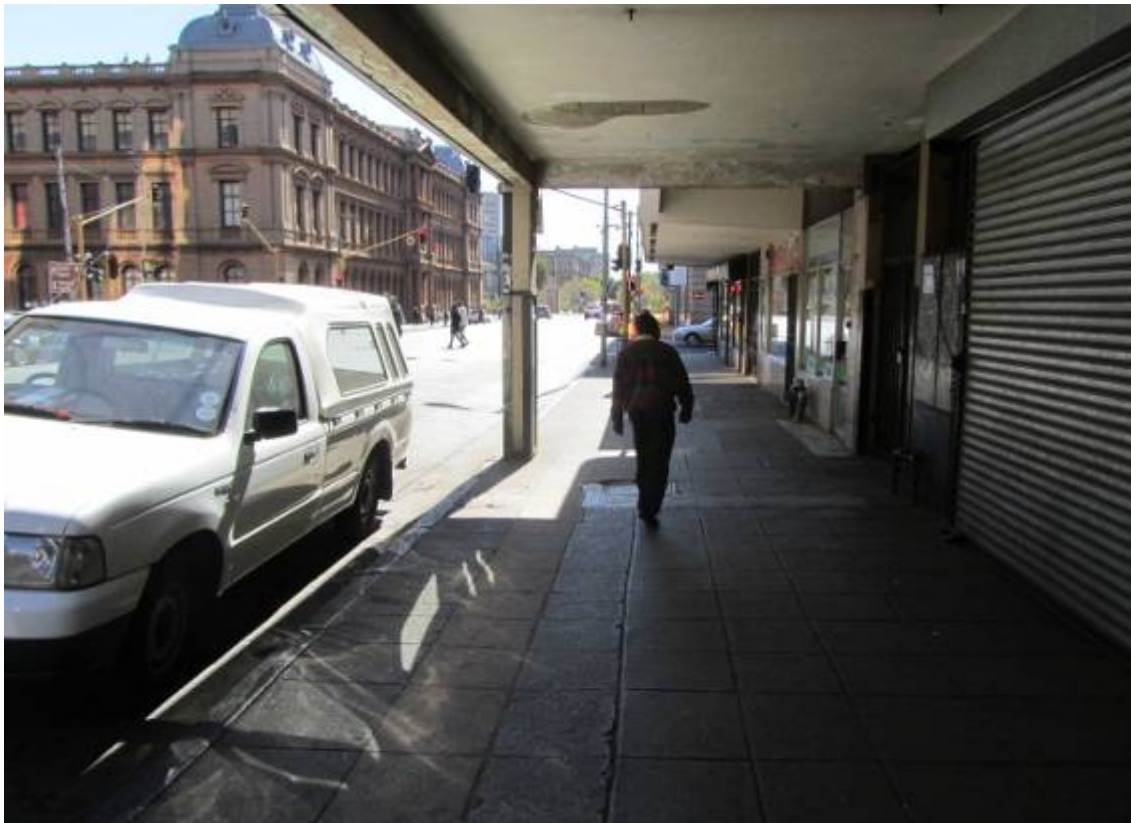
*Figure 235. Services covers are historical pieces and must be preserved. (P 1033)*

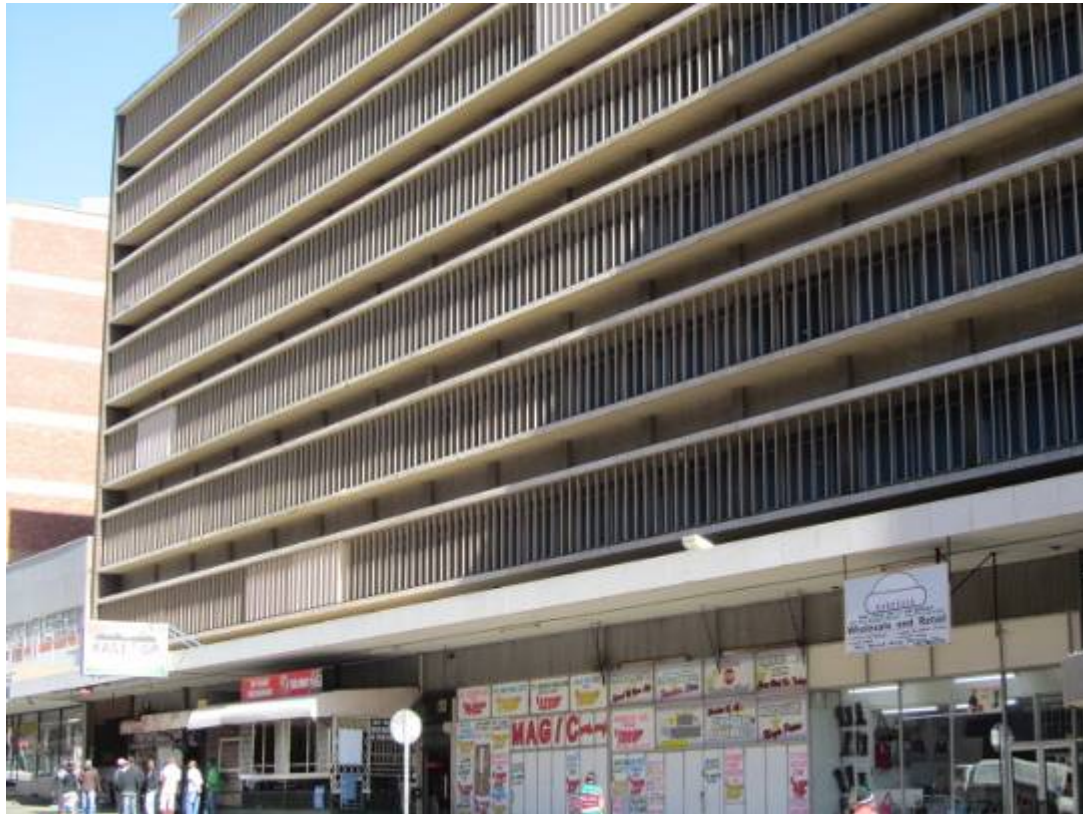
**Figures 242 and 243.** Provisionally protected building, and cement block paving and granite curbing defining old roadway. (P 1040 and P 1041).
