## **1st Phase**

**Cultural Heritage Resources Impact Assessment for proposed rapid bus service, Paul Kruger Street, Pretoria, Tshwane.**

**June 2011**

**Report compiled by Sidney Miller and Dr. Udo S. Küsel.**

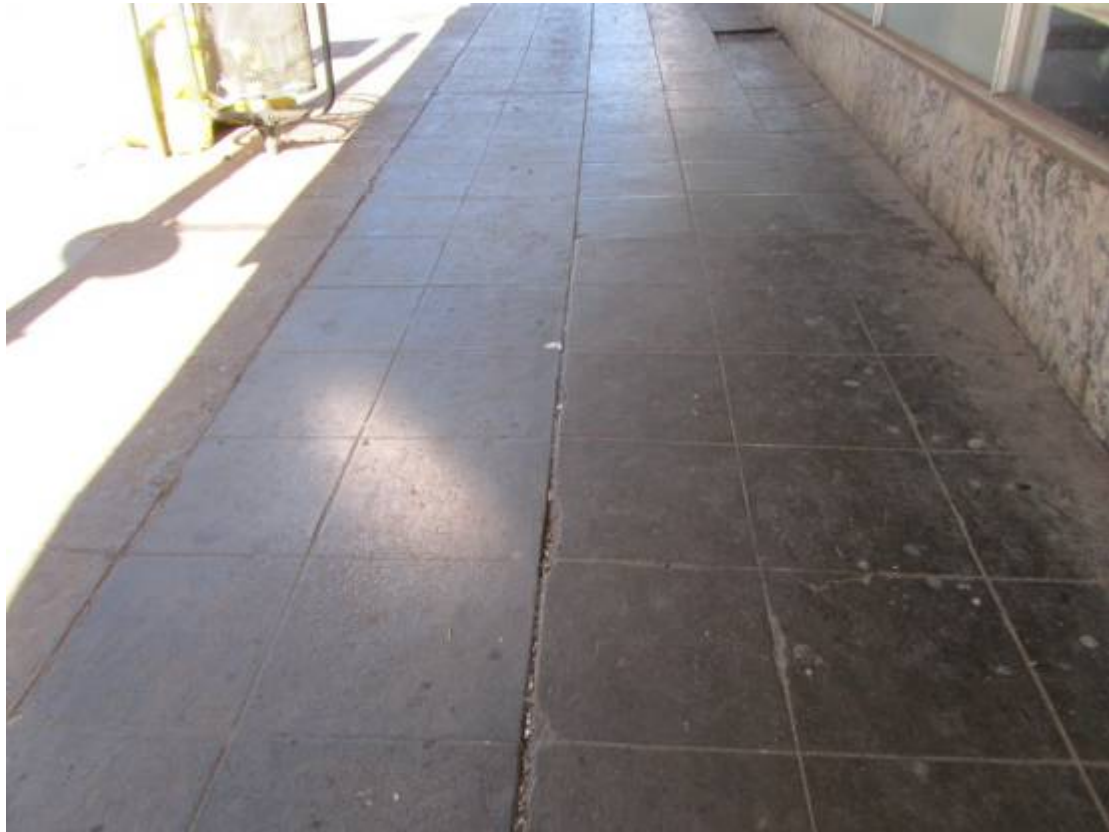
*Figure 245. Variety of paving material and granite curbing. (P 1043)*

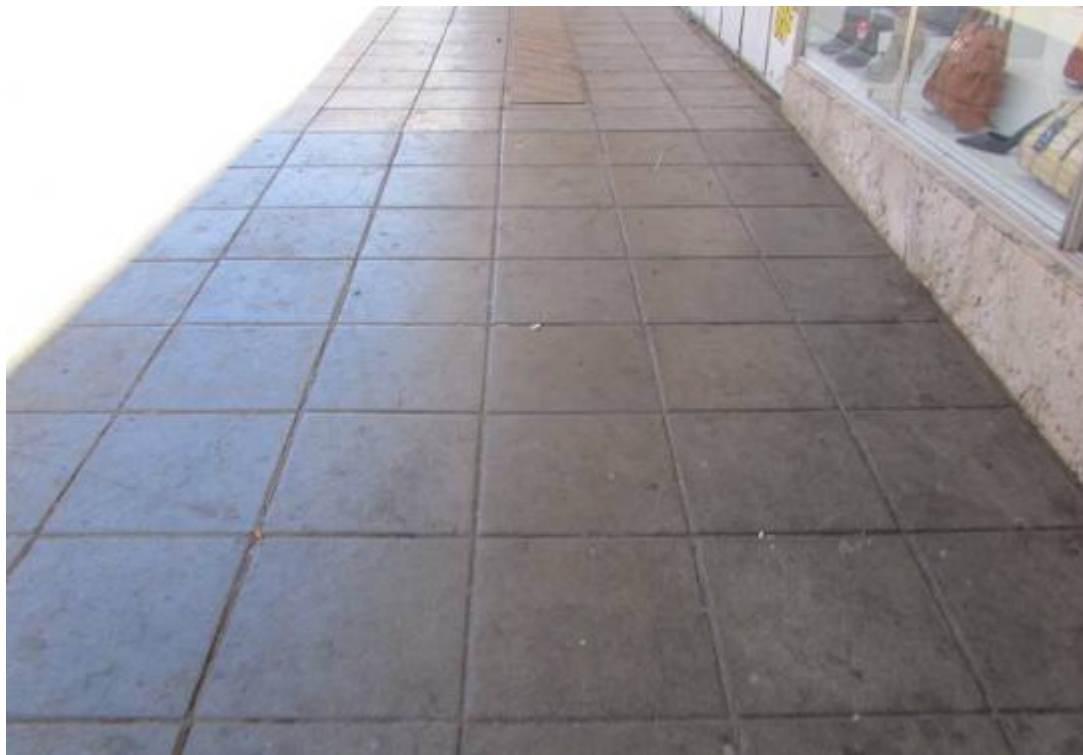
**Figure 246.** Variety of paving material. This 'glossy' cement blocks appears to be of an earlier application. (P 1044)

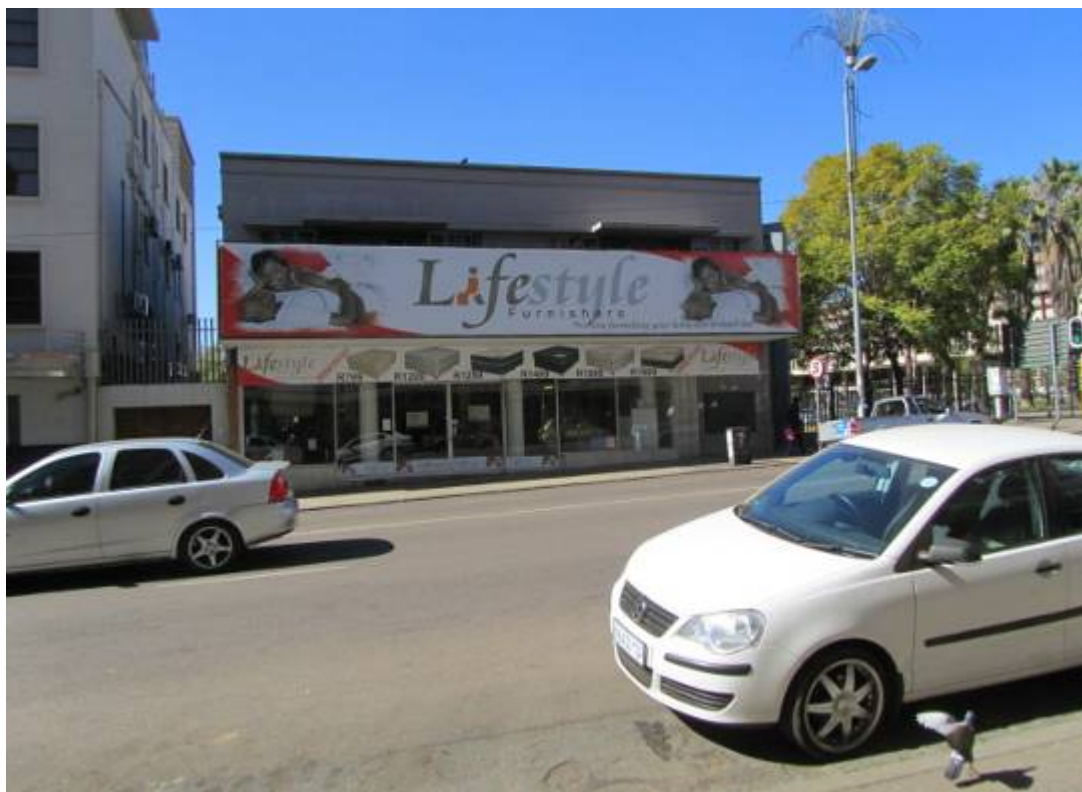
*Figure 250. Protected building. (P 1048)*

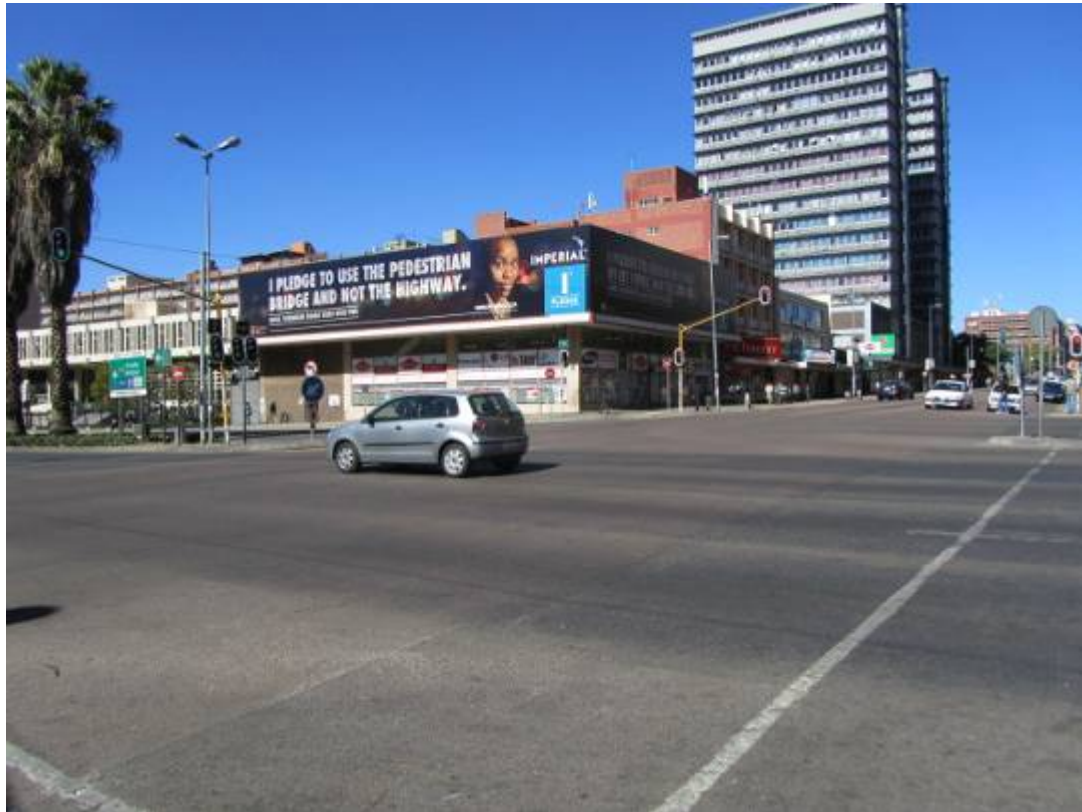
**Figure 253.** Provisionally protected building. (P 1051)

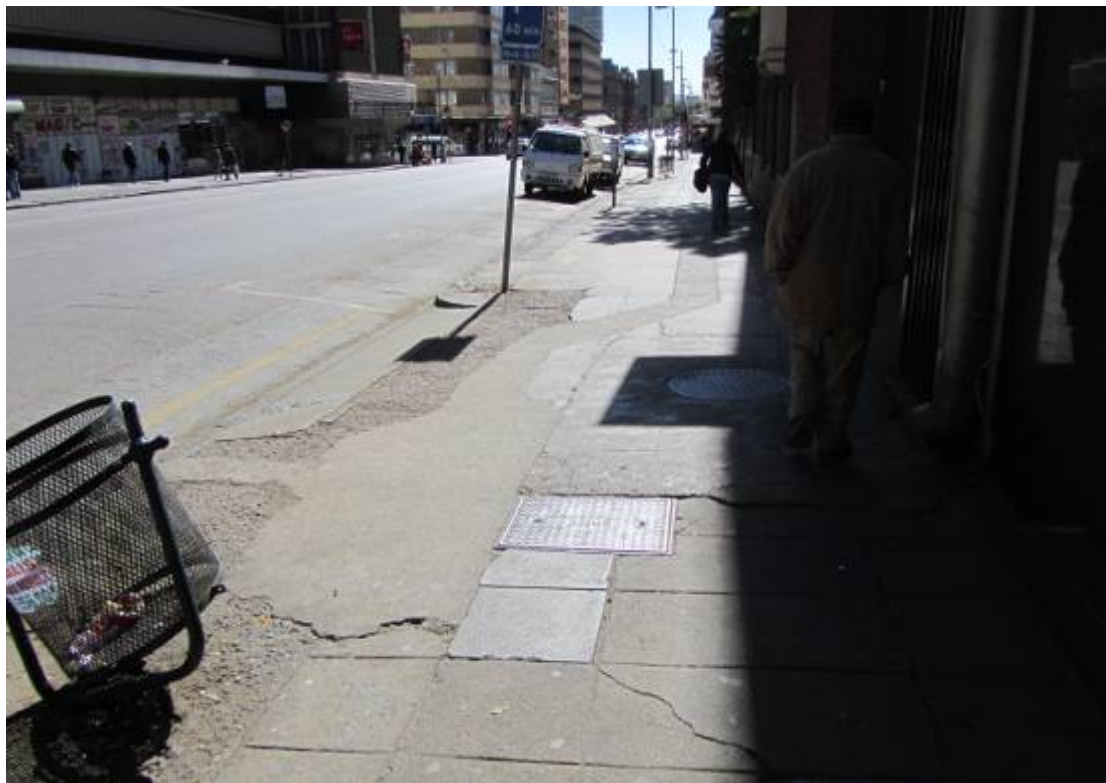
**Figure 256.** Variety of paving material and Note granite curbing. (P 1055)

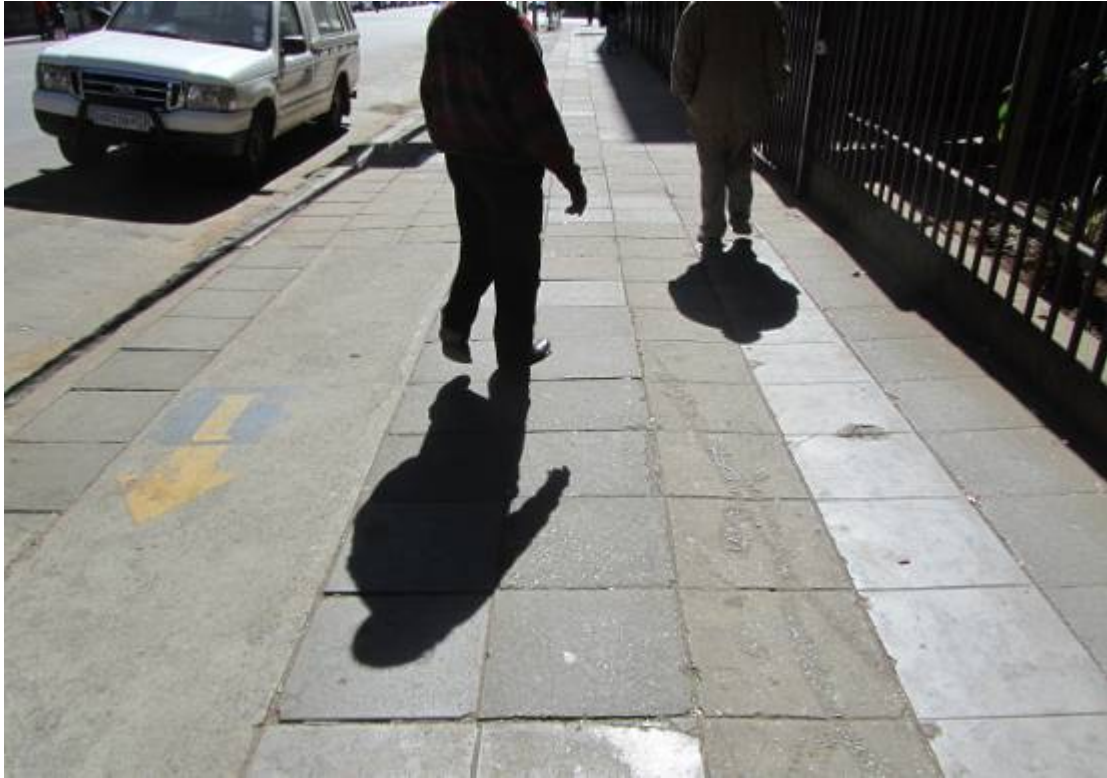
**Figure 257.** Variety of paving material. Note granite curbing. (P 1056)

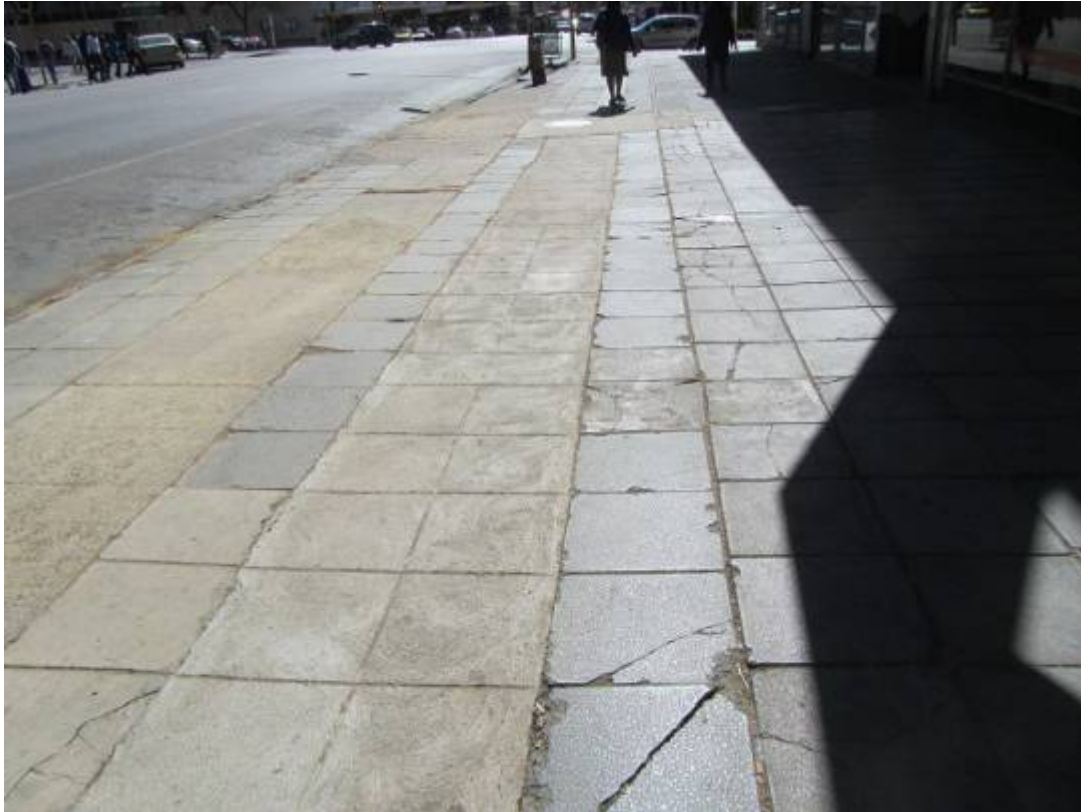
*Figure 264. Variety of paving materials. Note that the cement blocks also date from different eras. (P 1061)*

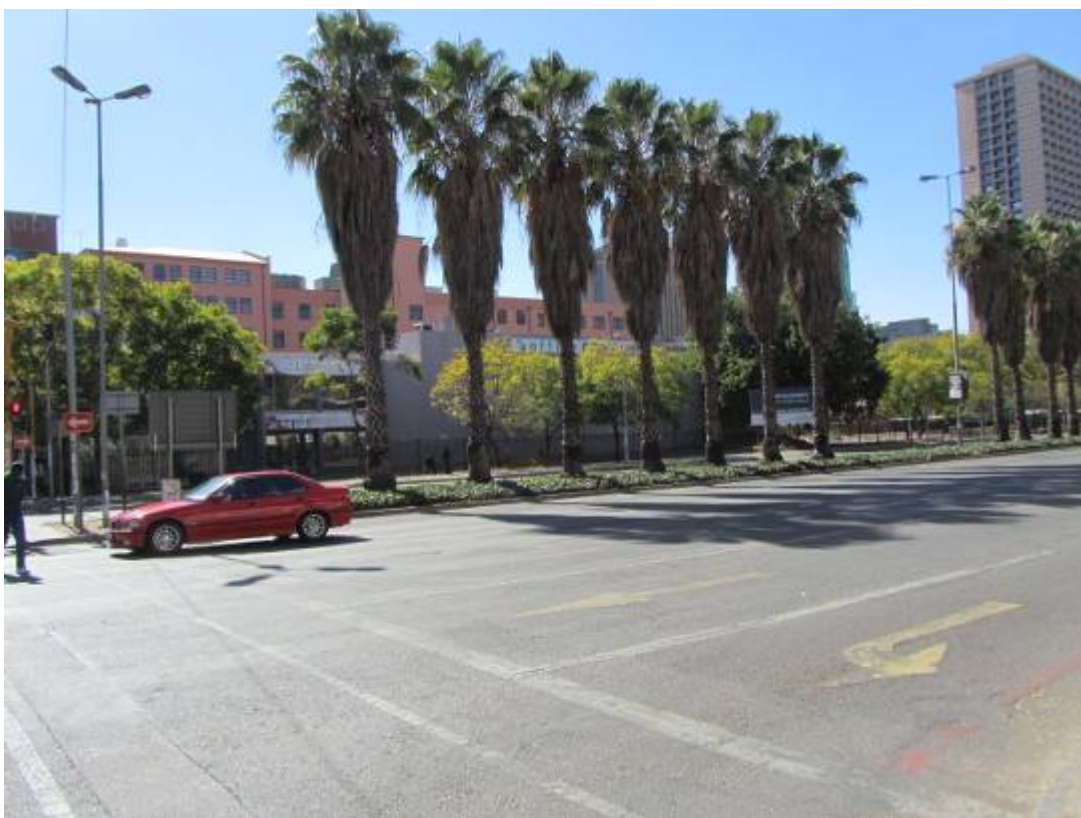
**Figure 267.** Variety of paving material. Note Granite curbing. (P 1064)

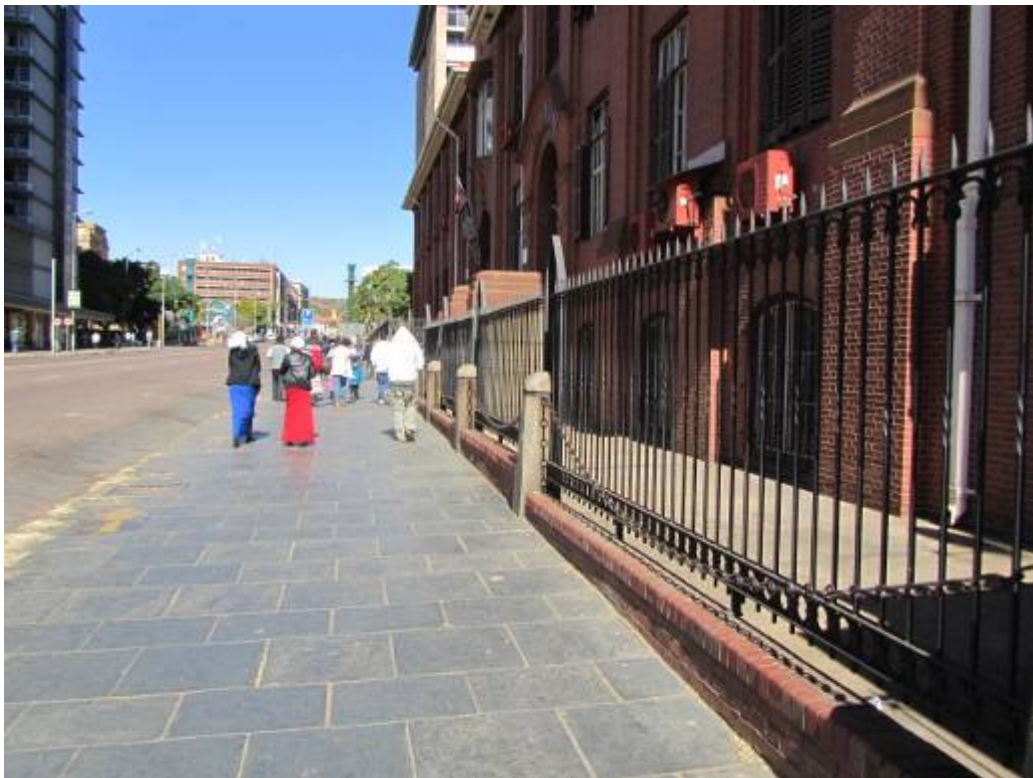
*Figure 271. As mentioned before there is a distinct difference in private and public domain as illustrated here. Note that chain fence disappeared, as all things metal do in modern Tshwane. (P 1069)*

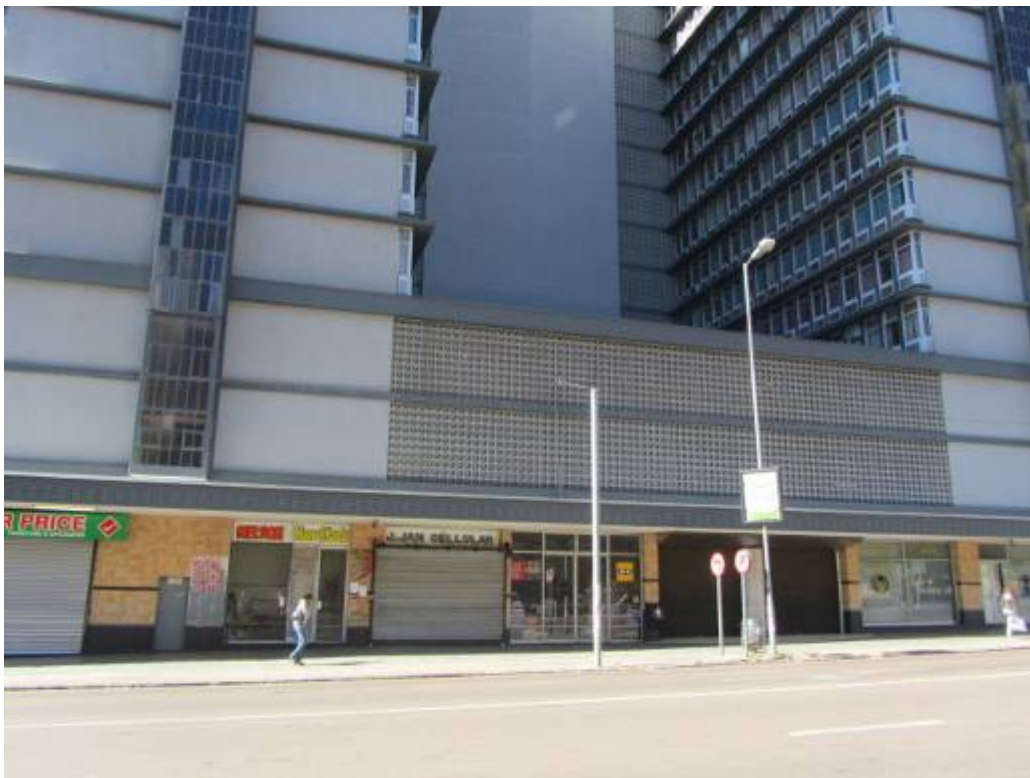
*Figure 273. Note extreme variation in height between sidewalk and roadway. Note Granite curbing. (P 1071)*

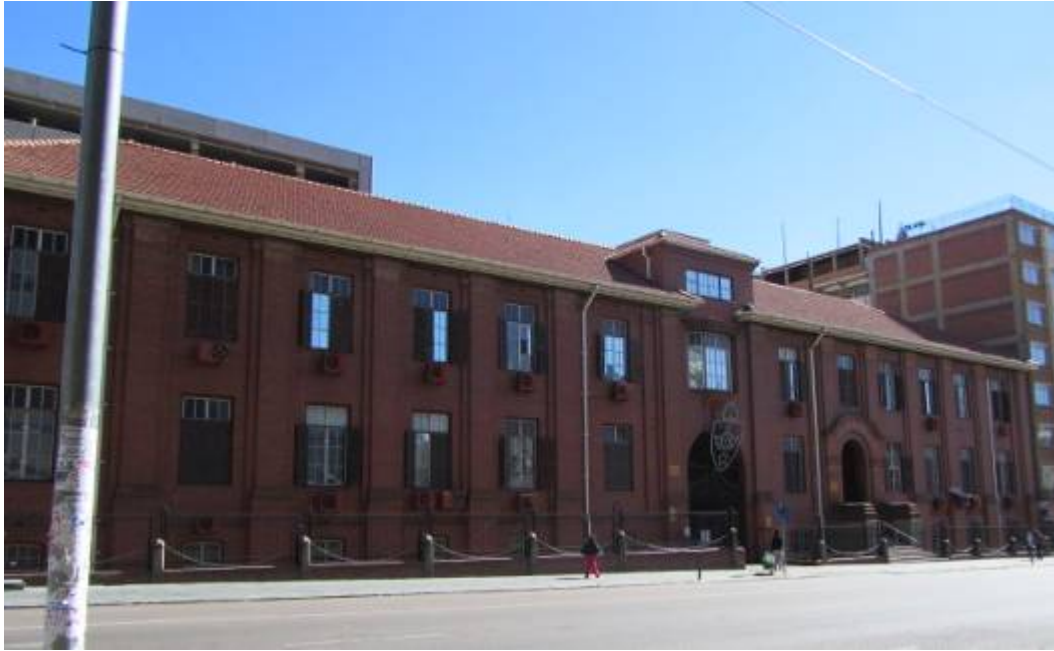
**Figures 279 and 280.** *This earlier type of cement block pavers can be attractive if uniformly laid to a design. There should be a 'repair policy for paving after service trenching and reinstatement. (P 1080 and (P 1081).*

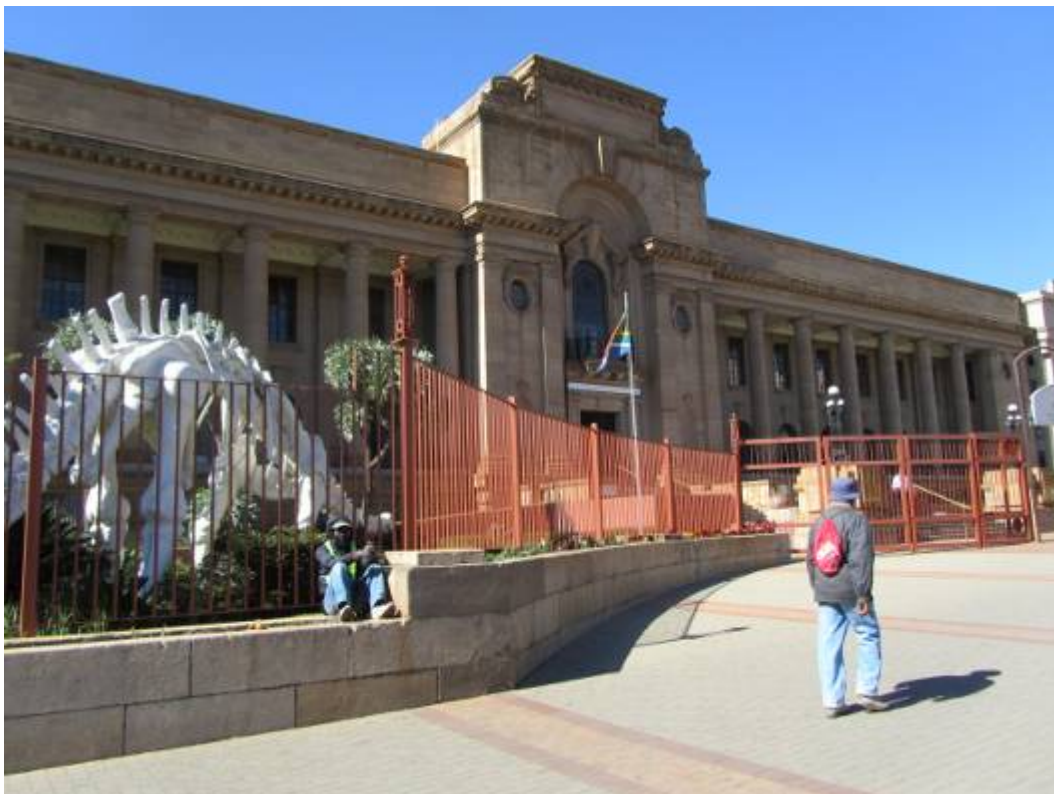
**Figure 287.** *With the renewal of the building some years ago the original paving was removed and replaced. Although attractive and well placed, it is the last option where original paving exist. (P 1085)*

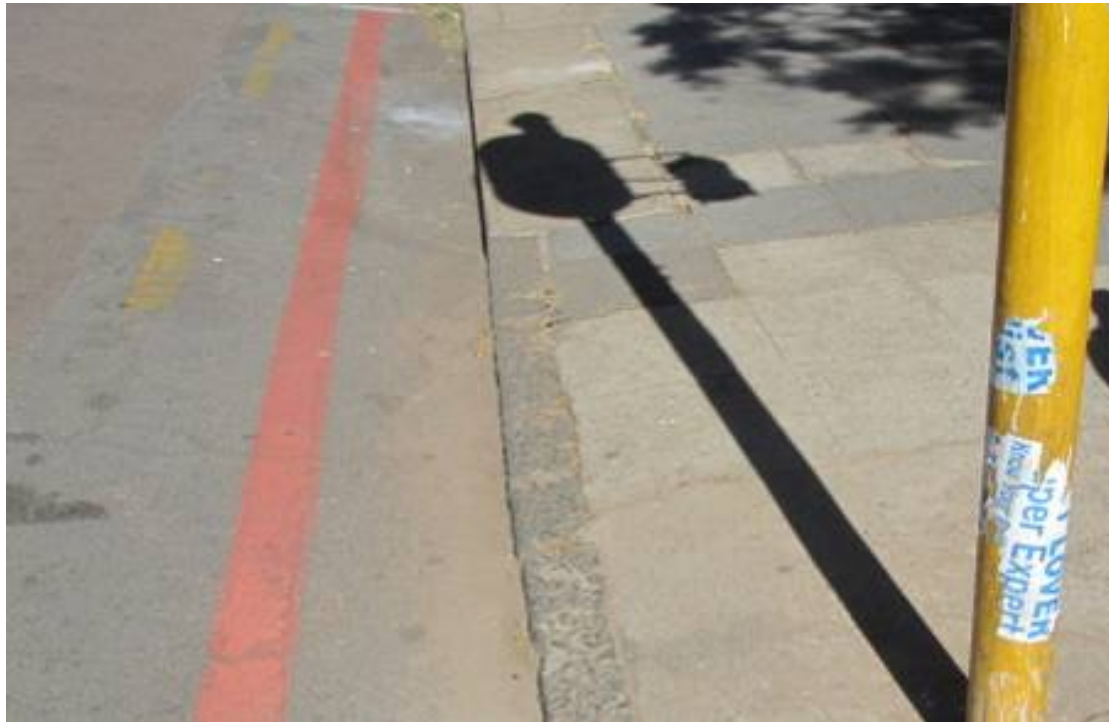
*Figure 296. Granite curbing and unsightly paving. (P 1121)*

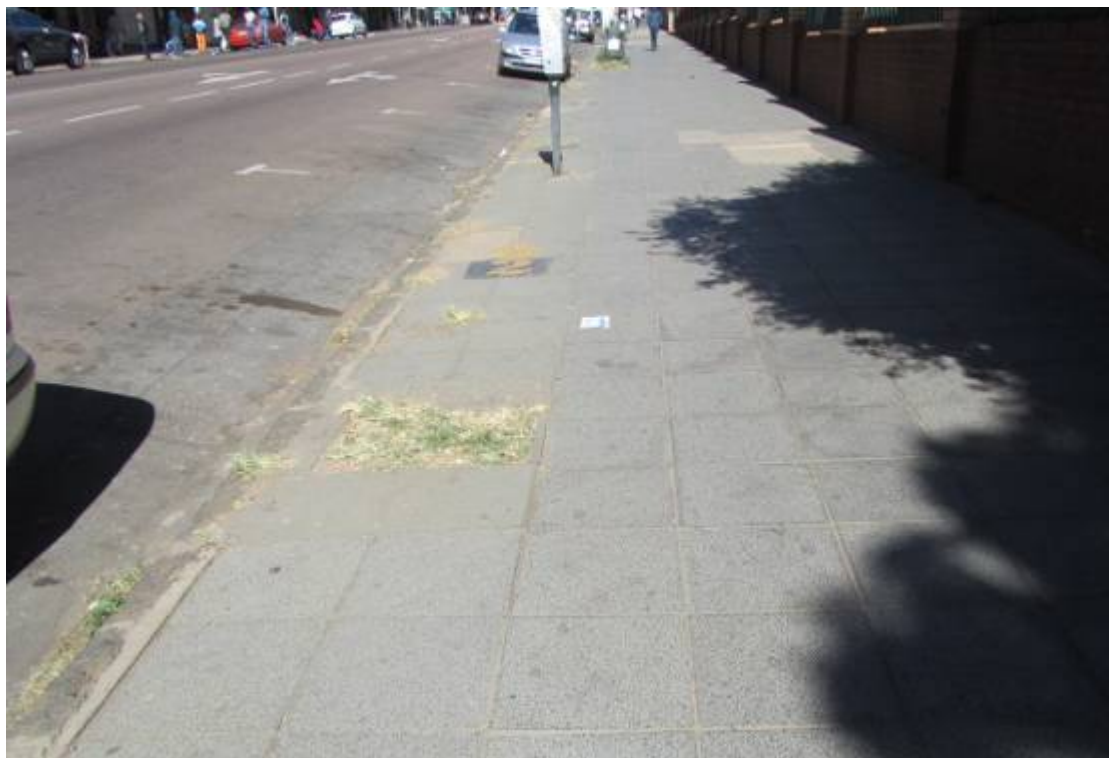
**Figure 297.** Granite curbing nearly covered by continuous re-surfacing. (P 1122)

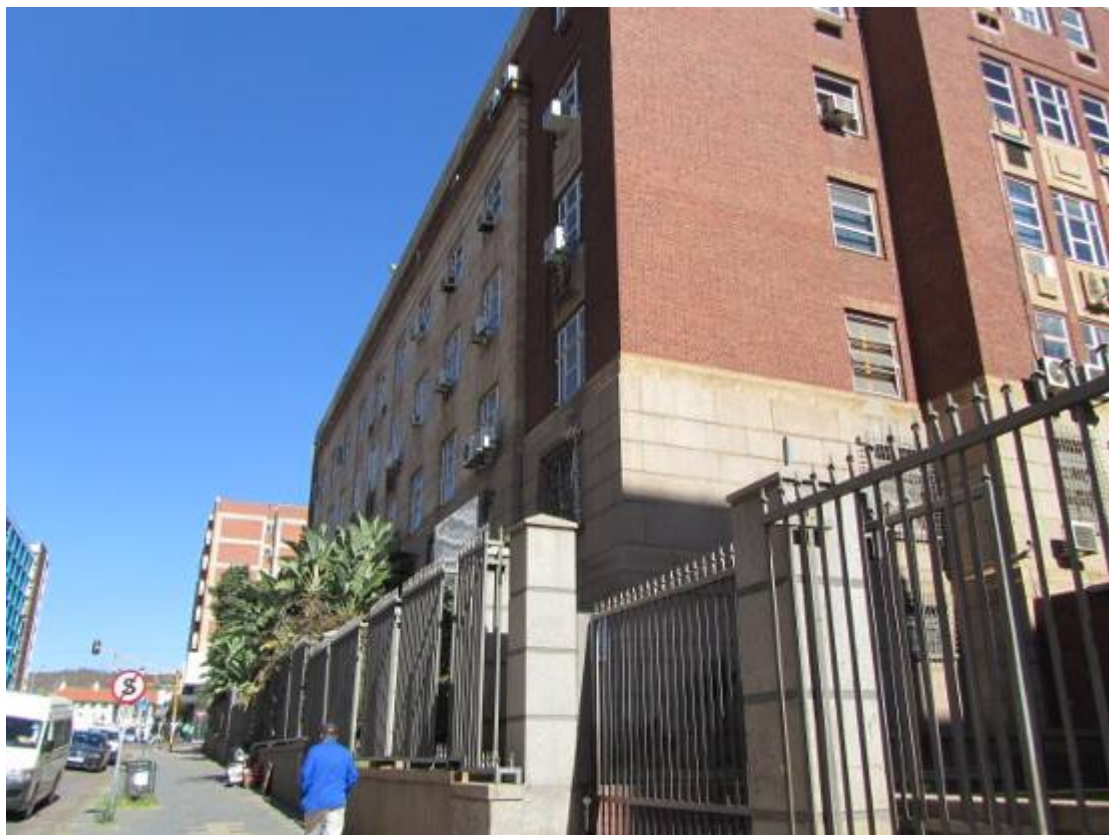
*Figure 299. Granite curbing and unsightly paving. (P 1124)*

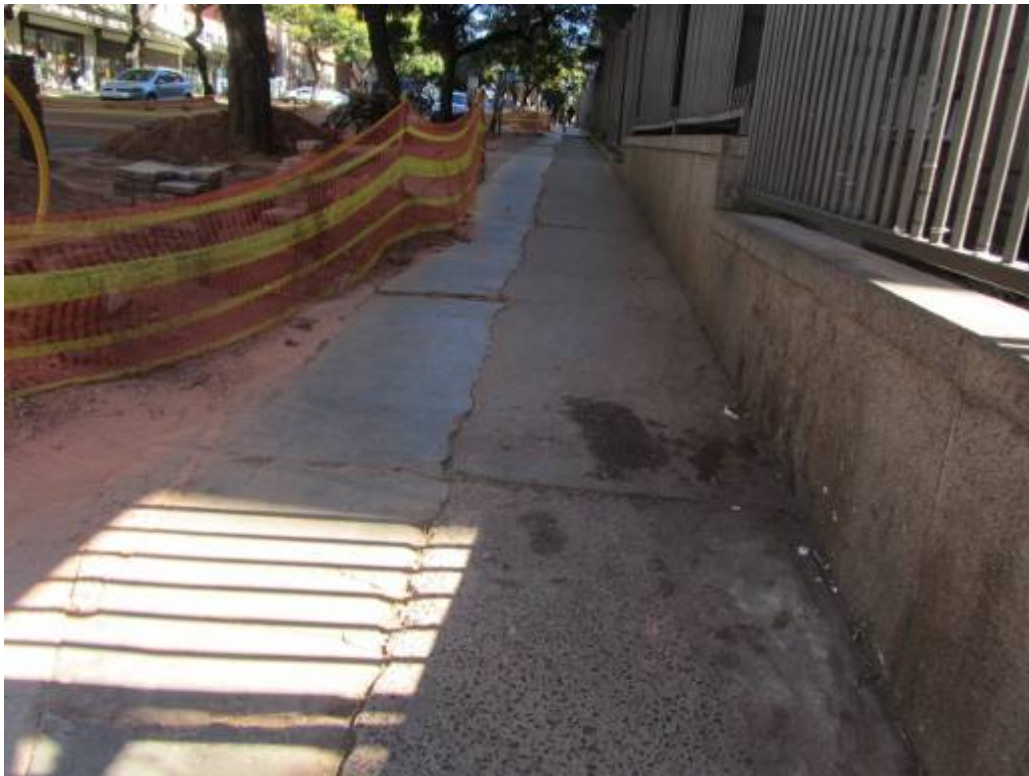
**Figure 306.** Services will be a continuous issue as will paving. The transition though from historic building to streetscape ought to be better than this. (P 1134)

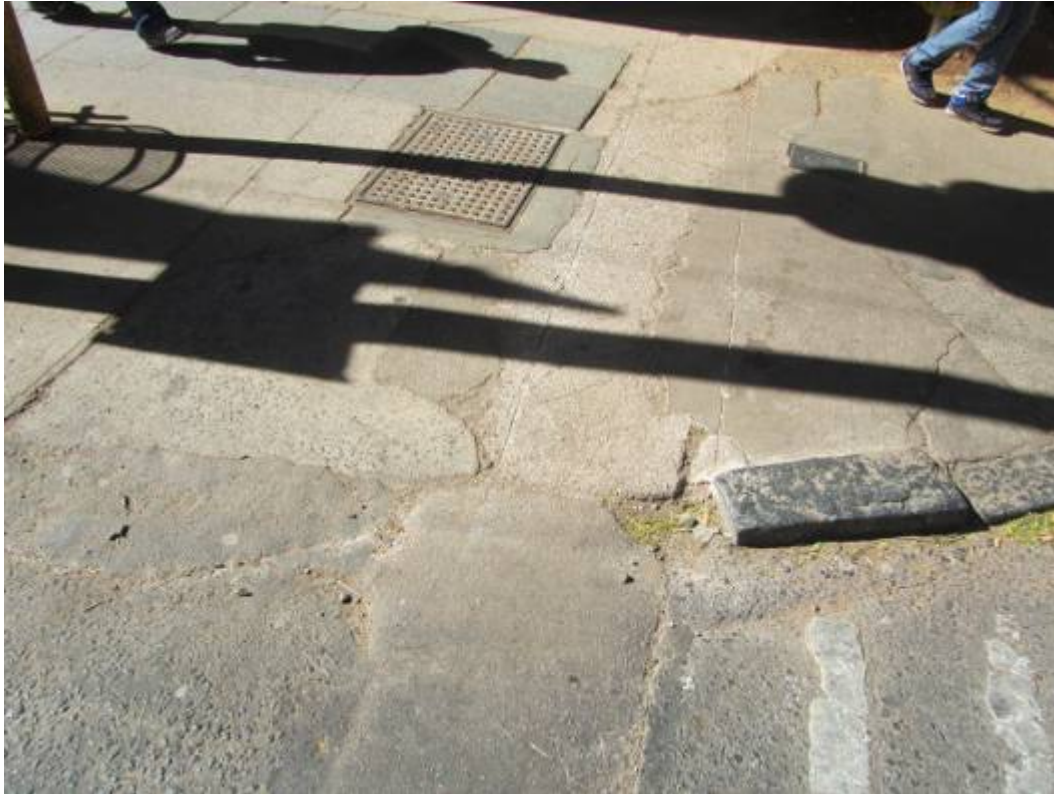
*Figure 307. Paving, services and wheelchair access in combat. (P 1135)*

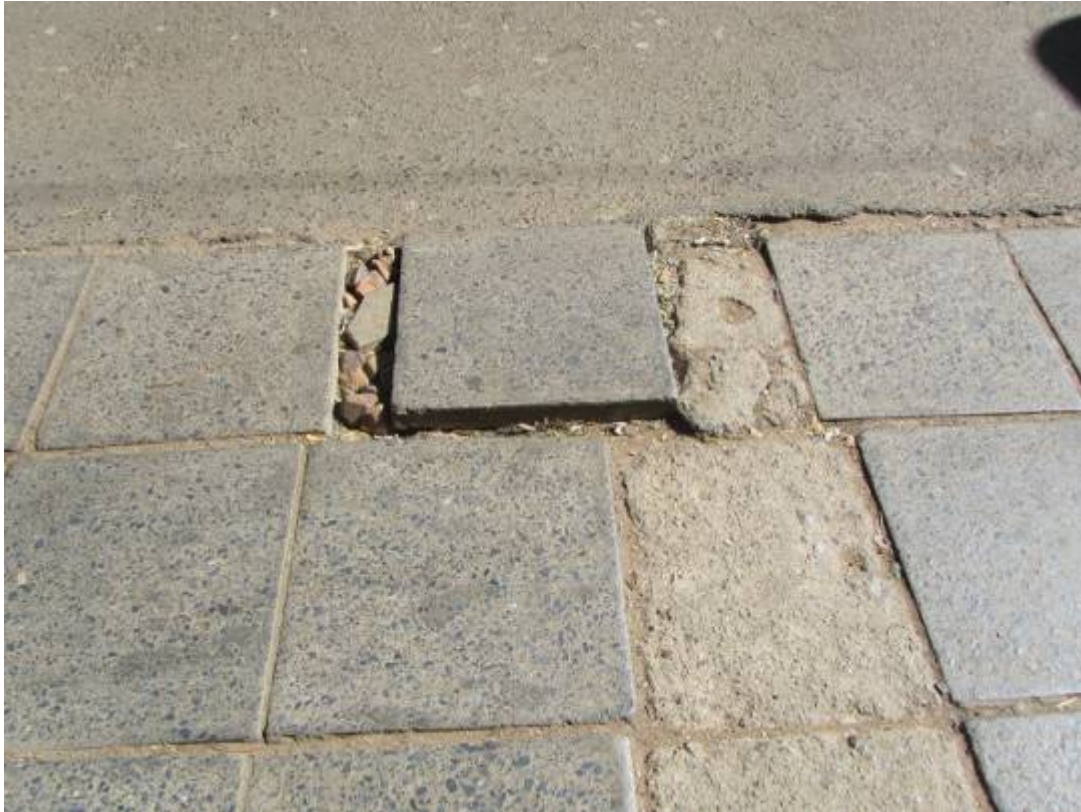
*Figure 309. These cement blacks are attractive but should be placed in a safe manner. (P 1137)*

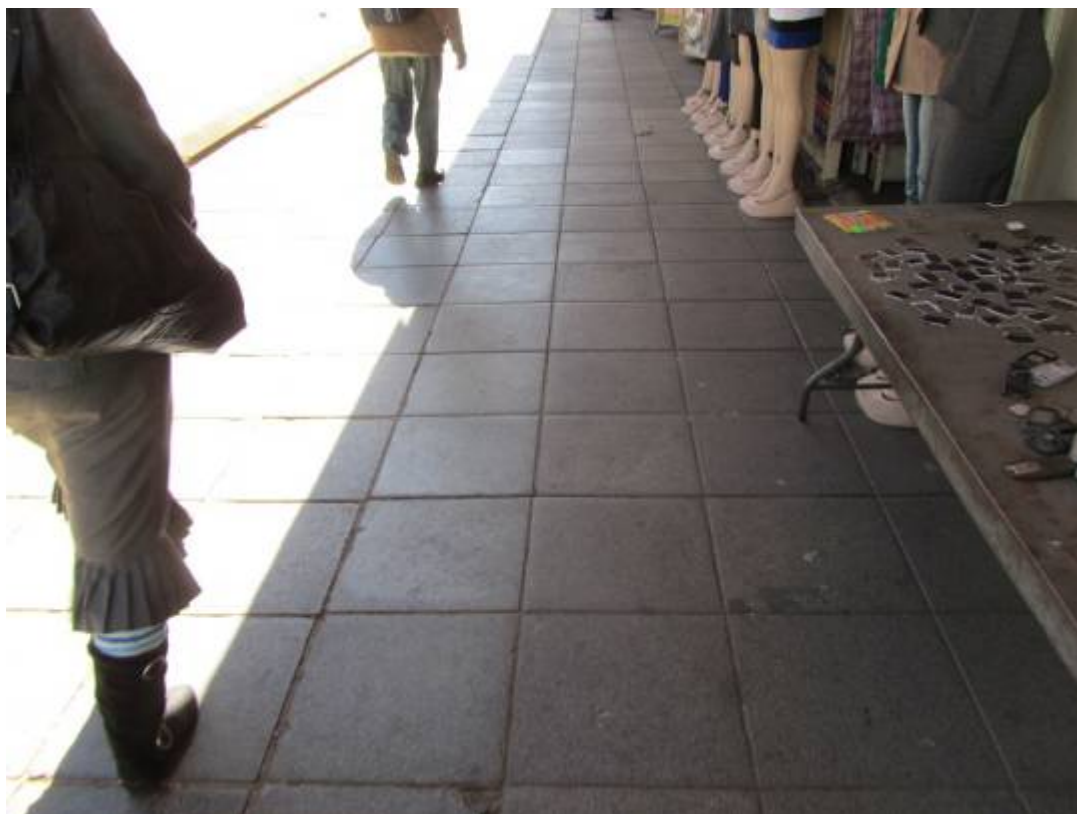
**Figure 311.** *Cement block paving. (P 1139)*

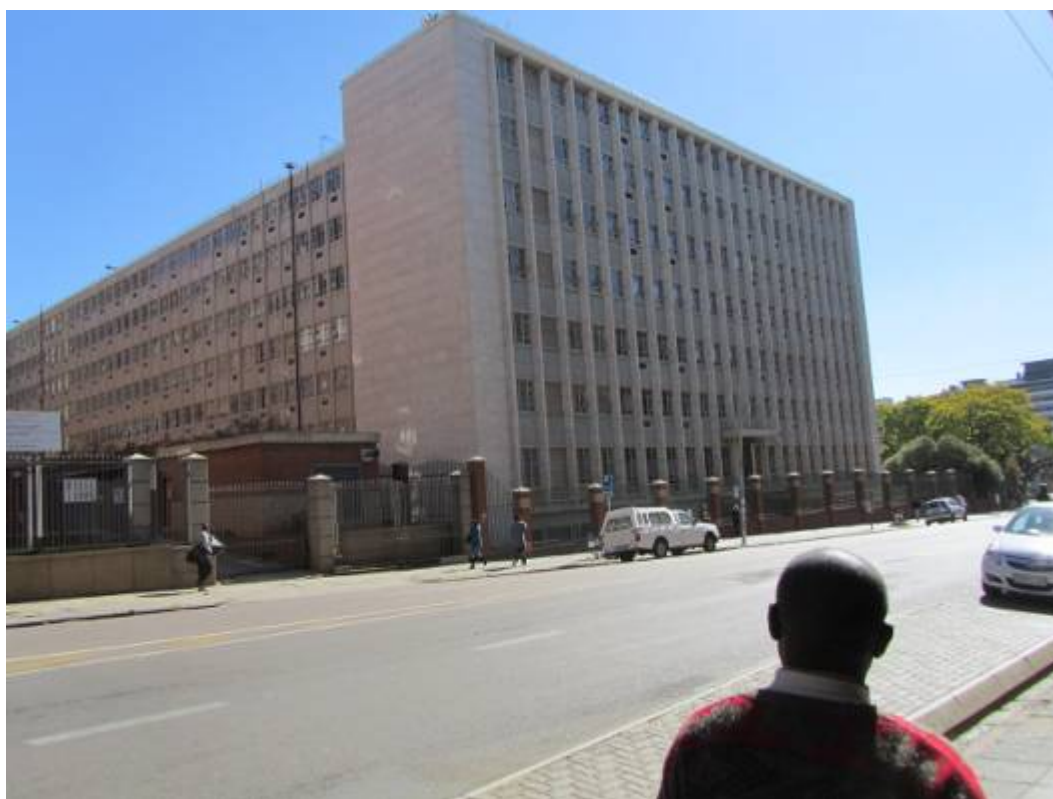
**Figure 312.** *Protected building. (P 1140)*

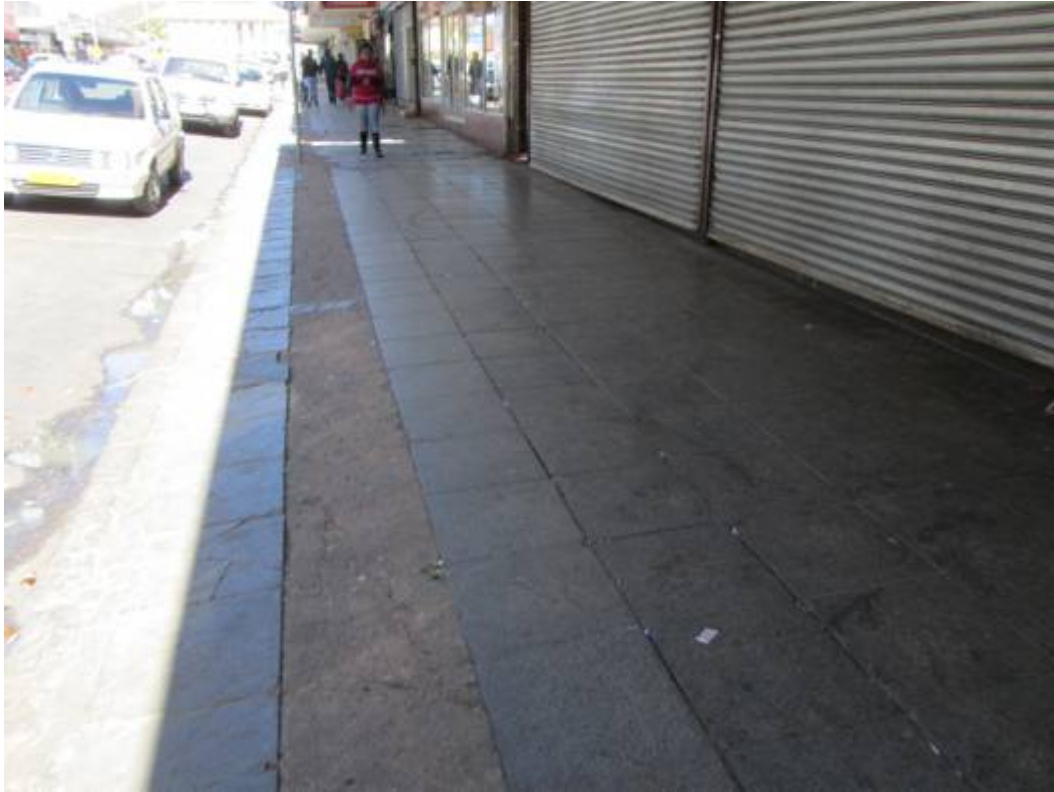
**Figure 323. Cement block paving. (P 1096)**

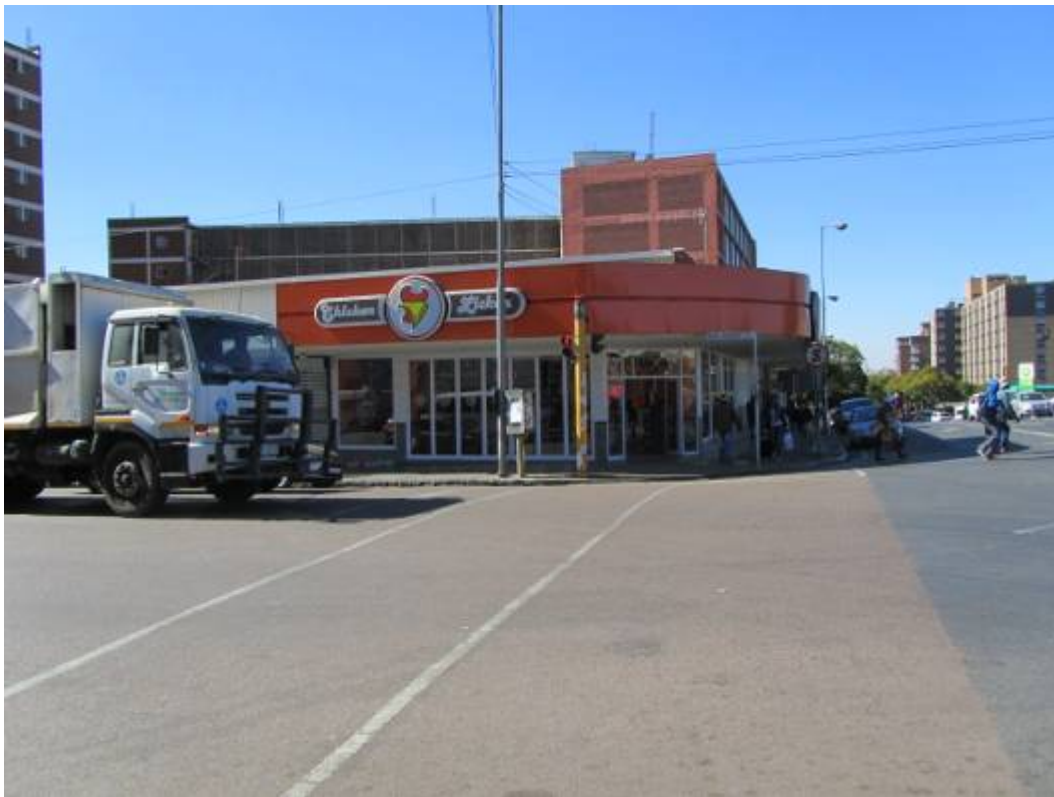
**Figure 330.** Provisionally protected building. (P 1104)

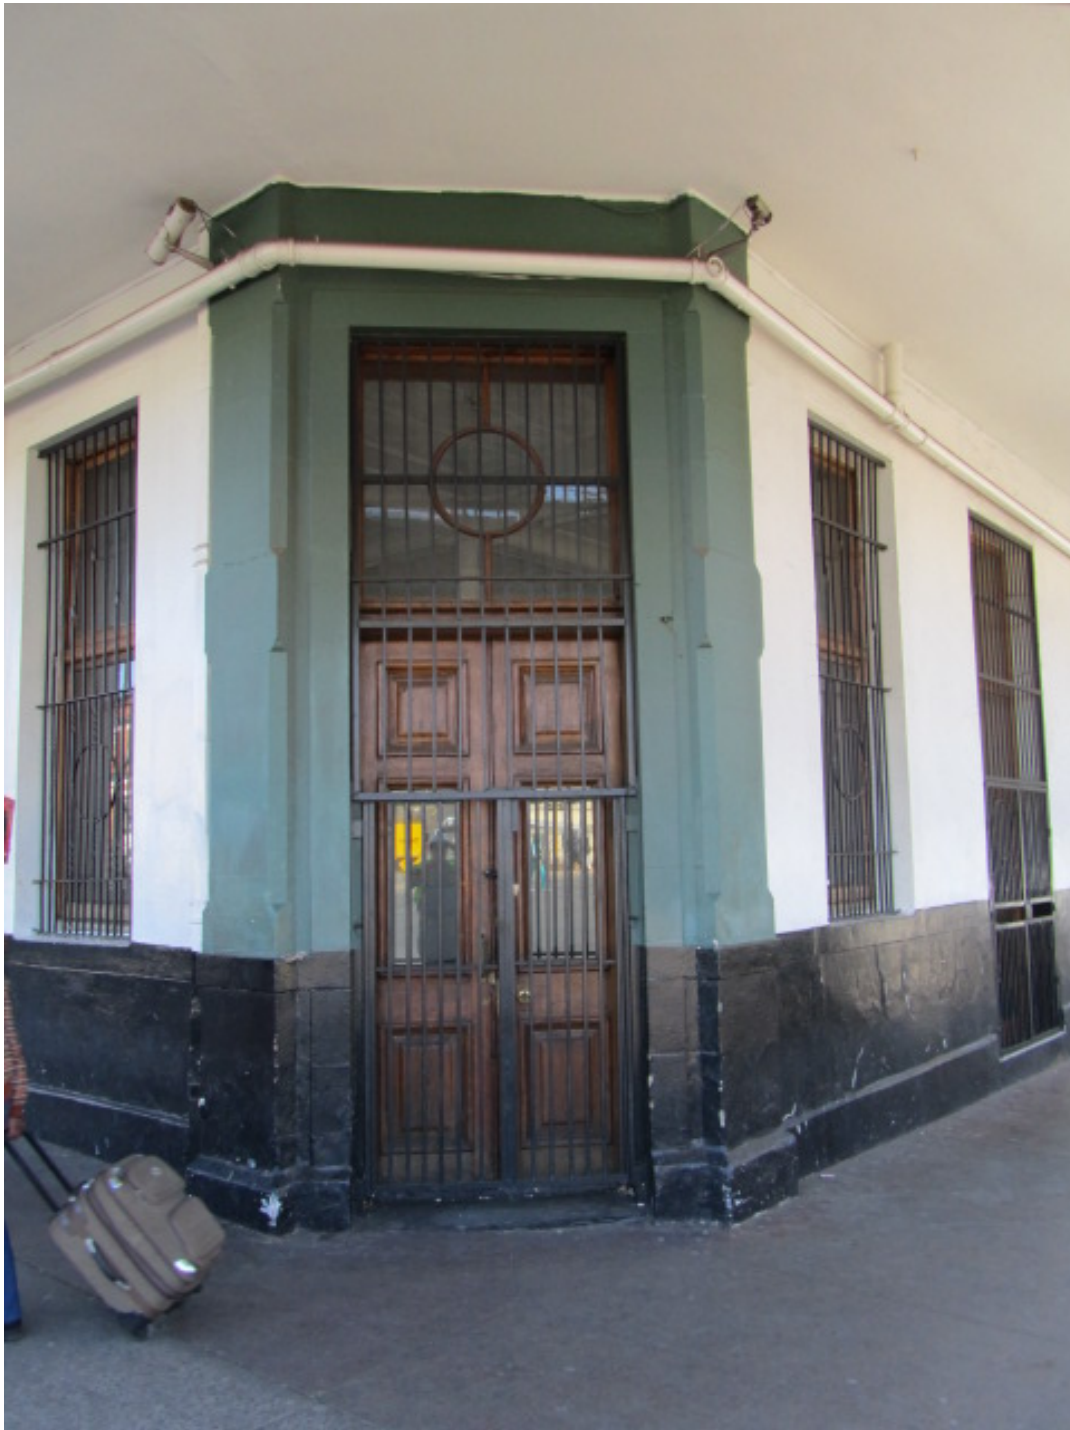
*Figure 331. Protected building. It is worrisome that a large number of historic buildings are not in proper use. Why is this hotel, so ideally located at the station not open for business? (P 1106)*

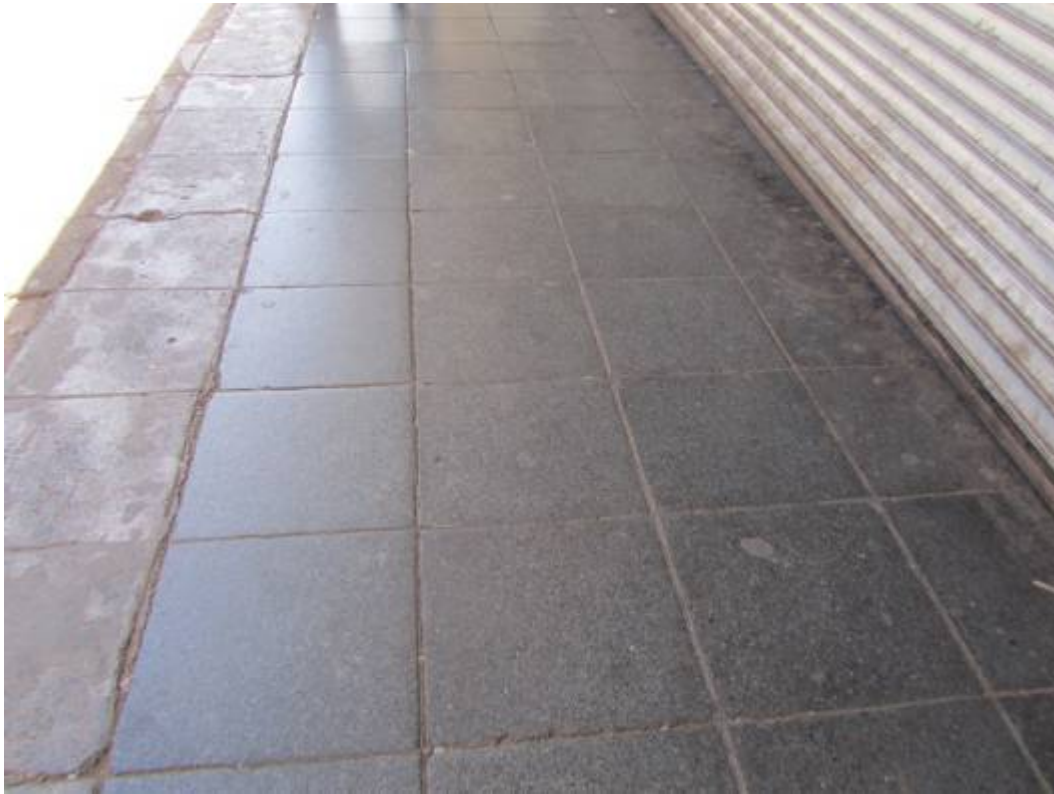
**Figure 334.** *Cement block paving. (P 1109)*

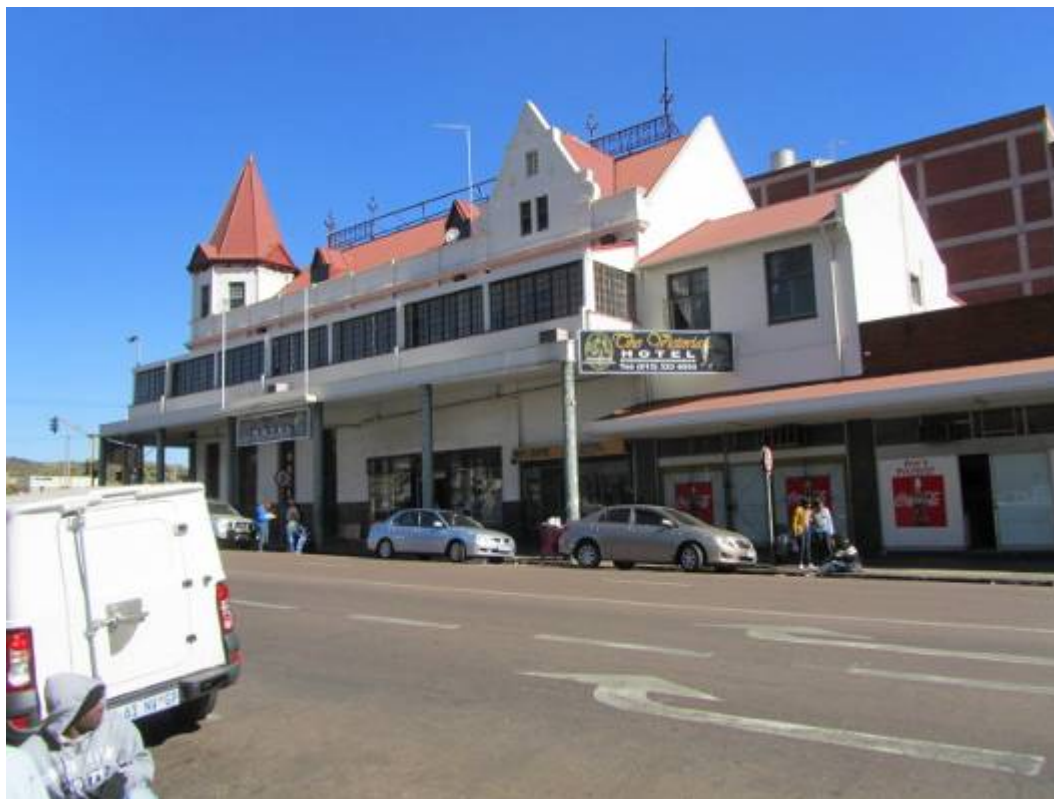
**Figure 335.** *Protected building. (P 1113)*

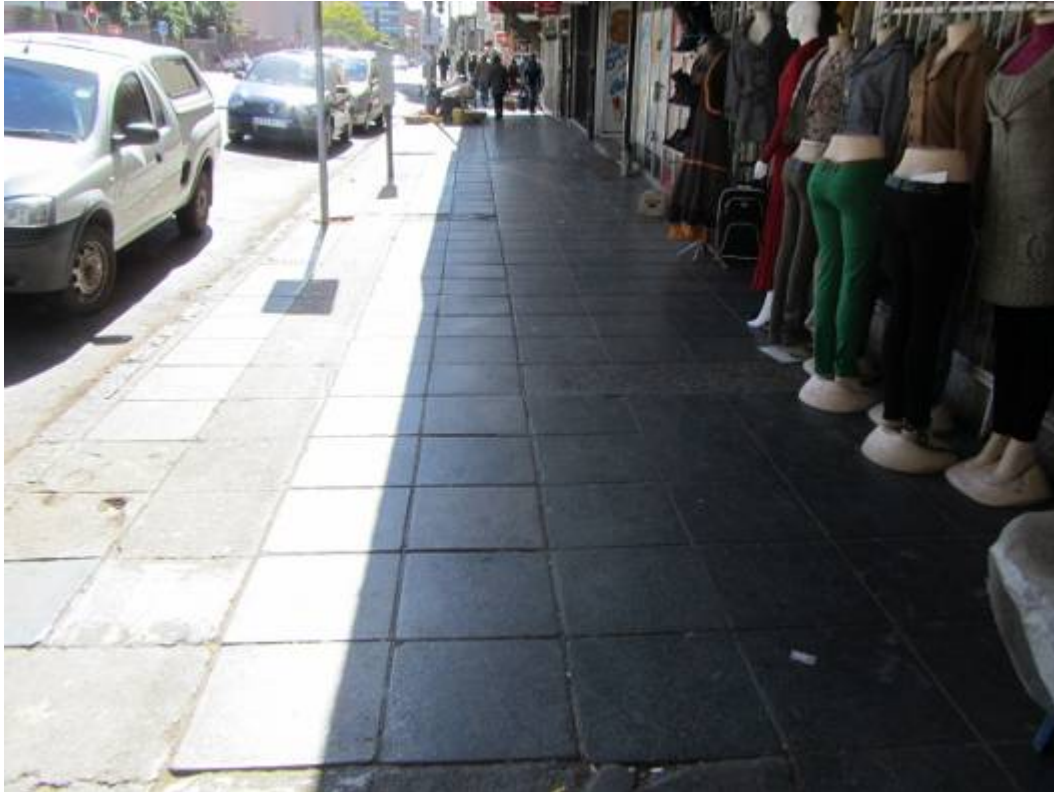
**Figure 340.** *Cement block paving. (P 1116)*
