## **1st Phase**

**Cultural Heritage Resources Impact Assessment for proposed rapid bus service, Paul Kruger Street, Pretoria, Tshwane.**

**June 2011**

**Report compiled by Sidney Miller and Dr. Udo S. Küsel.**

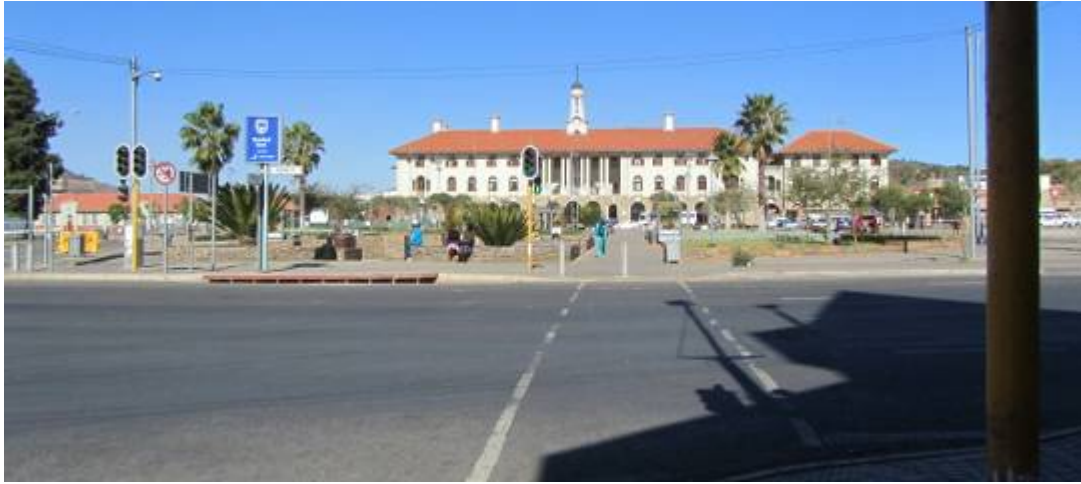
*Figure 344. Protected building. (P 1103)*
