Scoping Archaeological Impact Assessment

**Proposed Lunsklip Wind Farm on Portion 135 of Farm
Melkhoutfontein 480, Portions 2 and 3 of Farm 630, Remainder Farm
630, Remainder Portion 7 of Farm Luins Klip 472, Portion 1 of Farm
635, Portions 2 and 25 of Farm Luins Klip 472 and Farm 626,
Stilbaai, Western Cape Province**

18 July 2012

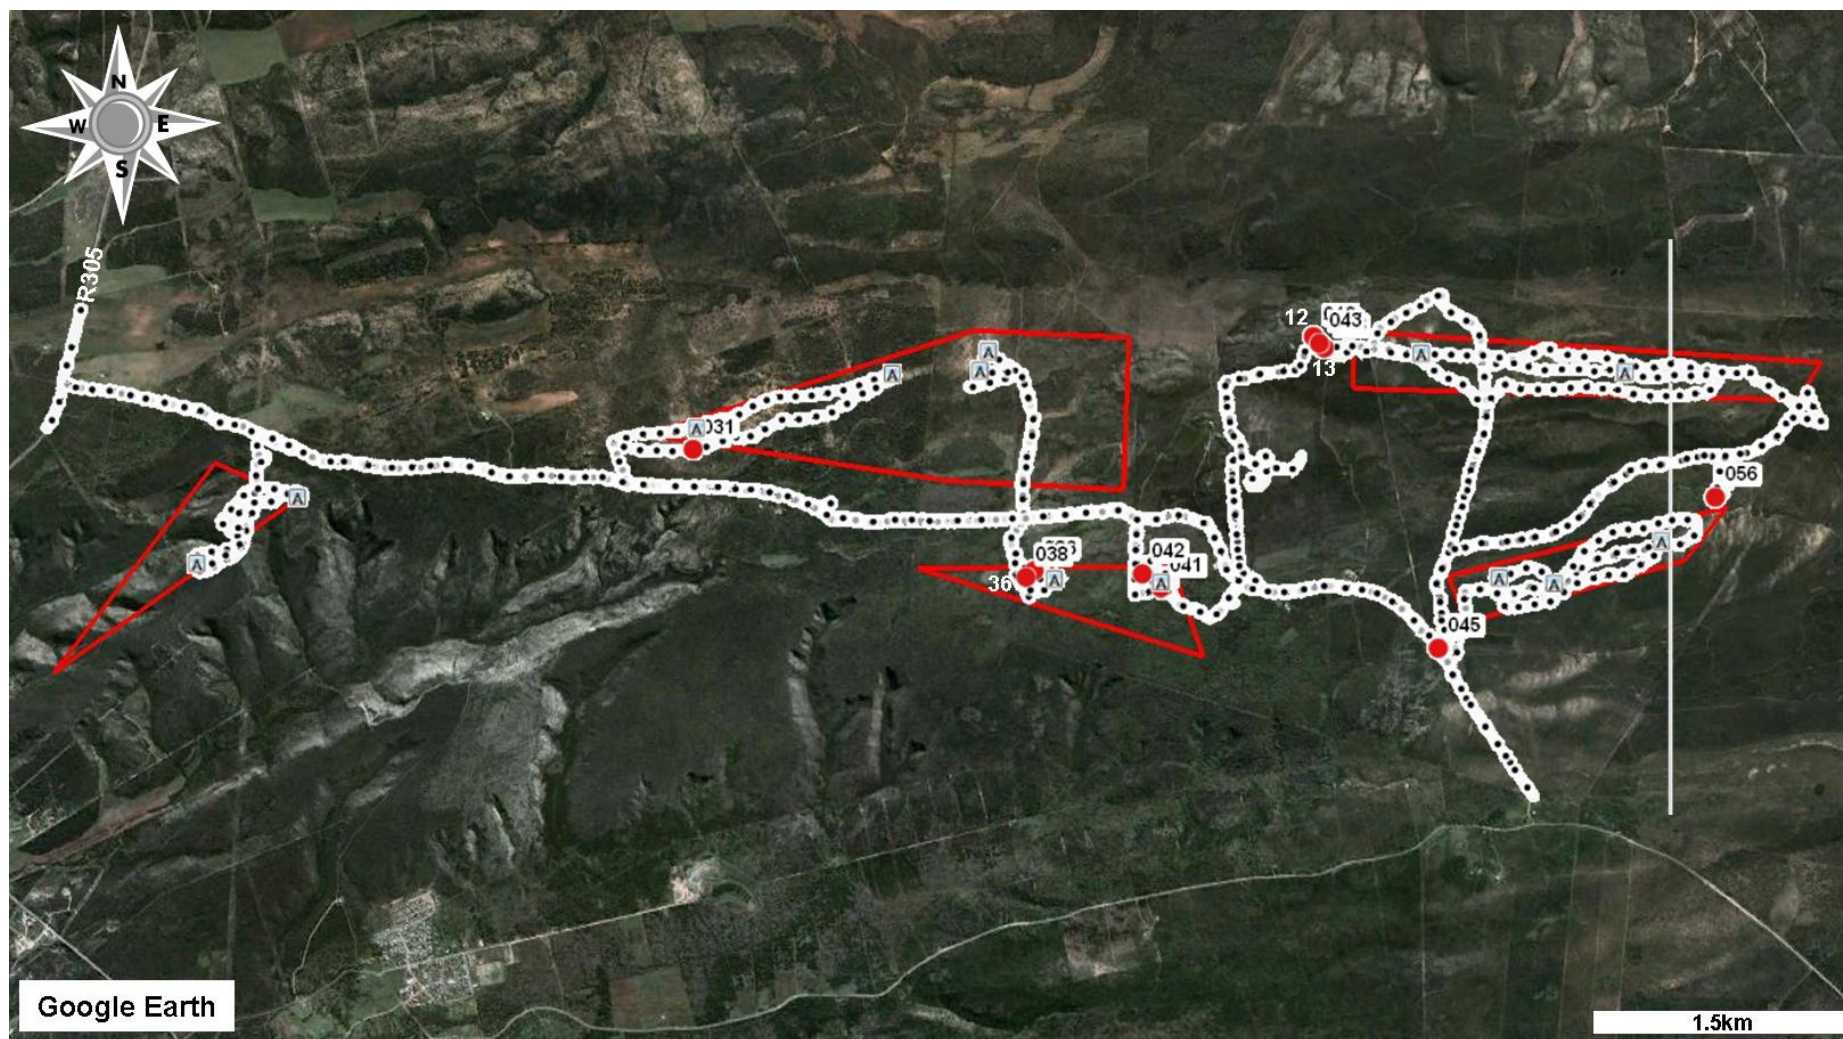
Figure 6. Enlarged area as indicated in Figure 2 showing survey tracks in white, archaeological occurrences (red dots) and wind turbine sites. Coordinate data for photo localities are given in Table 2 (see Plates 5 through 10).

Old, disused water collection structures/features are located at **waypoints 12, 43 and 56** (Figure 6 and Plates 5, 6 & 7). It appears that the circled feature to the west of waypoint 12, as seen on the Google Earth image in Plate 5, is also a water collection structure, but it was not known of or visible during field work. Typically, these features consist of exposed calcrete surfaces that are enclosed with calcrete walling, and according to Mr van Rensburg, the latter serve to keep animals out. Towards the lower lying parts of these walled areas at waypoints 12 and 43 are natural or partly man-made pools that, in places, are lined with plaster (Plate 6). The plaster would render the pools more watertight or seal natural cracks in the calcrete. At waypoint 56, the water collection mode is via a man-made dam (Plate 7). Although still functional, the above features are not currently used or maintained. A restored water collection structure, similar to those described above, is situated at **waypoint 45** where a roofed dam houses collected water (Figure 6 and Plate 8). All these features function in the same way; rain or surface water drains down slope atop the calcrete surfaces and then collects in natural, modified or man-made reservoirs.

The ruins of an old dwelling are located at **waypoint 13** and according to Mr van Rensburg this dwelling was occupied in the early 20th century (Figure 6 and Plates 5 & 9). Associated with this structure are two water collection structures/features to the NE and a garage/store and kraal to the W and WSW respectively (Plates 5 & 9). All the walls of these structures are made of calcrete, and mortar and plaster is clearly not modern (Plate 9). Measured on the outside, the dwelling is about 14m long by some 6m wide and consists of two rooms with separate external doorways. It is evident that the original structure consisted of only one room - with a fire place and chimney at one end – and that the second room was added later on. Remains of a wooden framework for the roof and the absence of other roofing materials suggest that the structure had a roof of thatch reed. *Restia* species are plentiful in the area. Like the second room, the garage/store and kraal seem to be of later construction. No artefacts of the historic period were seen in the area, but these may be covered by vegetation and/or soft surface sediments.
