# NEWCASTLE MUNICIPALITY

**RE: Historical and Architectural Report: St Dominics Curro School St Dominics Street (ERF 392, ERF 1 of 382, R/382, Rem of Erf 1, Erf 15571 ) NEWCASTLE**

1. BUILDING TYPE: Swimming Pool
2. PRESENT USE: Not used at present as it is dilapidated

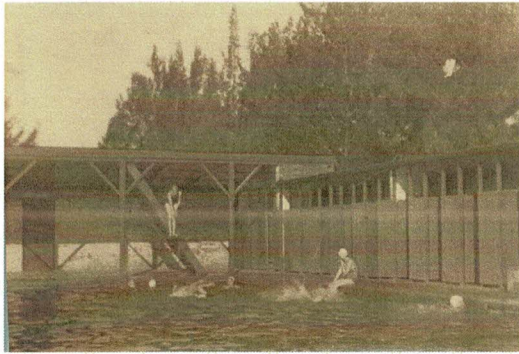
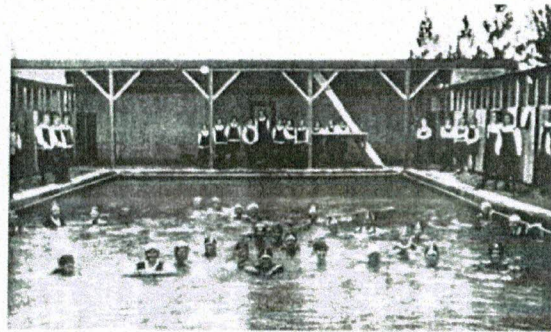
From the oldest photographs the architectural style is not visible from the outside. It however seems as if it was a very simple structure with no special embellishments or facades. On the inside there were changing cubicles with wooden doors on two opposite sides. Another wall with at least two doors are visible. It has a protruding corrugated iron roof supported by wooden pillars and supports. A type of ladder that leads to the roof is also visible on old photographs. Very little space is left between the swimming pool and the surrounding sides.
