SITE INSPECTION AND DOCUMENTATION OF HISTORIC STONE WALLS ON STANDVASTIGHEID 210/REM FOR THE PROPOSED KARUSA WIND ENERGY FACILITY, SUTHERLAND MAGISTERIAL DISTRICT, WESTERN CAPE

Required as pre-construction mitigation by SAHRA.

SAHRA Case ID: 218

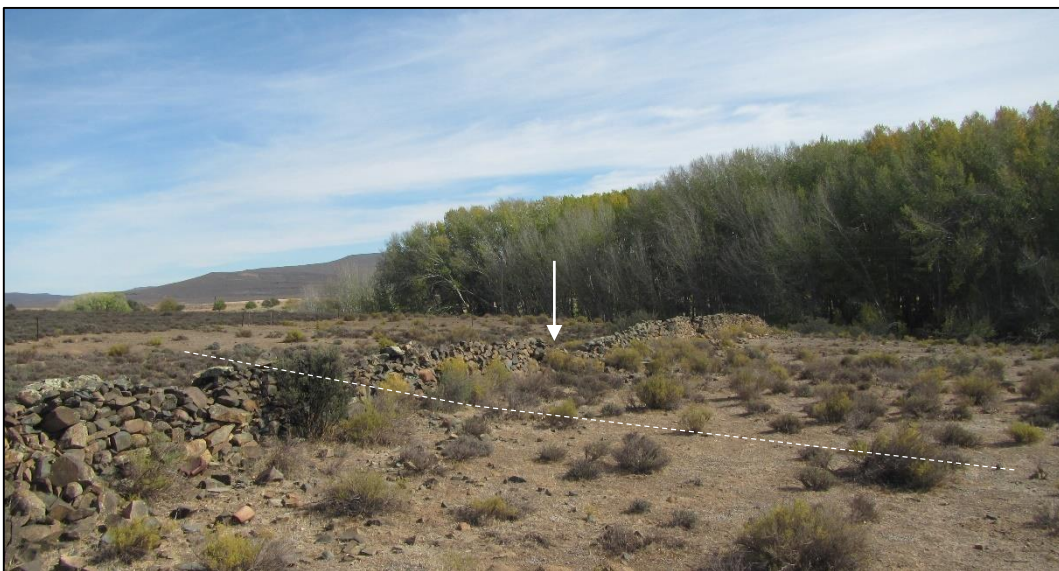
Figure 6: Looking towards the west along the new road alignment (white dashed line) where it would cross the historic stone walling at KSW2. The alternative alignment that is to be implemented crosses the walling at the arrow.

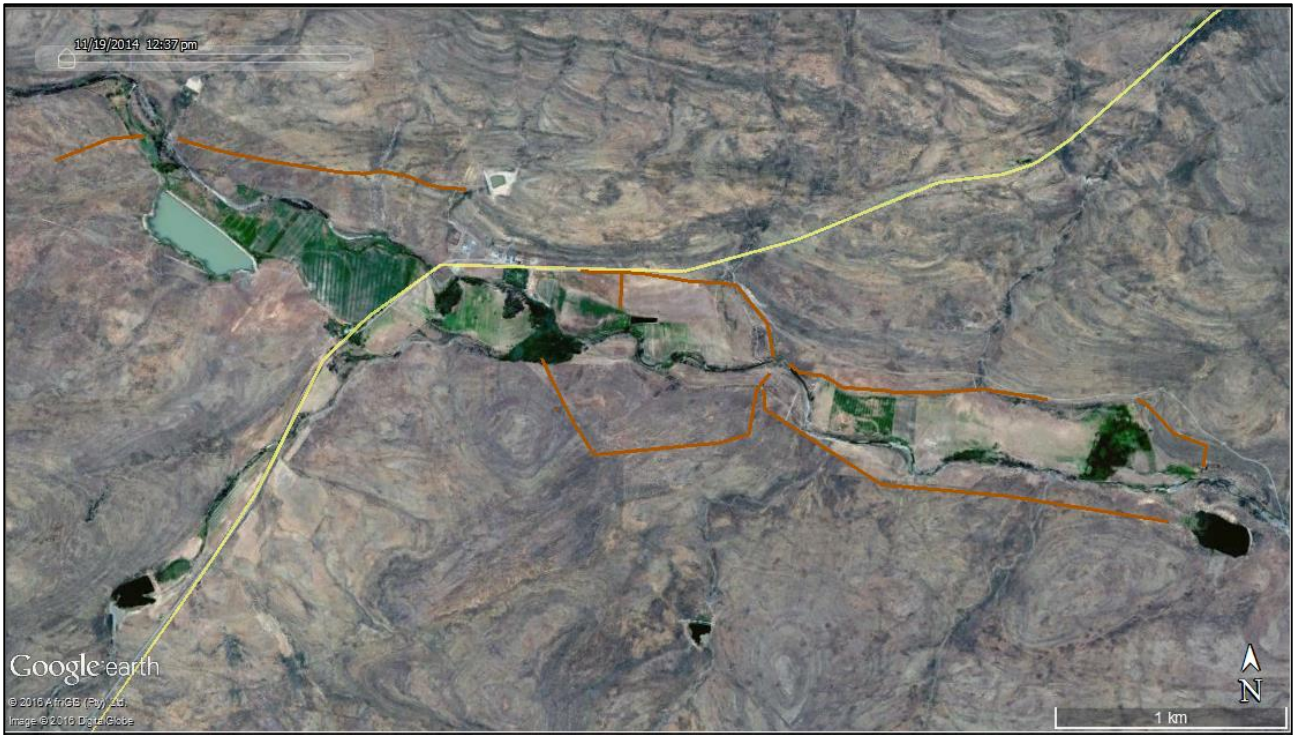
The walling is, in general, very poorly preserved with the full height only evident in a few areas. The farmer noted on site that over the years stones had been stripped from the wall along the road nearest the house for use elsewhere on the farm. This section was within the road reserve and was no doubt targeted because of the ease of access. It seems likely that rocks have been taken from many other parts of the wall as well with the capping slabs being most frequently targeted.

Figure 10: Aerial view of the broader study area showing the positions of all stone walling either seen on the ground or identified from aerial photography. Note that the nature and preservation states of the walling vary greatly throughout the area and this map does not differentiate these conditions.

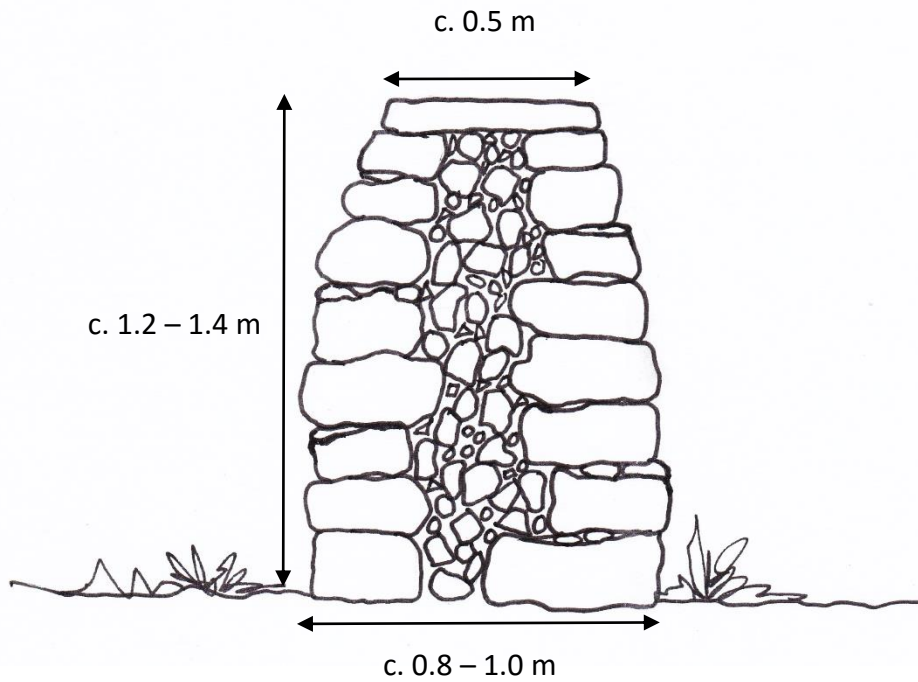
The nature of dry-packed stone walling and the stones of which it is made are such that it will never be exactly the same dimensions throughout. Figure 11 shows a schematic cross-section as would be seen through intact sections of walling. The lower half of the walling has vertical sides and is variably about 0.8 m to 1.0 m wide (although the base was difficult to measure accurately). Near the top it tapers gently to be approximately 0.5 m wide. The full height varies between 1.2 m and 1.4 m.

Figure 11: Schematic cross-section through the Standvastigheid stone walls showing an undamaged section.

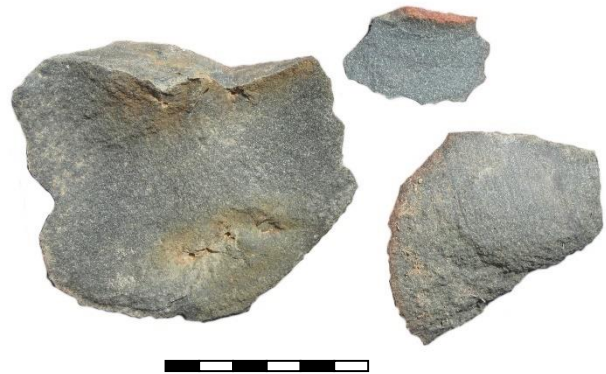
Figure 15: Three stone dressing flakes found alongside the wall (waypoint 079). Scale in cm.

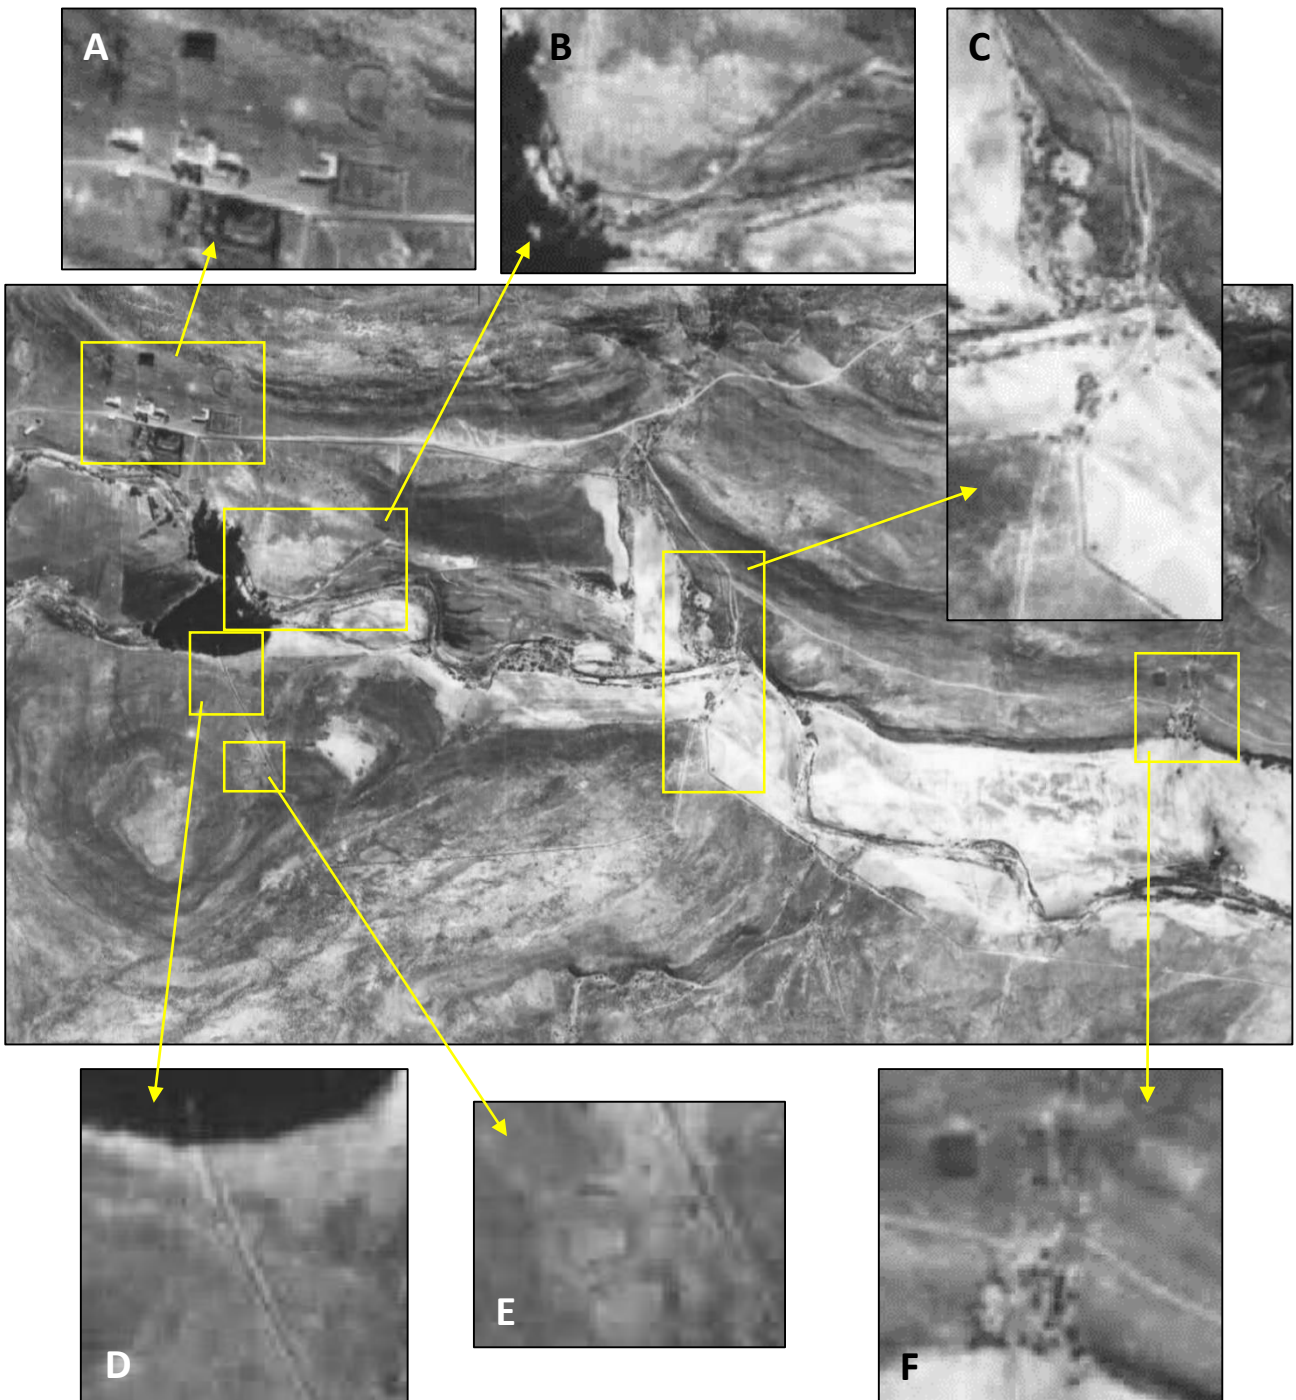
Unfortunately the wall has been badly damaged in a number of places and for a number of reasons. This damage has no doubt been effected over many years. Although it is not possible to tell when individual rocks ,may have been removed from the walls, the earliest significant damage is likely to have been during the 20th century and appears to post-date 1939 at which point historical aerial photography (Job 139A) shows the walling to be intact in the area examined (Figure 18B, C, D). Sections of walling were broken down when the wire wire fences were erected (e.g. waypoints 068 & 080), probably when the farm became more focused on sheep farming than on the breeding of horses. Other damage has resulted where sections of walling have been completely removed from the alluvial terraces close to the river (e.g. SW of waypoint 064 and NE of 091. This is presumably once they had become obsolete and it was more desirable to not waste any arable land. In one place (waypoints 092 to 093) there was a 54 m long, low mound of rocks at the edge of the lands and this obviously represents wall rocks that have been moved to the side to make way for agriculture. The next series of aerial photography dates to 1963 (Job 491) but unfortunately, due to the scale and the positioning of the flight paths, the photographs are not overly helpful. The only section of walling clearly visible is the SW-NE wall crossing the alluvial terrace on the north side of the river (just south of KSW3) which, at that time, was clearly still intact. The visibility is due to the stone wall contrasting with the ploughed soil.

Figure 18: 1939 aerial photography (Job 139A, strip 018, frame 25375) showing a number of features of the farm and its stone walling. A: The farm complex with the round kraal visible and the rectangular one appearing to be a different shape to today. B: Alluvial terrace over which the new road will run and showing the SW-NE trending stone wall to still be intact. C: Area where the stone walls run down to the river in order to facilitate a crossing point. D: Section of walling where today a chunk has been demolished to allow a fence to pass through. E: Stone feature just outside wall. F: Stone feature just north of access road which appears to be a different shape to today.

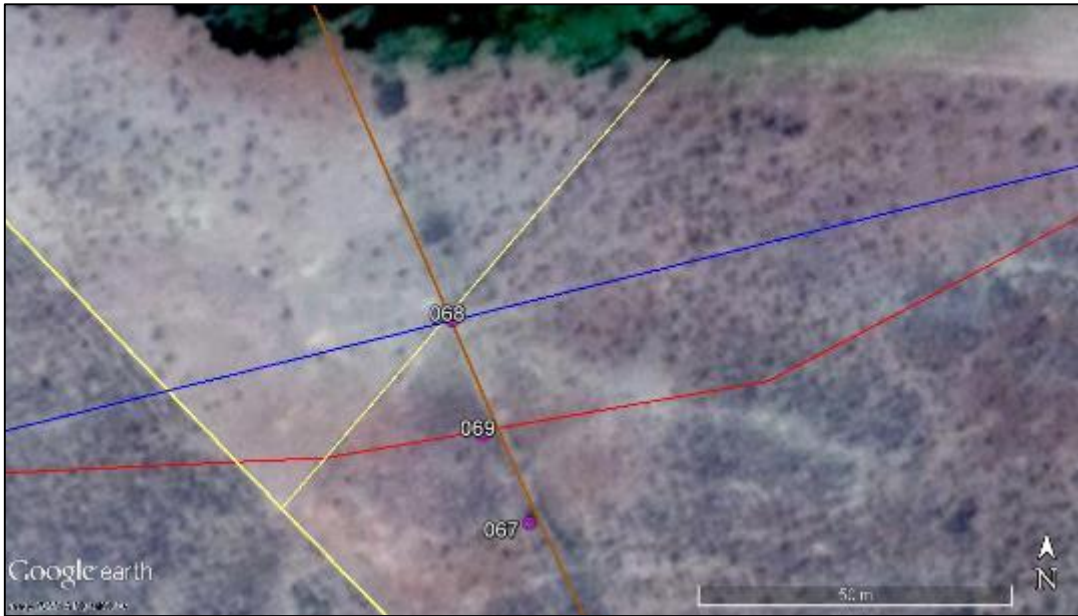
This is the western section of walling that needs to be crossed by the new road and is located at waypoint 069 (Figure 19). This section was partly standing and partly tumbled (Figure 20). The capping stones were all absent. The partly tumbled sections were reduced to about 0.5 m to 0.6 m high but with jumbled rocks on both sides, while the better-preserved parts of the wall here were

about 1.0 m high. The standing sections, although incomplete, showed no difference in construction methods from the generic example provided in Figure 11 above.

Figure 19: Aerial view of the vicinity of KSW2 showing the stone wall alignment (brown), the fence lines (yellow), the proposed road alignment (red) and the newly proposed alternative alignment (blue).

Some 15 m to the north of this point was where the wall is completely broken down to allow the wire fence line to cross (waypoint 068; Figure 21). As a result of this survey a recommendation was made to move the road alignment 15 m to the north to take advantage of this area where the wall was already completely demolished. This alternative is shown in Figure 19 and has now been instated as the preferred alternative and will be the routing for construction.

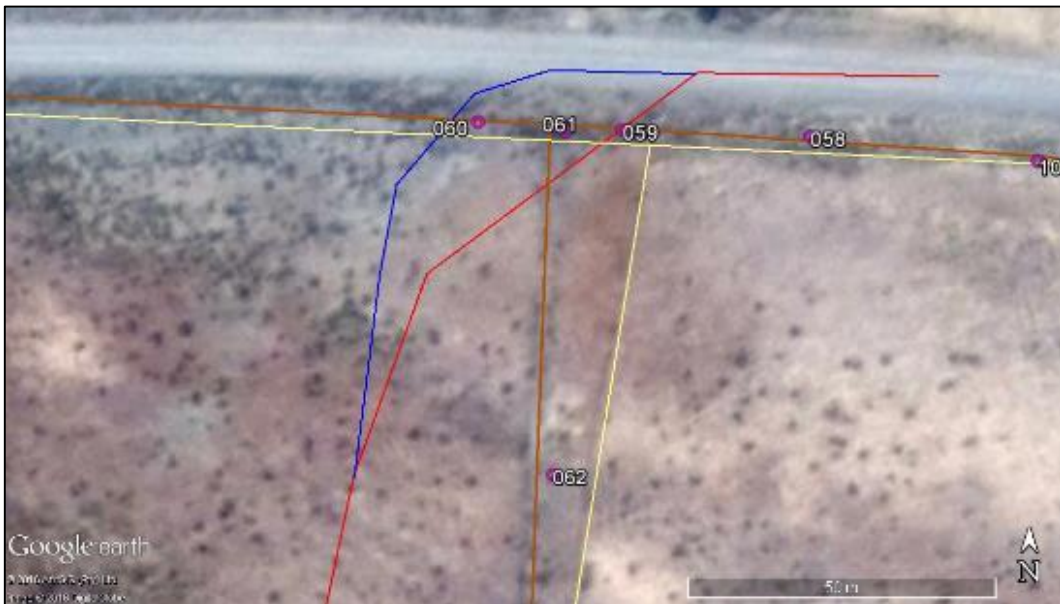
This section of wall lies alongside the main public access road to the north of the river and is located at the north-eastern end of the proposed new road alignment. It is almost completely broken down to ground level. There are actually two walls intersecting at this point (at waypoint 061) and the road alignment crosses through both of them, running just to the southeast of the meeting point (Figure 22). The east-west wall lies within the road reserve and it is this section that has been virtually entirely demolished and removed as noted previously (Figures 23 & 24).

Figure 22: Aerial view of the vicinity of KSW3 showing the stone wall alignments (brown), the fence lines (yellow), the proposed road alignment (red) and the newly proposed alternative alignment (blue).

The section of walling running at 90 degrees to the road is somewhat better preserved but is still largely destroyed (Figures 25 & 26). It varies between about 0.2 m and 0.4 m high with many tumbled rocks lying alongside it. The two walls in this area are far too poorly preserved to be able to establish their original height, but one can still see that the width conforms to that observed elsewhere and the two skins and a rubble fill were still evident. There is no reason to suspect that these walls were built any differently to the schematic diagram in Figure 11 above.

Because of the T-junction in the walling which preserves structural information concerning the layout of the walls, it was suggested that the bend of the new road could be moved some 15 m towards the northwest in order to bypass this junction. This alternative alignment is shown in Figure 22. It is now considered the preferred alignment and will be implemented during construction.

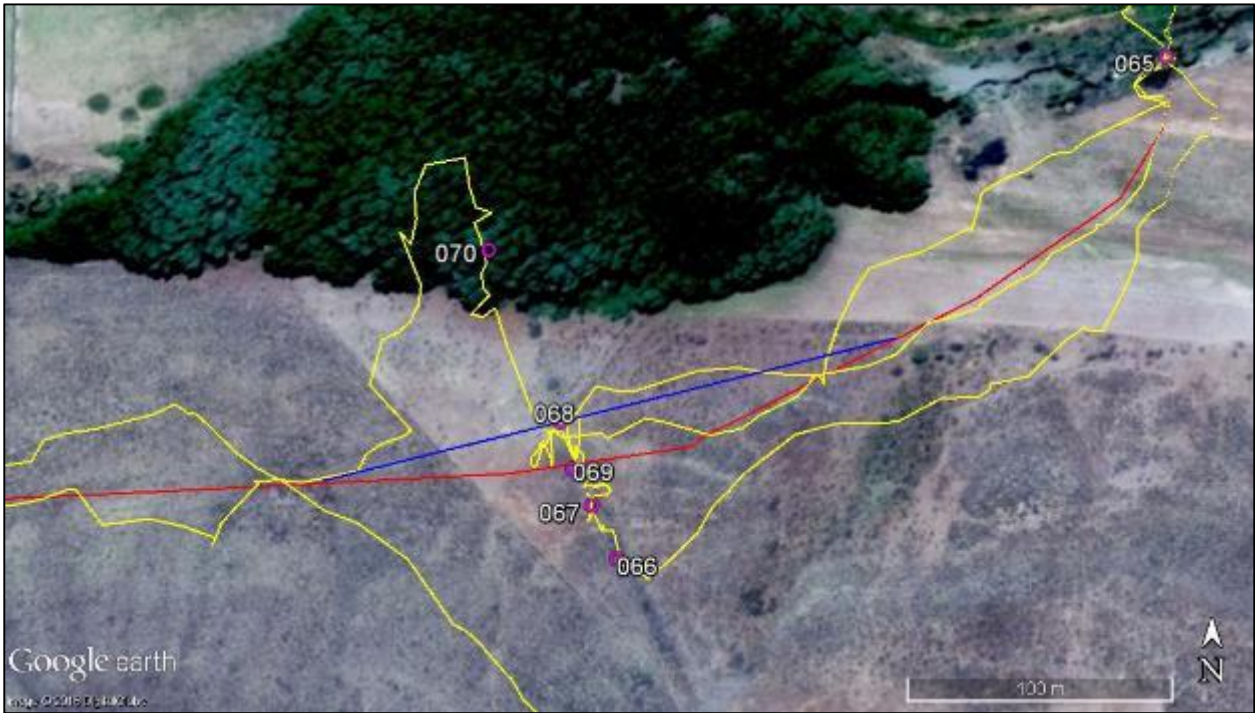
Figure A3.3: Aerial view of the vicinity of KSW2 showing the originally proposed new road alignment in red and the newly proposed alternative in blue.

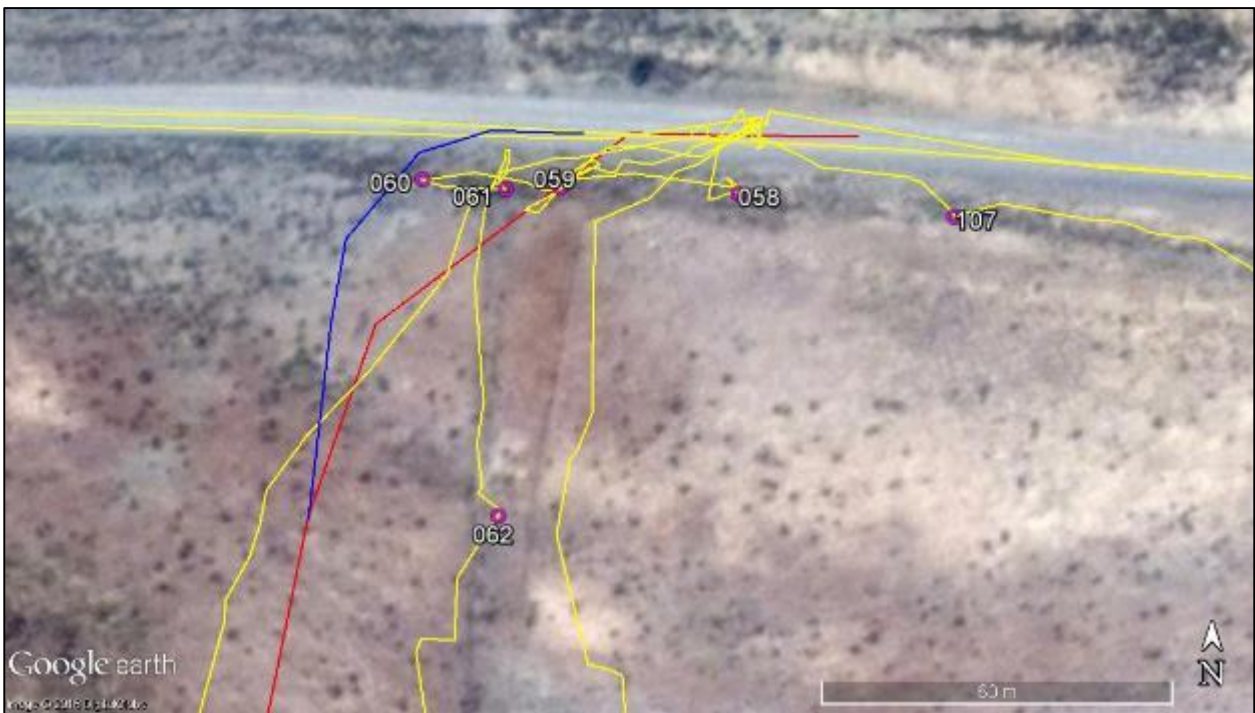
Figure A3.4: Aerial view of the vicinity of KSW3 showing the originally proposed new road alignment in red and the newly proposed alternative in blue.

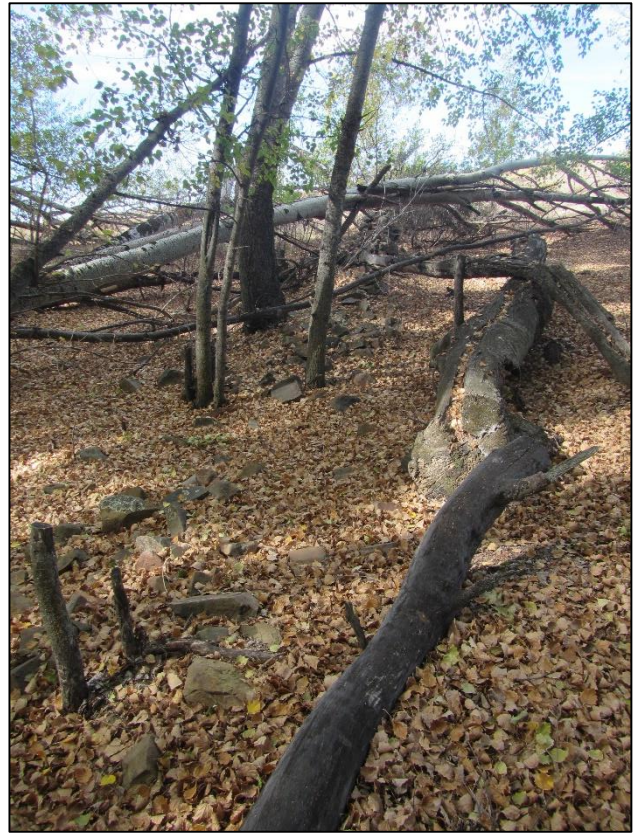
View towards the south of the northern-most wall stones visible in the poplar grove at waypoint 070.

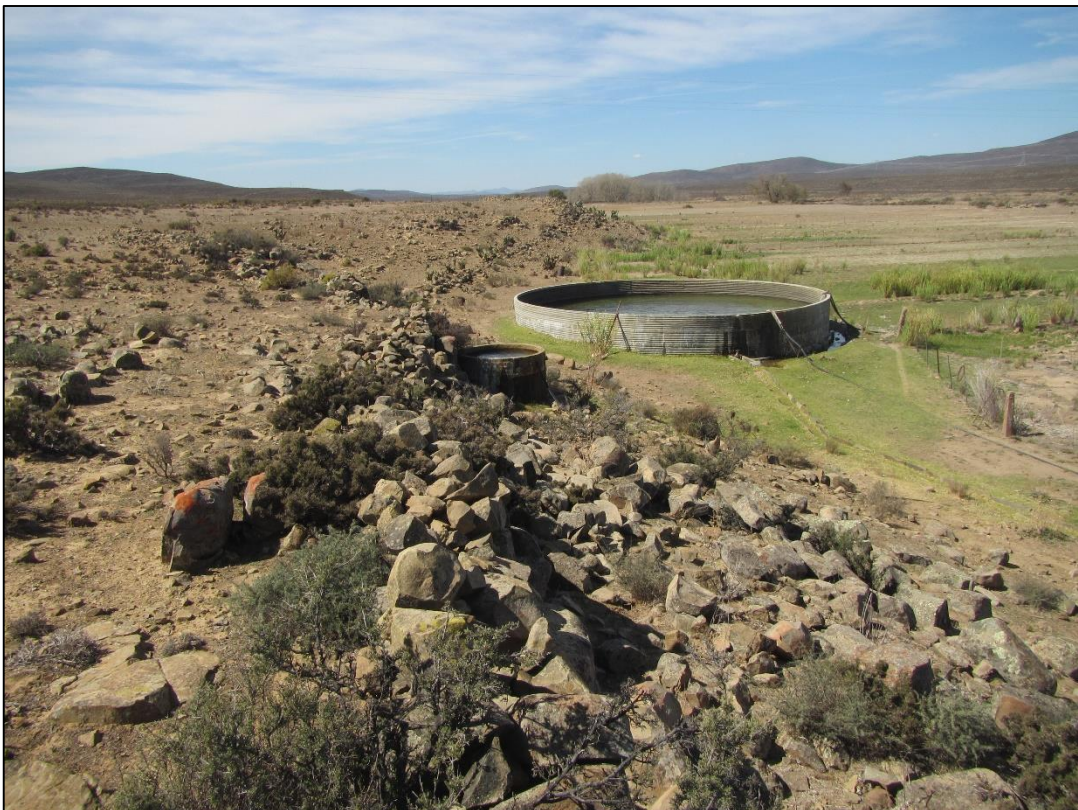
View towards the east along the edge of the river floodplain at waypoint 098 showing the light stone walling running along the top of the low cliff line.

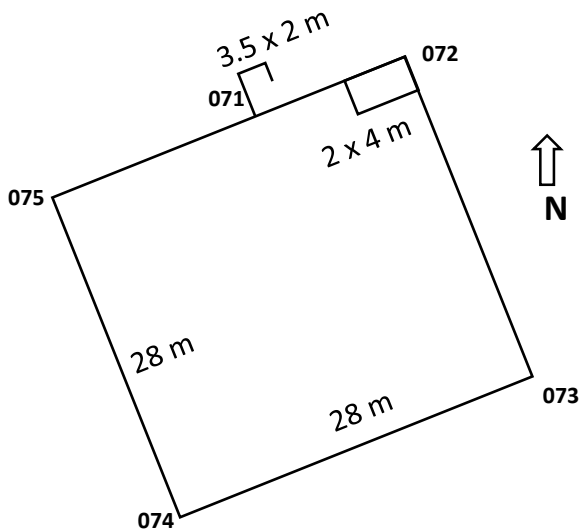
Some 150 m to the south of KSW2 there was a dry-packed stone structure that is assumed to be a kraal (Figures A5.1 & A5.2). It was located about 30 m to the west of the main stone wall and was approximately square measuring some 28 m in each direction. Inside the northern corner was a small 'room', while outside the north-western wall was an 'alcove'.

Figure A5.1: Schematic plan view of the stone feature found at waypoints 071 to 075.

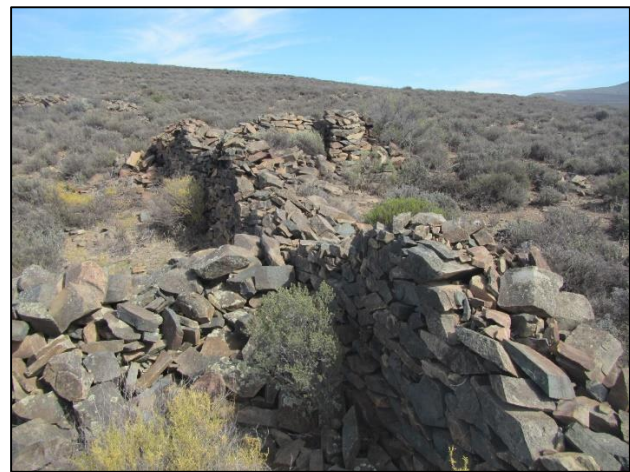
Figure A5.2: View towards the west along the north-western wall with the small 'room' in the foreground and the 'alcove' in the background.

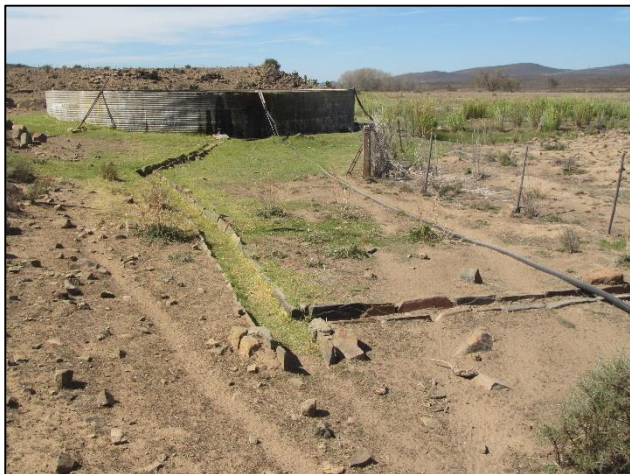
At waypoint 097 there are some cement dams (one broken down) and a wind pump. On the ground were noted some stone-lined furrows. The cement dams are obviously far younger than the stone walling on the farm and it may well be that the furrows, which are related to the dams, are made from capping slabs removed from the walling in the past (Figure A5.3).

Figure A5.3: The cement dam and stone-lined water furrows at waypoint 097.

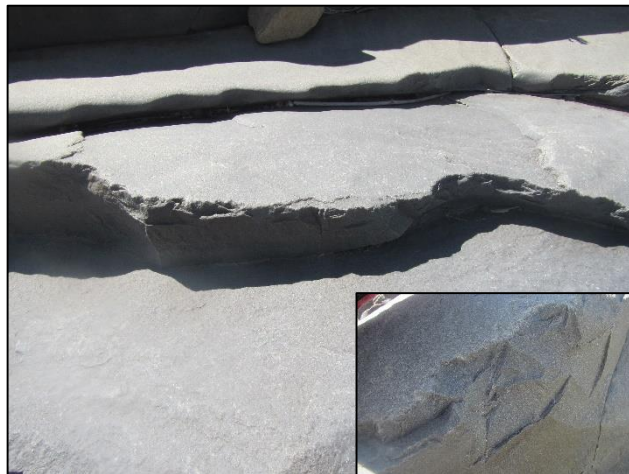
make a pool in the stream, while there is evidence of 'ledge-flaking' in the river where precolonial people sourced rock for stone artefacts (waypoint 115). This flaking was not caused by rocks bouncing down the river because the flaking is concentrated in certain places only with other proximate 'ledges' completely unflaked (Figure A5.4). Further evidence of precolonial people in the valley occurs in the form of a bored stone (digging stick weight) recovered from the arable lands in the past and now kept at the farm house.

Figure A5.4: The flaked rock ledges in the river at waypoint 115.

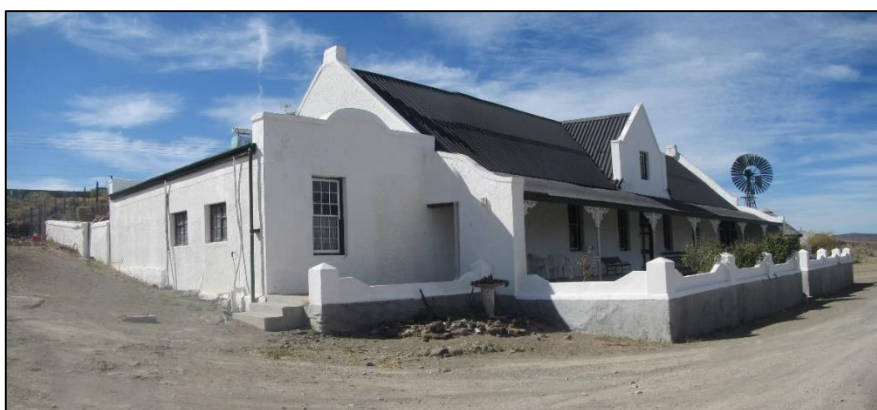
The main farm complex has a number of significant heritage resources associated with it and its presence serves as excellent motivation for the rerouting of the access road. The two most important are the main farm house and the graveyard. The house is built immediately alongside the main gravel road through the area (Figure A5.5). It is because of this proximity that the new road alignment has been proposed. The house is a well restored Karoostyle building with elements of Cape Dutch architecture and that has high cultural significance. Although it is not listed by Fransen (2004), the same gable style is evident on another historic house from near Loxton in the Karoo region. A number of other buildings, all predating 1939 (see Figure 18A) are present around the house, including two intact stone kraals and a ruined one.

Figure A5.5: View of the main farm house looking towards the northeast. The road to the right is the main public road through the farm.

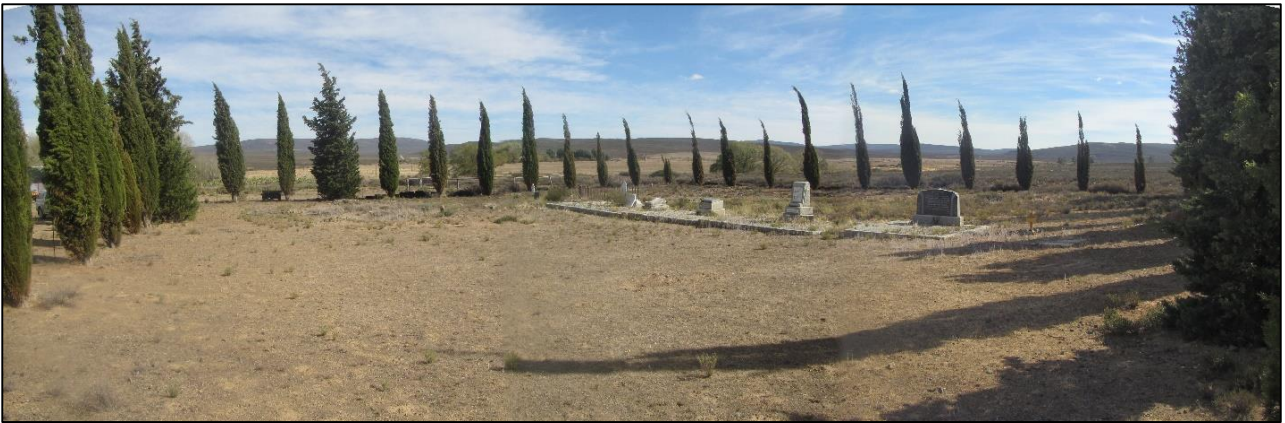
The graveyard was briefly described by Booth (2012) but further details are noted here for the record. The graveyard is a large, fenced area of some 90 m by 95 m surrounded by poplar trees (Figure A5.6). Although there is still much open space, there are approximately 106 graves present. The oldest graves are those of three Conradie children, all of whom died before their second birthday. These date to 1867, 1867 and 1869. The graveyard obviously started out as a farm graveyard but in 1923 it was surveyed and separated from the remainder of the farm to become Portion 1 (SG Diagram 750/23). This presumably indicated an intention that it should serve a wider area and might explain its great size. The majority of named graves are Conradie (10 graves, 1867-2014), but Smith (1880, 1884 & 1895), Du Plessis (1901), Visagie (1925) and Muller (1927 & 1931) are also represented. The vast majority of the graves are unmarked and must represent farm labourers. Most have stones packed over them with one serving as a headstone.

Figure A5.6: *View of the Standvastigheid graveyard.*
